Construction Noise and Vibration Monthly Report – May 2022

London Borough of Camden

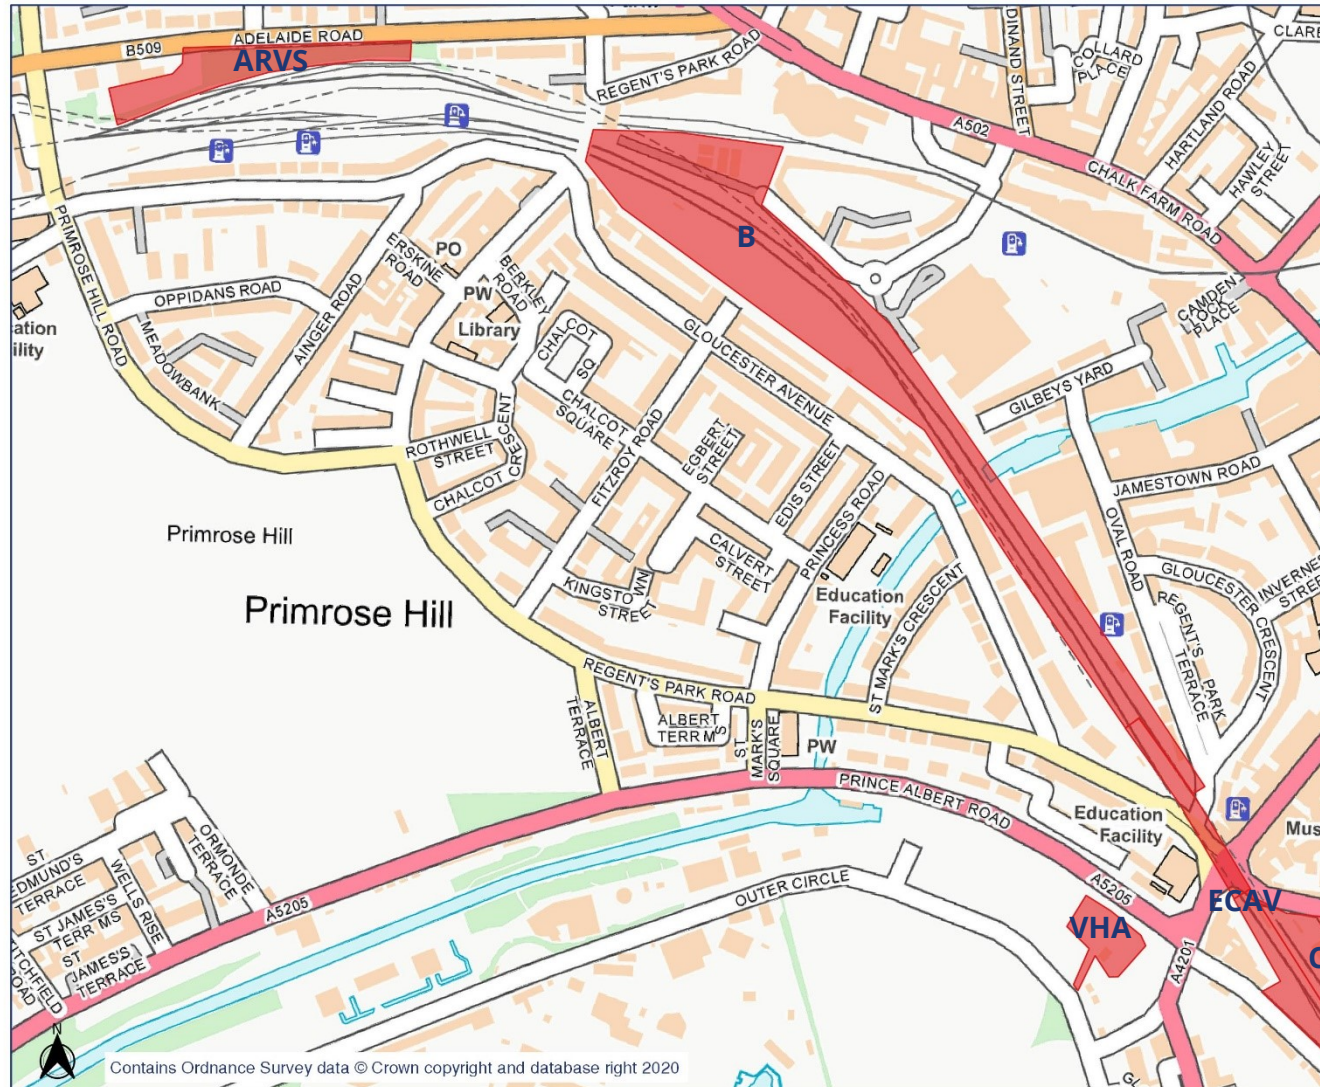
Worksite identification plan - 1

- Vehicle Holding Area worksite ref.: VHA (see plan 1 in Appendix A), where work activities included:
 - general compound operation (vehicle movements).

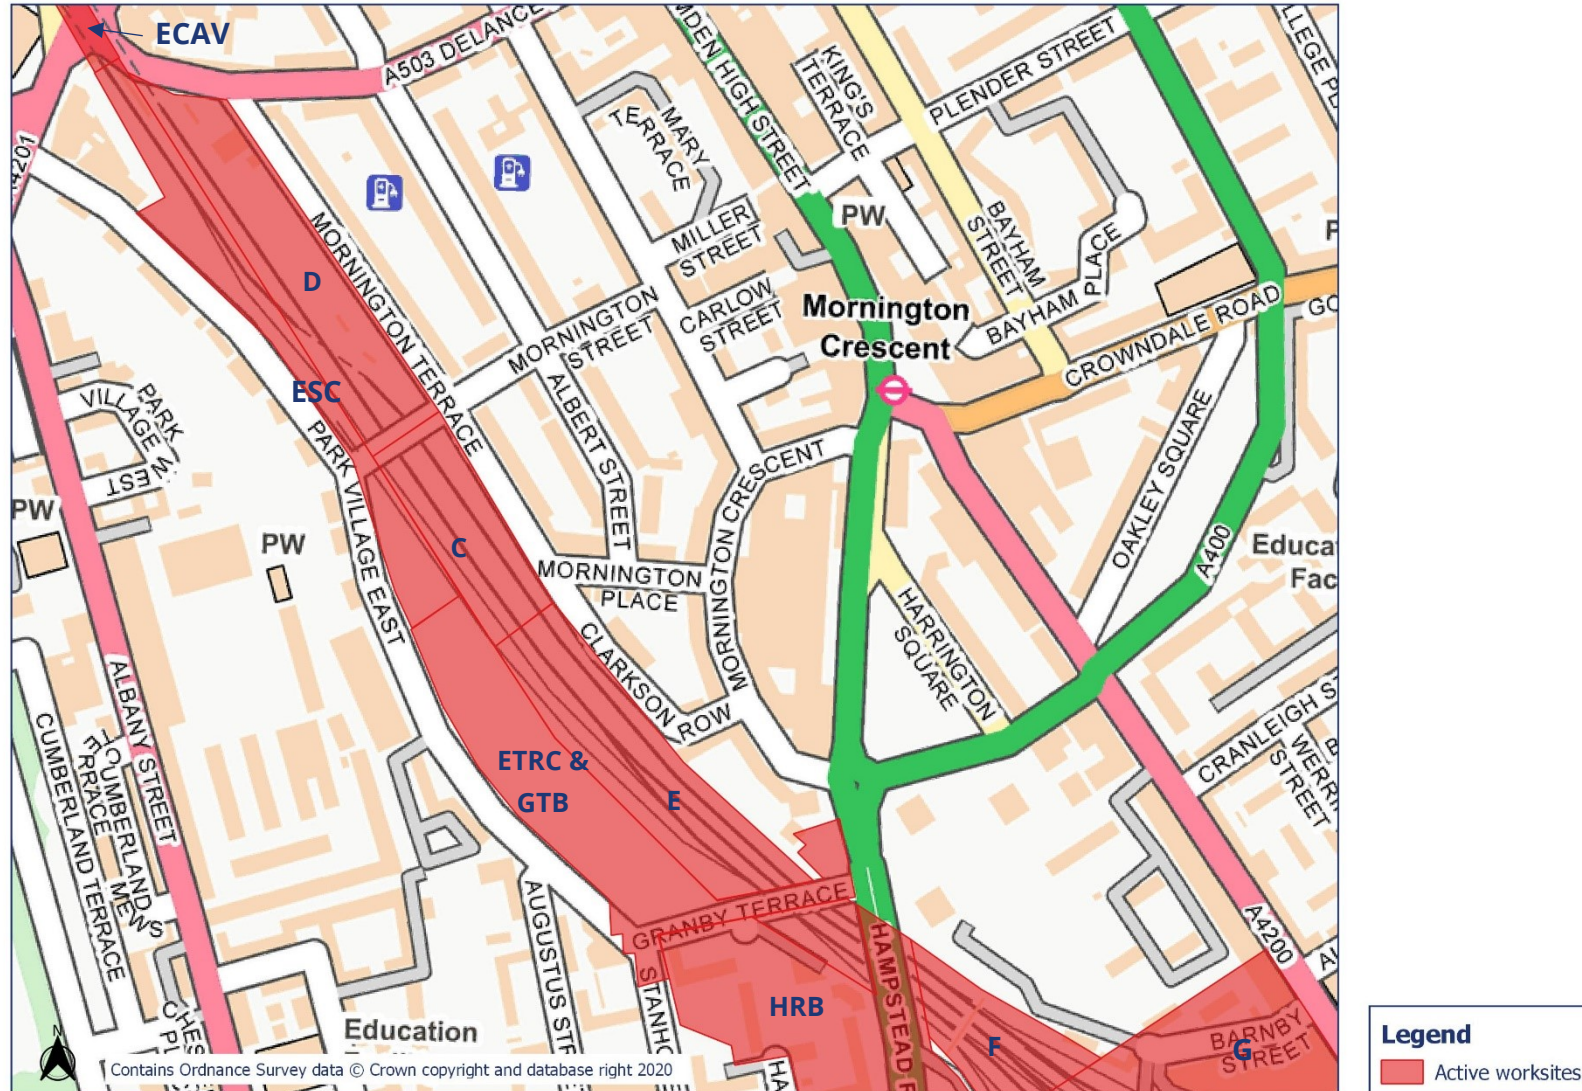
Worksite identification plan - 2

- The Adelaide Road ventilation shaft ref.: ARVS, (see plan 2 in Appendix A), where work activities included:
 - sheet piling;
 - test anchor installation;
 - coring of weep holes;
 - preparation works for the installation of new site cabins;
 - electrical and plumbing connections;
 - security alarm testing;
 - excavation works;
 - site monitoring;
 - vegetation clearance; and
 - surveys.

- Euston Throat Retained Cut and Granby Terrace Bridge worksite ref.: ETRC & GTB (see plan 2 in Appendix A), where work activities included:
 - installation of tower crane;

- capping beam construction.
- Euston Scissor Cut worksite ref.: ESC (see plan 2 in Appendix A), where work activities included:
 - continuous and in-abeyance piling;

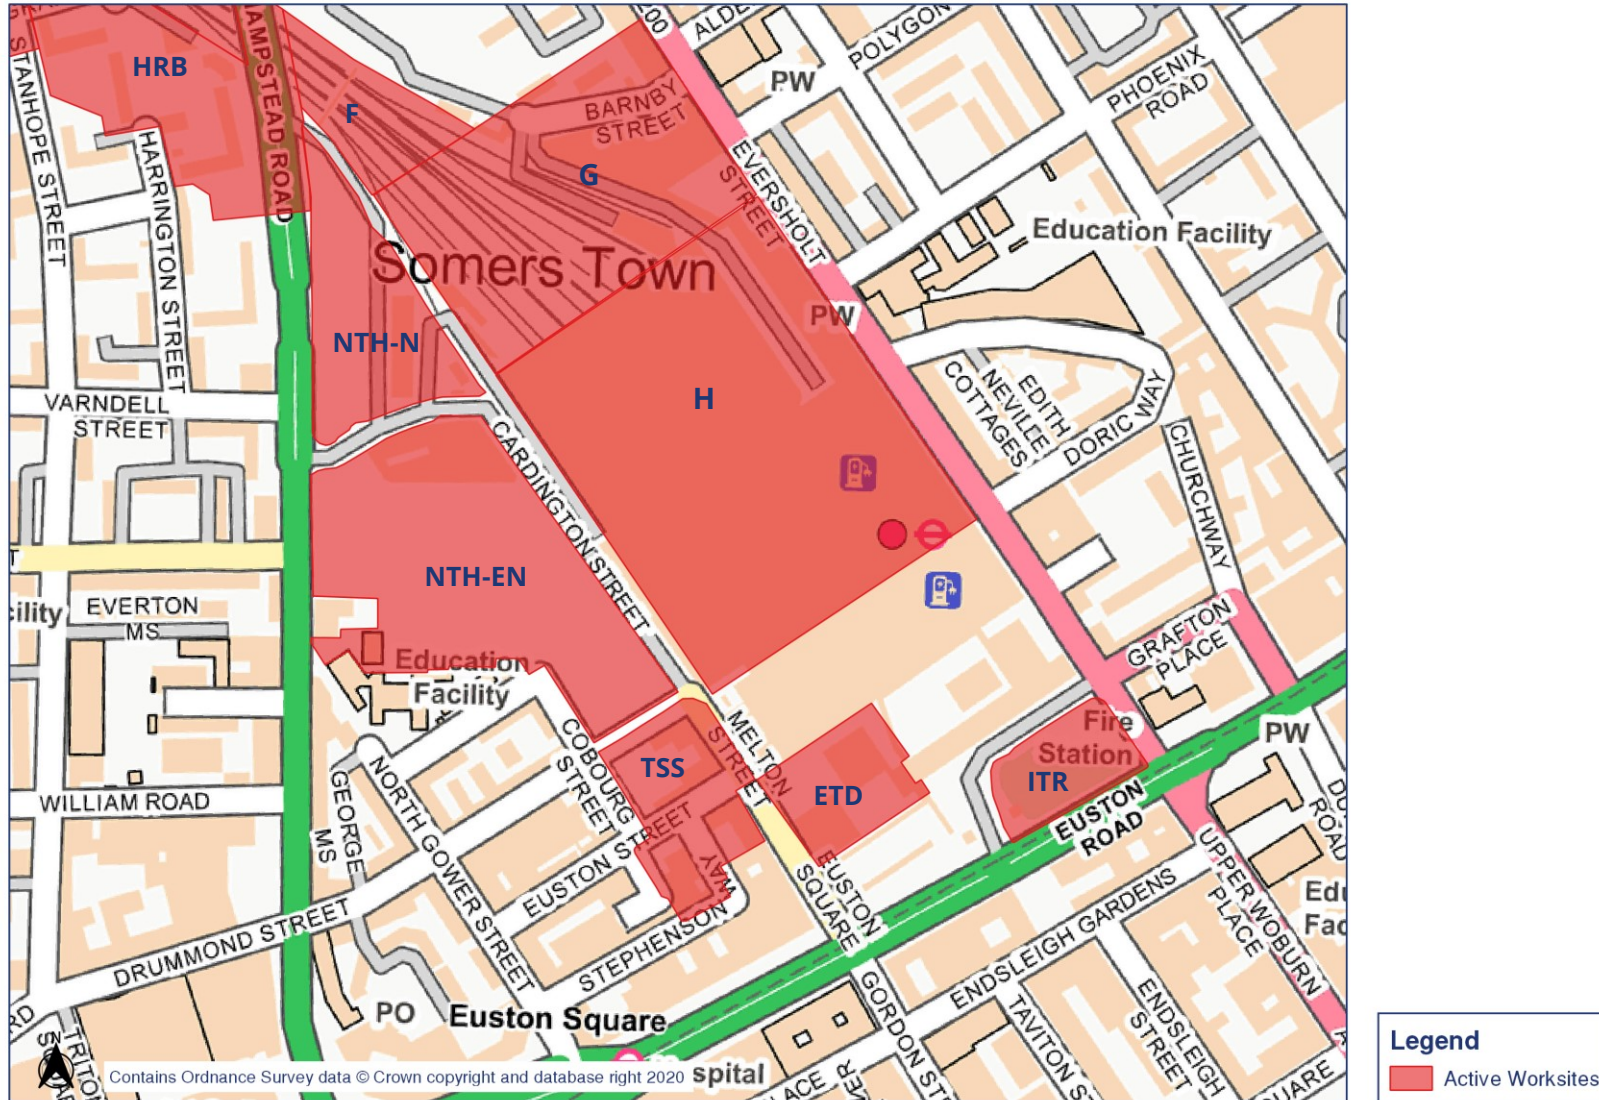
Worksite identification plan - 3

- concrete pouring;
 - saw cutting of concrete;
 - excavation works; and
 - retaining wall works.
- Hampstead Road Bridge worksite ref.: HRB (see plan 3 in Appendix A), where work activities included:

- sewer diversion works; and
 - pile mat preparation.
- Euston Cavern worksite ref.: ECAV (see plan 3 in Appendix A), where work activities included:
 - pile mat preparation;

- concrete pouring;
 - roadworks; and
 - retaining wall works.
- On-Network worksites ref.: B, C, D, E, F, G and H (see plan 3 in Appendix A), where work activities included:

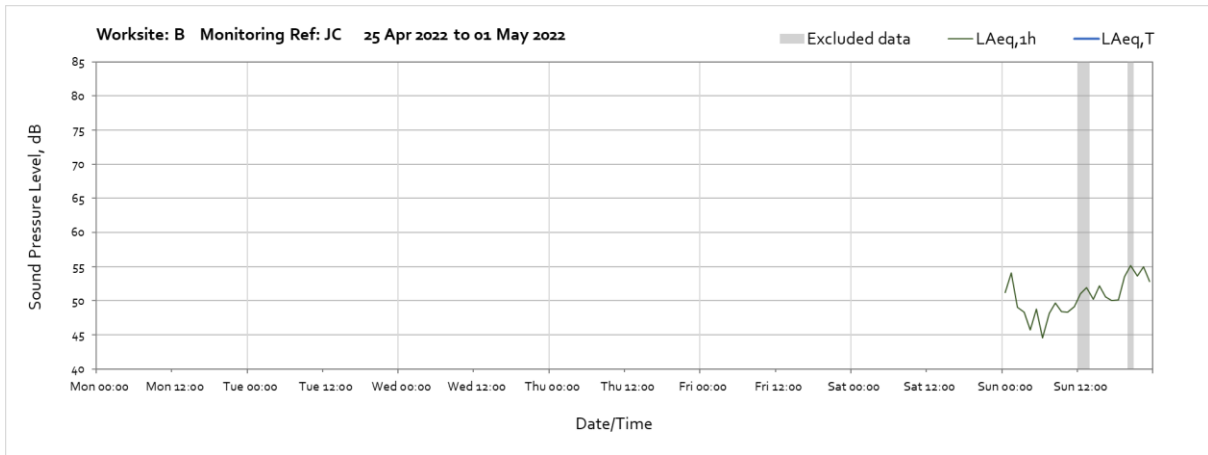
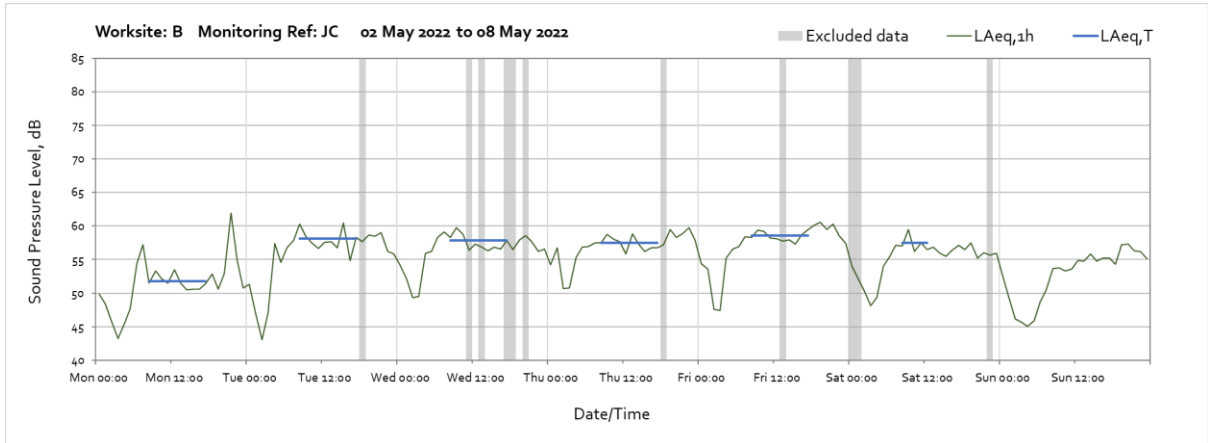
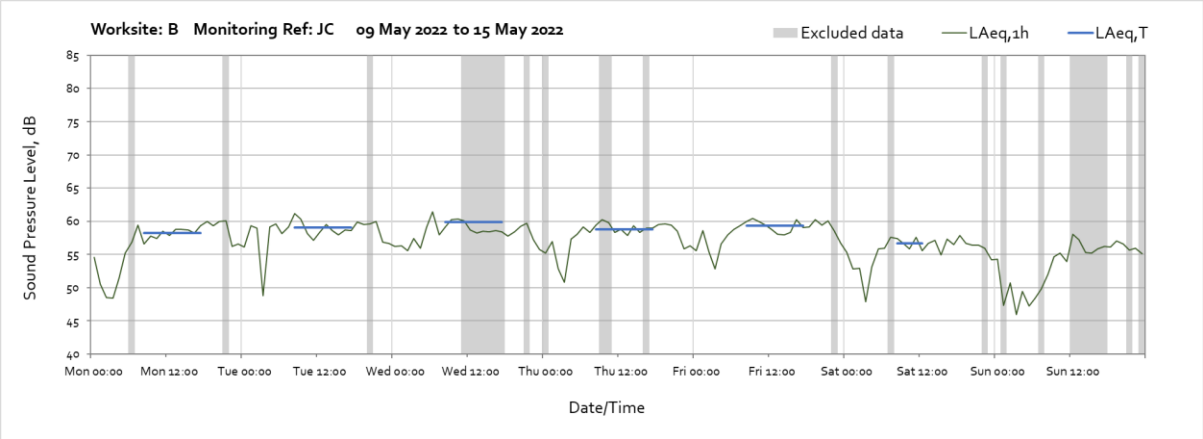
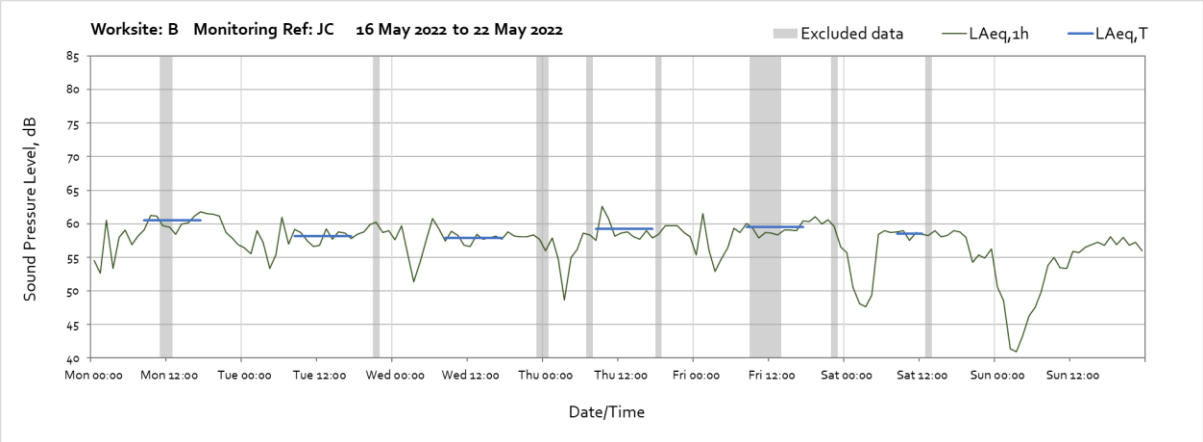
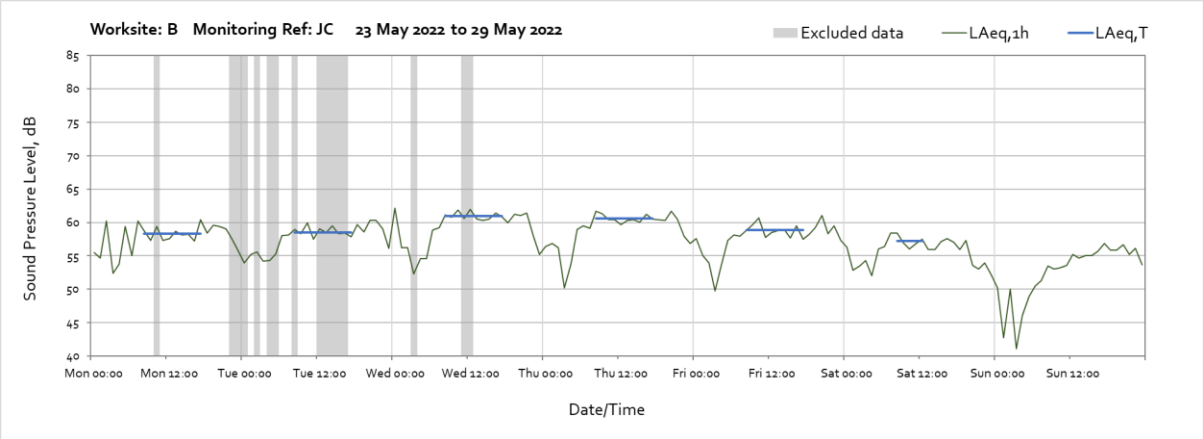
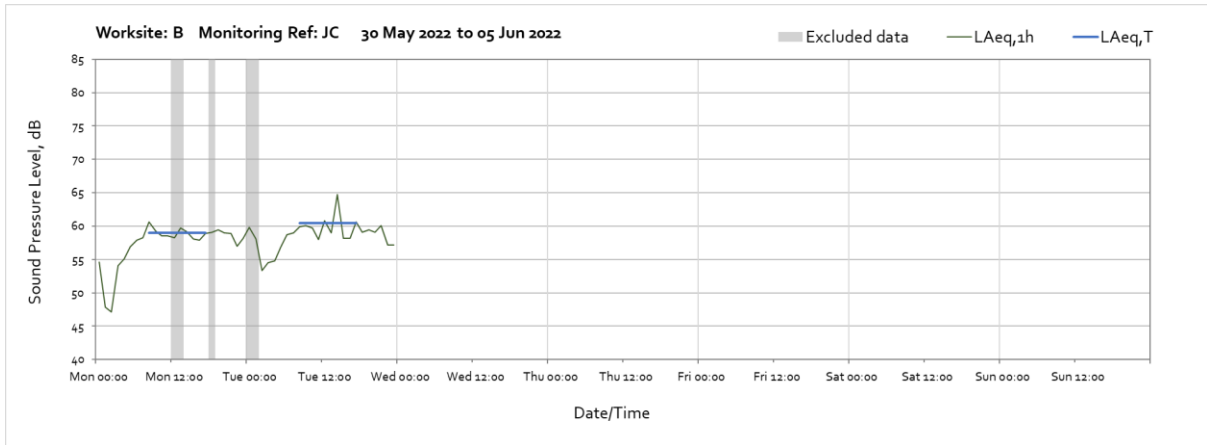
Worksite: B – Monitoring Ref: JC

2.1.3 Appendix C presents graphs of the noise and vibration monitoring data over the month for each of the measurement locations. Noise data presented consists of the hourly L_{Aeq} values and, where relevant, the $L_{Aeq,T}$ values (where the time period T has been taken to be the averaging period as specified in Table 1 of HS2 Information Paper E23). Vibration data presented consist of hourly PPV values. The full data set for the monitoring equipment can be found at the following location:

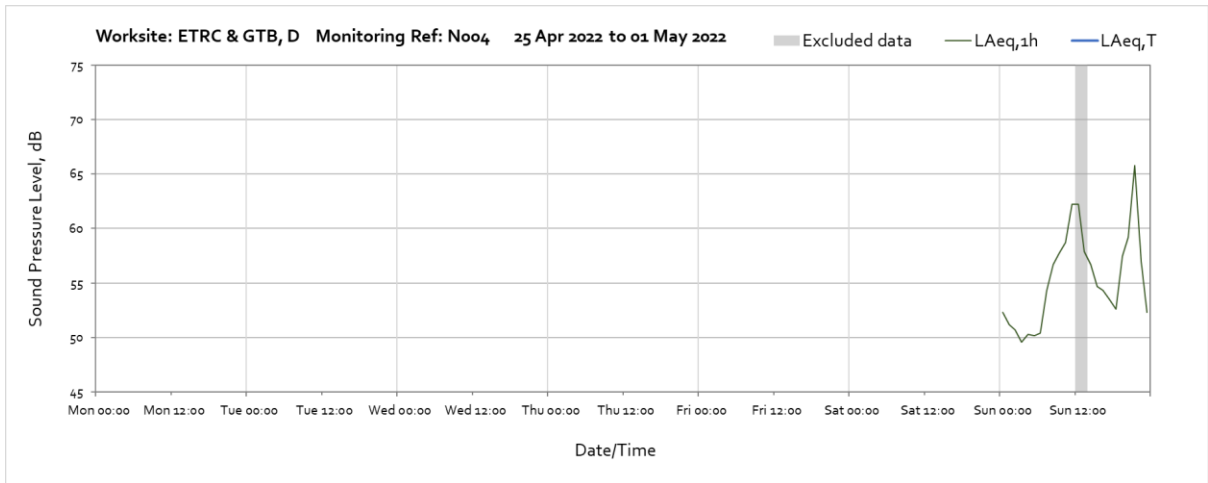
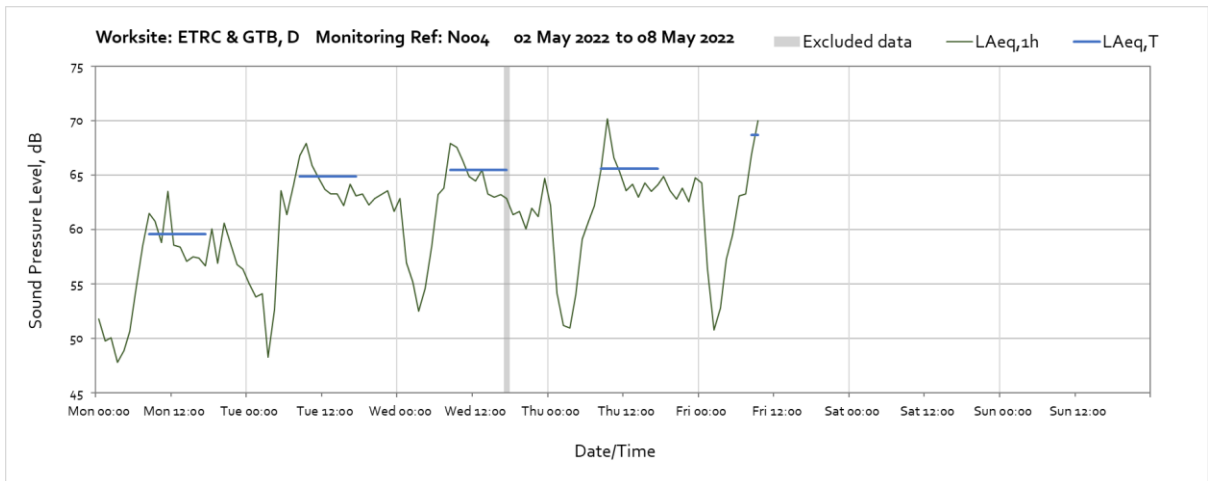
Worksite: ETRC & GTB, D – Monitoring Ref: N004

Note: Missing data between 10:00 on Friday 6th May 2022 and 14:00 on Friday 13th May 2022 was due to loss of power supply to the lighting column which powers the monitoring station.

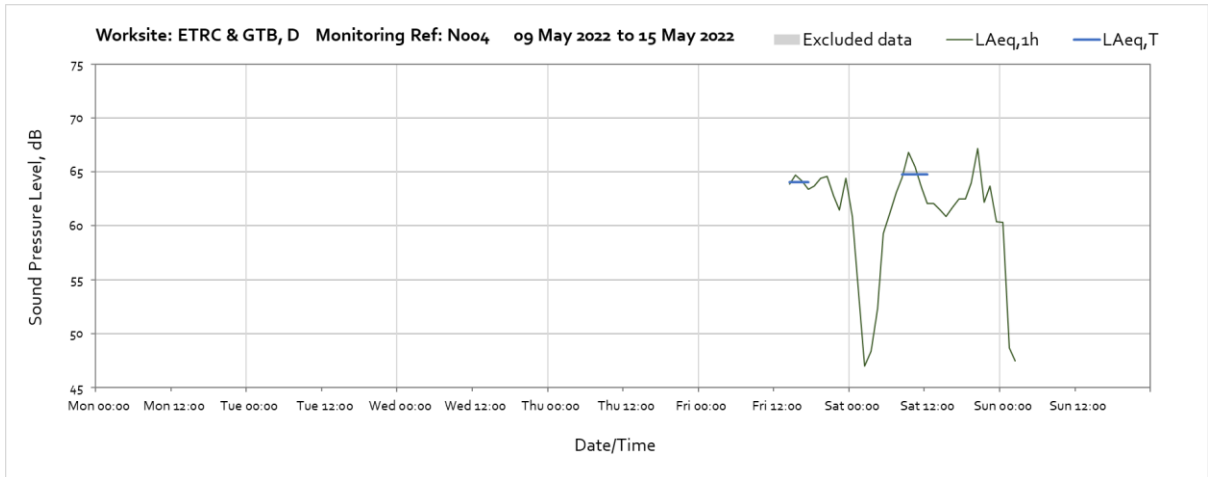
Note: Missing data between 10:00 on Friday 6th May 2022 and 14:00 on Friday 13th May and between 03:00 on Sunday 15th May until the end of the month was due to loss of power supply to the lighting column which powers the monitoring station.

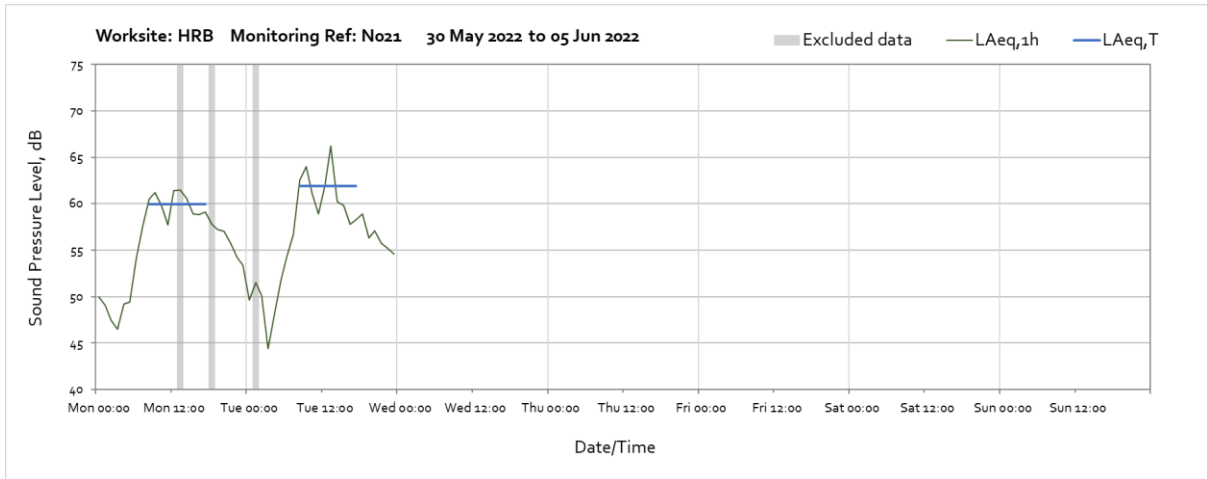
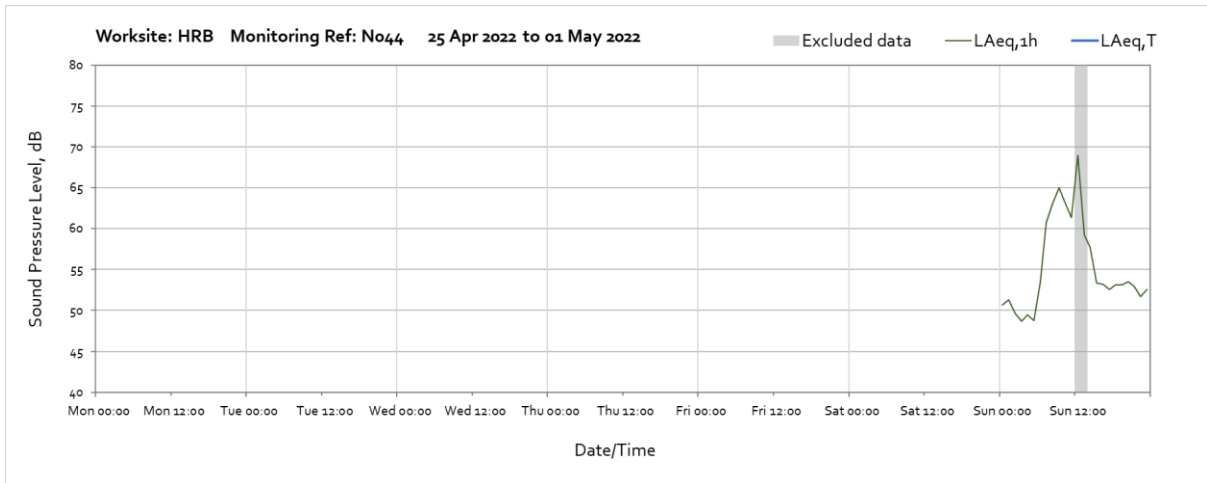
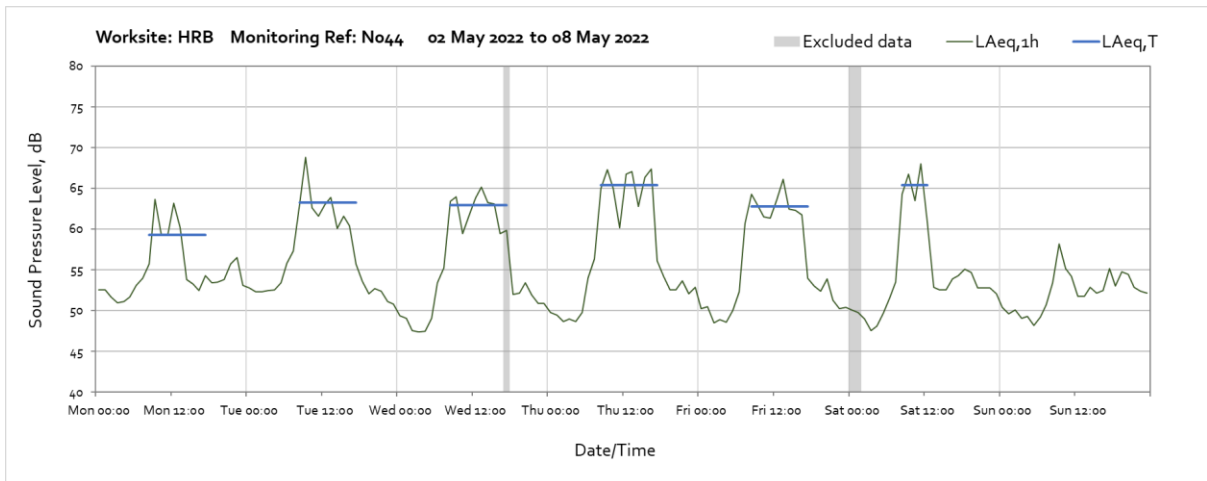
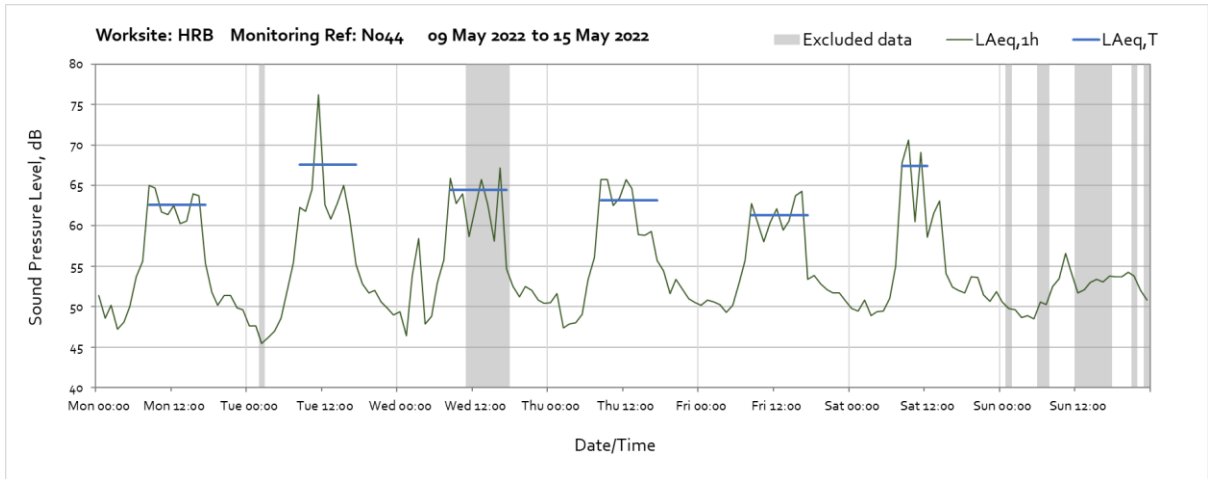
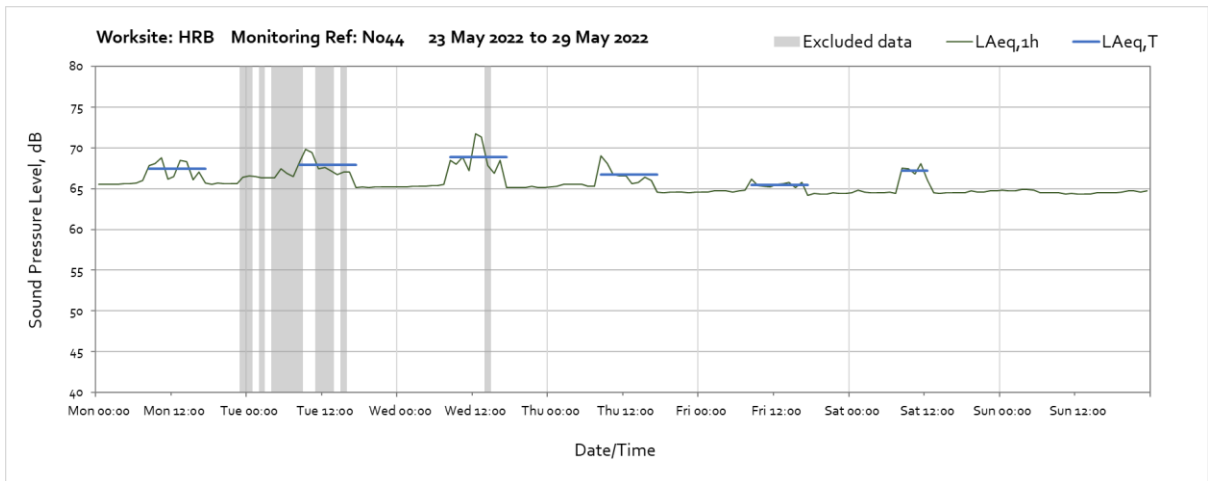
Worksite: HRB – Monitoring Ref: N044

Note: The flattening of noise curve from 16th May onwards was due to additional generator fans installed close to the noise monitor.

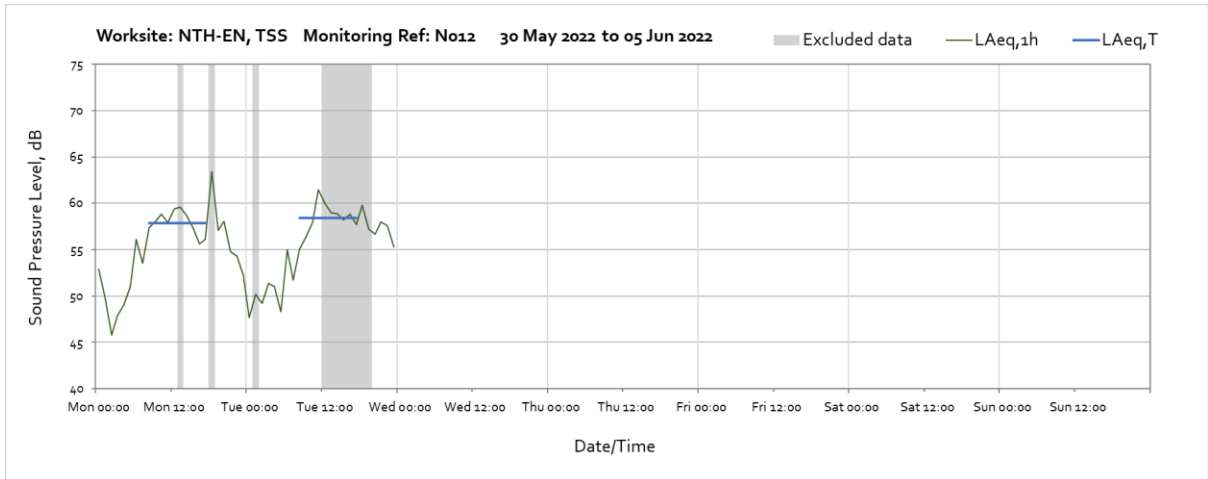
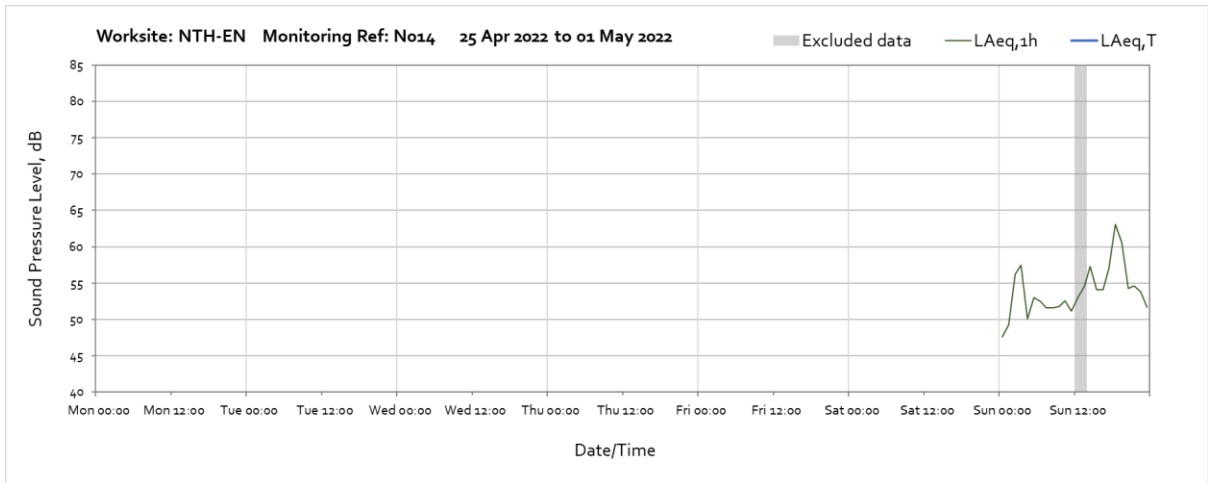
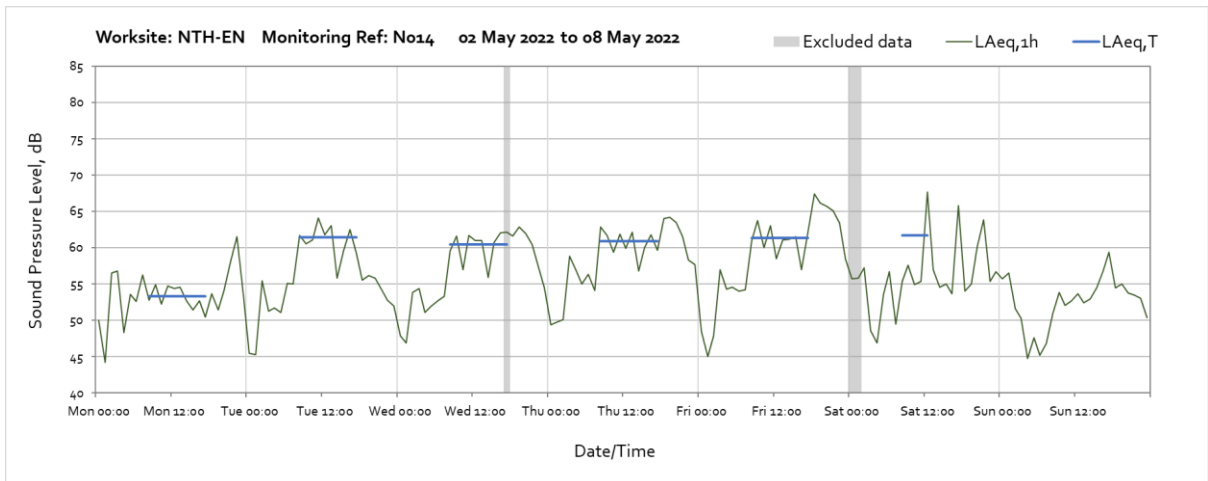
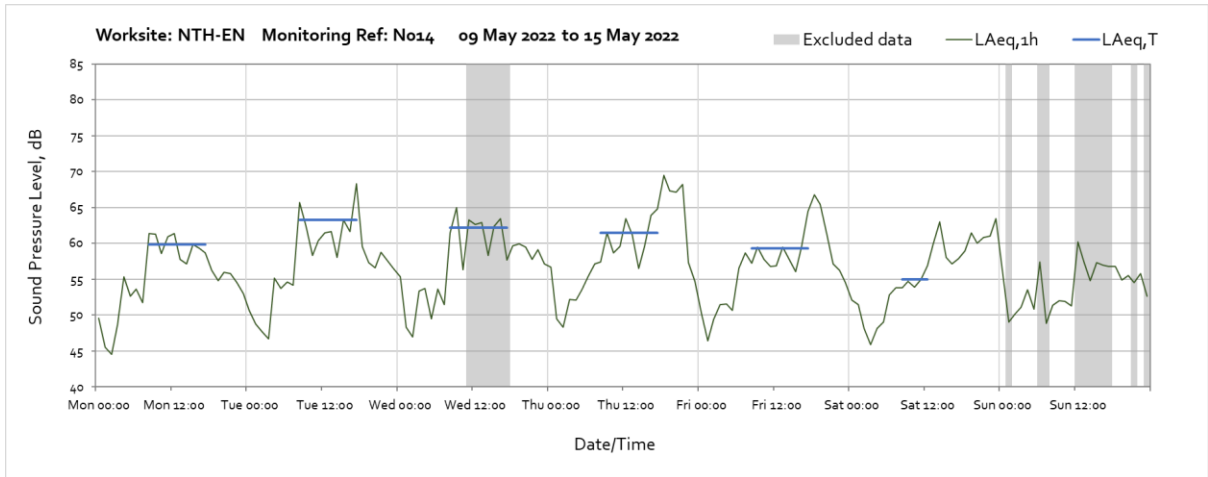
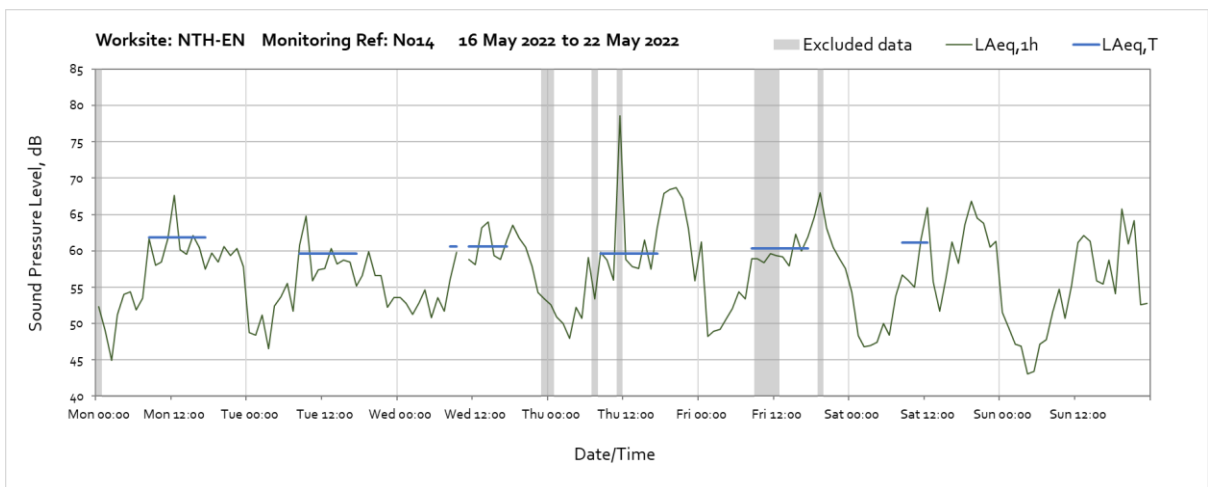
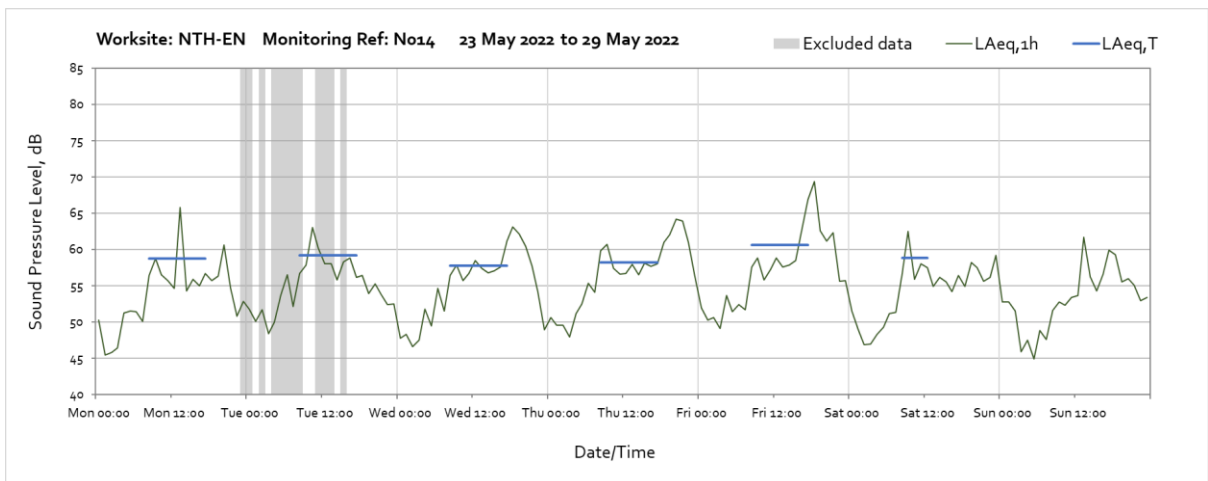
Worksite: NTH-EN - Monitoring Ref: N014

Note: Missing data between 10:00 and 11:00 on Wednesday 18th May 2022 was due to the monitoring station being switched off for routine maintenance.

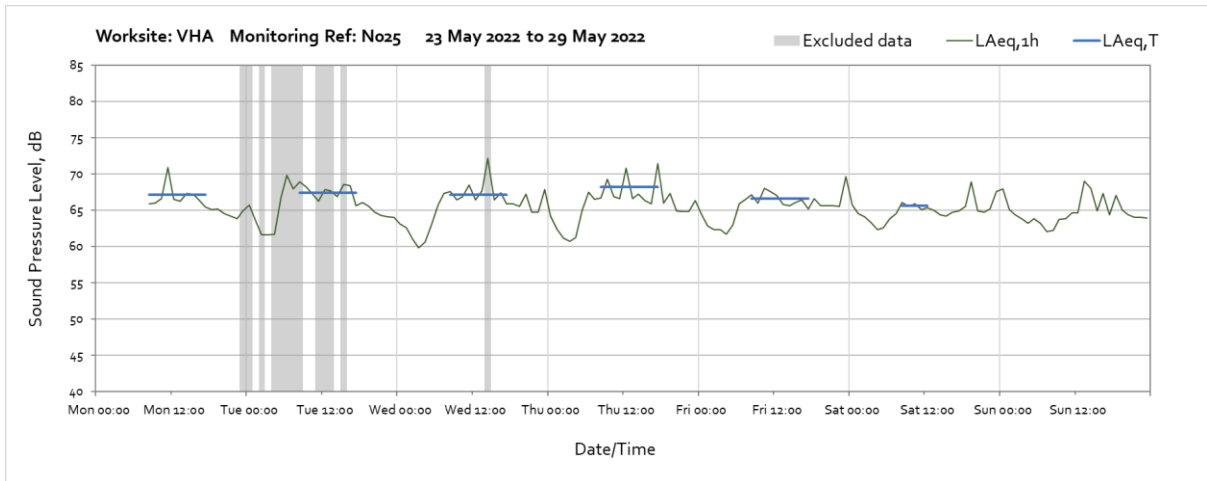
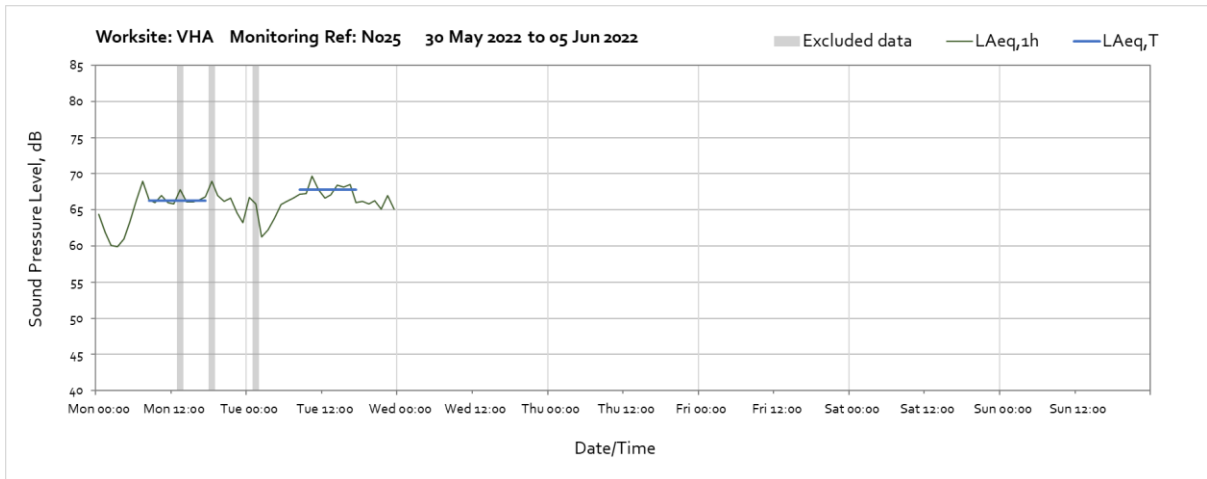
Vehicle Holding Area (VHA) – Monitoring Ref: N025

Note: Missing data from the beginning of the month to 08:00 on Monday 23rd May 2022 was due to loss of continuous power supply to the lighting column which powers the monitoring station.

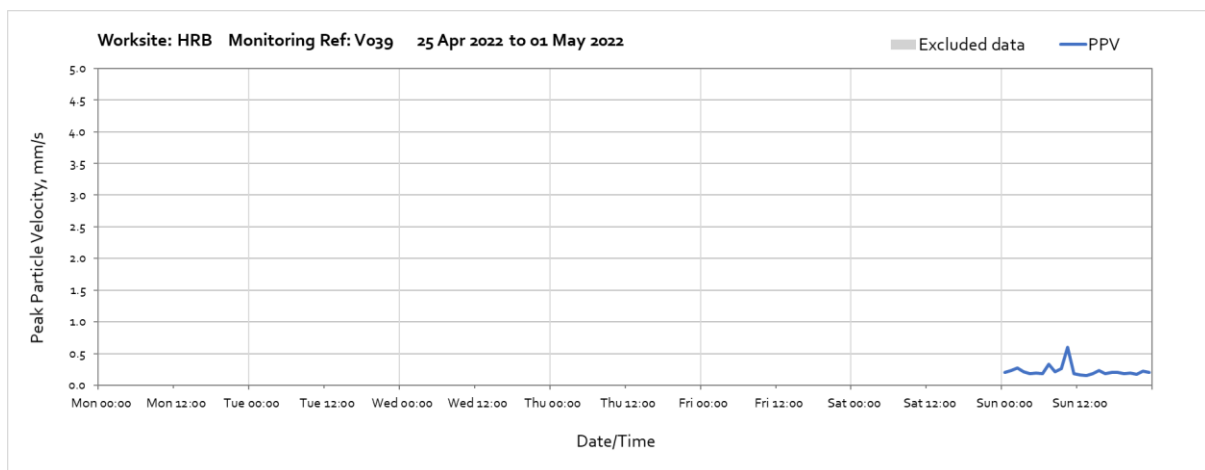
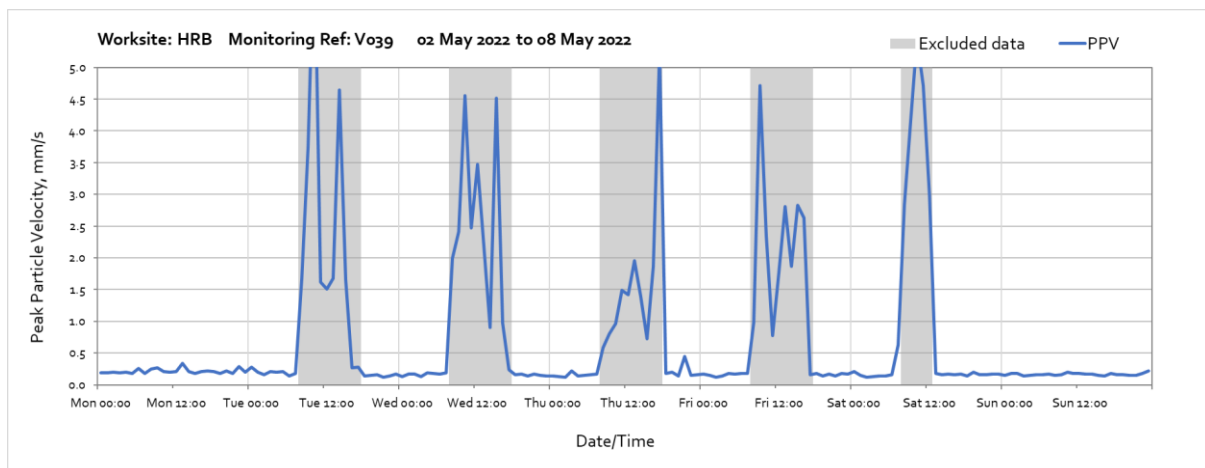
Worksite: HRB – Monitoring Ref: V039

Note: High levels of vibration measured throughout the week were due to pile mat preparation activities undertaken near to the monitoring station. The monitoring station is mounted on a kentledge block along the hoarding in an area of disturbed ground, vibration is likely to be amplified compared to what is experienced at building. Attended monitoring has been booked to acquire more representative data for the receptor.

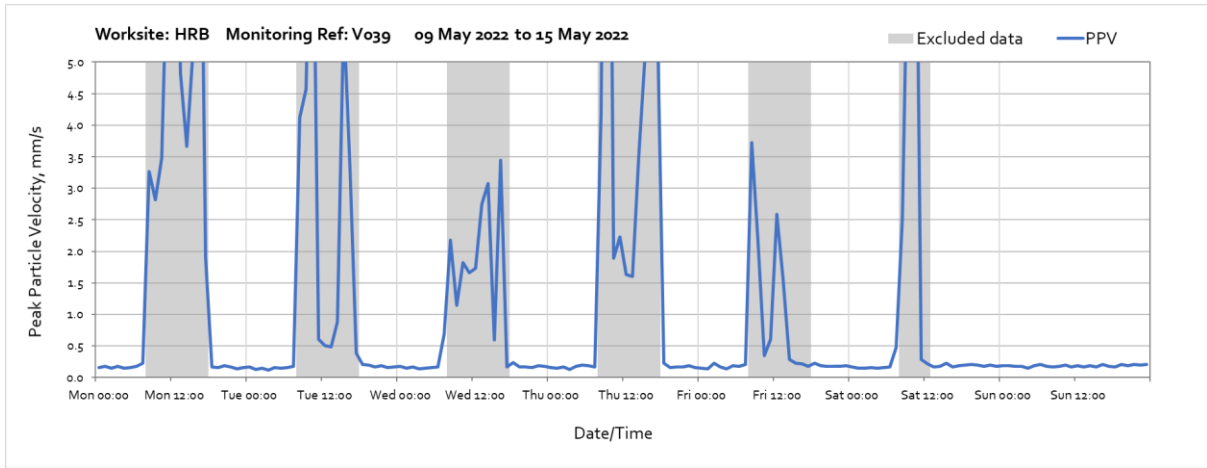
Note: High levels of vibration measured throughout the week were due to pile mat preparation activities undertaken near to the monitoring station. The monitoring station is mounted on a kentledge block along the hoarding in an area of disturbed ground, vibration is likely to be amplified compared to what is experienced at building. Attended monitoring has been booked to acquire more representative data for the receptor.

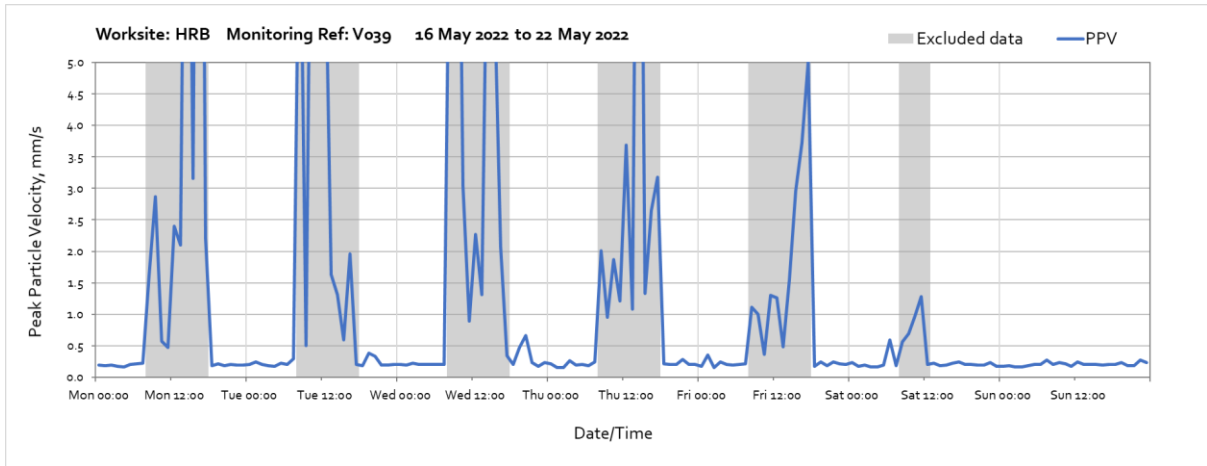
Note: High levels of vibration measured throughout the week were due to pile mat preparation activities undertaken near to the monitoring station. The monitoring station is mounted on a kentledge block along the hoarding in an area of disturbed ground, vibration is likely to be amplified compared to what is experienced at building. Attended monitoring has been booked to acquire more representative data for the receptor.

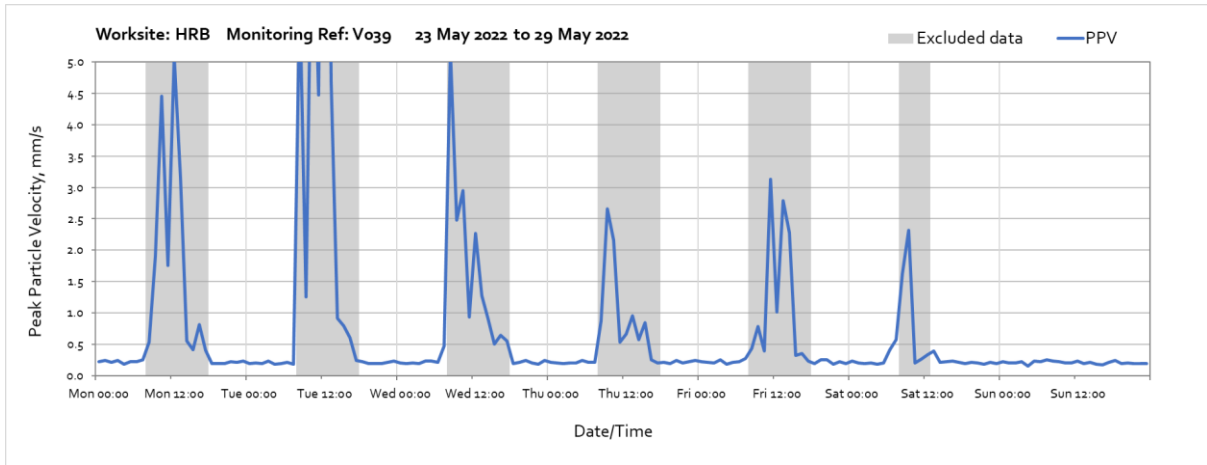
Note: High levels of vibration measured throughout the week were due to pile mat preparation activities undertaken near to the monitoring station. The monitoring station is mounted on a kentledge block along the hoarding in an area of disturbed ground, vibration is likely to be amplified compared to what is experienced at building. Attended monitoring has been booked to acquire more representative data for the receptor.

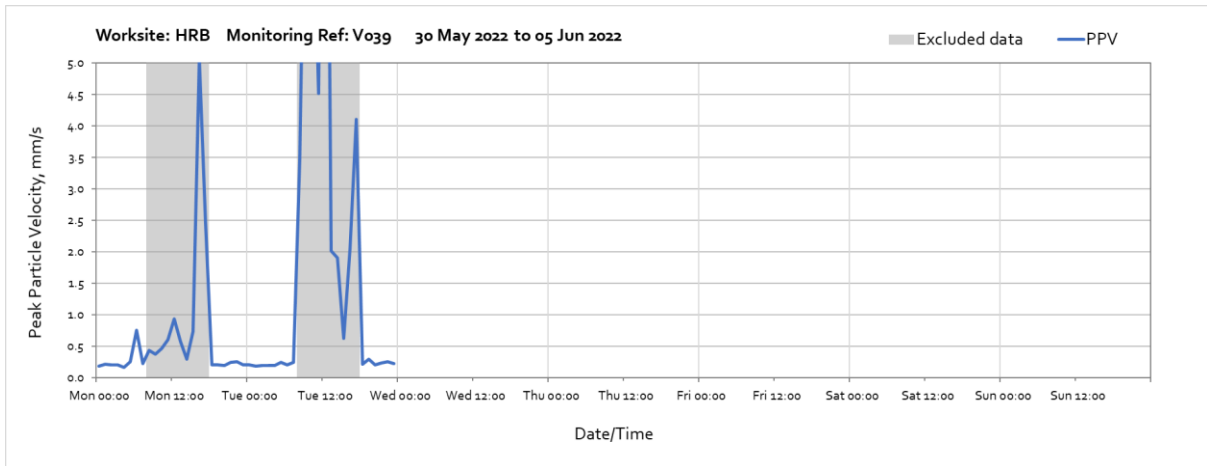
Note: High levels of vibration measured throughout the week were due to pile mat preparation activities undertaken near to the monitoring station. The monitoring station is mounted on a kentledge block along the hoarding in an area of disturbed ground, vibration is likely to be amplified compared to what is experienced at building. Attended monitoring has been booked to acquire more representative data for the receptor.
