Construction Noise and Vibration Monthly Report – May 2022

London Borough of Camden

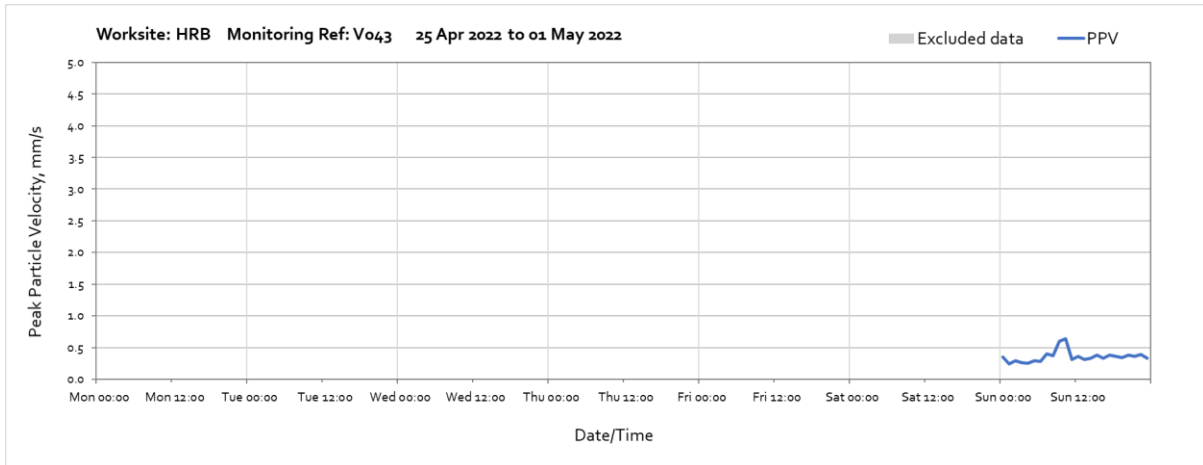
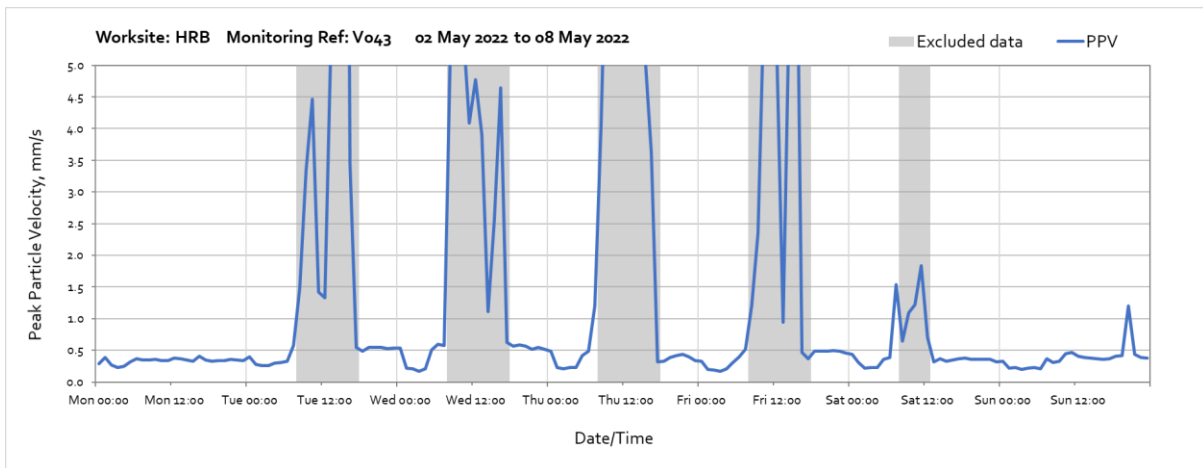
Worksite: HRB – Monitoring Ref: V043

Note: High levels of vibration measured throughout the week were due to utility diversion works undertaken in proximity to the monitoring station. The monitor has had to be moved from its mounting to make way to advancing utility diversion works in the area and is therefore not firmly connected to a structure while a permanent location is being arranged with Camden Council. Due to this, readings are not representative of actual impacts.

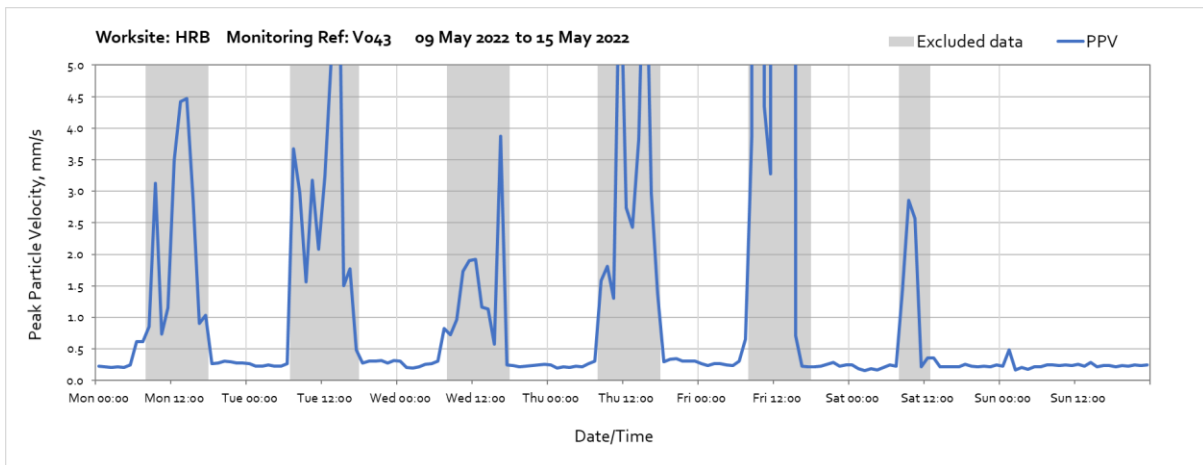
Note: High levels of vibration measured throughout the week were due to utility diversion works undertaken in proximity to the monitoring station. The monitor has had to be moved from its mounting to make way to advancing utility diversion works in the area and is therefore not firmly connected to a structure while a permanent location is being arranged with Camden Council. Due to this, readings are not representative of actual impacts.

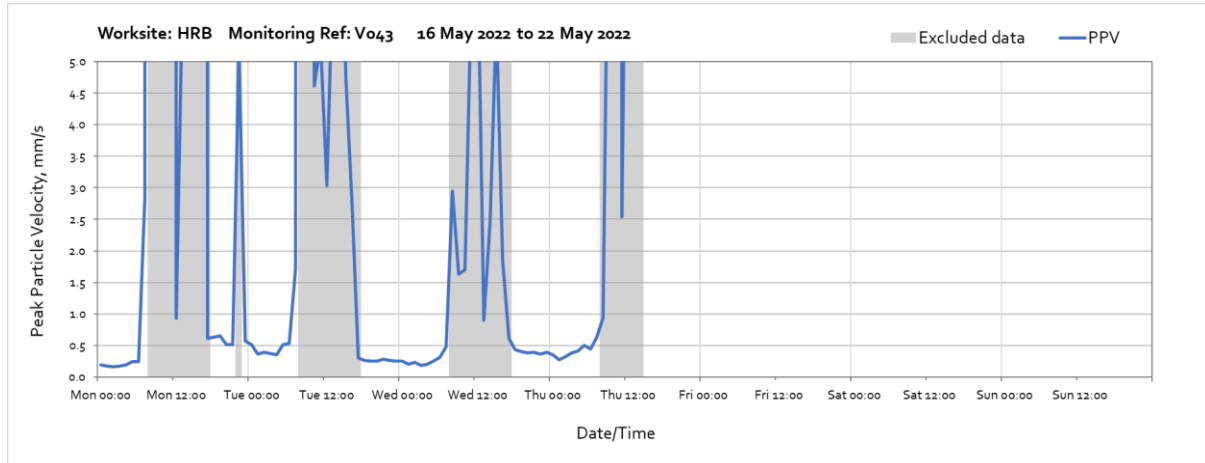
Note: High levels of vibration measured throughout the week were due to utility diversion works undertaken in proximity to the monitoring station. The monitor has had to be moved from its mounting to make way to advancing utility diversion works in the area and is therefore not firmly connected to a structure while a permanent location is being arranged with Camden Council. Due to this, readings are not representative of actual impacts. The vibration monitor was temporarily retrieved on 19th May 2022.

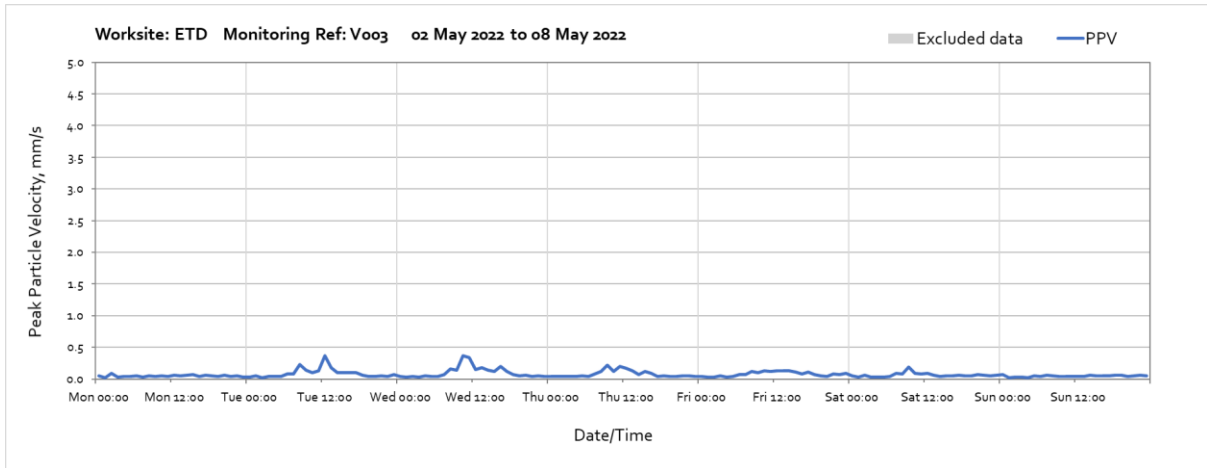
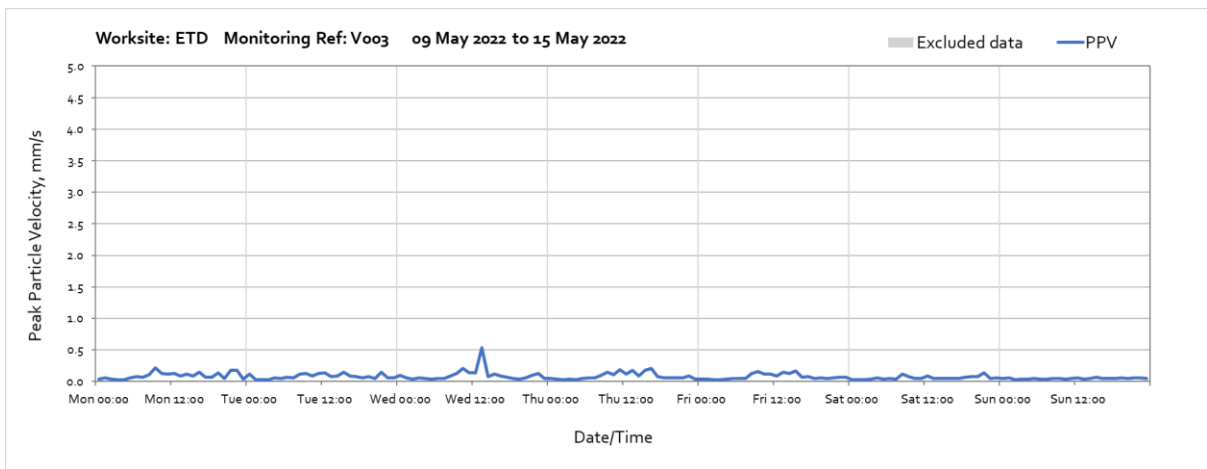
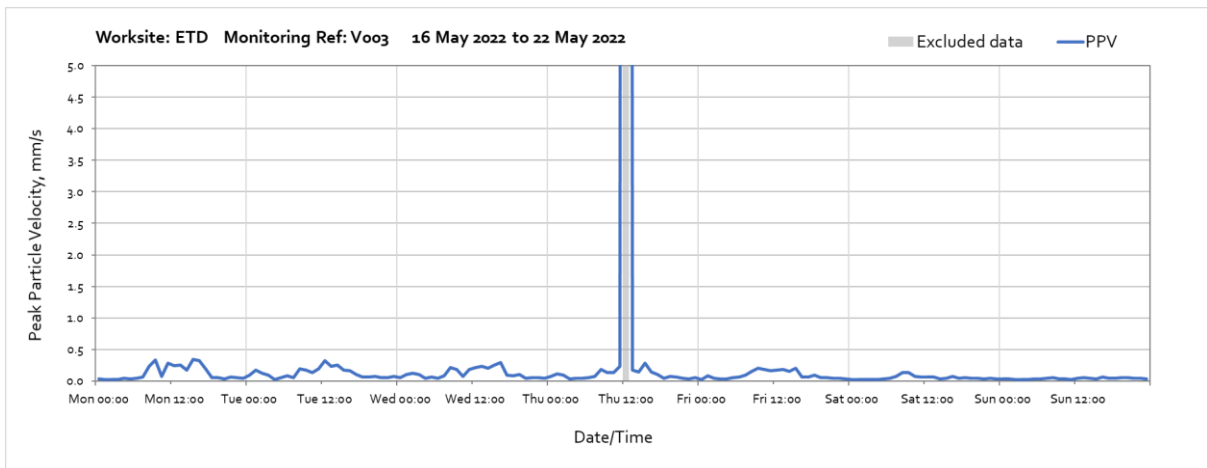
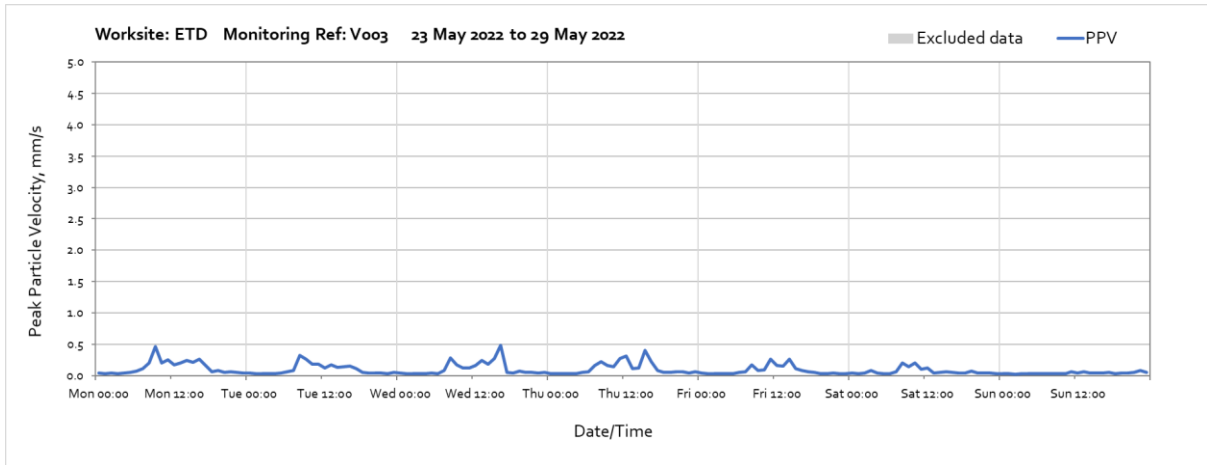
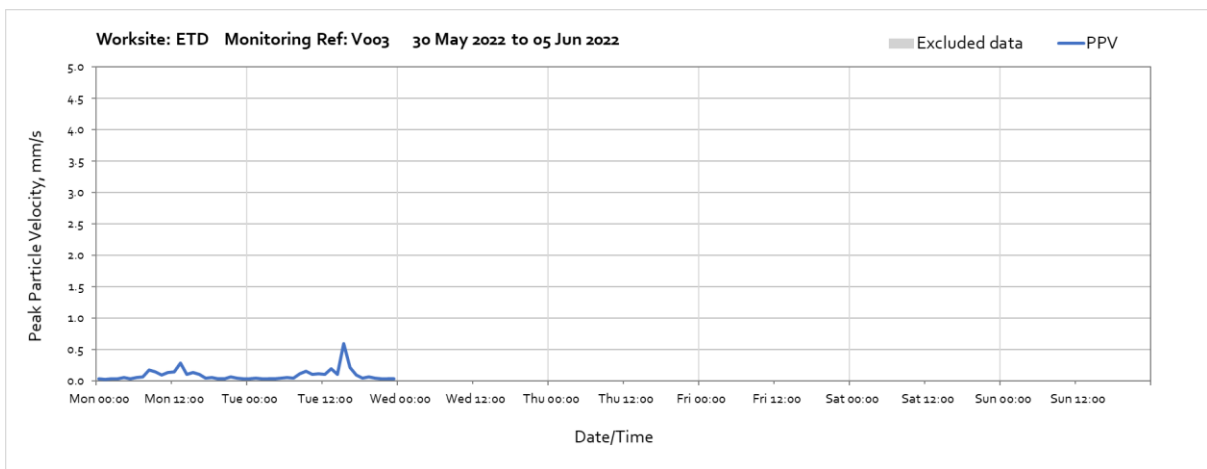
Worksite: ETD, TSS – Monitoring Ref: V003

The following graphs show the hourly measured peak particle velocity PPV recorded during the monitoring period. The graphs show the resultant PPV due to vibration components on three orthogonal axes x, y and z. Where resultant PPV data is not available (monitors V039 and V043), the highest vibration component in either of the three axes is presented for each 1hr measurement period respectively. Where high values of PPV were caused by local interference with the vibration monitor, which are not representative of HS2 construction works, these values have been greyed out in the following charts and have been excluded to calculate values in Table 4 of the main report.
