June 2022

HS2

Air Quality and Dust Monitoring Monthly Report – June 2022 **Buckinghamshire** Council

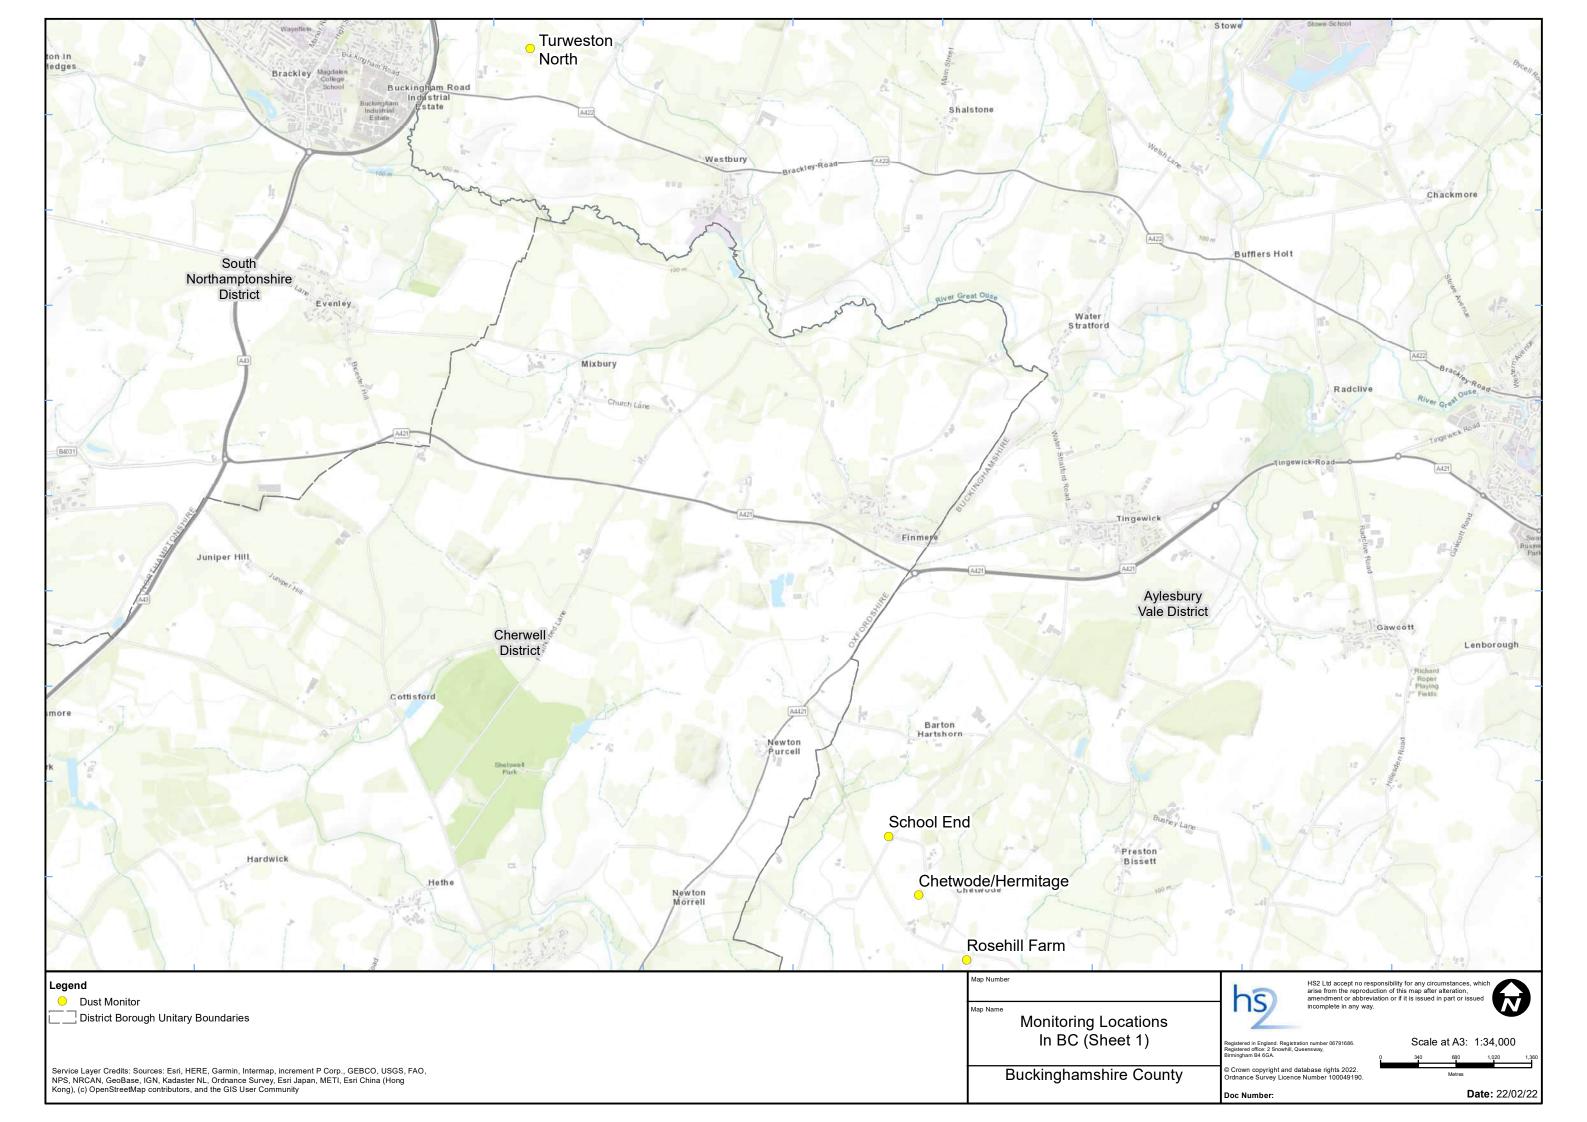
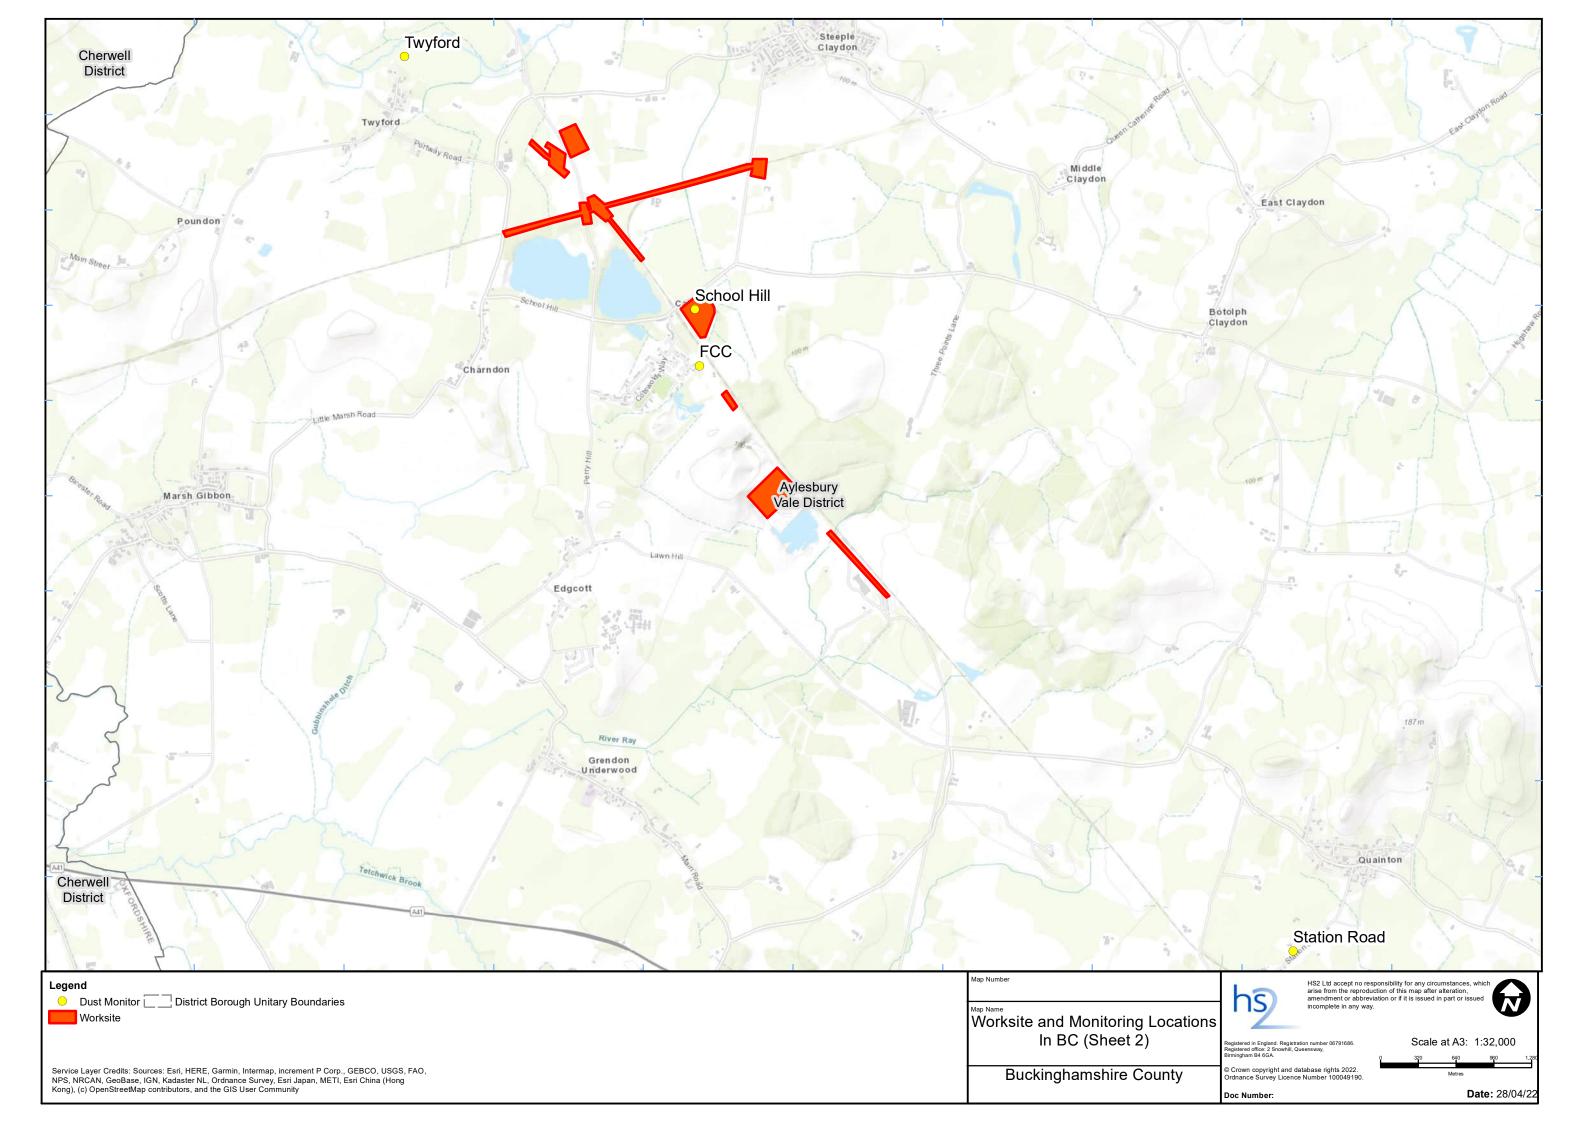
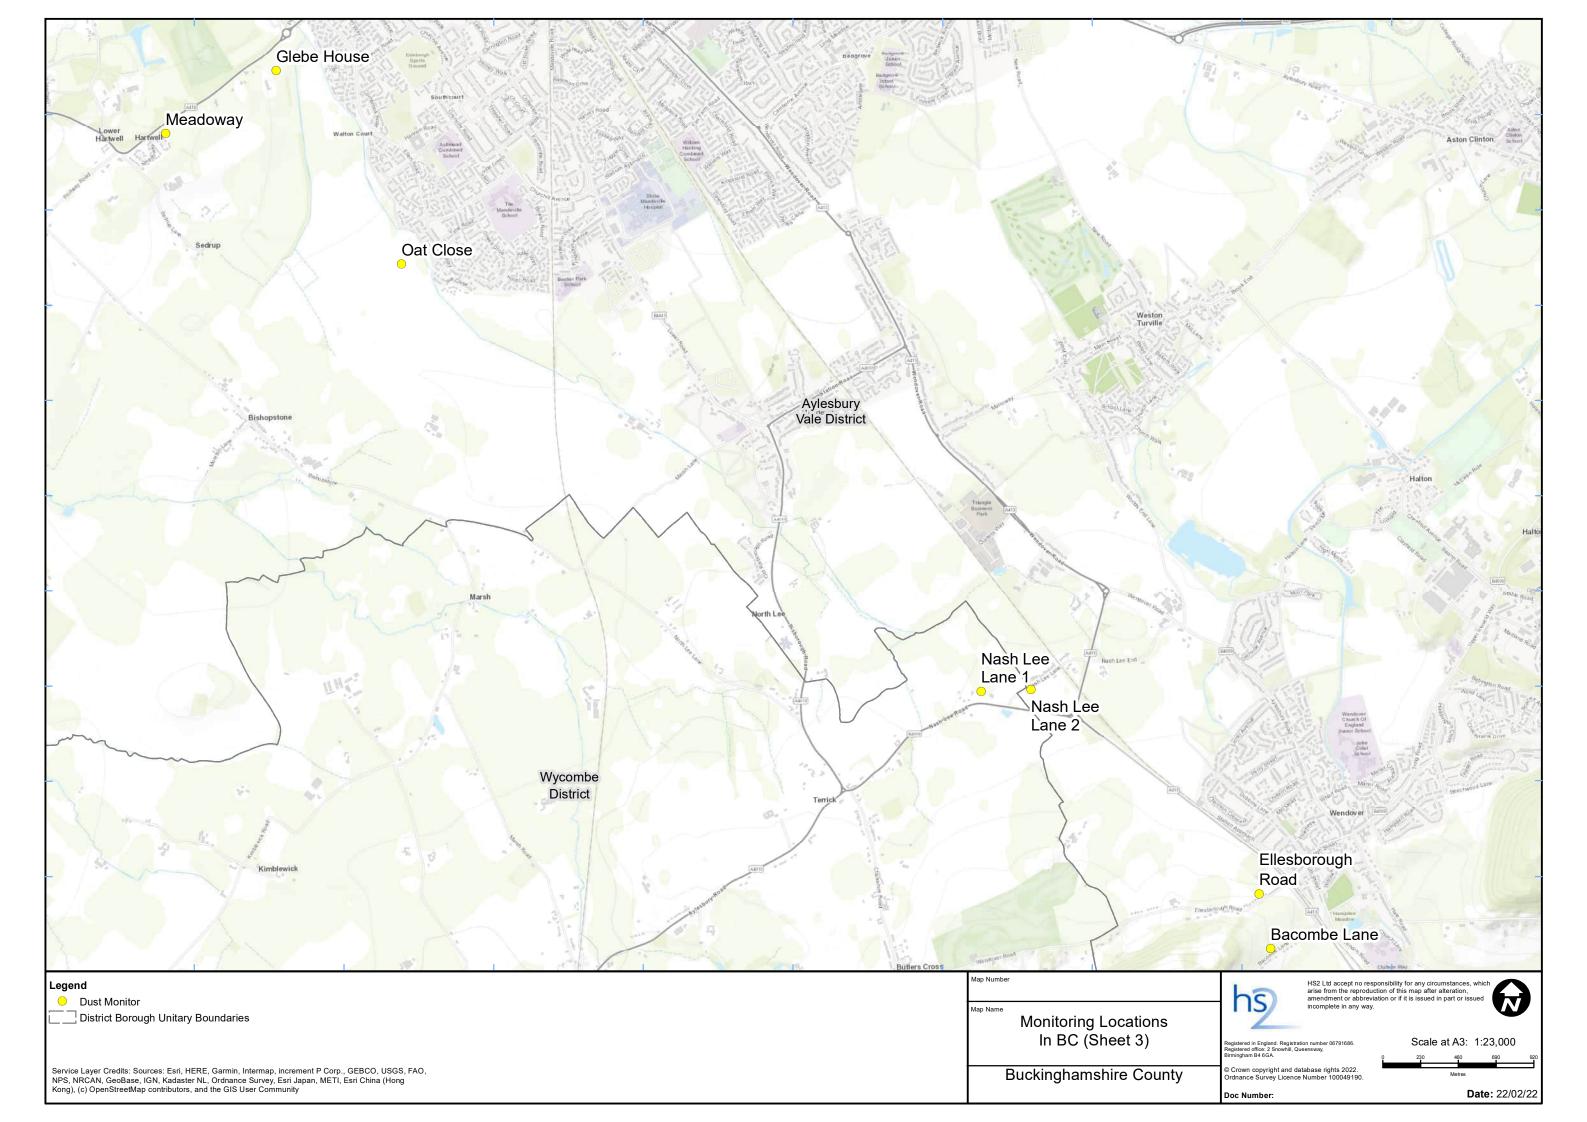
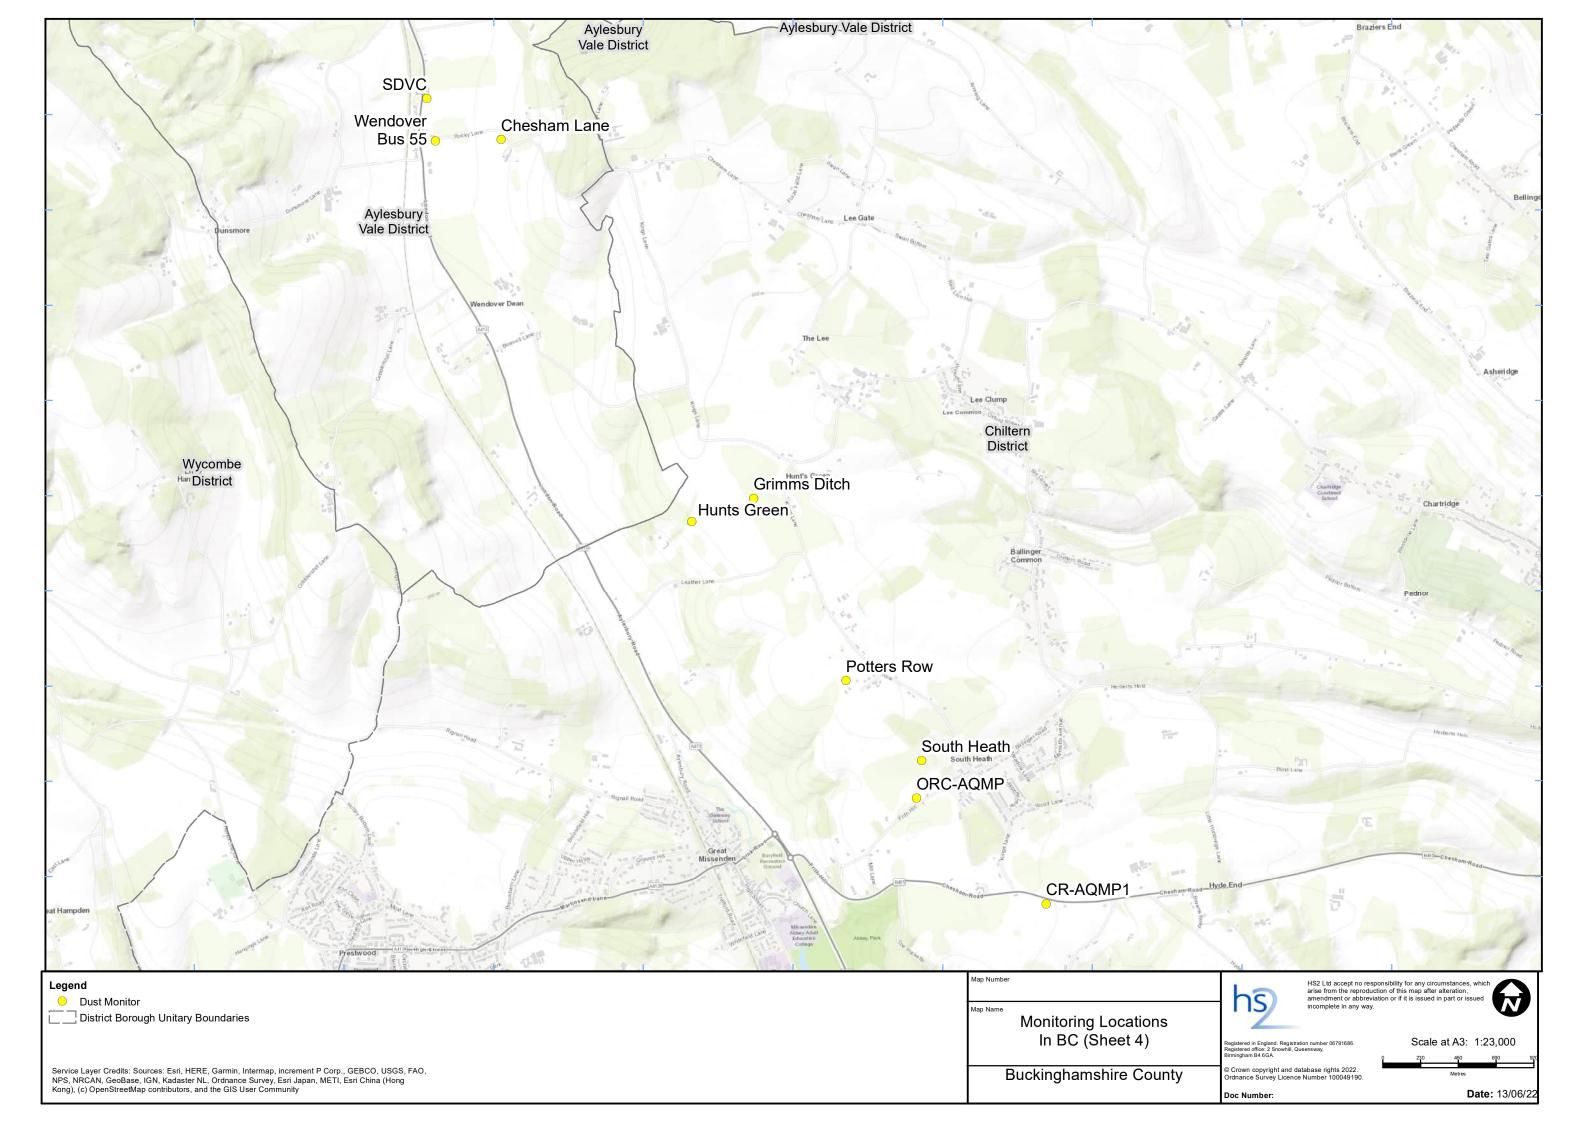
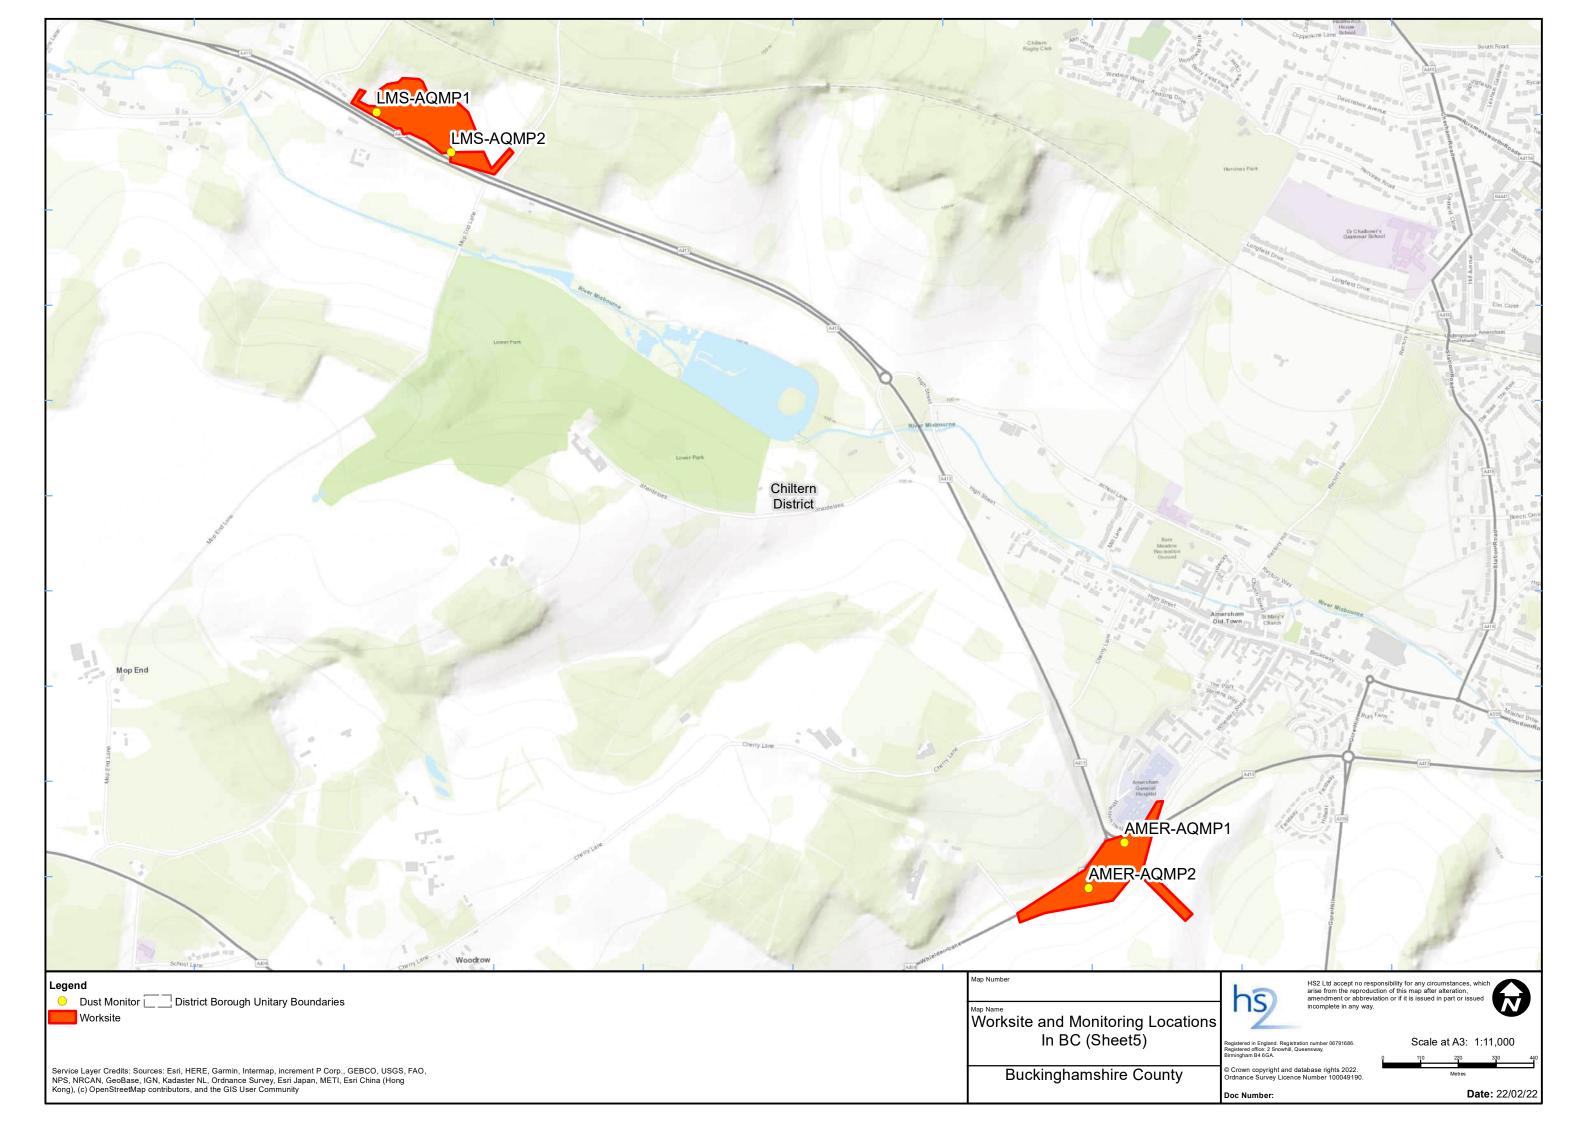
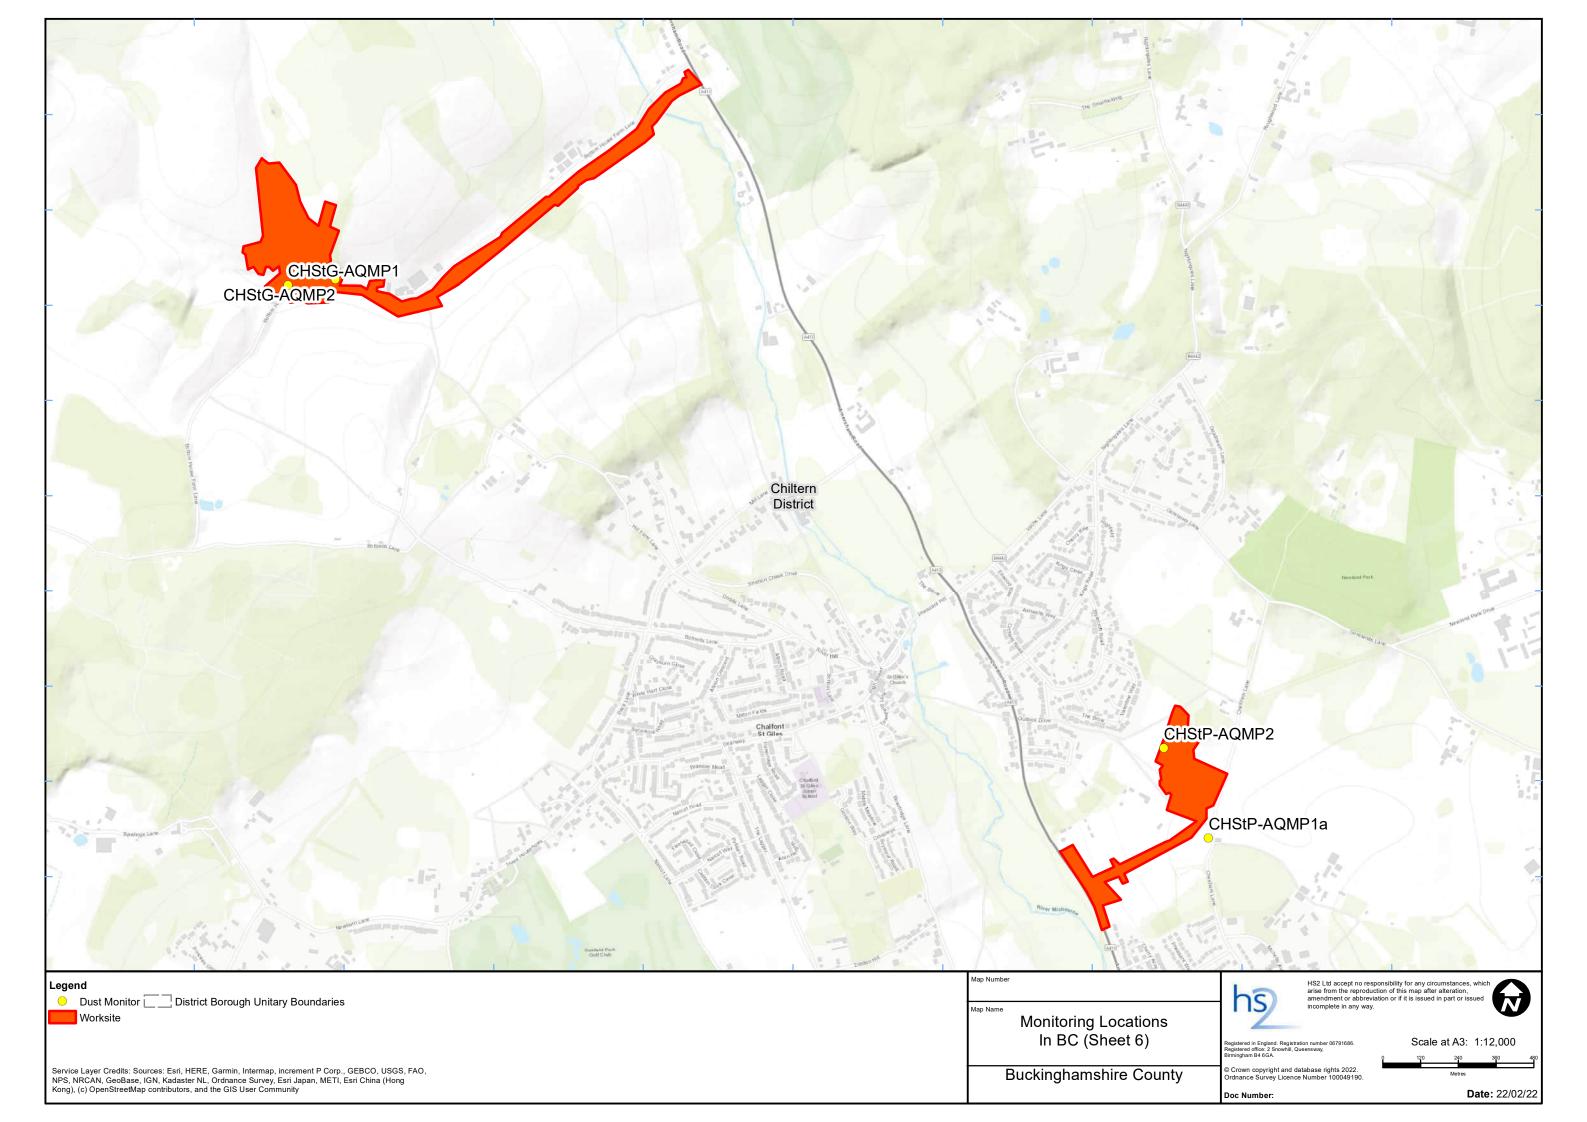
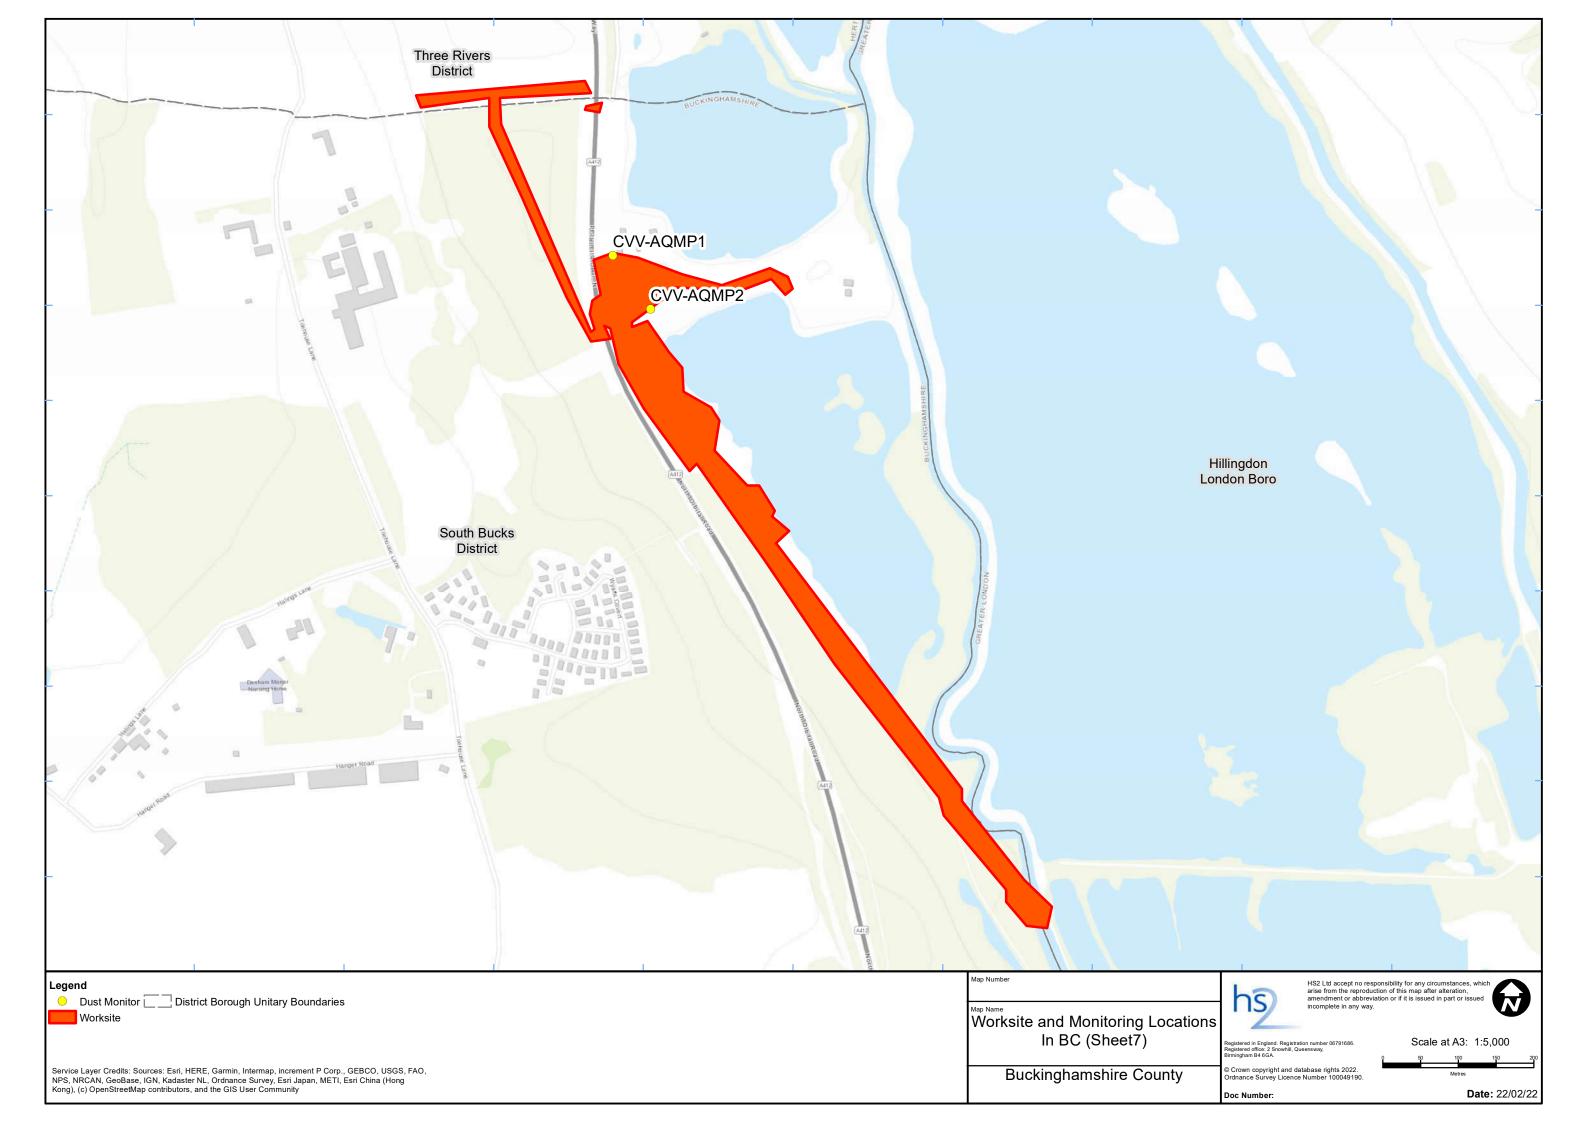
Figure 1-7: Worksite and monitoring locations within the BC

- 1.1.2 Figures 1-7 in Appendix A present the current worksites together with the dust monitoring locations for June 2022.
- 1.1.3 This summary should be read in conjunction with the overview monitoring report available from www.gov.uk/government/collections/monitoring-the-environmental-effects-of-hs2, which highlights the applicable standards and guidance, as well as the air quality and dust monitoring methodologies to be implemented by nominated undertakers throughout construction.

- 1.1.4 The current worksites, as presented in Appendix A, Figures 1-7, include:

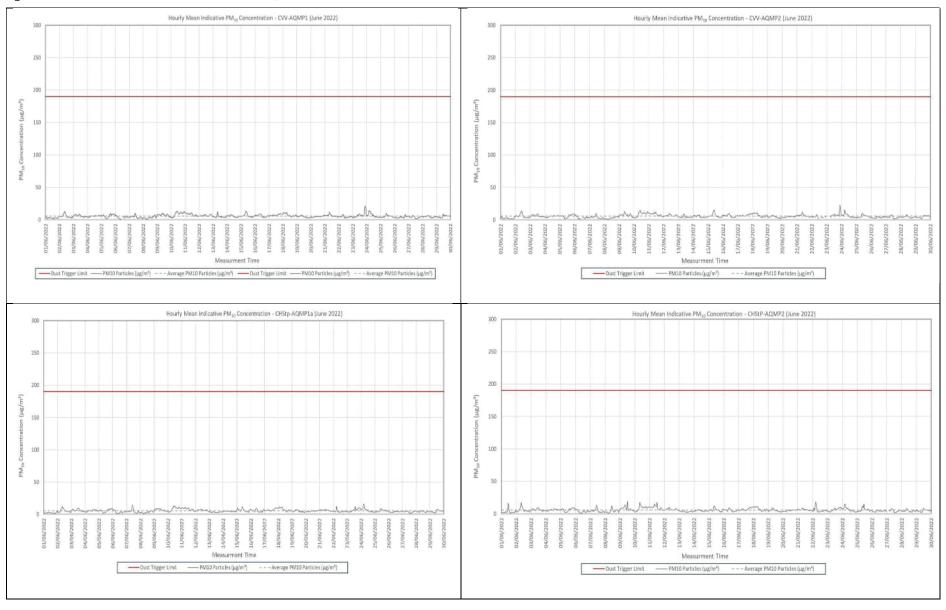
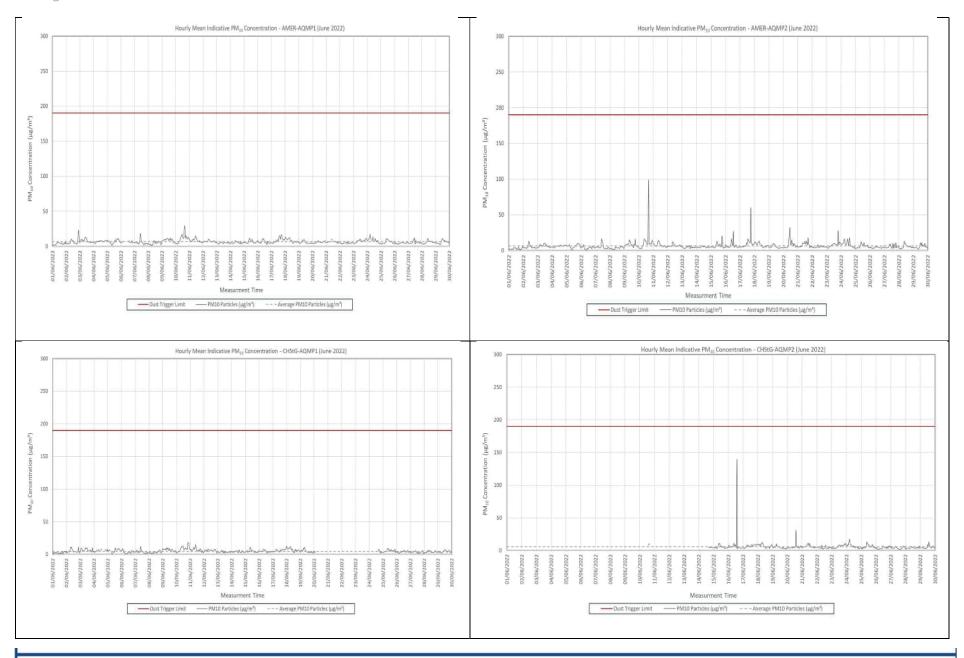
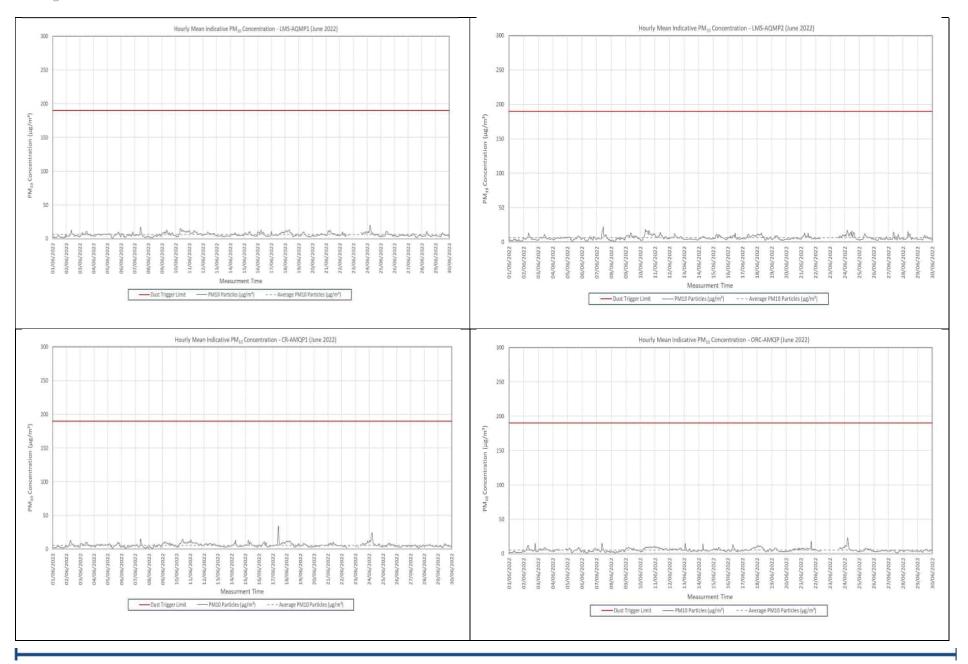
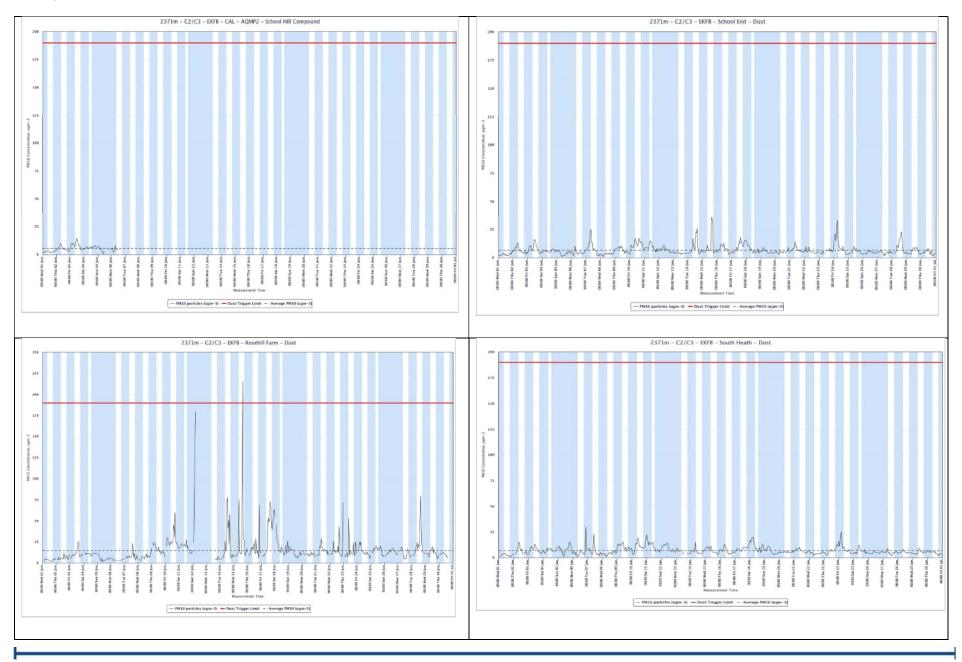
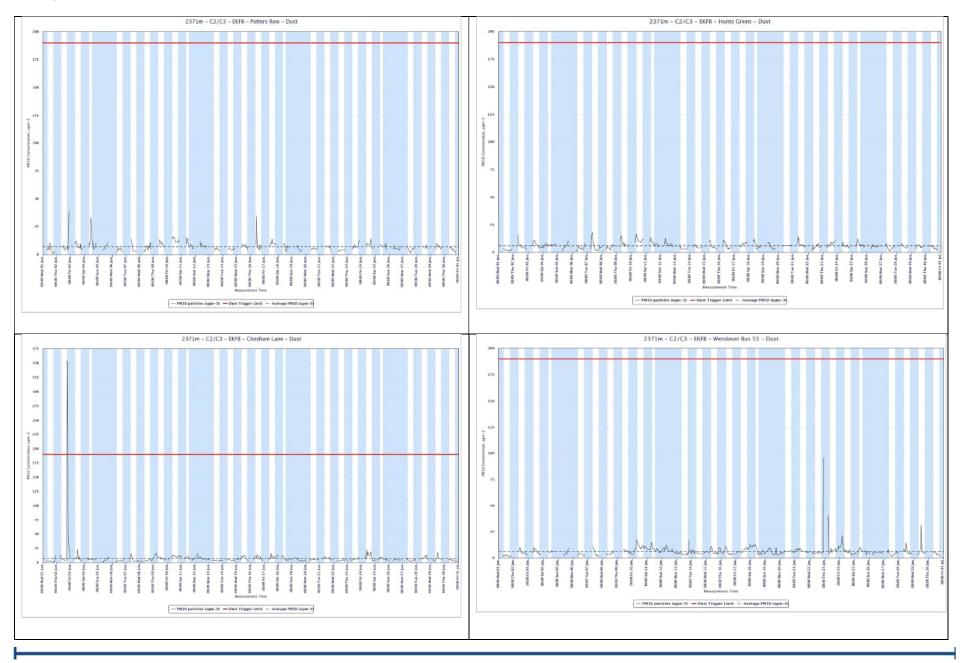
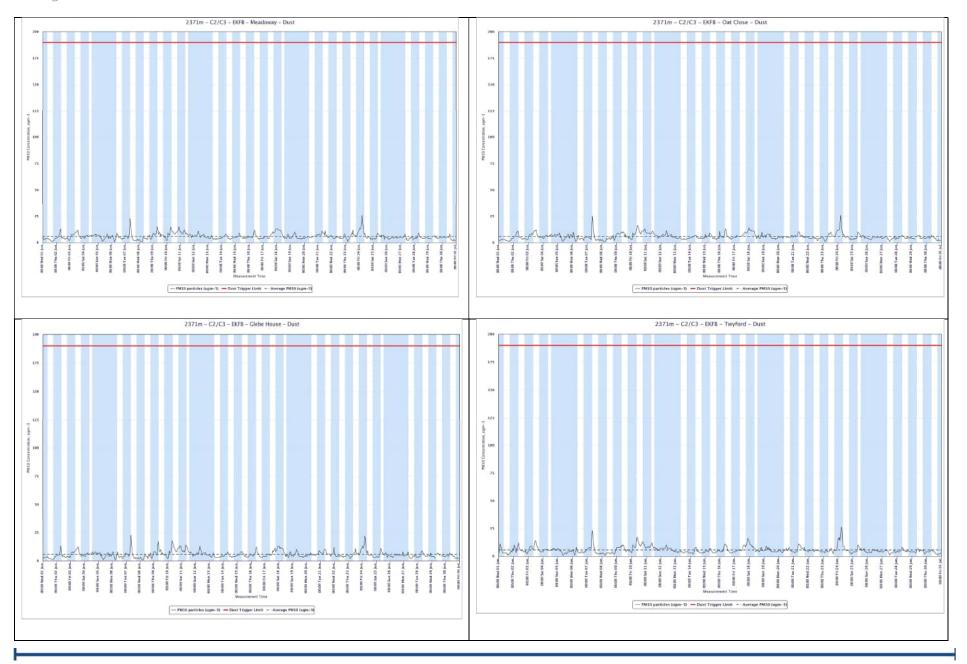
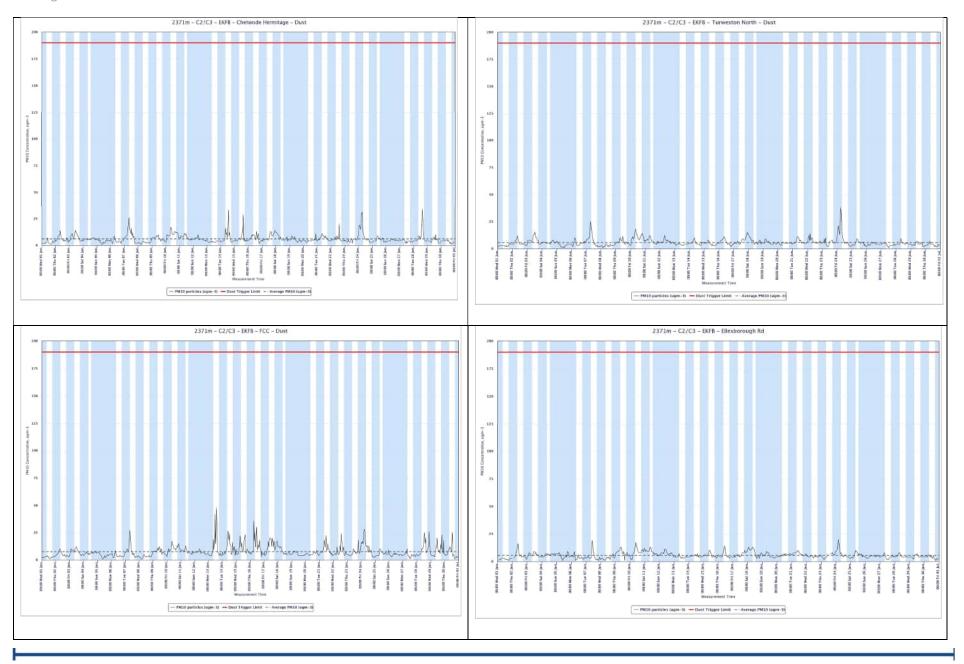
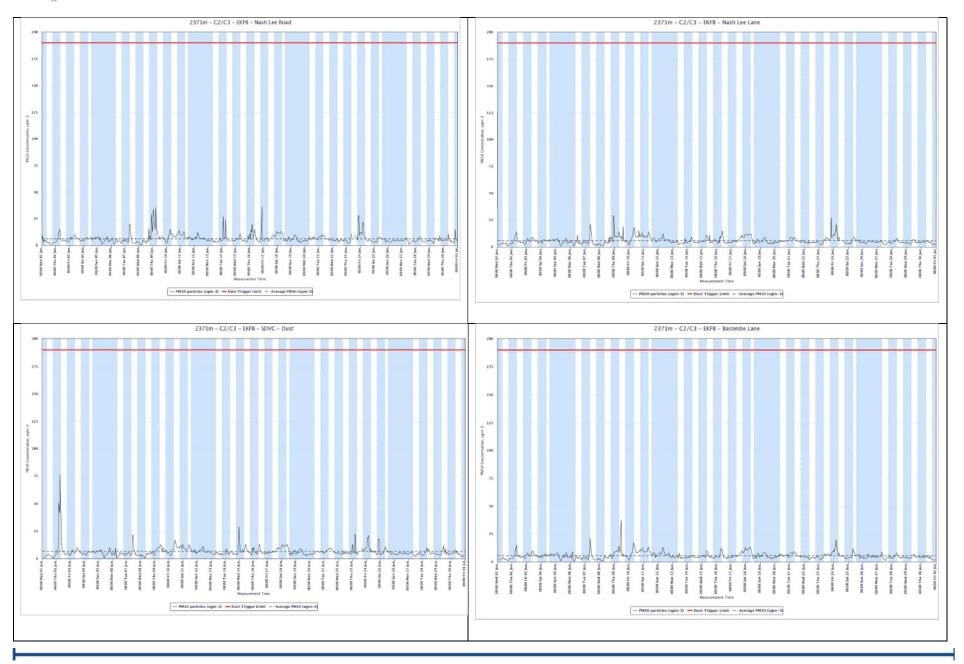
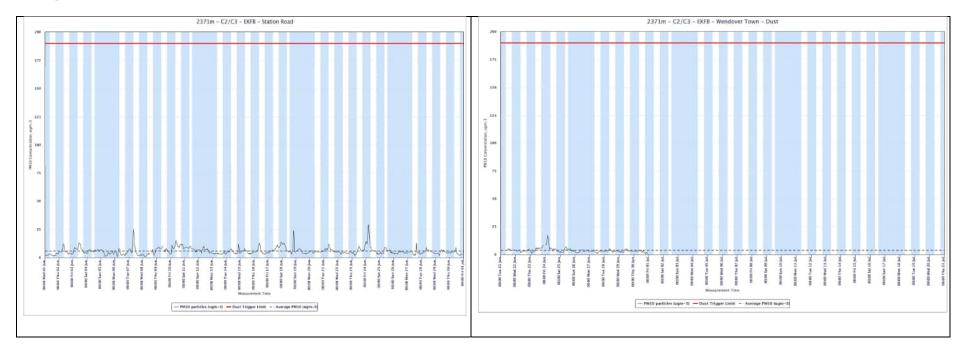
Figure 8: Continuous dust 1-hour mean indicative PM₁₀ concentration for all monitors

- 1.1.6 Dust monitoring locations and results for June 2022 are presented in Appendix B, Table 2, together with line charts of monthly data from each dust monitor presented in Figure 8. All continuous dust monitoring is undertaken using indicative monitors. Despite being Environment Agency (MCERTS) certified, indicative monitors carry a higher level of uncertainty than reference monitors, and therefore cannot be strictly compared with Air Quality Standards for human health and the environment. The purpose of the monitoring undertaken is to ensure the effectiveness of the on-site mitigation.

- 1.1.7 The trigger level for PM_{10} concentrations of 190 μ g/m³, measured as a 1-hour mean, in accordance with the updated guidance document 'Guidance on Monitoring in the Vicinity of Demolition and Construction Sites (October 2018)' has been applied.

Monitoring Site ID	Period of trigger alert &	Investigation	Outcomes / Resolution / Remedial measures implemented
	Concentration recorded		
Chesham Lane – Dust	02/06/22 18:00 - 18:59; 354 µg/m ³	No works undertaken by EKFB after 18:00h	N/A
Rosehill Farm – Dust	15/06/22 14:00 - 14:59; 216.3 μg/m ³	During this day, EKFB were moving materials (Subsoil/Topsoil) from Chetwode North Excavation to Twyford. The dust exceedance was recorded by Rosehill Farm monitoring, located 50m from the site access road. It was a particular dry day and works have to stop during the afternoon due to amount of dust.	activities were observed on site. Therefore, dust exceedances may have been generated by ADTs movement.
