August 2022

HS2

Construction Noise and Vibration Monthly Report – June 2022

Warwick District Council

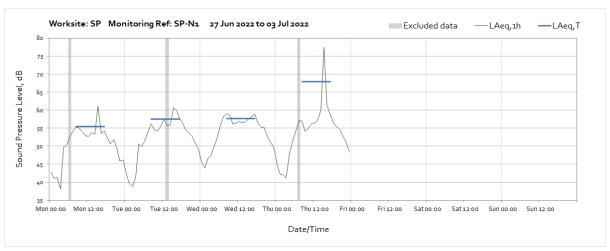
Worksite: SP - Monitoring Ref: SP-N2

Note: Noise monitor has been installed on 23rd June 2022.

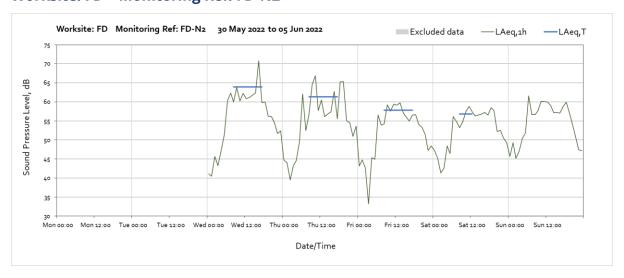
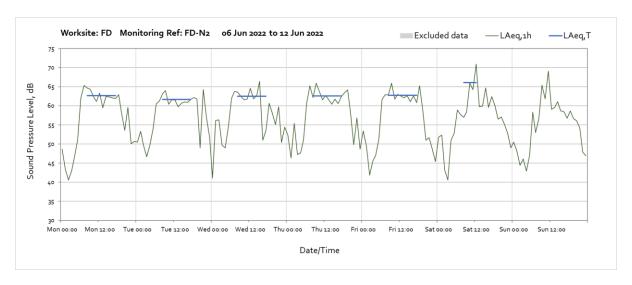
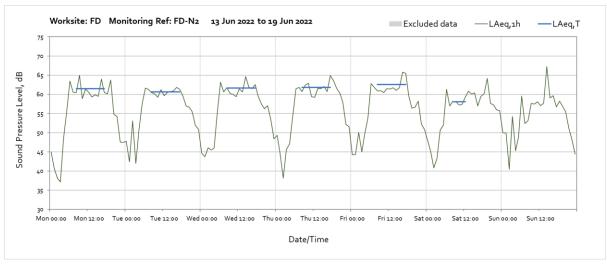
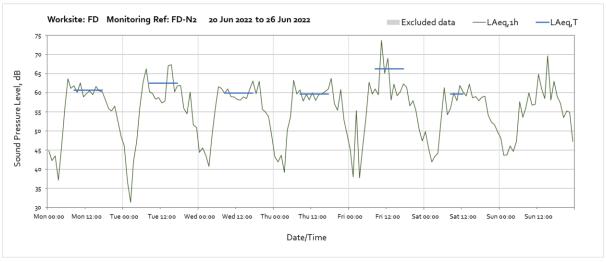
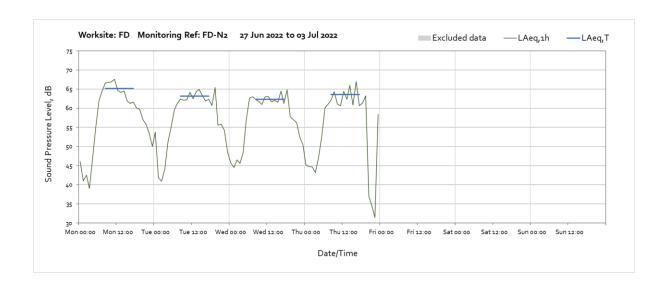
Worksite: FD - Monitoring Ref: FD-N2

2.2.8 One (1) night-time SOAEL exceedance at monitoring location ref.: FD-N2 was due to HS2 construction works during June 2022.

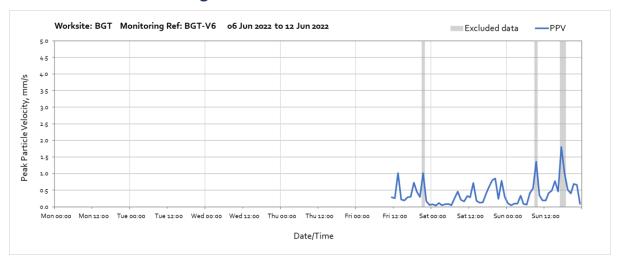
Worksite: BGT - Monitoring Ref: BGT-V6

Note: Vibration monitor has been installed on 10th June 2022. High PPV levels recorded on 10th and 12th June were not due to HS2 related construction activities but due to local disturbances.

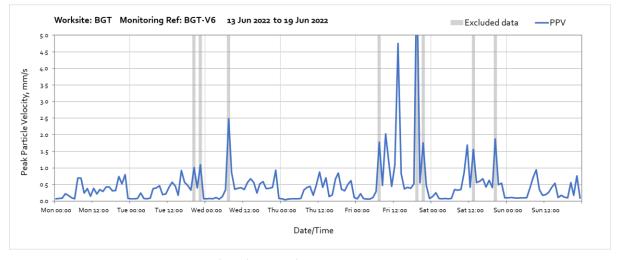
Note: High PPV levels recorded on 15th, 17th and 18th June 2022 (the greyed-out area) were not due to HS2 related construction activities but due to local disturbances. High PPV levels recorded on 17th were due to OFFICIAL

HS2 related construction activities such as stockpiling, Articulated Dumper Truck movement and haul road compaction.

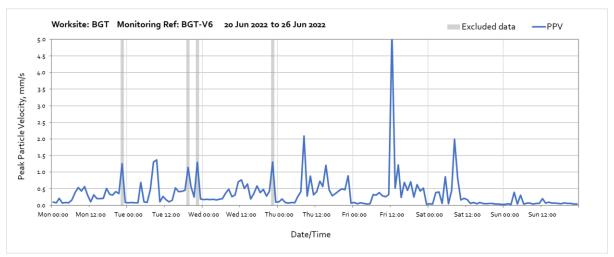
Note: High PPV levels recorded on 20th, 21st and 22nd June 2022 (the greyed-out area) were not due to HS2 related construction activities but due to local disturbances. High PPV levels recorded on 21st, 23rd, 24th and 25th June 2022 were due to HS2 related construction activities such as stockpiling, Articulated Dumper Truck movement and haul road compaction.
