SAFETY ALERT:

Subject: Standing Seam Roofs

Number: SA 2022-09

Standing Seam Roofs

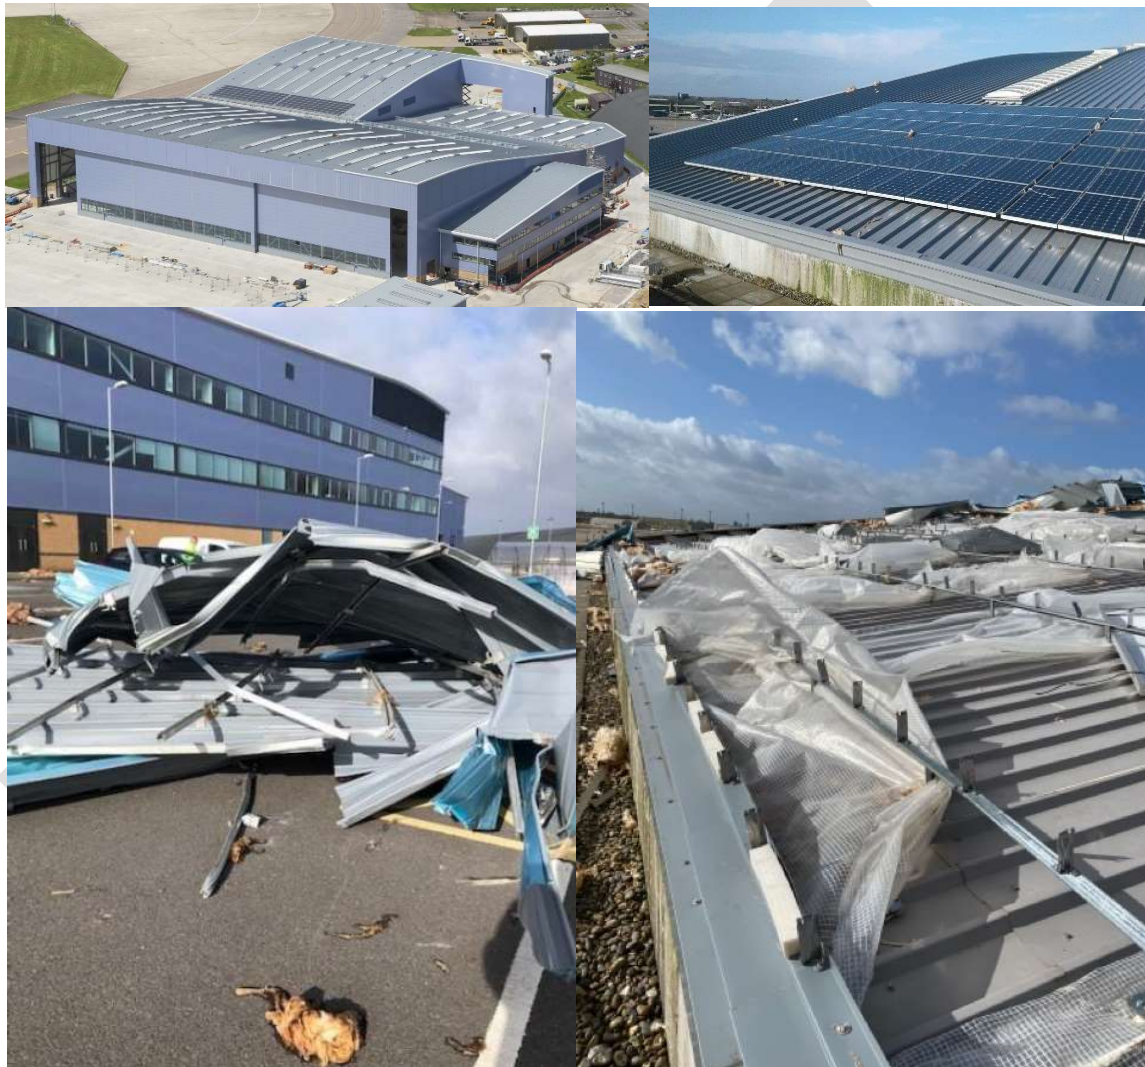
A standing seam roof is constructed of narrow metal cladding panels which may be well over 25m long and extended further using welded splices. Each panel is attached to its neighbour by a rolled seam which is formed during installation. Panels are secured to the structure below by halter clips, which are held captive within the rolled seam. The heads of the clip are a loose fit within the seam connection which allows the roof to expand and contract as temperature varies. – An example of this detail is shown in figure 1.

N.B – Section detail of Euroseam
ECZIP-SS110 stainless steel halter
Within a zipped Euroseam sheet.

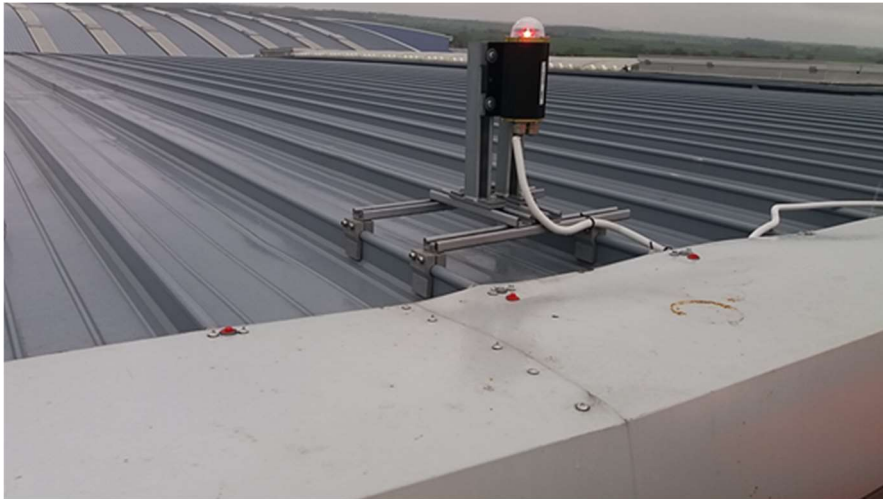
- A) The fixtures on a standing seam roof are hidden. This makes it extremely difficult if not impossible for an inspector to identify defects to the fixings and halter clip connections. – It is not possible to comply with the minimum inspection requirements specified by BS5427 section 8.1 table 16.

Figure 2: The fixings for the grey cladding are not visible to an inspector

- B) Examples of defects to the connections which may remain hidden include:
- c. missing or damaged screws to the base of the halter clip.
 - d. halter clips which are not fully engaged with the seams
 - e. excessive wear to the inside of the cladding at the point of contact with the halter clip.
 - f. corrosion to fixings or steelwork.
- C) The only way to confirm items a, c and d is by unzipping the seams of the roof, removing the cladding and then reinstalling. –It is not possible to remove small sections of cladding or to open seams in the middle of a standing seam roof under tension. Checks would amount to complete removal and reinstallation of the cladding system.
- D) Given that connections may be prone to degradation over time and the connections cannot be adequately inspected, older roofs may be at very high risk of failure.
