PHASE 1 DESK STUDY AND PHASE 2 INTRUSIVE INVESTIGATION; INTERPRETATIVE REPORT

Northstowe Phase 2 – Phase 2B

JANUARY 2020

Report No 10018973-ARC-XX-XX-RP-YY-0004-03-Ph2B interpretative report

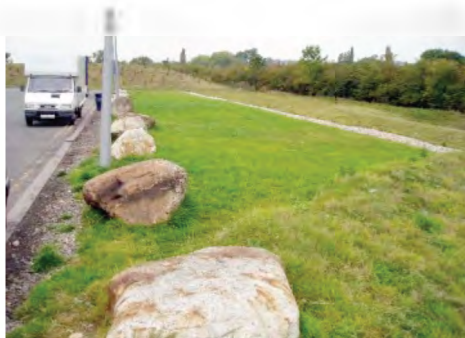
FILTER STRIPS

Filter strips are uniformly graded and gently sloping strips of grass or other dense vegetation that are designed to treat runoff from adjacent impermeable areas by promoting sedimentation, filtration and infiltration.

Location and Use on Site: Highways will drain via filter-strips into larger conveyance swales bordering the site.
