IN SITU PIEZO CONE PENETRATION TEST
 SITE INVESTIGATION CPT 1205
 insitusi.com

Client: **ARCADIS**
 Job Title: **OAKINGTON, CAMBRIDGESHIRE**

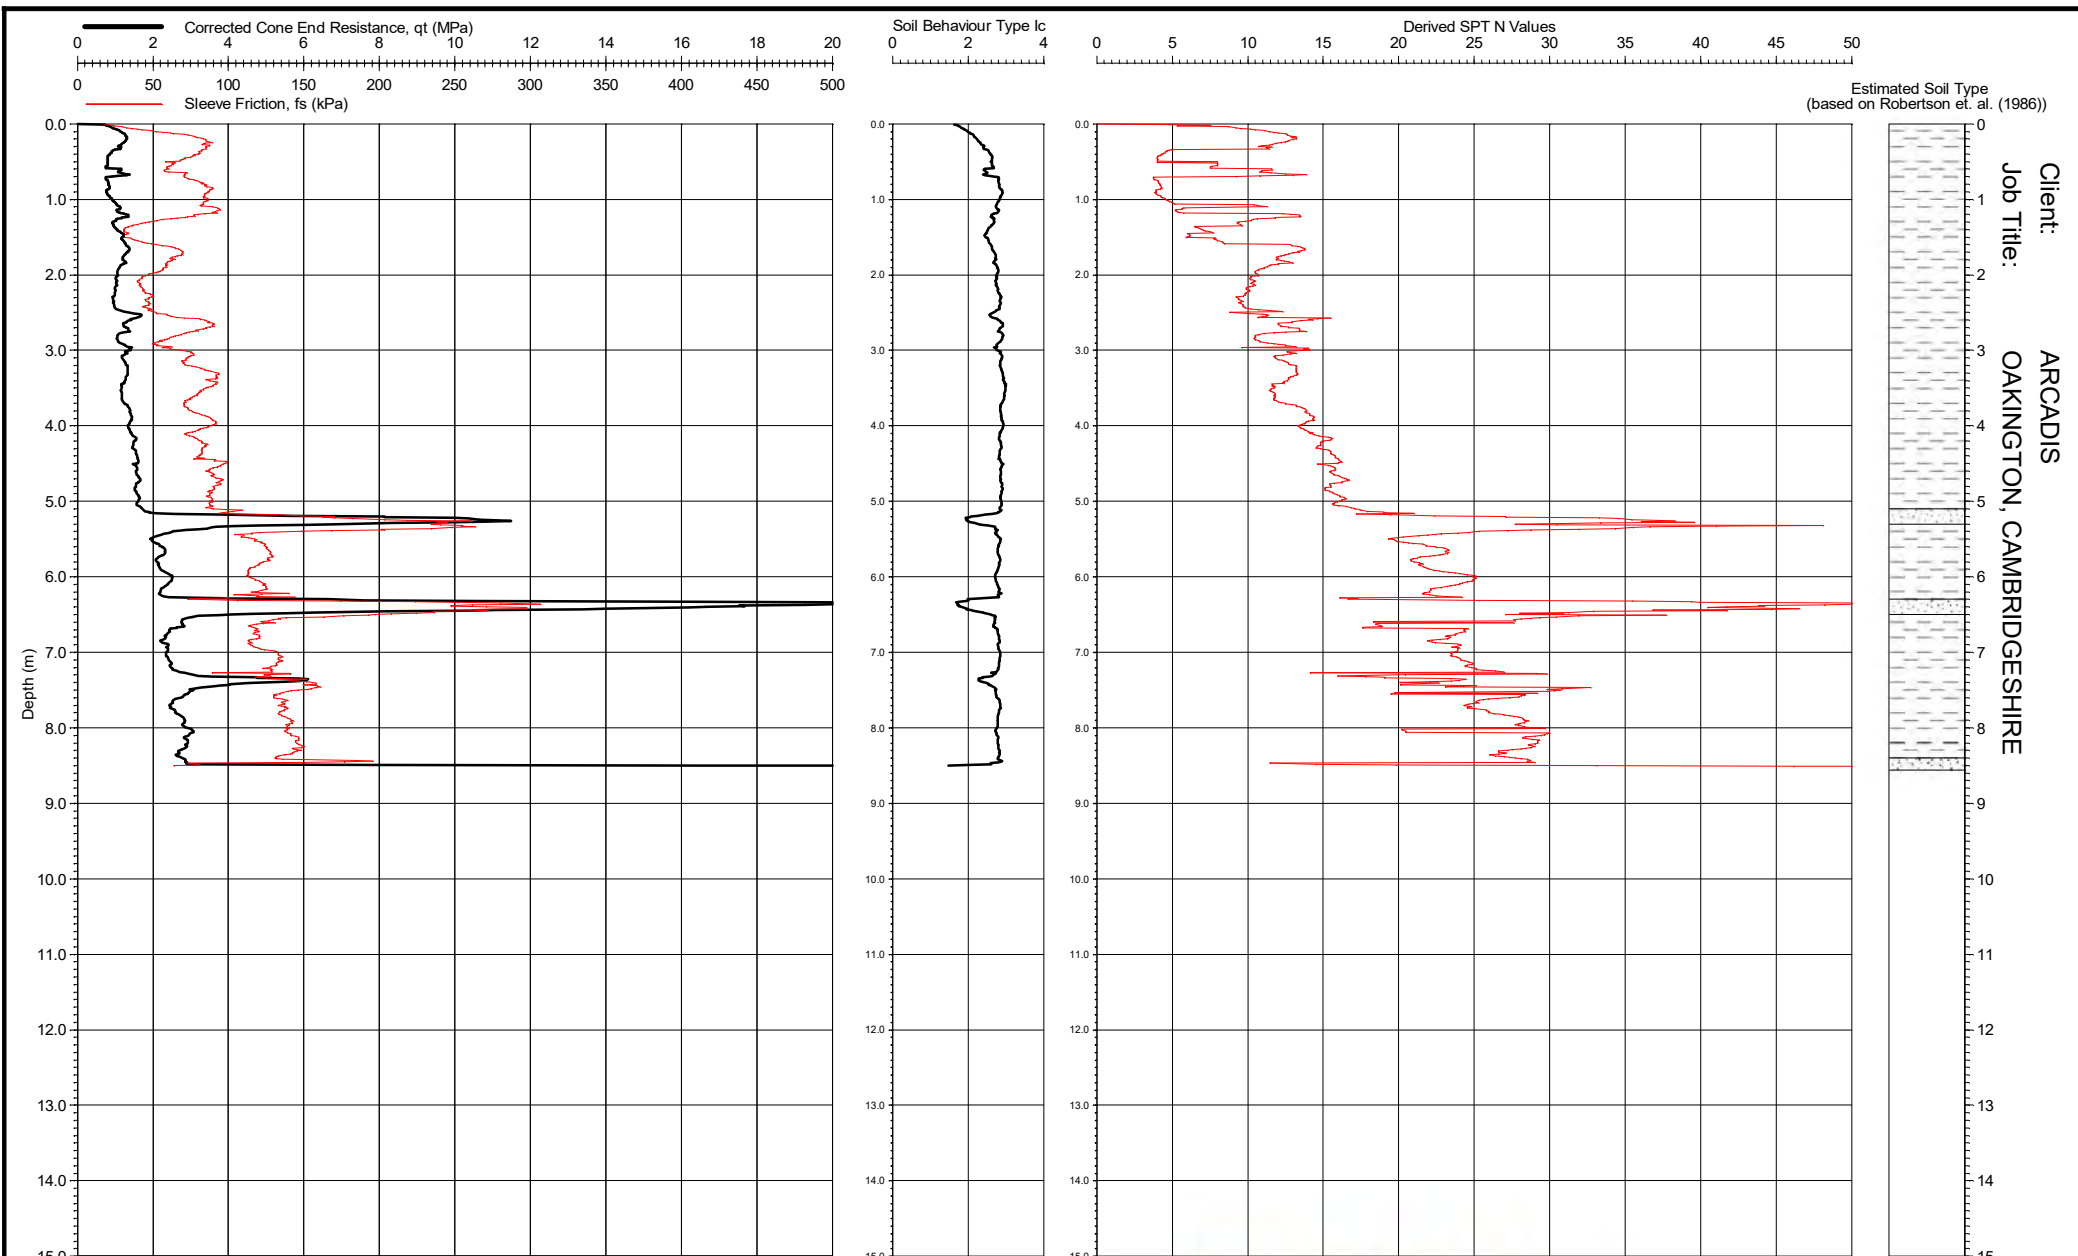
Location: Oakington
 Coordinates: -
 Ground Level: -
 Cone & Rig Used: S15-CFIP.1458 - CPT 007
 Remarks: Test refused on total pressure.

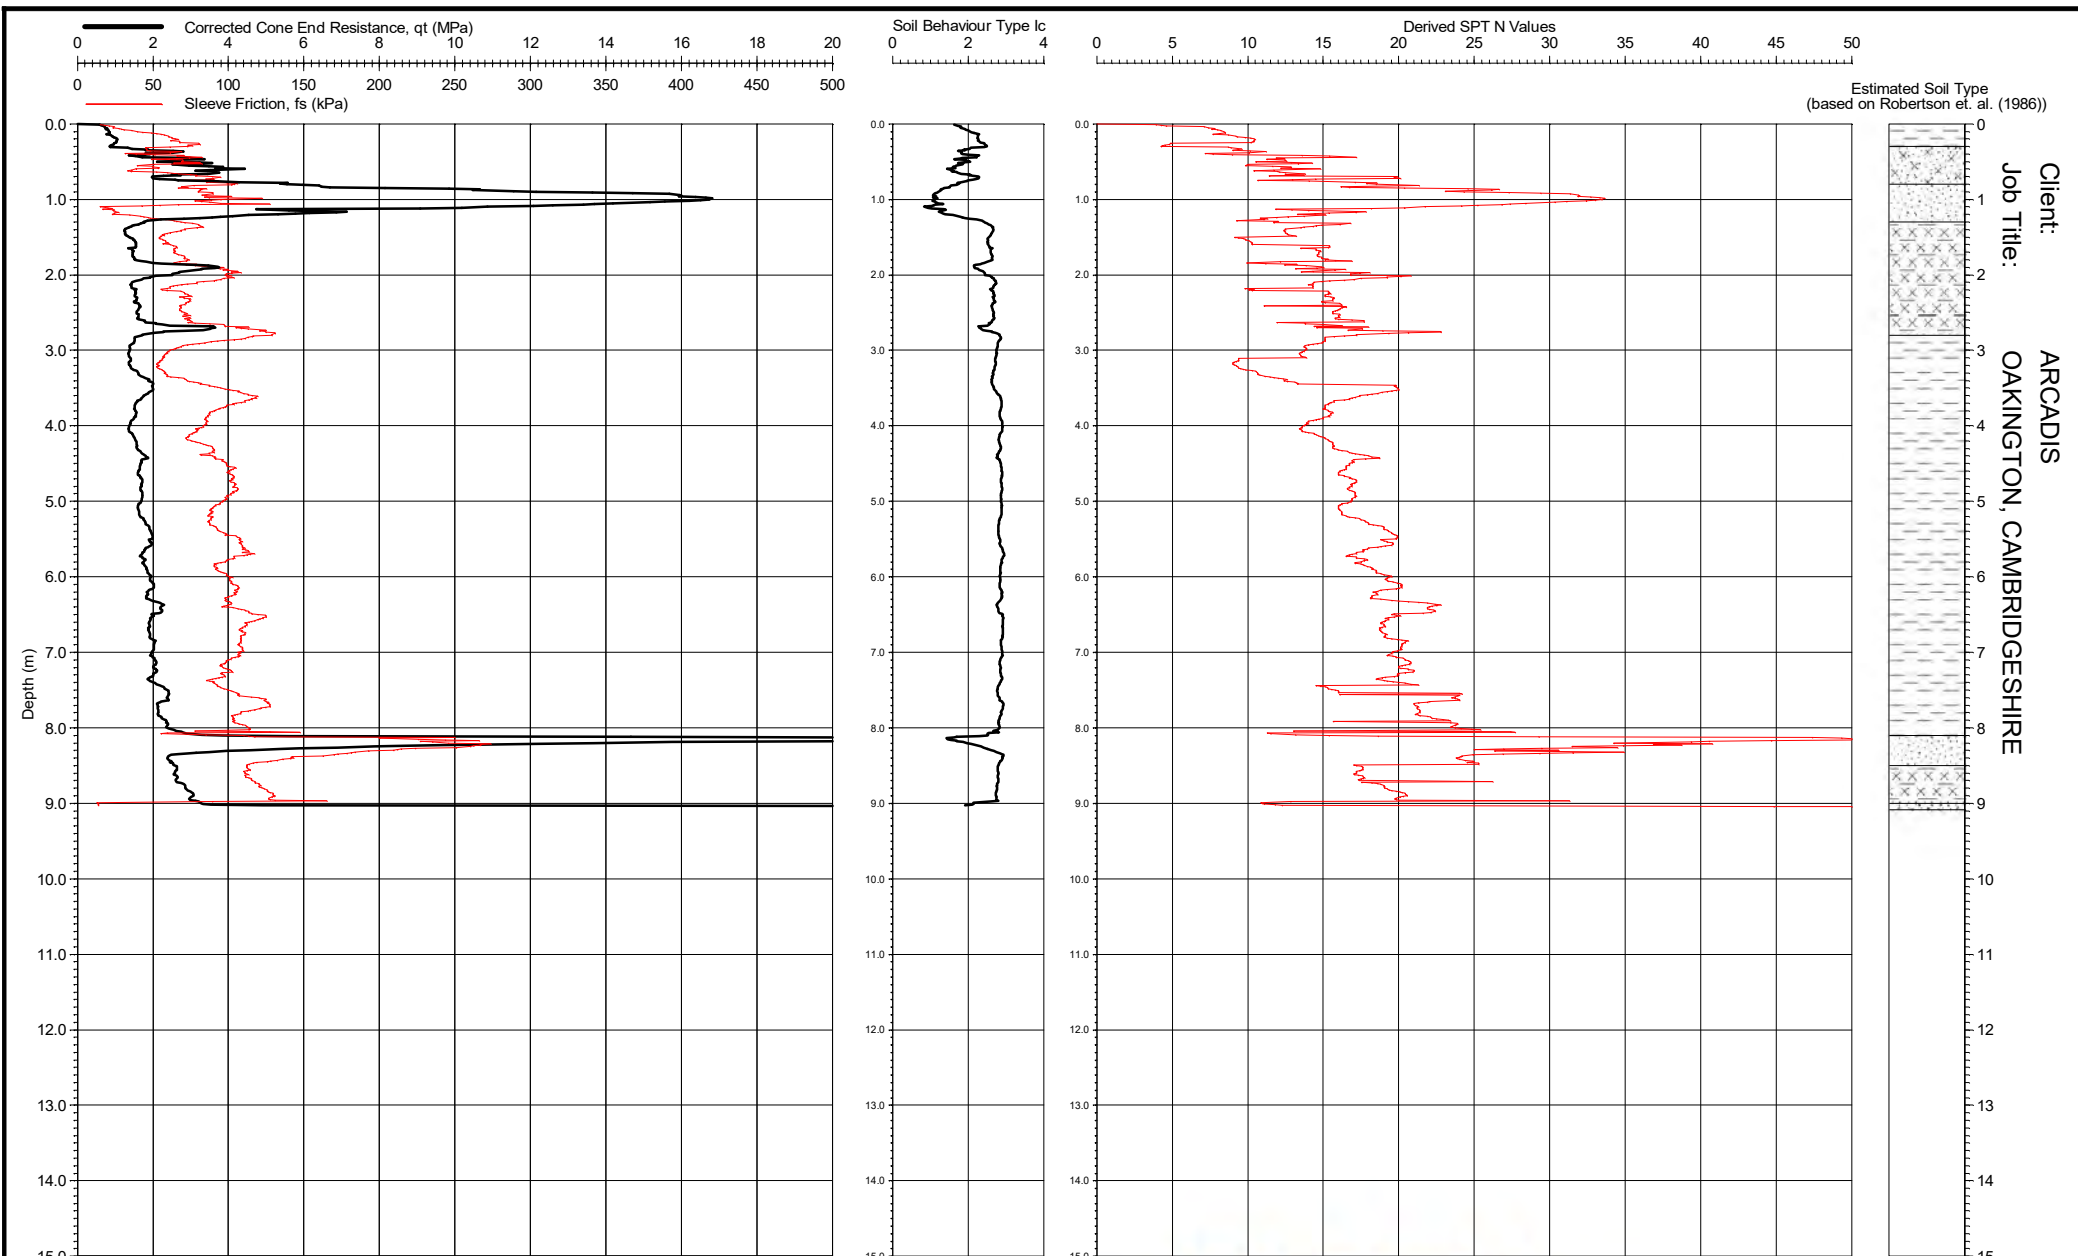
IN SITU PIEZO CONE PENETRATION TEST
 SITE INVESTIGATION CPT 1210
 insitusi.com

Location: Oakington
 Coordinates: -
 Ground Level: -
 Cone & Rig Used: S15-CFIP.1458 - CPT 007
 Remarks: Test refused on total pressure.
