NORTHSTOWE PHASE 2

Ground Investigation Report

April 2017

Report No UA008426-AFS-GLR-G001

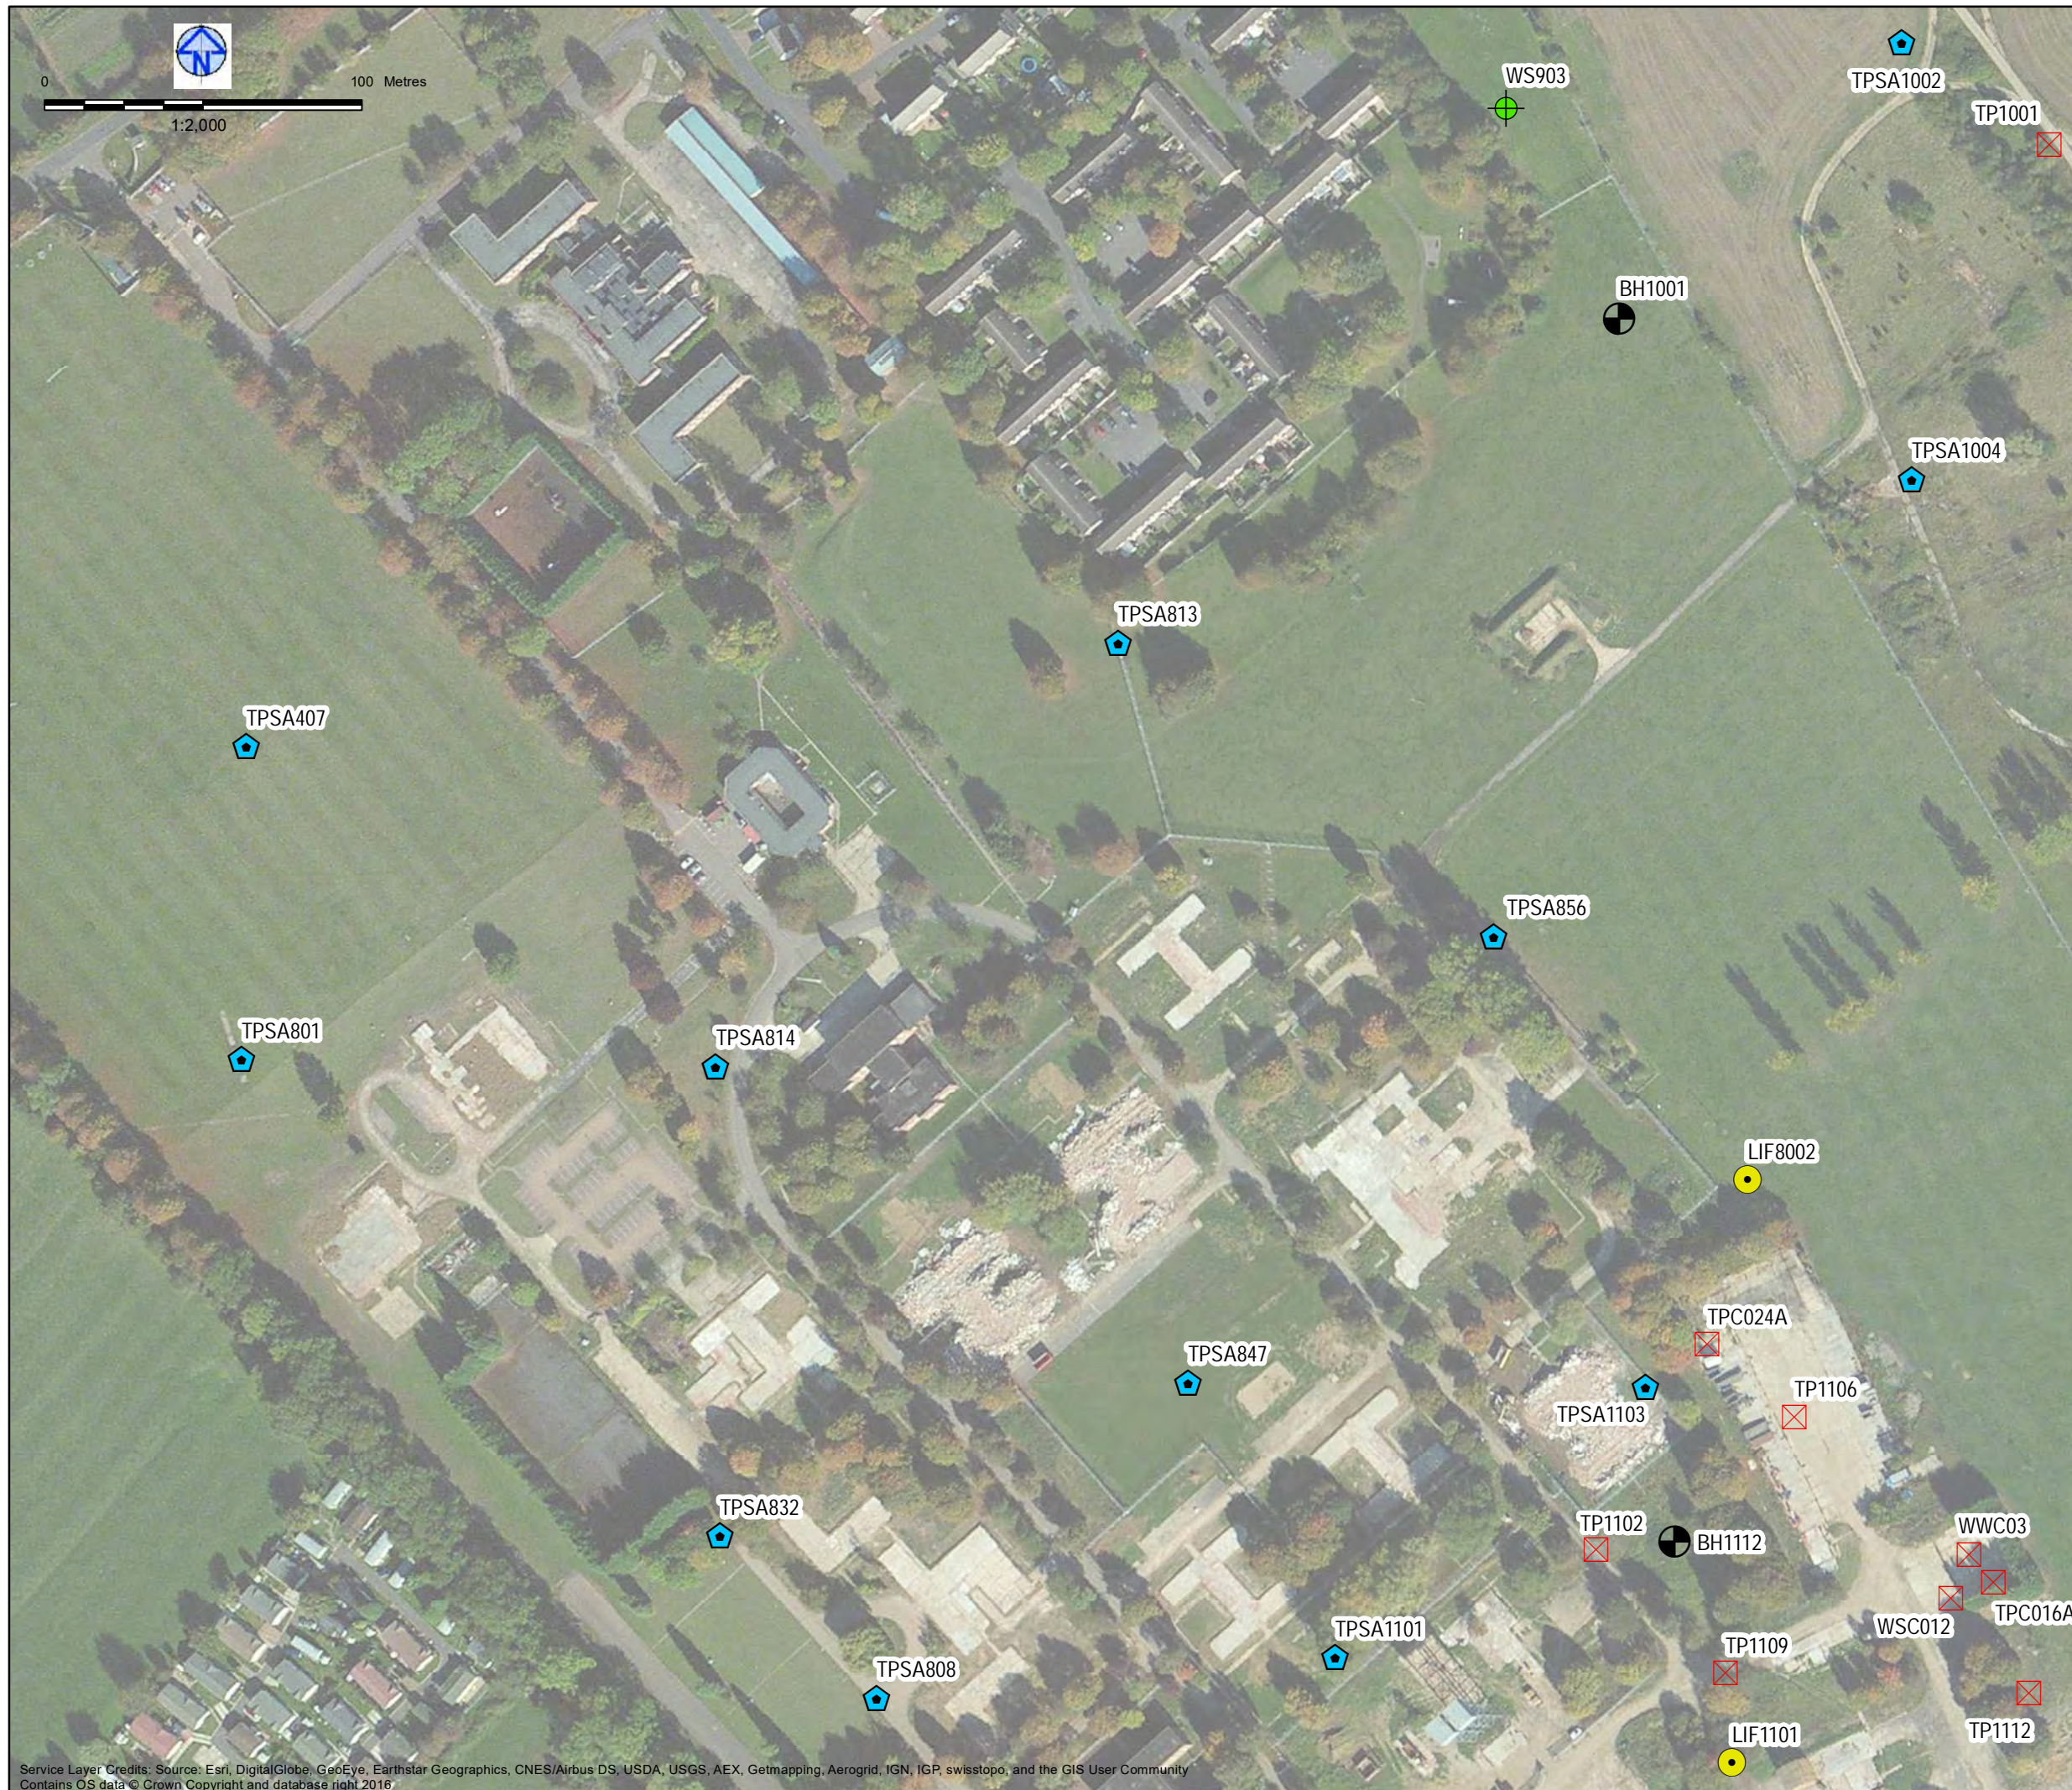
Drawing Number:	UA008426-07-13-GLR-EHP-0001	Revision:	01
-----------------	-----------------------------	-----------	----

- Cable Percussion Borehole
- LIF
- Trial Pit
- Trial Pit with soakway
- Windowless Sample

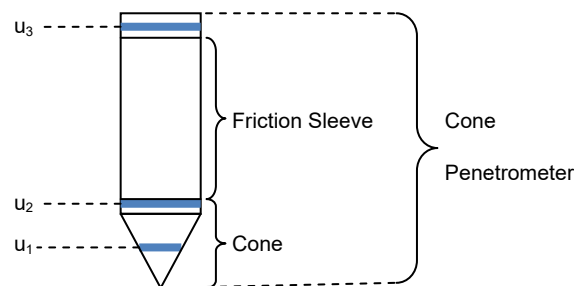
Figure 3.2: Diagram showing pore pressure filter locations (after Lunne *et al.*, 1997)

The filter element can be mounted in one of three positions. For the tests carried out in this report the filter was mounted in the u_2 , or shoulder position (see figure 3.2)

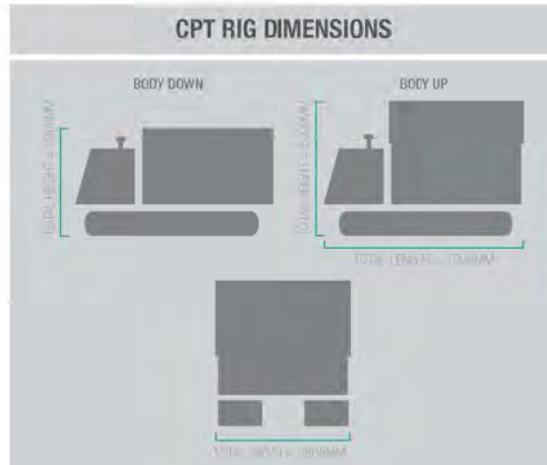
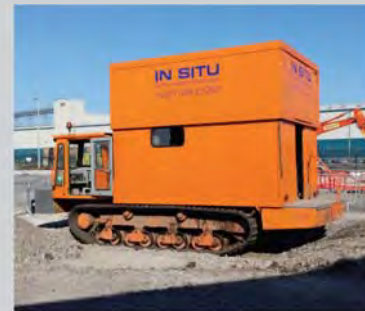
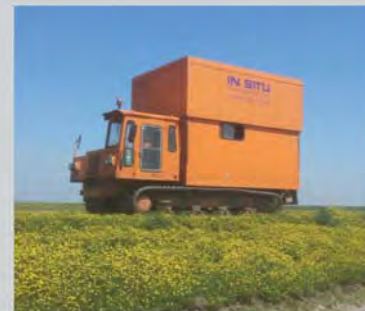
CPT RIG DETAILS	
DRIVE SYSTEM	RUBBER TRACKED
TOTAL WEIGHT	20 TONNES
GROUND BEARING PRESSURE	35KPA
CPT RAM THRUST CAPACITY	20 TONNES
MAXIMUM PENETRATION	30-40M DEPENDING ON THE GROUND CONDITIONS
PERFORMANCE RATES	100-150M OF TESTING IN A DAY DEPENDING ON ACCESS TO POSITIONS
TYPICAL SITES FOR THIS RIG	SOFT BOGGY SITES. THE RIG HAS LOW GROUND BEARING PRESSURE.

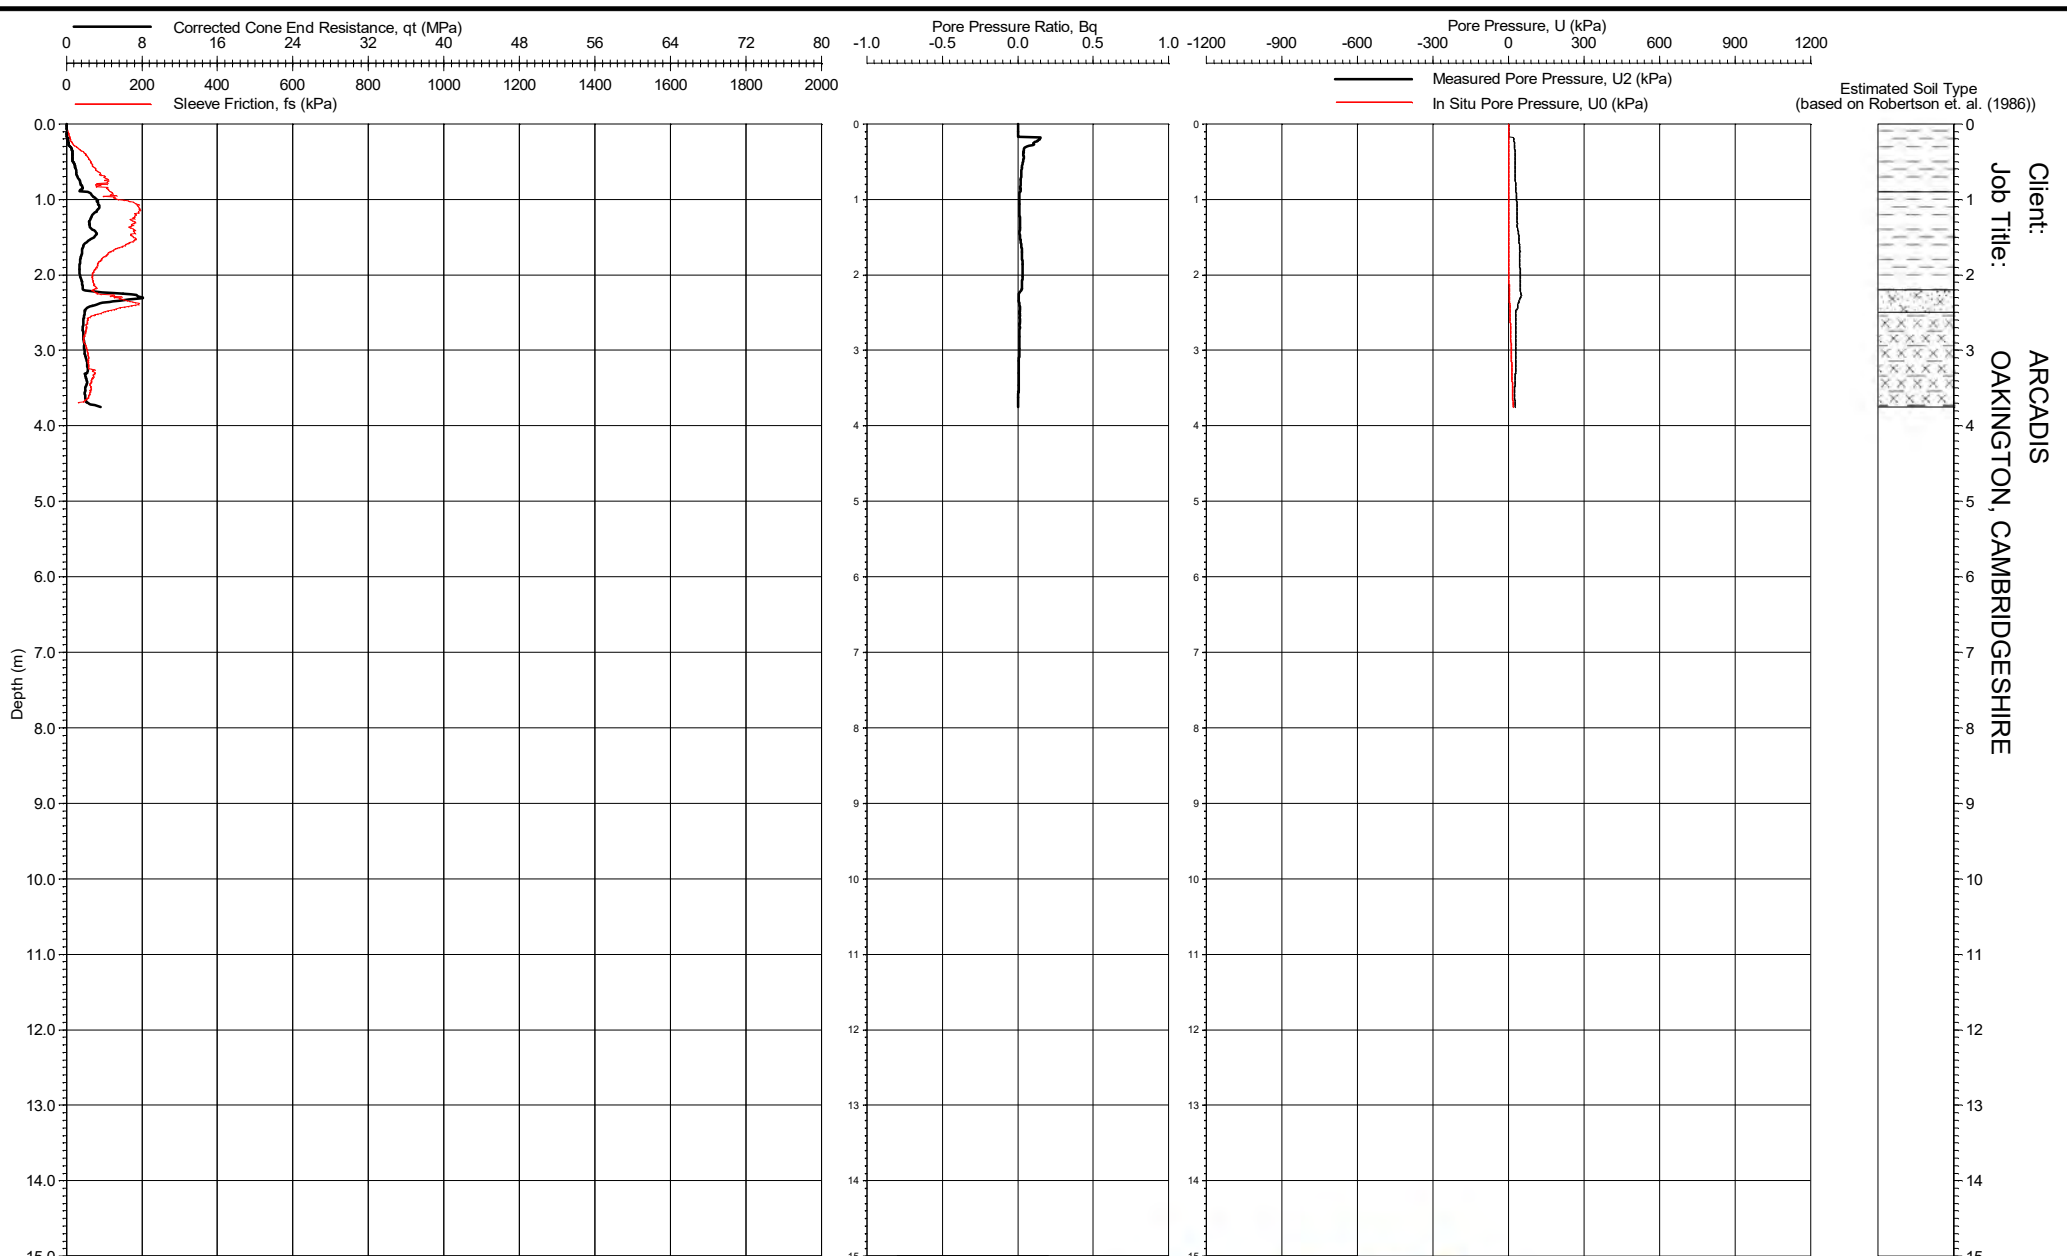
PIEZO CONE PENETRATION TEST
CPT 1212
insitushi.com
 Form: CPT0001

Location: Oakington
 Coordinates: -
 Ground Level: -
 Cone & Rig Used: S15-CFIP.1032 - CPT 001
 Remarks: Test refused on total pressure.
