PROJECT: NORTHSTOWE REMEDIAL STRATEGY

LOCATION OF ORGANICS EXCEEDANCES IN GROUNDWATER SAMPLES (ARCADIS ROUND 1 & 2)

# **NORTHSTOWE – PARCEL 2A**

July 2018

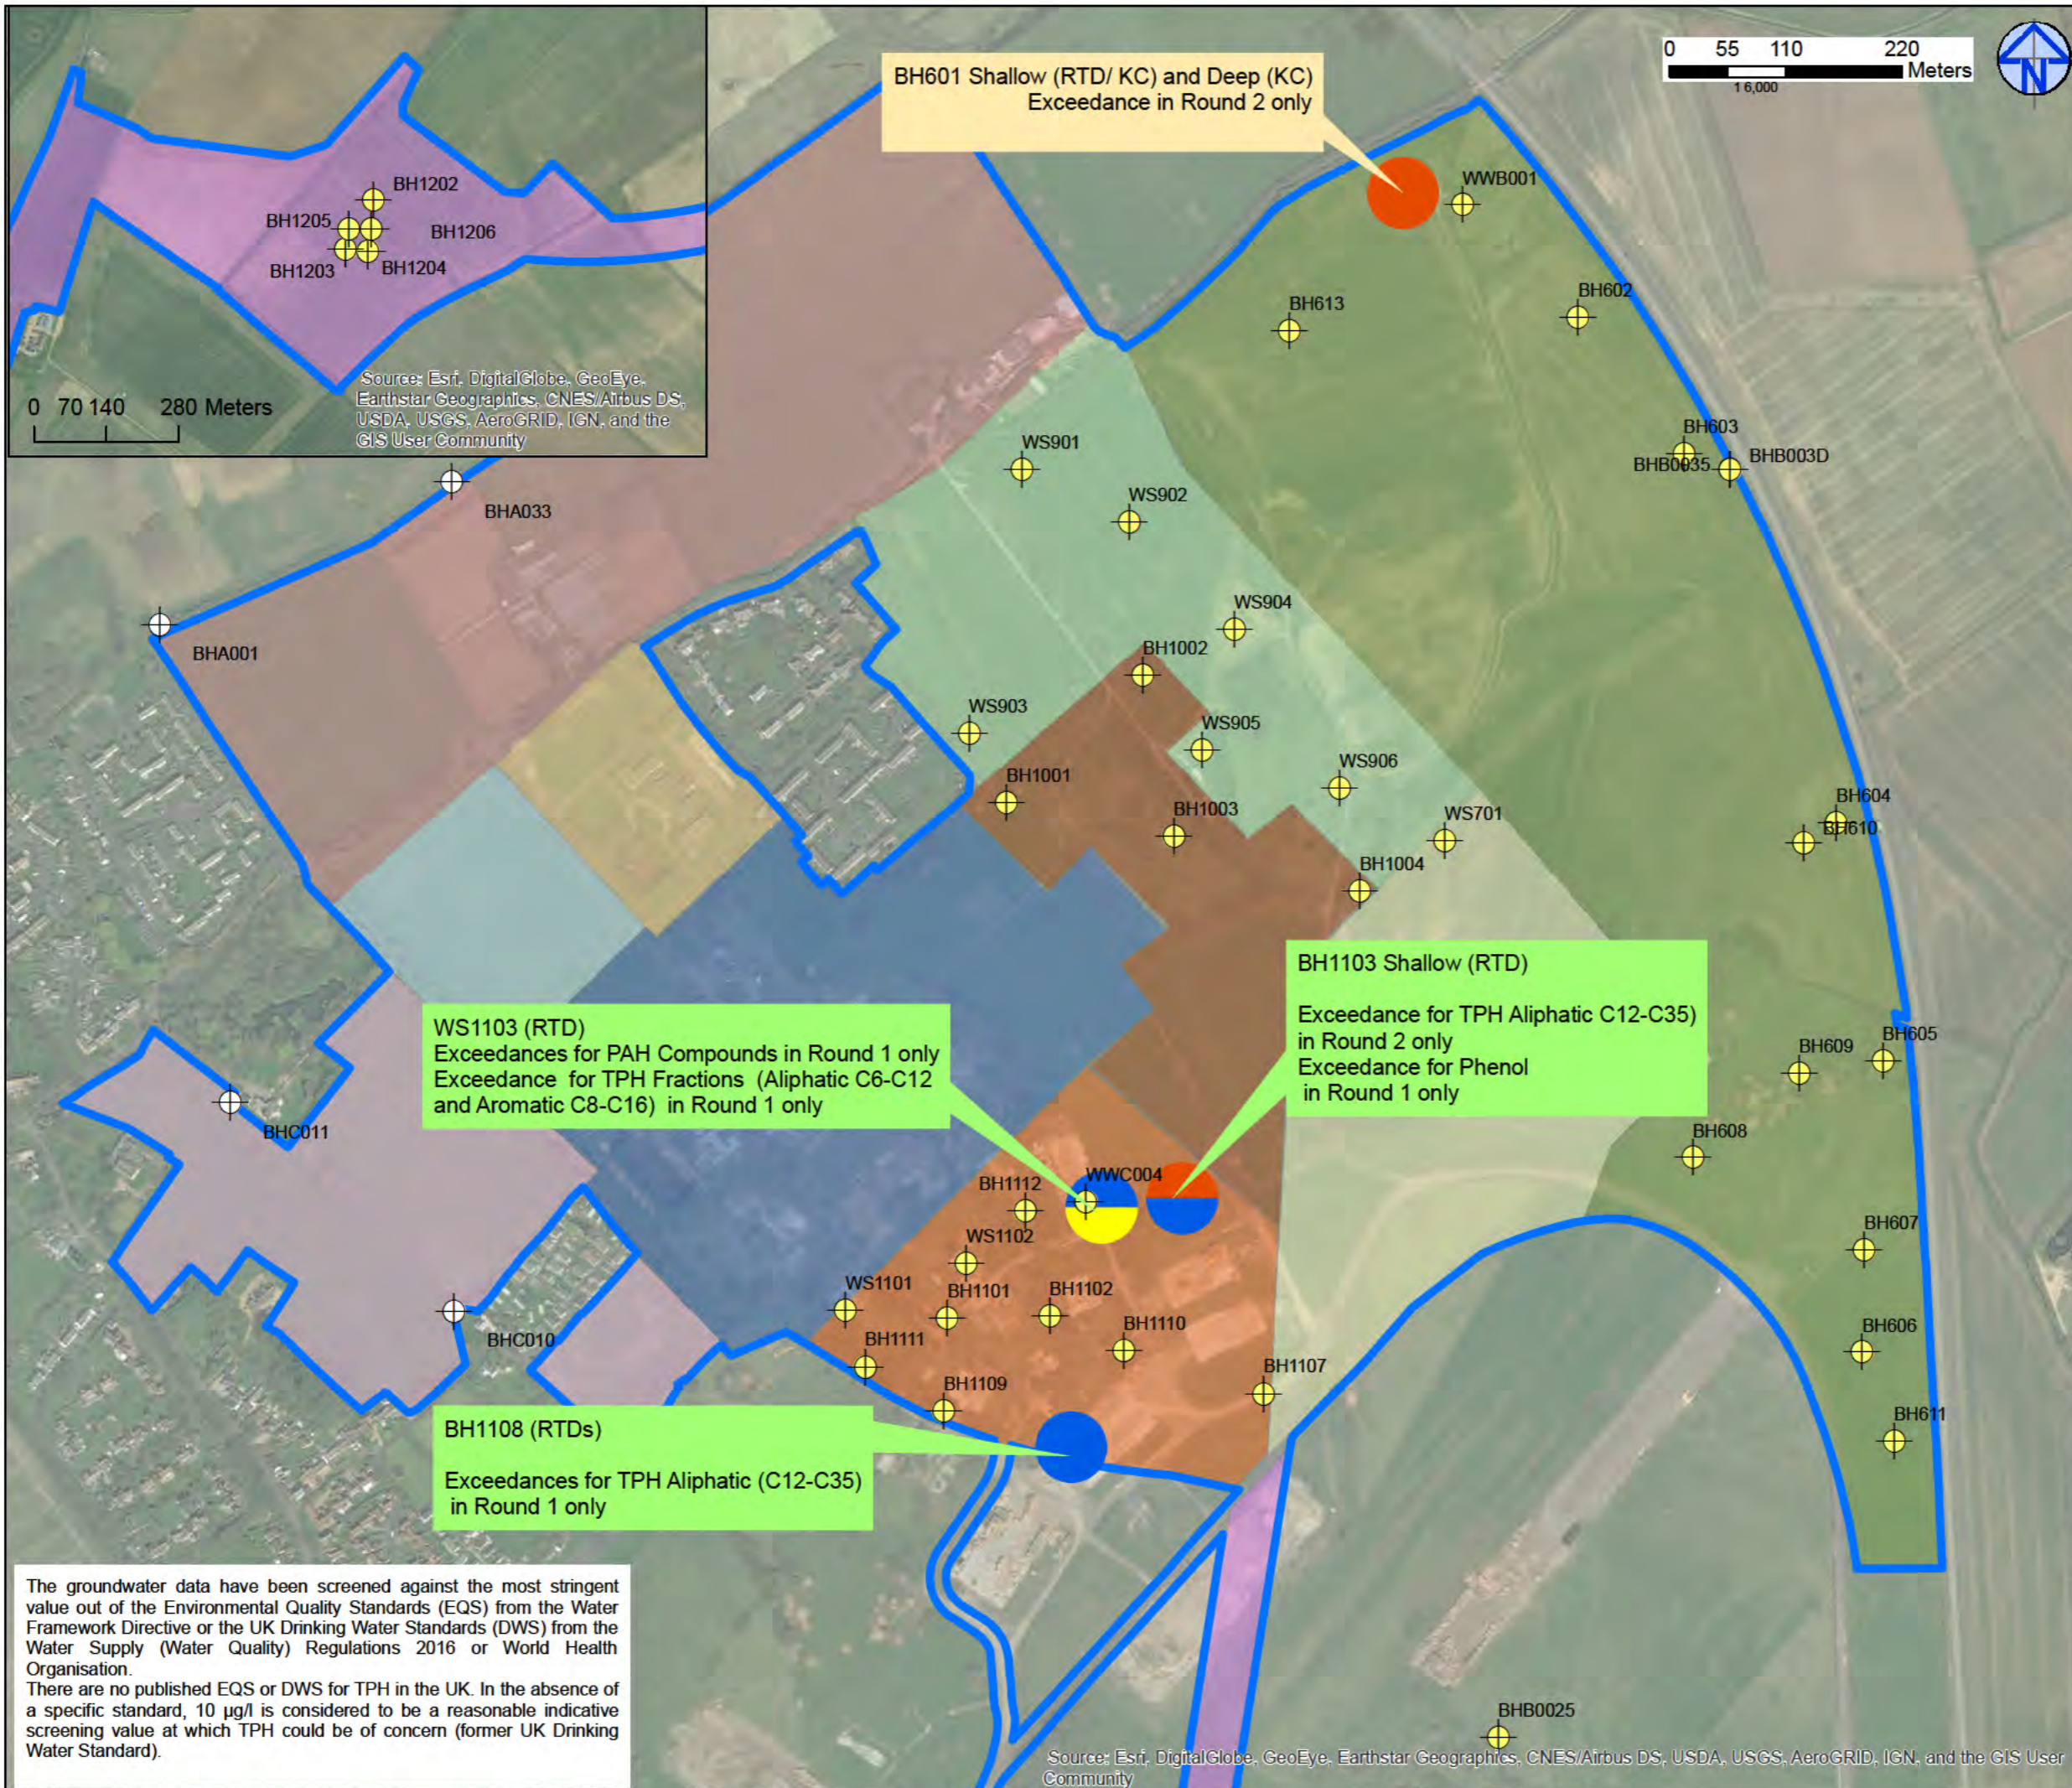
Drawing Number: Figure 7

The groundwater data have been screened against the most stringent value out of the Environmental Quality Standards (EQS) from the Water Framework Directive or the UK Drinking Water Standards (DWS) from the Water Supply (Water Quality) Regulations 2016 or World Health Organisation.

There are no published EQS or DWS for TPH in the UK. In the absence of a specific standard, 10 µg/l is considered to be a reasonable indicative screening value at which TPH could be of concern (former UK Drinking Water Standard).

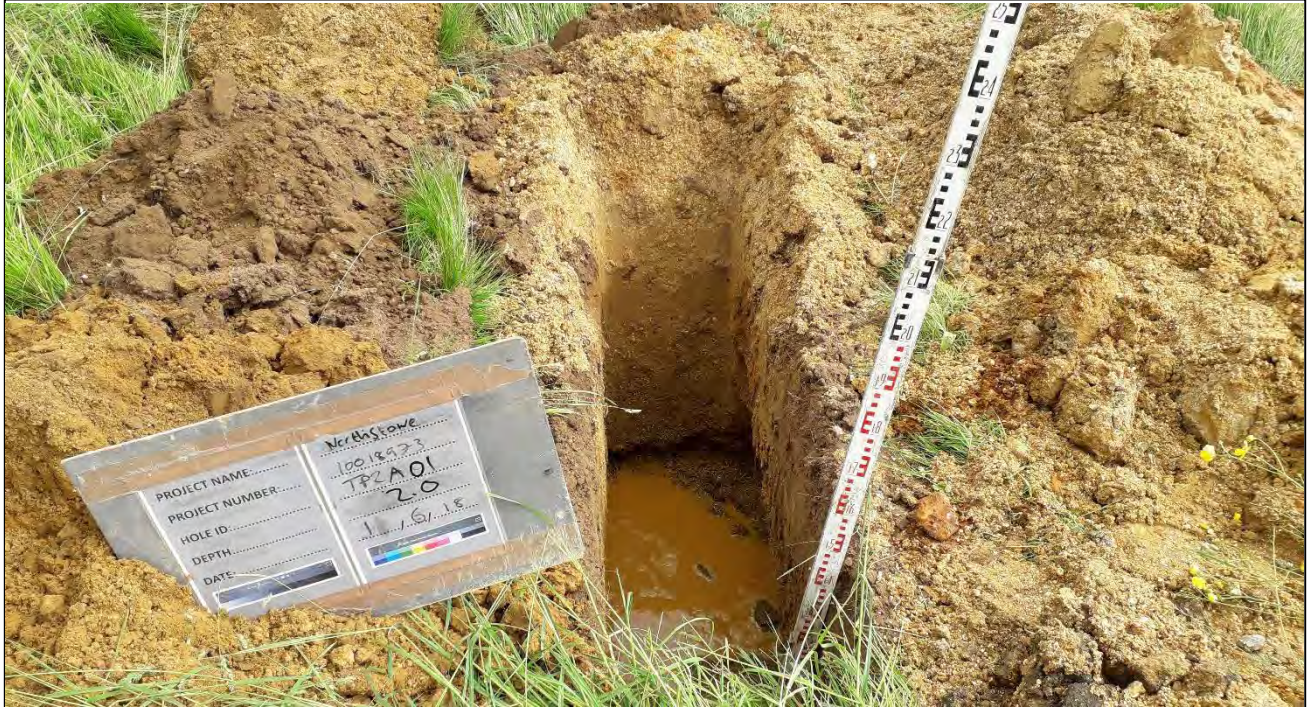
**TP2A01 Trial Pit. Depth 2.0m**

<p><b>PLAN DETAILS</b></p> <p>Long Axis Orientation:</p> <p>Shoring / Support: None</p> <p>Stability: Poor</p> <p>Groundwater (description):</p>	<p><b>Remarks</b></p> <p>Water strike at 1.0mbgl. Trial Pit terminated due to side wall collapse. Please refer to attached sketch for greater detail regarding discontinuity. PID results not included as equipment became moisture sensitive.</p> <p>Termination Depth: <b>2.00m</b></p>
--	---

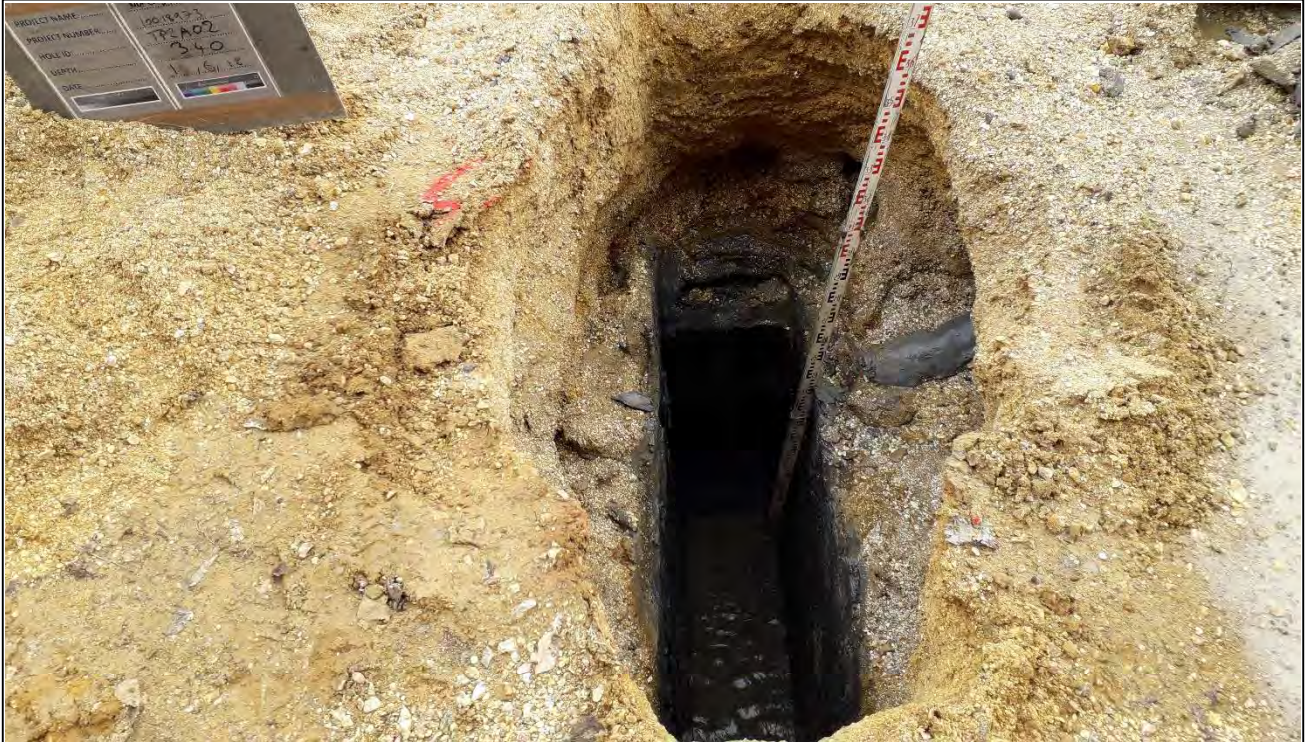
**TP2A02 Trial Pit. Depth 3.40m**

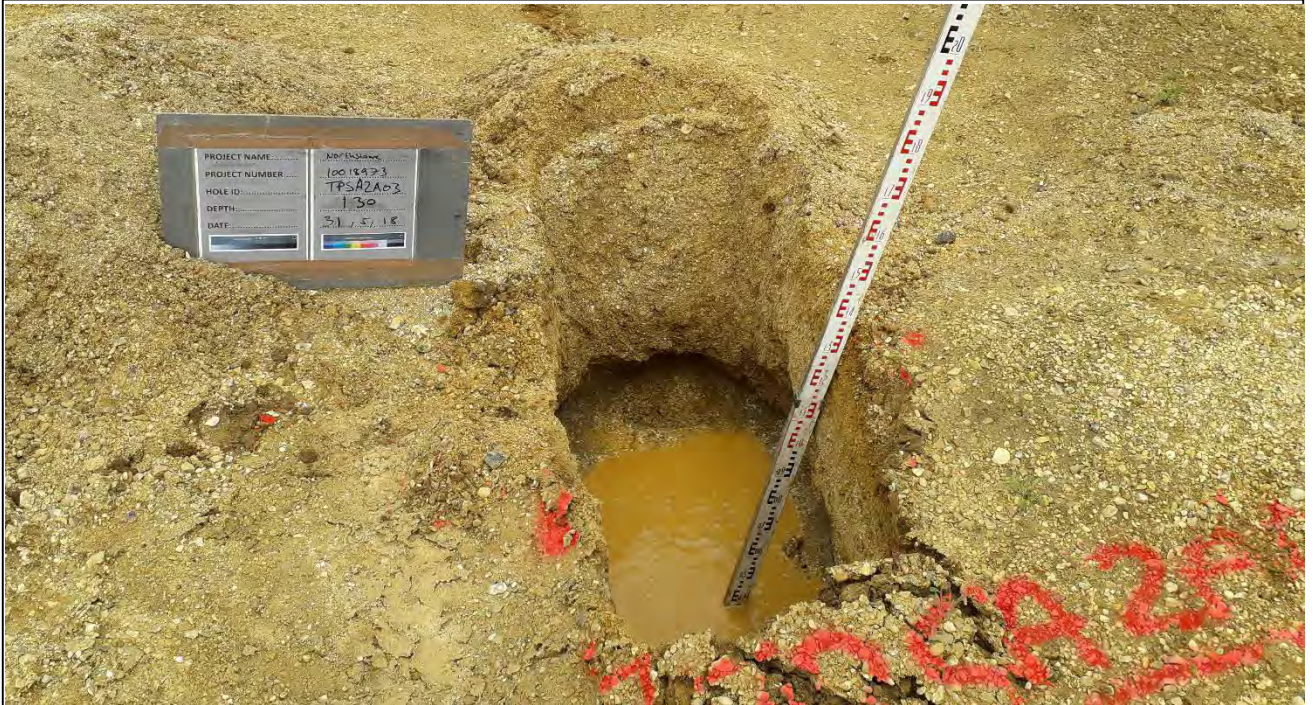
**TPSA2A03 Trial Pit. Depth 1.30m**

<p><b>PLAN DETAILS</b></p> <p>Long Axis Orientation:</p> <p>Shoring / Support: None</p> <p>Stability: Poor</p> <p>Groundwater (description):</p>	<p><b>Remarks</b></p> <p>Trial Pit terminated due to side wall collapse. Water strike at 0.85mbgl, and clay at 1.2mbgl made the pit unsuitable for soakaway testing. Trial Pit backfilled and moved 3m east and named TPSA2A03A. PID results not included as equipment became moisture sensitive.</p> <p>Termination Depth: <b>1.30m</b></p>
--	--

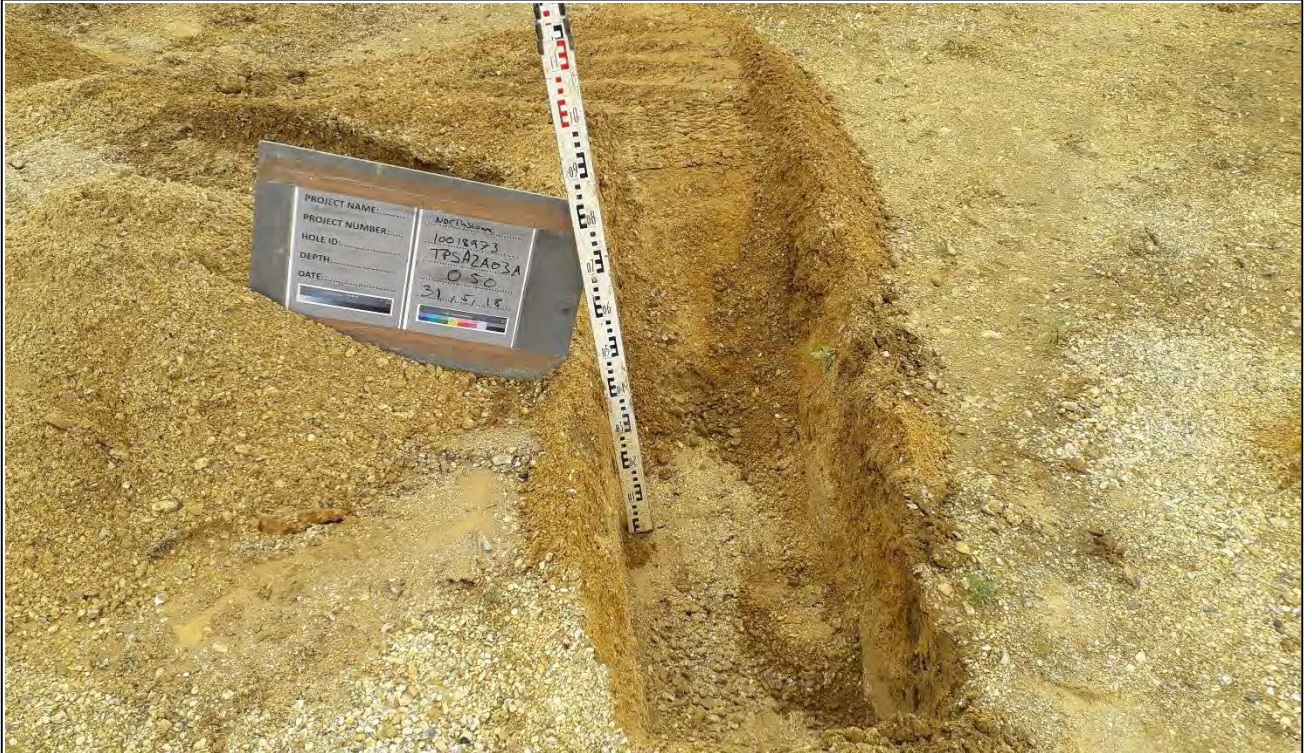
**TPSA2A03A Trial Pit. Depth 0.50m**

<p><b>PLAN DETAILS</b></p> <p>Long Axis Orientation:</p> <p>Shoring / Support: None</p> <p>Stability: Poor</p> <p>Groundwater (description):</p>	<p><b>Remarks</b></p> <p>Trial Pit terminated above clay at 0.50mbgl in order to preform soakaway test. Roughly 0.50m of soil stripped by archaeologists at location exposing river terrace deposits. PID results not included as equipment became moisture sensitive.</p> <p>Termination Depth: <b>0.50m</b></p>
--	---

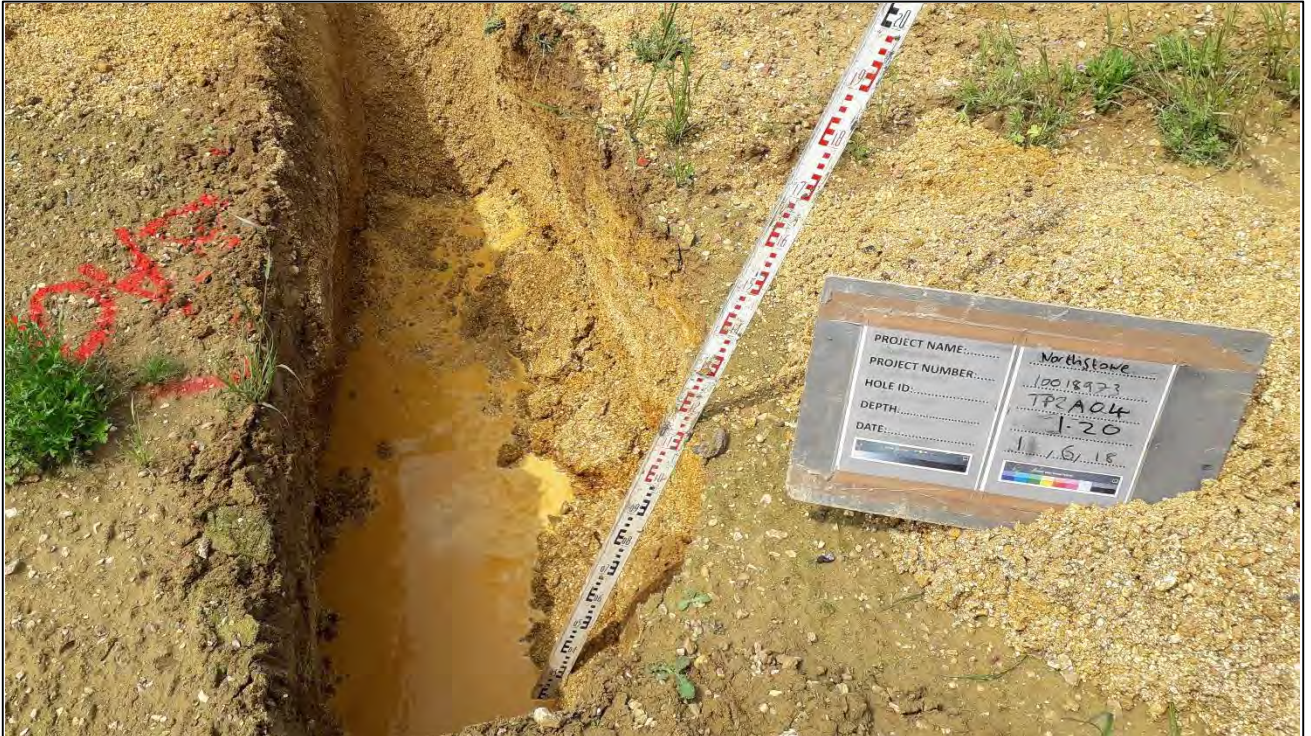
**TP2A04 Trial Pit. Depth 1.20m**

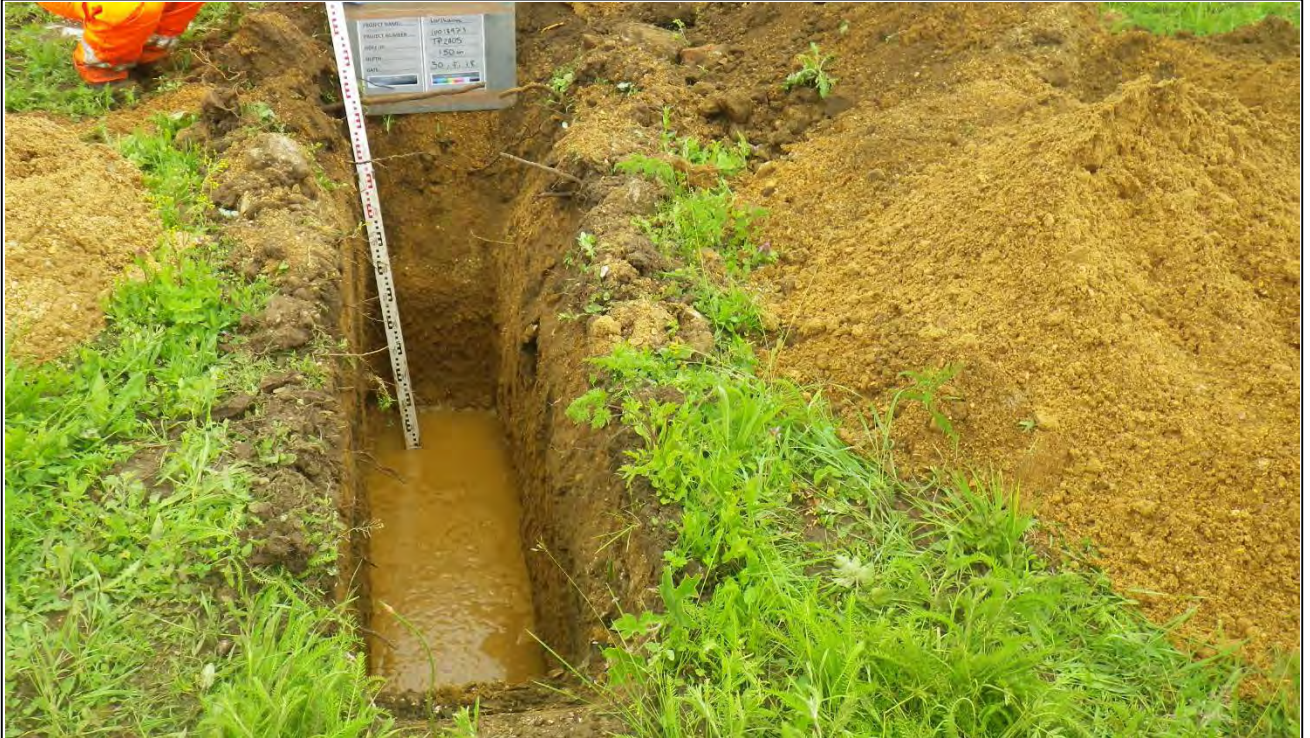
**TP2A05 Trial Pit. Depth 1.50m**

<p><b>PLAN DETAILS</b></p> <p>Long Axis Orientation:</p> <p>Shoring / Support: None</p> <p>Stability: Poor</p> <p>Groundwater (description):</p>	<p><b>Remarks</b></p> <p>Water strike at 1.5mbgl. Trial Pit terminated at 1.50mbgl due to water ingress making pit unstable. PID results not included as equipment became moisture sensitive.</p> <div style="border: 1px solid black; padding: 5px; width: fit-content; margin-left: auto;"> <p>Termination Depth: <b>1.51m</b></p> </div>
--	---

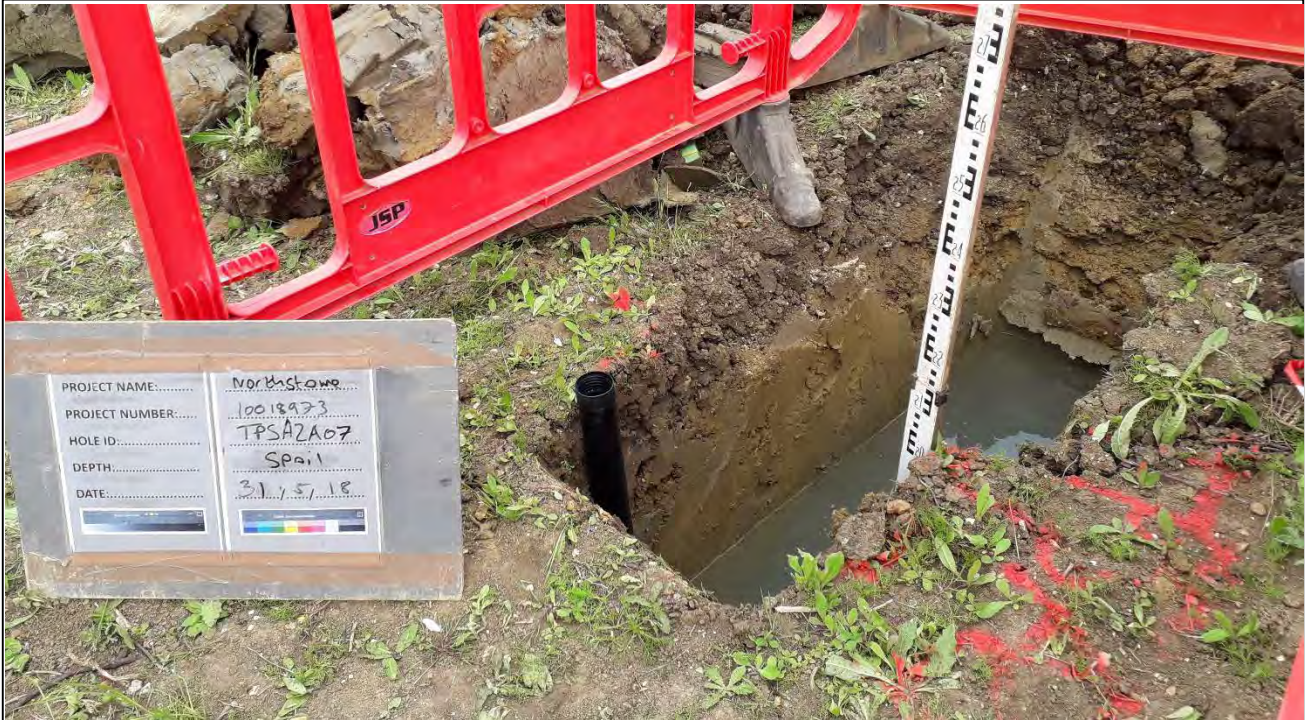
**TPSA2A07 Trial Pit. Depth: 2.10m**

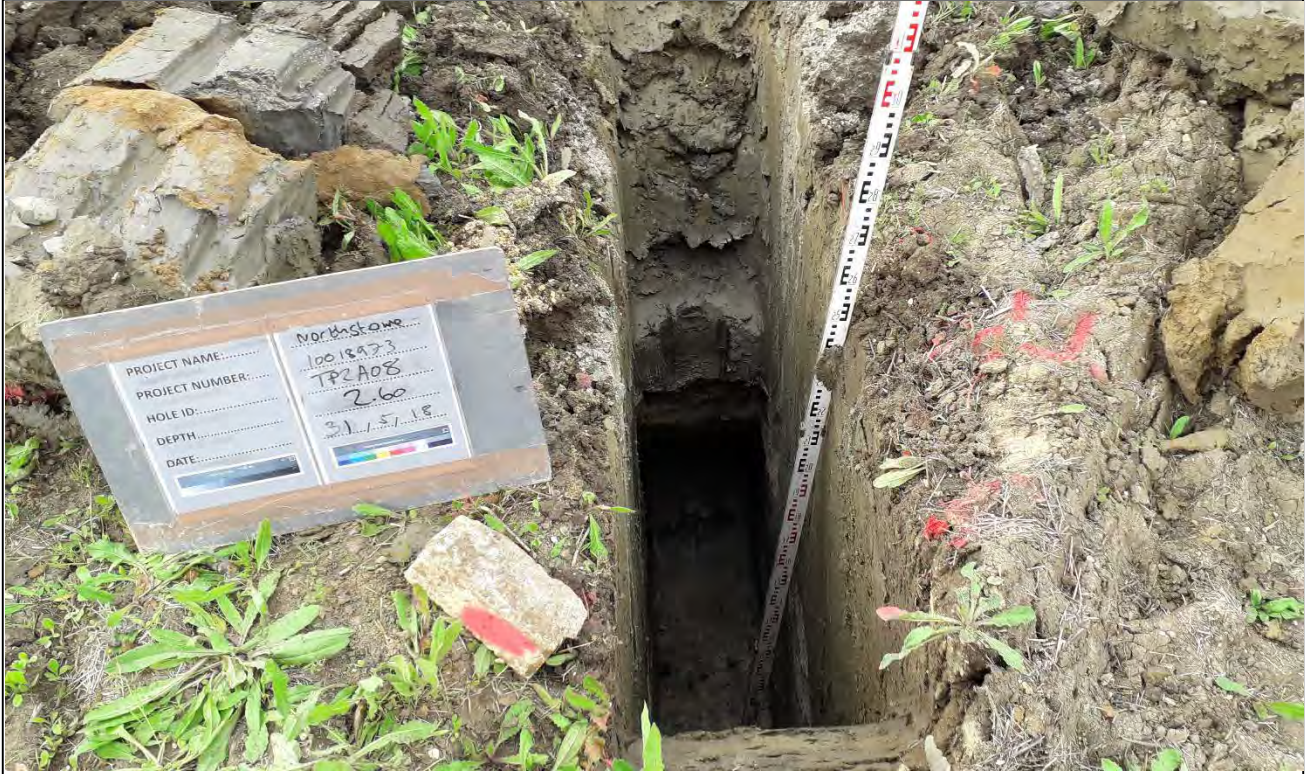
**TP2A08 Trial Pit. Depth 2.60m**

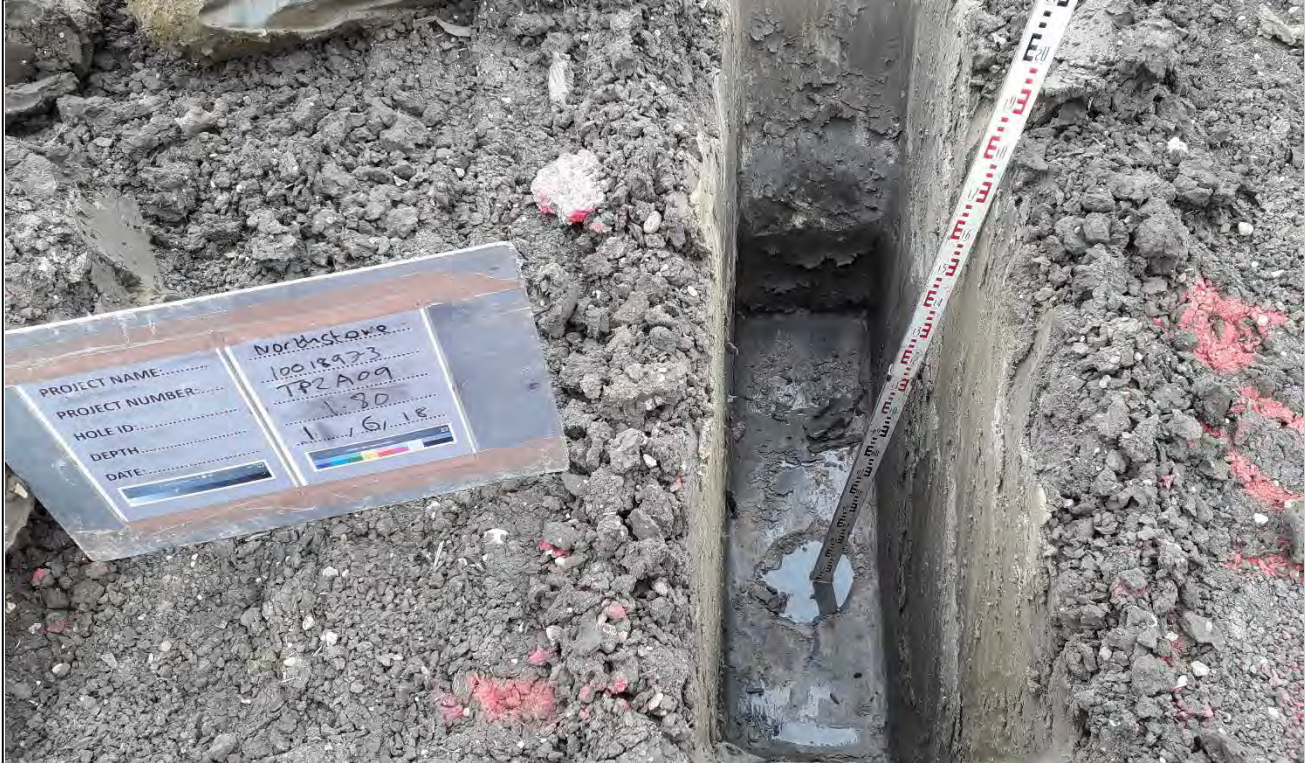
**TP2A09 Trial Pit. Depth 1.80m**

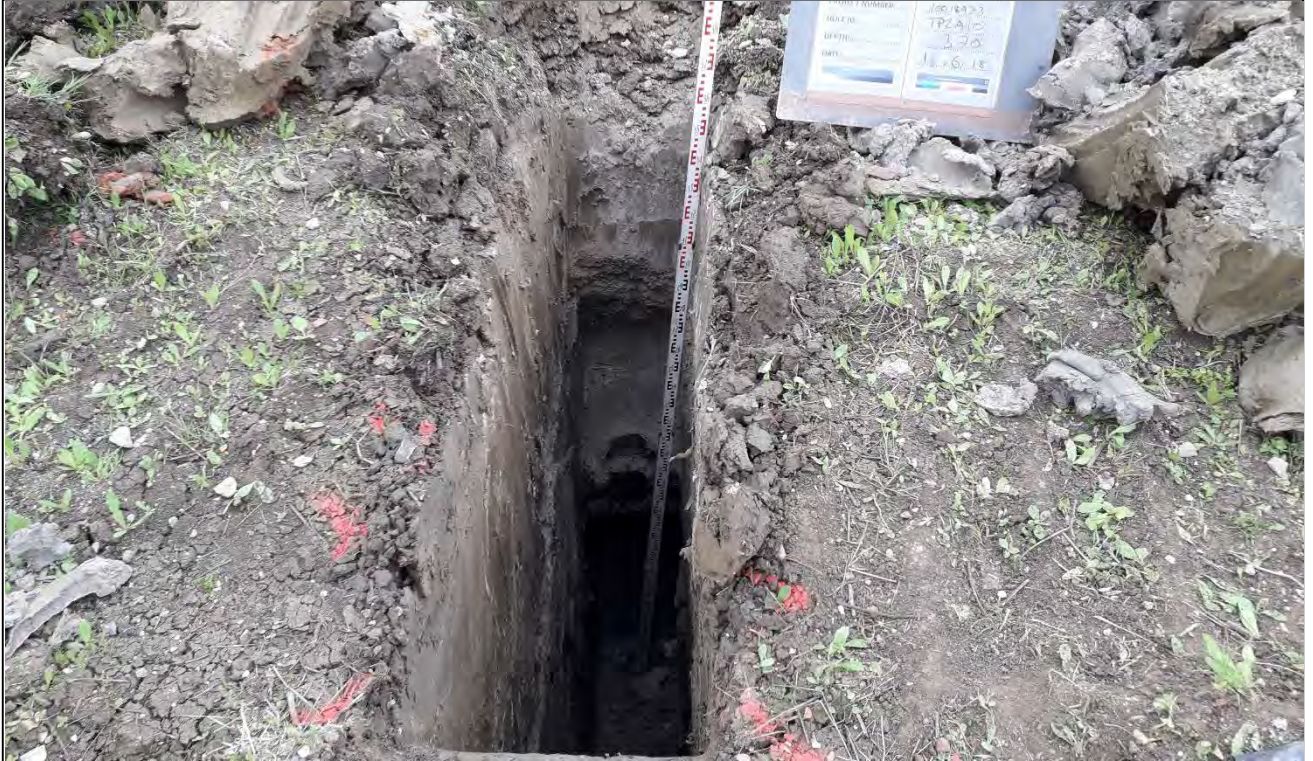
**TP2A10 Trial Pit. Depth 3.60m**

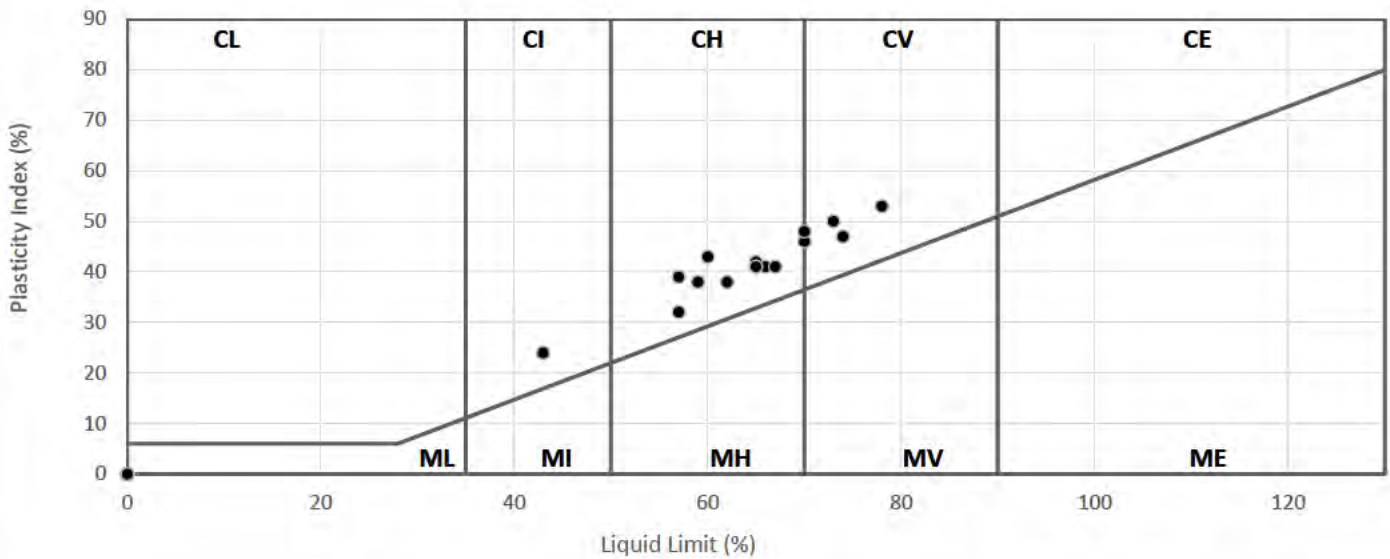
**PLASTICITY CHART FOR CASAGRANDE CLASSIFICATION  
BS 5930:1999+A2:2010**
