## Air Quality and Dust Monitoring Monthly Report – July 2022 Buckinghamshire Council

A report prepared by EWCs and MWCCs on behalf of HS<sub>2</sub> Ltd.

- 1.1.1 This Summary Report is published in fulfilment of commitments detailed in the High-Speed Rail (London-West Midlands) Environmental Minimum Requirements, Annex 1: Code of Construction Practice, for the nominated undertaker to present the results of dust monitoring undertaken in the Buckinghamshire Council (BC) during July 2022.

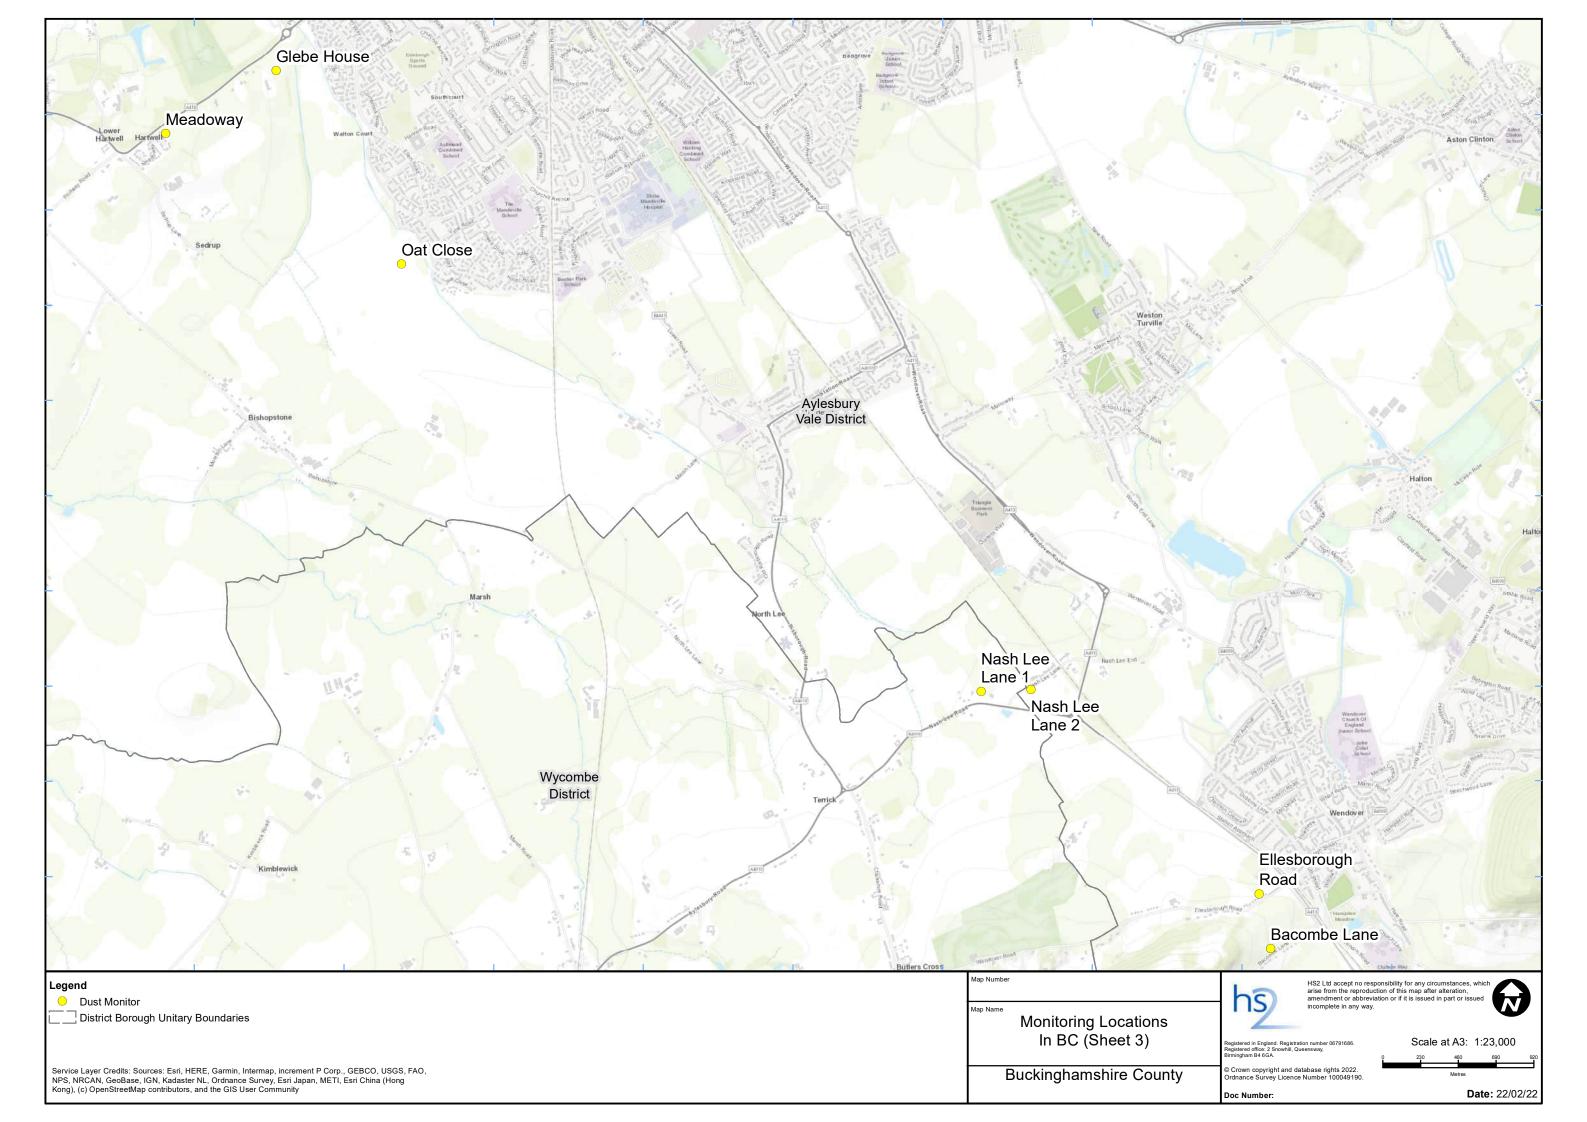
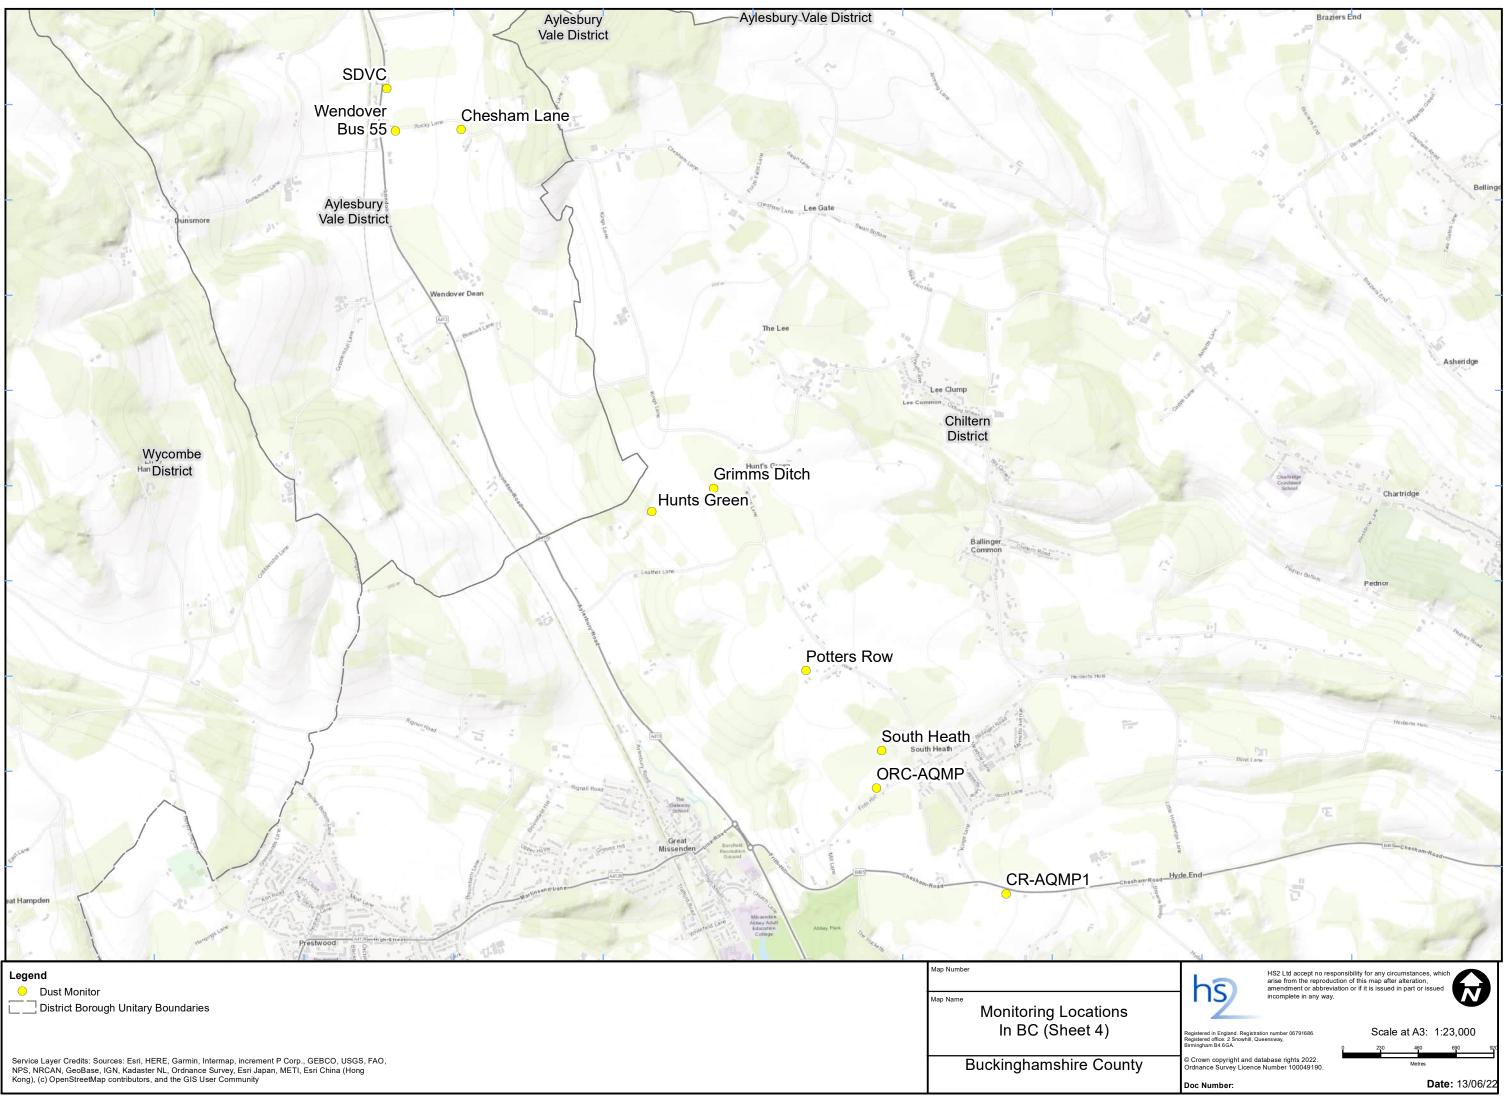
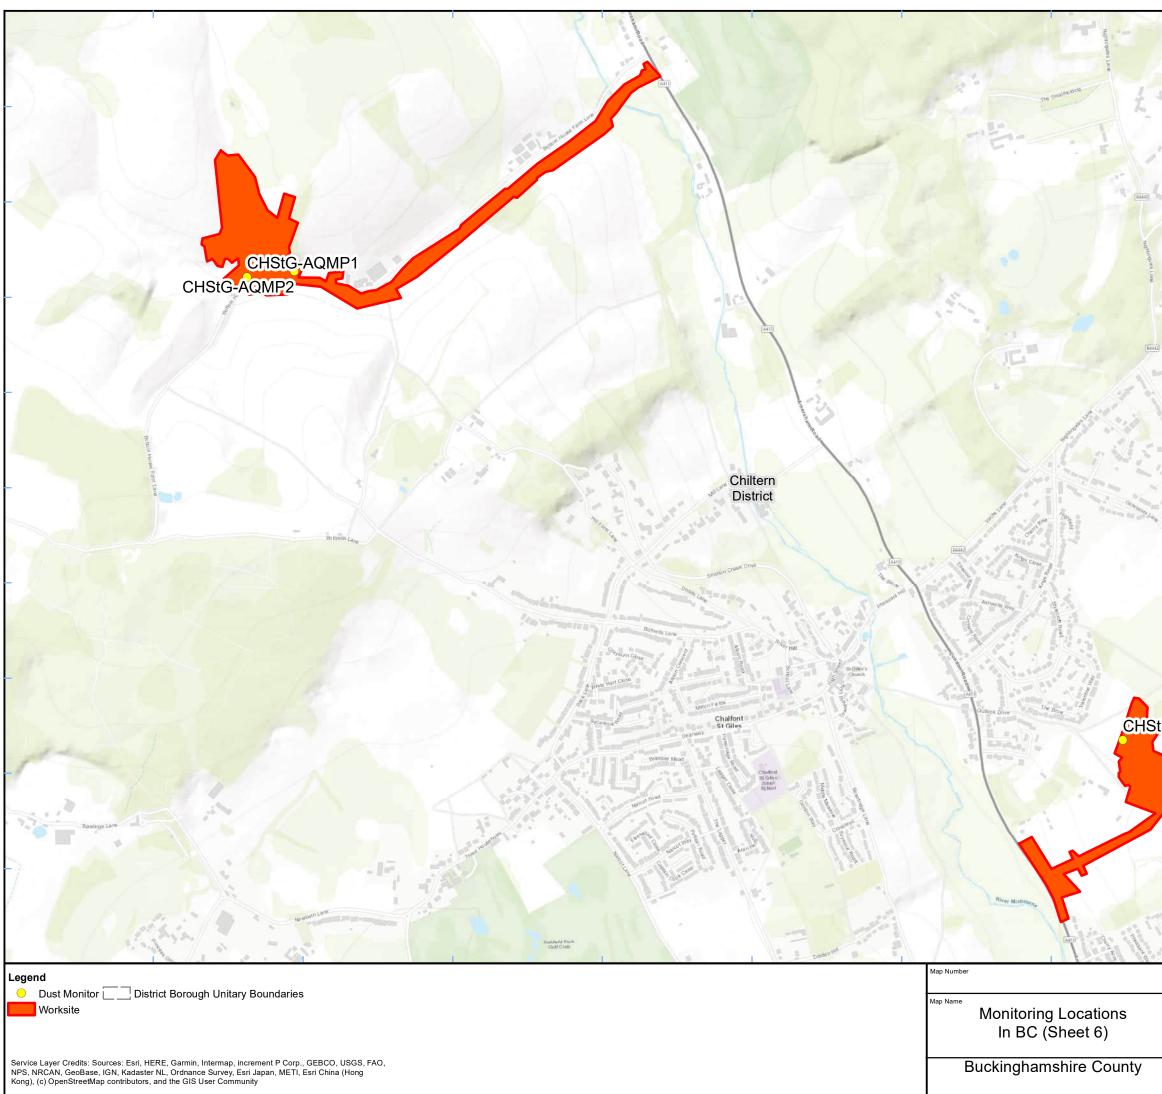
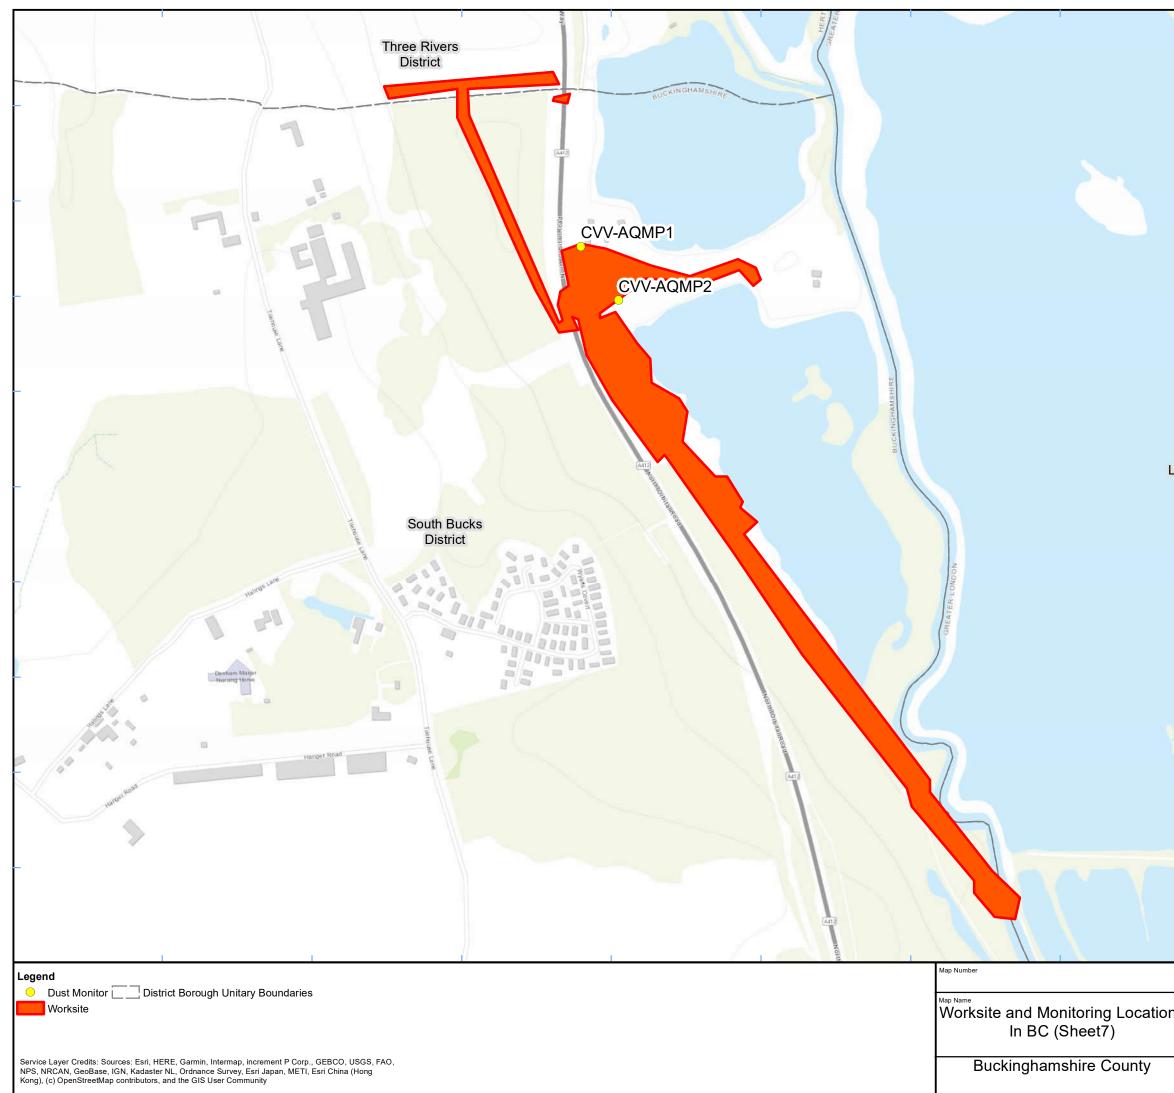
Figure 1-7: Worksite and monitoring locations within the BC

- 1.1.2 Figures 1-7 in Appendix A present the current worksites together with the dust monitoring locations for July 2022.
- 1.1.3 This summary should be read in conjunction with the overview monitoring report available from <a href="www.gov.uk/government/collections/monitoring-the-environmental-effects-of-hs2">www.gov.uk/government/collections/monitoring-the-environmental-effects-of-hs2</a>, which highlights the applicable standards and guidance, as well as the air quality and dust monitoring methodologies to be implemented by nominated undertakers throughout construction.

- 1.1.4 The current worksites, as presented in Appendix A, Figures 1-7, include:
