## **Construction Noise and Vibration Monthly Report – July 2022**

**Buckinghamshire**

This Noise and Vibration Monitoring Report fulfils HS2 Limited's commitment detailed in the Environmental Minimum Requirements (EMRs), Annex 1, Code of Construction Practice, to present the results of noise monitoring carried out within Buckinghamshire (BS) during the month of July 2022.

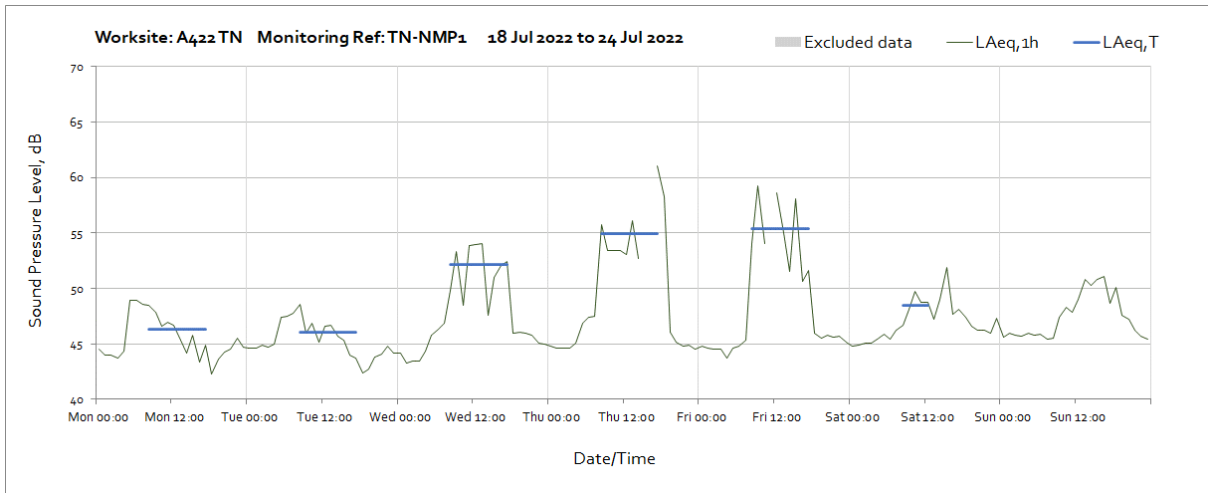
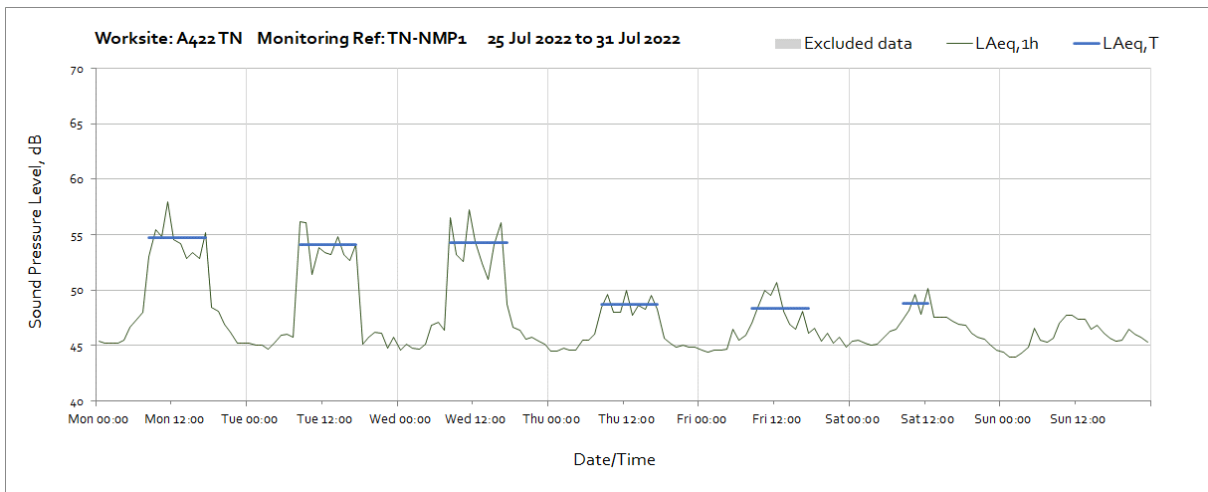
### Worksite: A422 TN – Monitoring Ref: TN-NMP1

Note: Missing data between 15:00 and 17:00 on the 21<sup>st</sup> July and 11:00 and 12:00 on the 22<sup>nd</sup> July was due to monitor maintenance.
