Construction Noise and Vibration Monthly Report – July 2022

Warwick District Council

Non-Technical Summary

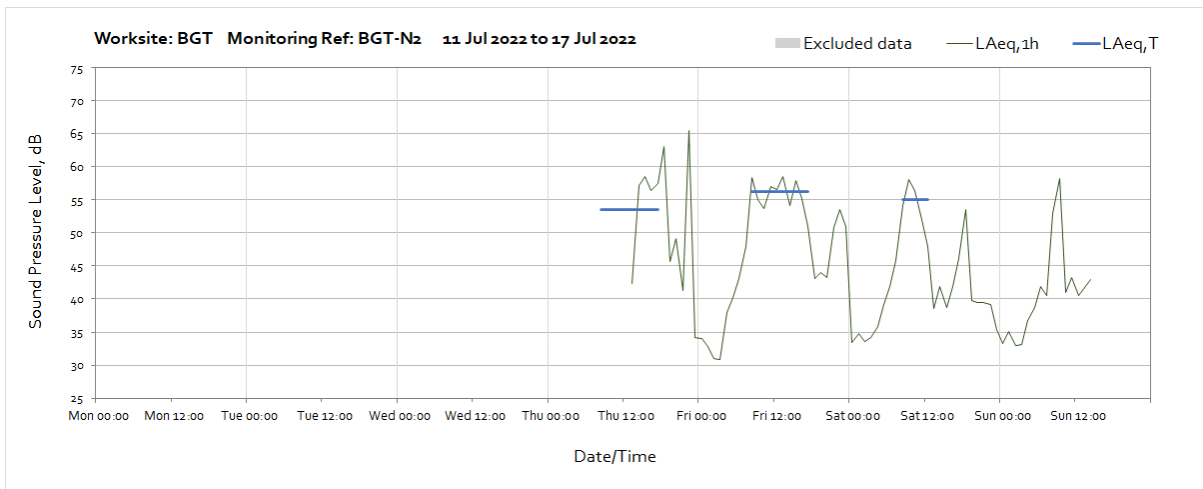
Worksite: BGT - Monitoring Ref: BGT-N2

Note: Noise monitor was installed on Thursday 14th July 2022. Missing data between 15:00 on Sunday 17th July and 09:00 on Monday 18th July were due to a monitoring station memory card error.
