August 2022

# Air Quality and Dust Monitoring Monthly Report - August 2022 Buckinghamshire Council

- 1.1.1 This Summary Report is published in fulfilment of commitments detailed in the High-Speed Rail (London-West Midlands) Environmental Minimum Requirements, Annex 1: Code of Construction Practice, for the nominated undertaker to present the results of dust monitoring undertaken in the Buckinghamshire Council (BC) during August 2022.

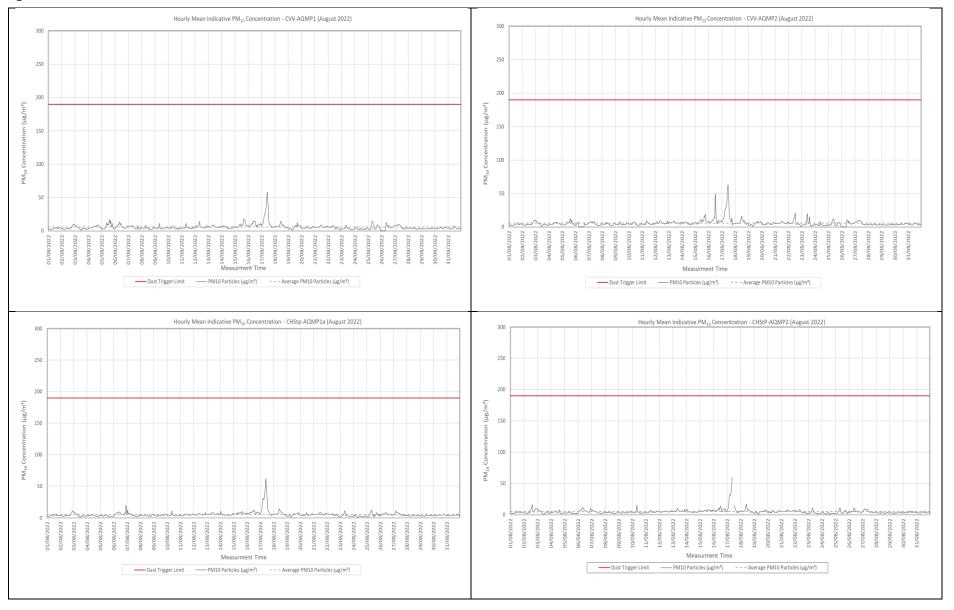
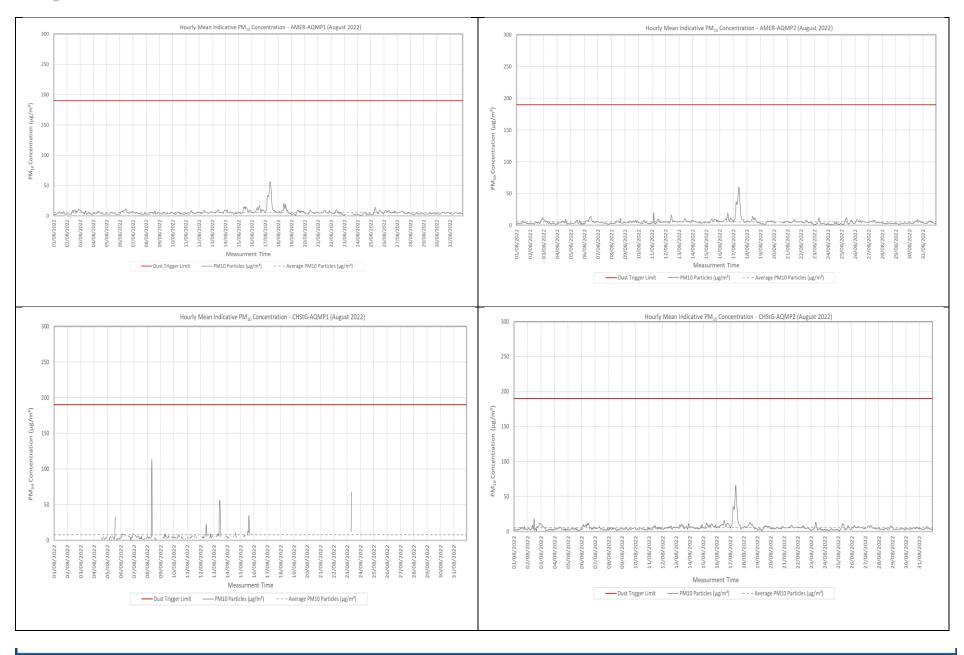
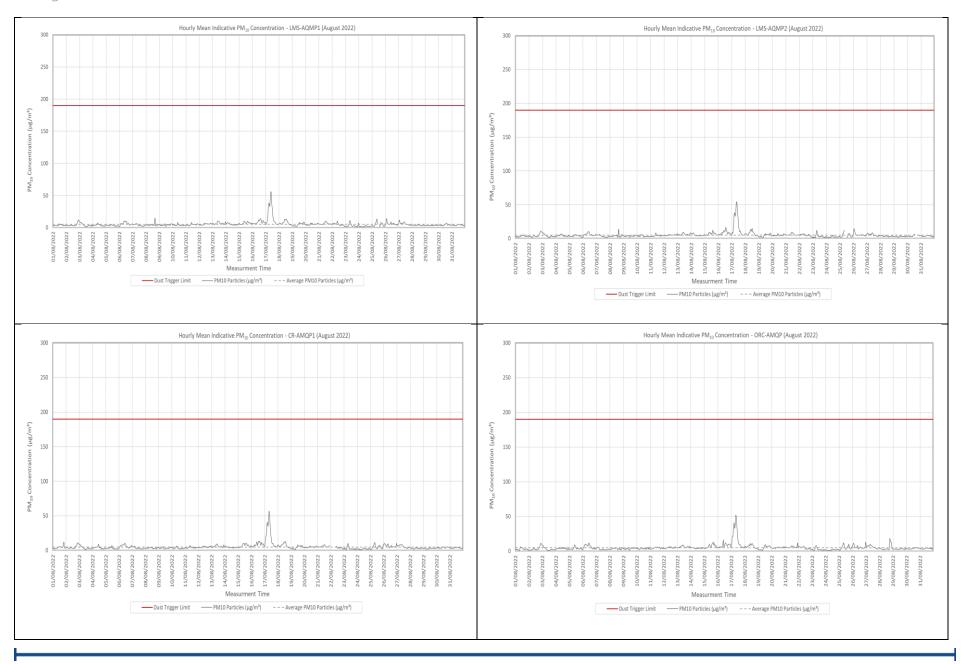
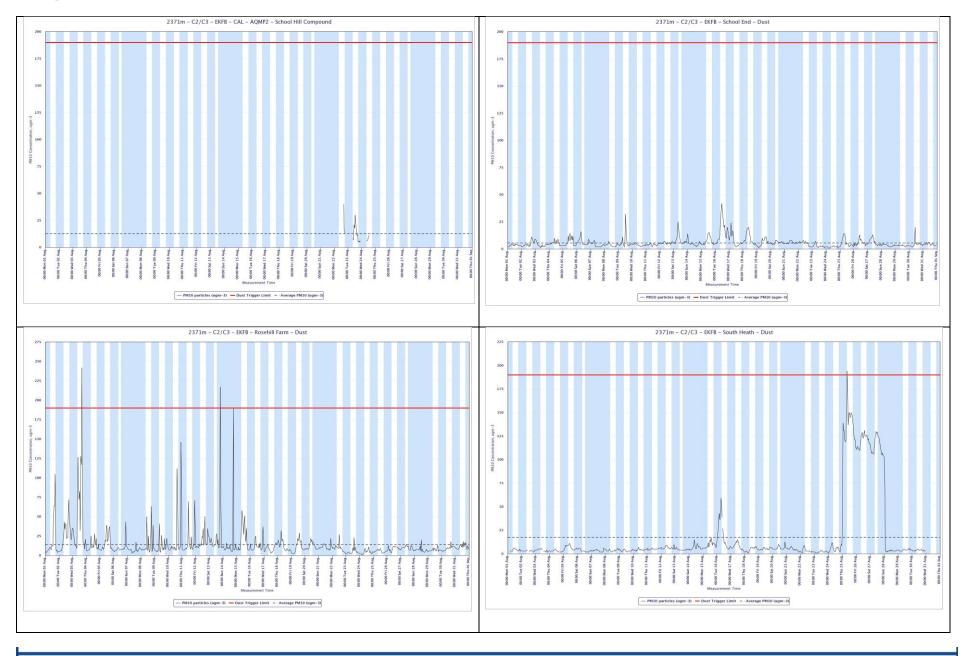
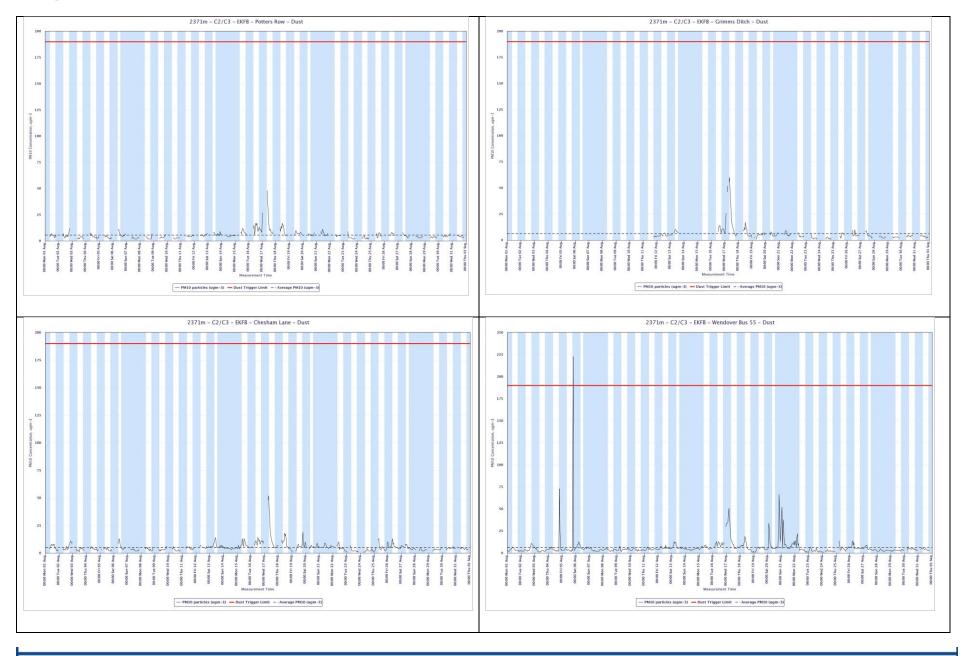
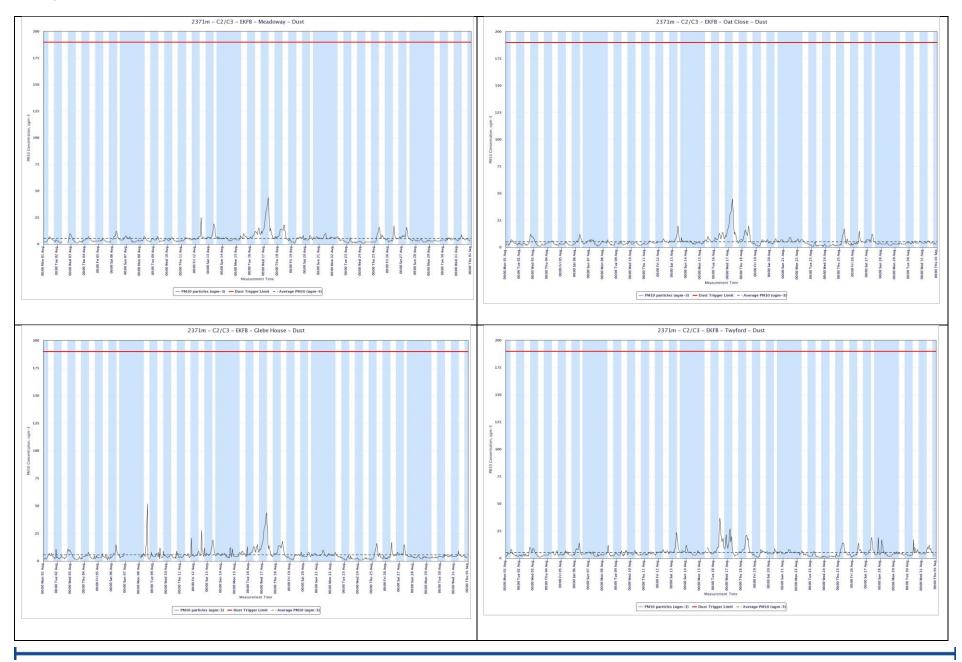
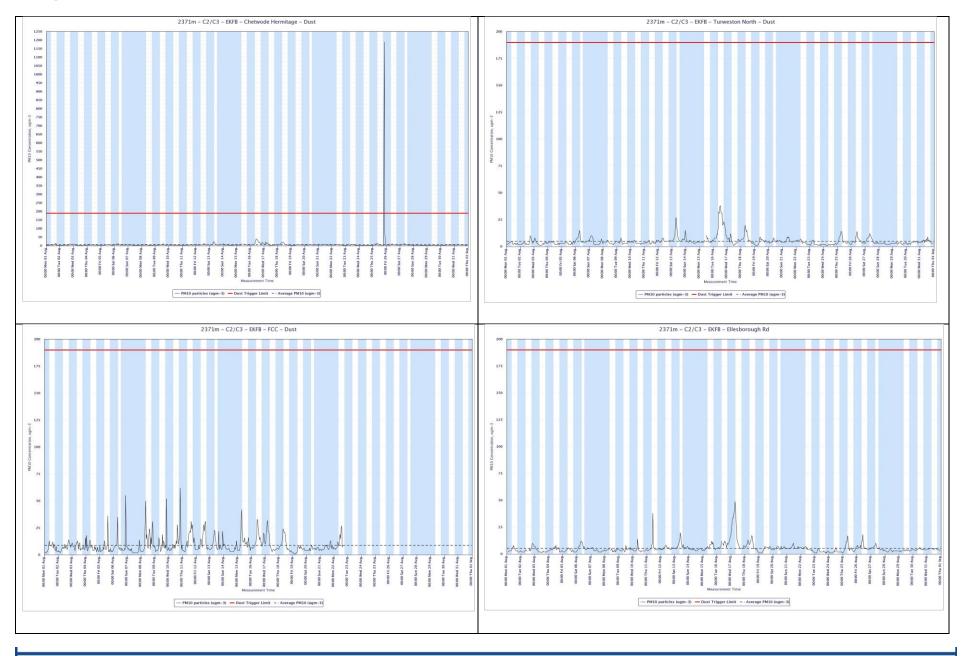
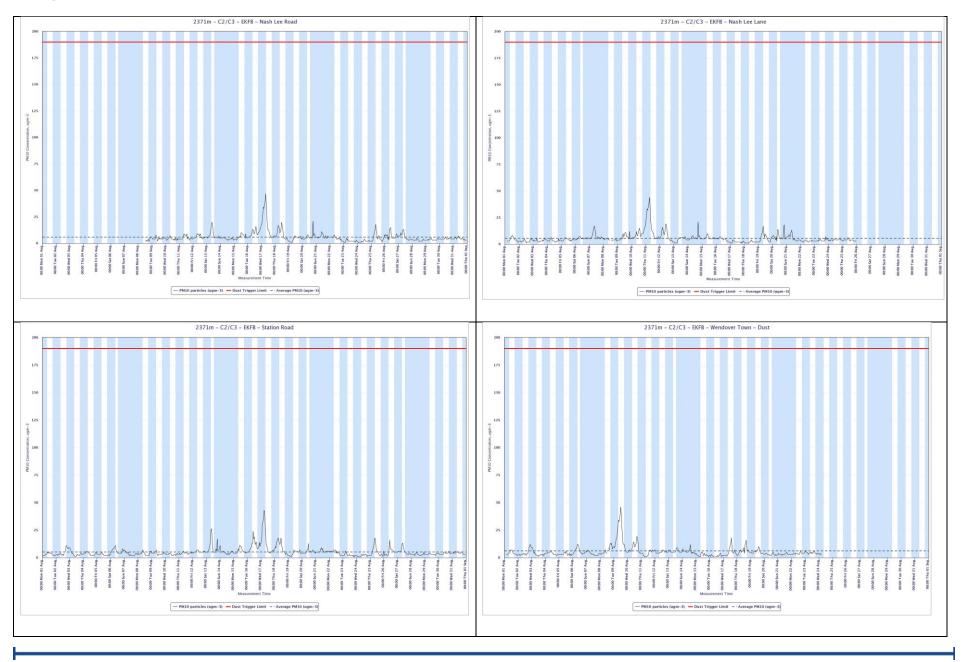
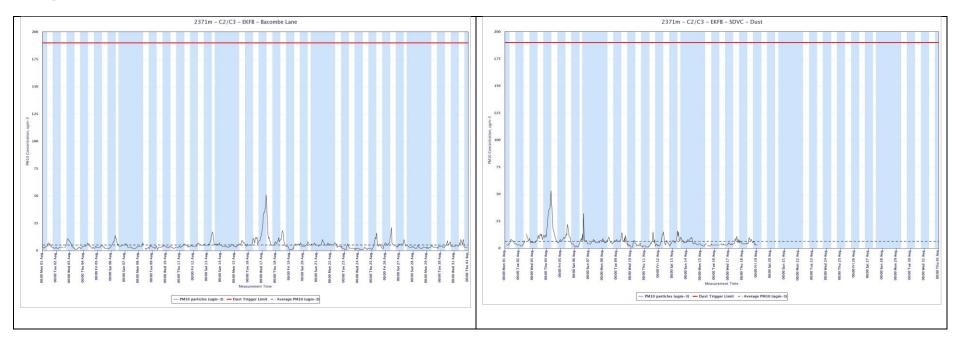
Figure 8: Continuous dust 1-hour mean indicative PM<sub>10</sub> concentration for all dust monitors

- 1.1.6 Dust monitoring locations and results for August 2022 are presented in Appendix B, Table 2, together with a line chart of monthly data from each dust monitor presented in Figure 8. All continuous dust monitoring is undertaken using indicative monitors. Despite being Environment Agency (MCERTS) certified, indicative monitors carry a higher level of uncertainty than reference monitors, and therefore cannot be strictly compared with Air Quality Standards for human health and the environment. The purpose of the monitoring undertaken is to ensure the effectiveness of the on-site mitigation.

- 1.1.7 The trigger level for  $PM_{10}$  concentrations of 190  $\mu$ g/m³, measured as a 1-hour mean, in accordance with the updated guidance document 'Guidance on Monitoring in the Vicinity of Demolition and Construction Sites (October 2018)' has been applied.
