Construction Noise and Vibration Monthly Report – August 2022

Buckinghamshire

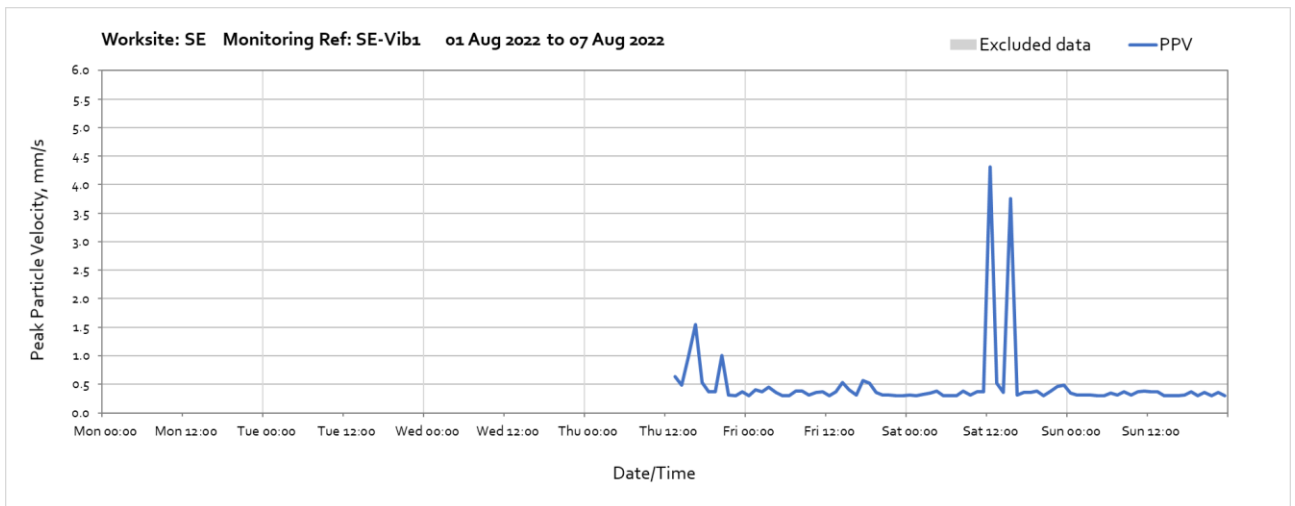
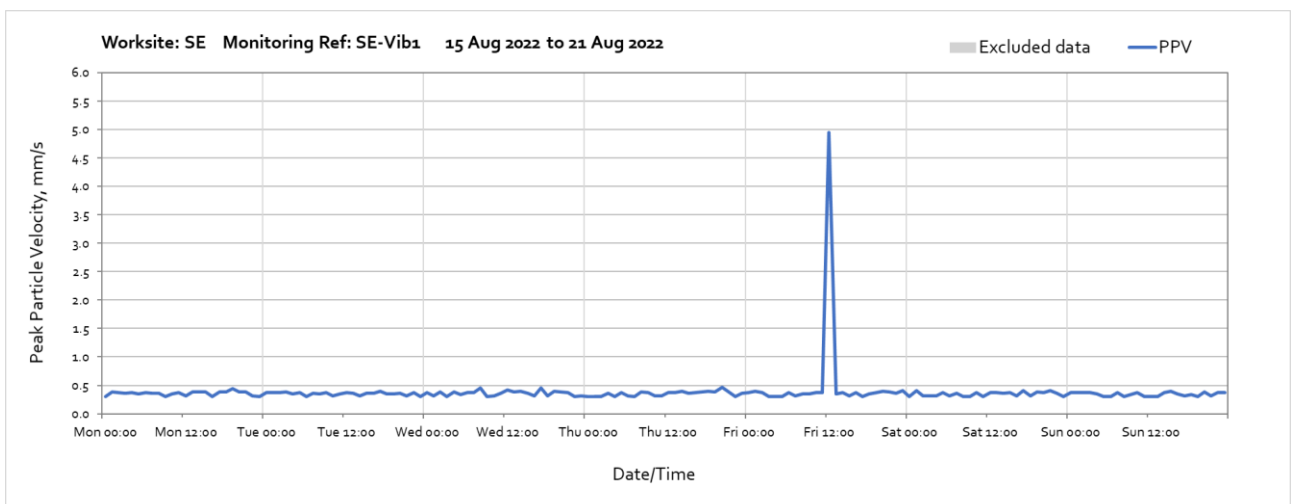
Worksite: SE – Monitoring Ref: SE-Vib 1

Note: The monitor, that was retrieved due to possible water ingress, has been repaired and re-installed on Thursday 4th August

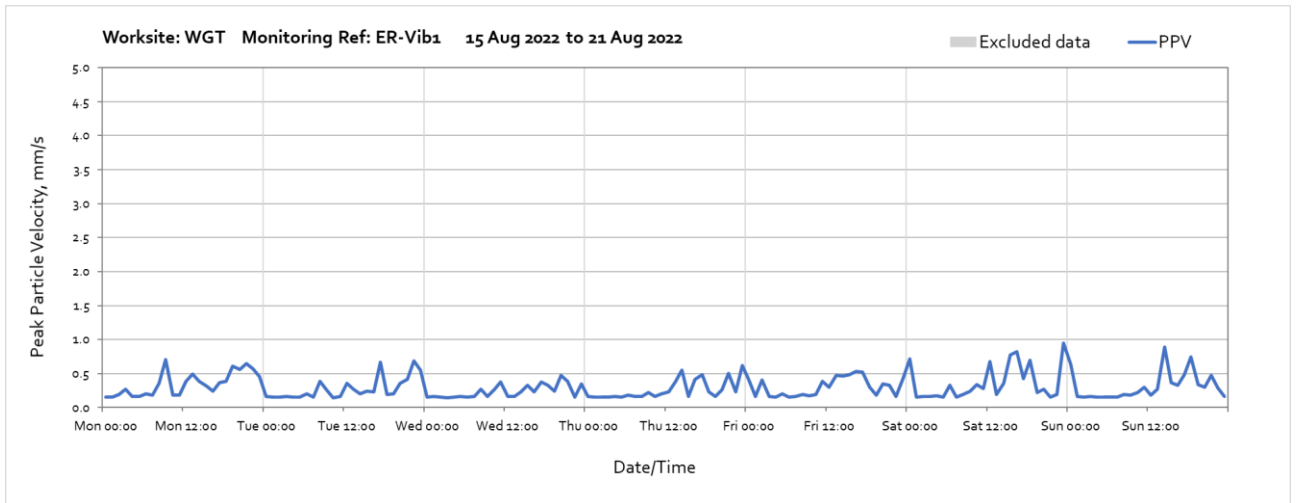
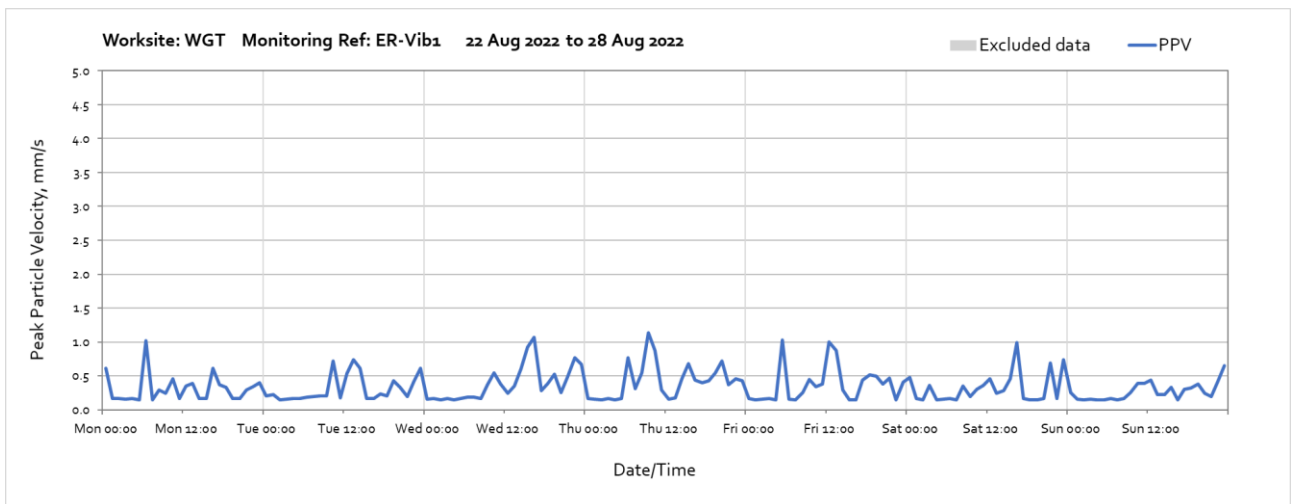
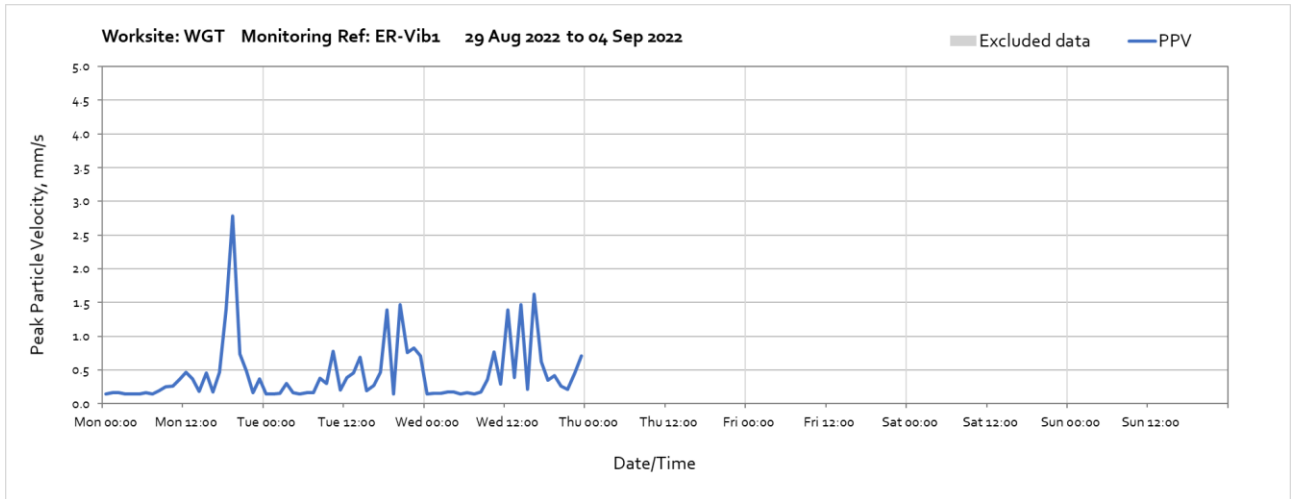
Worksite: WGT – Monitoring Ref: ER-Vib 1

Note: Missing data from 18:00 on Saturday 6th August to 11:00 on Friday 12th August were due to power outage.
