| <b>Innateq/Karl Schnell /KS Emulsifier F320 Type 094</b> | |
| <b>Alert Number</b> | 2208-0383 |

## Product Recall

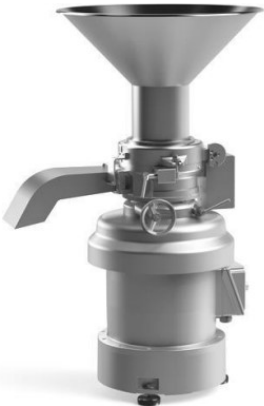
| <b>Innateq/Karl Schnell /KS Emulsifier F320 Type 094</b> | |
|--|--|
| <b>Images</b> | |

| <b>Innateq/Karl Schnell /KS Emulsifier F320 Type 094</b> | |
|--|--|
| <b>Product Description</b> | The F320 emulsifier is used for emulsifying bones, slaughterhouse waste and vegetables etc. The machine comprises a large inlet hopper, an electrically powered drive mechanism used to power the cutting system, and an outlet chute from which the processed food material exits the machine. The cutting system consists of a rotating knife plate and stationary perforated plate. After processing, the food material is forced by the paddles of a rotating expeller to the outlet chute. |
| <b>Risk Type</b> | Risk of serious personal injury due to entanglement, shearing and crushing hazards from contact with dangerous moving parts of machinery. |
| <b>Risk Description</b> | <p>An incident occurred in April 2022 in which an employee of a food processing business operating an F320 emulsifier machine sustained partial amputation injuries to two fingers after their hand made contact with the rotating paddles of the expeller whilst clearing food material from the outlet chute.</p> <p>HSE examined the incident machine and found that it did not meet the essential health and safety requirements of the Supply of Machinery (Safety) Regulations 2008: Dangerous moving parts of the machine i.e. the cutting system and expeller, were readily accessible via the outlet opening. There were no physical safeguards at the outlet opening to prevent part of a person's body (hands and fingers) accessing these parts of the machine. The dimensions of the outlet opening and length / configuration of the outlet chute did not restrict access either, and do not meet the requirements of BS EN ISO 13857:2008 '<i>Safety of machinery - Safety distances to prevent hazard zones being reached by upper and lower limbs</i>'.</p> <p>The manufacturer provided a design risk assessment for the machine in which they acknowledged that reaching through the outlet opening was possible. However, the need for risk reduction measures in this</p> |

| | area do not appear to have been considered further. |

| <b>Corrective measures</b> | The UK importer has withdrawn the machine from the market and has confirmed they do not hold any machines of this type in stock. They have written to all customers in GB (four) to provide revised safety information. We are informed that they are working with the manufacturer to identify a design solution that will adequately safeguard future machines. |
