Passenger trapped by tram doors and dragged at Shudehill tram stop, Manchester, 27 May 2022

Summary of the accident

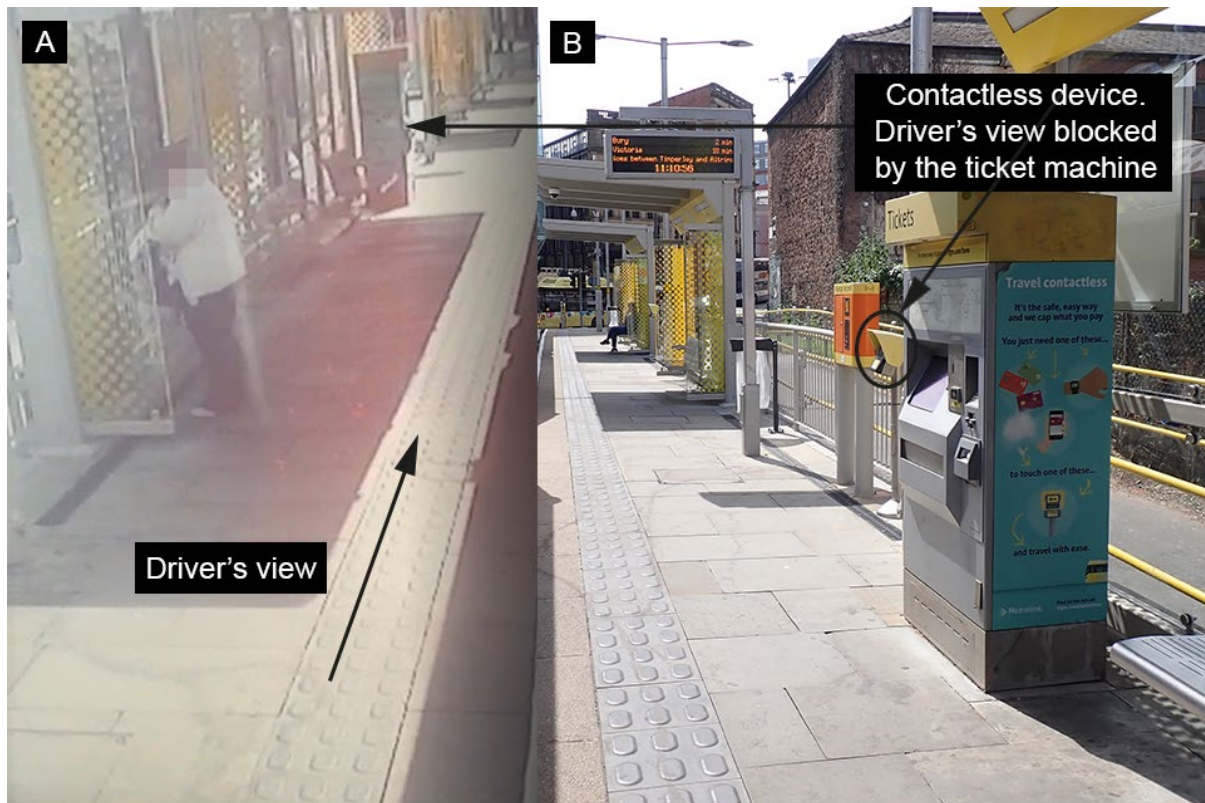
Image A: View from cab CCTV monitor providing mirror image view looking along Shudehill tram stop platform (reconstruction). Image B: Location of contactless device where passenger was stood.

In the case of this accident, the driver reported that they undertook the first CCTV check required by the Driver's Rule Book, before closing the doors. However, the driver would not have been able to see the passenger at this stage in the dispatch process because the passenger would have been masked from the view of the tram's CCTV system by the ticket machine. This masking effect of the ticket machine was confirmed during a reconstruction by RAIB.
