September 2022

HS2

Air Quality and Dust Monitoring Monthly Report - September 2022 **Buckinghamshire** Council

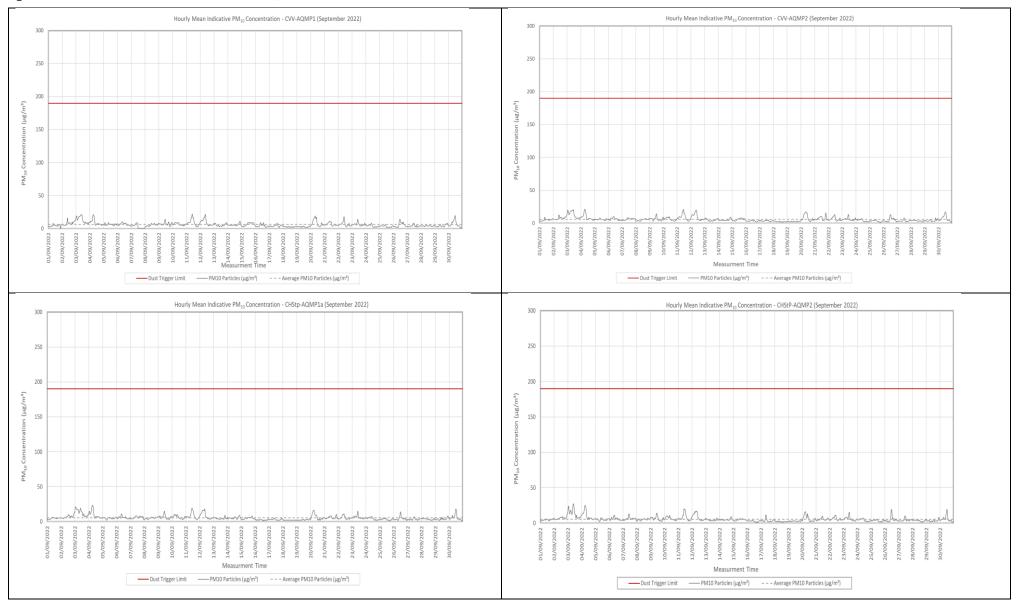
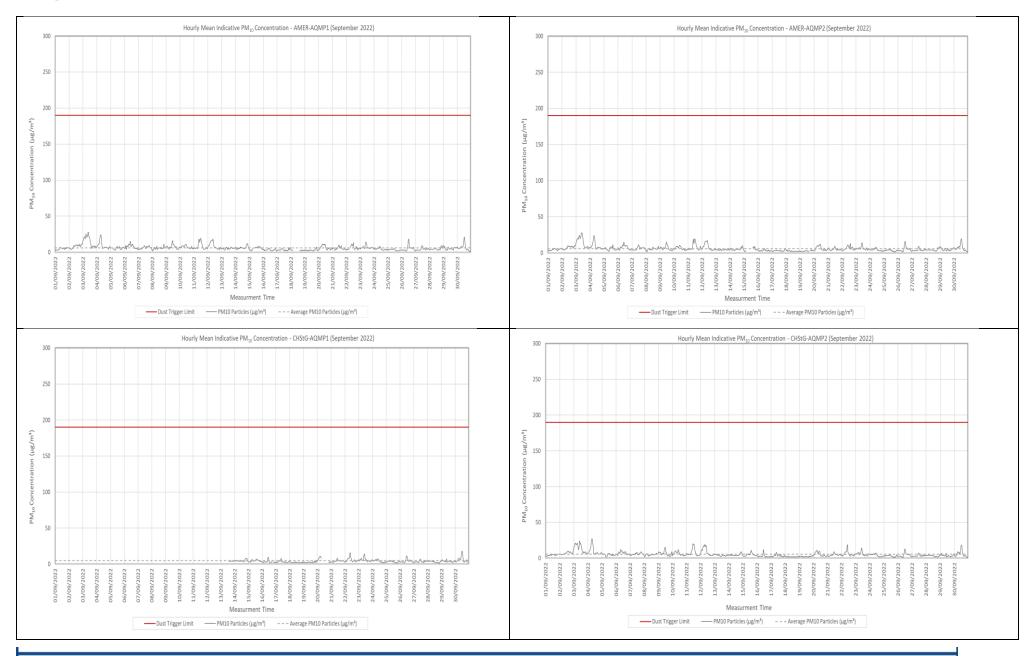
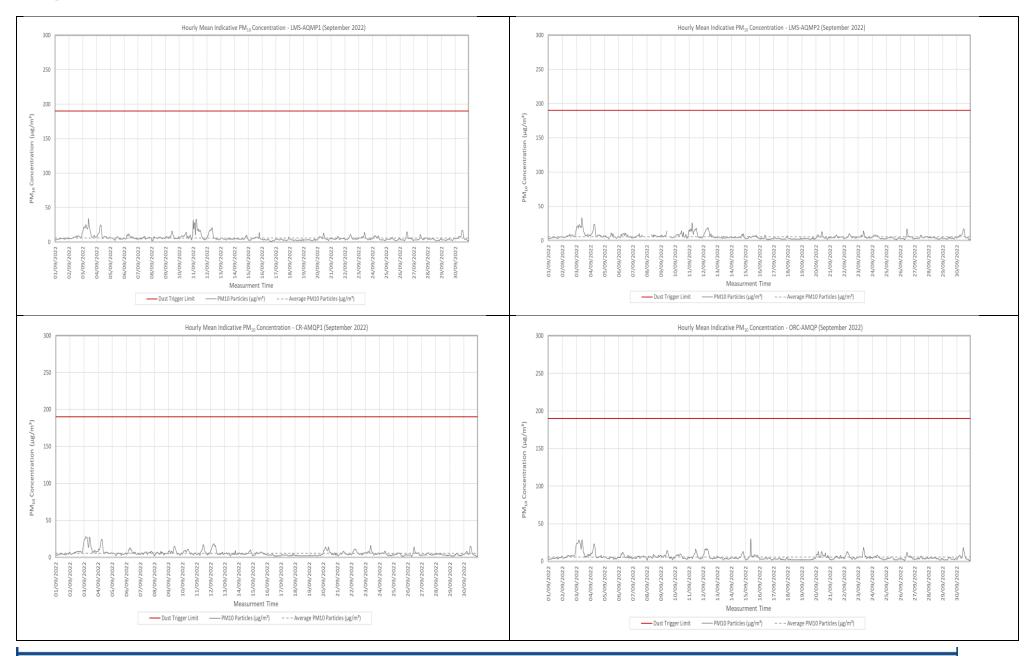
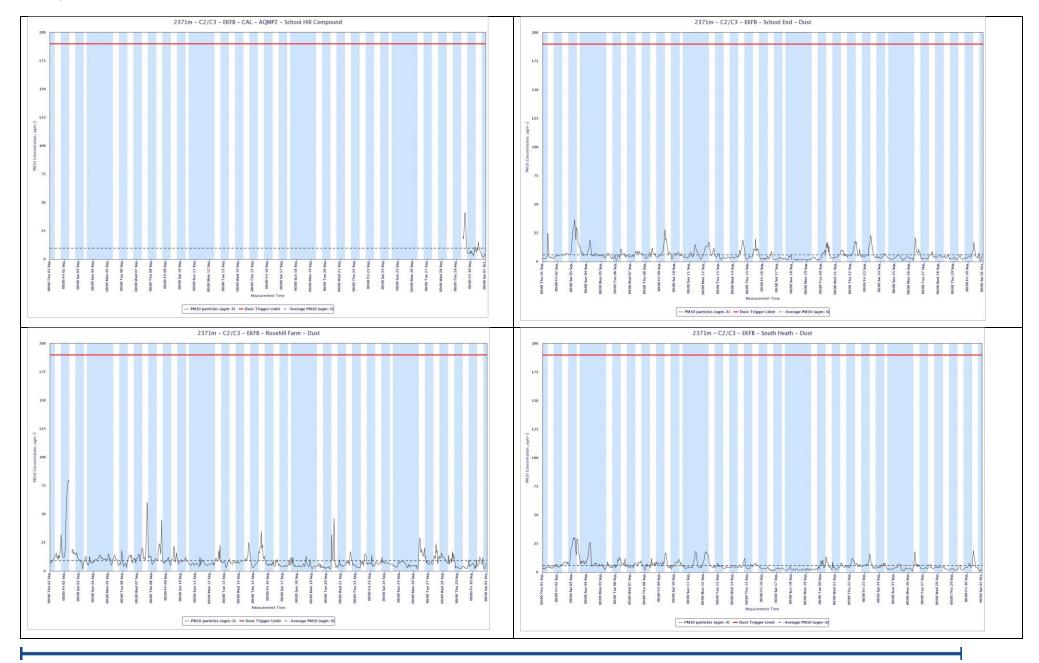
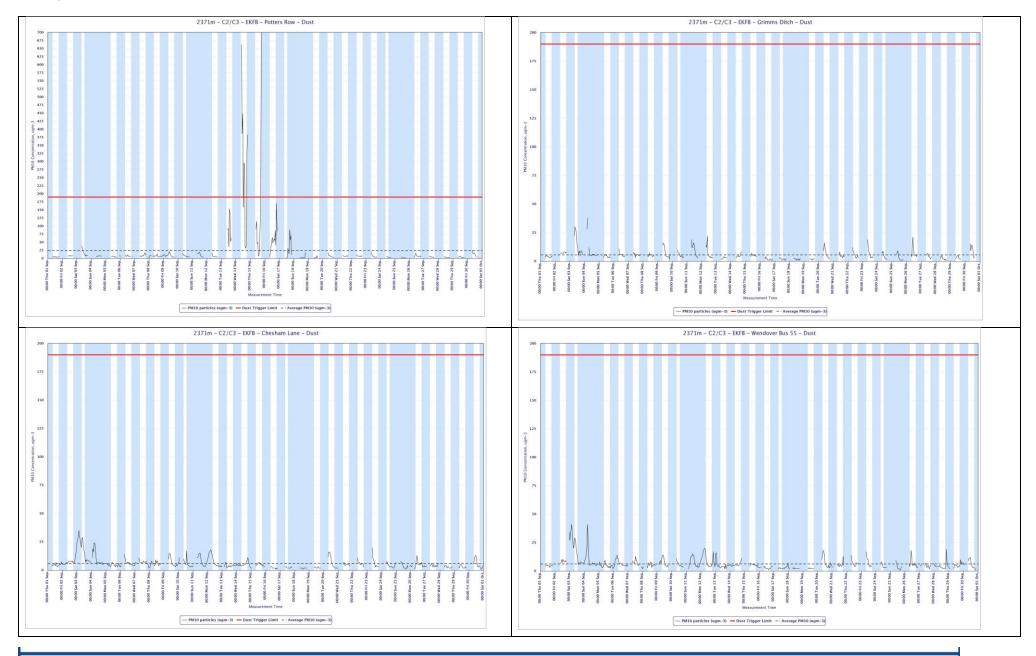
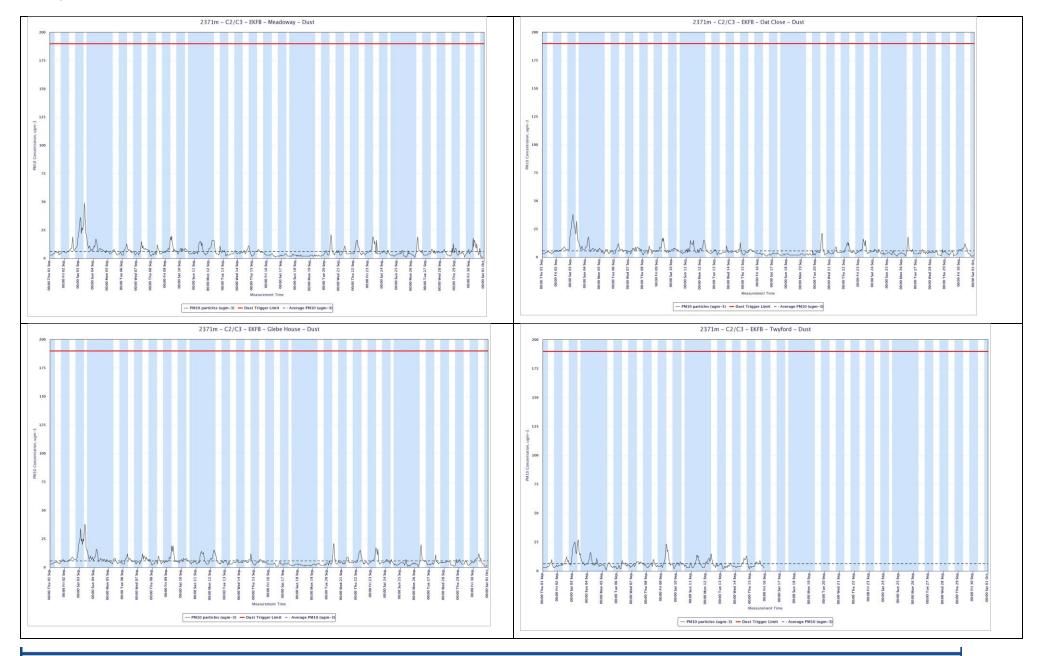
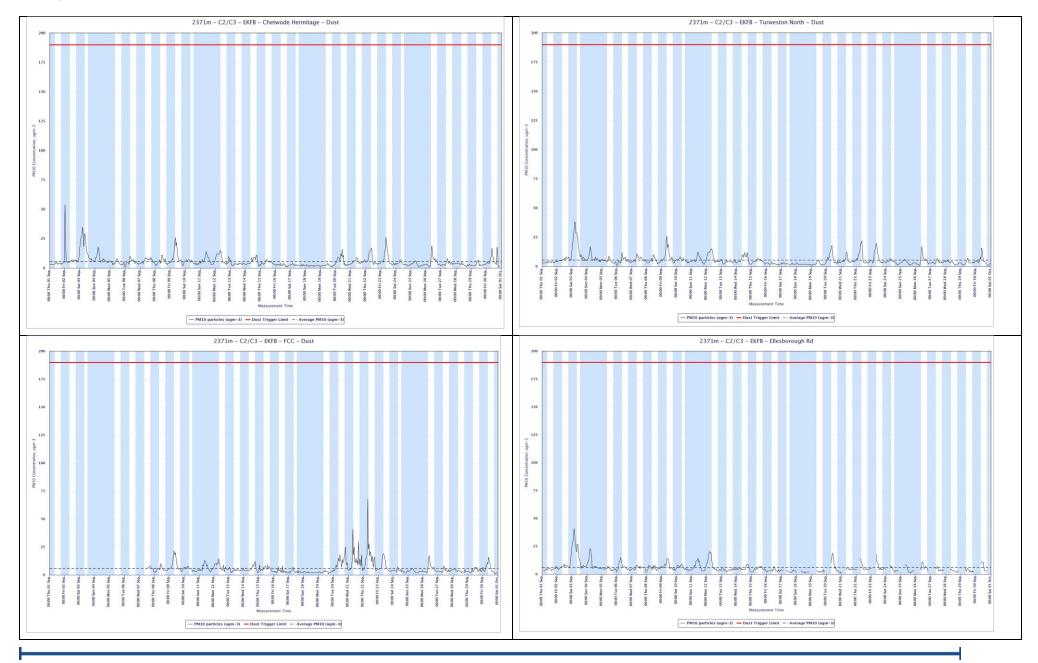
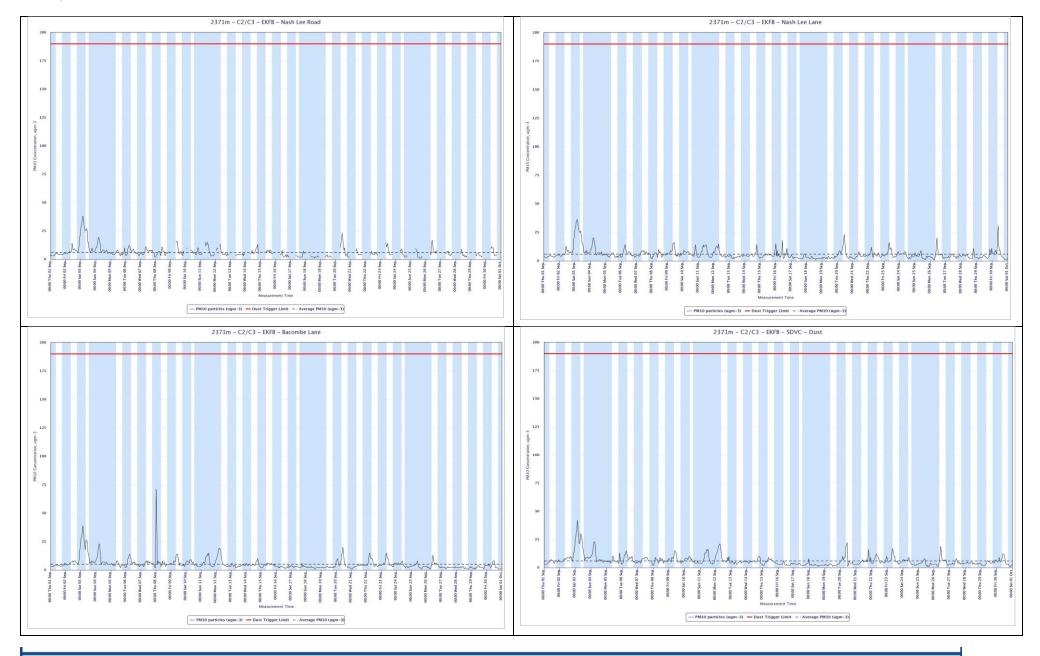
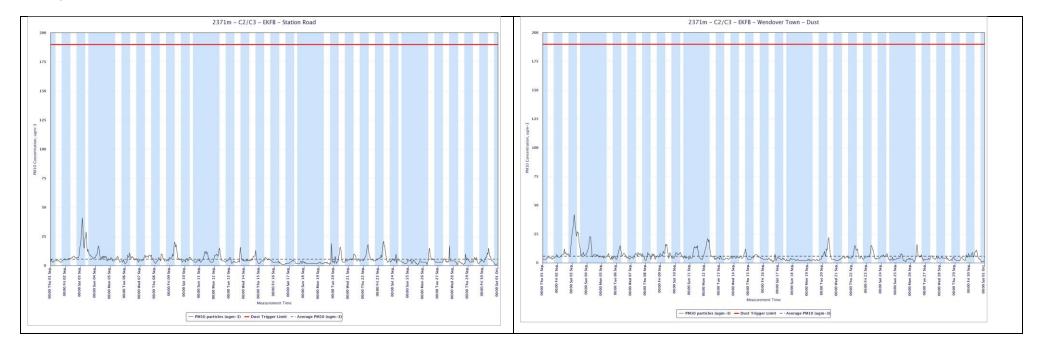
Figure 8: Continuous dust 1-hour mean indicative PM₁₀ concentration for all monitors

- 1.1.7 The trigger level for PM_{10} concentrations of 190 μ g/m³, measured as a 1-hour mean, in accordance with the updated guidance document 'Guidance on Monitoring in the Vicinity of Demolition and Construction Sites (October 2018)' has been applied.
- 1.1.8 Details of the trigger alert investigations and remediations are presented in Appendix B, Table 2. All other results were in line with expected ranges.
- 1.1.9 Data capture was below 90% for multiple monitors due to technical issues and/or loss of power due to insufficient sunlight/wind and/or damages.
- 1.1.10 No (0) complaints were received during the monitoring period (September 2022).

Monitoring Site ID	Period of trigger alert & Concentration recorded	Investigation	Outcomes / Resolution / Remedial measures implemented
Potters Row – Dust	14/09/2022 09:00 – 9:59; 662 µg/m³ 10:00 – 10:59; 387 µg/m³ 11:00 – 11:59; 446 µg/m³ 13:00 – 13:59; 296 µg/m³ 14:00 – 14:59; 289 µg/m³ 18:00 – 18:59; 328 µg/m³	Upon investigation, vegetation clearance works were being carried between 10m and 50m from Potters Row monitor.	Environmental Team liaised with Works Manager to send dust mitigation measures to the location (water bowser). The incident was raised to HS2 via Horace and internally via Airsweb.
Potters Row – Dust	14/09/2022 19:00 – 19:59; 383 μg/m ³	Upon investigation, EKFB did not undertake any activities at this time. Discounted as outside of site working hours agreed with Buckinghamshire Council.	N/A
Potters Row – Dust	15/09/2022 17:00 – 17:59; 218 µg/m³ 18:00 – 18:59; 840 µg/m³	Upon investigation, EKFB did not undertake any activities at this time. Discounted as outside of site working hours agreed with Buckinghamshire Council.	N/A
