Air Quality and Dust Monitoring Monthly Report - September 2022 London Borough of Camden

A report prepared by EWCs and MWCCs on behalf of HS2 Ltd.

Monthly Summary

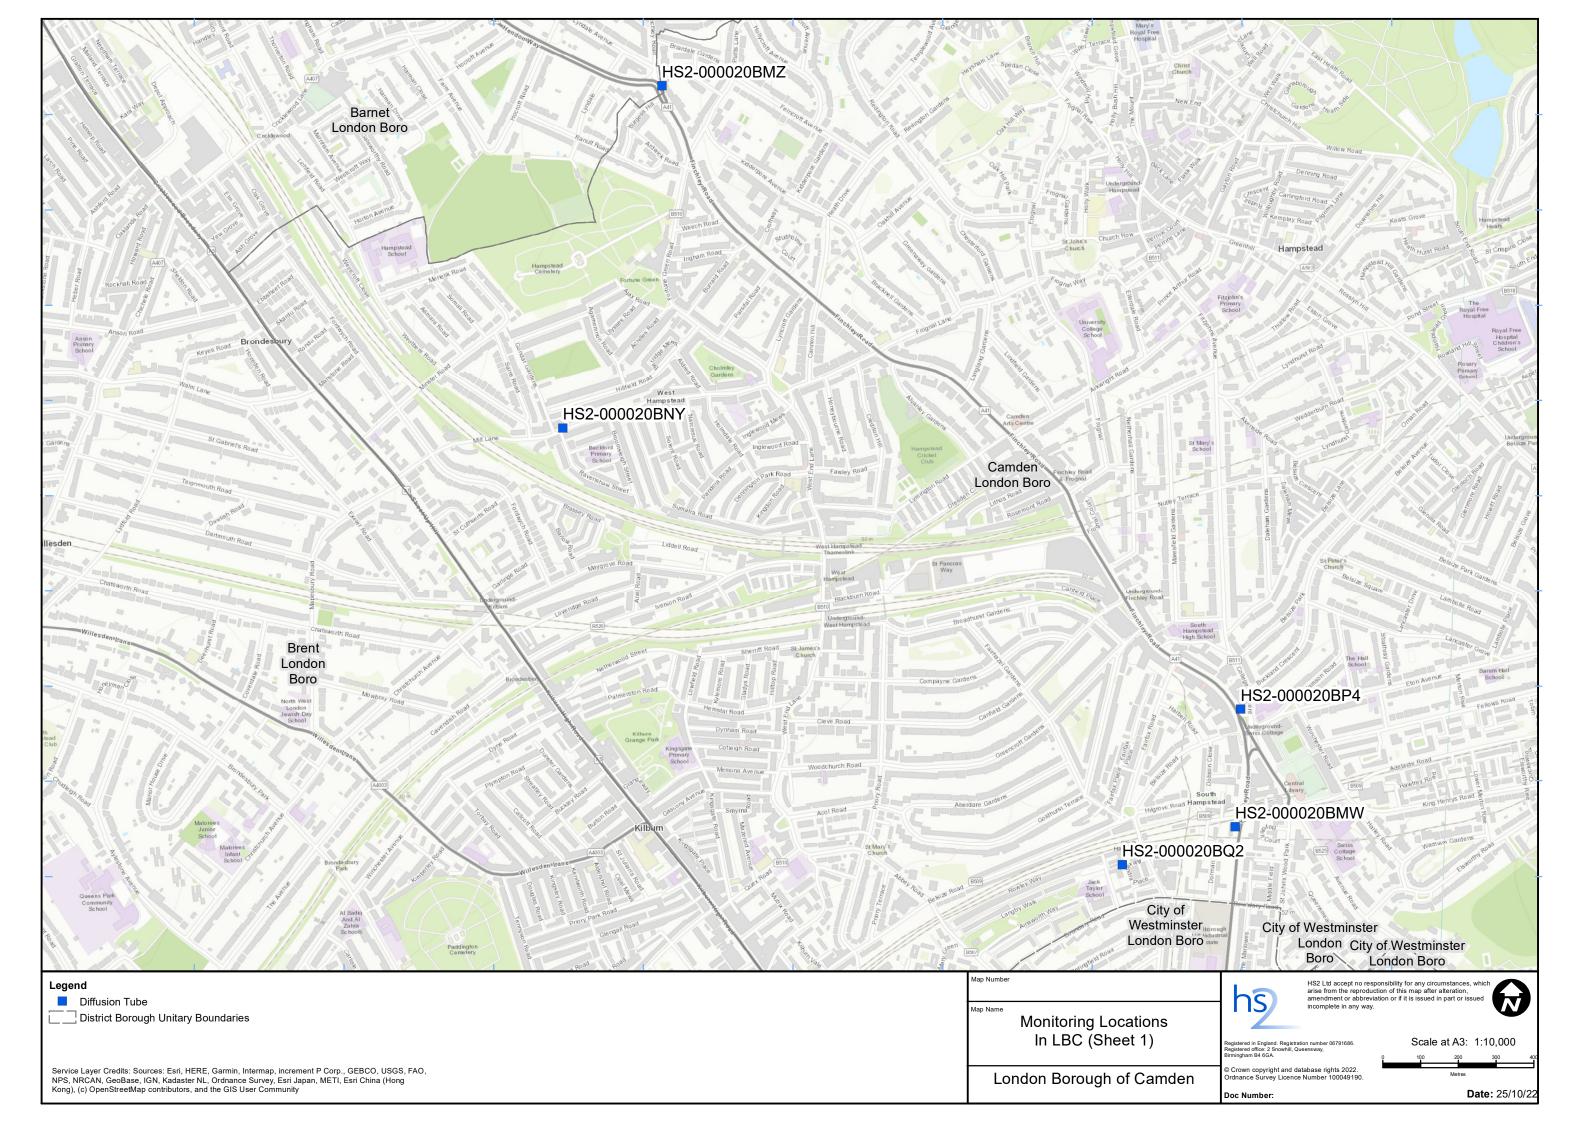
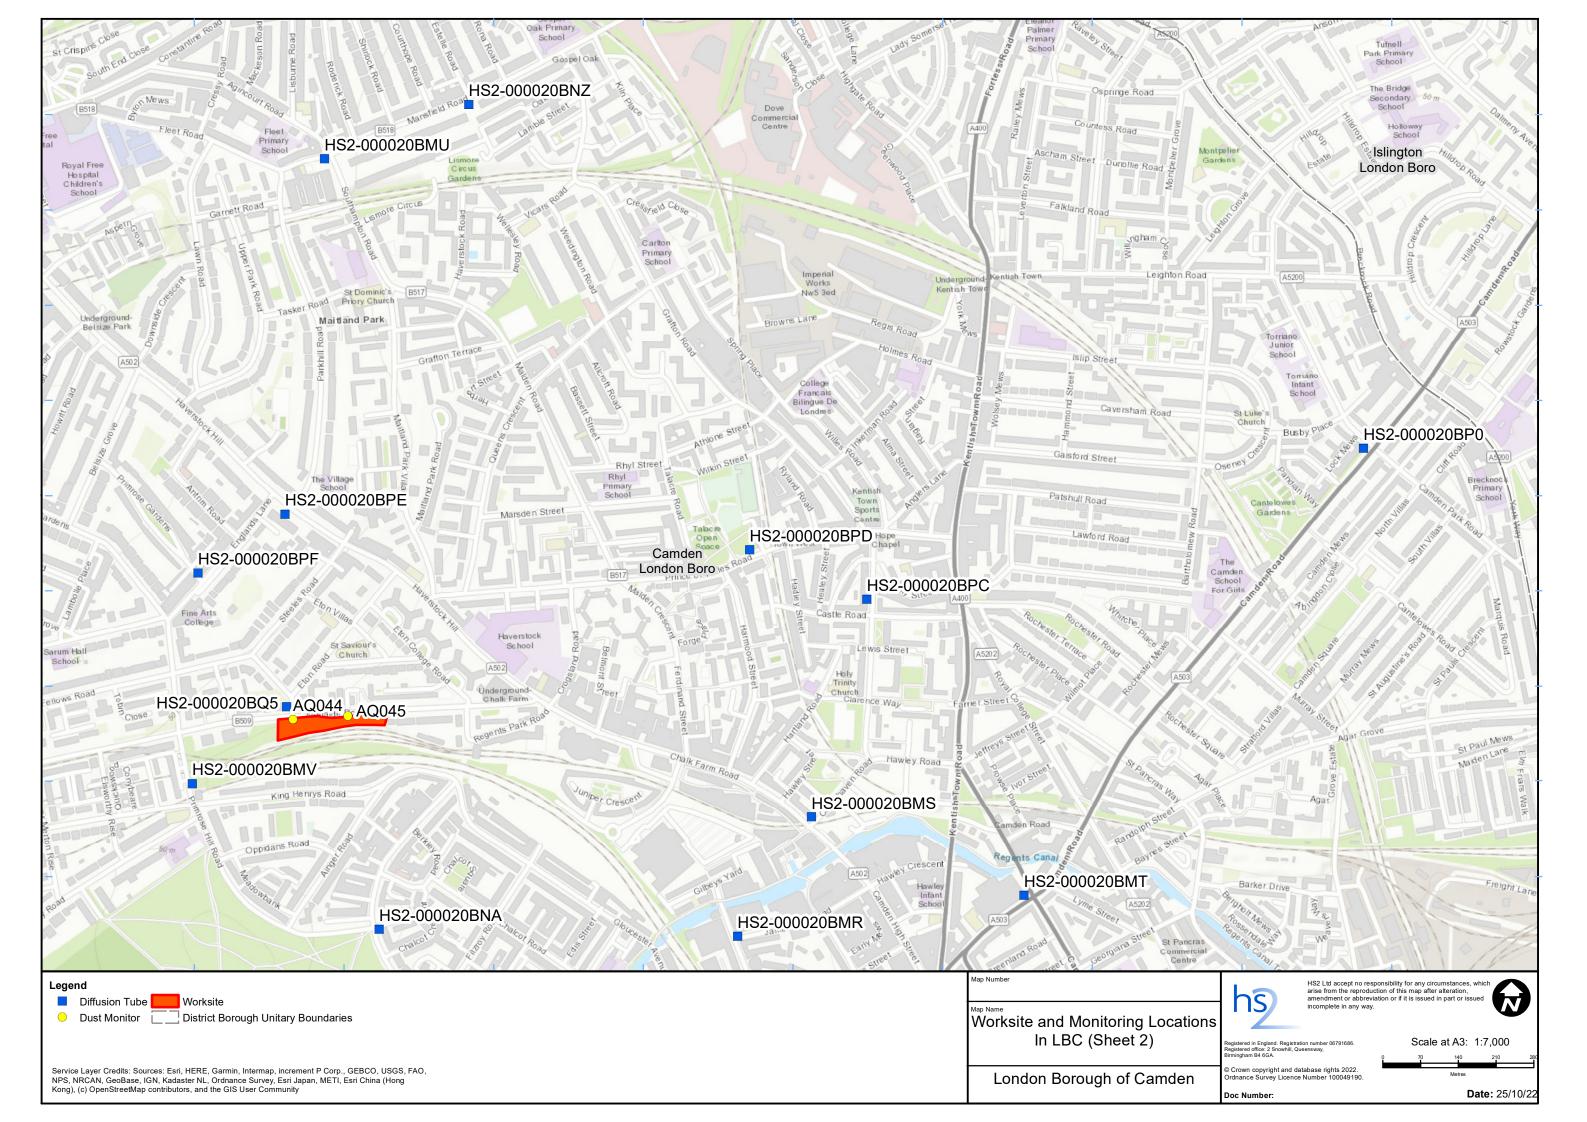
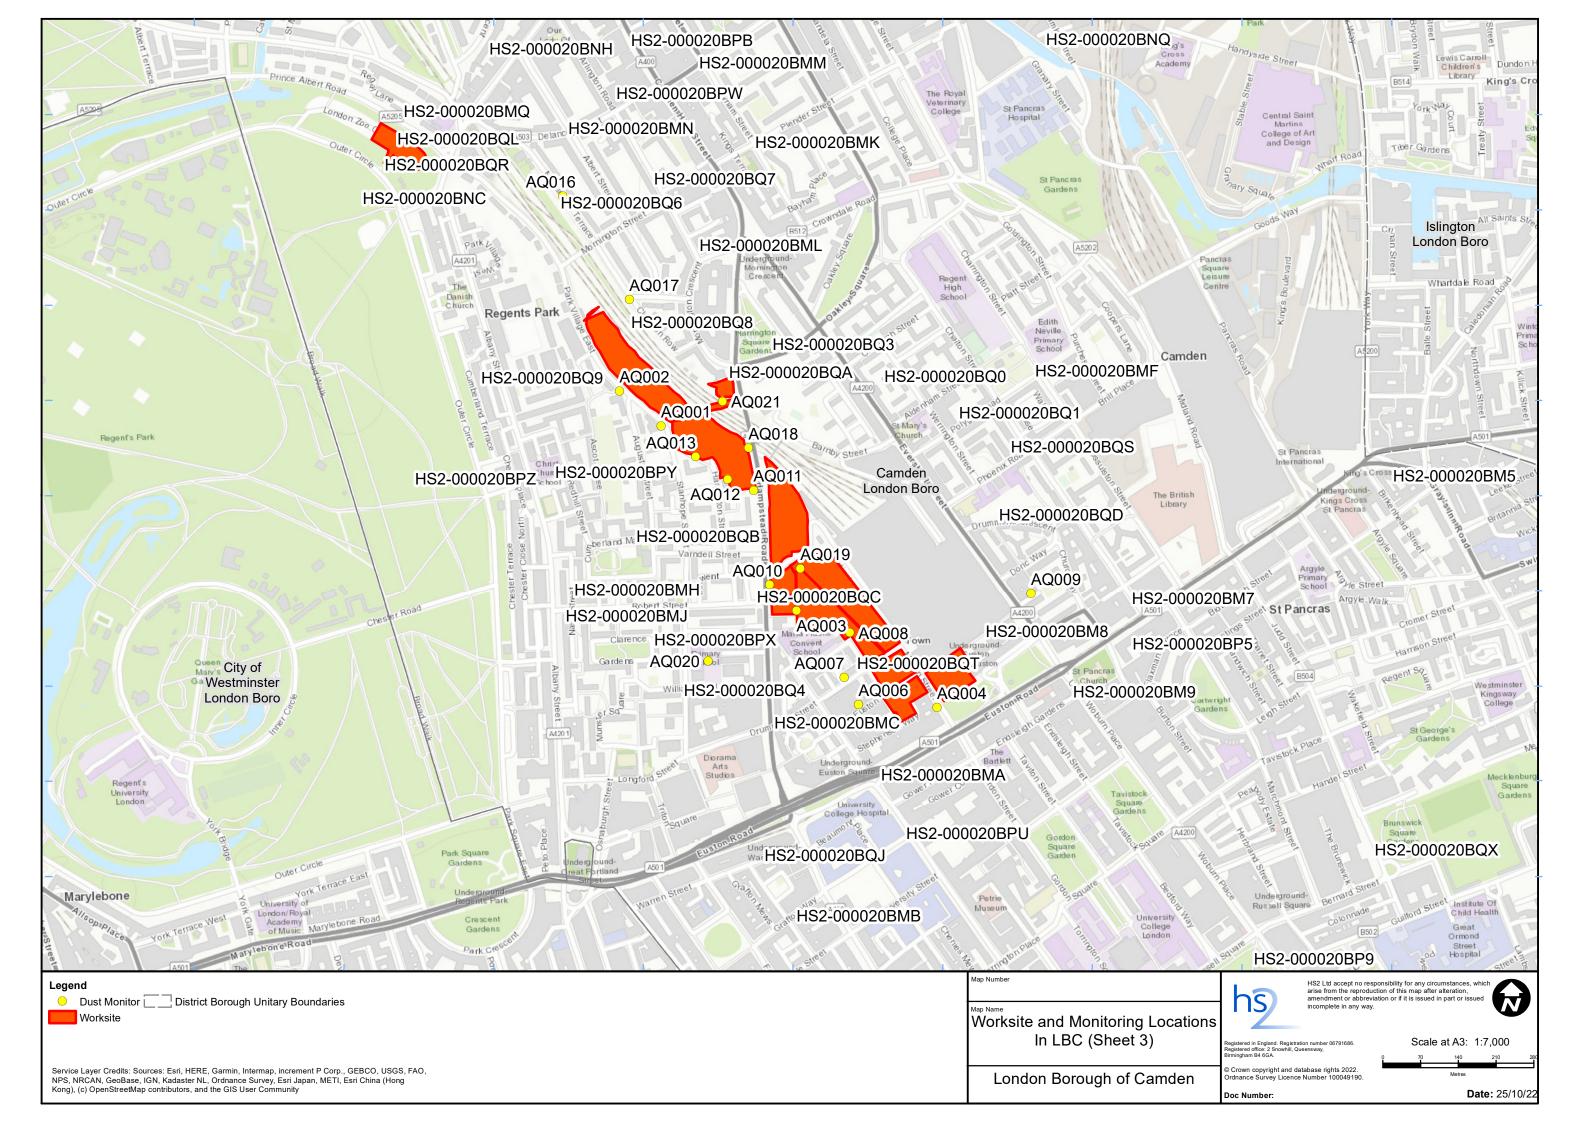
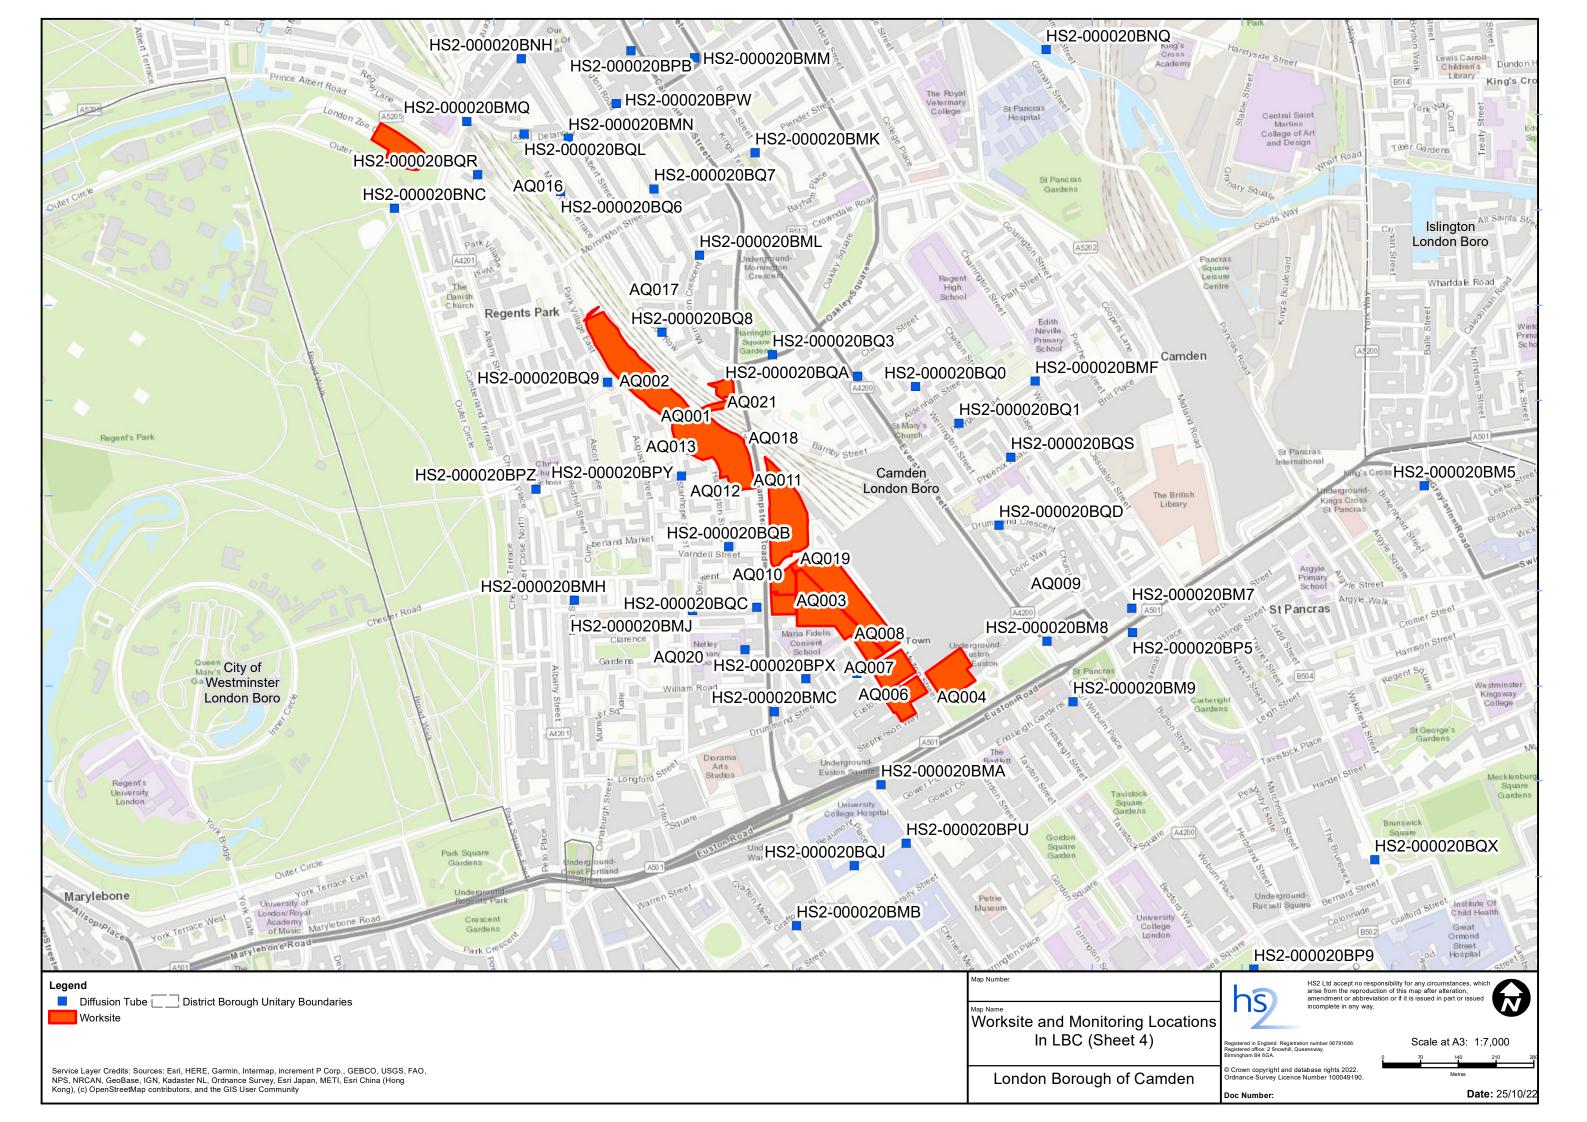
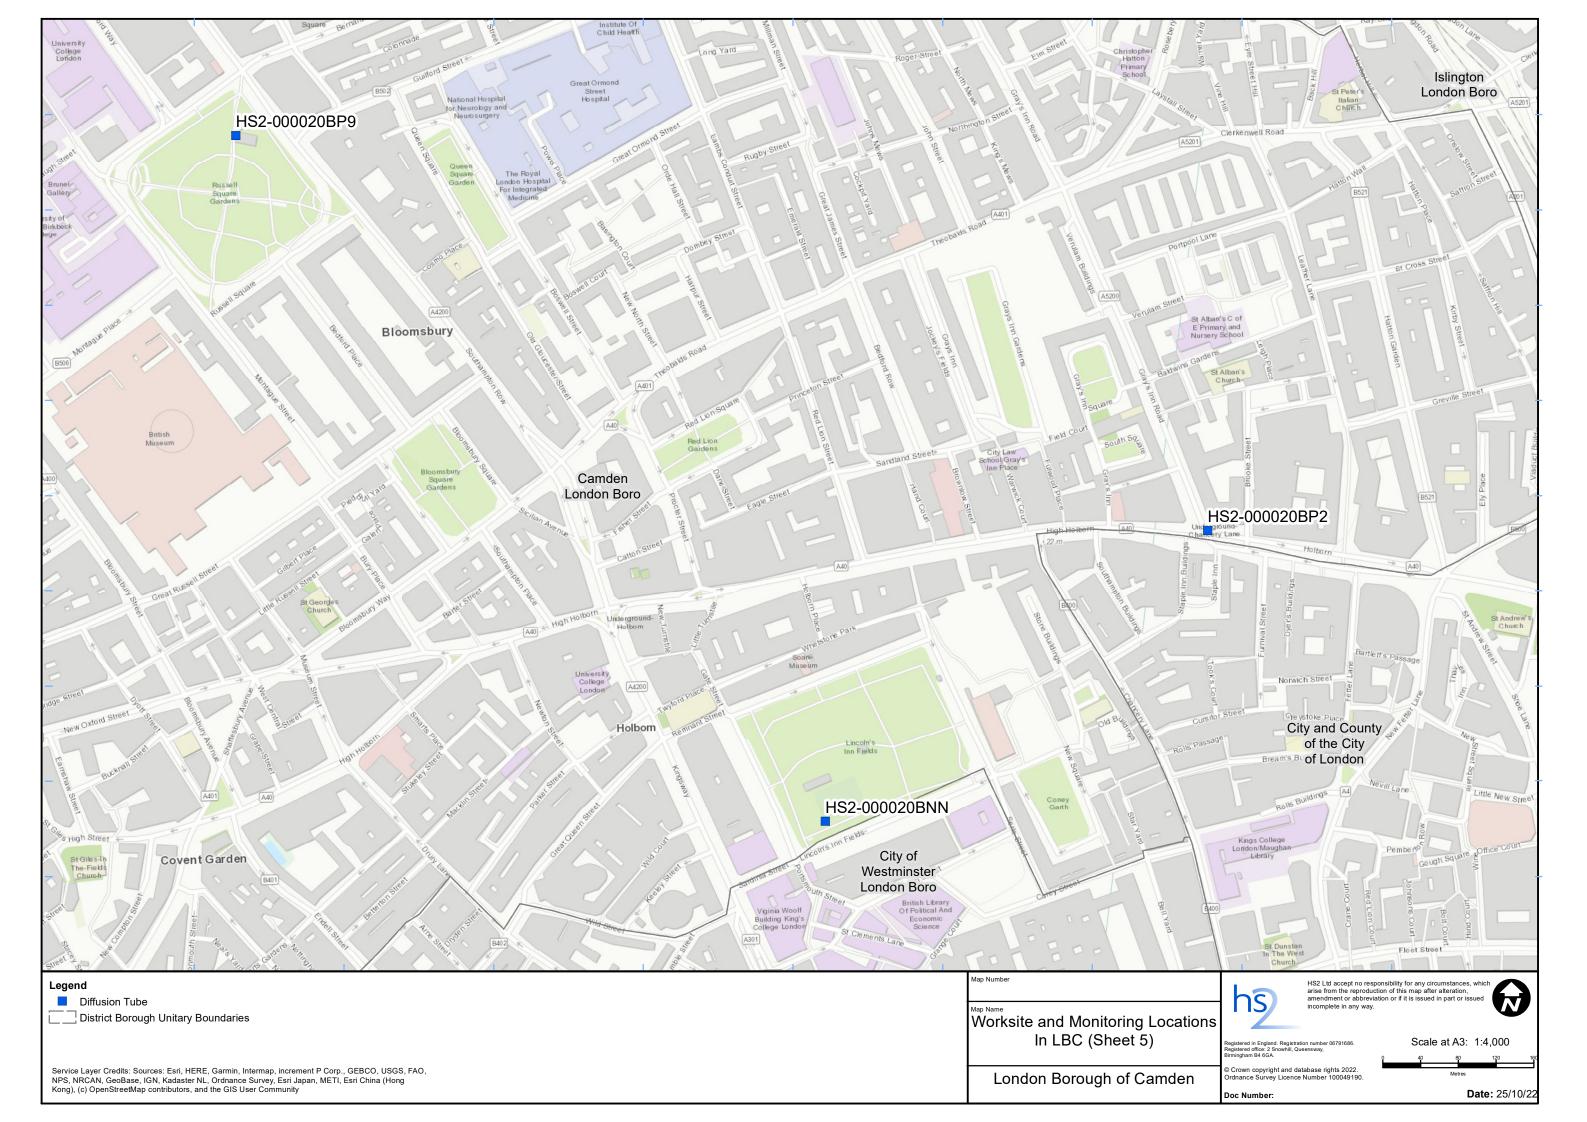
Figure 1 to Figure 5: Worksites and monitoring locations within the LBC

- 1.1.2 Figure 1 to Figure 5 in Appendix A indicate the current worksites together with air quality and dust monitoring locations.
- 1.1.3 This summary should be read in conjunction with the overview monitoring report available from www.gov.uk/government/collections/monitoring-the-environmental-effects-of-hs2, which highlights: the applicable standards and guidance, as well as the air quality and dust monitoring methodologies to be implemented by nominated undertakers throughout construction.

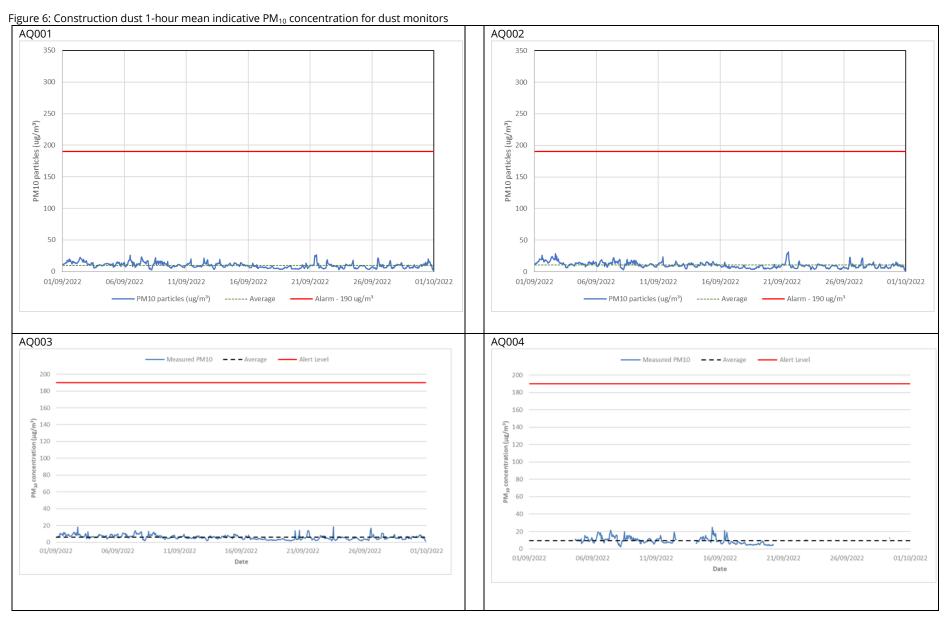
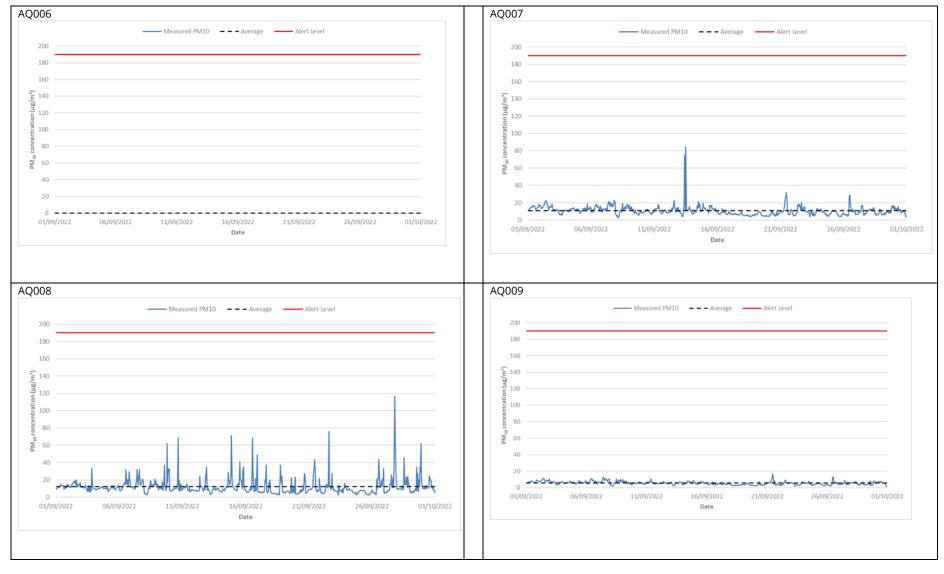
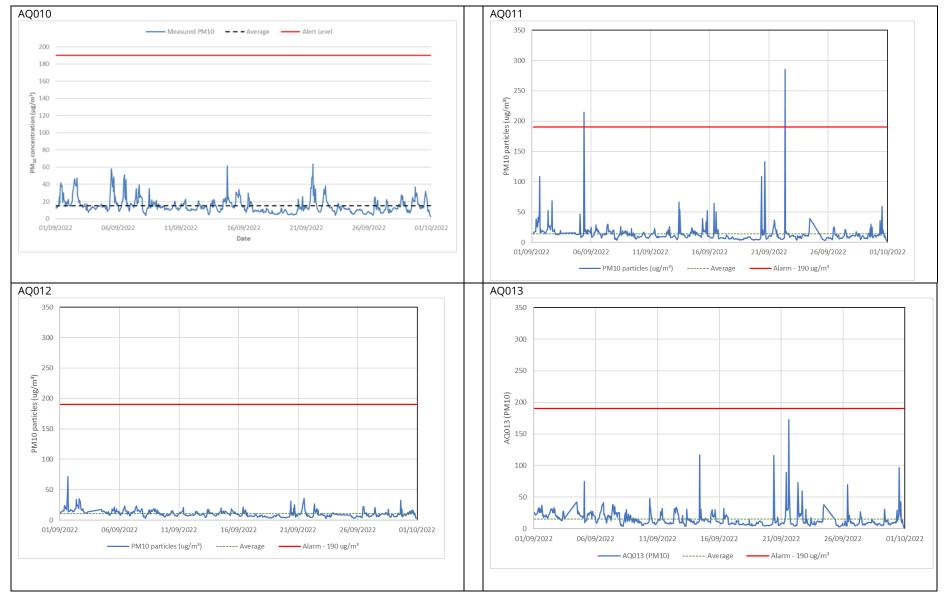
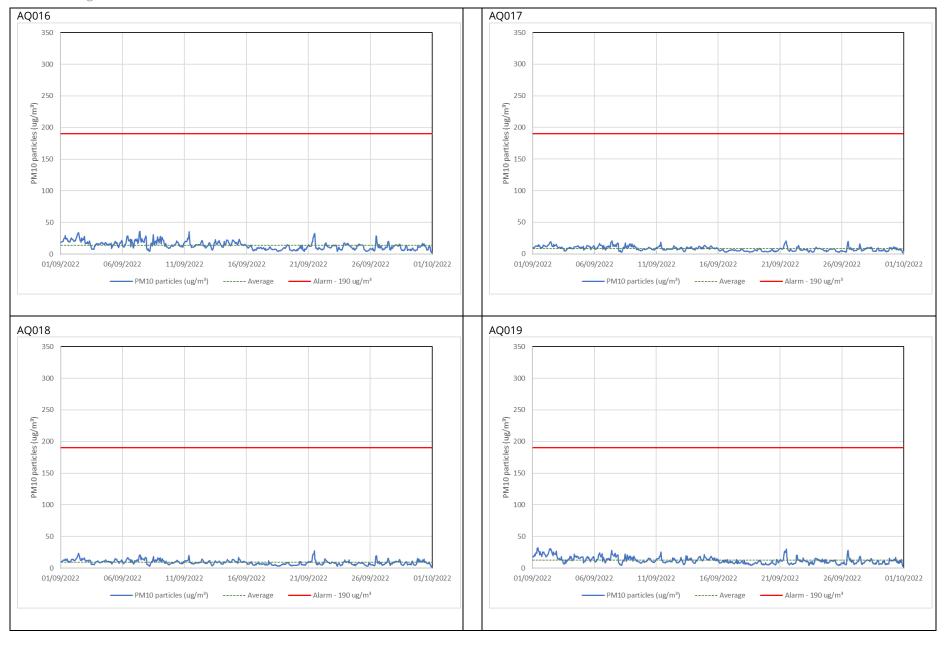
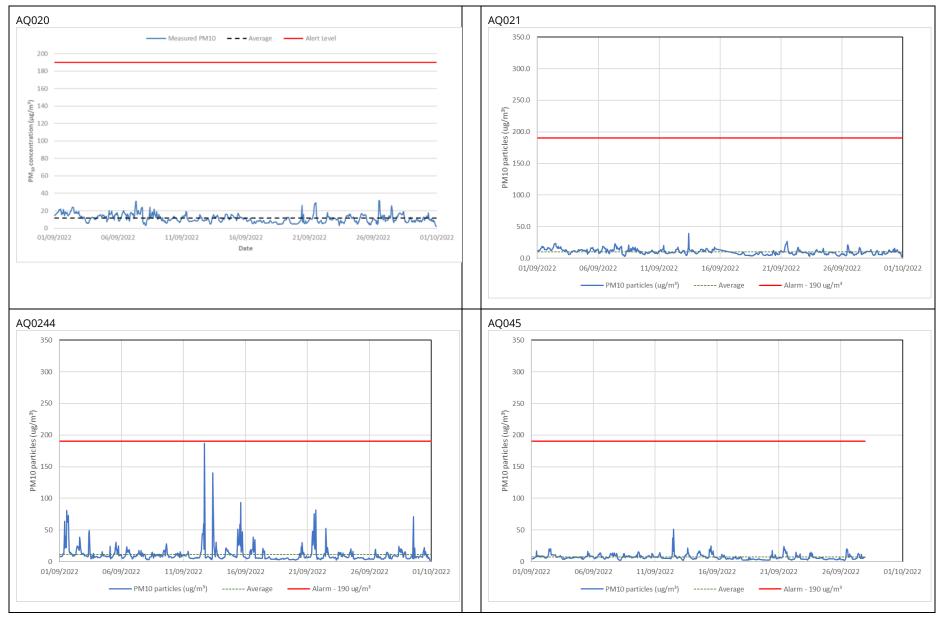
- Demo works to North East corner
- Demo basement & vertical elements
- L shaped blocks installed to utilities corridor
- Backfill to L shaped blocks
- 1.1.5 Twenty (20) dust monitors are installed around worksites, where works are underway. These sites returned a medium to high dust risk rating.
- 1.1.6 Dust monitoring locations and results are presented in Appendix B, Table 1, together with line charts of monthly data from each dust monitor in Figure 6. All continuous dust
