HMS Daedalus

Walkover Gamma Survey

Title: Gamma Walkover Survey: HMS Daedalus

RADIATION WALKOVER SURVEY AT DAEDALUS

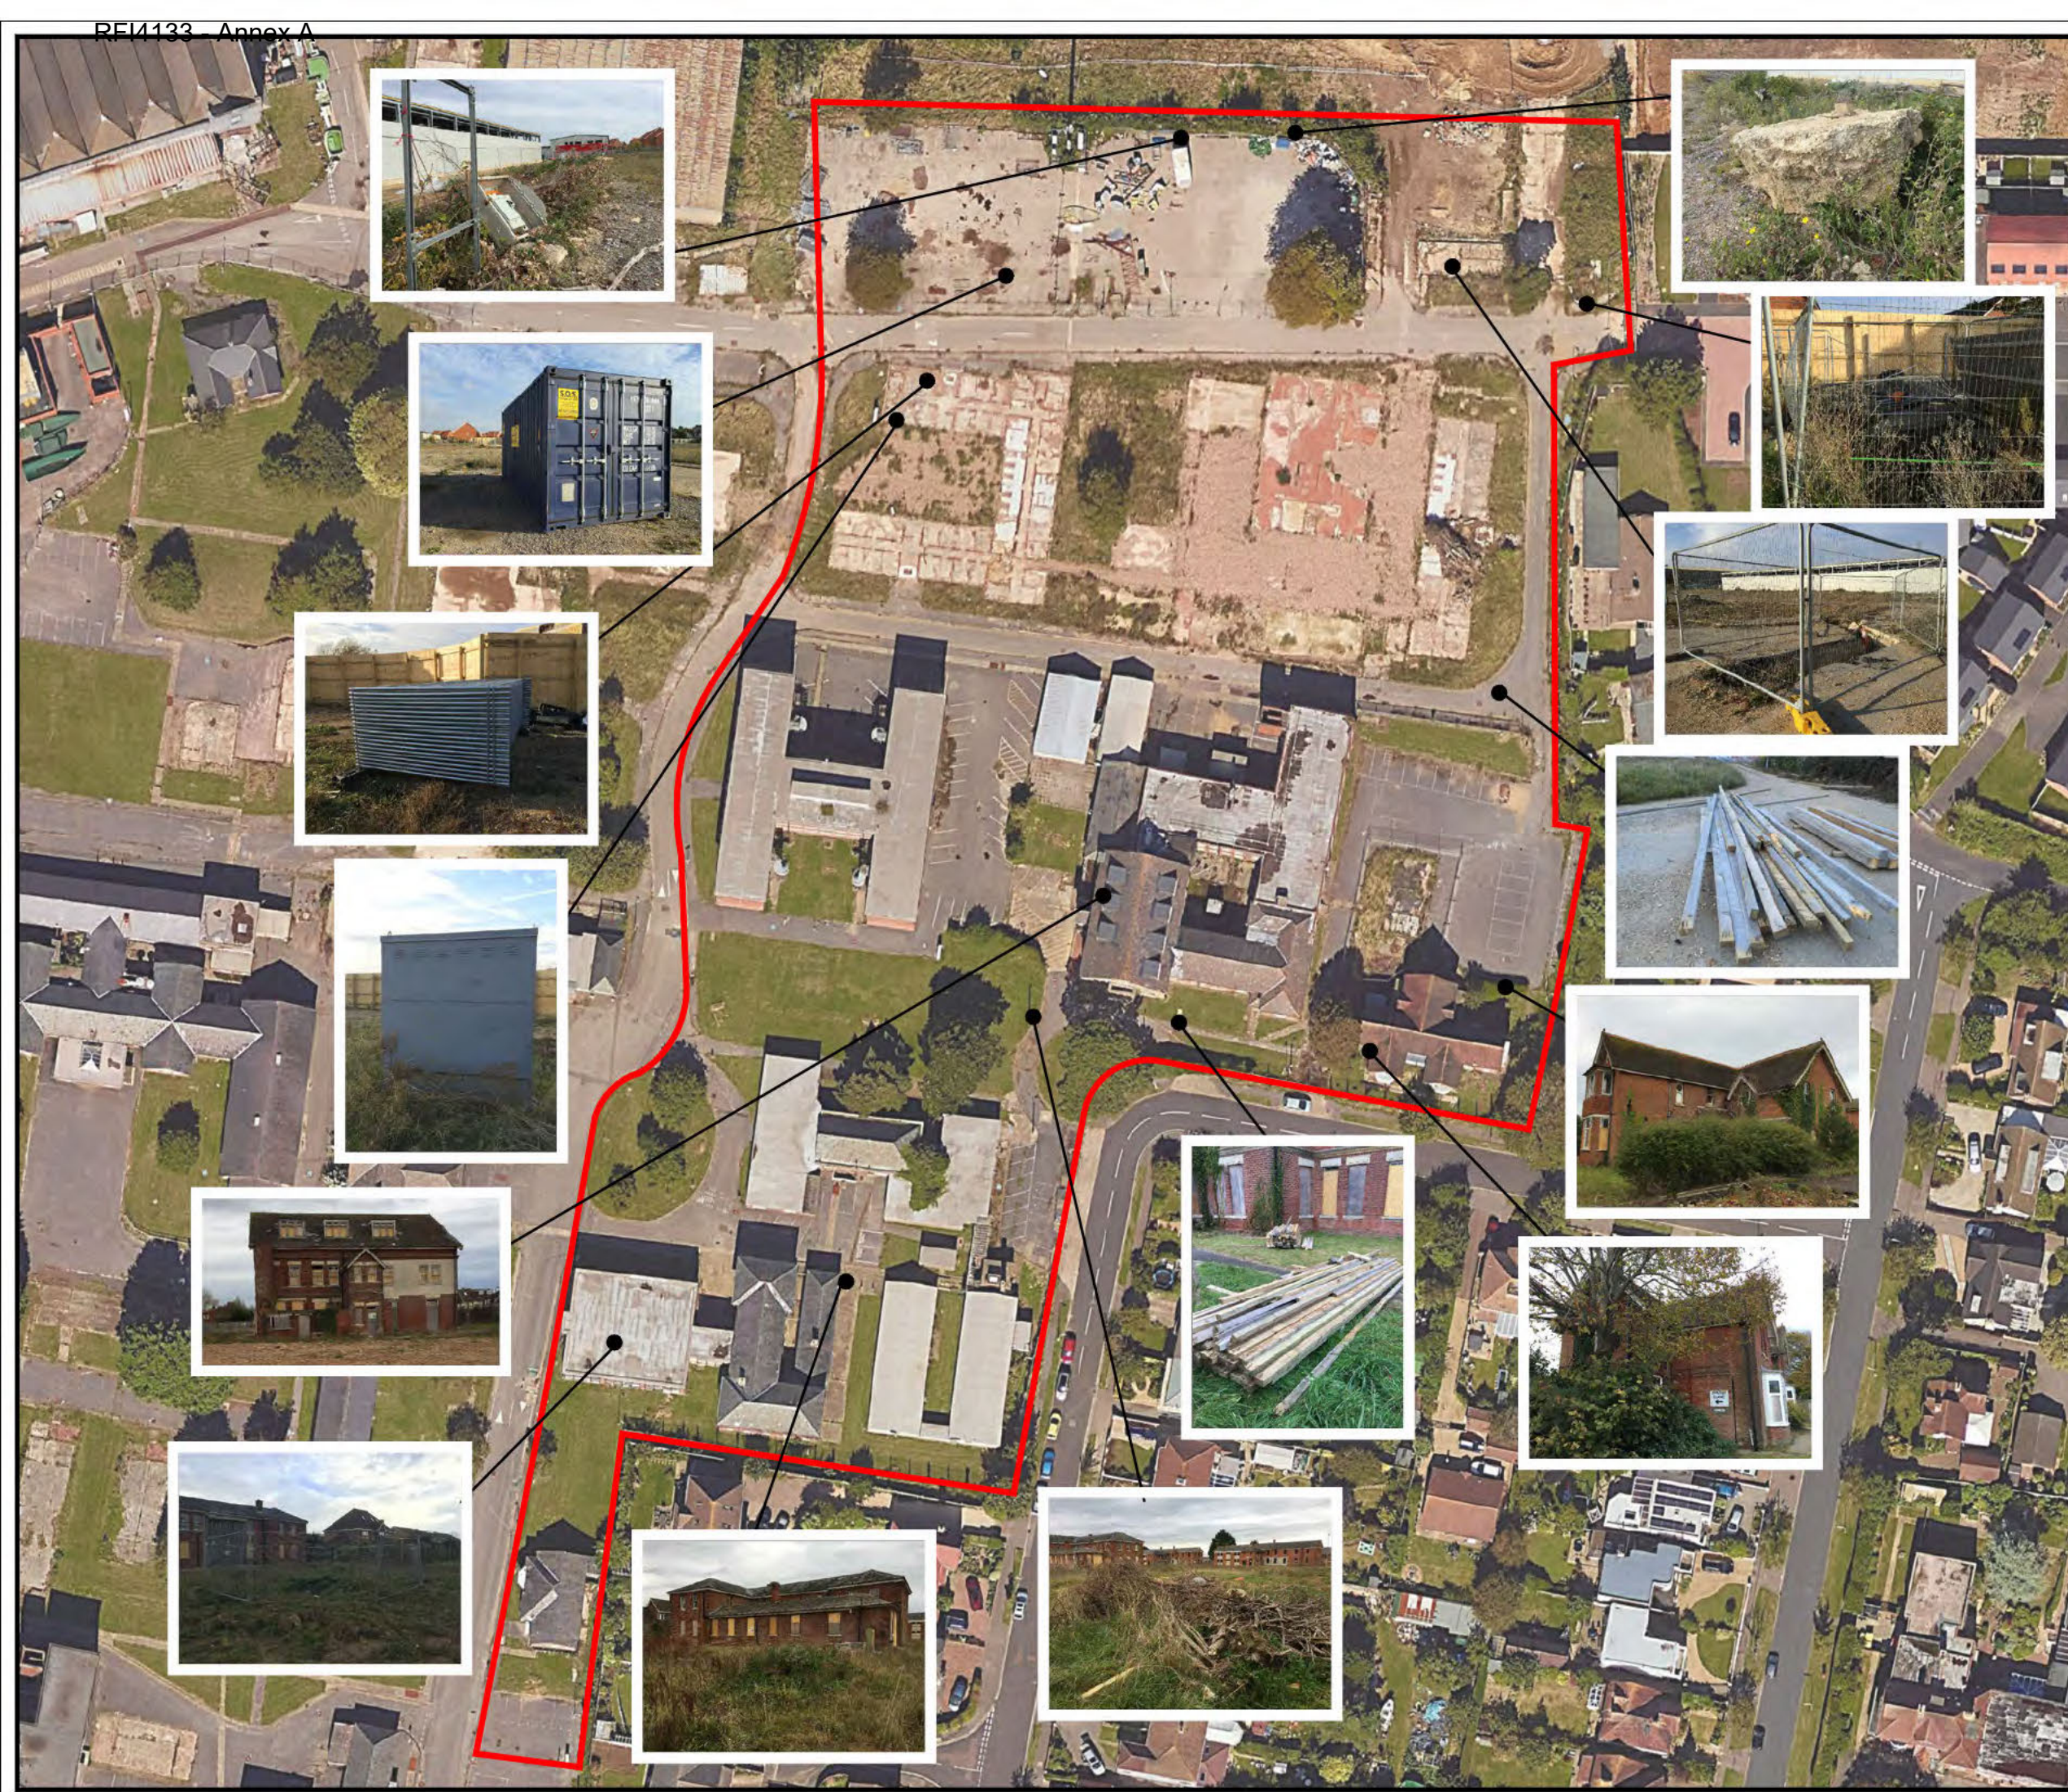
FIGURE 2

In the Eastern site there are several points marked and photographed in Figure 2 that were not covered by the walkover, due to the ground being inaccessible or an object covering the surface.

TITLE
SITE CONSTRAINTS PLAN

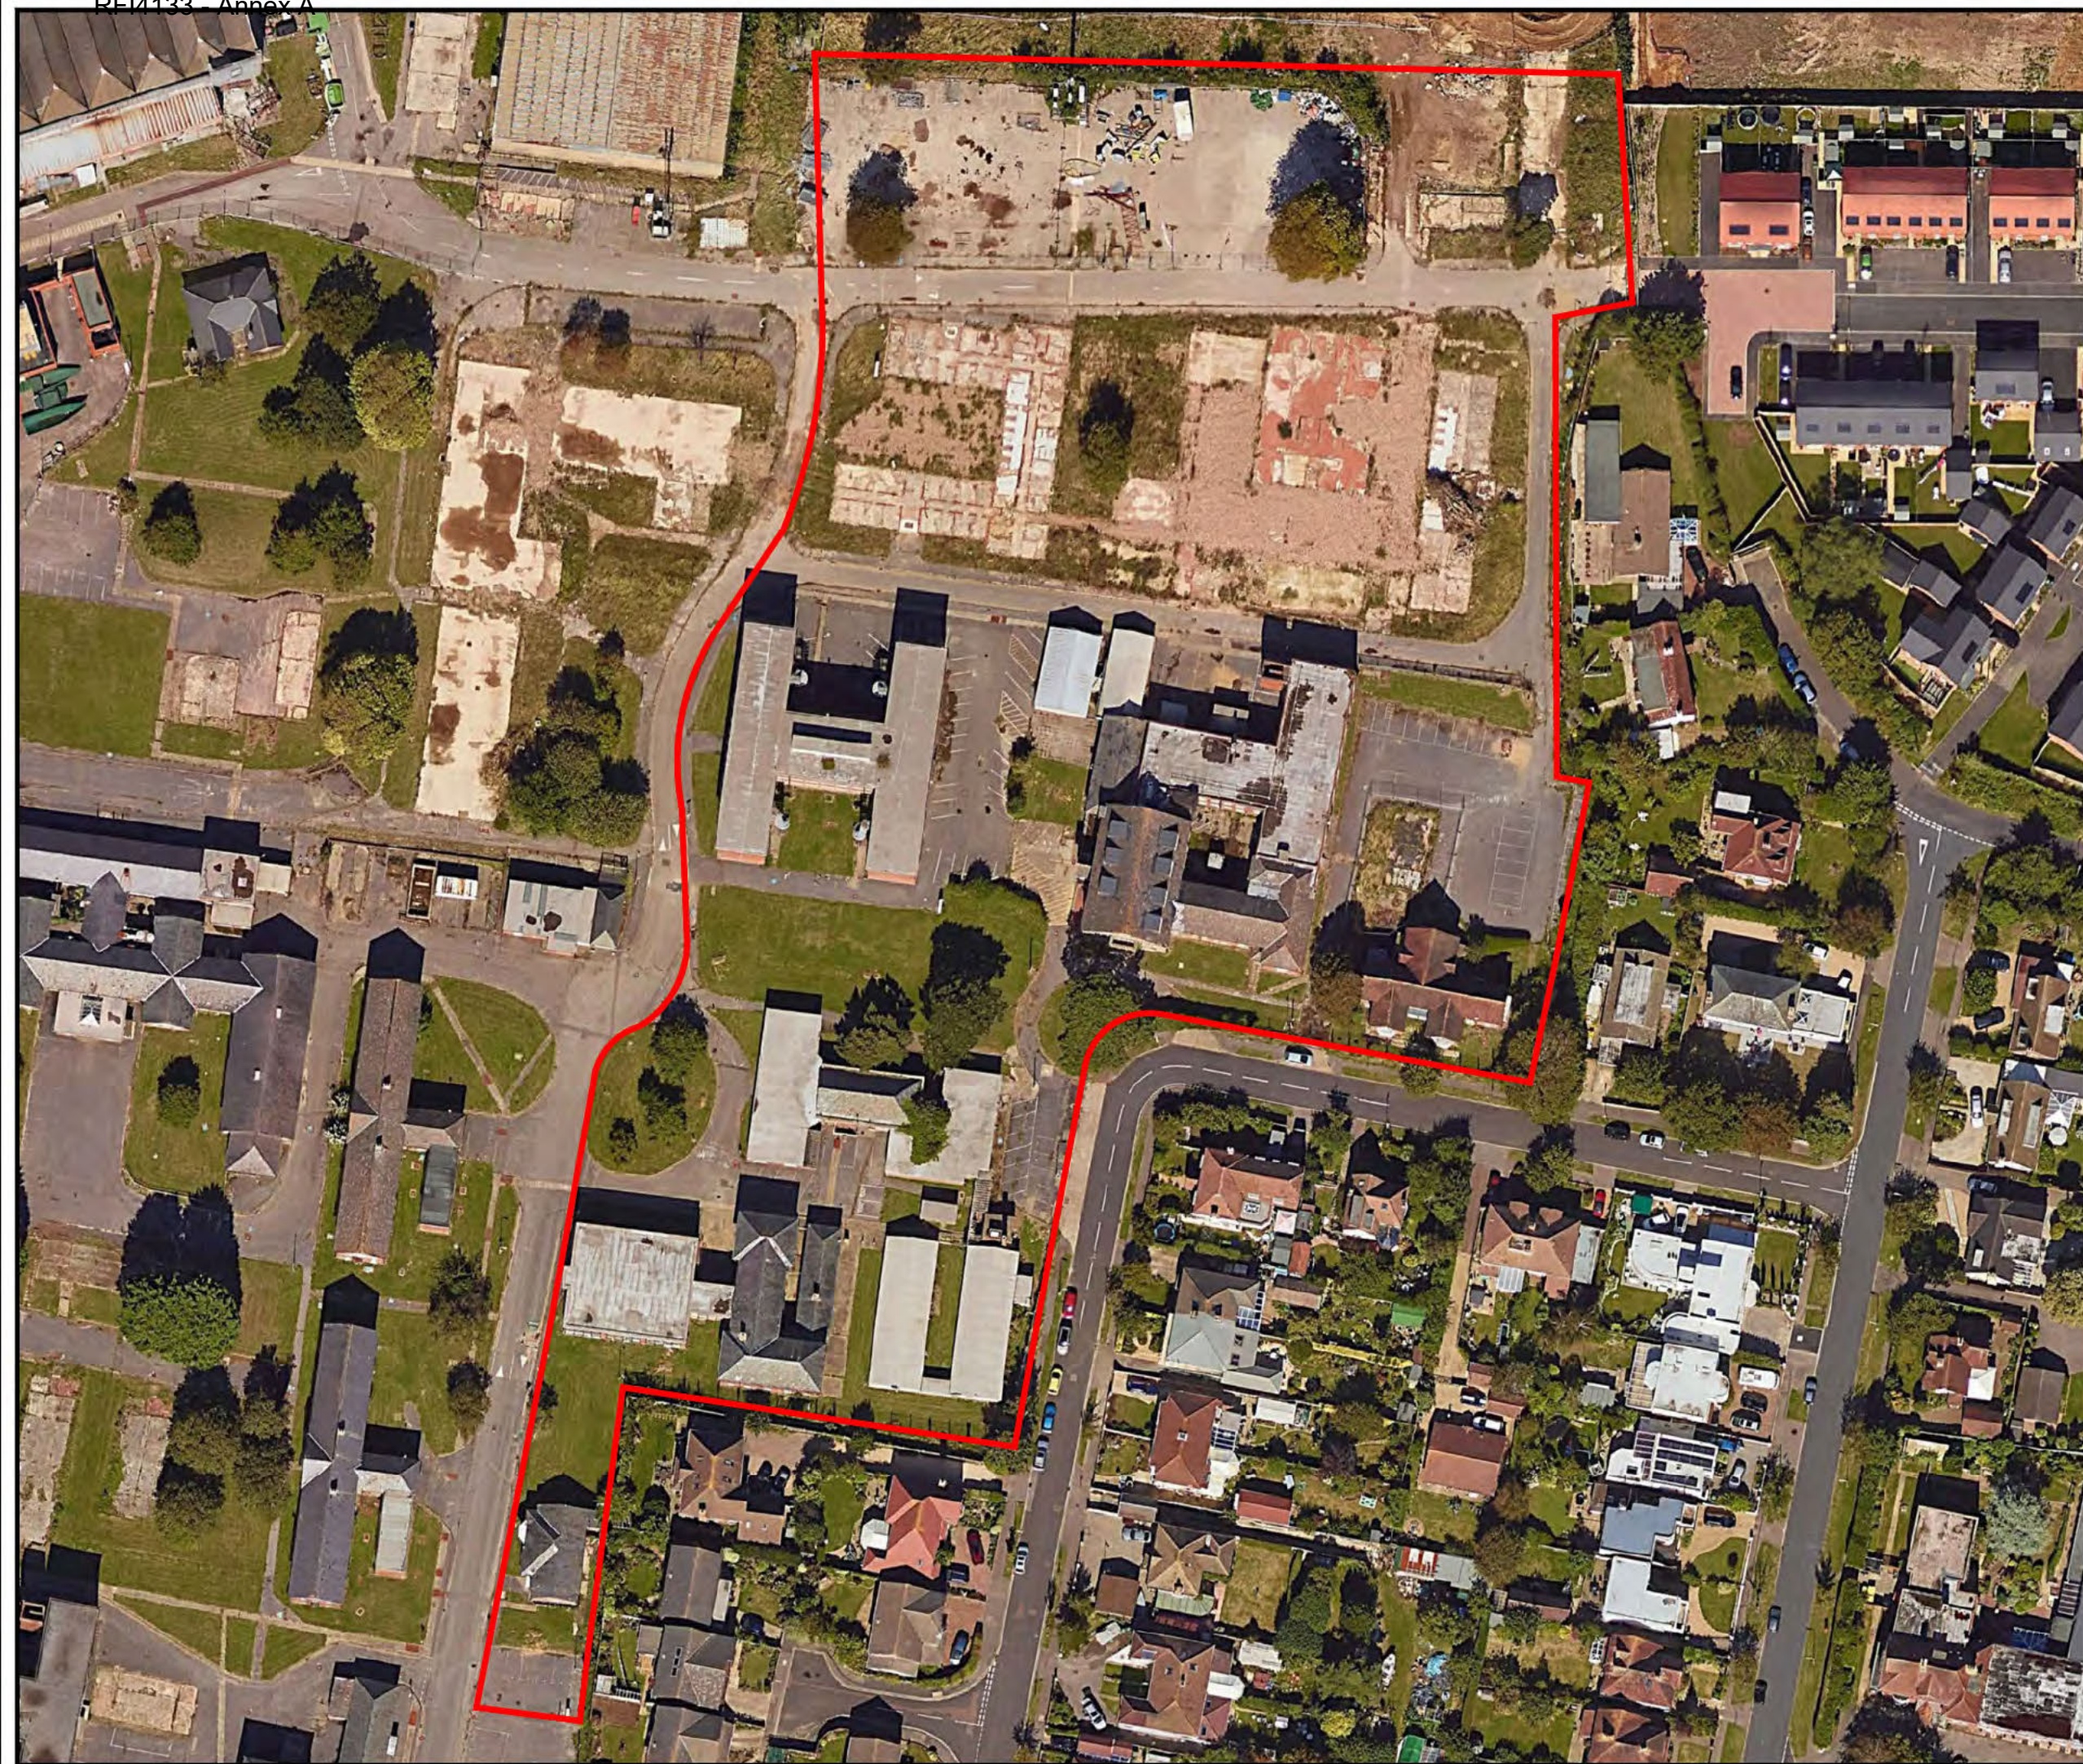
CLIENT	WATES RESIDENTIAL				
PROJECT	DAEDALUS GAMMA SURVEY				
TITLE	EASTERN SITE SURVEY AREA				
JOB No.:	810200		DRAWING FILE:	810200-L01(00)D003A	
BY:	DATE:	CONTRACT NO.	FIGURE 3	REV:	A
AP	12.11.18

The survey was conducted on the Eastern parcel of land that is being developed by Wates Residential, with an area of approximately 2.61 ha (Figure 3). Additionally, a subsection of the Western parcel of land, which was not surveyed under previous contracts, was included in this survey exercise (Figure 4). Most of the Eastern parcel consisted of made ground typically containing soil mixed with variable sized fragments of brick, metal, glass, etc. Many areas featured a mixture of vegetation. Some survey areas consisted of concrete slabs, pathways and tarmac. Whilst existing buildings on site prevented survey work at those specific locations as they were not accessed, the survey did cover the immediate accessible area around the buildings.

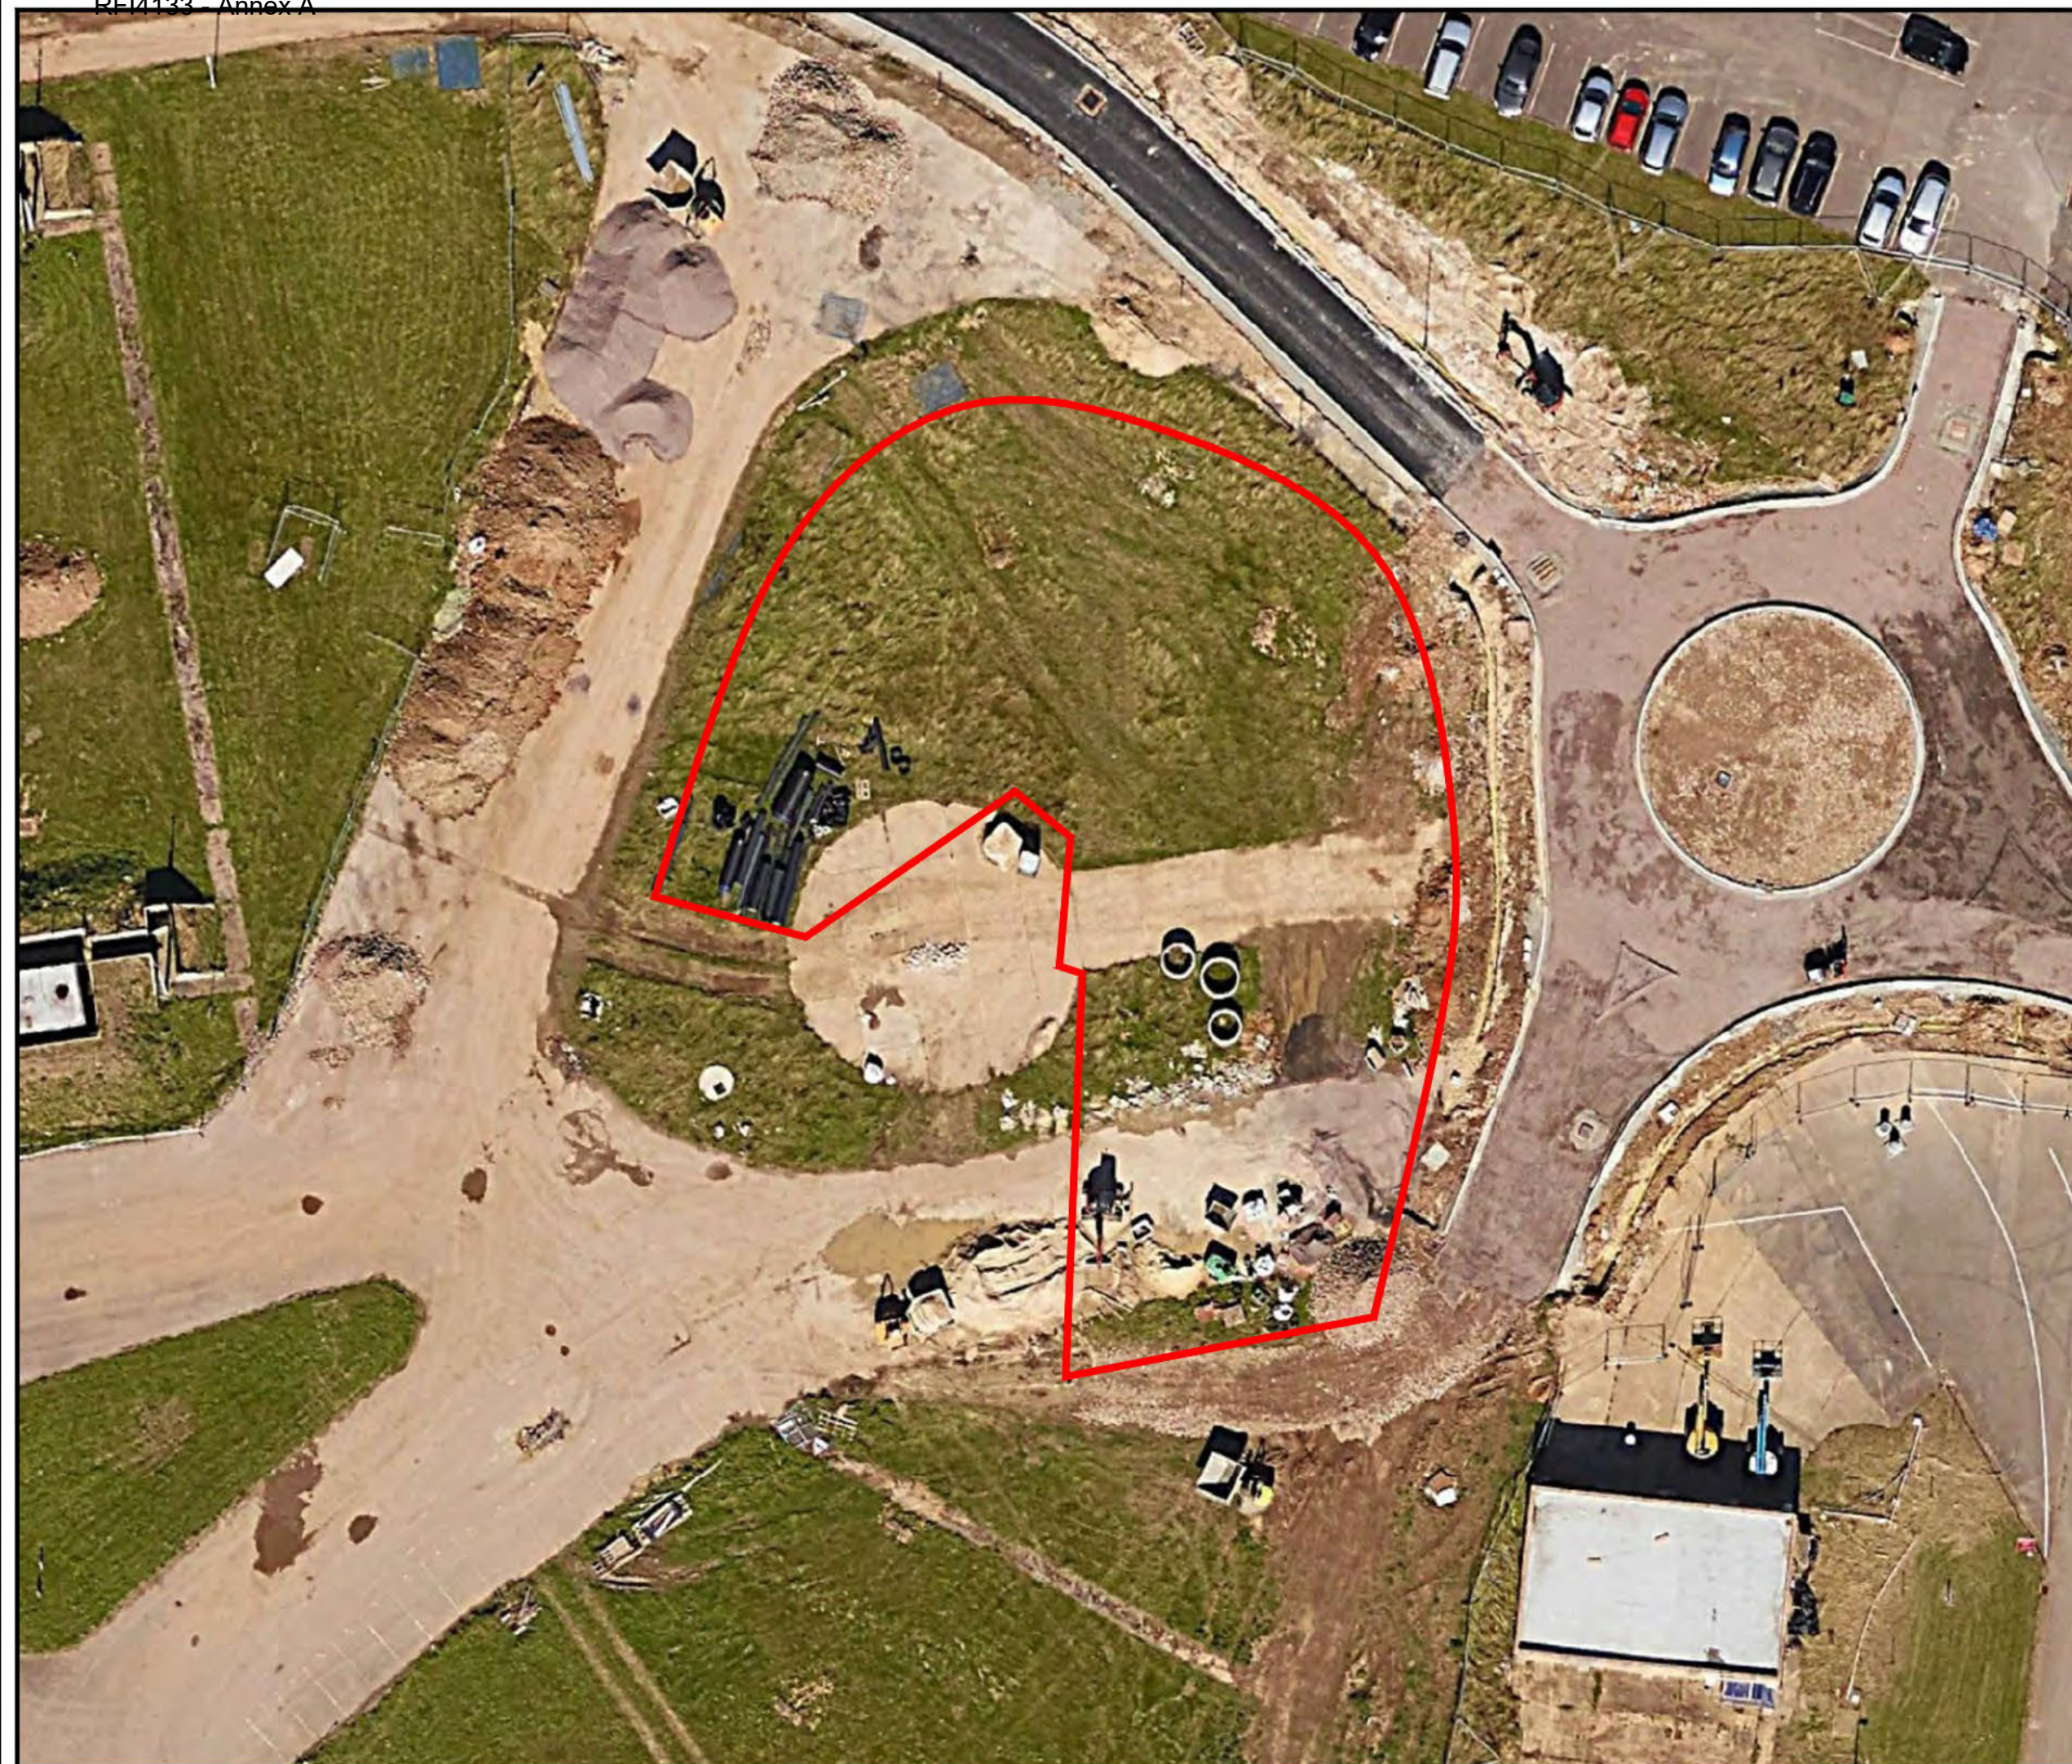
CLIENT	WATES RESIDENTIAL				
PROJECT	DAEDALUS GAMMA SURVEY				
TITLE	WESTERN SITE SURVEY AREA				
JOB No.:	810200		DRAWING FILE:	810200-L01(00)D004A	
BY:	DATE:	CONTRACT NO.:	FIGURE 4	REV:	A
AP	12.11.18

The area that required surveying on the Western site did not have obvious indications of the boundary, consequently a larger area than required was surveyed to ensure all necessary ground was covered.

The area surveyed from the Western parcel consisted of only made ground and did not contain the large pieces of brick, metal and glass found in the Eastern site.

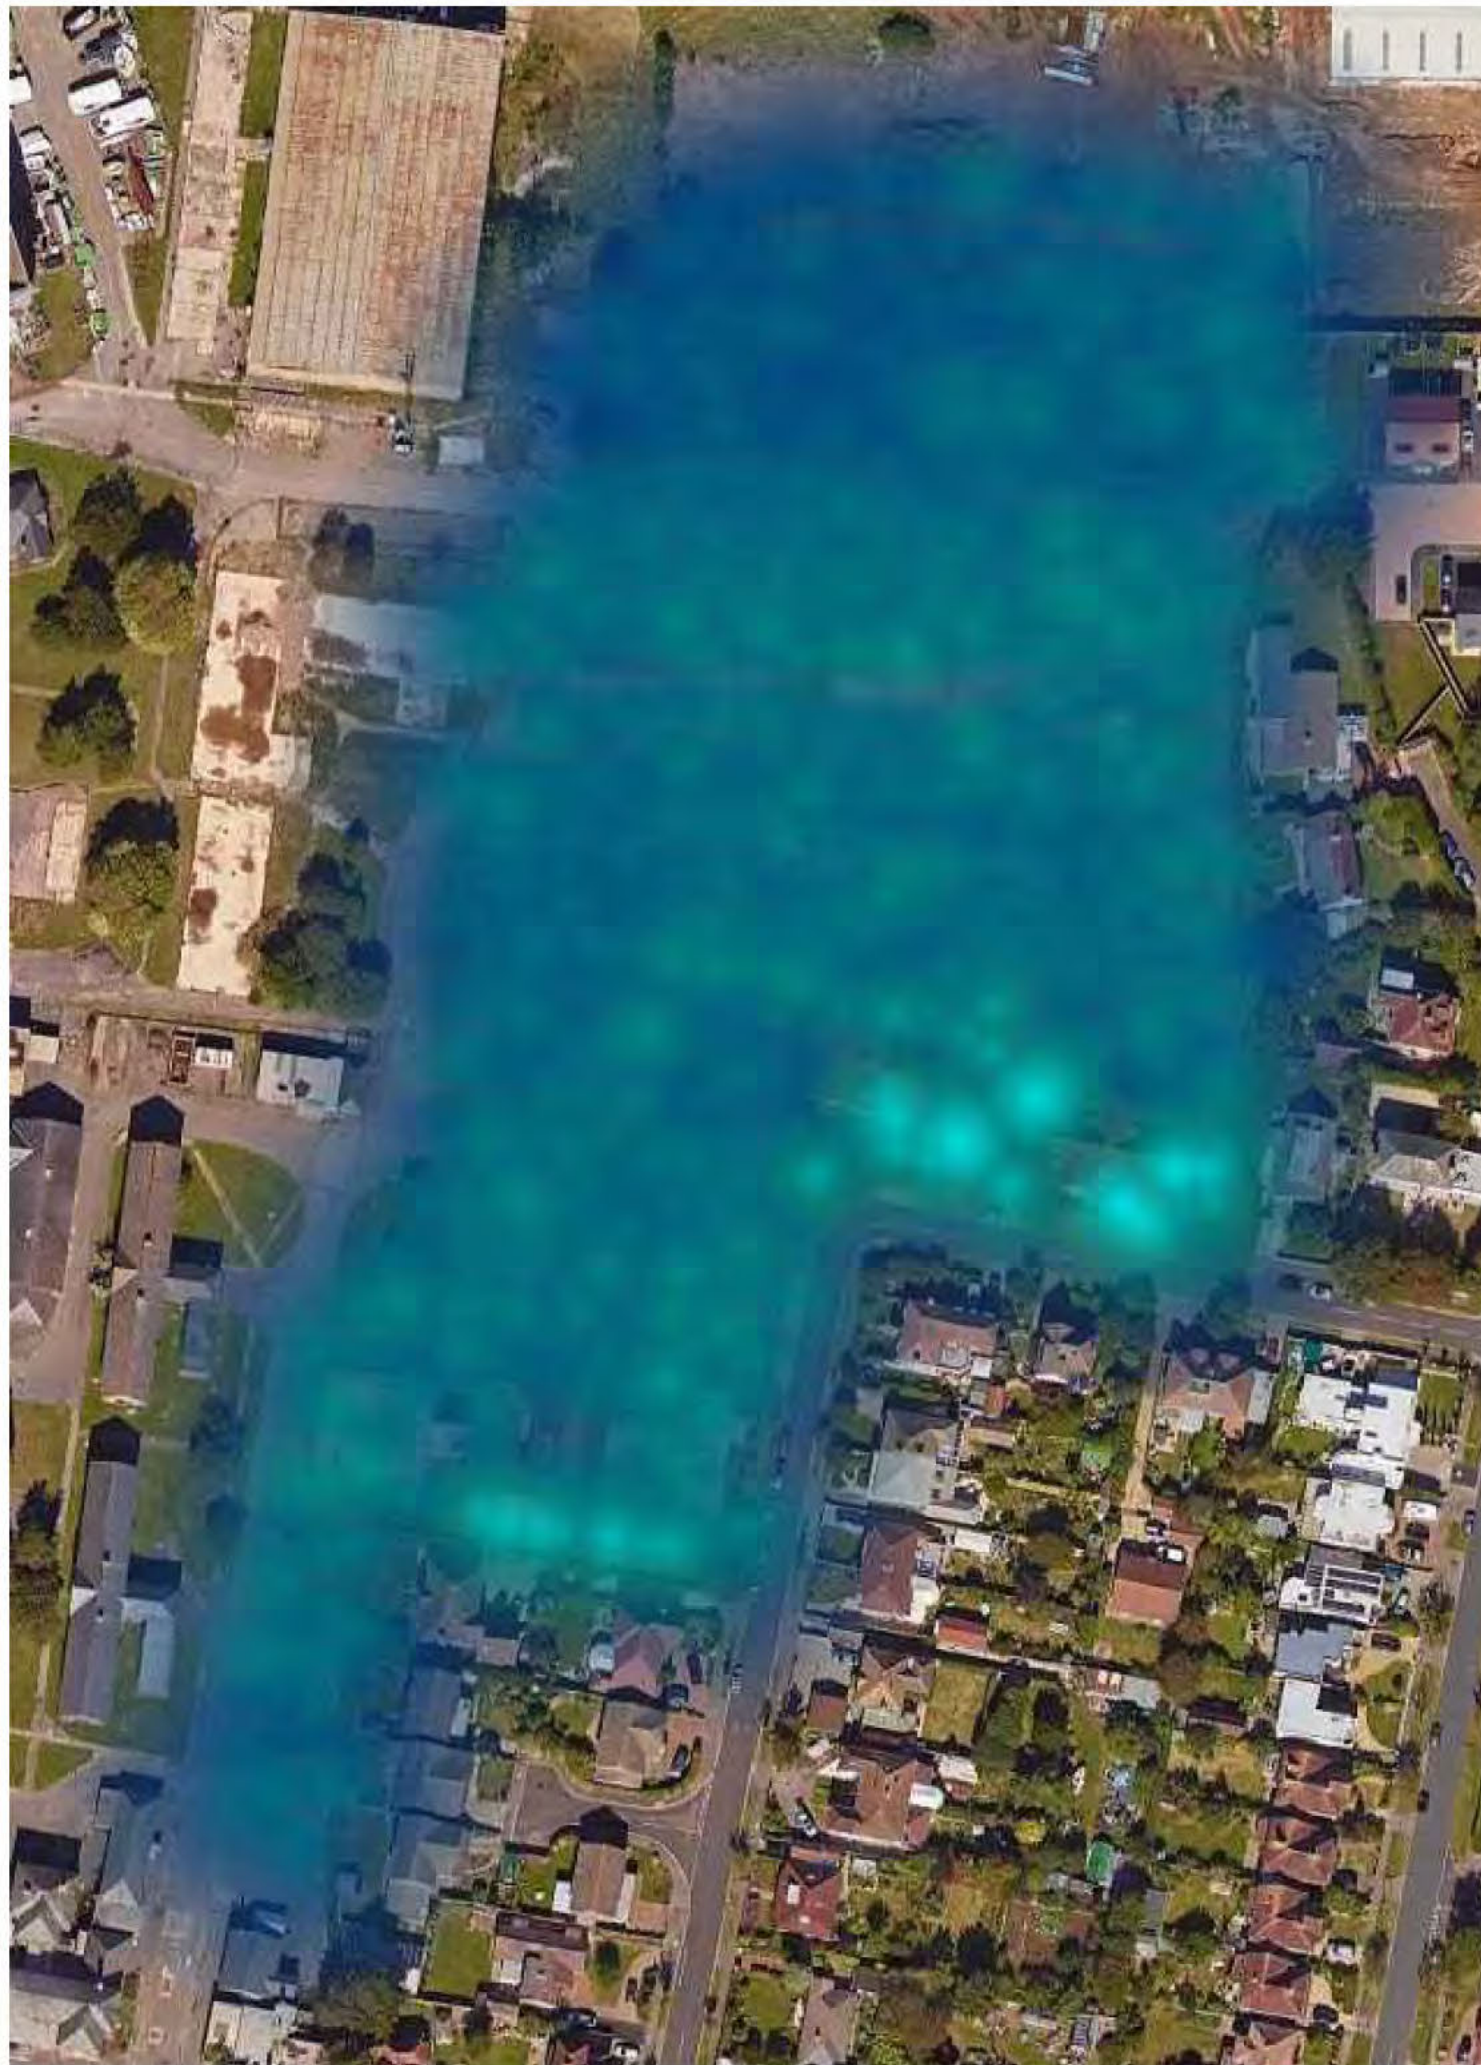
BY:	DATE:	CONTRACT NO.:	FIGURE 5	REV:
HD	14.11.18			A

- there are approximately 100 data points in the upper 5%
- these occur in areas of the Eastern site where existing buildings are present
- the upper 5% results up to the maximum observed of 208 cps are typical of certain types of brickwork commonly encountered on sites. All Targeted Gamma Measurements confirmed the presence of natural Thorium and Potassium-40, both of which are expected natural inclusions in building materials.

The results of the walkover survey can be seen in Figures 5 and 6 for the Eastern site and the Western site respectively.

TITLE
EASTERN SITE GAMMA HEAT MAP

No area of the site is considered to warrant further radiological investigation.

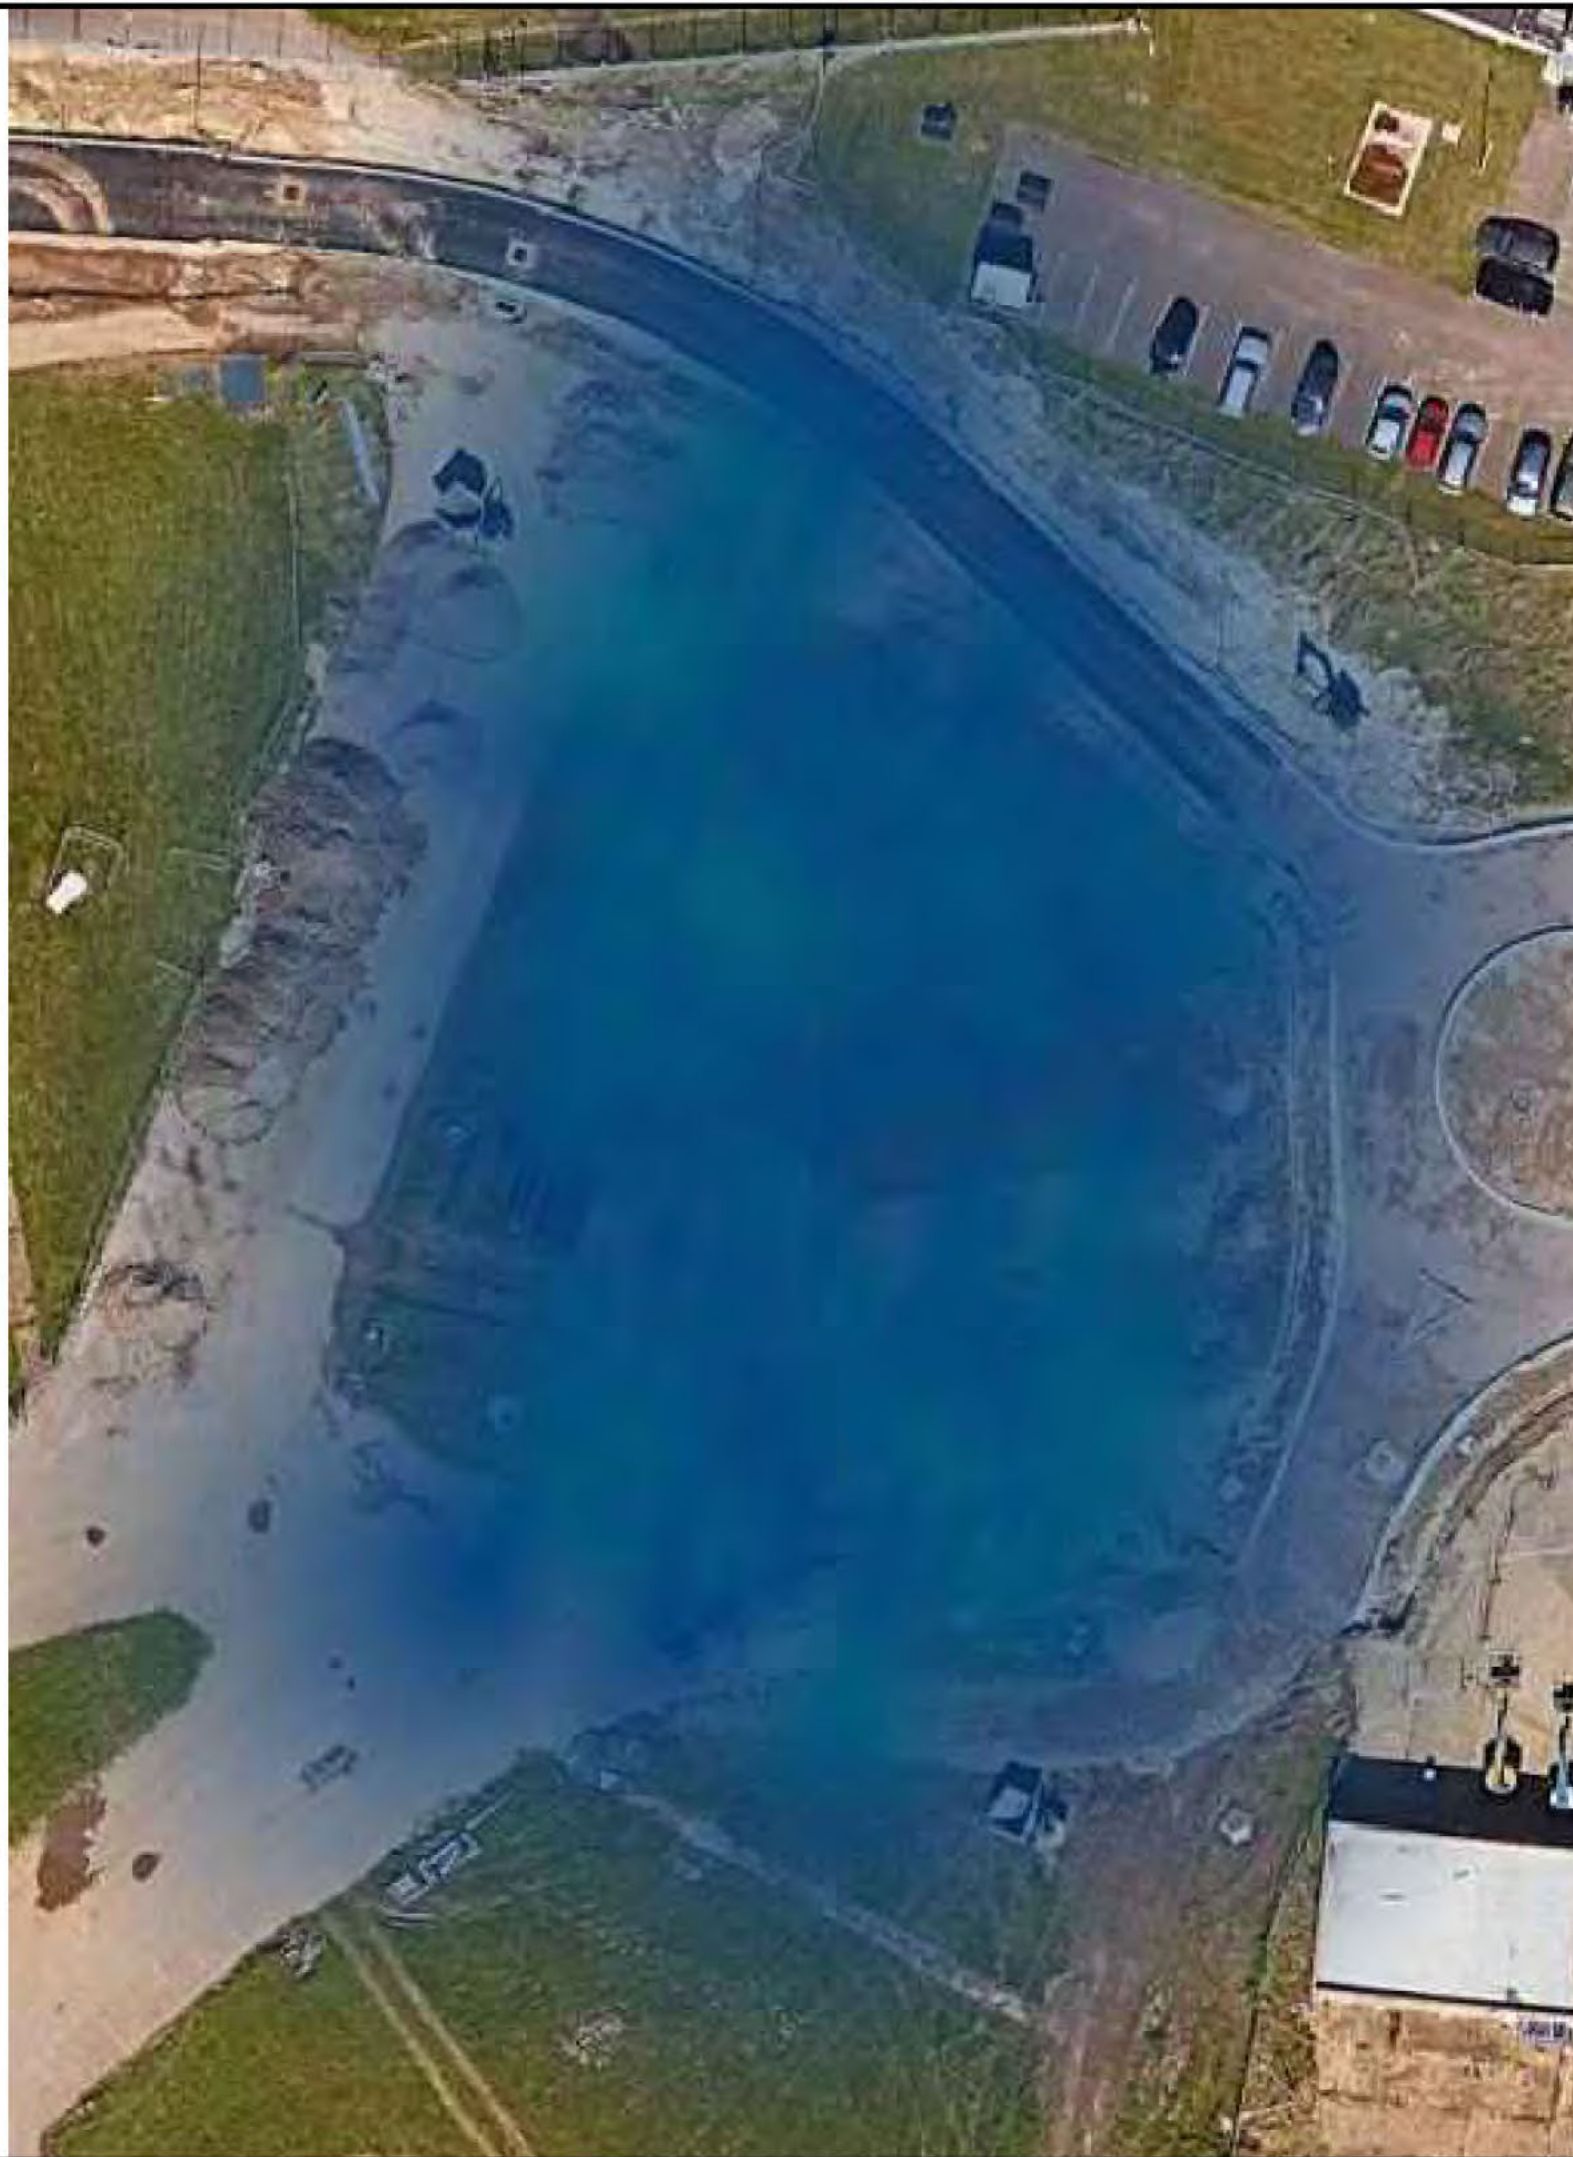
BY:	DATE:	CONTRACT NO.	FIGURE 6	REV:
HD	14.11.18		FIGURE 6	A

TITLE
WESTERN SITE GAMMA HEAT MAP

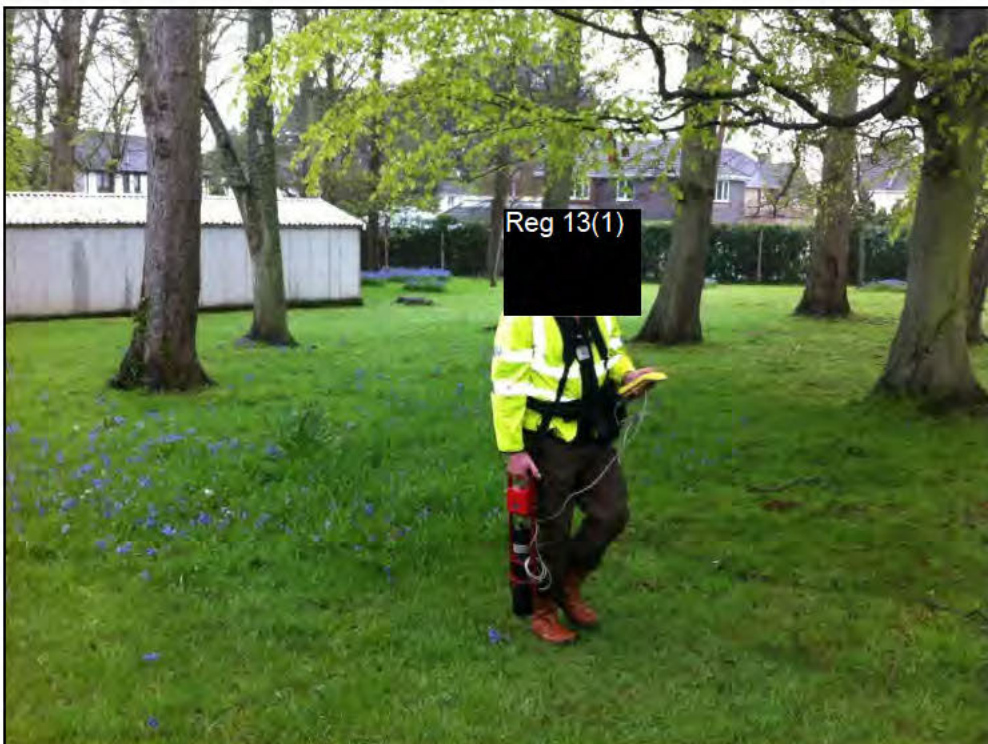
The survey was undertaken using Aurora's 'RadSurvey' System (RadSurvey), as shown in Figure 1 below. The RadSurvey instrument consists of a sensitive gamma radiation detection system linked to a Global Positioning System (GPS) enabling accurate gamma radiation contour mapping of the site. The data collected during the survey is used to accurately demonstrate and validate the radiological status of the identified areas.

The survey system is configured using real time differentially corrected GPS to provide continual spatial reference information allowing the survey unit to be operated at sub-metre accuracy. Radiation and positional information is displayed and collected autonomously in the data logger.

Figure 1. Aurora's RadSurvey system in use.

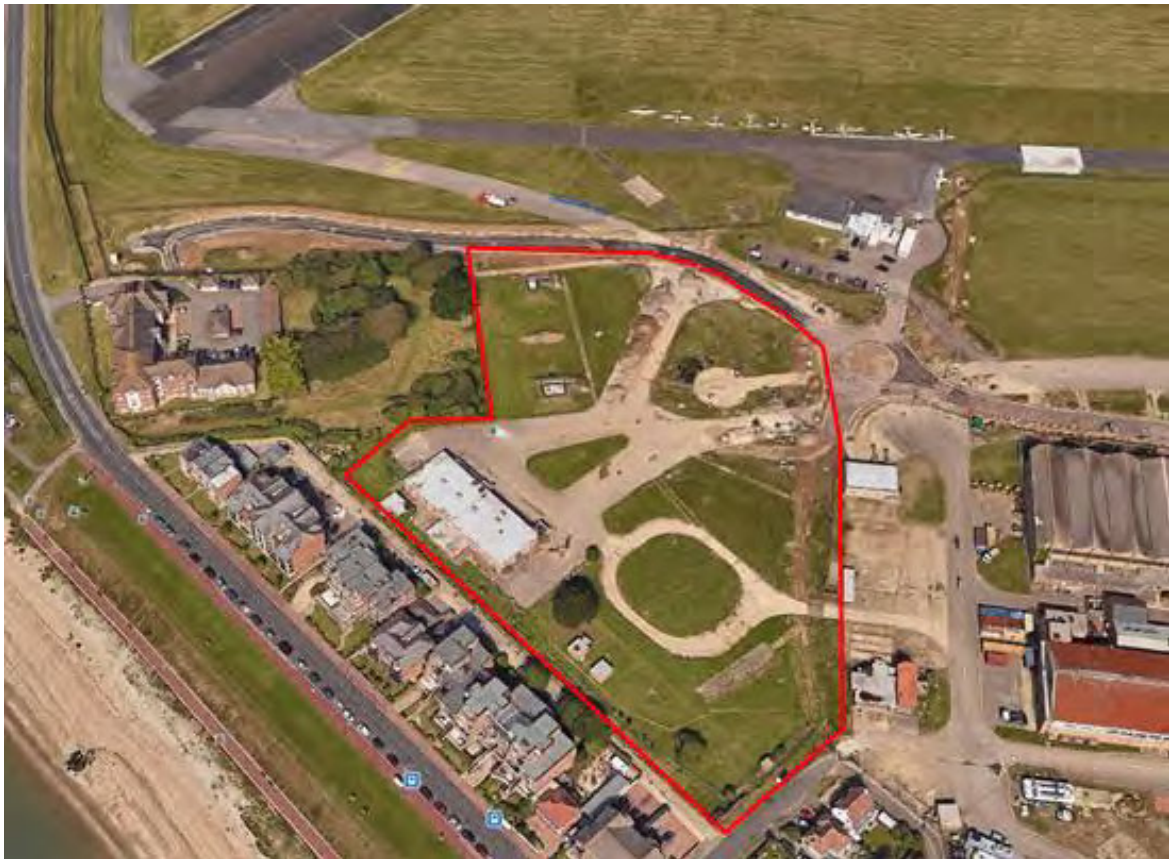
Using a Geographical Information System (GIS) the gathered data is displayed in map form. Interpolation was carried out on the data to provide a display of the radiation contours of the site as a surface picture. The area of the survey was confirmed with Campbell Reith at the site to ensure that the survey area was consistent with the intended development. This area is bounded approximately by the red line shown in Figure 2 below.

Figure 2. Plan view of the area surveyed within red line boundary.

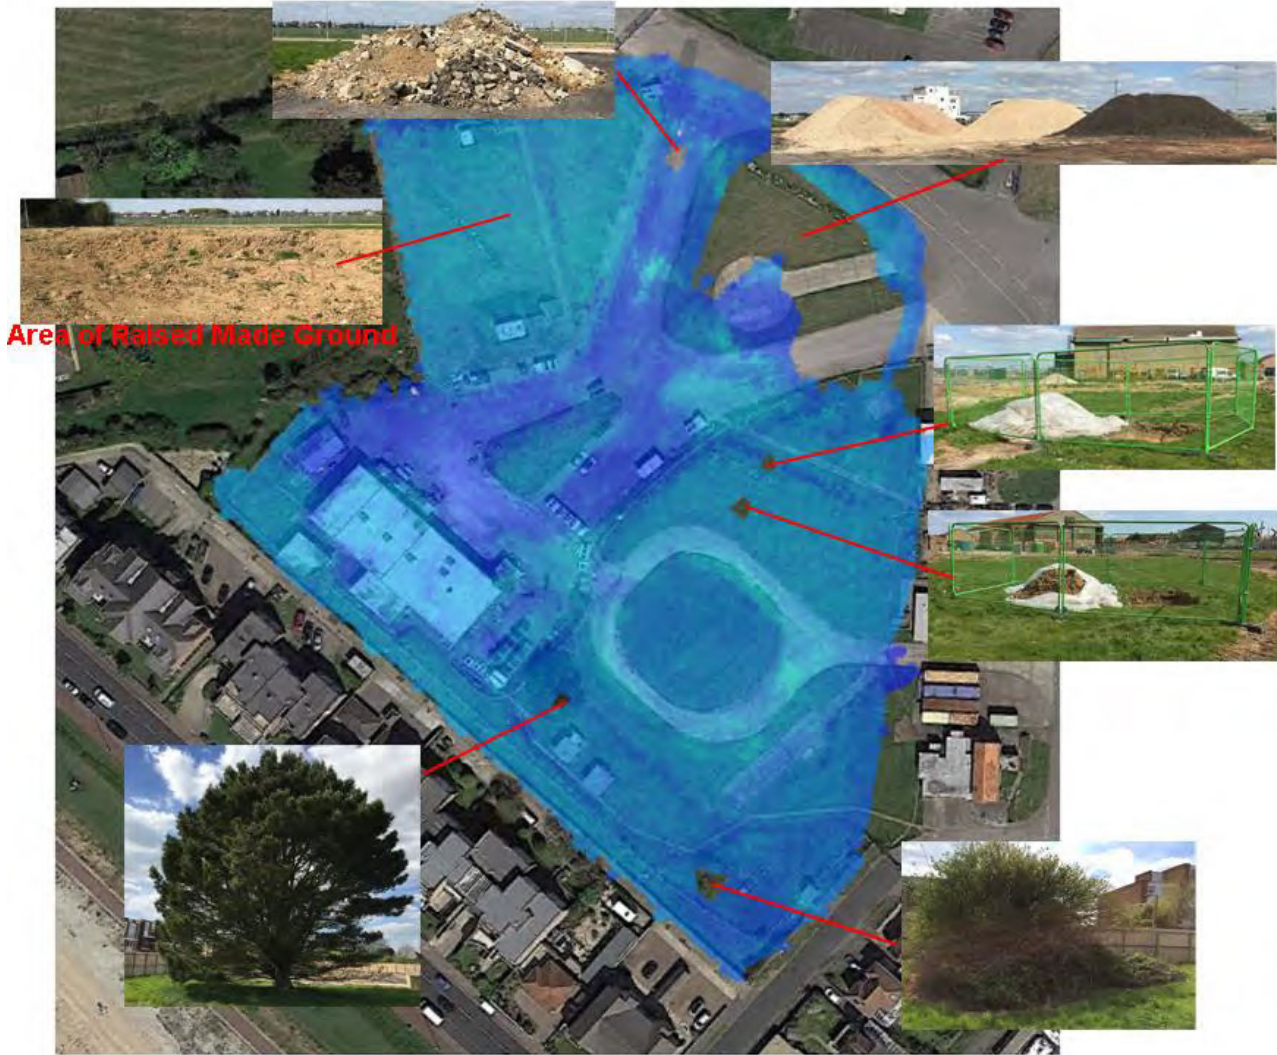
signal being recorded the data is reviewed by the operator to confirm that no elevated reading are present in the data. The areas of missed coverage can be seen in Figure 4 below.

In addition, there was a section to the West side of the site that was composed of 'made ground' with up to approximately 50 cm additional depth of material (see Figure 4). Therefore, the surface measurements in this area are not representative of the material that is below the original ground.

Figure 4. RadSurvey map showing locations that could not be surveyed
