Construction Noise and Vibration Monthly Report – October 2022

London Borough of Camden

Non-Technical Summary

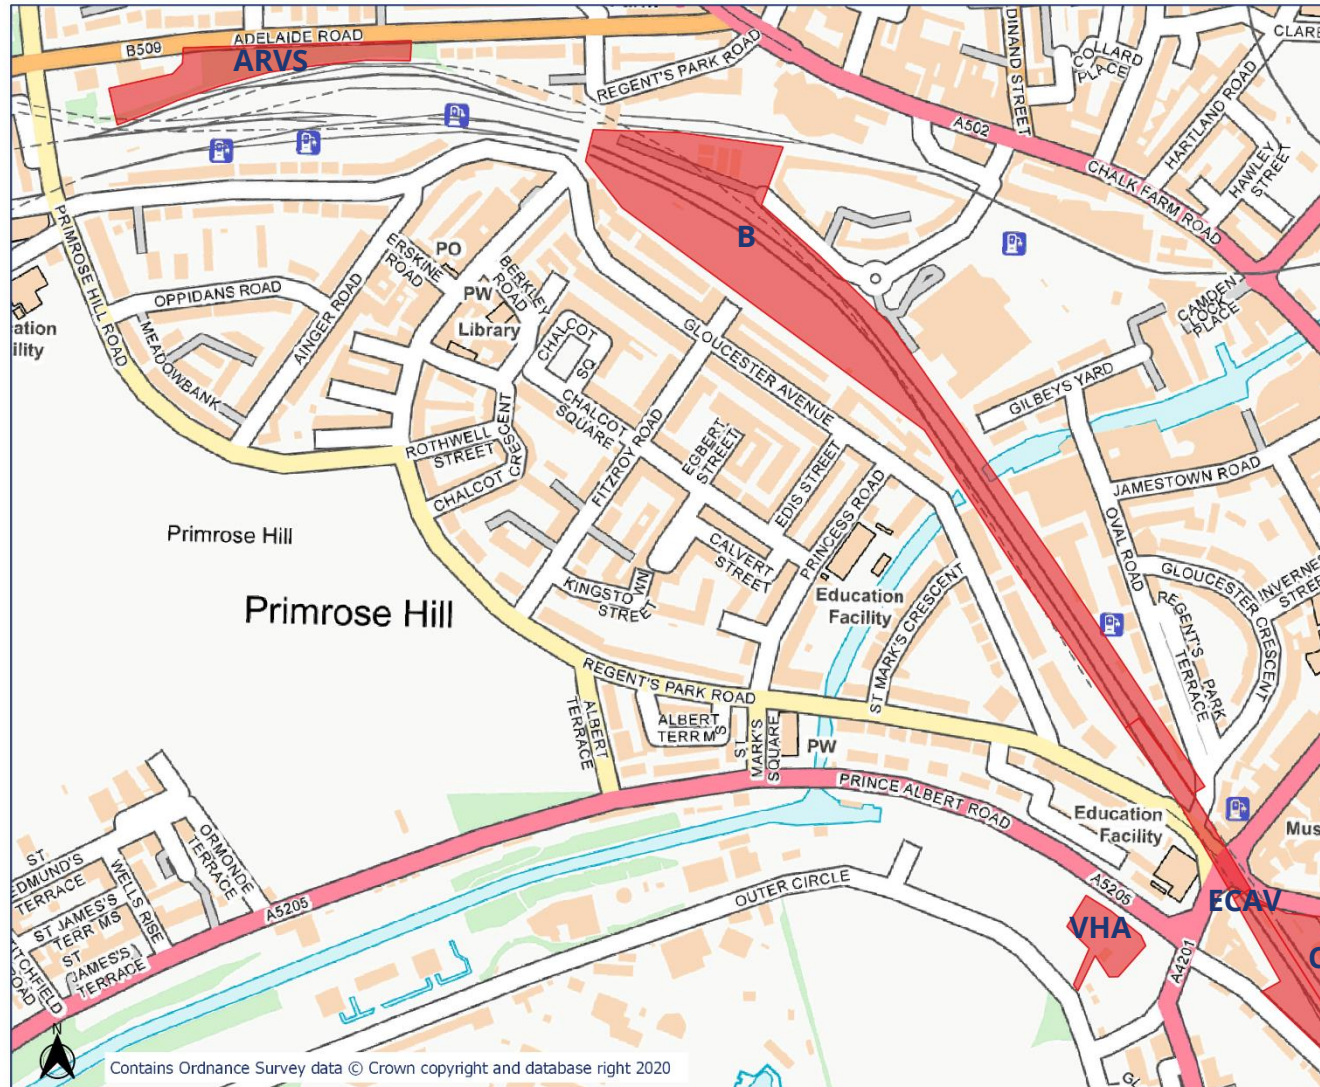
Worksite Identification Plan - 1

- Handrail works
- Installation of throughs and cabling works.
- Removal of working platforms.
- Vehicle Holding Area worksite ref.: VHA (see plan 1 in Appendix A), where work activities included:

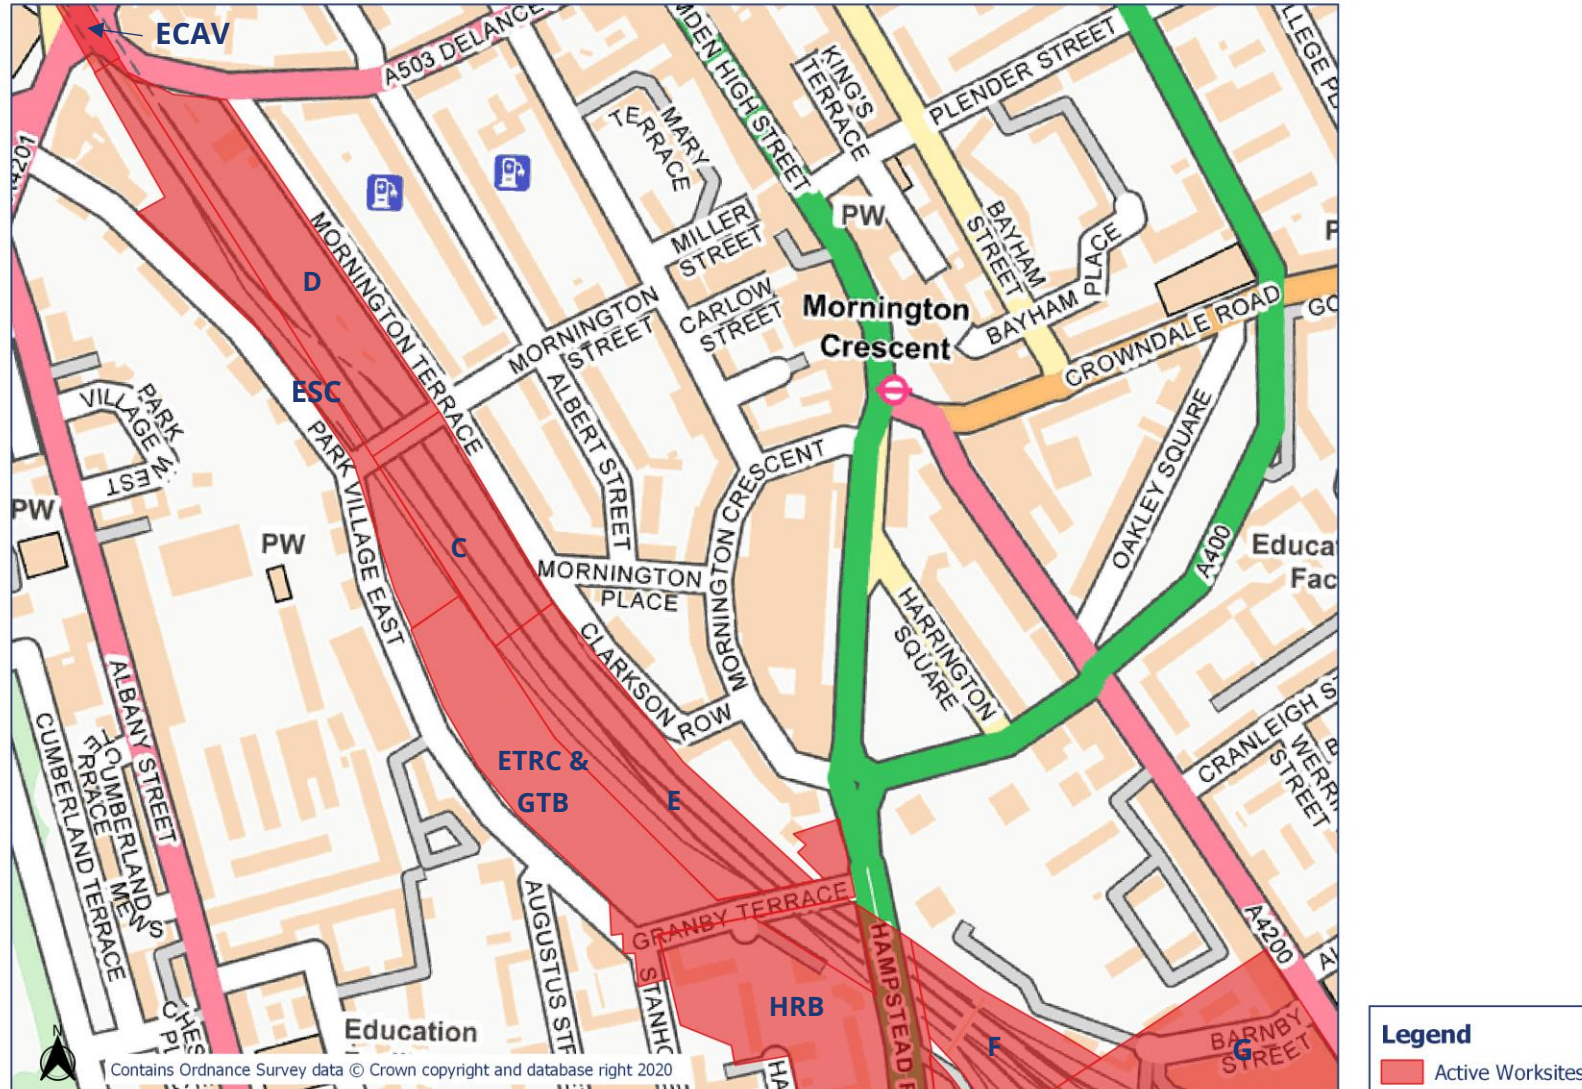
Worksite Identification Plan - 2

- The Adelaide Road ventilation shaft ref.: ARVS, (see plan 2 in Appendix A), where work activities included:
 - Working platform construction, including vacuum excavations and reinforced concrete works.
 - Foundation works.
 - Extension of concrete crane base.
 - Site power connections.
 - Concrete breaking out.
 - Excavations.
 - Sheet piling works, including installation of anchors and forming holes.
 - Site drainage installation.
 - Removal of vegetations and concrete blocks from site.

- General compound operation and installation of tank.
- Euston Throat Retained Cut and Granby Terrace Bridge worksite ref.: ETRC & GTB (see plan 2 in Appendix A), where work activities included:

- Utility diversion works.
- Euston Scissor Cut worksite ref.: ESC (see plan 2 in Appendix A), where work activities included:
 - Site maintenance.
 - Site mobilisation and deliveries.

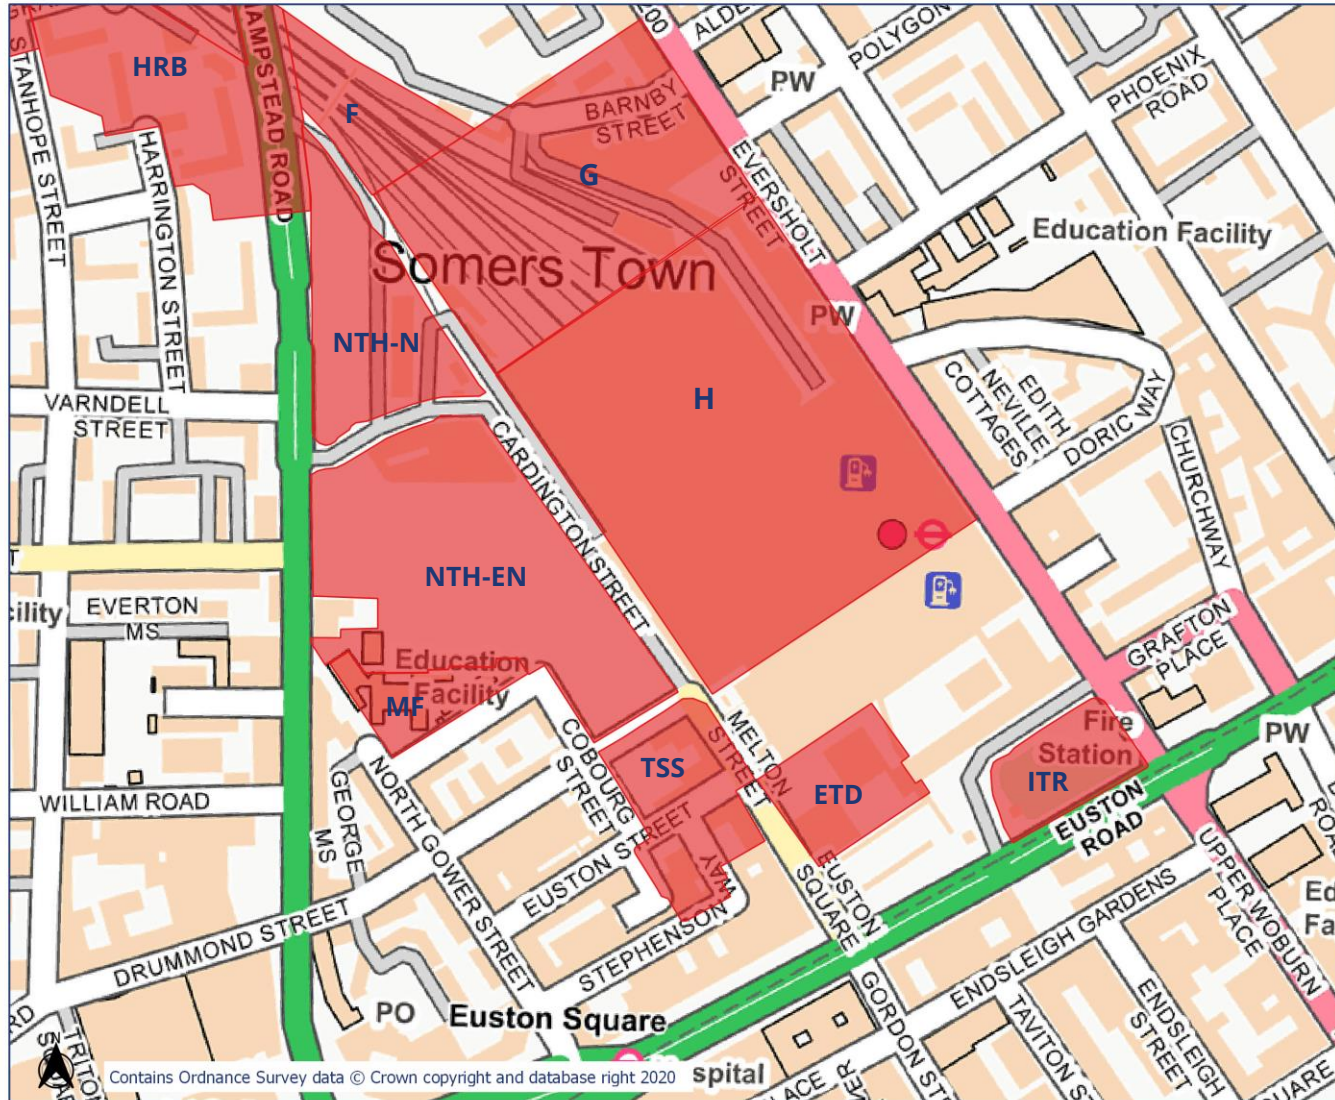
Worksite Identification Plan - 3

- Hampstead Road Bridge worksite ref.: HRB (see plan 3 in Appendix A), where work activities included:
 - Sewer diversion works.
 - Traffic management.
 - Hoarding works.

- Utility works.
- Euston Cavern worksite ref.: ECAV (see plan 3 in Appendix A), where work activities included:
 - Reinforced concrete works.
 - Mitigation works.

- Intrusive surveys at road level.
 - Tunnelling works.
 - Utility diversions.
 - Groundwater and gas monitoring.
 - Sewer lining.
- On-Network worksites ref.: B, C, D, E, F, G and H (see plan 3 in Appendix A), where work activities included:

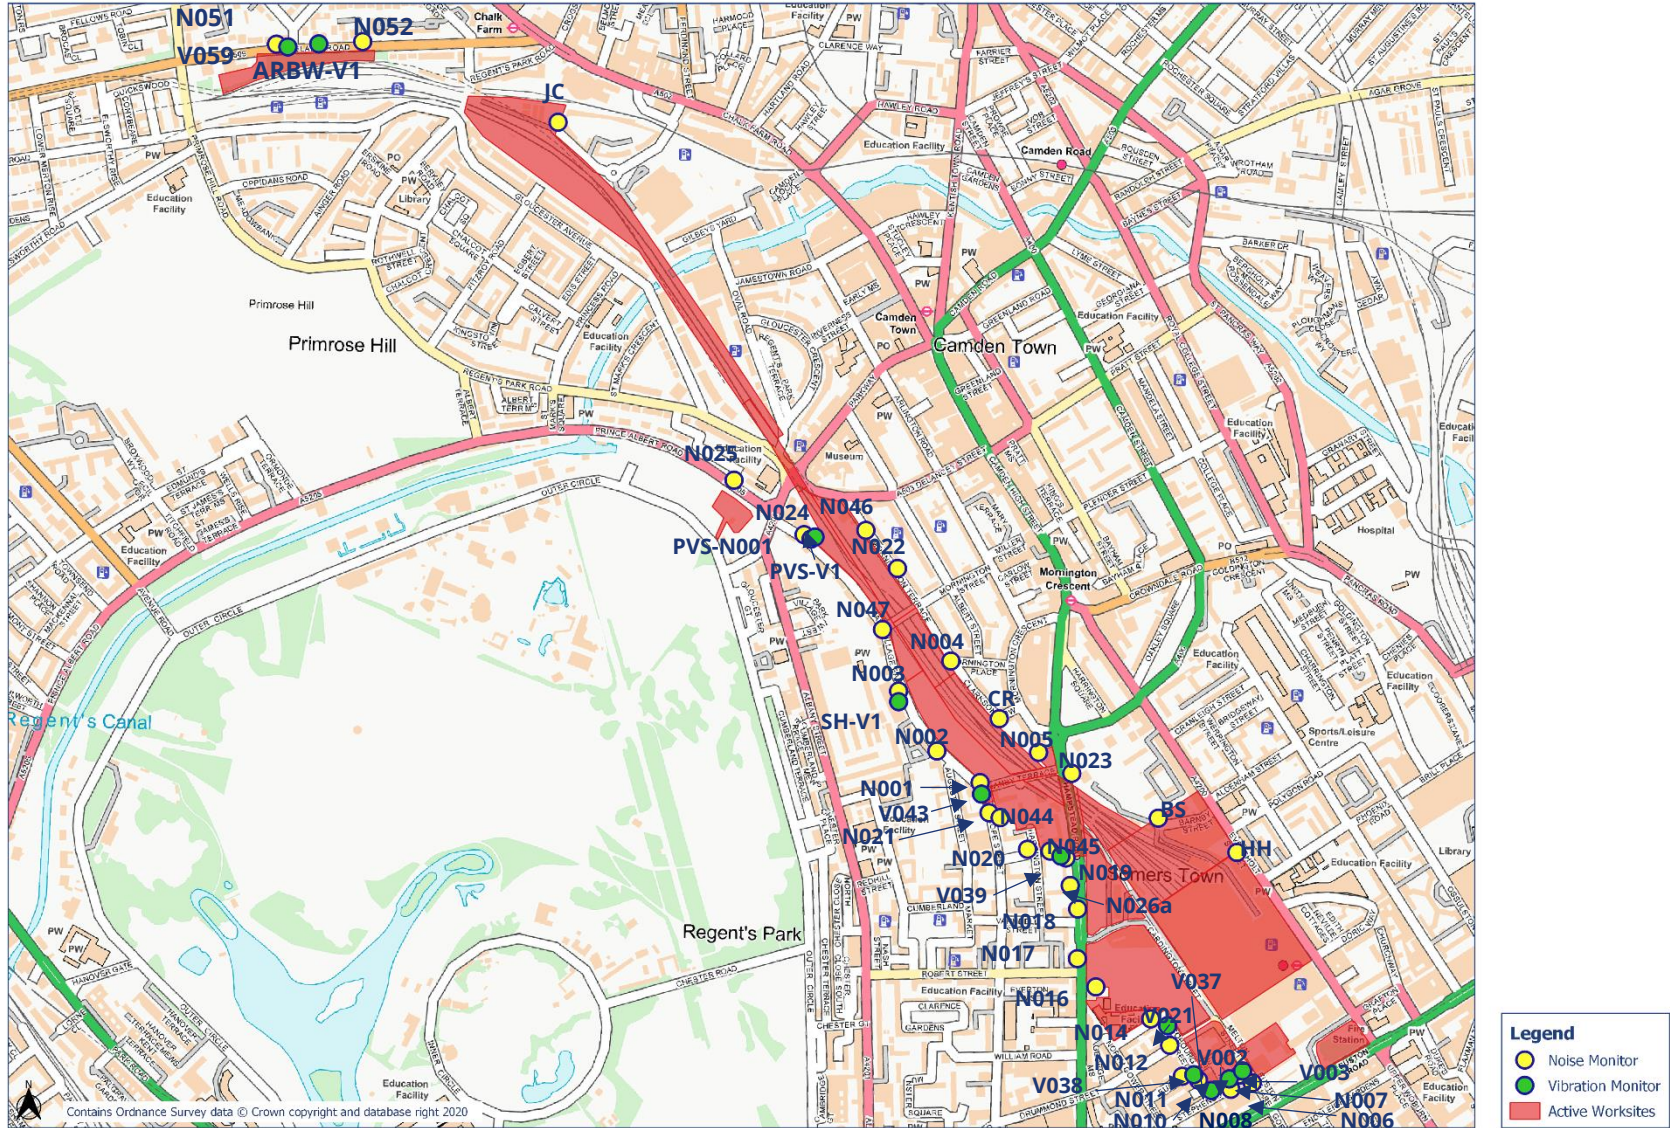
Noise and Vibration Monitoring Plan - Overview

1.2.3 Maps showing the position of noise and vibration monitoring installations are presented in Appendix B.

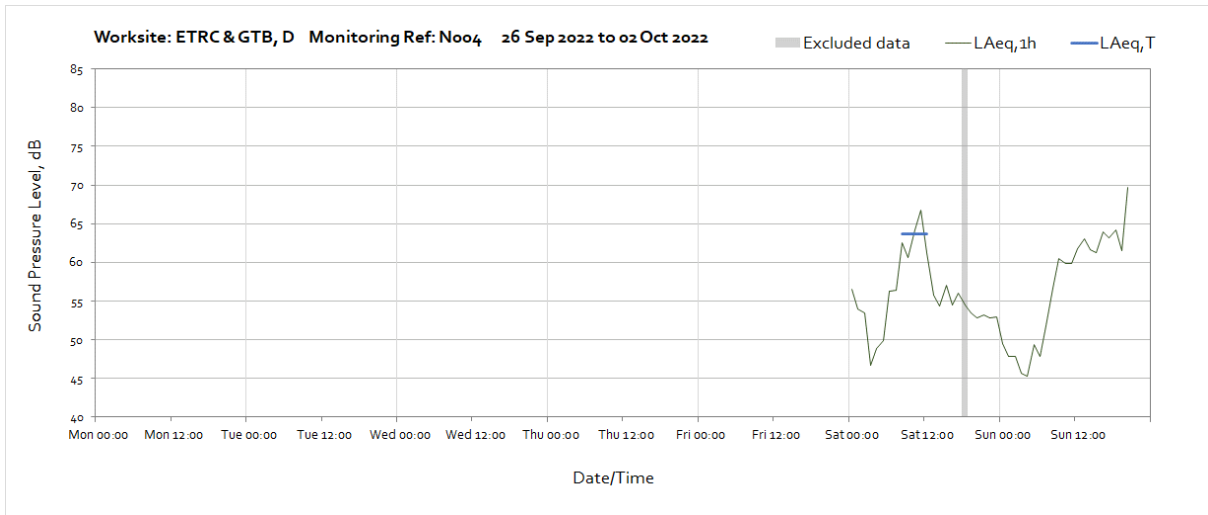
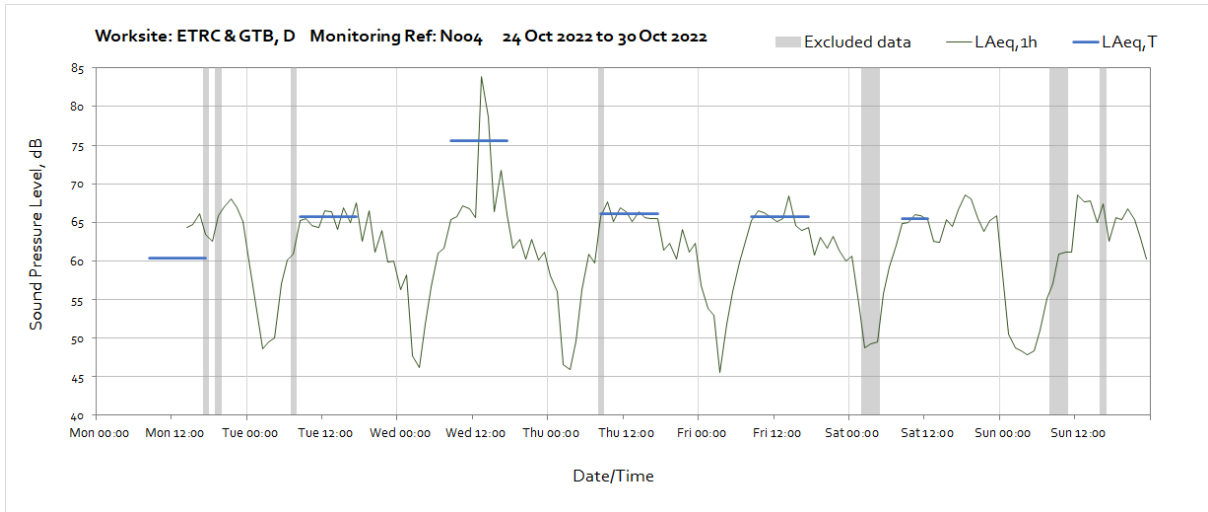
Worksite: ETRC & GTB, D – Monitoring Ref: N004

Note: Missing data between 21:00 on Sunday 2nd October and 14:00 on Monday 24th October were due to loss of power at the monitoring station.

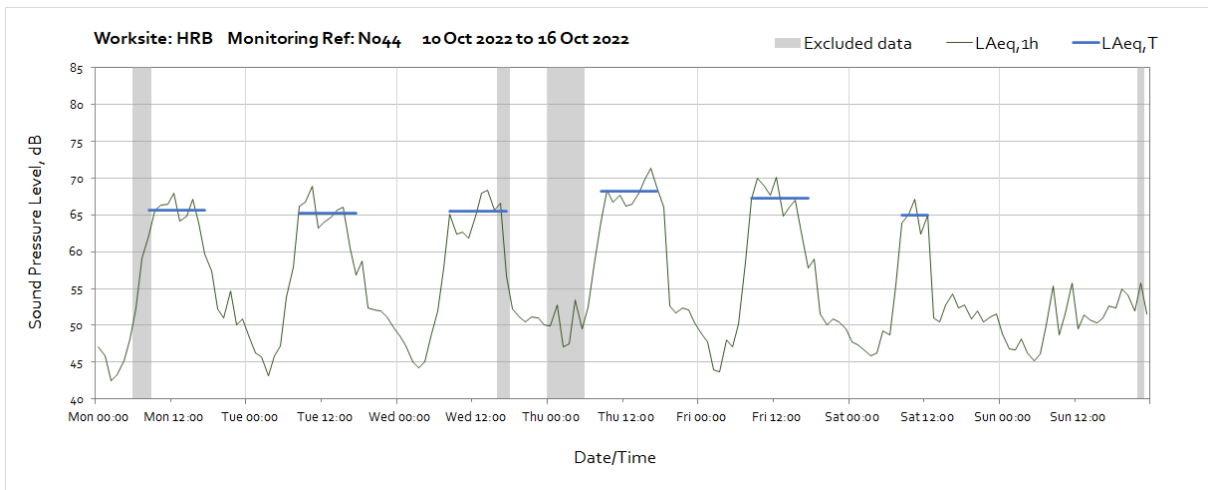
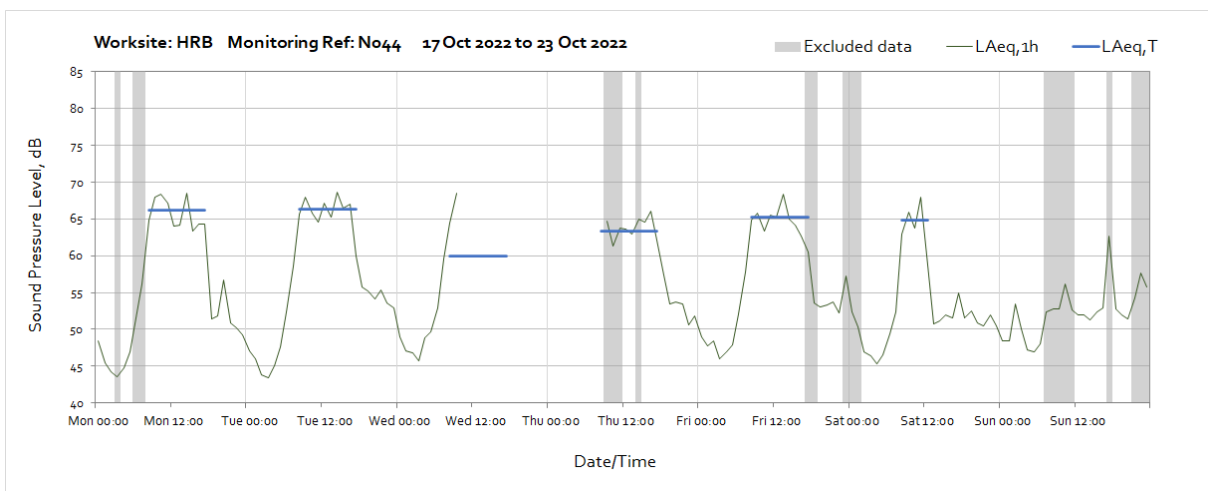
Worksite: HRB – Monitoring Ref: N044

Note: Missing data between 11:00 on Wednesday 19th and 09:00 on Thursday 20th October were due to loss of power at the monitoring station.

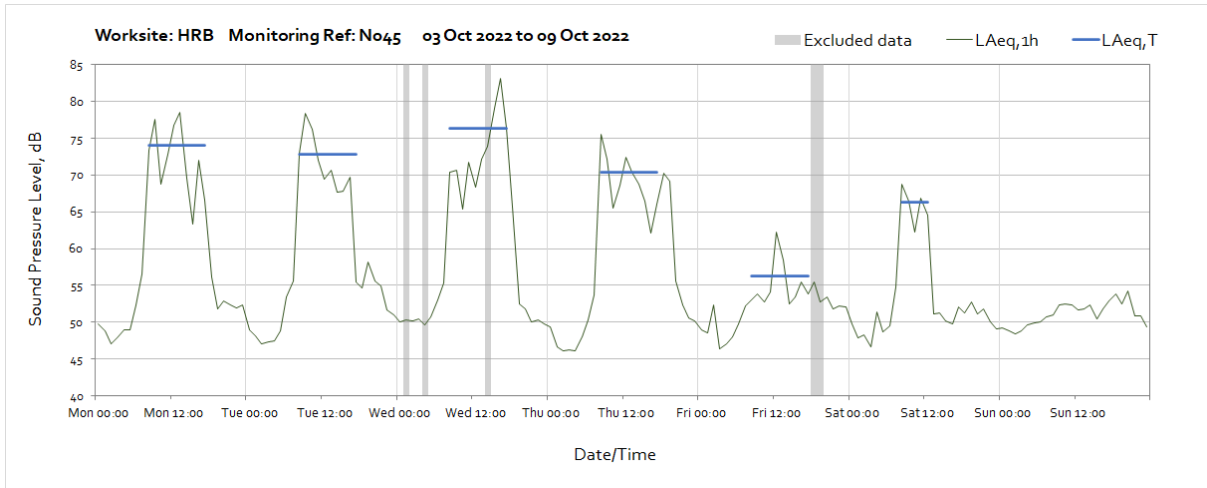
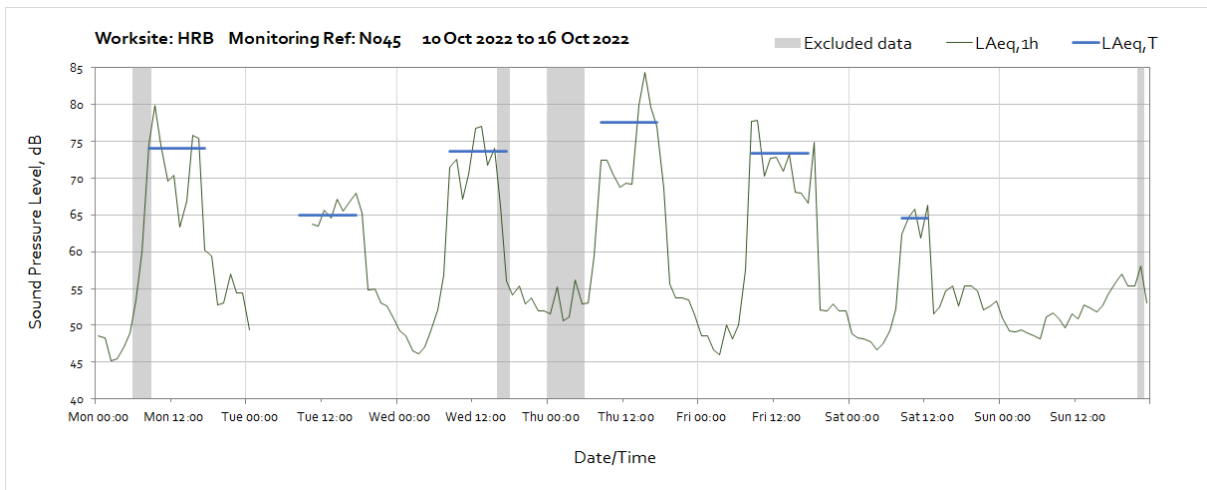
Worksite: HRB - Monitoring Ref: N045

Note: Missing data between 01:00 and 10:00 on Tuesday 11th October were due to loss of power at the monitoring station.

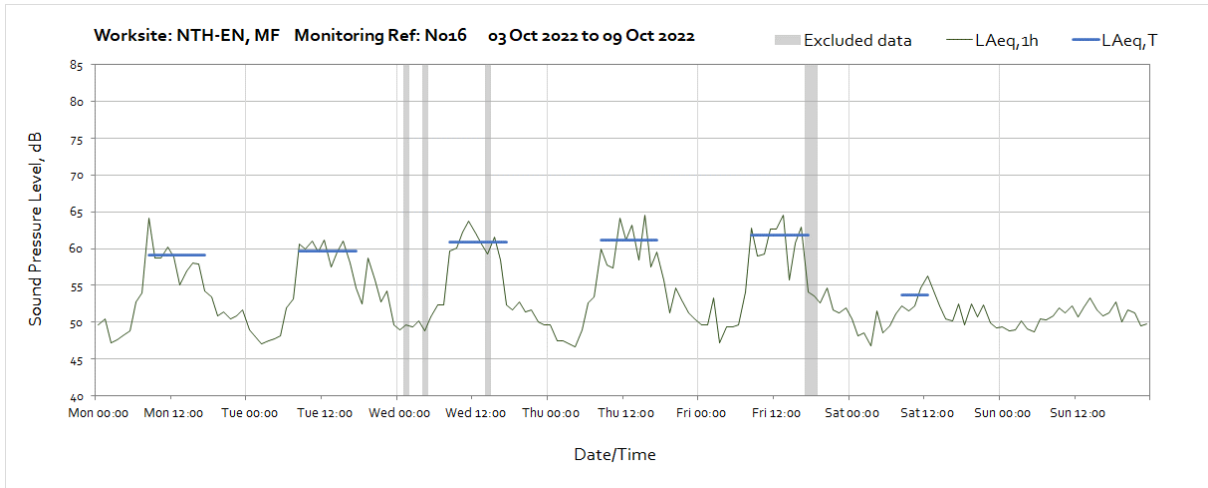
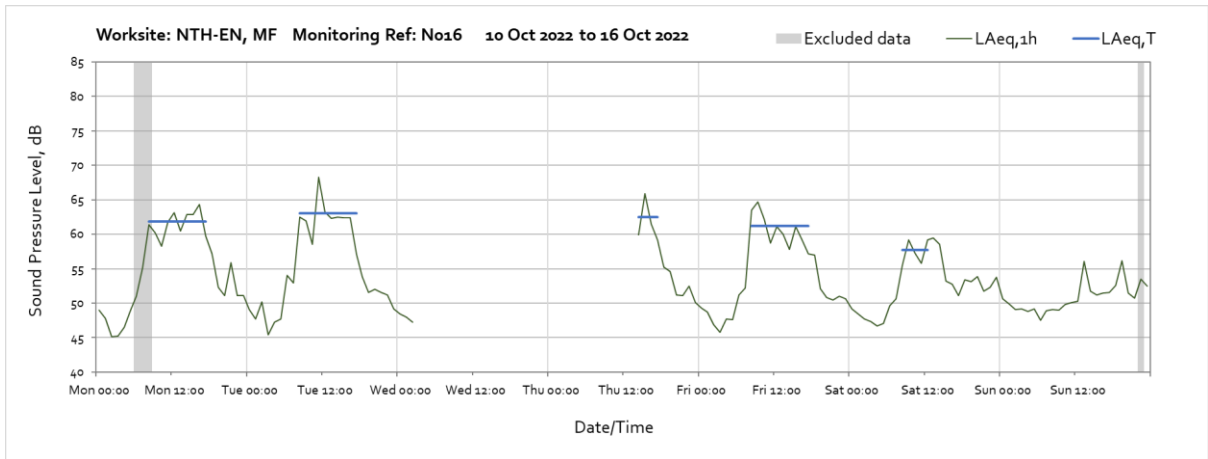
Worksite: NTH-EN, MF - Monitoring Ref: N016

Note: Missing data between 03:00 on Wednesday 12th and 14:00 on Thursday 13th October were due to loss of power at the monitoring station.

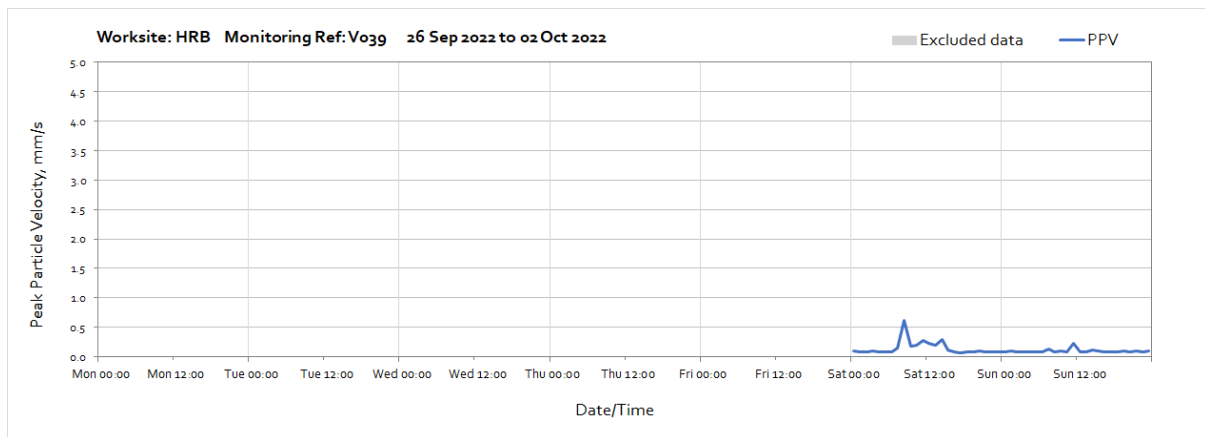
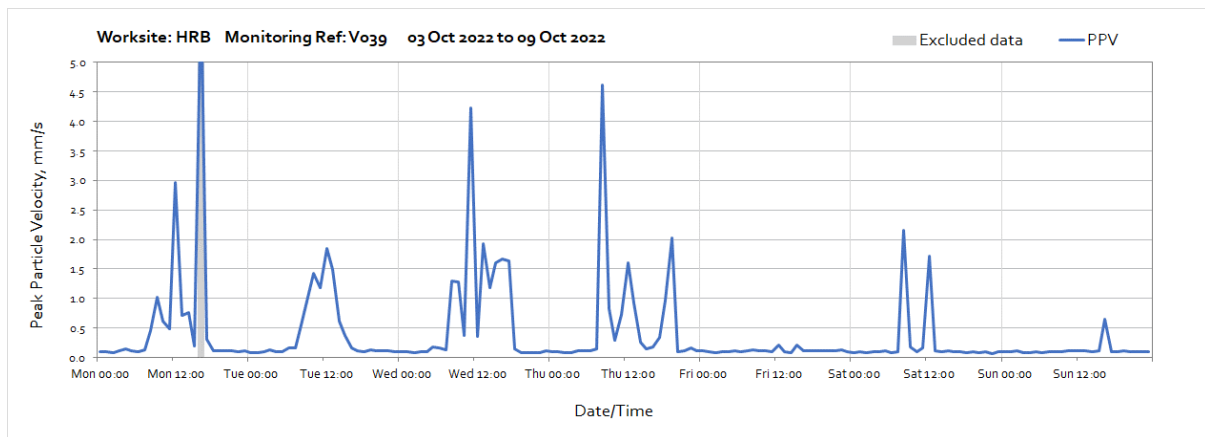
Worksite: HRB – Monitoring Ref: V039

*Note: Vibration levels at monitoring locations V039 and V043 are affected by restrictive mounting/location conditions causing amplification of vibration levels from nearby plant that are not representative of HS2 works at nearby receptors.

The following graphs show the hourly measured peak particle velocity PPV recorded during the monitoring period. The graphs show the resultant PPV due to vibration components on three orthogonal axes x, y and z. Where resultant PPV data is not available (monitors V039 and V043), the highest vibration component in either of the three axes is presented for each 1 hr measurement period respectively. Where high values of PPV were caused by local interference with the vibration monitor, which are not representative of HS2 construction works, these values have been greyed out in the following charts and have been excluded to calculate values in Table 4 of the main report.

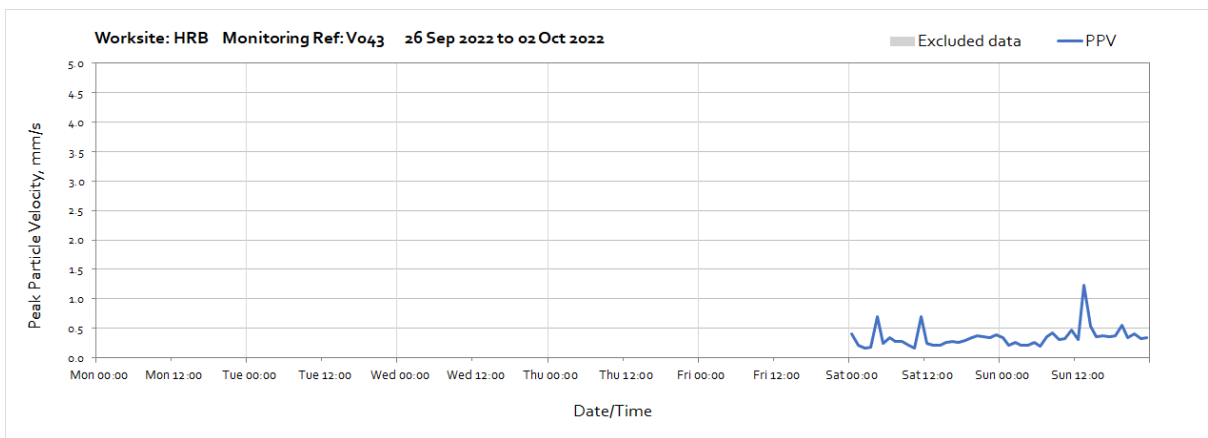
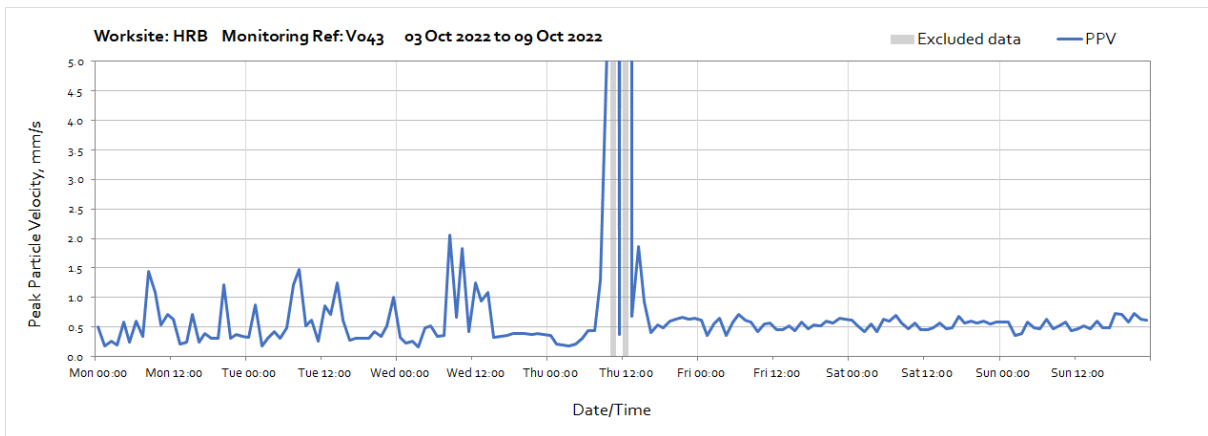
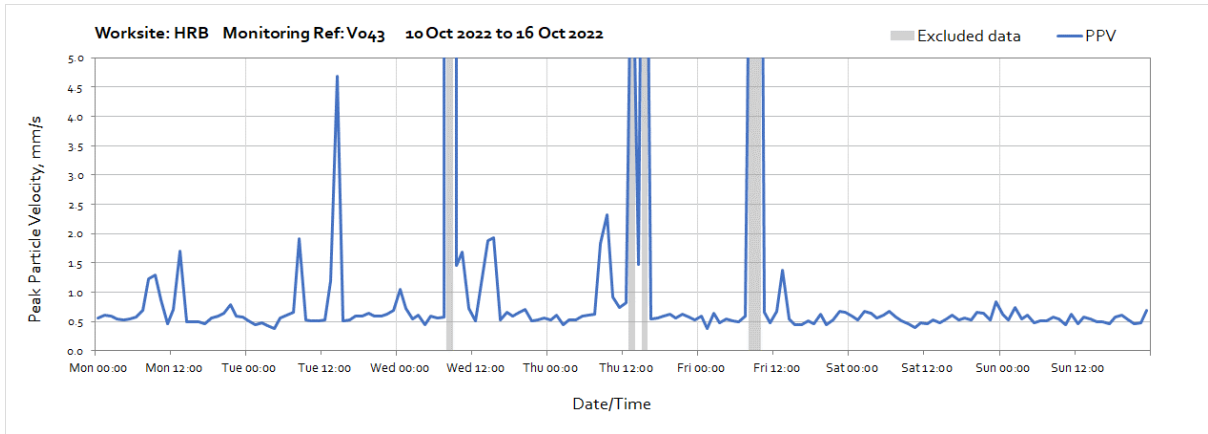
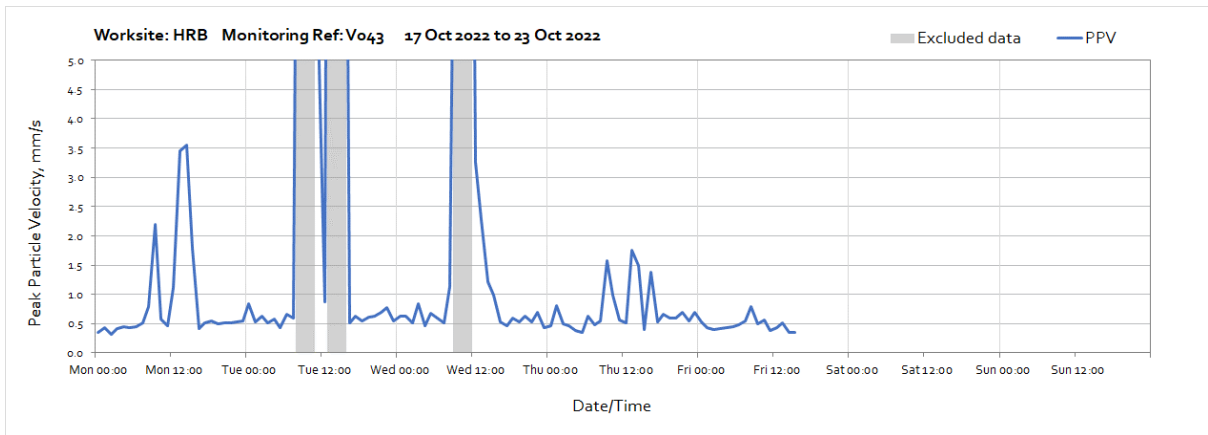
Worksite: HRB – Monitoring Ref: V043

Note: Missing data from 16:00 on Friday 21st October to the end of the month were due to an internal 16:00pm to 31st October 00:00 was due to internal monitor fault.

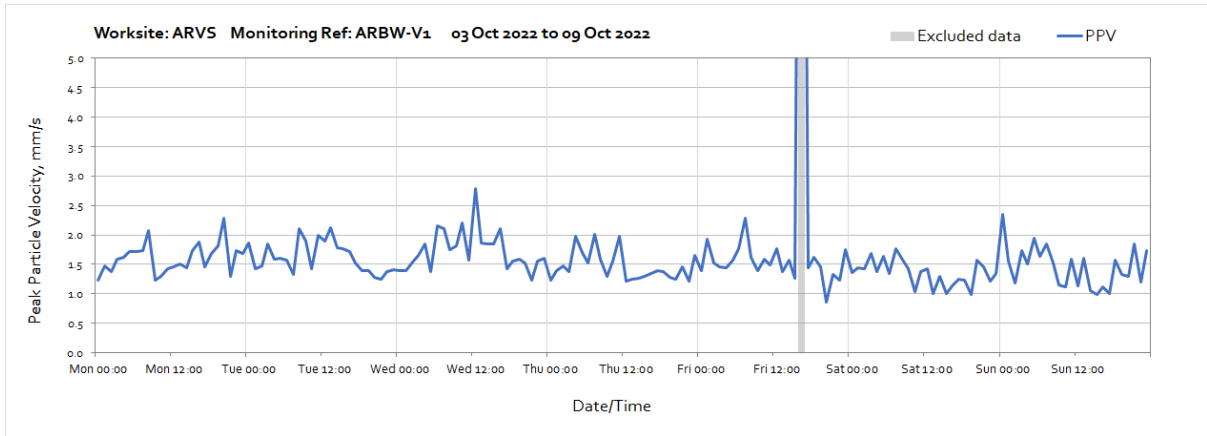
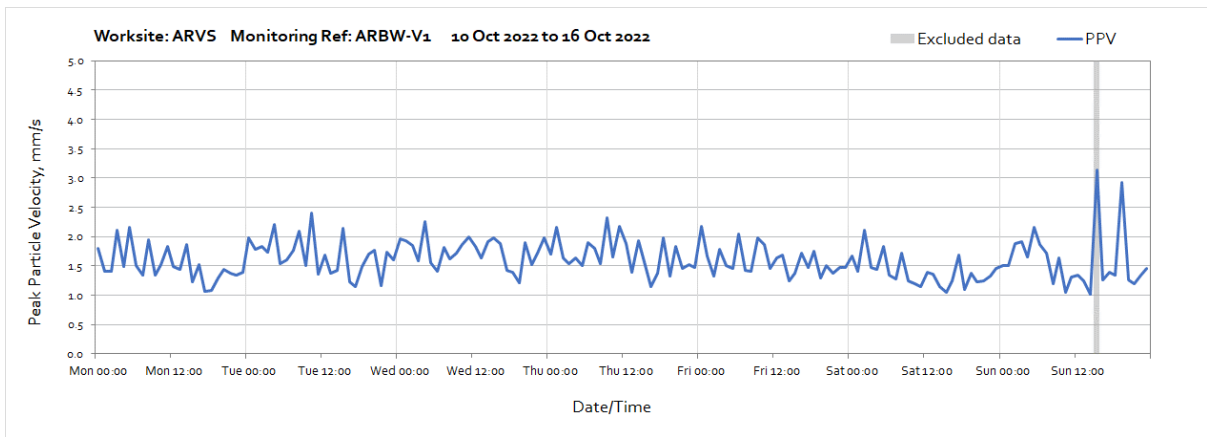
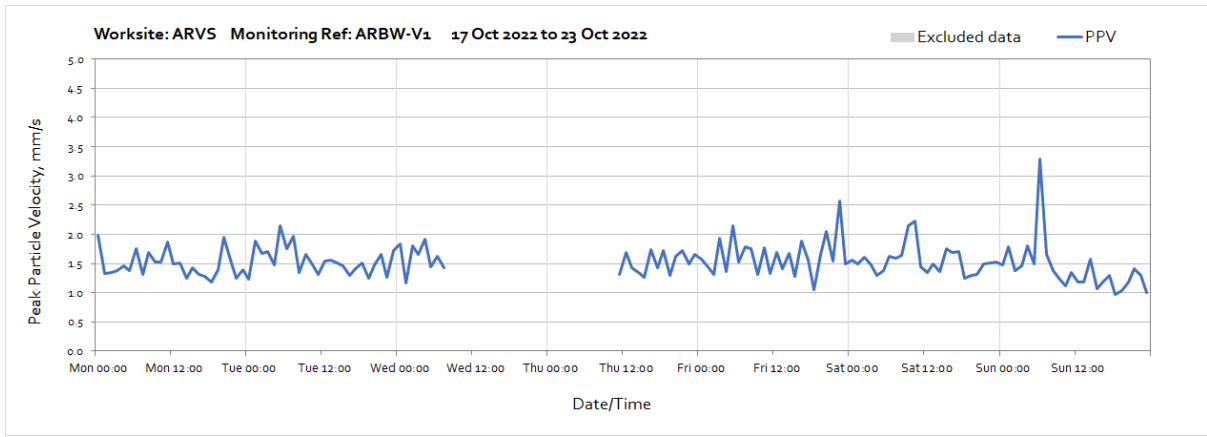
Worksite: ARVS – Monitoring Ref: ABRW-V1

Note: Missing data between 08:00 on Wednesday 19th and 11:00 on Thursday 20th October were due to loss of power at the monitoring station.
