Construction Noise and Vibration Monthly Report – October 2022

Lichfield District Council

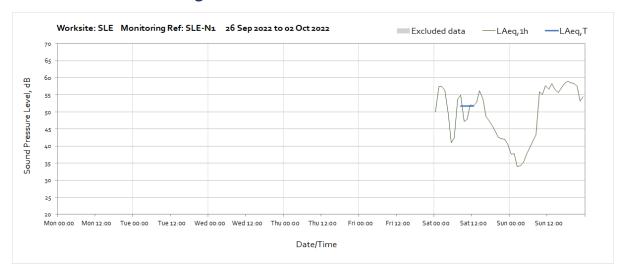
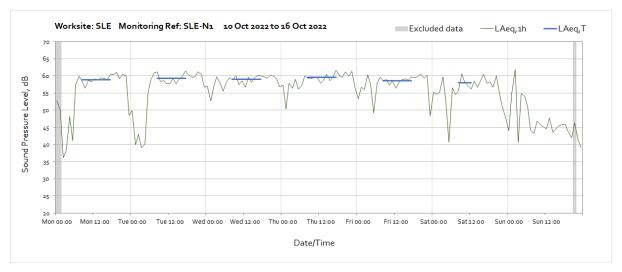
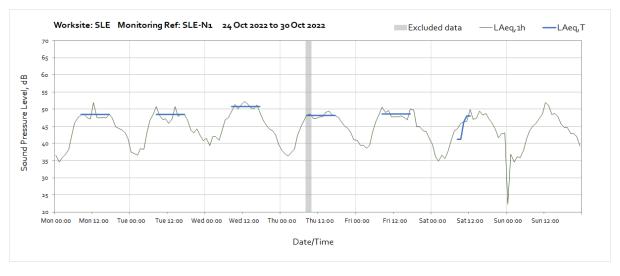
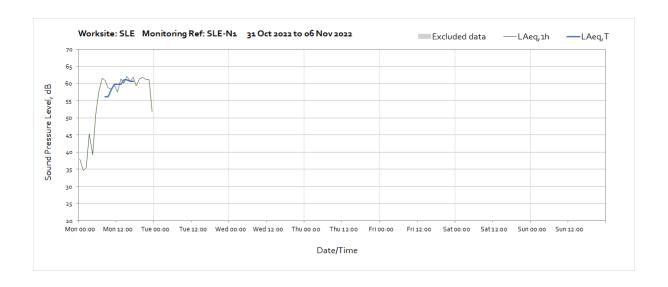
Worksite:SLE - Monitoring Ref: SLE-N1

The following graphs show the hourly measured ambient noise level $L_{Aeq,1h}$ and, where relevant, the averaged noise level $L_{Aeq,T}$ values, where the time period T is as specified in Table 1 of HS2 Information Paper E23. Periods with adversely weather affected noise levels are greyed out and have been excluded from the calculation of the $L_{Aeq,T}$ values in Table 3 of the main report.

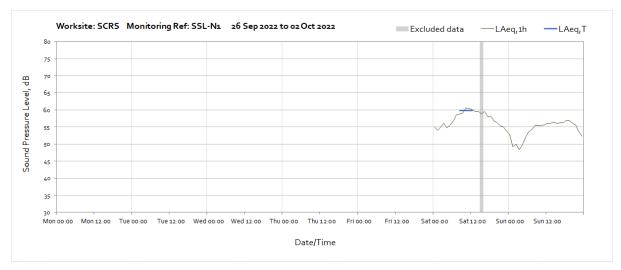
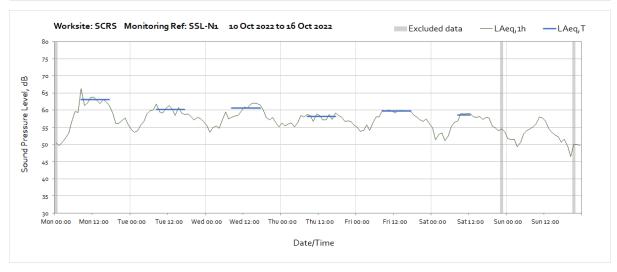
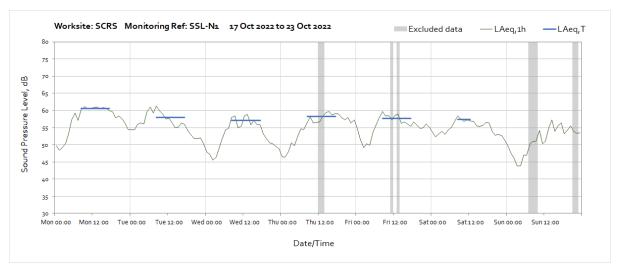
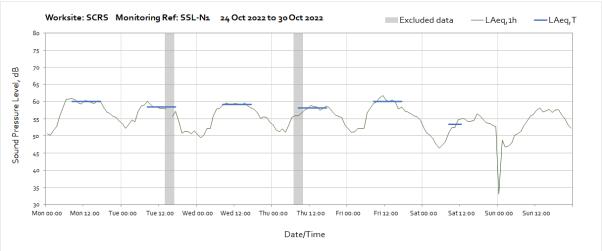
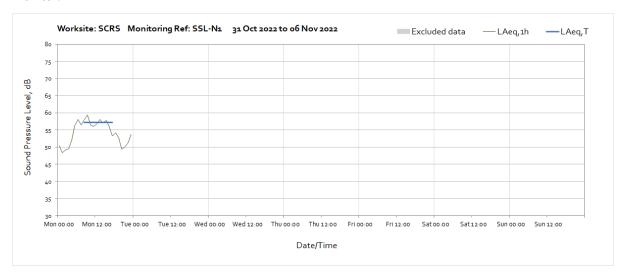
Worksite: SCRS - Monitoring Ref: SSL-N1

Note: Missing data at 15:00 on 25th October 2022 was due to malfunction of memory card of the noise monitor.

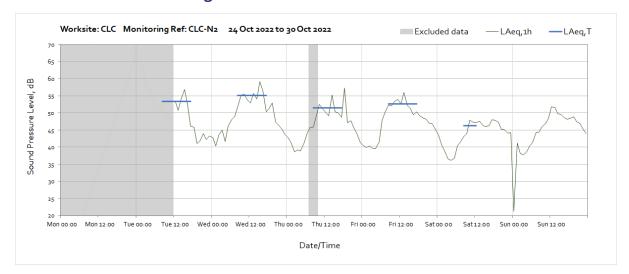
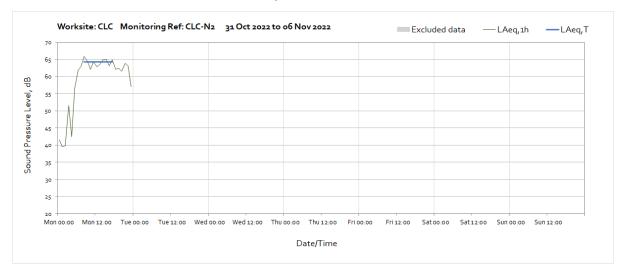
Worksite: CLC - Monitoring Ref: CLC-N2

Note: Monitor was installed at 12:00 on Tuesday 25th October 2022.

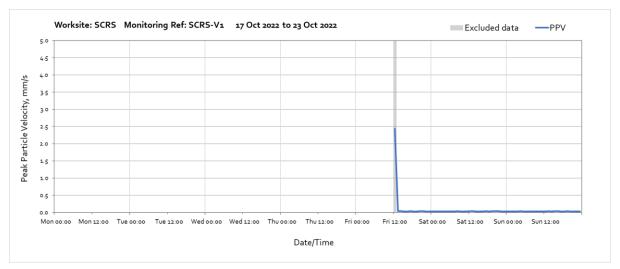
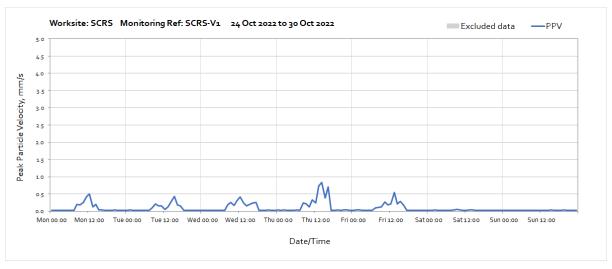
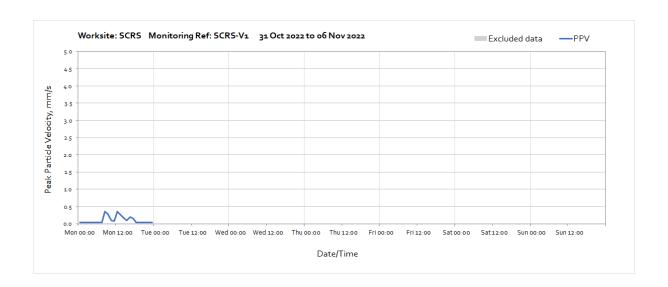
Worksite: SCRS - Monitoring Ref: SCRS-V1

Note: Missing data between 00:00 on Saturday 1st October and 12:00 on Friday 21st October was due to damage of the fuse caused by vegetation clearance resulting in loss of power to the equipment.
