Construction Noise and Vibration Monthly Report – December 2022

Buckinghamshire

This Noise and Vibration Monitoring Report fulfils HS2 Limited's commitment detailed in the Environmental Minimum Requirements (EMRs), Annex 1, Code of Construction Practice, to present the results of noise monitoring carried out within Buckinghamshire (BS) during the month of December 2022.

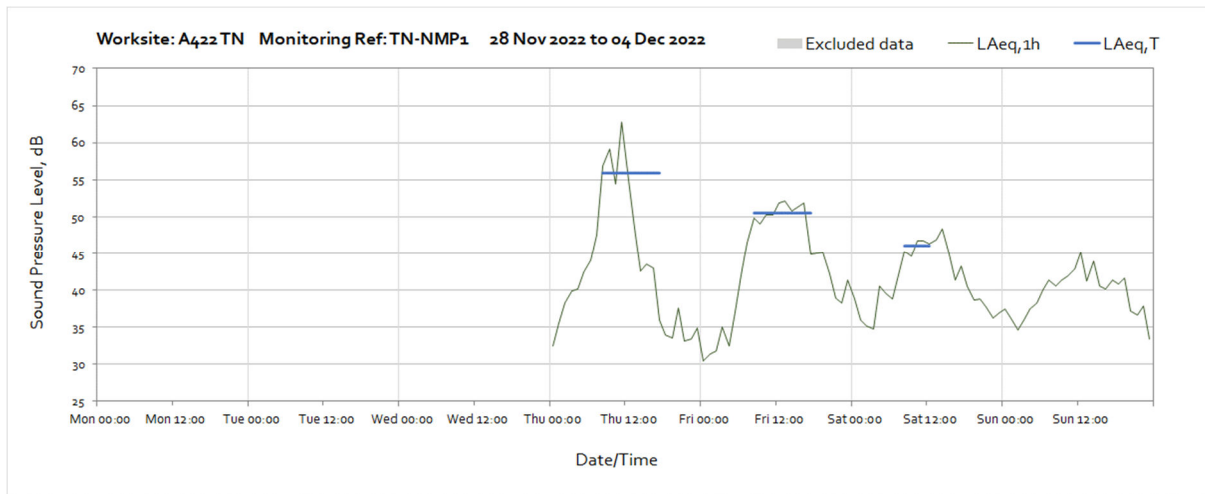
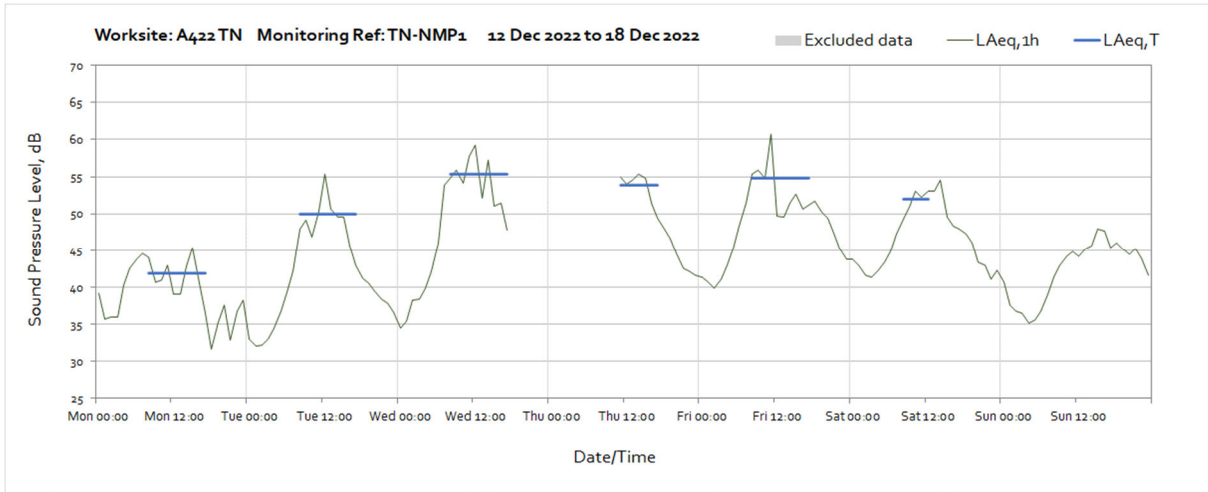
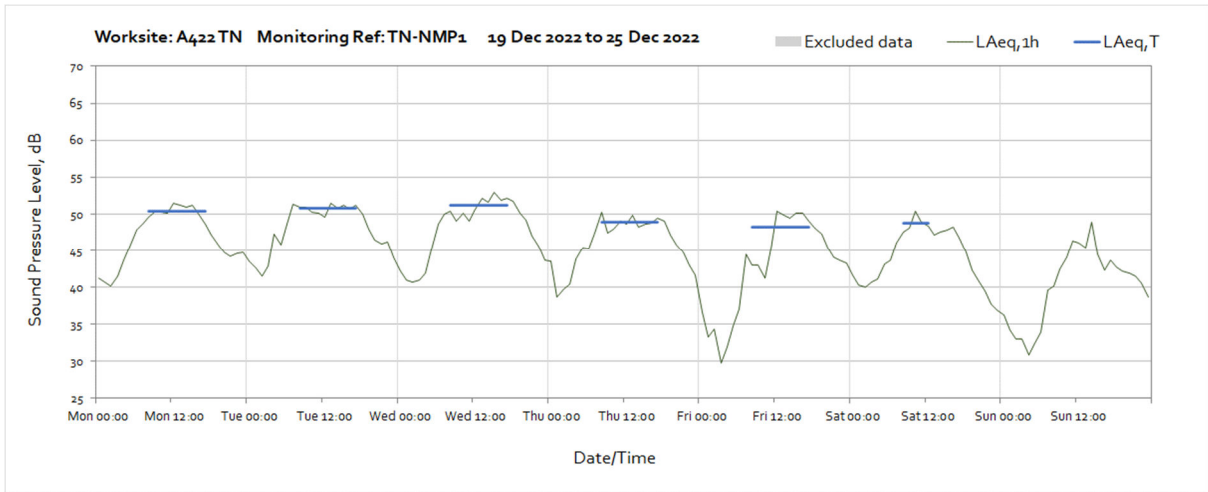
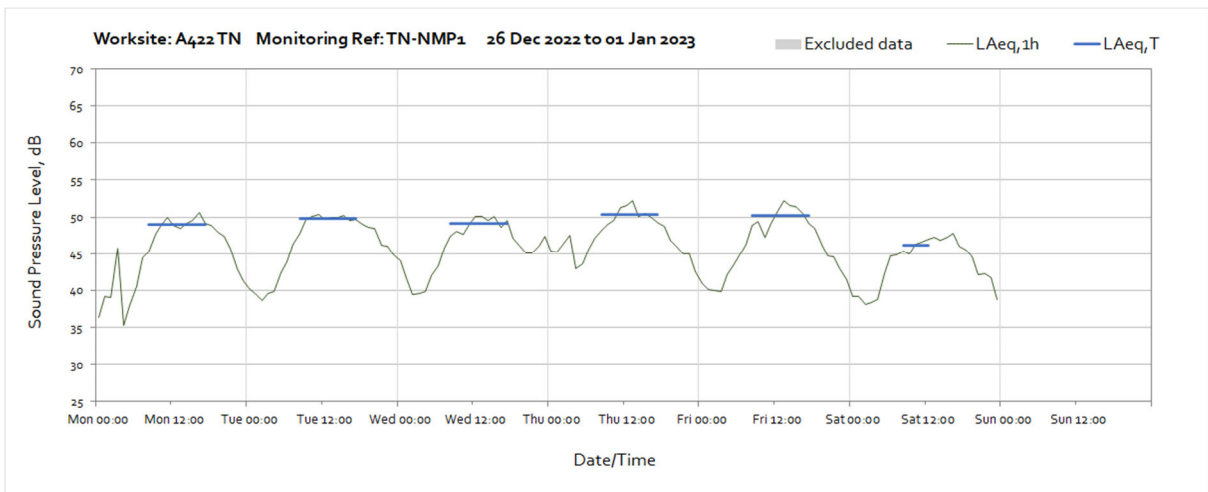
Worksite: A422 TN - Monitoring Ref: TN-NMP1

Note: Missing data between 18:00 on 14th December until 10:00 on 15th December was due to monitor depleted battery.

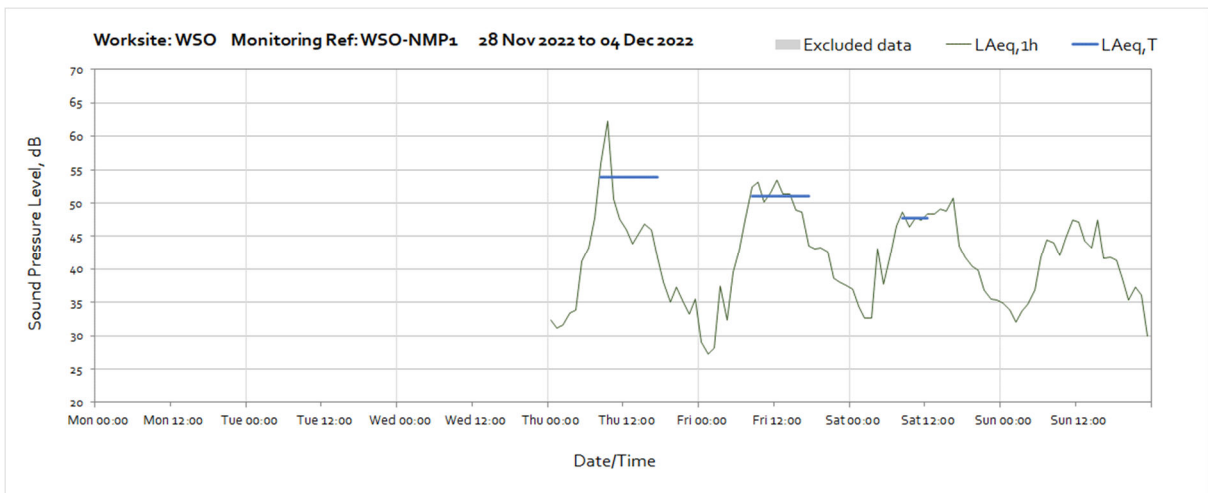
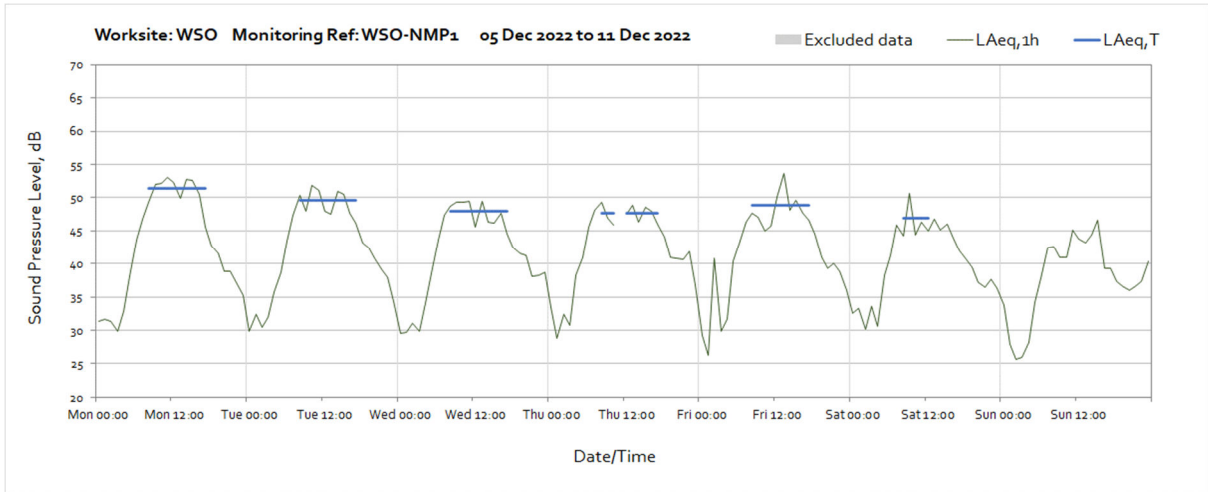
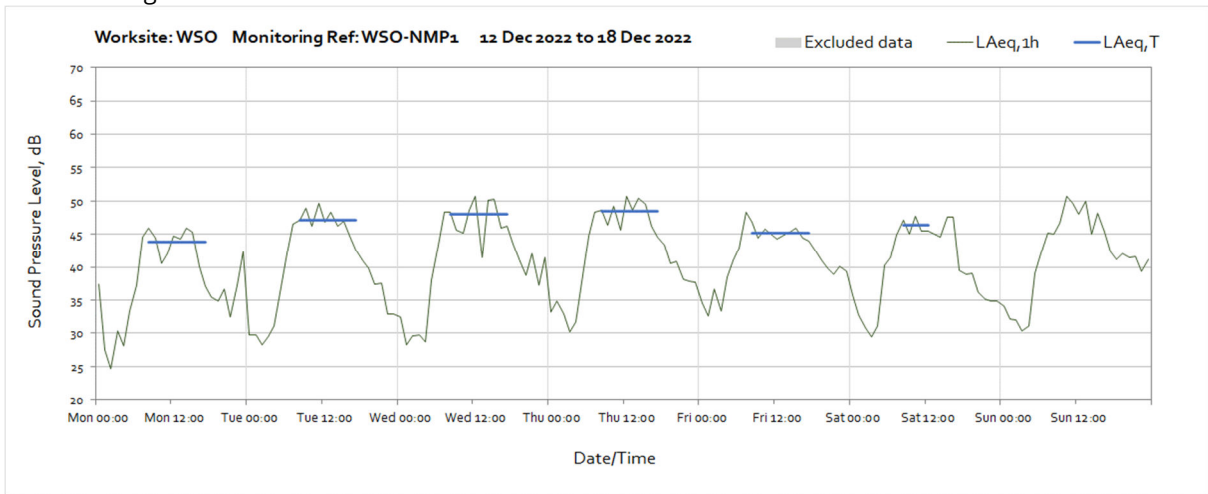
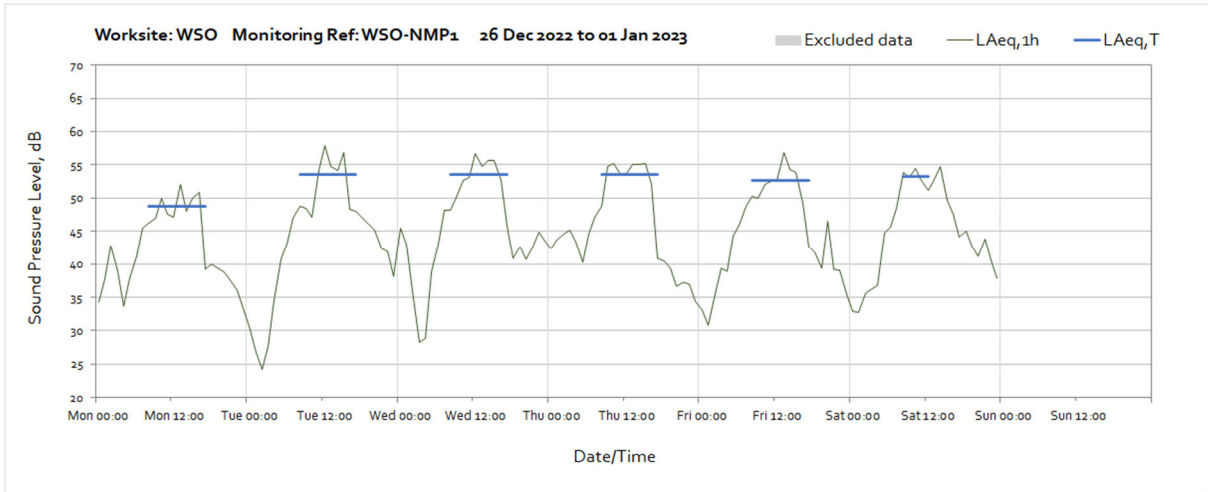
Worksite: WSO – Monitoring Ref: WSO-NMP1

Note: Missing data between 11:00 and 12:00 on 8th December was due to monitor maintenance.

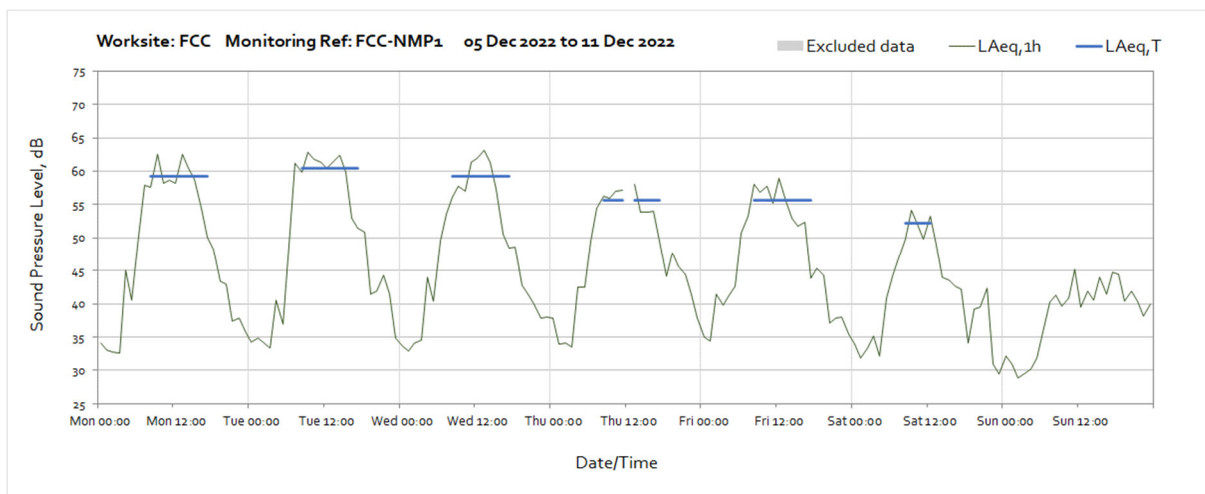
Worksite: FCC – Monitoring Ref: FCC-NMP1

Note: Missing data between 12:00 and 13:00 on 8th December was due to monitor maintenance.

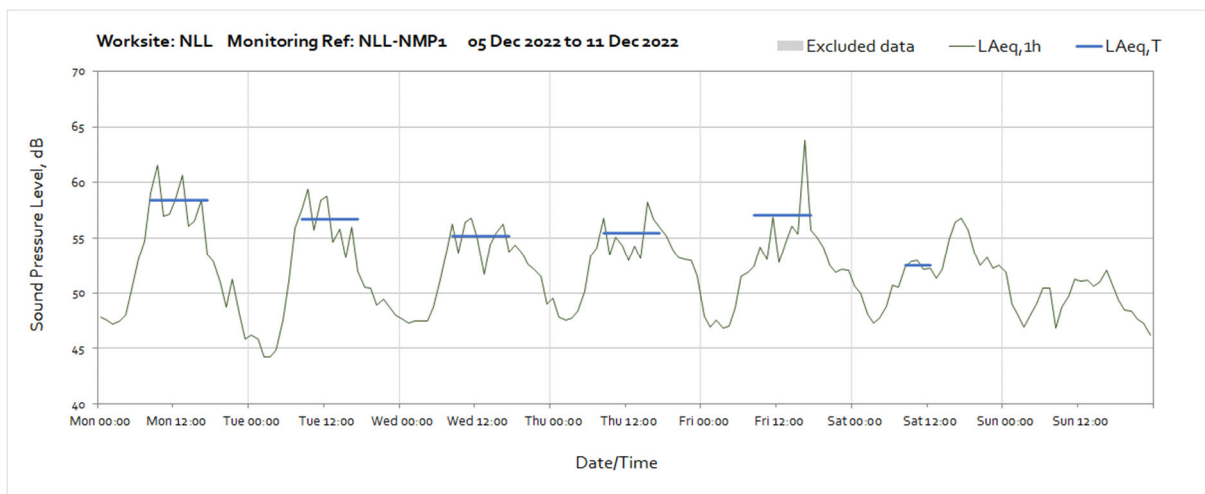
Worksite: NLL – Monitoring Ref: NLL-NMP1

Note: Missing data from 20:00 on 14th December until 13:00 on 19th December was due to depleted monitor battery.

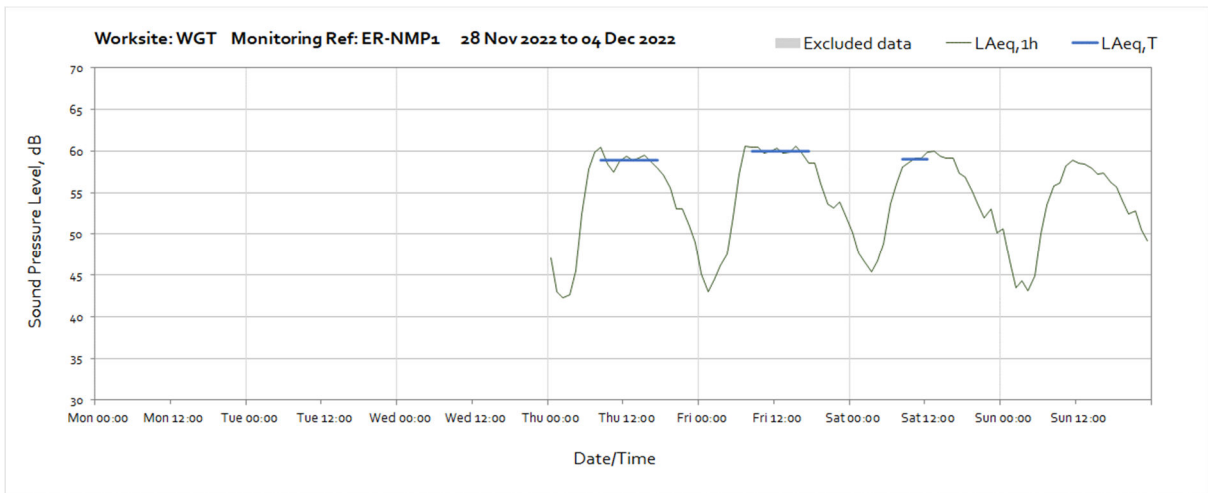
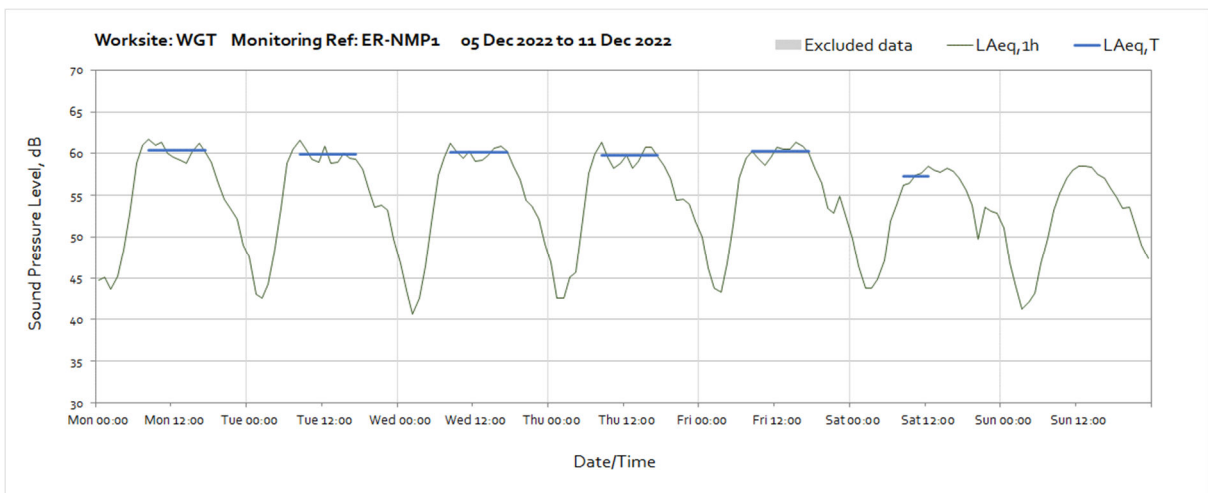
Worksite: WGT - Monitoring Ref: ER-NMP1

Note: Missing data from 20:00 on 15th December until 11:00 on 21st December was due to depleted monitor battery.

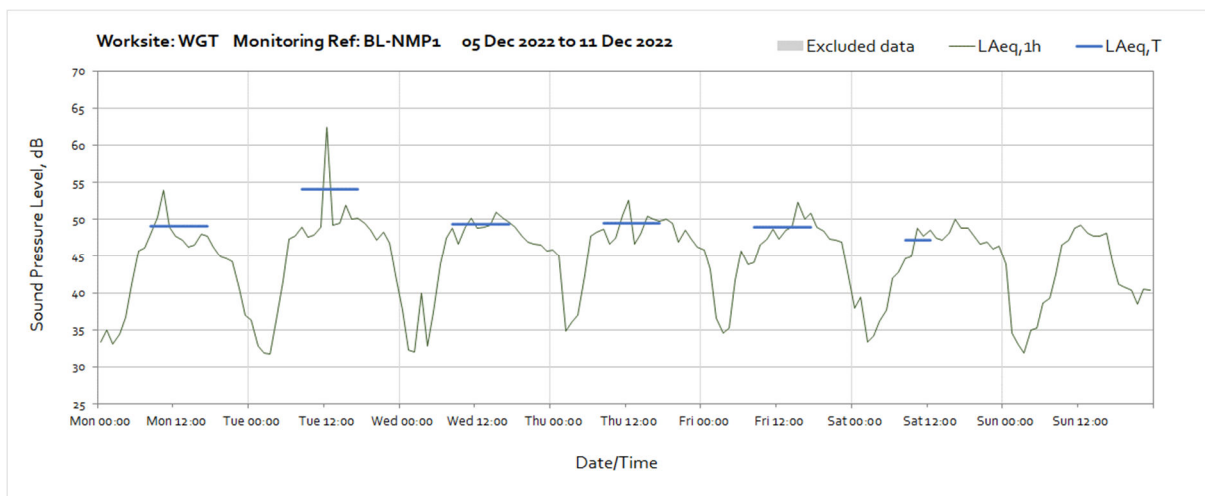
Worksite: WGT – Monitoring Ref: BL-NMP1

Note: Missing data from 12:00 on 14th December until 11:00 on 20th December was due to depleted monitor battery.

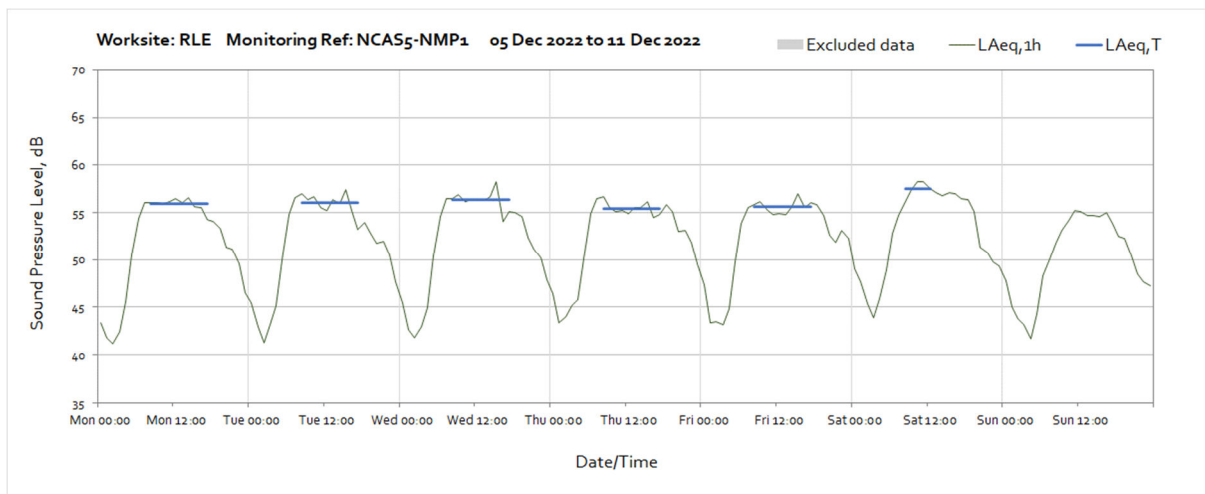
Worksite: RLE – Monitoring Ref: NCAS5-NMP1

Note: Missing data from 06:00 until 10:00 on 15th December was due to depleted monitor battery.

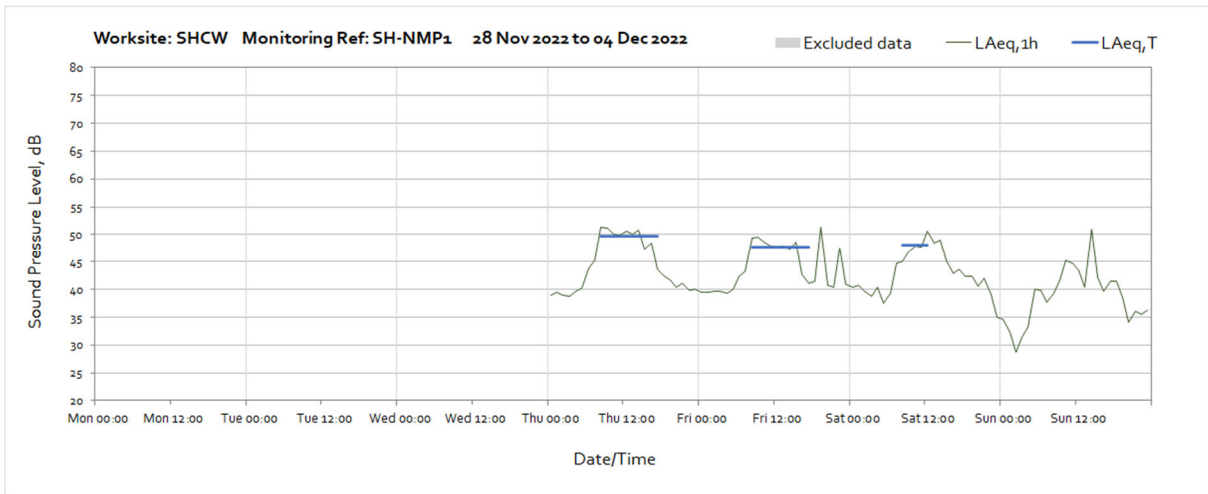
Worksite: SHCW - Monitoring Ref: SH-NMP1

Note: Missing data from 14:00 on 17th December until month end was due to battery charging problem, solar enclosure has been retrieved for repair.

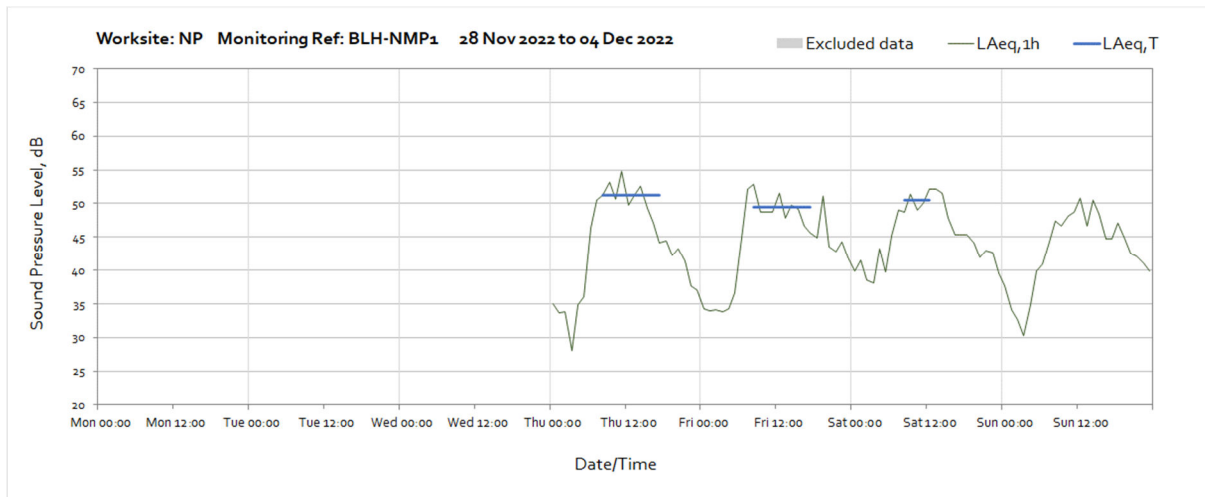
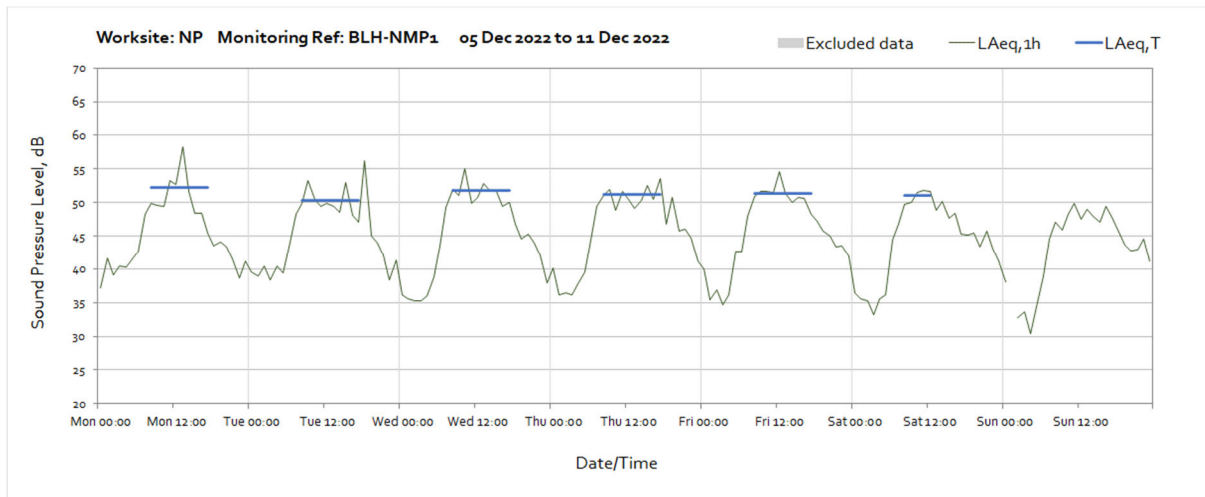
Worksite: NP – Monitoring Ref: BLH-NMP1

Note: Missing data between 01:00 and 02:00 on 11th December was due to a technical issue causing loss of data during data extraction.

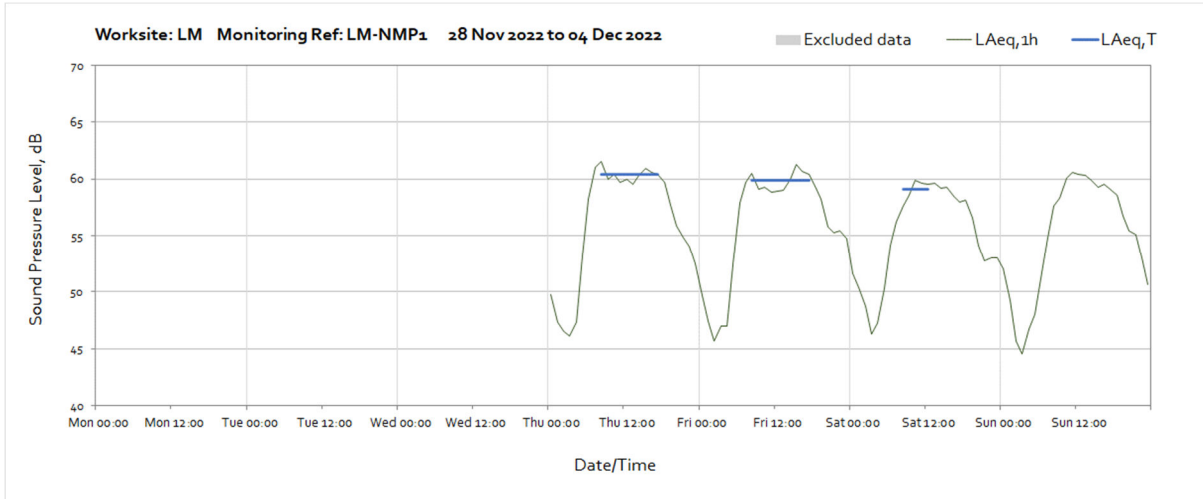
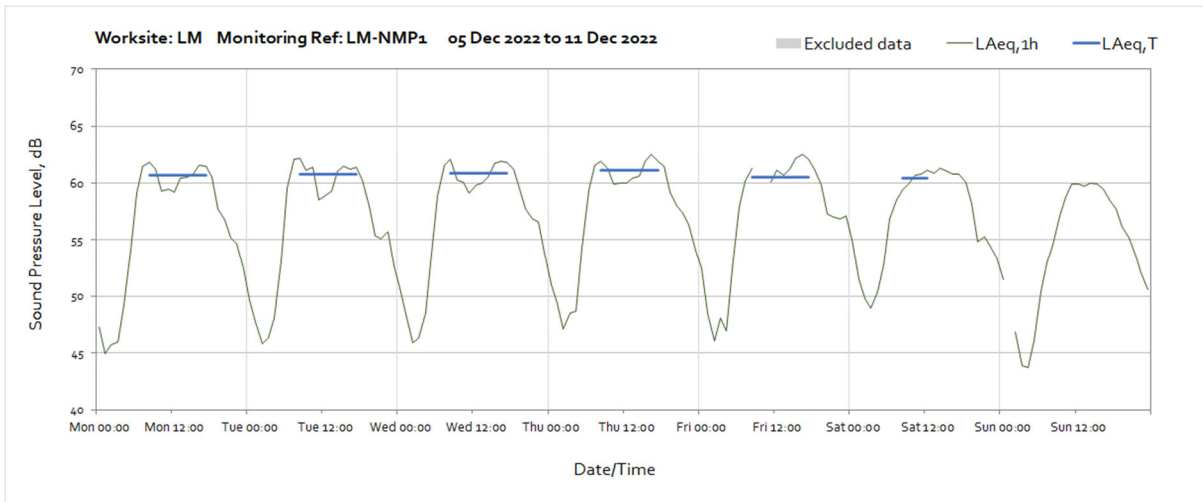
Worksite: LM – Monitoring Ref: LM-NMP1

Note: Missing data between 09:00 and 11:00 on 9th December was due to a solar panel power issue. Missing data between 01:00 and 02:00 on 11th December was due to a technical issue causing loss of data during data extraction.

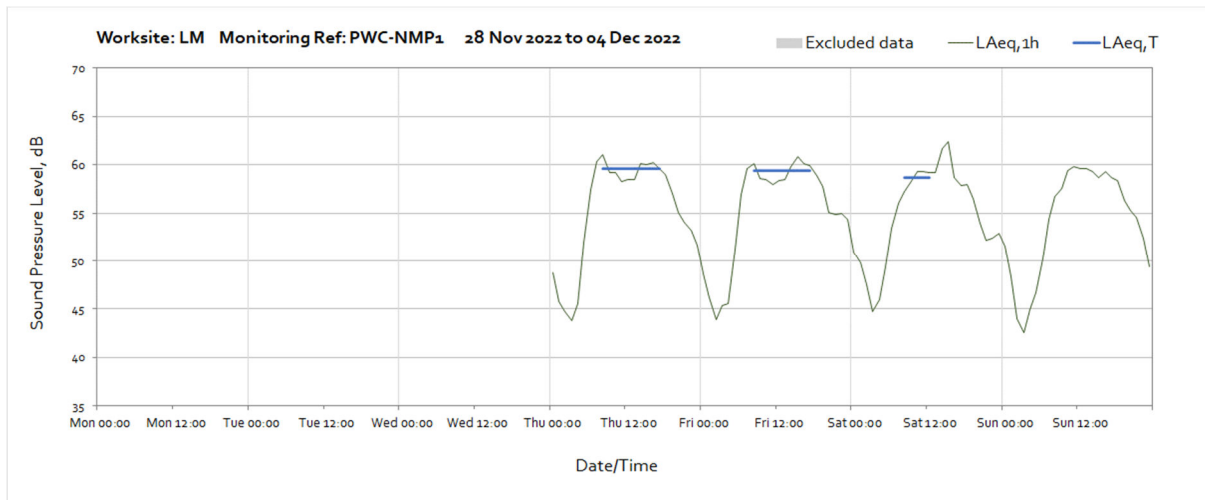
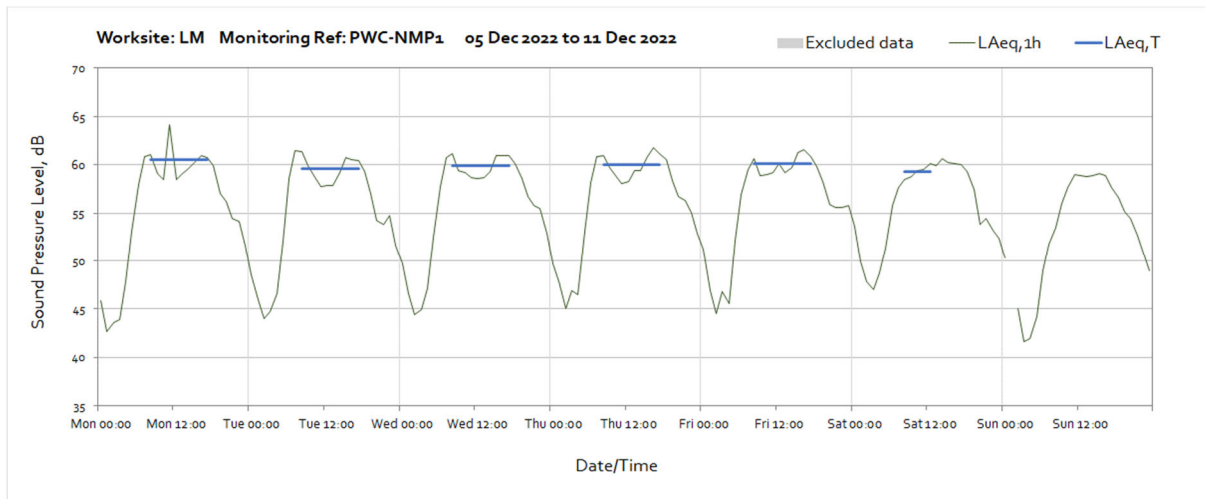
Worksite: LM – Monitoring Ref: PWC-NMP1

Note: Missing data between 01:00 and 02:00 on 11th December was due to a technical issue causing loss of data during data extraction.

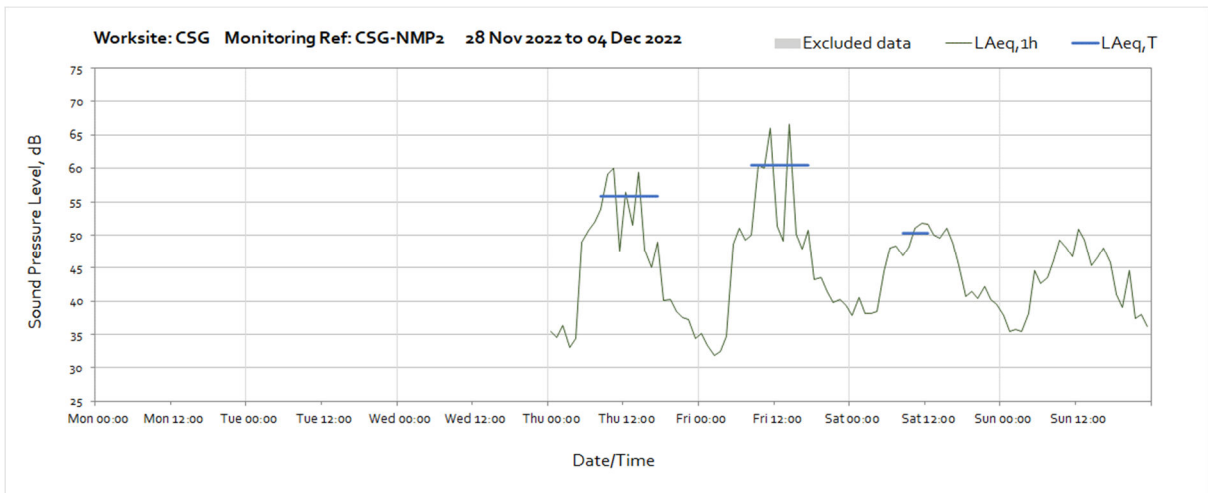
Worksite: CSG – Monitoring Ref: CSG-NMP2

Note: Missing data between 01:00 and 02:00 on 11th December was due to a technical issue causing loss of data during data extraction.

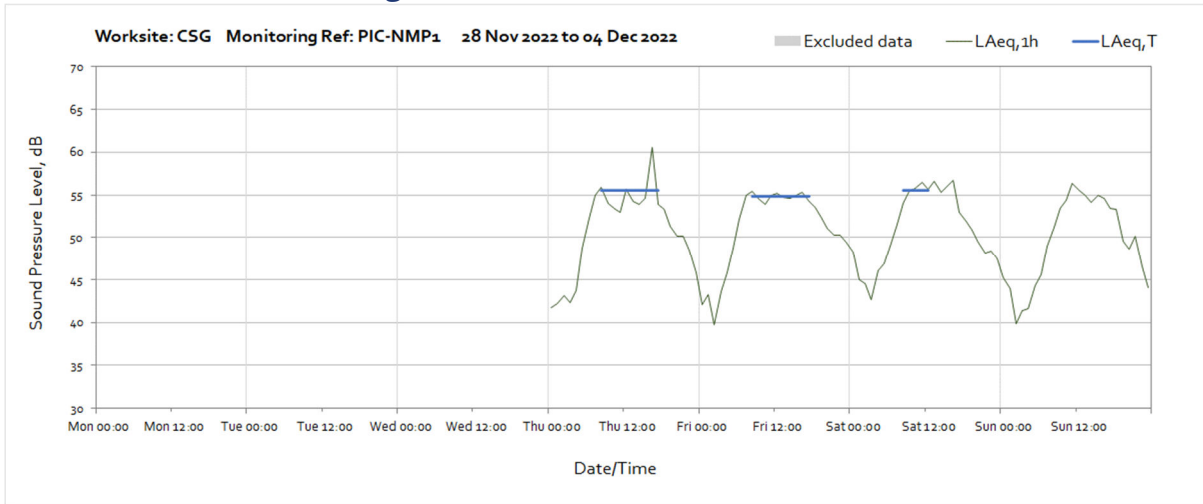
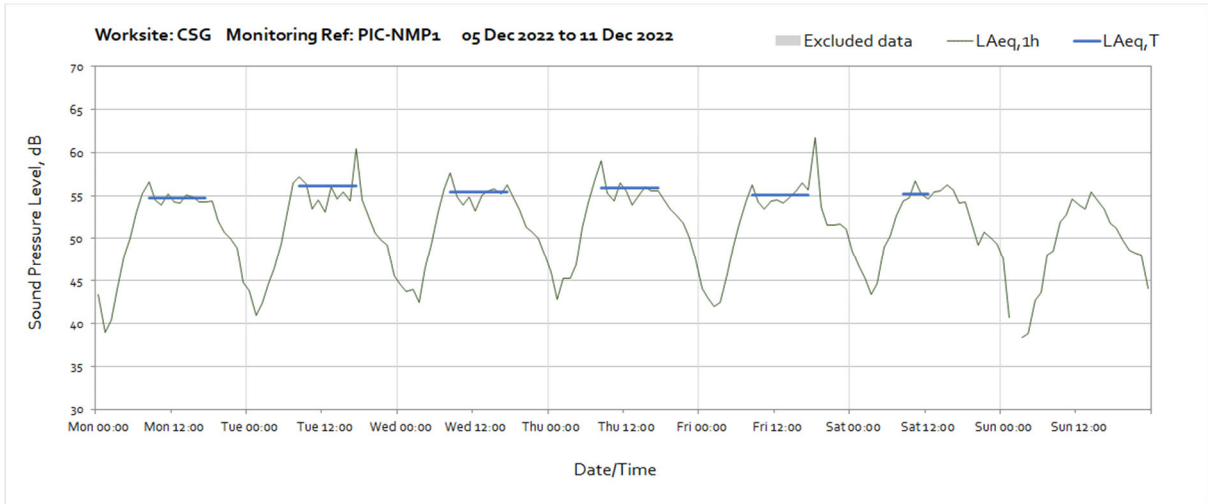
Worksite: CSG – Monitoring Ref: PIC-NMP1

Note: Missing data between 02:00 and 03:00 on 11th December was due to a technical issue causing loss of data during data extraction.

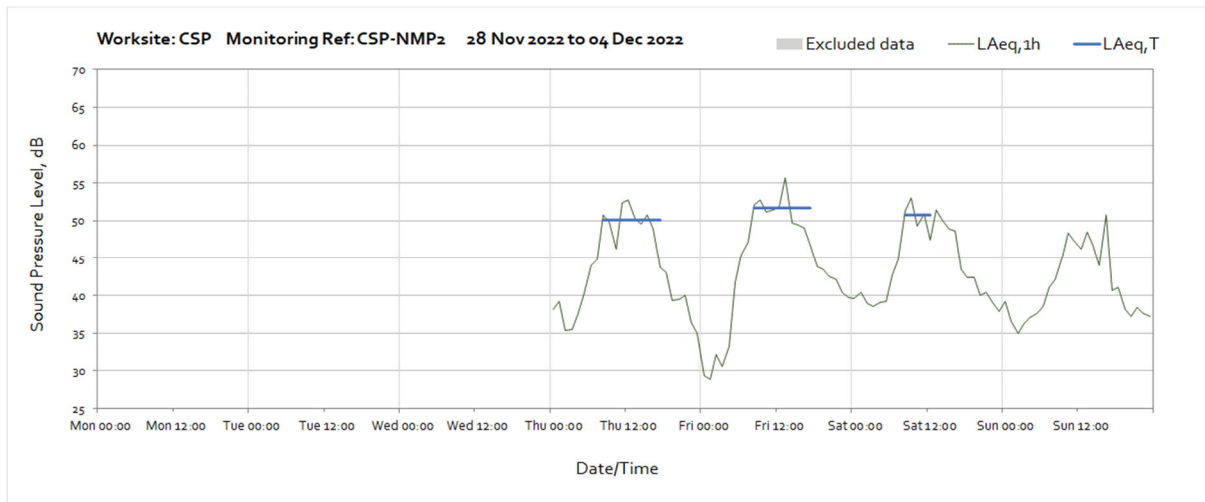
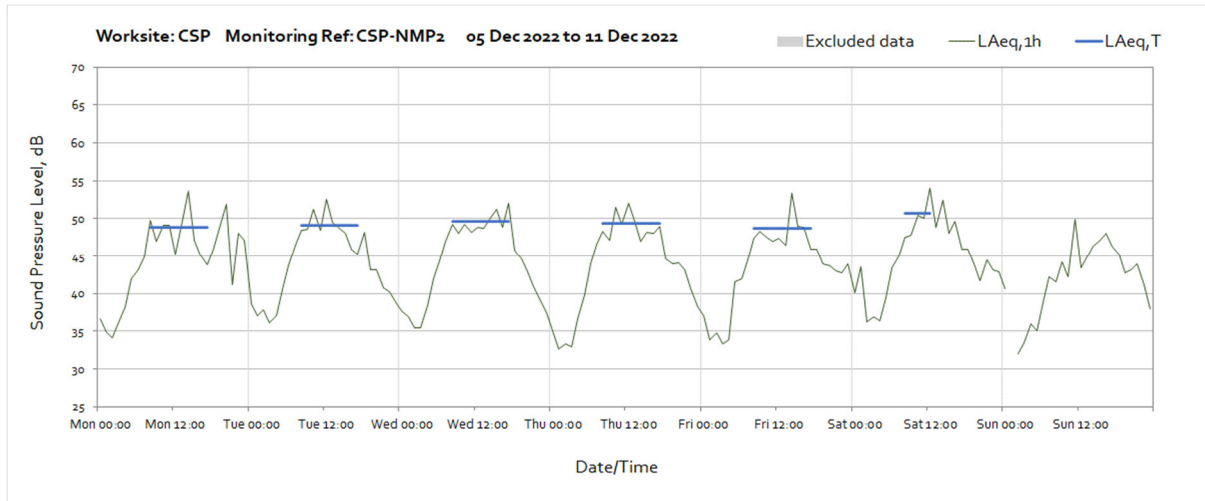
Worksite: CSP – Monitoring Ref: CSP-NMP2

Note: Missing data between 01:00 and 02:00 on 11th December was due to a technical issue causing loss of data during data extraction.

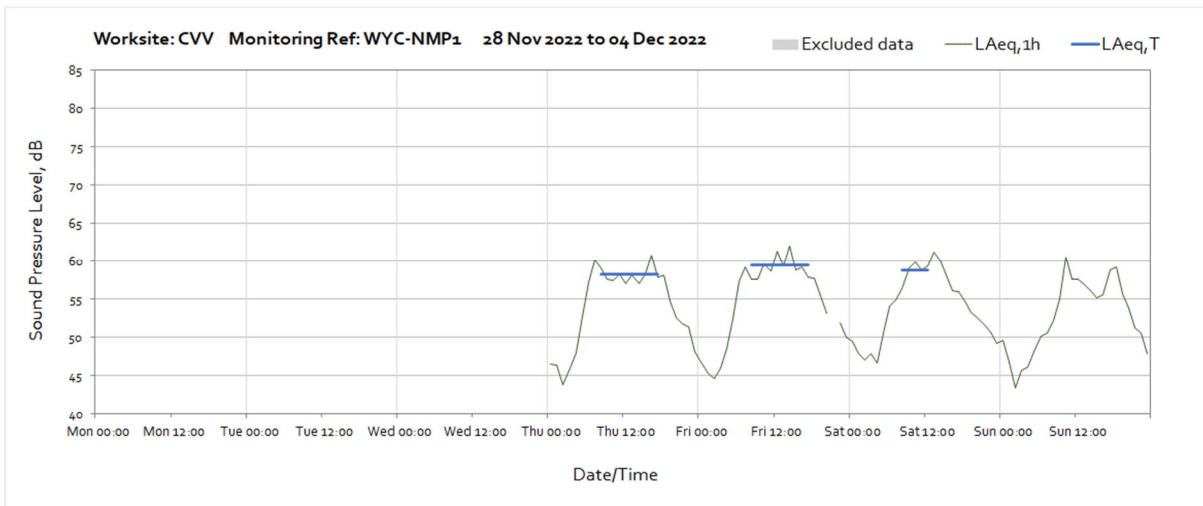
Worksite: CVV – Monitoring Ref: WYC-NMP1

Note: Missing data between 21:00 and 22:00 on 2nd December was due to a data transfer issue.

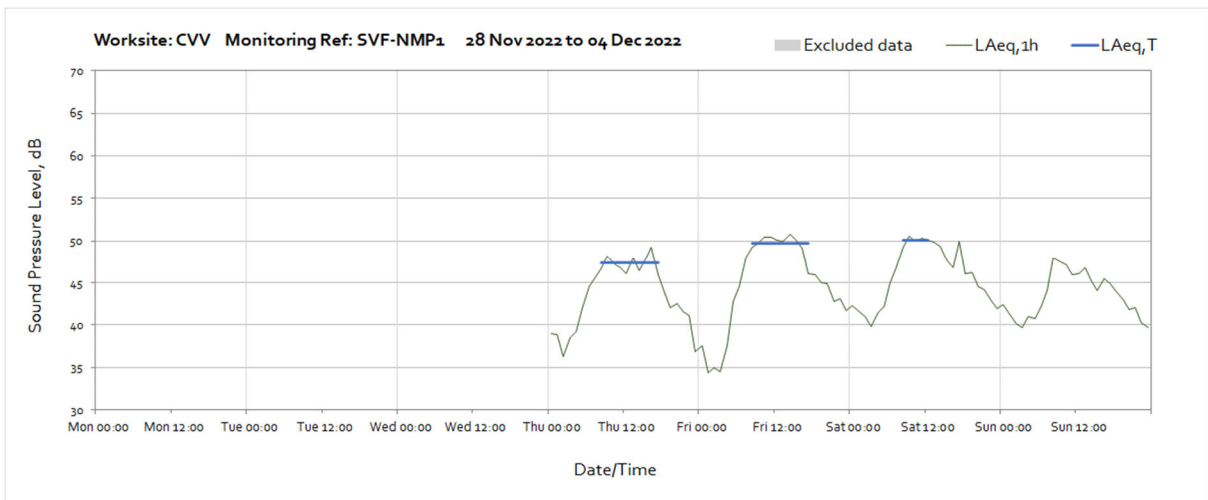
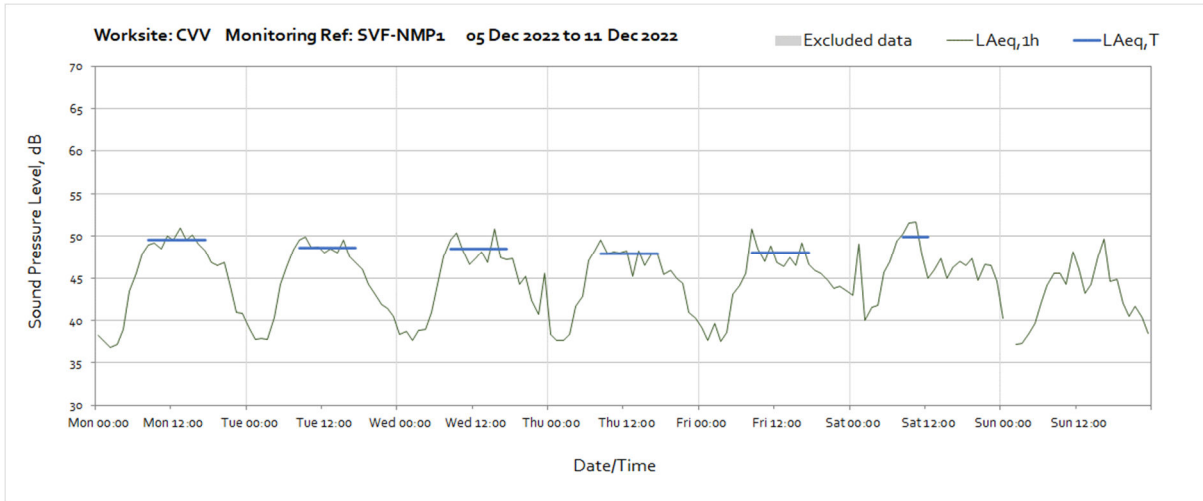
Worksite: CVV – Monitoring Ref: SVF-NMP1

Note: Missing data between 01:00 and 02:00 on 11th December was due to a technical issue causing loss of data during data extraction.

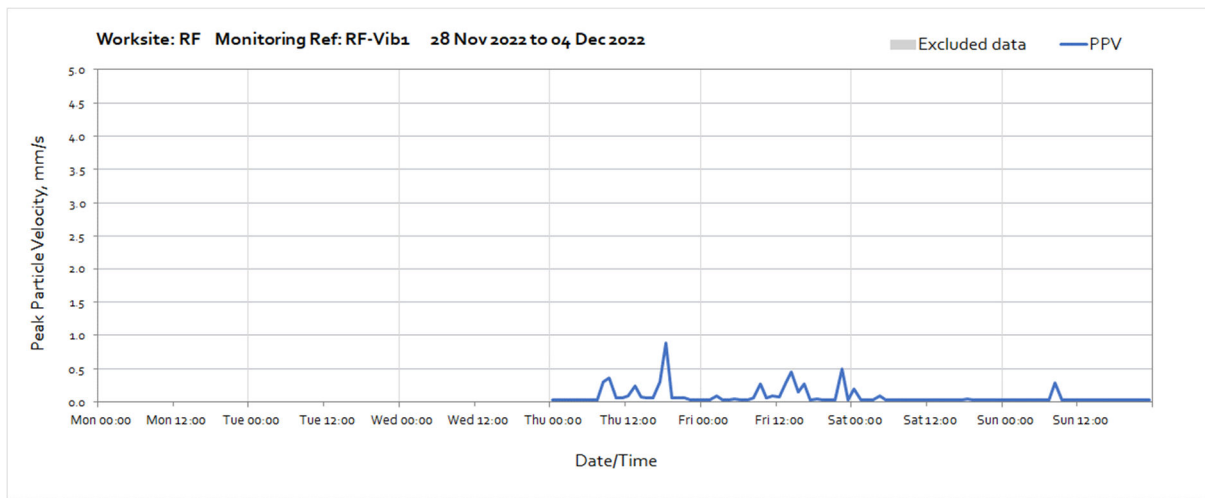
Worksite: RF – Monitoring Ref: RF-Vib 1

The following graphs show the hourly measured peak particle velocity PPV recorded during the monitoring period. The graphs show the highest PPV of the three orthogonal axes x, y and z. Where high values of PPV were caused by local interference with the vibration monitor, which are not representative of HS2 construction works, these values have been greyed out in the following charts and have been excluded to calculate values in Table 4 of the main report.
