1. Design and operation of user worked level crossings

Purpose of this summary

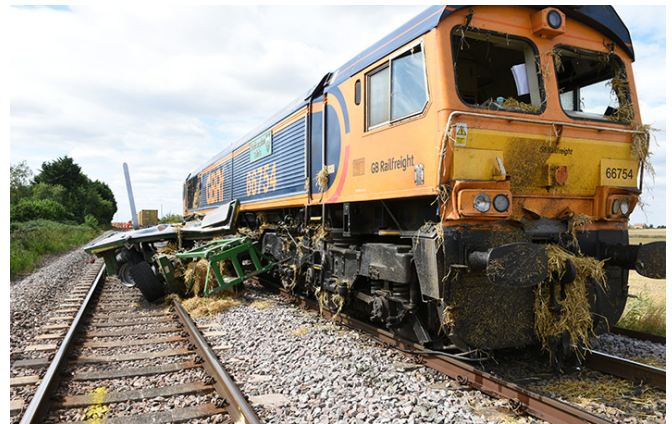
The aftermath of the collision at Kisby crossing in 2021.

- Near miss at Coltishall user worked crossing, Norfolk, 21 January 2021 ([report 03/2022](#))
- Collision between a train and agricultural equipment at Kisby user worked crossing, Cambridgeshire 19 August 2021 ([report 12/2022](#))

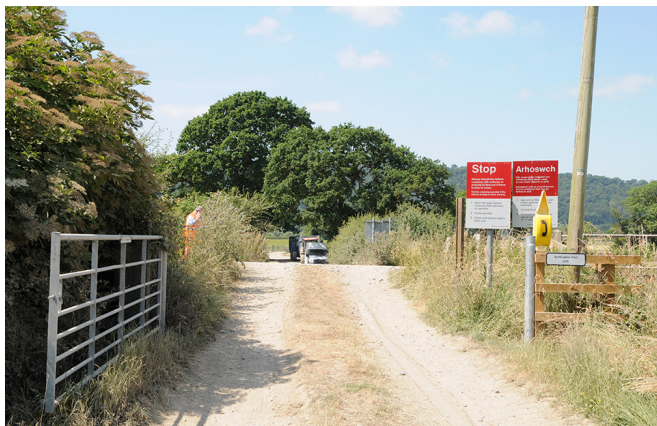
A user worked level crossing in Wales. Gates being left open is a regular problem at some crossings.

Where private roads, which lead to houses, farms or other commercial premises, cross the railway on the level, it is normally necessary for crossing users to operate the crossing gates or barriers themselves. In many cases, it is not possible to get sufficient warning of approaching trains by looking along the line, and telephones are provided for users to contact the railway signaller to obtain permission to cross.

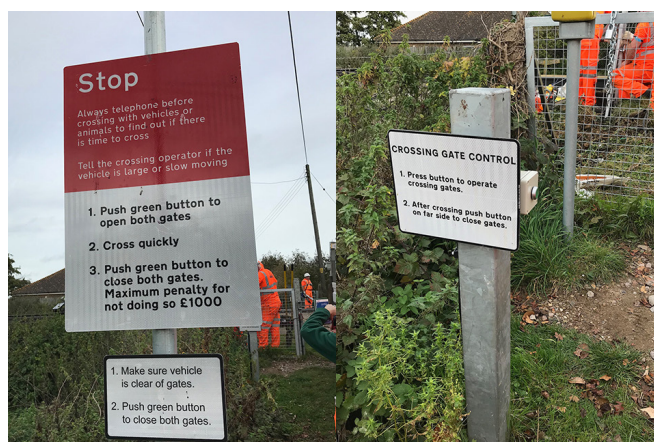
Signs at a user worked crossing.

At present, the signs that may be provided at user worked crossings are specified and described in the Private Crossings (Signs and Barriers) Regulations 1996. The signs which are specified do not reflect current thinking on how to convey information, are badly designed and can be confusing and hard to understand. In addition, the regulations do not include signs suitable for use with the various novel technologies that have been introduced in recent years, such as power operated gates and barriers. We have recommended that the Department for Transport (DfT), working with the industry and the regulator, should revise and update the regulations so that clear, effective signs can be used at these crossings ([report 13/2009](#) and [report 12/2018](#)). DfT has undertaken public consultation on new regulations which would replace the existing signs authorised for user worked crossings on private roads with a set of new prescribed signs. DfT has indicated that it intends to introduce these regulations during 2023.

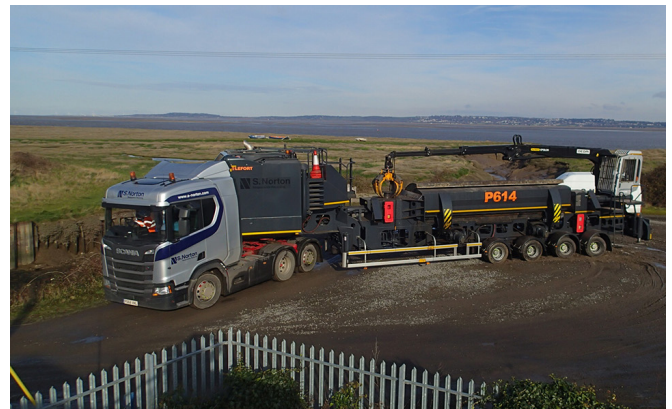
A large vehicle preparing to go over the user worked crossing at Bagillt.

Communication between the signaller and the user may not result in a clear understanding of the type of user and how long they need to cross safely. The signaller may have to rely heavily on the road user's assessment of the time they need to cross, when assessing what sort of protection is required. Following RAIB's investigation of the dangerous occurrence at Bagillt, Flintshire, in 2018, we have recommended improvements to the communications protocols used by signallers, and clarification of the method of operation when heavy or long road vehicles need to use crossings ([report 11/2019](#)).
