Construction Noise and Vibration Monthly Report – January 2023

Buckinghamshire

1 Introduction

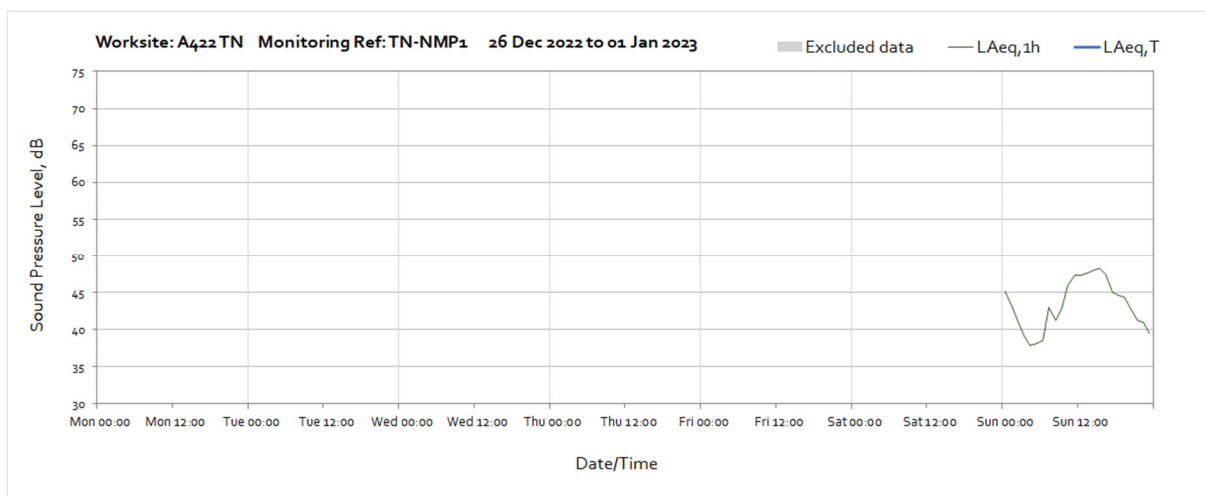
Worksite: A422 TN – Monitoring Ref: TN-NMP1

Note: Missing data between 12:00 and 15:00 on 6th January was due to monitor maintenance.

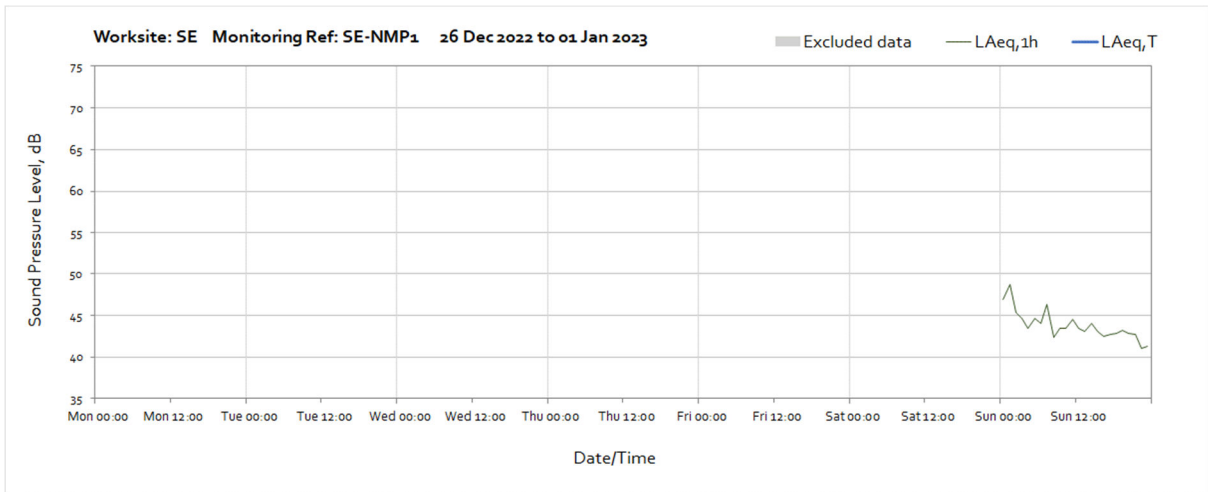
Worksite: SE – Monitoring Ref: SE-NMP1

Note: Missing data between 11:00 and 12:00 on 11th January was due to monitor maintenance.

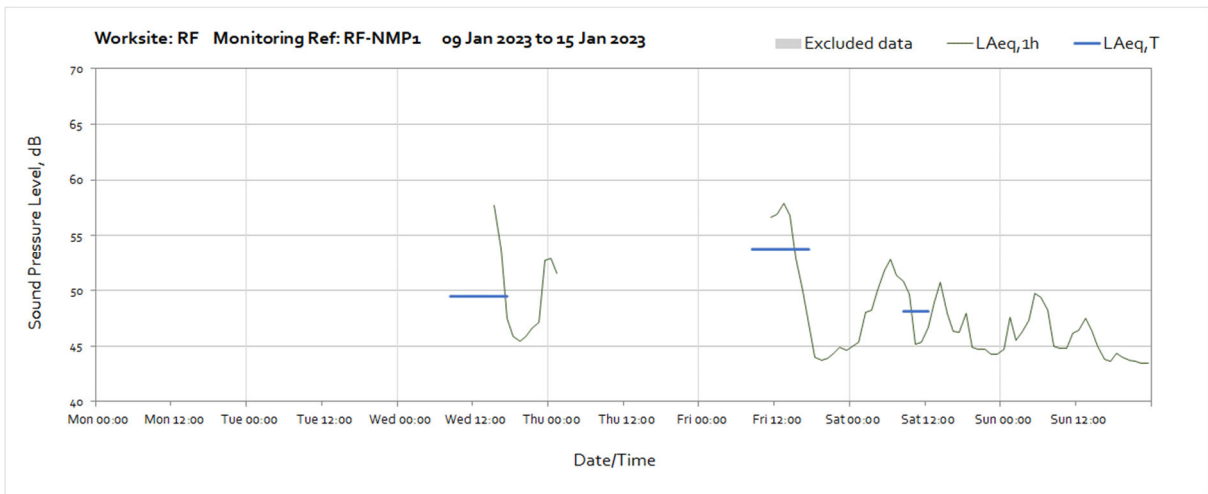
Worksite: RF – Monitoring Ref: RF-NMP1

Note: Missing data from the start of the month until 15:00 on 11th January and between 02:00 on 12th January until 11:00 on 13th January was due to loss of power to monitor.

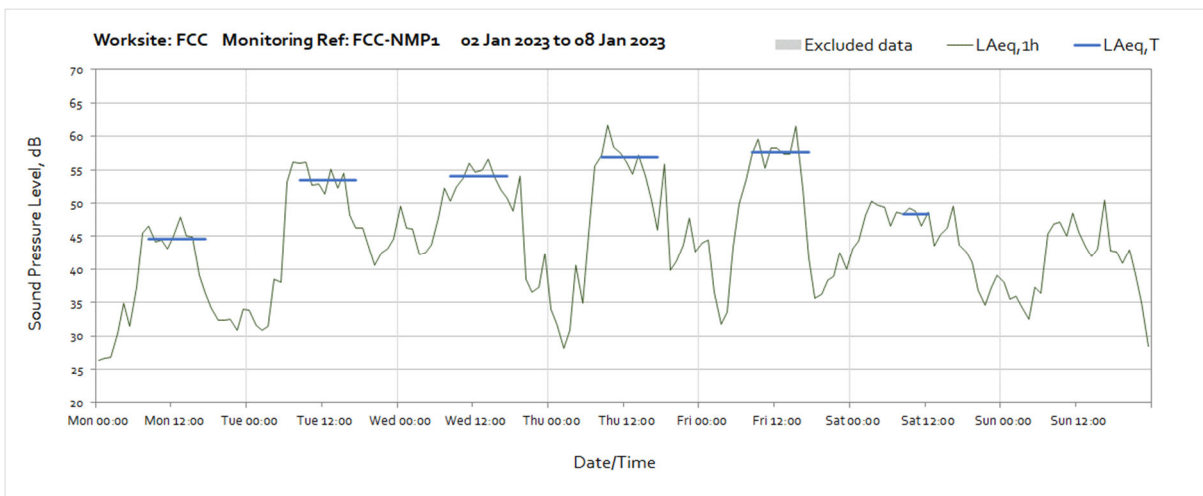
Worksite: FCC – Monitoring Ref: FCC-NMP1

Note: Missing data between 14:00 and 15:00 on 13th January was due to monitor maintenance.

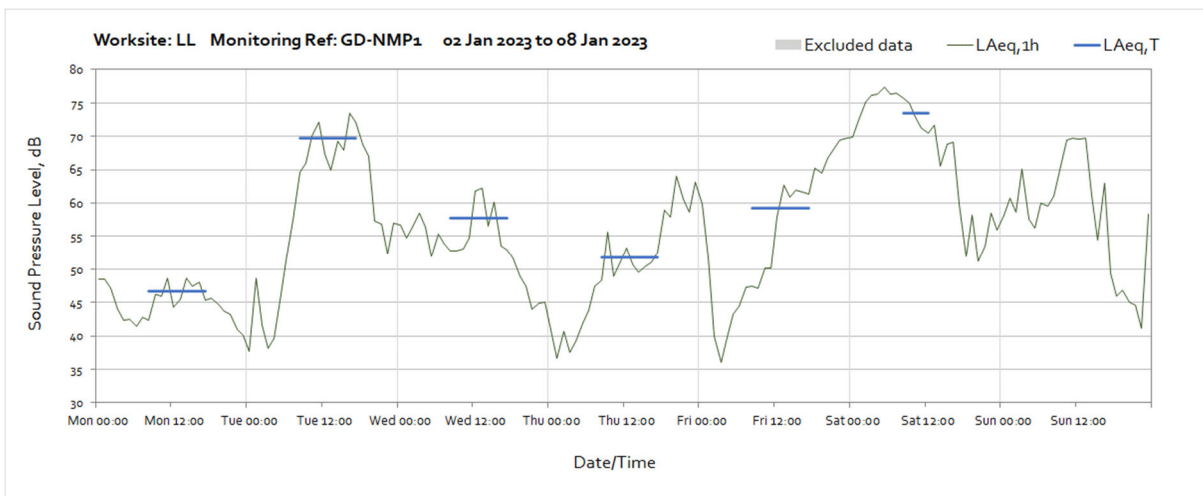
Worksite: LL - Monitoring Ref: GD-NMP1

Note: Missing data between 13:00 and 14:00 on 31st January was due to monitor maintenance.

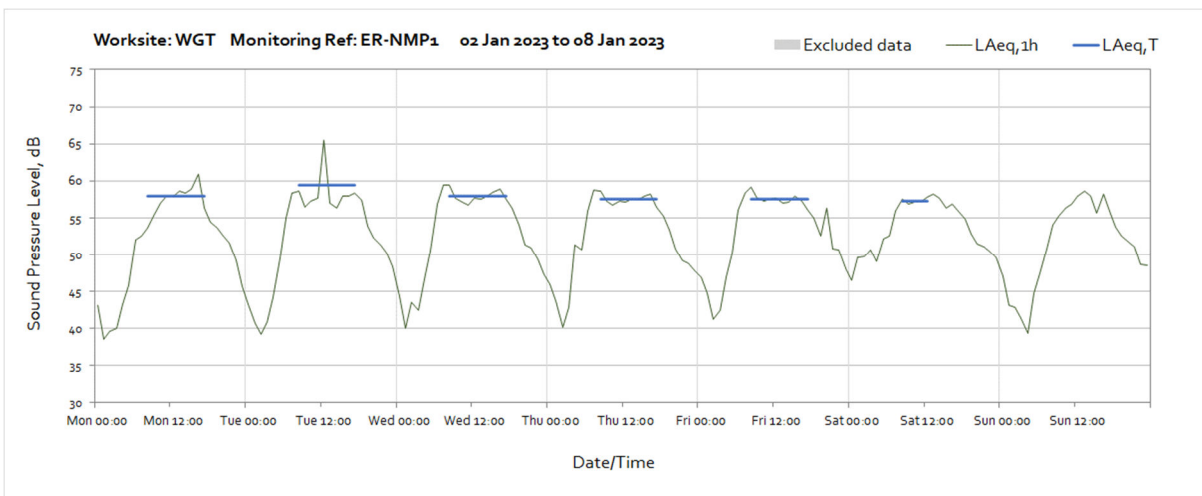
Worksite: WGT - Monitoring Ref: ER-NMP1

Note: Missing data between 12:00 and 13:00 on 24th January and between 13:00 and 14:00 on 25th January was due to monitor maintenance.

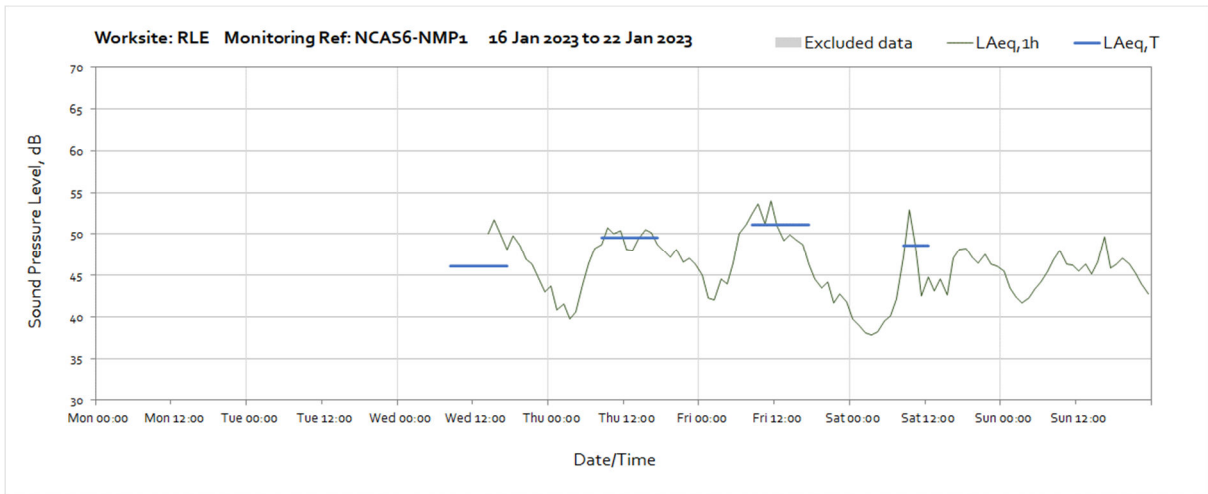
Worksite: RLE - Monitoring Ref: NCAS6-NMP1

Note: Monitor was reinstalled at 14:00 on 18th January.

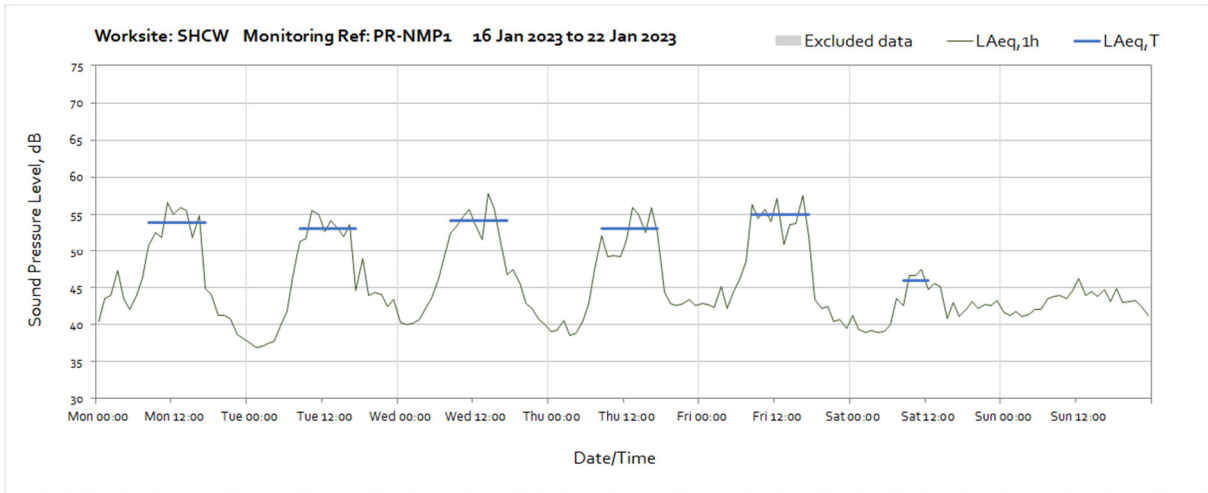
Worksite: SHCW – Monitoring Ref: PR-NMP1

Note: Missing data between 13:00 and 14:00 on 31st January was due to monitor maintenance.

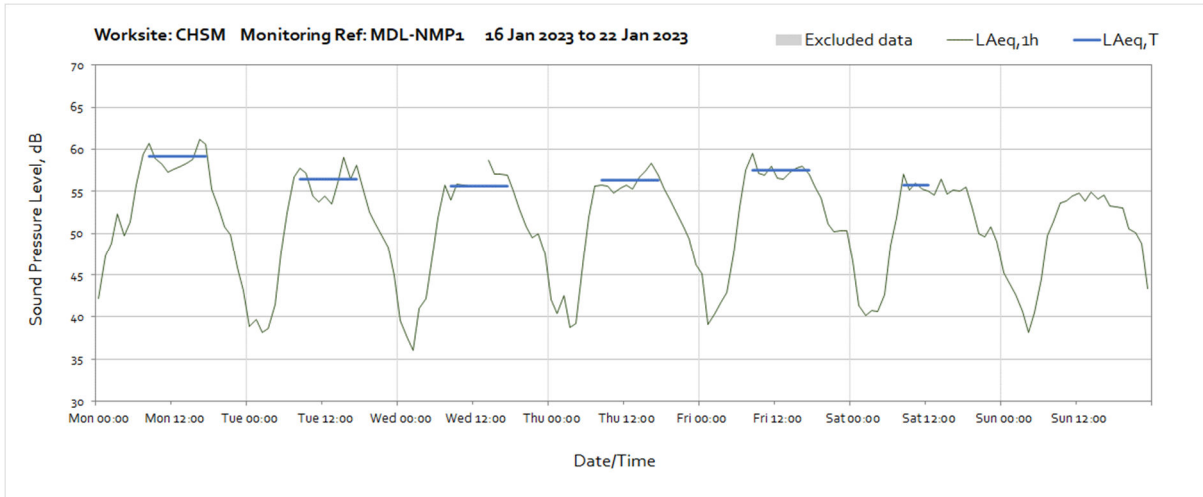
Worksite: CHSM – Monitoring Ref: MDL-NMP1

Note: Missing data between 12:00 and 14:00 on 18th January was due to monitor maintenance and field calibration.

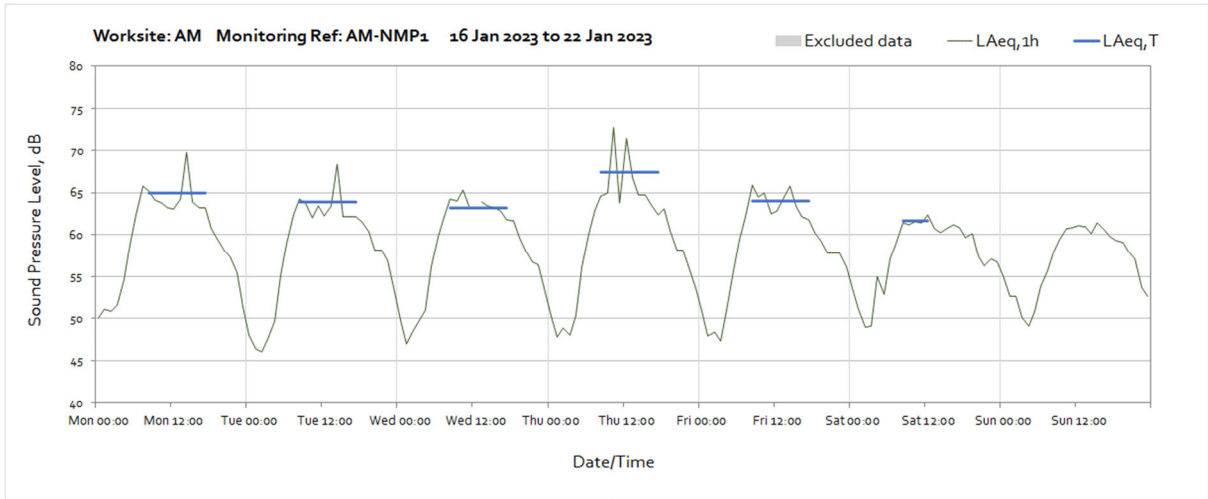
Worksite: AM - Monitoring Ref: AM-NMP1

Note: Missing data between 12:00 and 13:00 on 18th January was due to monitor field calibration.

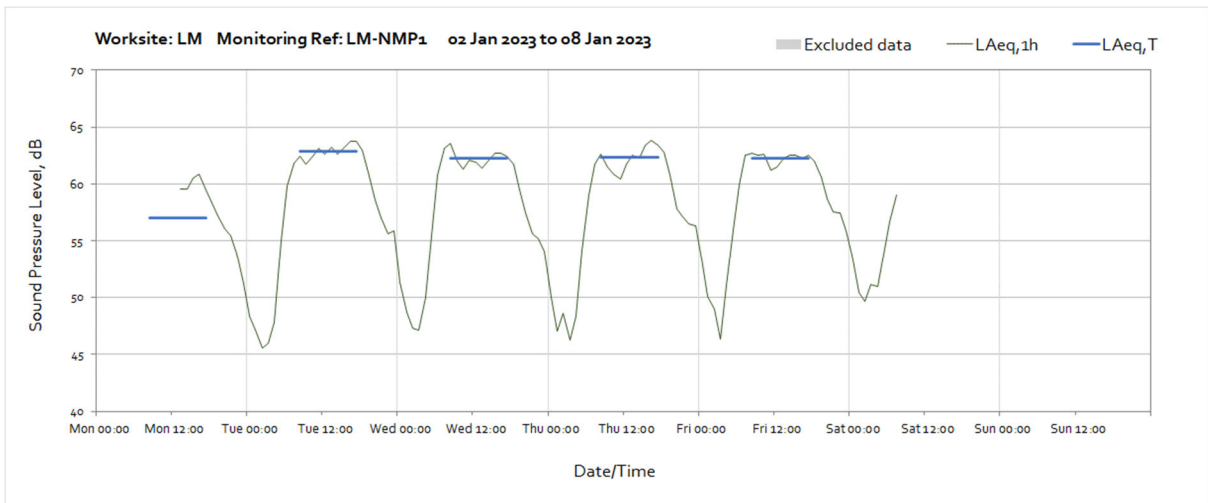
Worksite: LM – Monitoring Ref: LM-NMP1

Note: Missing data between 00:00 on 1st January until 13:00 on 2nd January was due to monitor power issue. Missing data between 08:00 on 7th January until 12:00 on 11th January was due to monitor power issue.

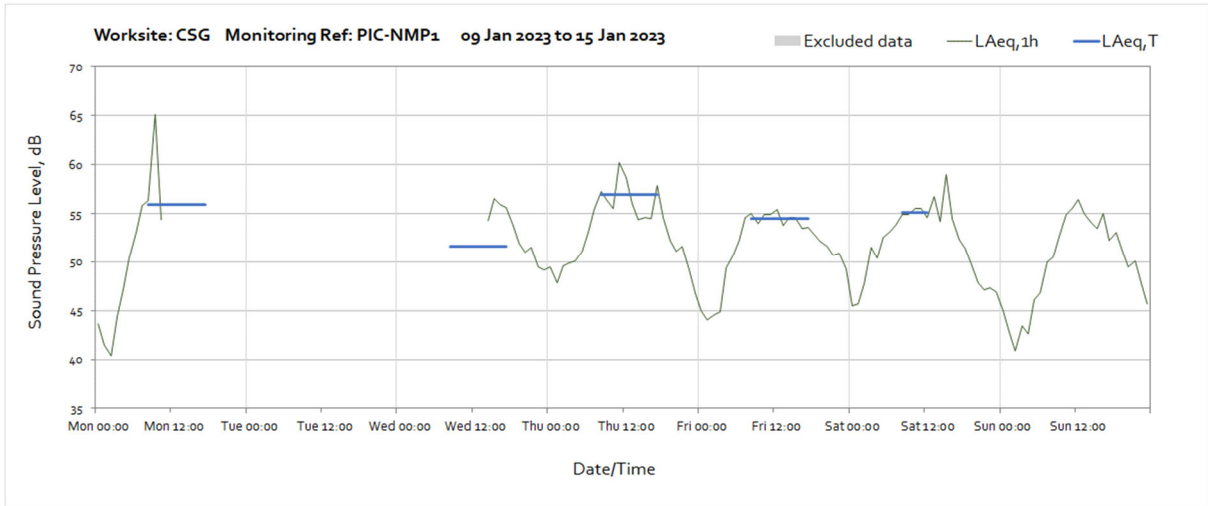
Worksite: CSG – Monitoring Ref: PIC-NMP1

Note: Missing data between 11:00 on 9th January and 14:00 on 11th January was due to monitor loss of power.

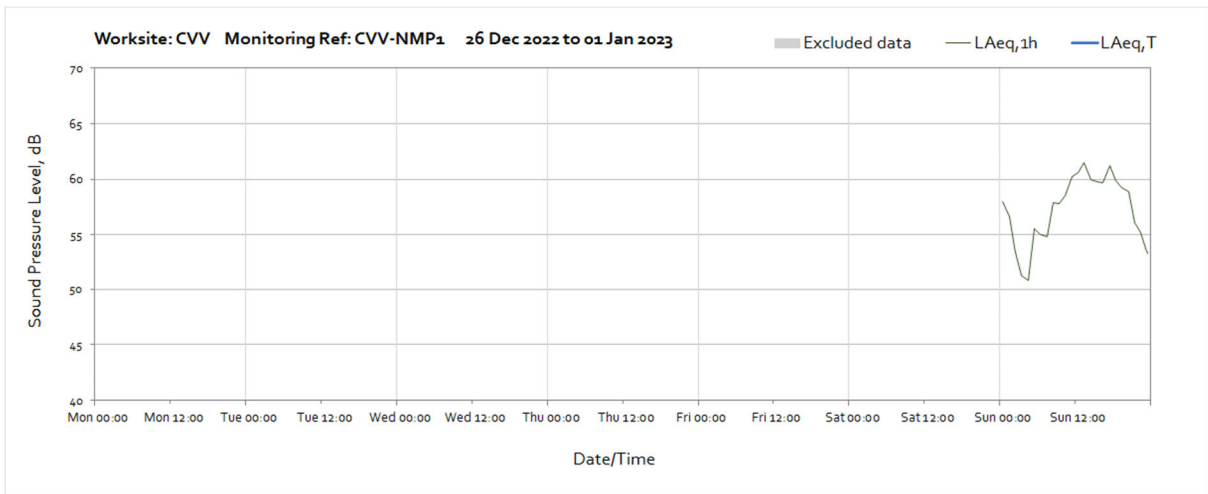
Worksite: CVV- Monitoring Ref: CVV-NMP1

Note: Missing data between 06:00 and 07:00 on 17th January was due to monitor maintenance. Missing data between 13:00 and 14:00 on 18th January was due to monitor field calibration.

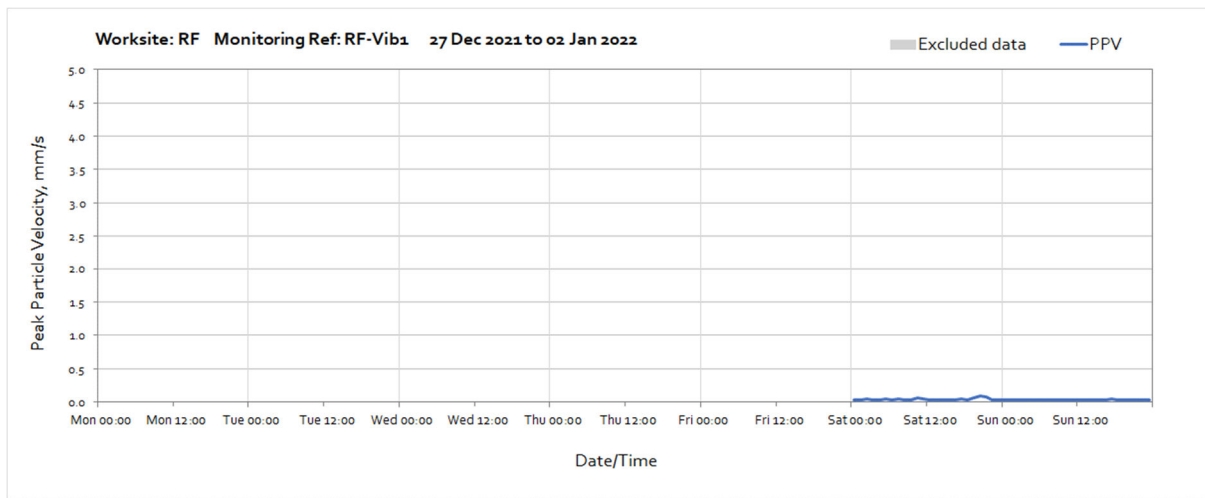
Worksite: RF – Monitoring Ref: RF-Vib 1

Note: Missing data between 01:00 on 6th January until 16:00 on 11th January was due to loss of power to the monitor.

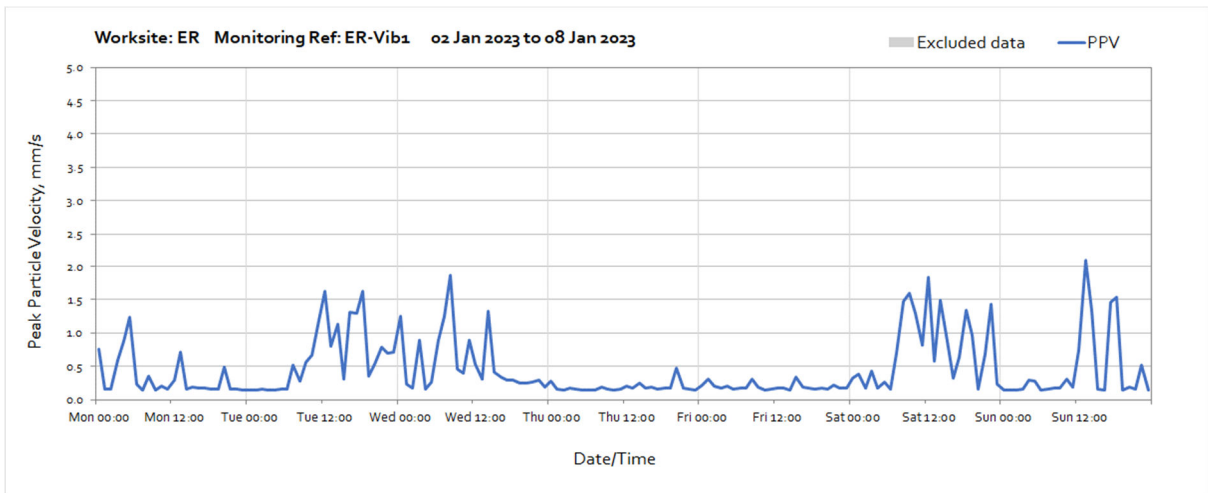
Worksite: WGT - Monitoring Ref: ER-Vib 1

Note: Missing data between 09:00 on 15th January and 10:00 on 20th January was due to depleted monitor battery.
