Construction Noise and Vibration Monthly Report – January 2023

London Borough of Camden

Non-Technical Summary

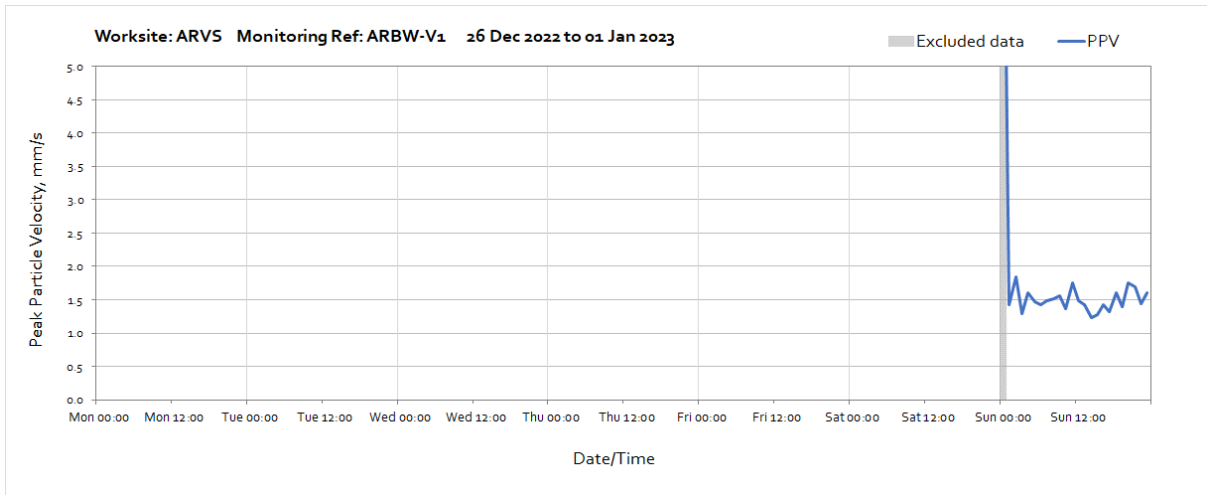
Worksite: ARVS – Monitoring Ref: ABRW-V1

Note: Missing data from 00:00 until 01:00, 03:00 until 04:00 and 14:00 until 15:00 on Tuesday 10th January was due to an equipment error which is currently under investigation.

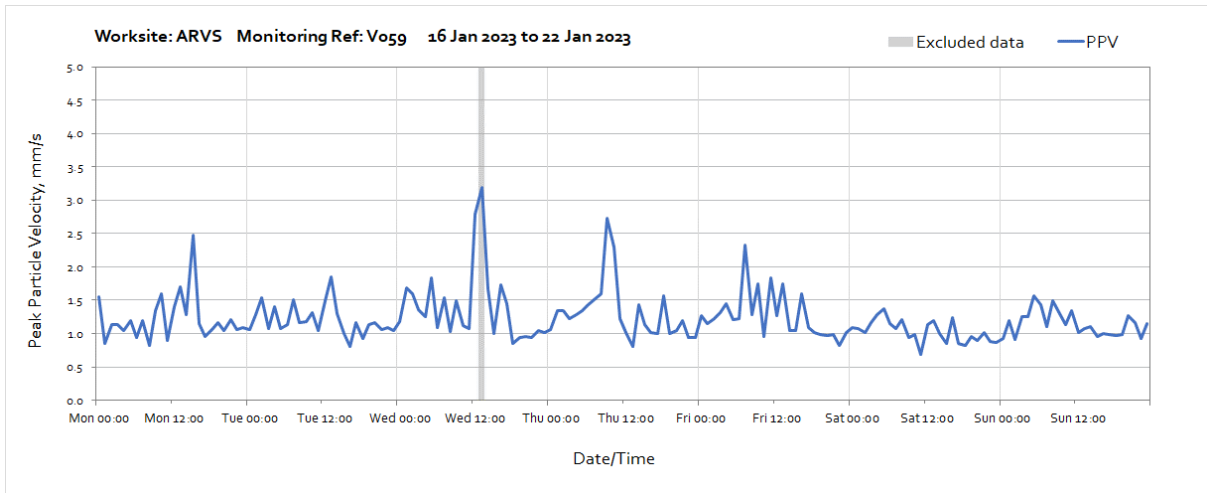
Worksite: ARVS – Monitoring Ref: V059

Note: Missing data throughout the week was due to an equipment error which is currently under investigation.
