Construction noise and vibration Monthly Report – January 2023

London Borough of Hillingdon

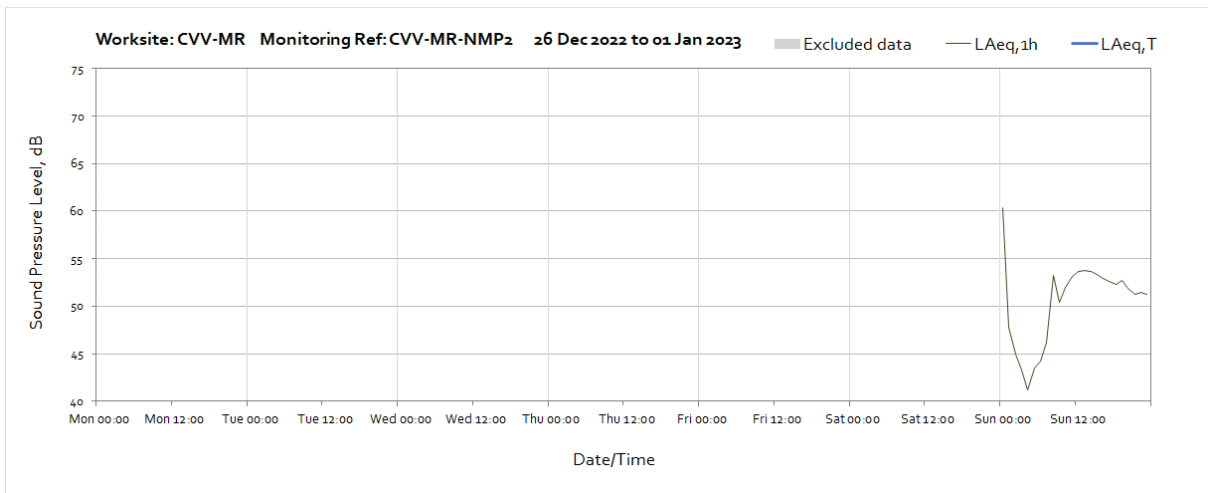
Monitoring Ref: CVV-MR-NMP2

Note: High noise levels measured at 00:00 on Sunday 1st January were due to New Year Night celebration.

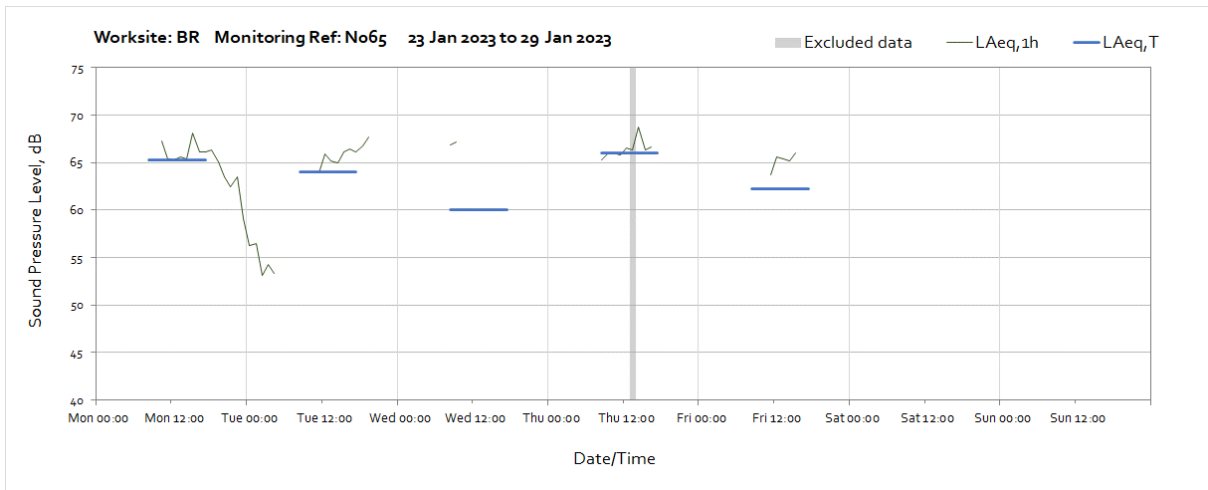
Note: Missing data throughout the week was due to loss of battery power at the monitoring station.

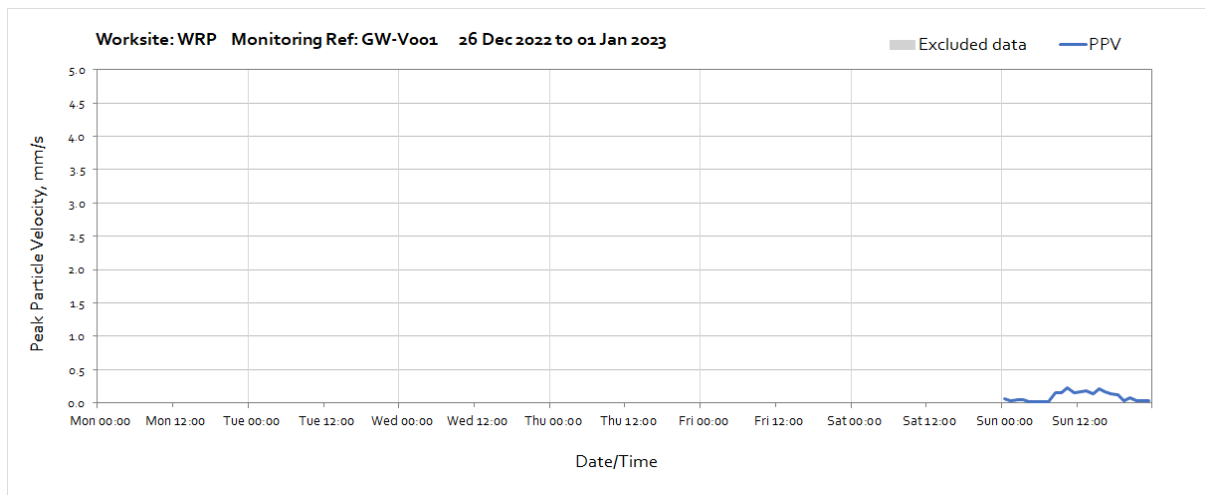
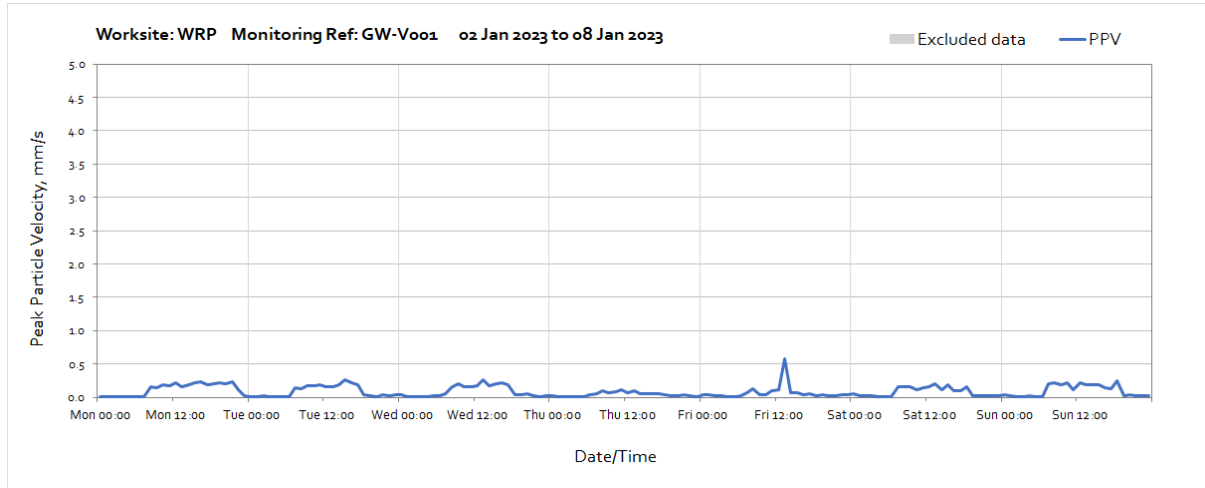
Worksite: West Ruislip Portal (WRP) – Monitoring Ref: GW-V001

The following graphs show the hourly measured peak particle velocity PPV recorded during the monitoring period. The graphs show the highest PPV of the three orthogonal axis x, y and z. Where high values of PPV were caused by local interference with the vibration monitor, which are not representative of HS2 construction works, these values have been greyed out in the following charts and have been excluded to calculate values in Table 4 of the main report.

Worksite Reference	Measurement Reference	Monitor Address	Highest PPV measured in any axis, mm/s
WRP	GW-V001	95 The Greenway, Ickenham, Uxbridge	0.59 (Y-axis)
