## **Construction Noise and Vibration Monthly Report – January 2023**

**Lichfield District Council**

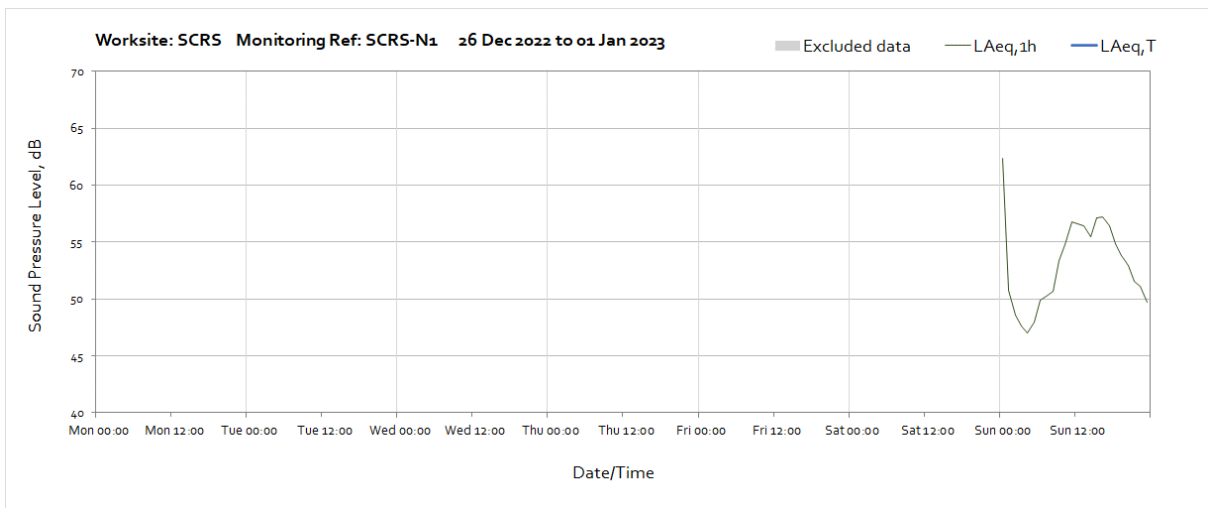
**Worksite:SCRS – Monitoring Ref: SCRS-N1**

Note: High noise levels measured at 00:00 on Sunday 1<sup>st</sup> January were due to New Year Night celebration.

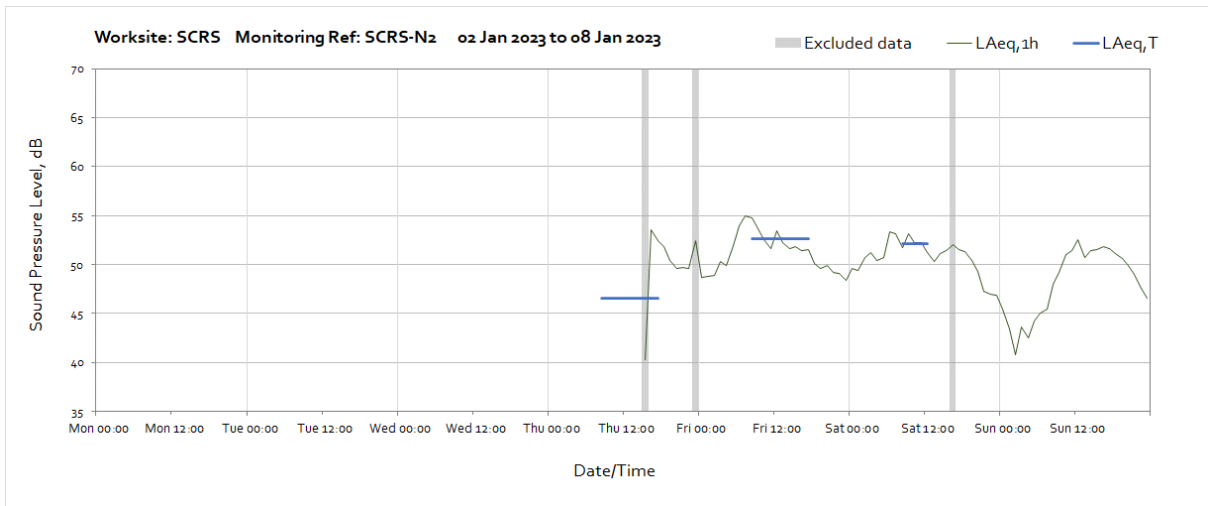
### Worksite:SCRS – Monitoring Ref: SCRS-N2

Note: Missing data between 00:00 on Sunday 1<sup>st</sup> January and 15:00 on Thursday 5<sup>th</sup> January was due to loss of power to the monitor from the solar panel supply.

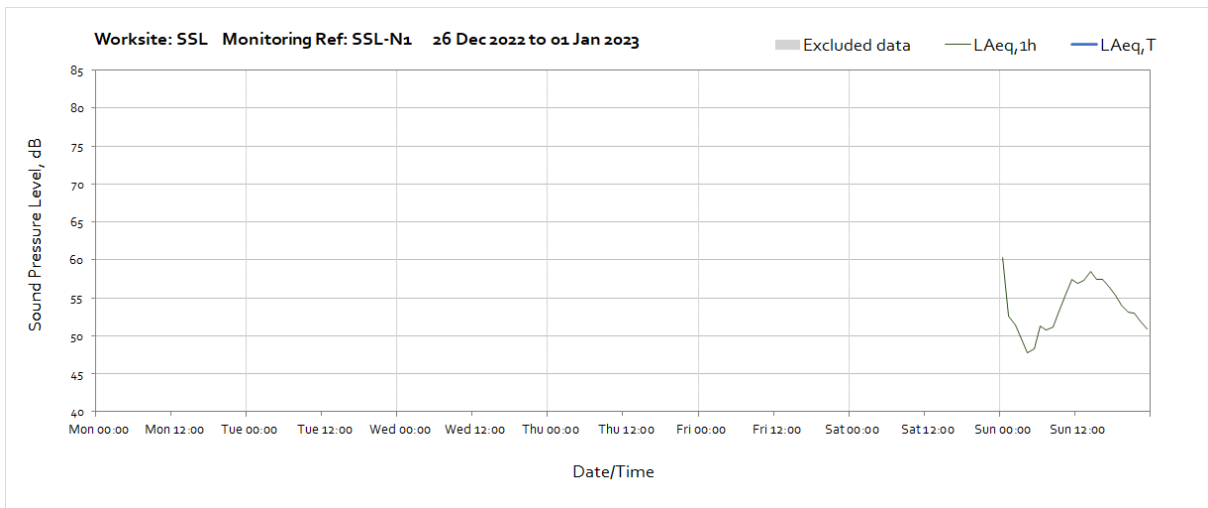
### Worksite: SCRS – Monitoring Ref: SSL-N1

Note: High noise levels measured at 00:00 on Sunday 1<sup>st</sup> January were due to New Year Night celebration.

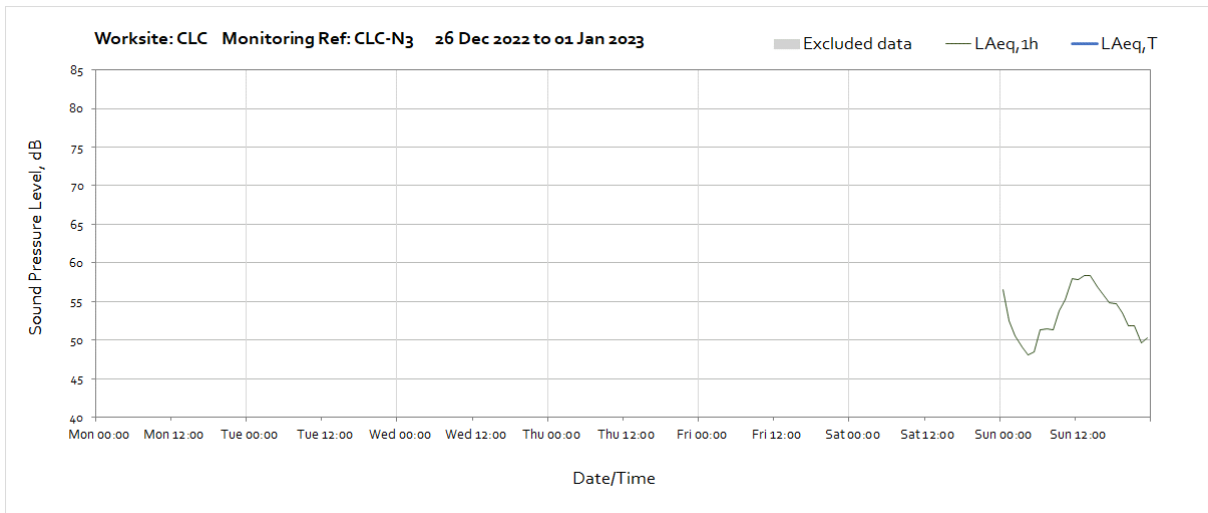
### Worksite: CLC - Monitoring Ref: CLC-N3

Note: High noise levels measured at 00:00 on Sunday 1<sup>st</sup> January were due to New Year Night celebration.

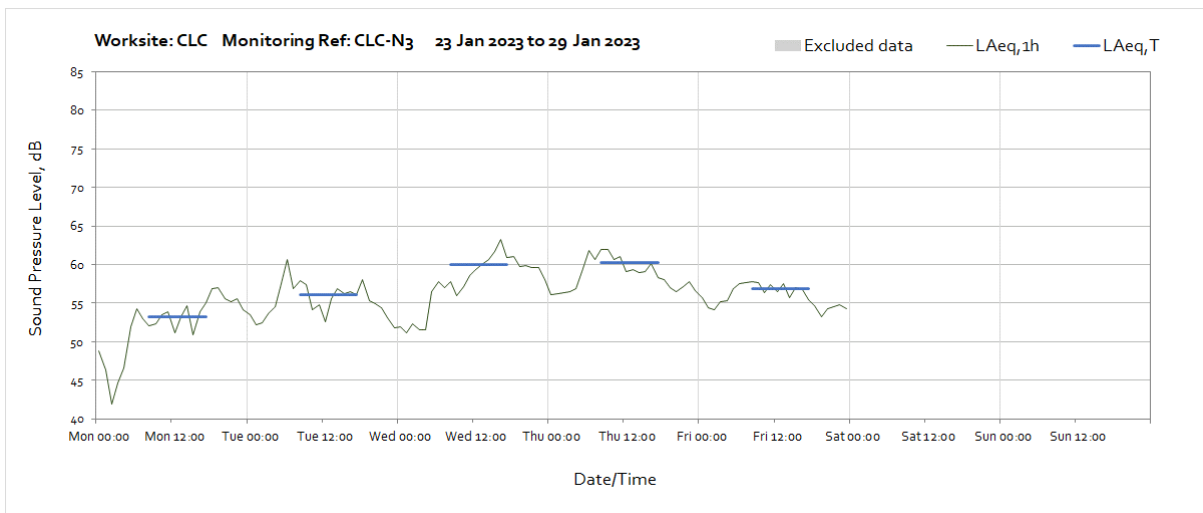
Note: Missing data from 00:00 on 28<sup>th</sup> January until the end of the month was due to monitor decommissioning.

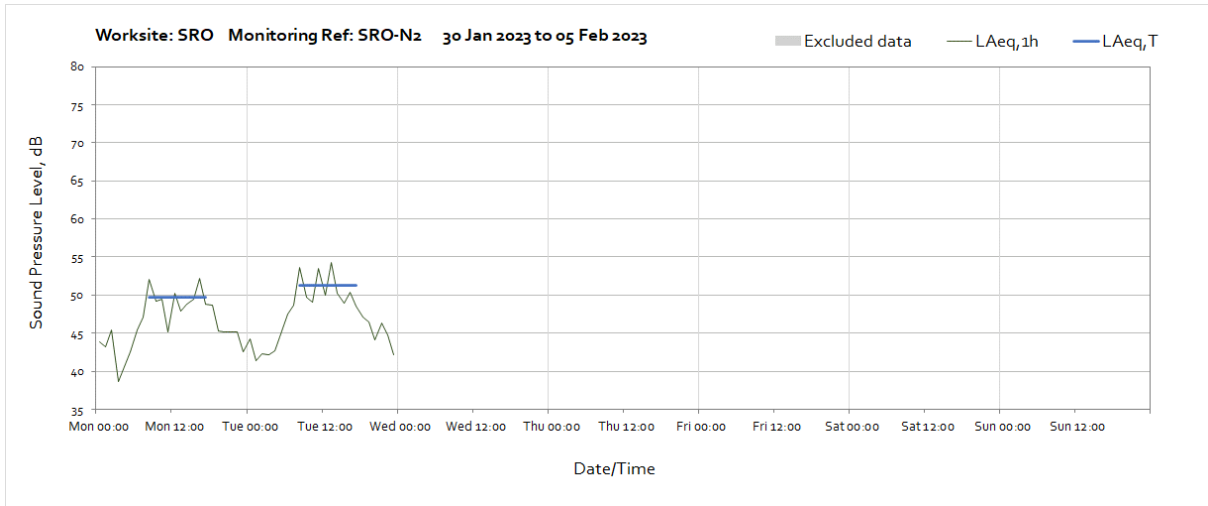
## Worksite: SRO – Monitoring Ref: SRO-N2

Note: Noise monitor installed at 14:00 on 10<sup>th</sup> January 2023.

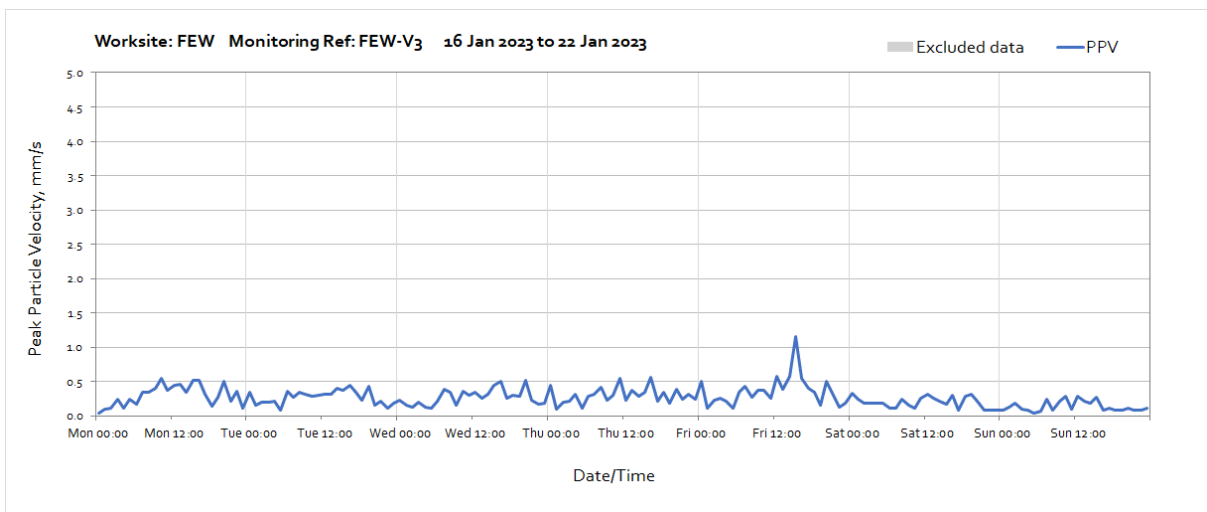
### Worksite: FEW – Monitoring Ref: FEW-V3

Note: High vibration levels measured at 15:00 on Friday 20<sup>th</sup> January was due to stripping works in the vicinity of the monitor.

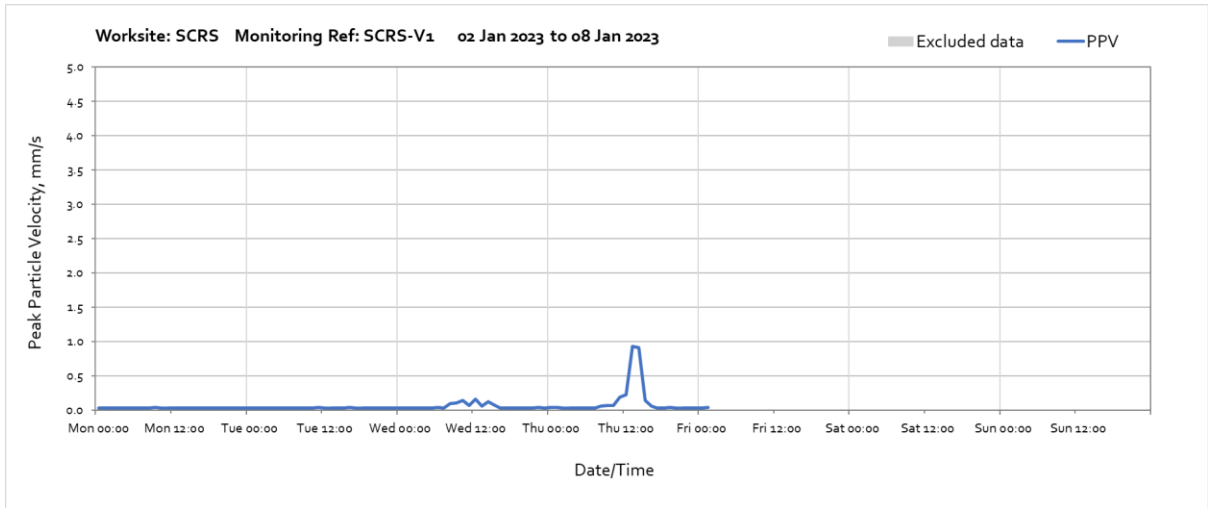
### Worksite: SCRS – Monitoring Ref: SCRS-V1

Note: Missing data from 02:00 on Friday 6<sup>th</sup> January till the end of the week was due to loss of power to the monitor from the solar panel supply.

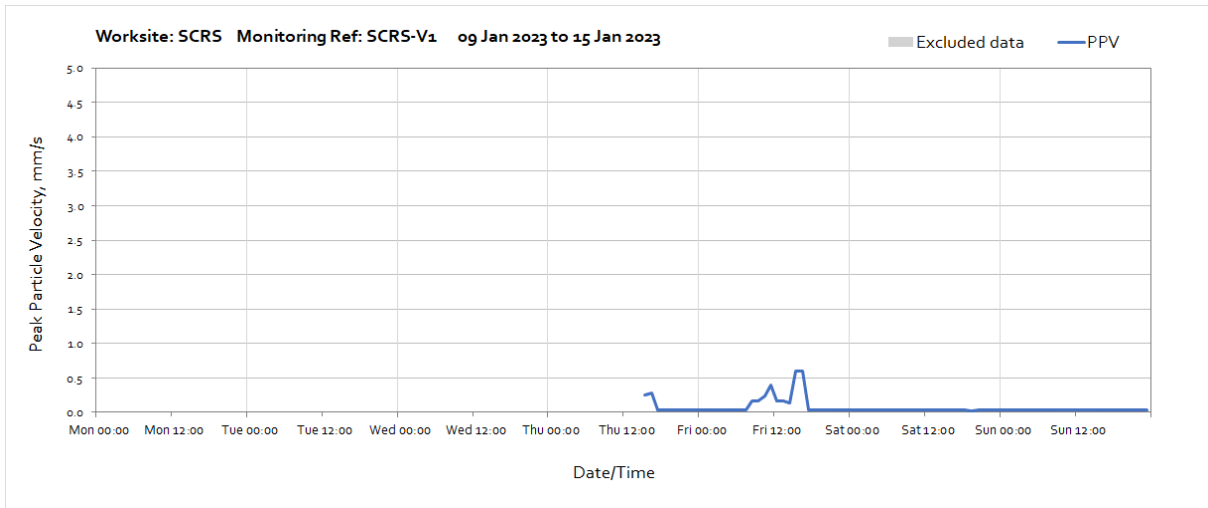
Note: Missing data between 00:00 on Monday 9<sup>th</sup> January and 15:00 on Thursday 12<sup>th</sup> January was due to loss of power to the monitor from the solar panel supply.

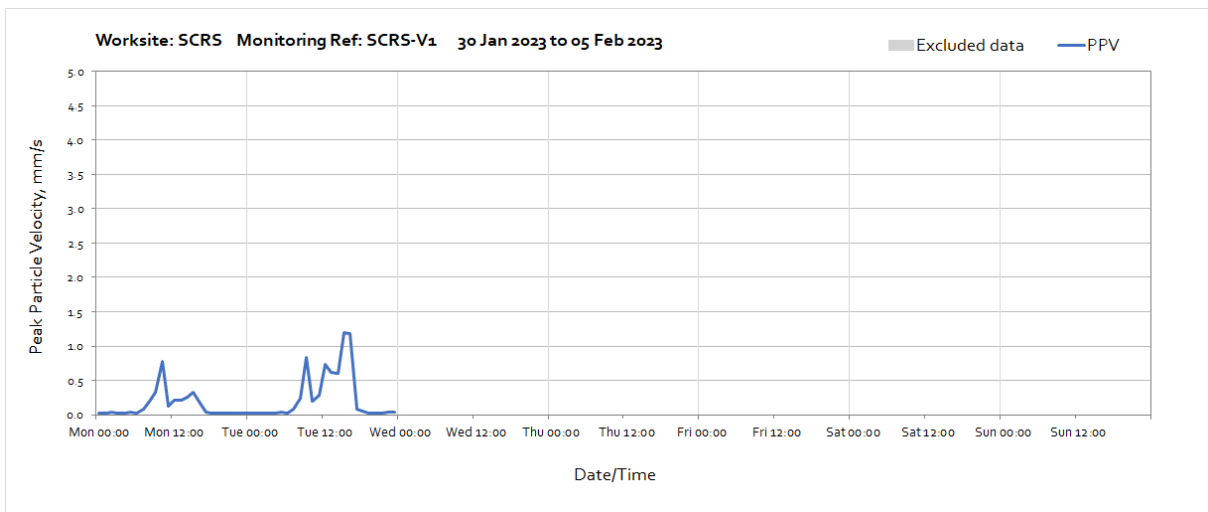
Note: High vibration levels measured between 15:00 and 17:00 on Monday 31<sup>st</sup> January was due to piling works in the vicinity of the monitor.

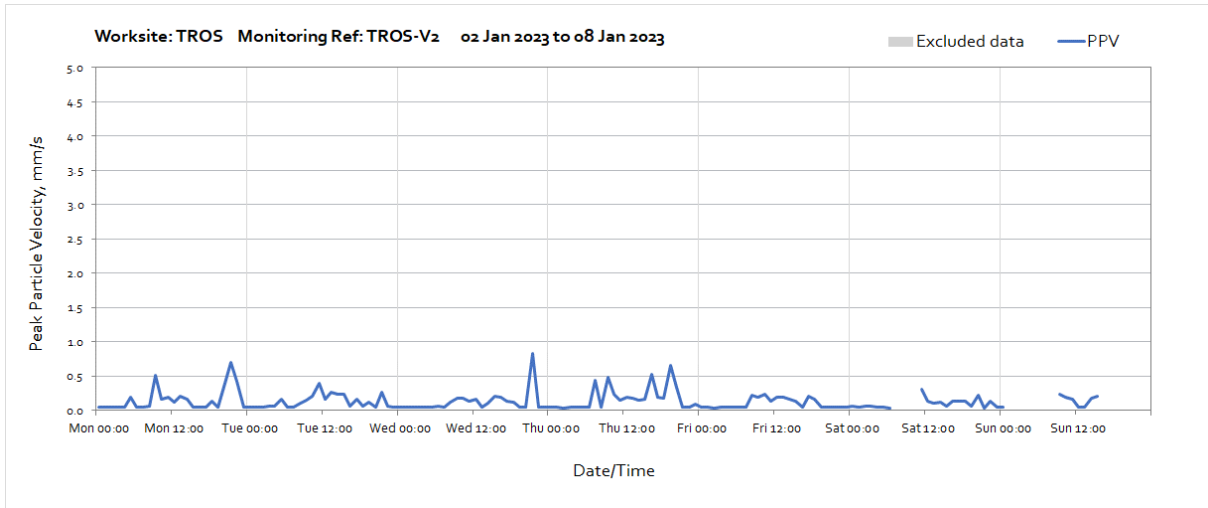
### Worksite: TROS – Monitoring Ref: TROS-V2

Note: Missing data between 07:00 and 11:00 on 7<sup>th</sup> January, between 01:00 and 09:00 on 8<sup>th</sup> January and from 16:00 on 8<sup>th</sup> January until the end of the week was due to loss of power to the monitor from the solar power supply.

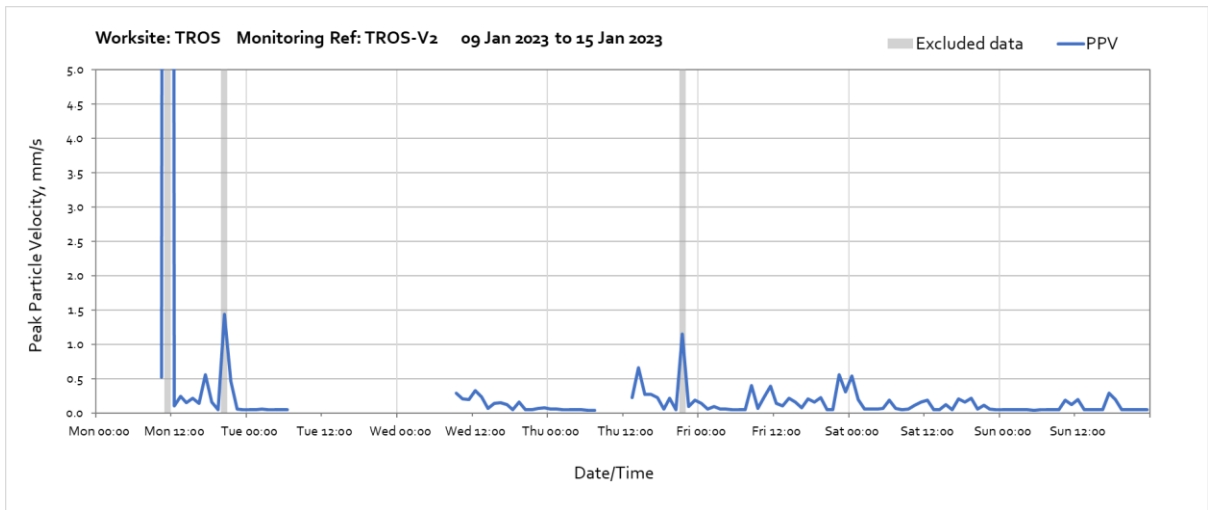
Note: Missing data from 00:00 to 10:00 on Monday 9<sup>th</sup> January, between 07:00 on 10<sup>th</sup> January and 09:00 on 11<sup>th</sup> January, between 08:00 and 13:00 on 12<sup>th</sup> January was due to loss of power to the monitor from the solar power supply.
