March 2023

Construction Noise and Vibration Monthly Report – January 2023

Warwick District Council

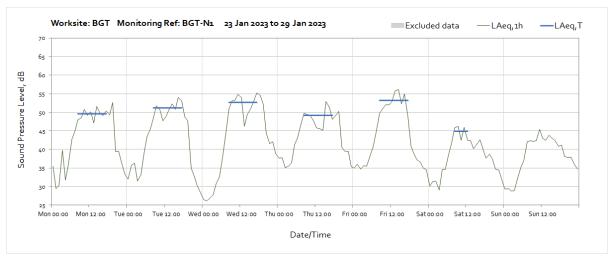
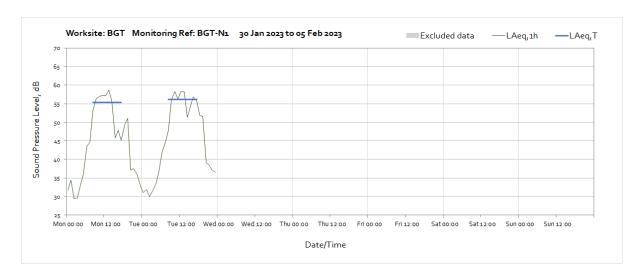
Worksite: BGT - Monitoring Ref: BGT-N1

The following graphs show the hourly measured ambient noise level $L_{Aeq,1h}$ and, where relevant, the averaged noise level $L_{Aeq,T}$ values, where the time period T is as specified in Table 1 of HS2 Information Paper E23. Periods with adversely weather affected noise levels are greyed out and have been excluded from the calculation of the $L_{Aeq,T}$ values in Table 3 of the main report.

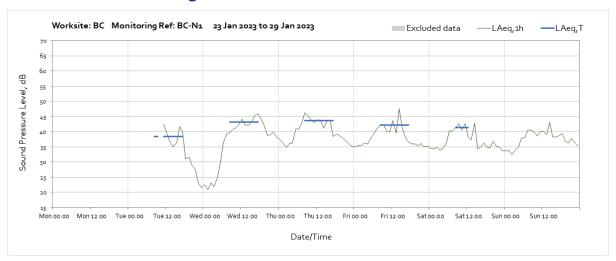
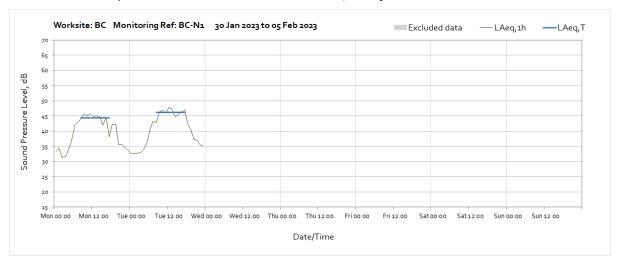
Worksite: BC - Monitoring Ref: BC-N1

Missing data from 1st January to 24th January due to equipment difficulties at monitoring location BC-N1. The monitor was replaced between 10:00 and 11:00 on 24th January.

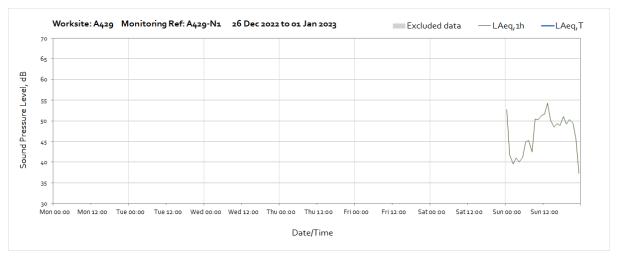
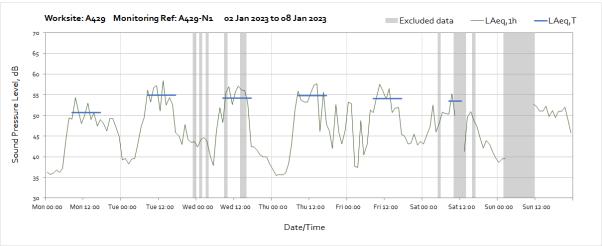
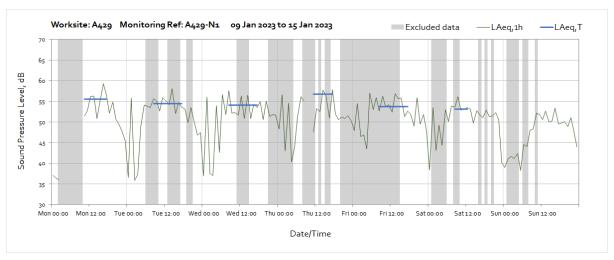
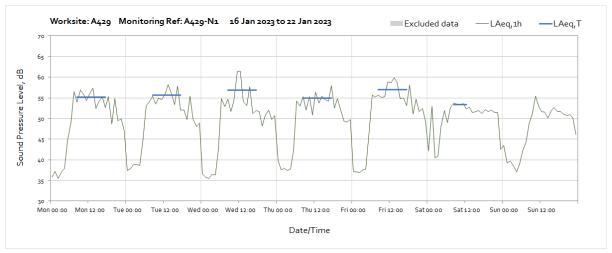
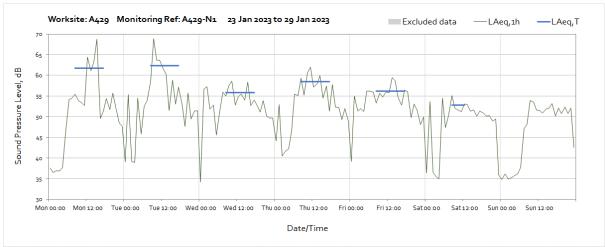
Worksite: A429 - Monitoring Ref: A429-N1

Note: Data intermittently missing until the batteries were replaced on 12 January.

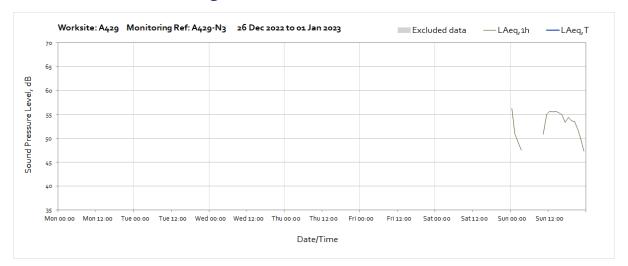
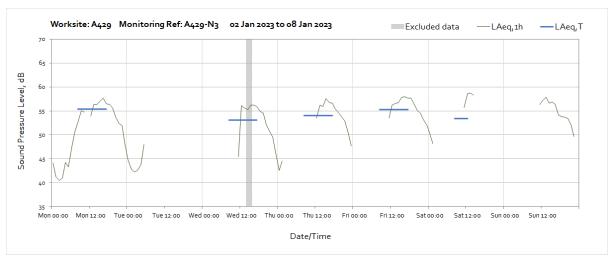
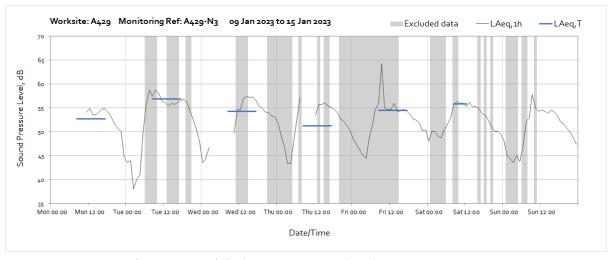
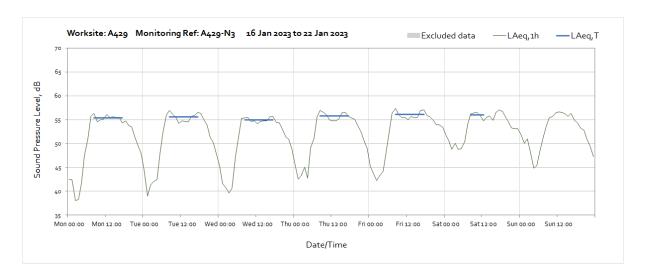
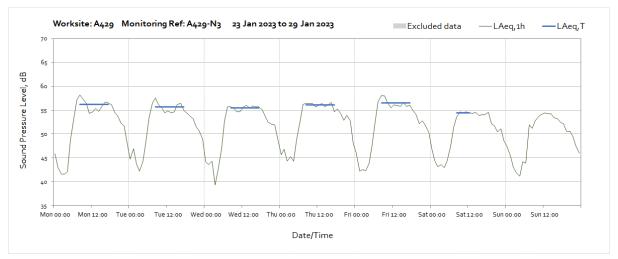
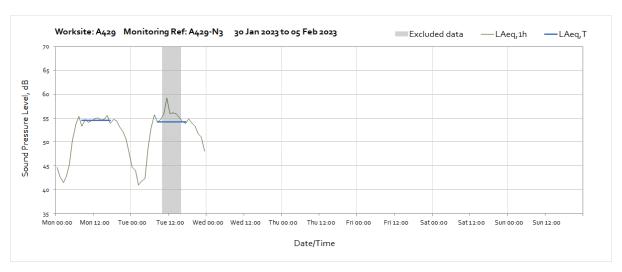
Worksite: A429 - Monitoring Ref: A429-N3

Note: Data intermittently missing until the batteries were replaced on 12 January.

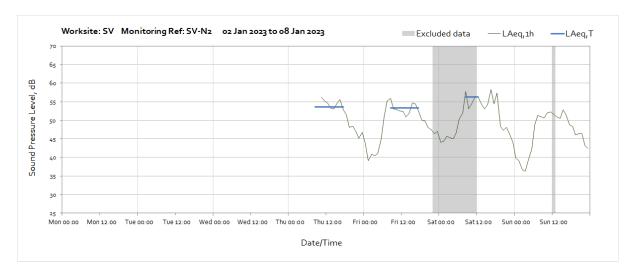
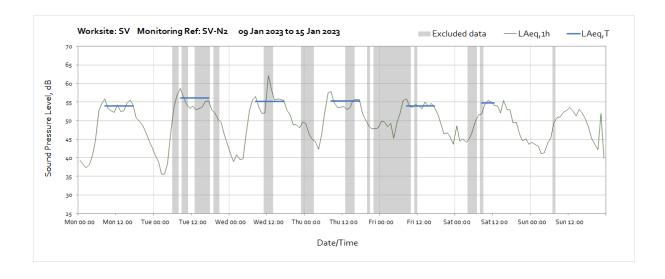
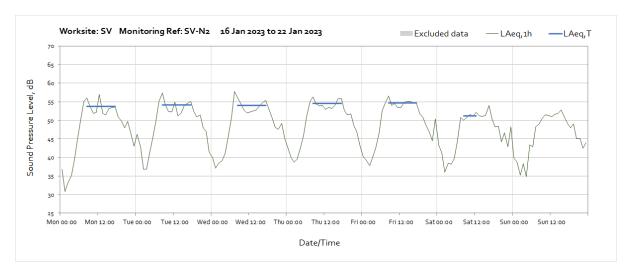
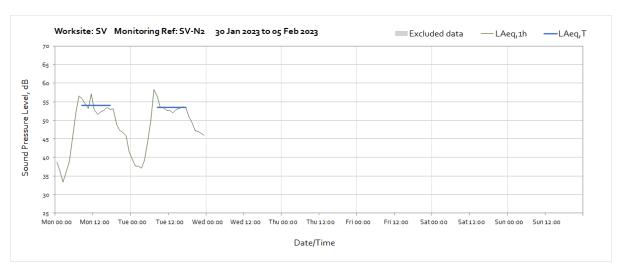
Worksite: SV - Monitoring Ref: SV-N2

Note: Missing data before 10:00 on 5th January was because of water damage to original meter which has been replaced.

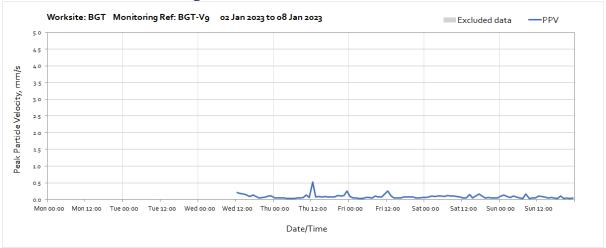
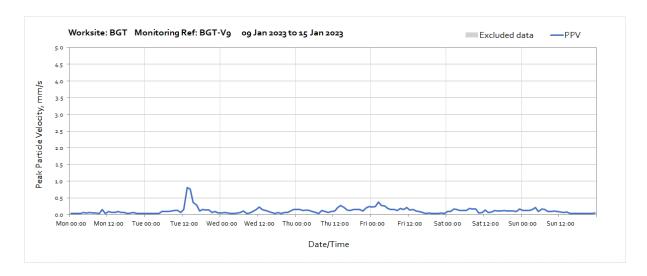
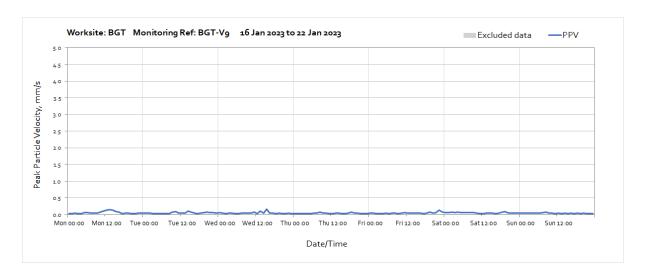
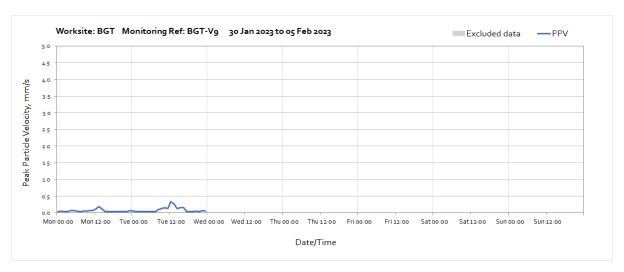
Worksite: BGT - Monitoring Ref: BGT-V9

The following graphs show the hourly measured peak particle velocity PPV recorded during the monitoring period. The graphs show the resultant PPV due to vibration components on three orthogonal axes x, y and z. Where resultant PPV data is not available, the highest vibration component in either of the three axes is presented for each 1hr measurement period respectively. Where high values of PPV were caused by local interference with the vibration monitor, which are not representative of HS2 construction works, these values have been greyed out in the following charts and have been excluded to calculate values in Table 4 of the main report.

Note: From the beginning of the month until midday on 4th January there were power problems at this location.
