**PHASE 1 GEO-ENVIRONMENTAL  
DESK STUDY AND PRELIMINARY RISK ASSESSMENT**

**LAND AT PINES HILL  
STANSTED MOUNTFITCHET  
ESSEX**

**Reference Number 2691/Rpt 1v4  
August 2021**

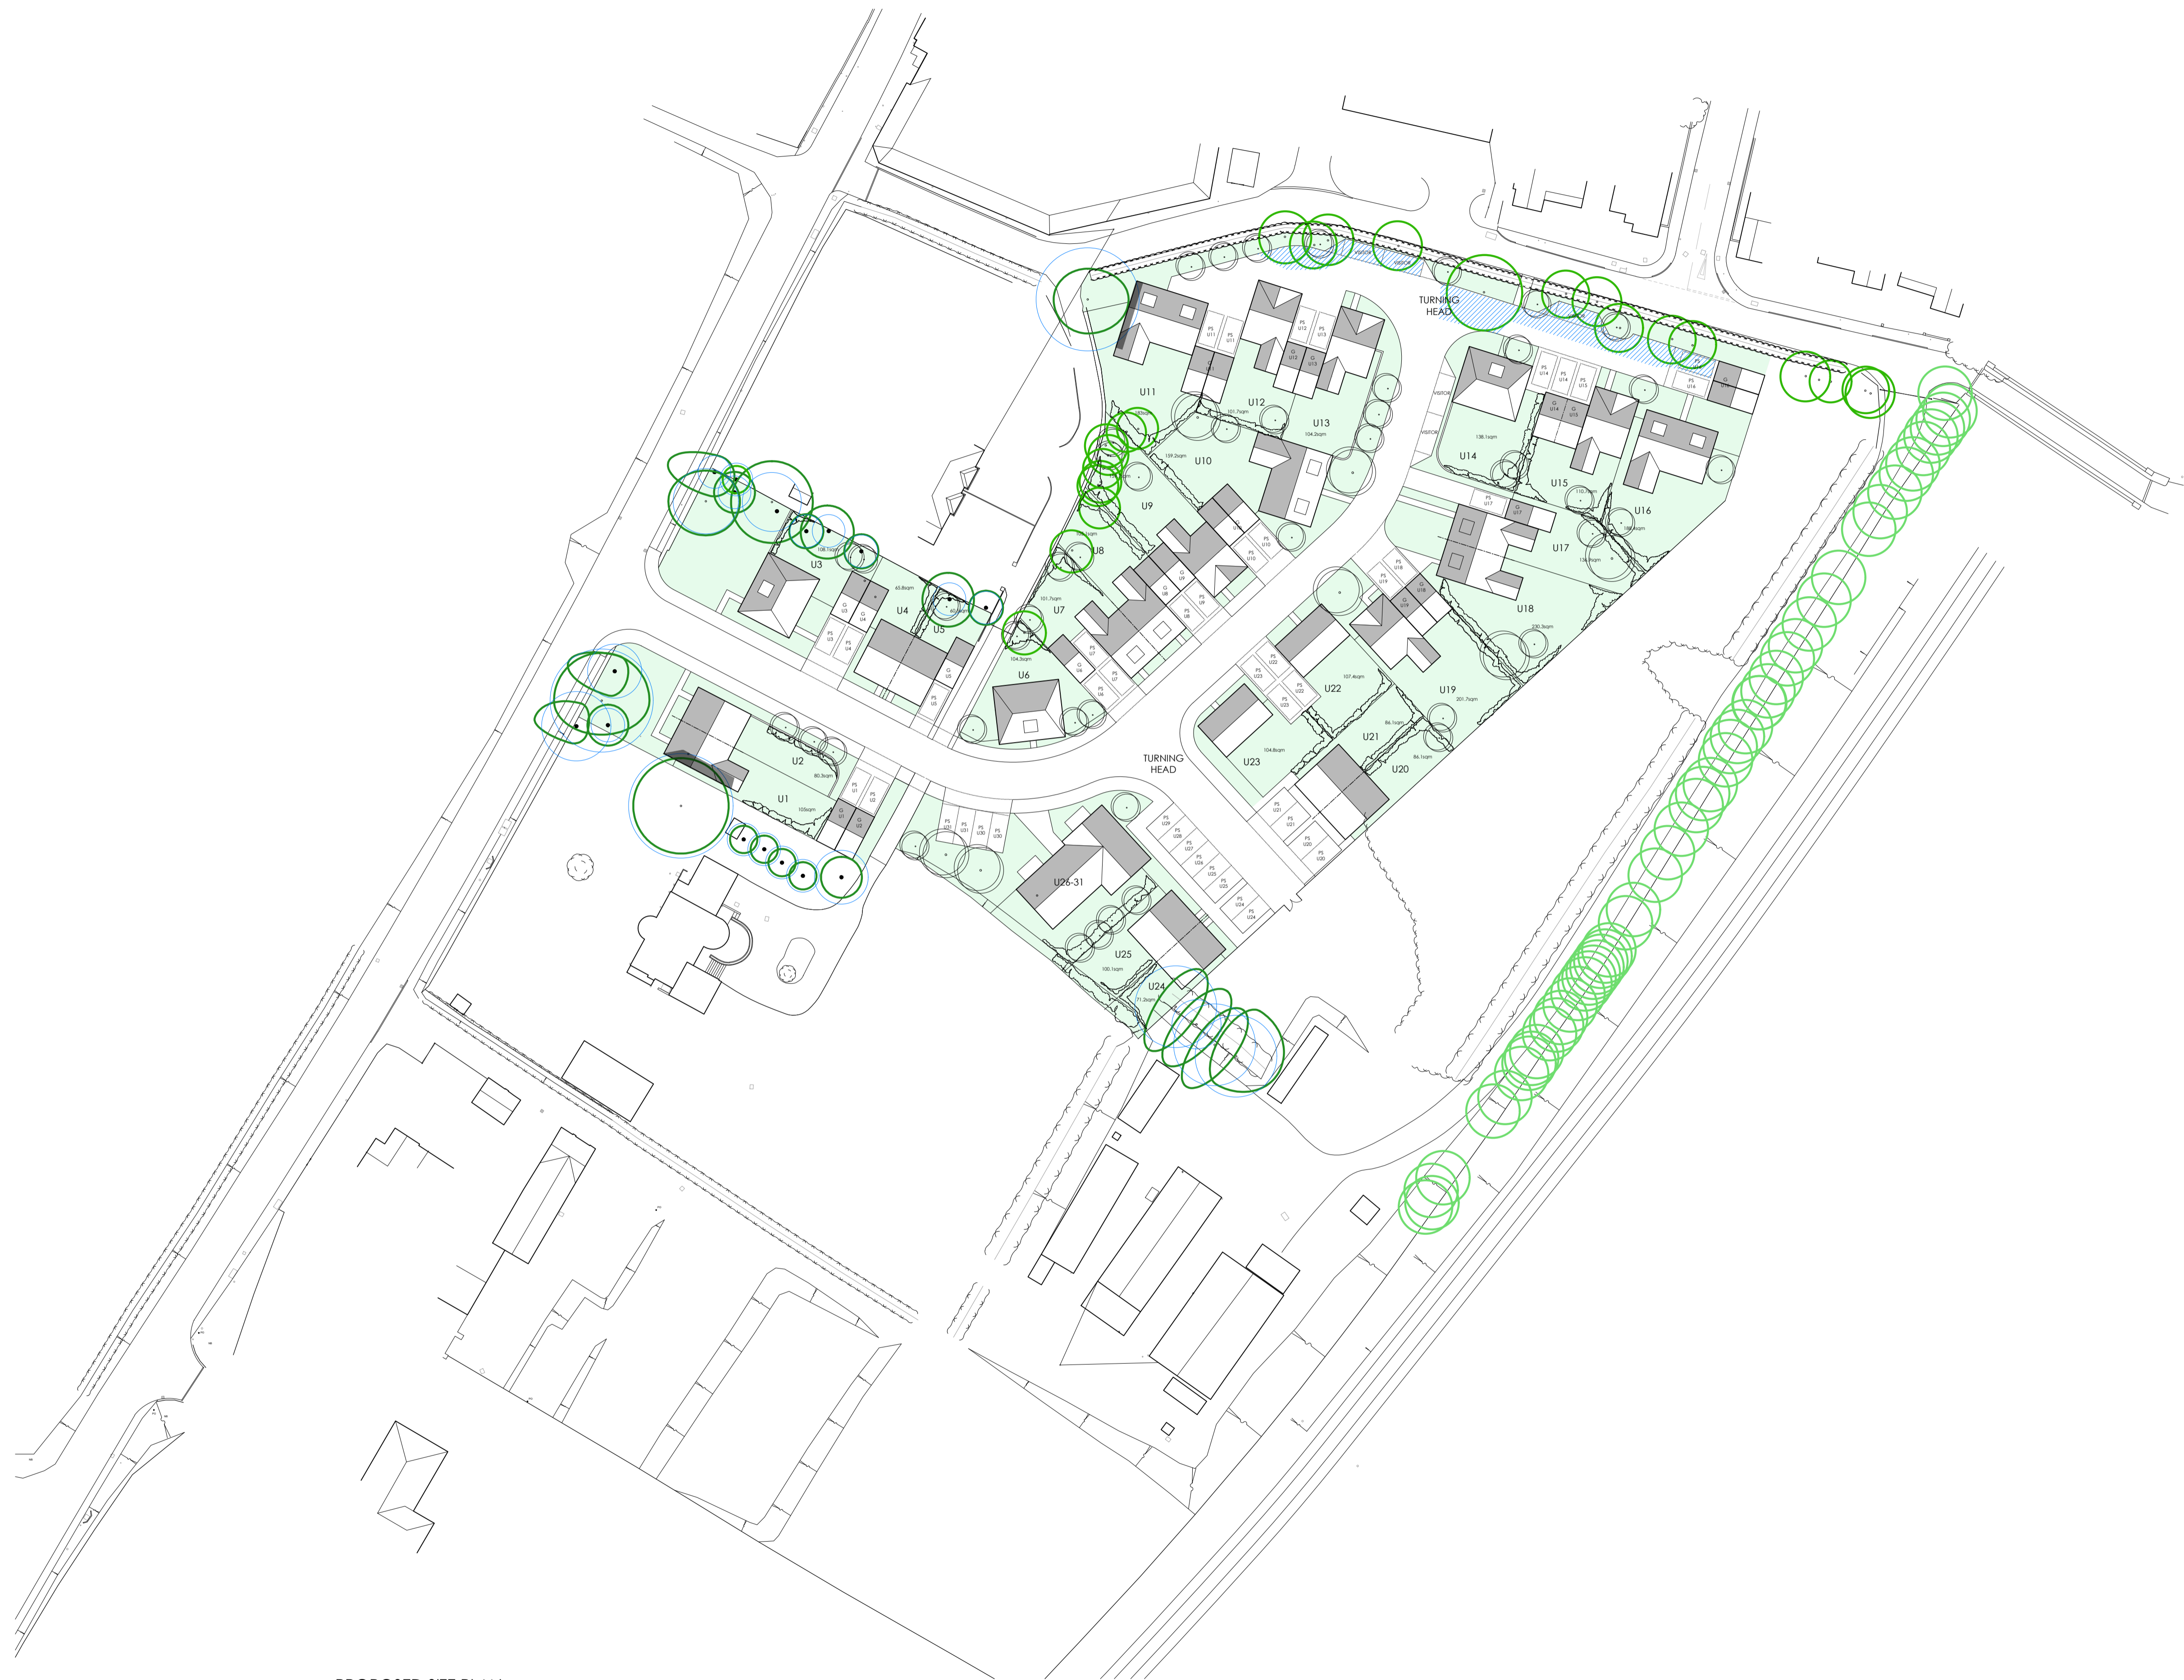
PROPOSED SITE PLAN

The work was commissioned to provide information for a planning application to redevelop the subject site. It is proposed to redevelop the site for residential usage consisting of houses with private gardens, a block of flats with communal gardens and parking. The proposed development layout is presented in Appendix II.

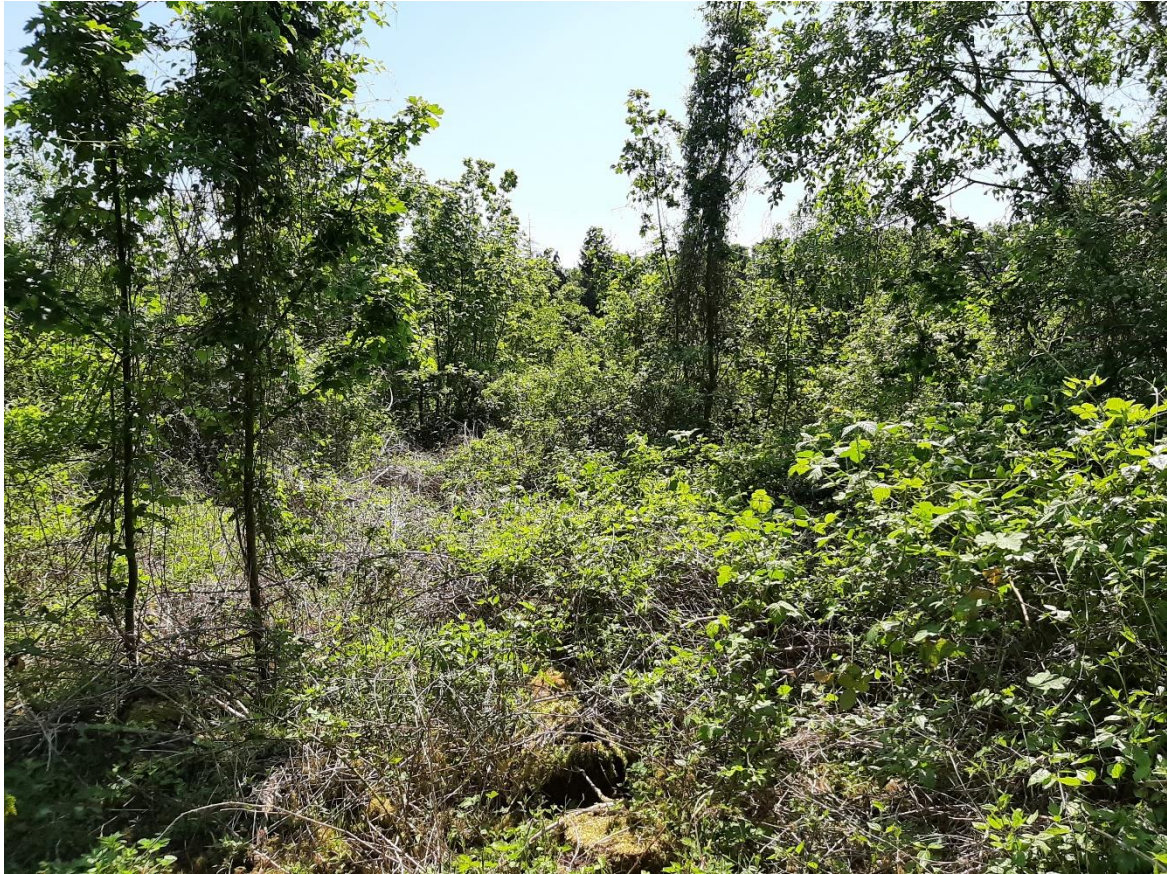
At the time of the site walk-over the site was vacant land that was covered by small trees, shrubs and bushes. Along the boundary lines of the site there are larger pine trees.

**Typical view across the site.**
