# PHASE I DESK STUDY AND PRELIMINARY RISK ASSESSMENT Jacks, Warish Hall Farm, Takeley, Essex, CM22 6NT

#### Project Reference: CON01-WARI-070

28 January 2021

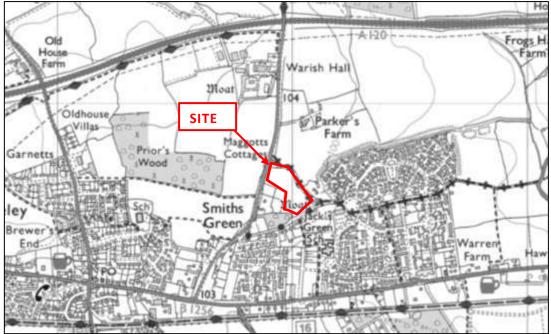
The site is located at Jacks, Warish Hall Farm, Takeley, Essex, CM22 6NT and is approximated by the National Grid reference: TL 570216. The site location is shown in Figure 1.

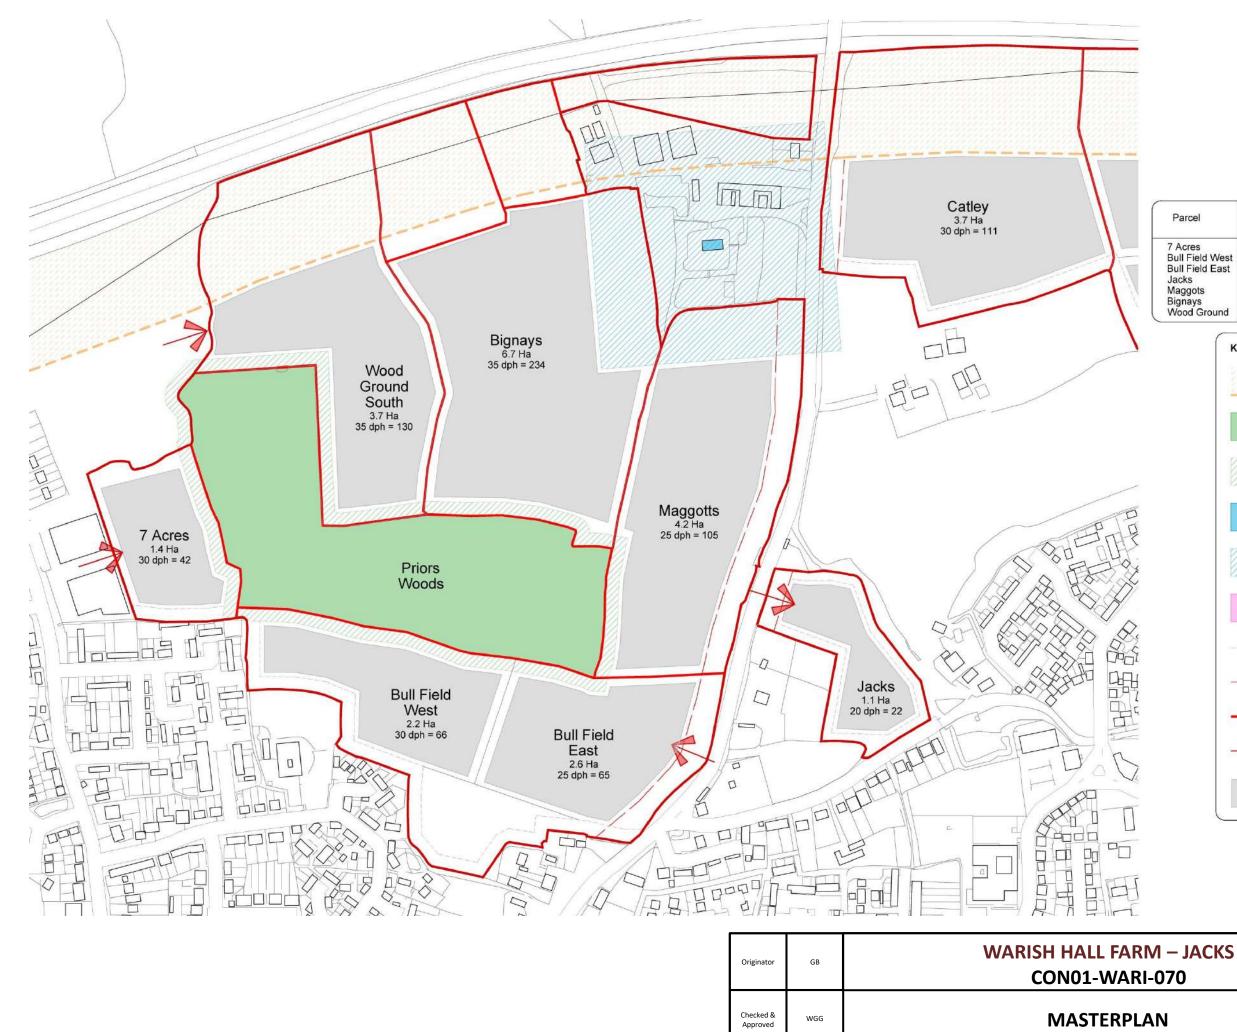
Parcel	Hectare	Dwellings Per Hectare	Dwellings		
7 Acres Bull Field West Bull Field East Jacks Maggots Bignays Wood Ground	1.4 2.2 2.6 1.1 4.2 6.7 3.7	30 30 25 20 25 35 35 35	42 66 65 22 105 234 130		
К	ey:-				
		Acoustic Buff 55DP from A			
		Protected Woodland			
	15 meter Ecology Buffer to Woodland				
	Ancient Historic Monument				
	Buffer Zone to Ancient Monument, to be revie				
		Area Allocated for Community Infrastructure			
-		15 Meter Urb in line with El			
-	_	20 Meter Offs with existing			
-	_	Title Boundar	y Line		
-	$\rightarrow$	Potential Access Points			
		Developable Parcel Ar

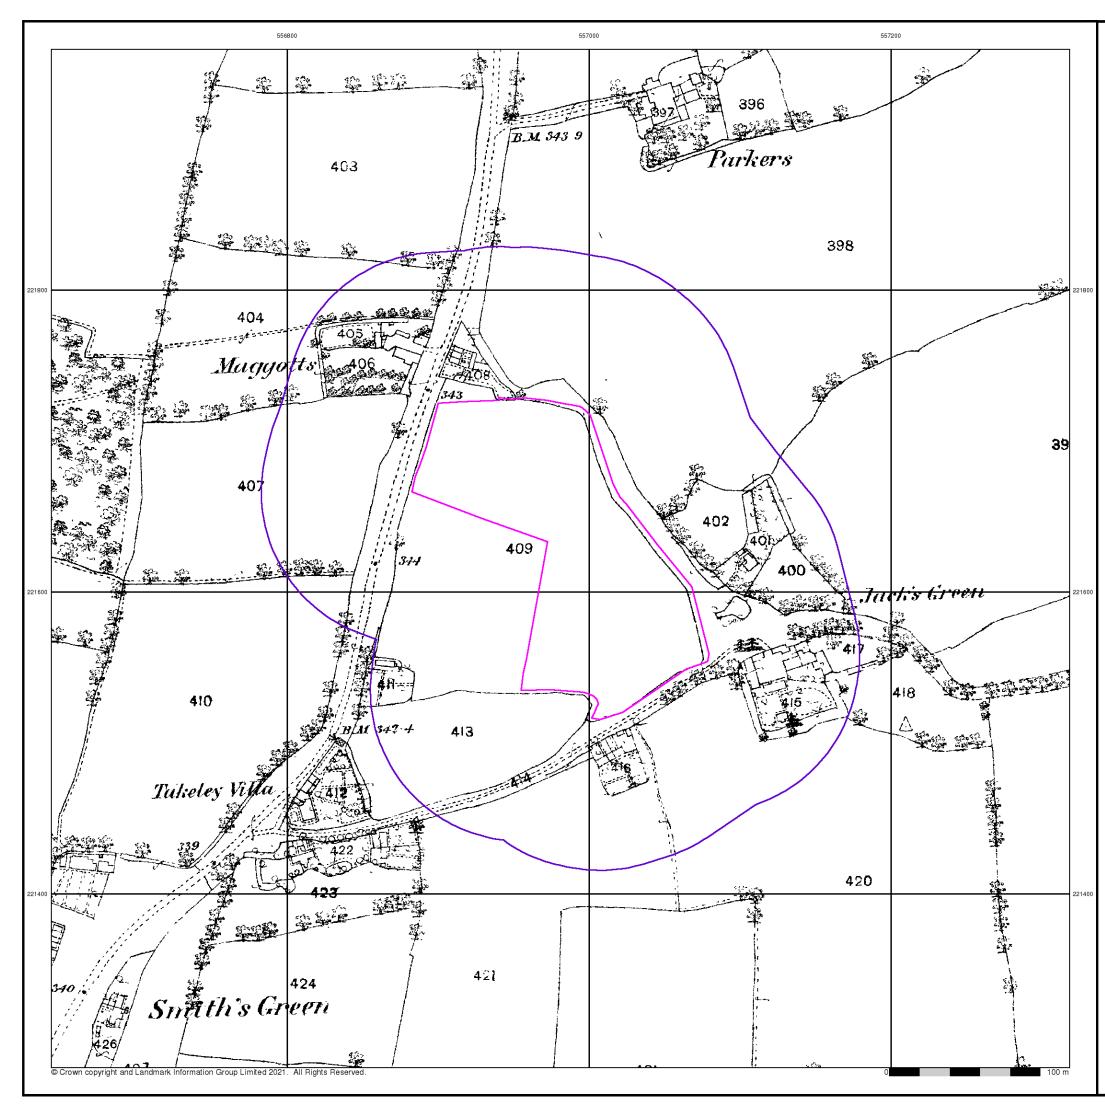
## Published 1876

#### Essex

TABLE 2: Historical	Maps			
Map, Date & Scale	On-Site	f-Site		
Essex 1876 1:2500 1881 1:10560	The site is shown as part of a field. A track is shown running along the southern and western boundaries while open countryside forms the remaining boundaries.	A number of structures were present to the immediate northwest labelled Maggotts with Prior's Wood beyond. Jack's Green and a pond were present 13m to the east. Takeley Villa was present 20m to the southwest, with Smith's Green beyond. Warish Hall Farm Yard was present some 450m to the north.		
Essex 1897 1:2500 1897 – 1898 1:10560	No apparent changes to the site.	Residential development has occurred some 200m to the south. A pond has appeared some 20m to the northwest.		
Essex 1920 1:2500 1923 1:10560	No apparent changes to the site.	A plant nursery comprising three greenhouses, a wind pump and several tanks have appeared 100m to the southeast.

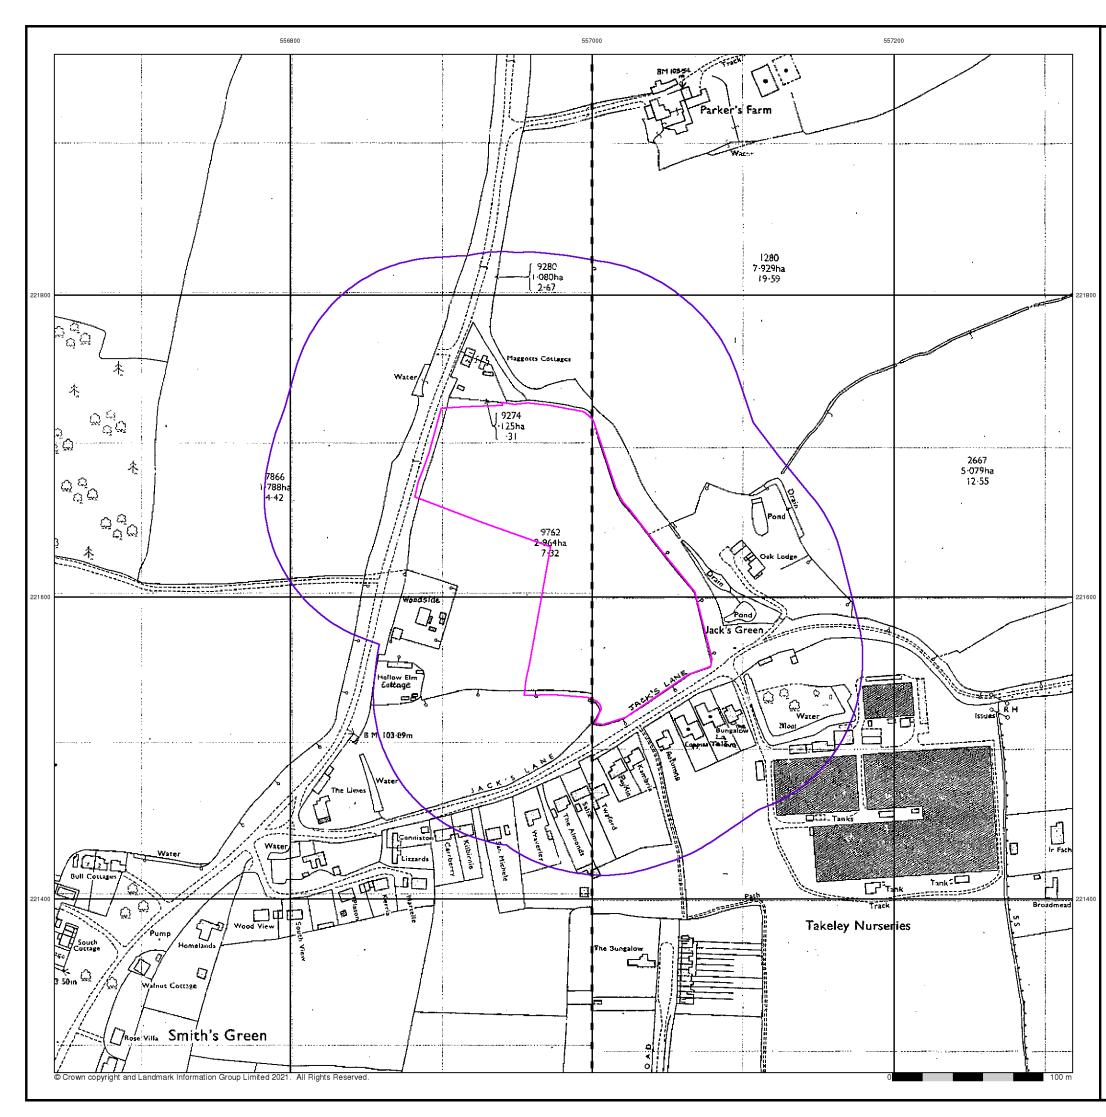
## Published 1978 - 1987

## Source map scale - 1:2,500

The SIM cards (Ordnance Survey's `Survey of Information on Microfilm') are further, minor editions of mapping which were produced and published in between the main editions as an area was updated. They date from 1947 to 1994, and contain detailed information on buildings, roads and land-use. These maps were produced at both 1:2,500 and 1:1,250 scales.

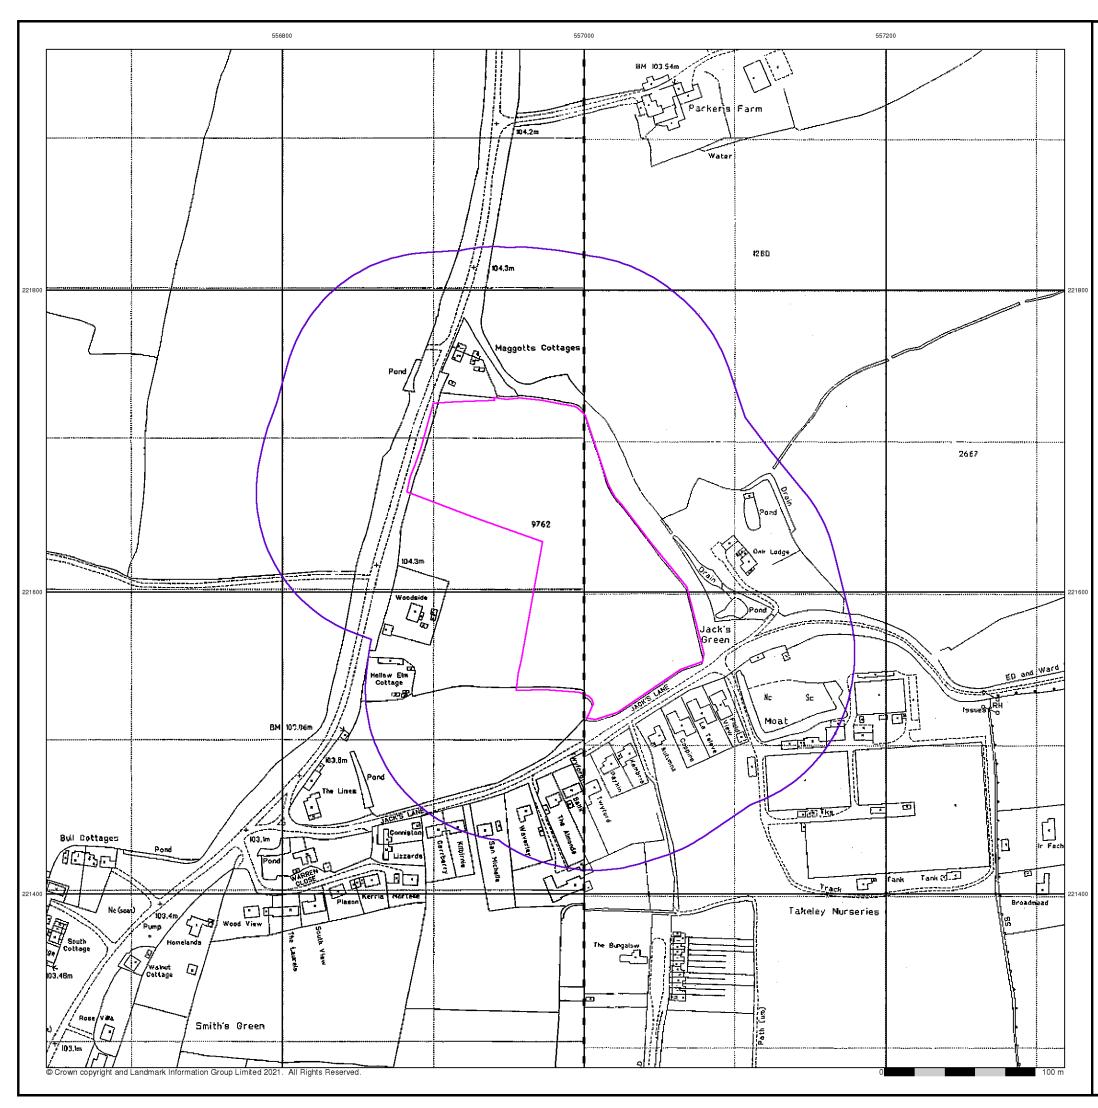
## Large-Scale National Grid Data Published 1993

'Large Scale National Grid Data' superseded SIM cards (Ordnance Survey's 'Survey of Information on Microfilm') in 1992, and continued to be produced until 1999. These maps were the fore-runners of digital mapping and so provide detailed information on houses and roads, but tend to show less topographic features such as vegetation. These maps were produced at both 1:2,500 and 1:1,250 scales.

### Map Name(s) and Date(s) TL5621 1993 1:2,500 TL5721 1993 1:2,500 **Historical Map - Segment A13** A22 Δ23 - Ai 3 A2 AB **Order Details** Order Number: 271774066\_1\_1 CON01-WARI-070 (Jacks) Customer Ref: National Grid Reference: 556980, 221630 Slice: А Site Area (Ha): Search Buffer (m): 2.1 100 Site Details Jacks, Takeley, BISHOP'S STORTFORD, CM22 6NT 0844 844 9952 Tel: Landmark Fax: 0844 844 9951 Web: www.envirocheck.co.uk A Landmark Information Group Service v50.0 18-Jan-2021 Page 10 of 12
