Air Quality and Dust Monitoring Monthly Report – February 2023 London Borough of Hillingdon

A report prepared by EWCs and MWCCs on behalf of HS2 Ltd.

Monthly Summary

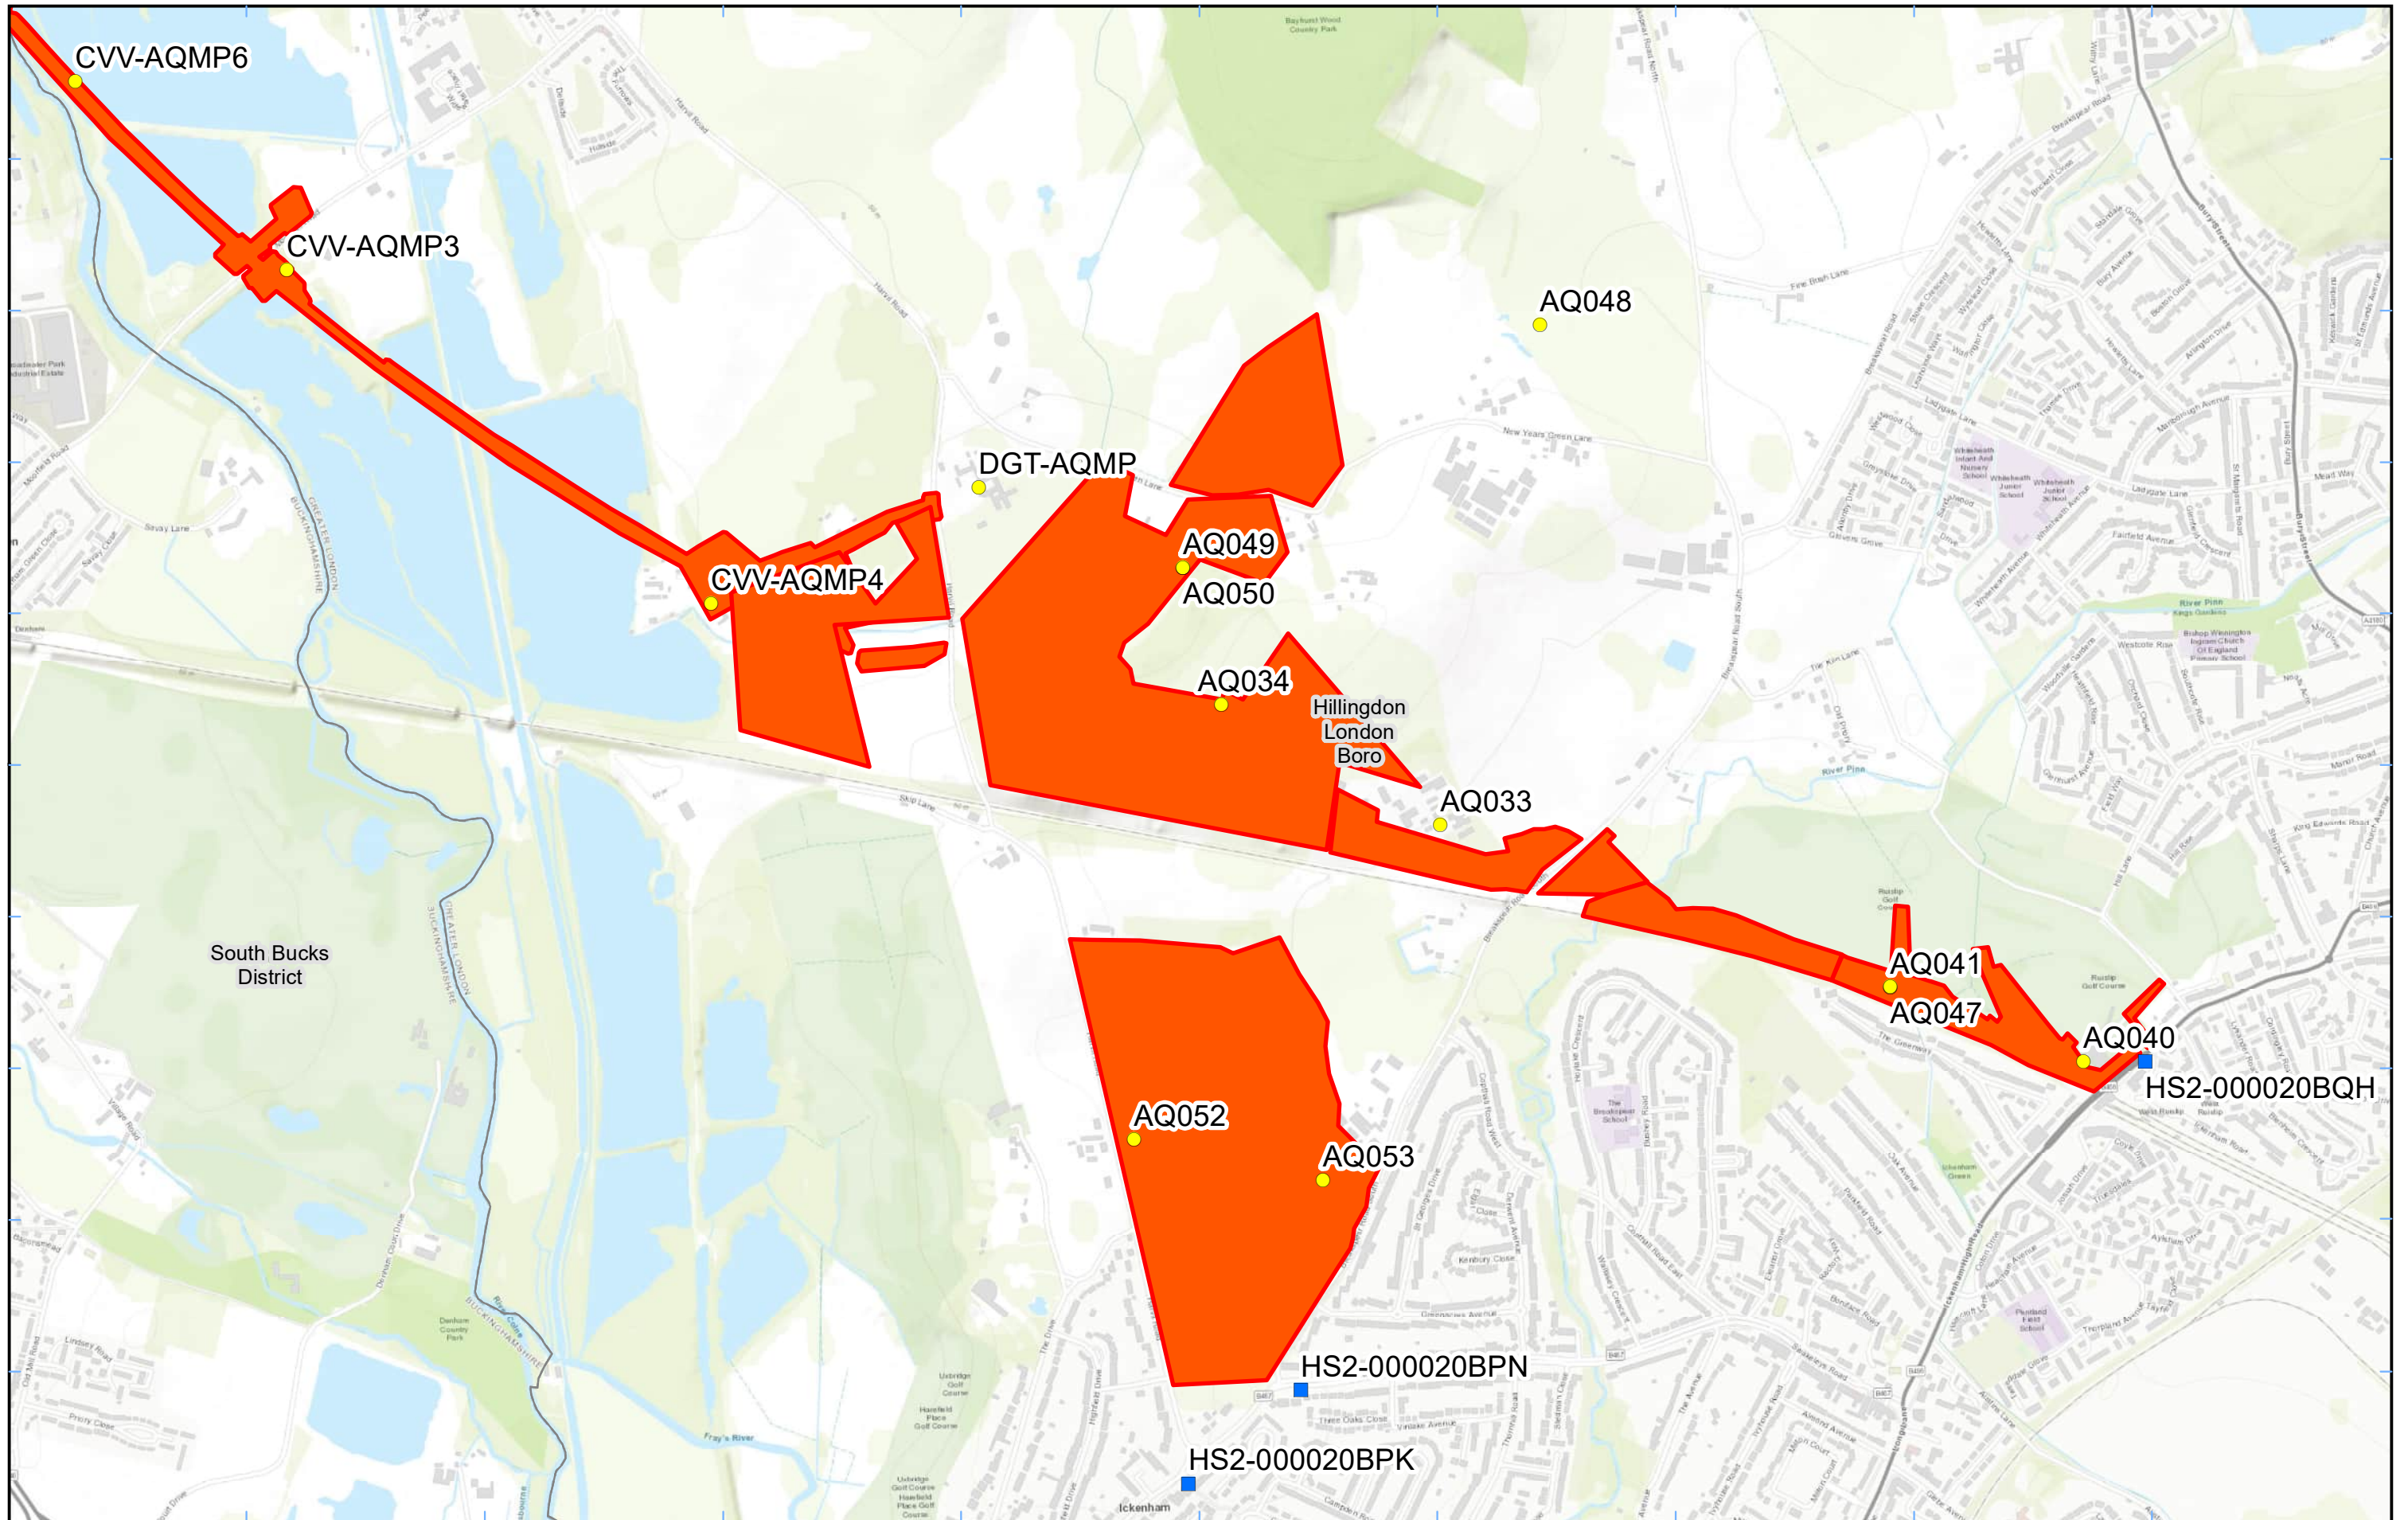
Map Name
**Worksite & Monitoring Locations
 in LBH (Sheet 1)**

- 1.1.2 Figure 1 to Figure 4 in Appendix A indicate the current worksites, together with air quality monitoring locations.
- 1.1.3 This summary should be read in conjunction with the overview monitoring report available from www.gov.uk/government/collections/monitoring-the-environmental-effects-of-hs2, which highlights: the applicable standards and guidance, as well as the air quality and dust monitoring methodologies to be implemented by nominated undertakers throughout construction.

Figure 1 to Figure 4: Current monitoring locations within the LBH

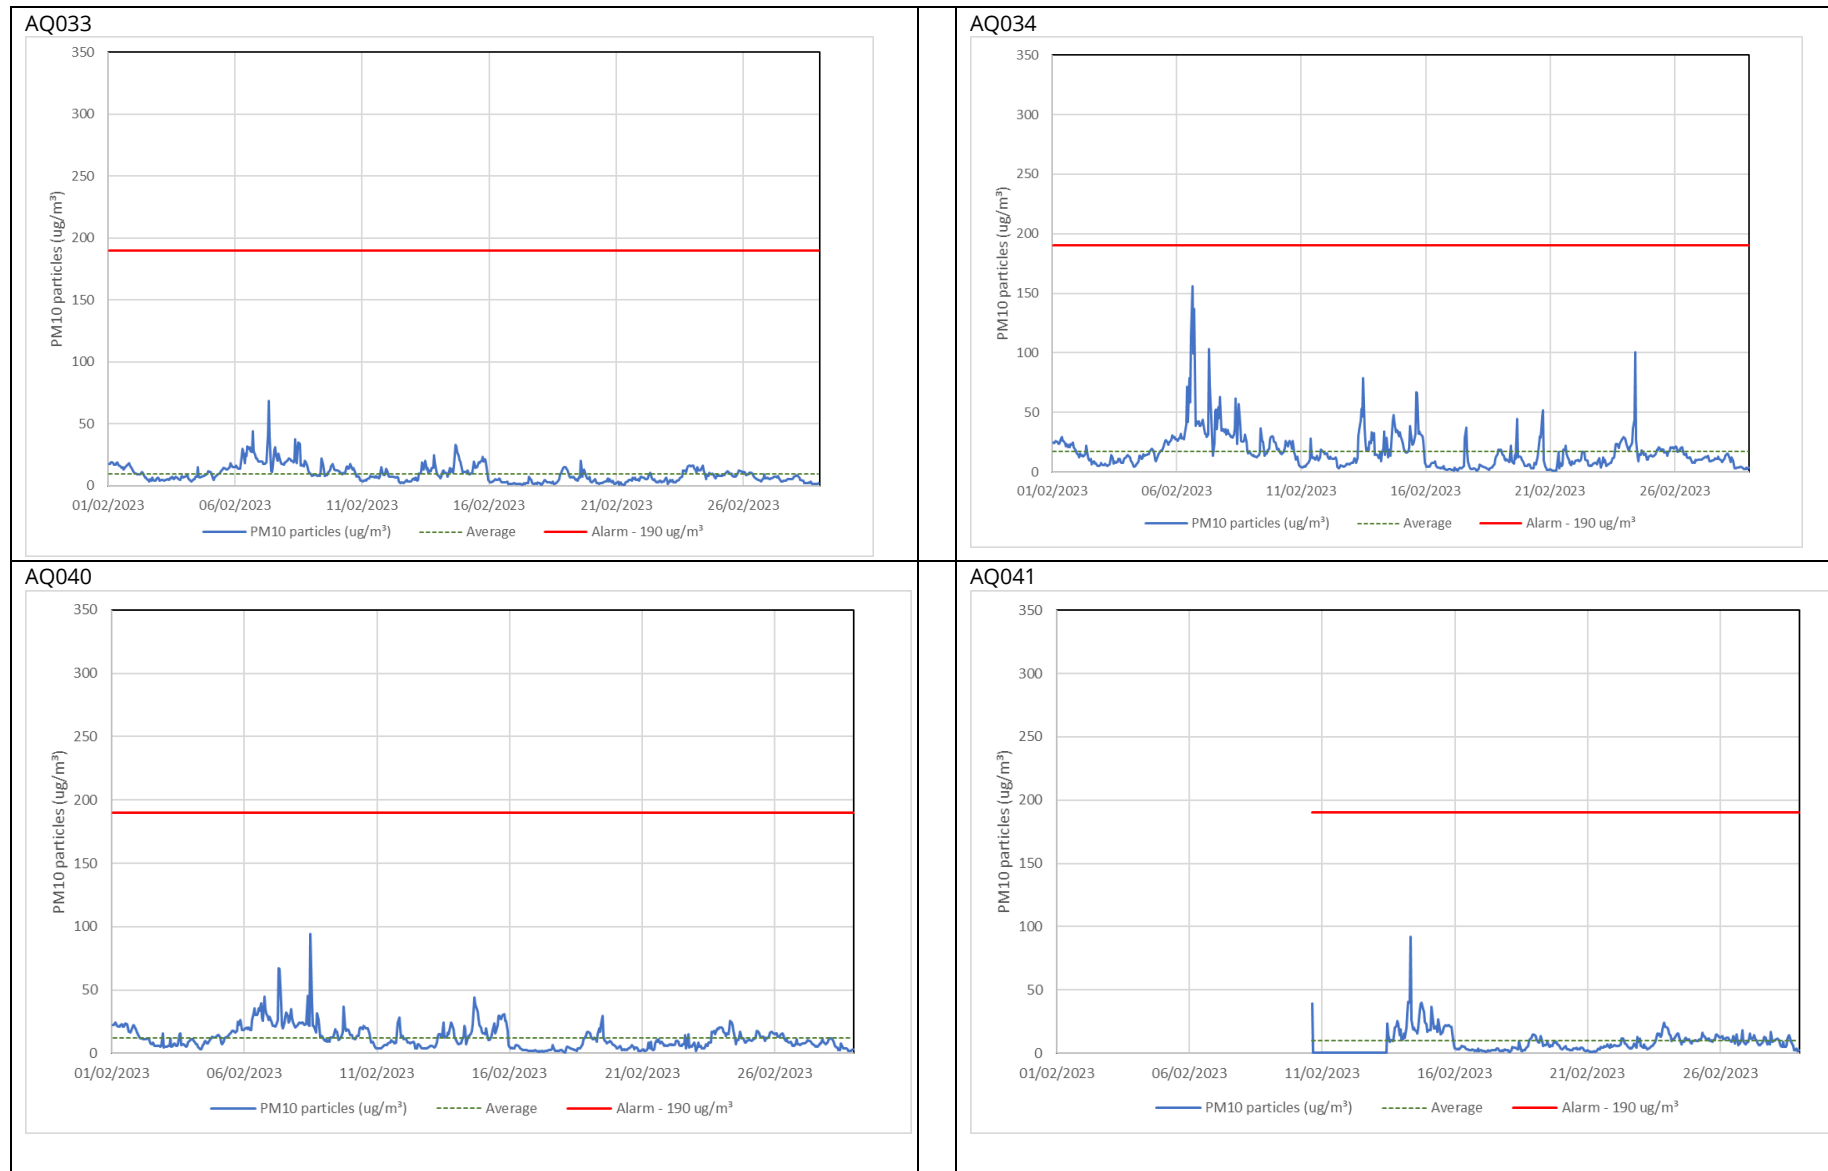
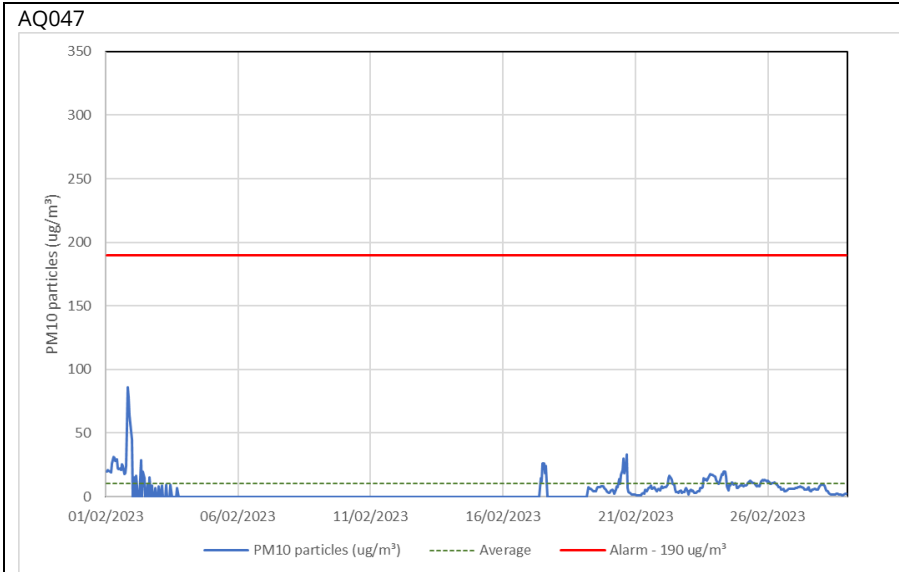
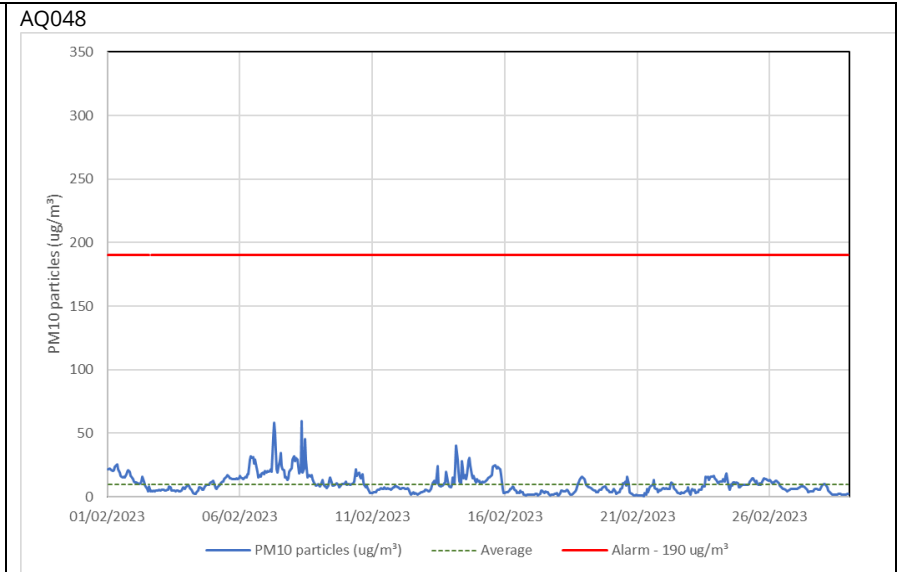
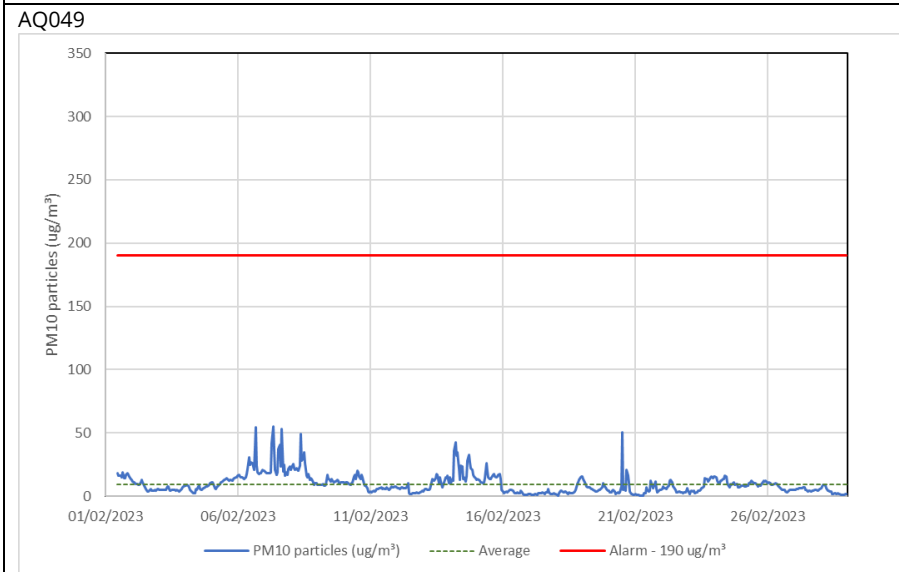
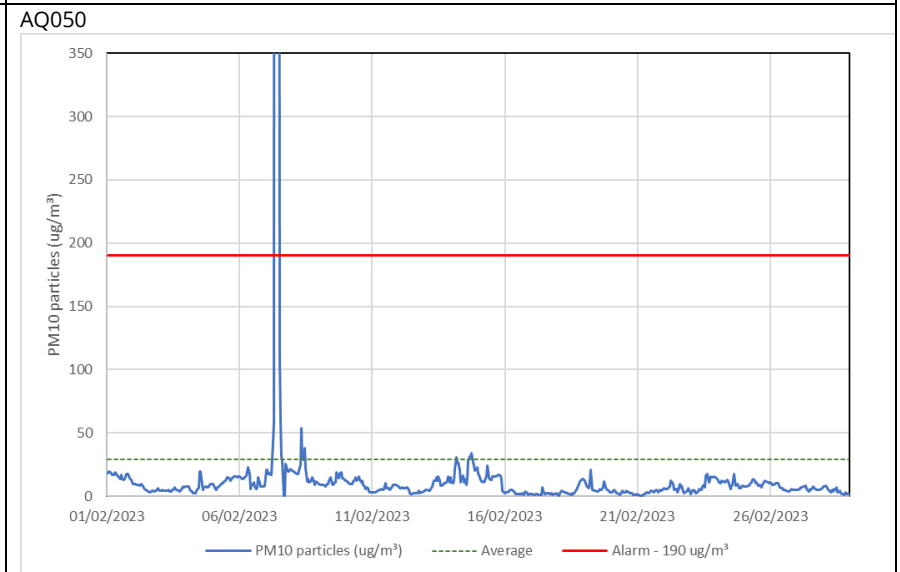
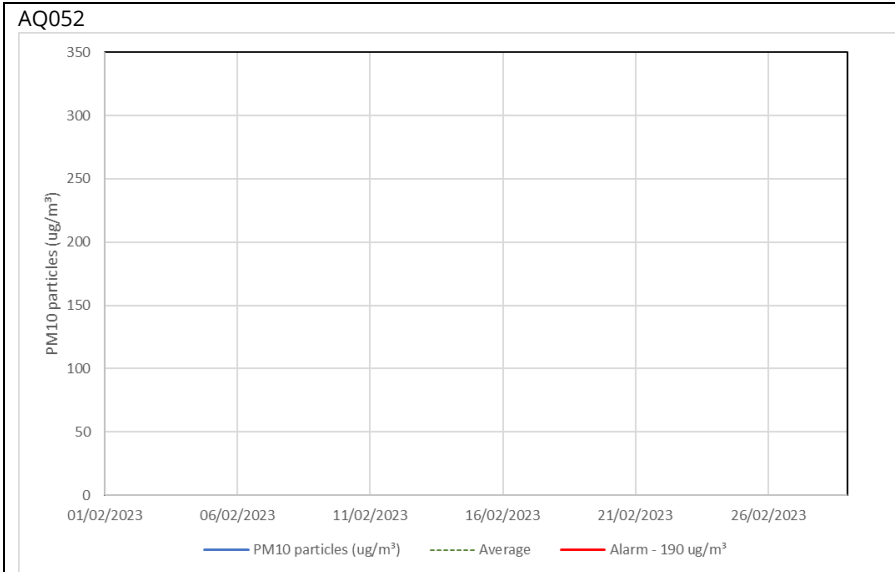
Figure 5: Construction dust 1-hour mean indicative PM₁₀ concentration for dust monitors

- 1.1.6 Dust monitoring locations and results are presented in Appendix B, Table 1, together with line charts of monthly data from each dust monitor in Figure 5. All continuous dust monitoring is undertaken using indicative monitors. Despite being Environment Agency (MCERTS) certified, indicative monitors carry a higher level of uncertainty than reference monitors, and therefore cannot be strictly compared with Air Quality Standards for human health and the environment. The purpose of the monitoring undertaken is to ensure the effectiveness of the on-site mitigation.

- 1.1.7 The trigger level for PM₁₀ concentrations of 190µg/m³, over a 1-hour period, in accordance with the updated guidance document '*Guidance on Monitoring in the Vicinity of Demolition and Construction Sites - (October 2018)*' has been applied.

Monitoring site ID	Period exceeding trigger level	Investigation	Outcomes / Resolution / Remedial measures implemented
AQ050	07/02/2023 07:01 – 08:00; 1926.92 µg/m ³ 08:01 – 09:00; 4602.32 µg/m ³ 09:01 – 10:00; 5254.44 µg/m ³ 10:01 – 11:00; 1761.42 µg/m ³	The triggers were received as the site power was lost and the monitor transferred to internal battery and its pump and heater slowly ran down. Power was restored at the end of the day.	Power restored
