Construction Noise and Vibration Monthly Report – February 2023

Buckinghamshire

This Noise and Vibration Monitoring Report fulfils HS2 Limited's commitment detailed in the Environmental Minimum Requirements (EMRs), Annex 1, Code of Construction Practice, to present the results of noise monitoring carried out within Buckinghamshire (BS) during the month of February 2023.

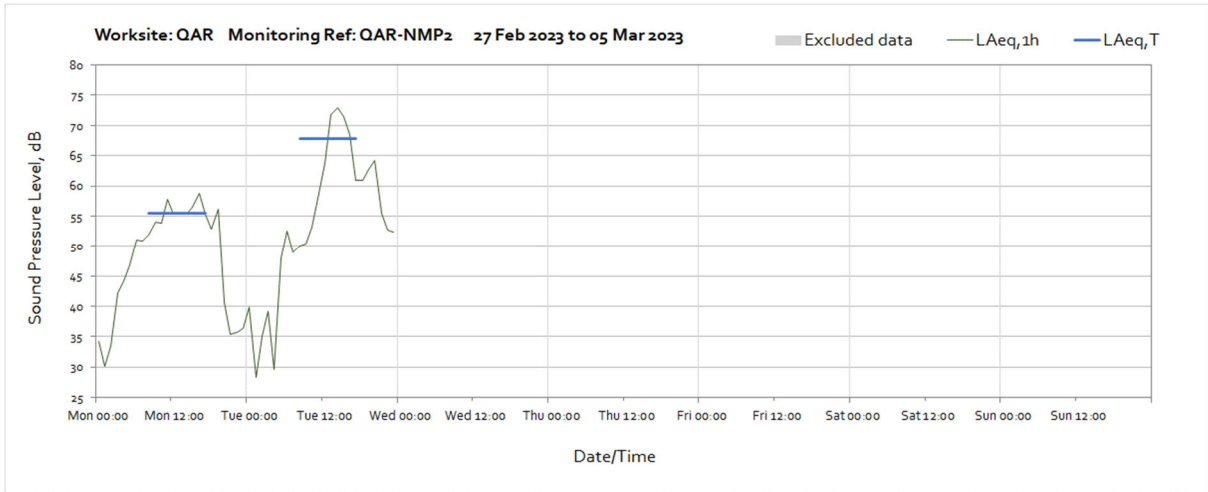
Worksite: LL - Monitoring Ref: HG-NMP1

Note: Missing data between 13:00 and 14:00 on 27th February was due to monitor maintenance.

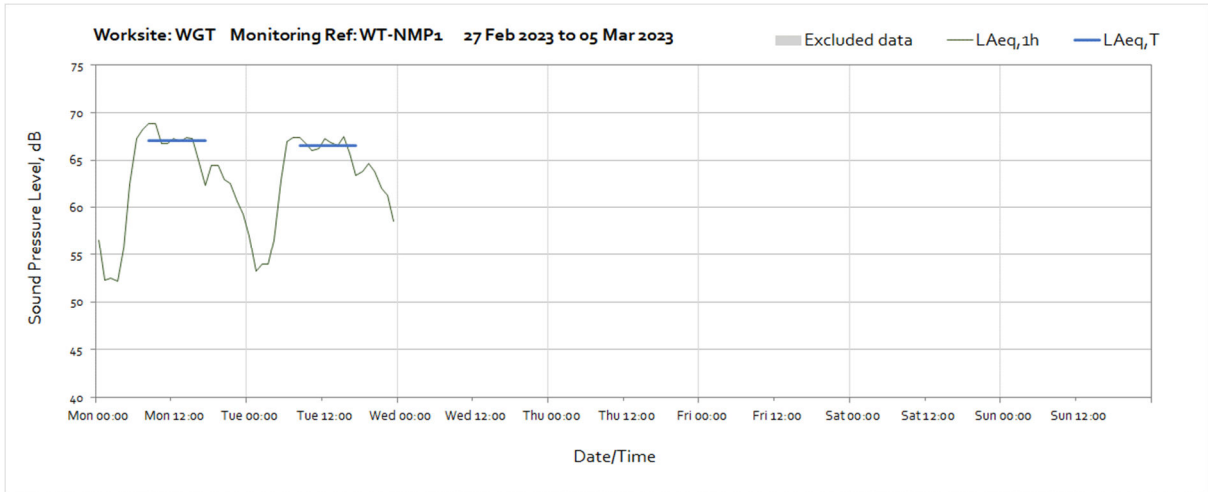
Worksite: GF – Monitoring Ref: GF-NMP1

Note: Missing data between 12:00 and 13:00 on 23rd February was due to monitor maintenance.

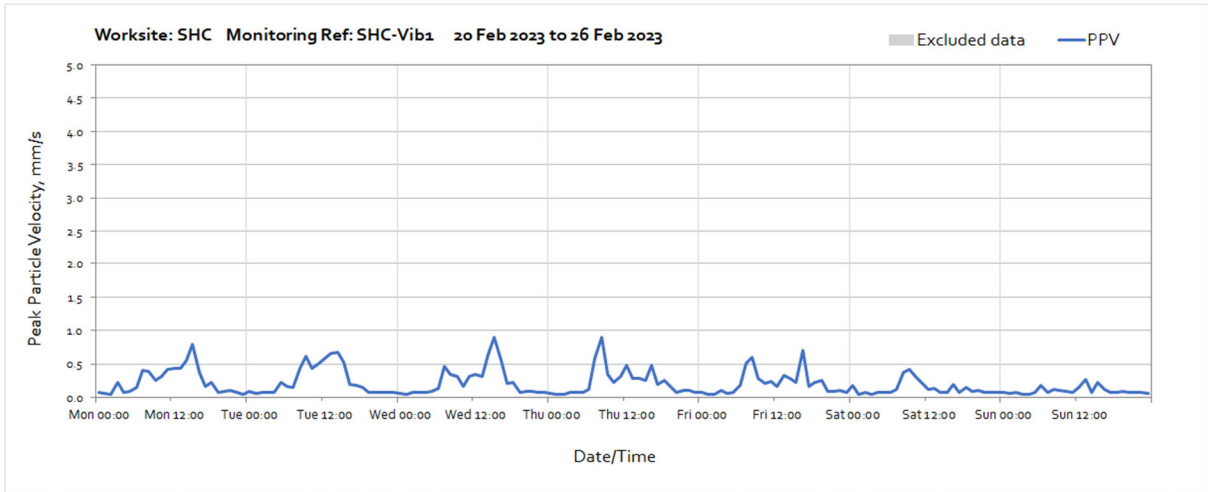
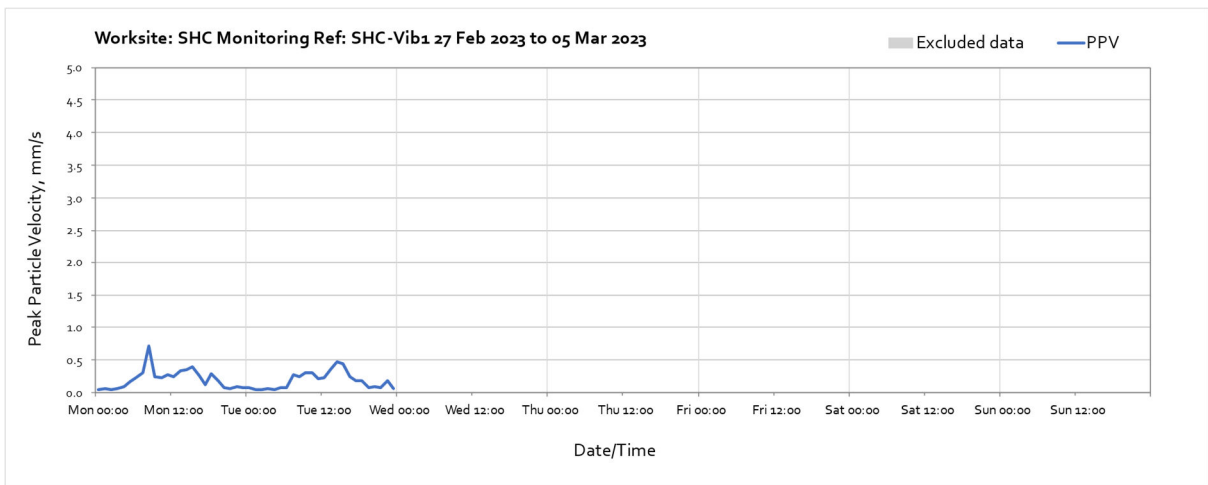
Note: Monitor was installed at 17:00 on 16th February.
