## Construction Noise and Vibration Monthly Report – March 2023

Buckinghamshire

# Non-Technical Summary

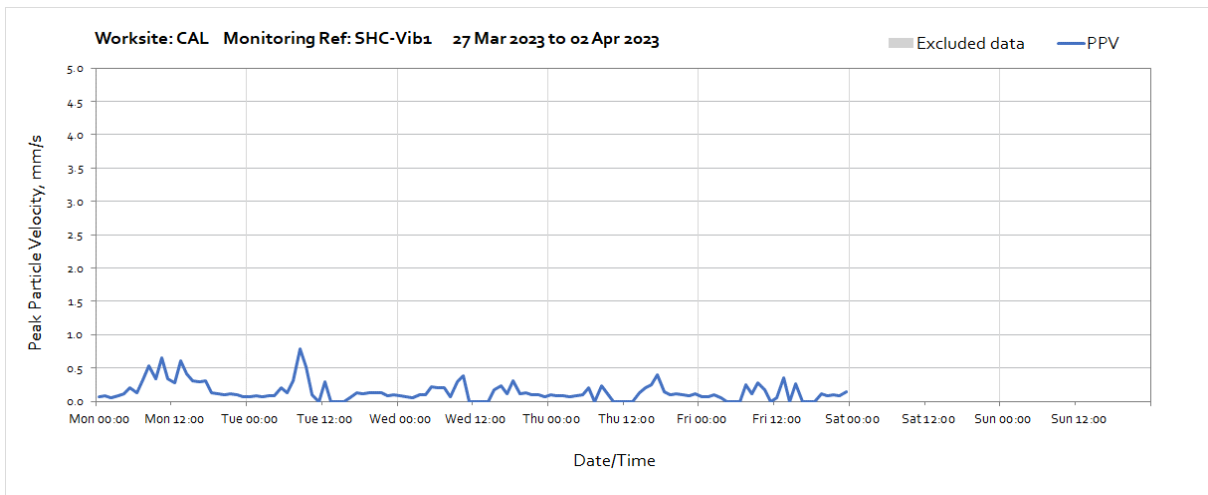
Note: Missing data between 01:00 and 03:00 on Sunday 26th March was due to a monitor time adjustment at the start of British Summertime.
