## **Construction Noise and Vibration Monthly Report – March 2023**

**London Borough of Camden**

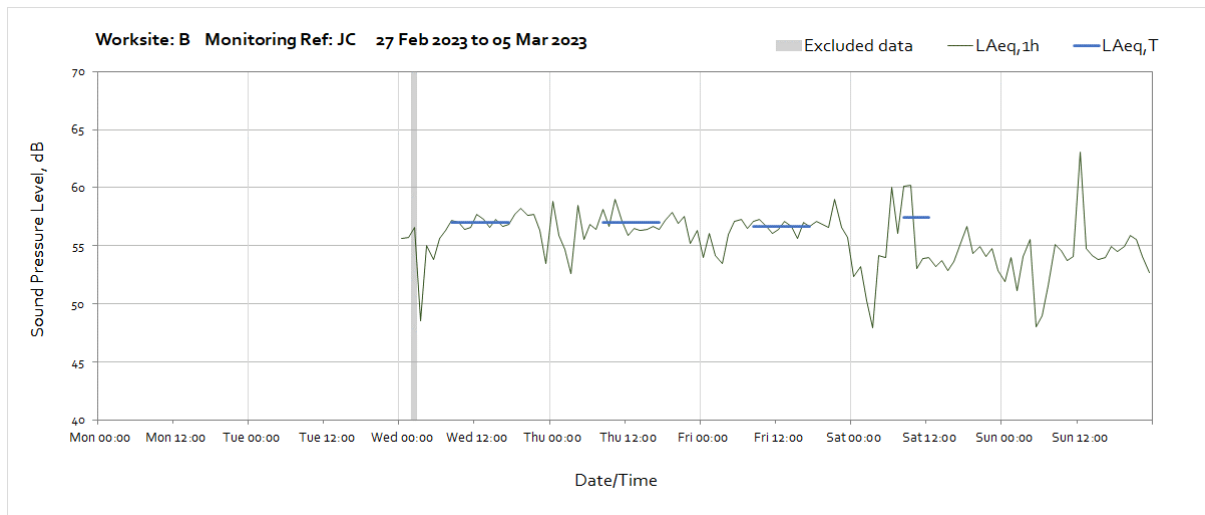
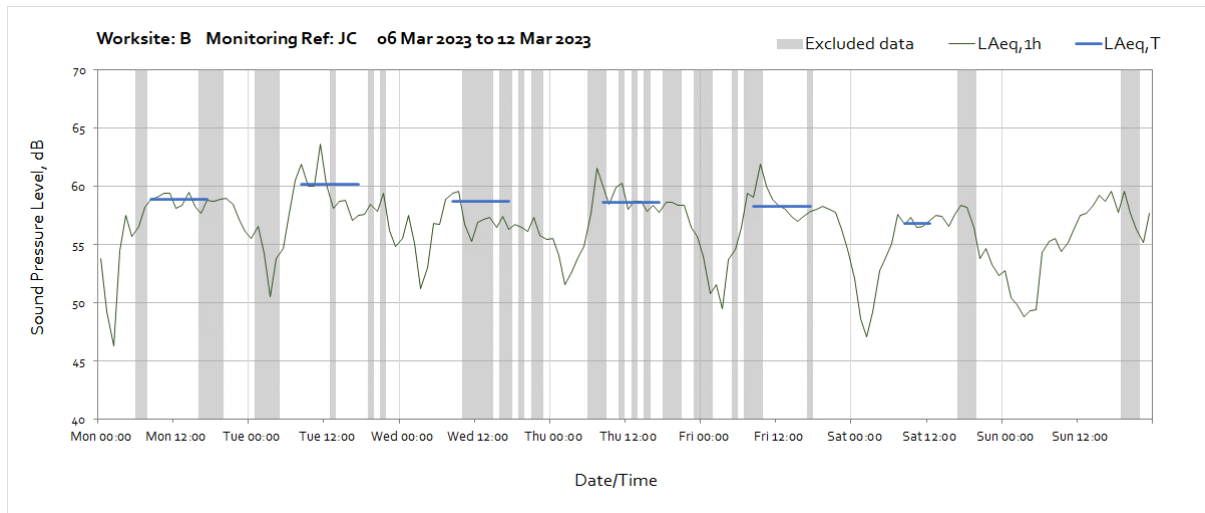
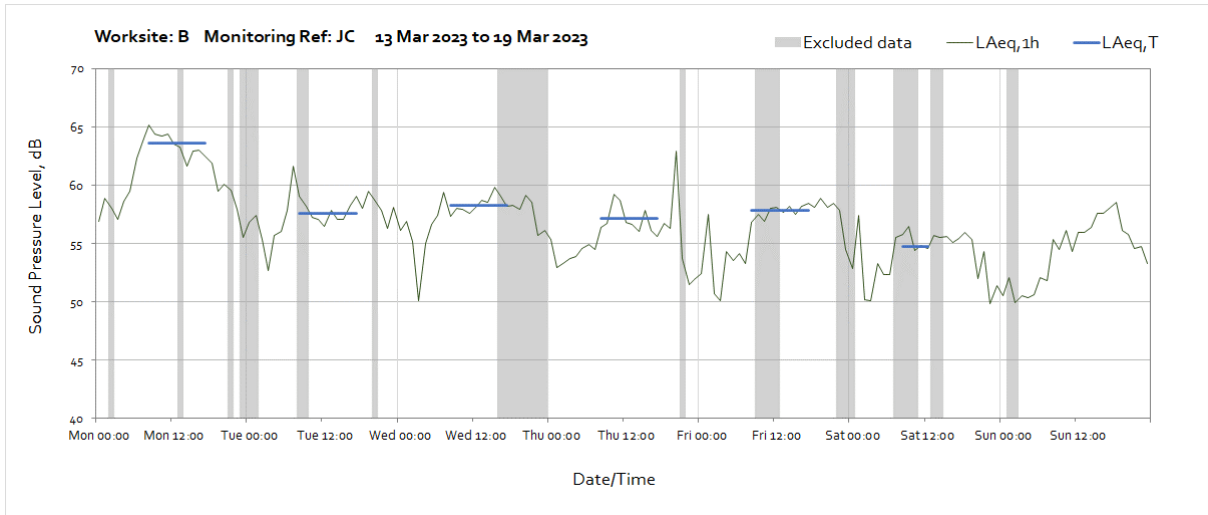
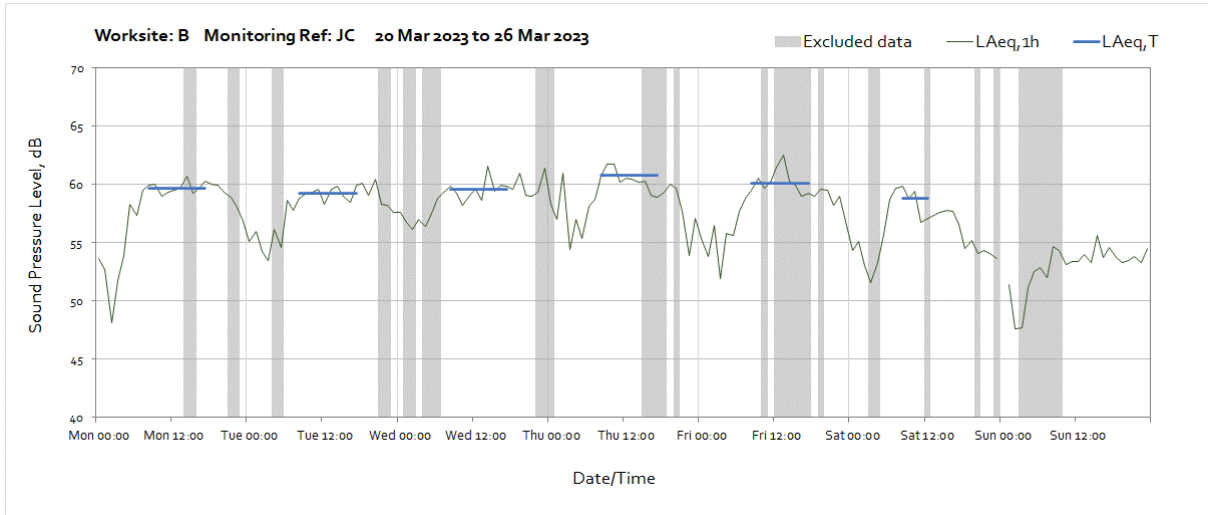
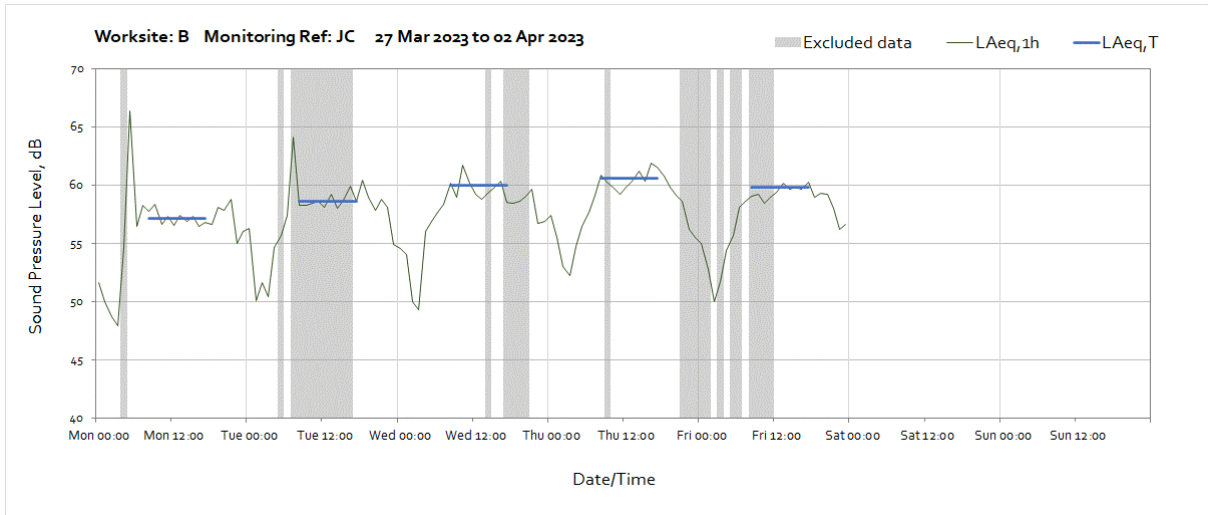
### Worksite: B – Monitoring Ref: JC

Note: Missing data between 01:00 and 03:00 on Sunday 26th March was due to a monitor time adjustment at the start of British Summer Time.

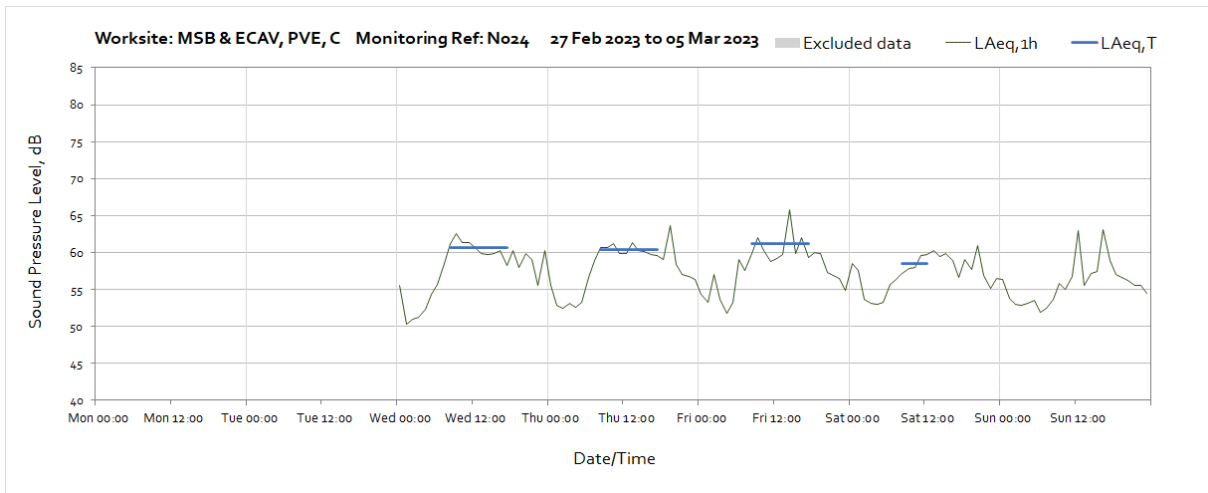
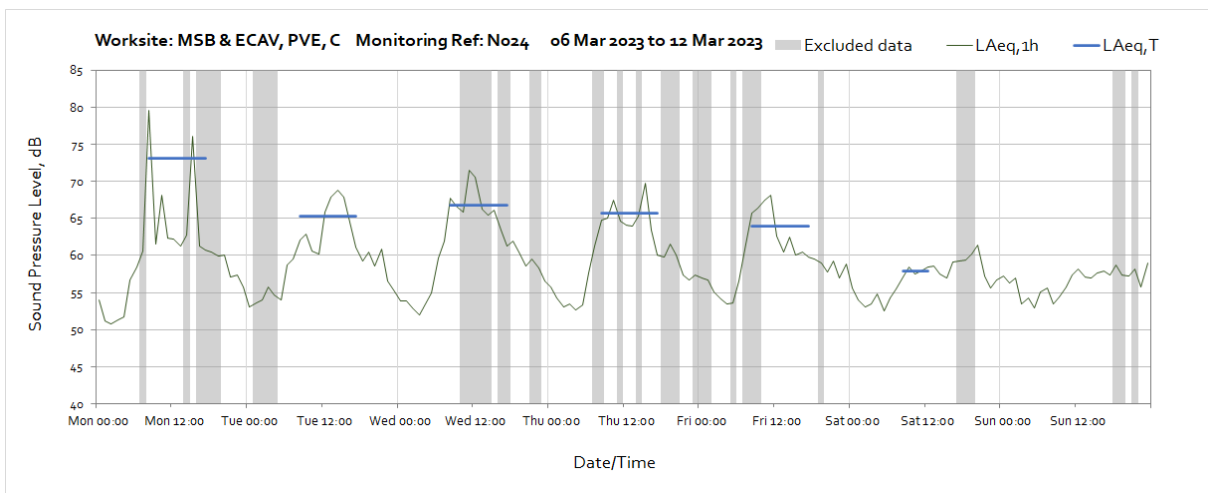
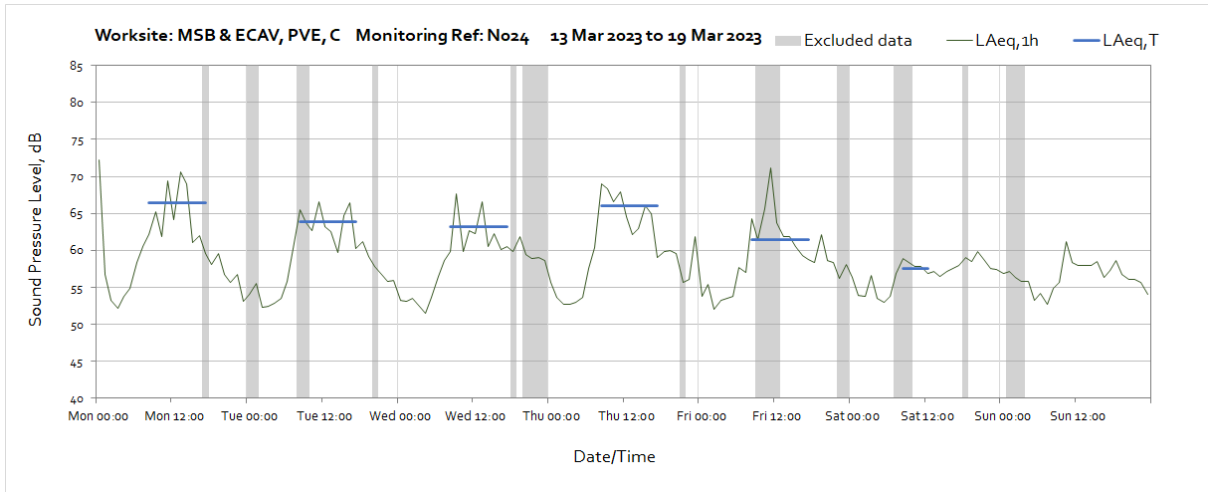
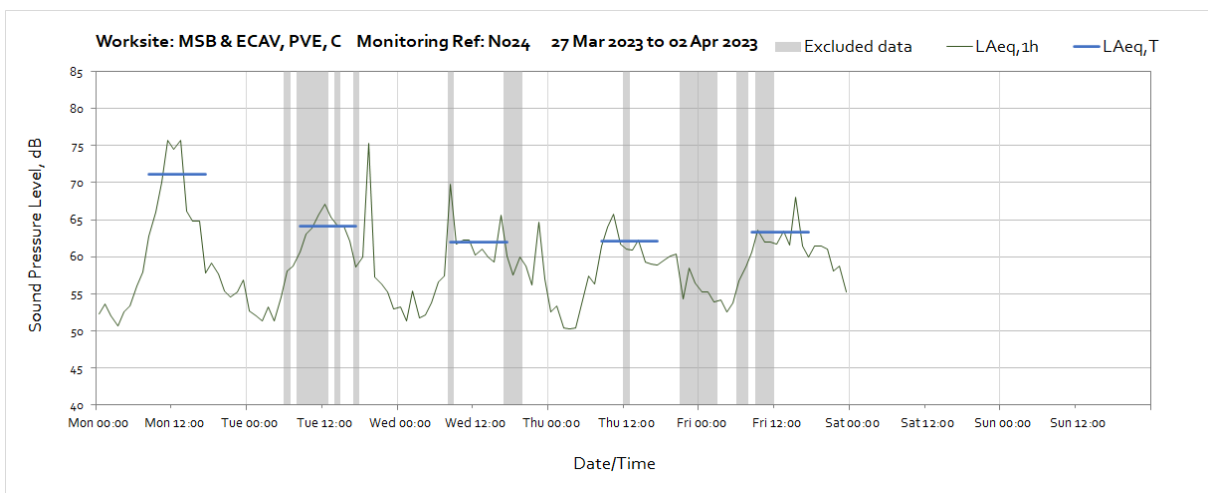
**Worksite: MSB & ECAV, PVE, C – Monitoring Ref: N024**

Note: Missing data between 01:00 and 03:00 on Sunday 26th March was due to a monitor time adjustment at the start of British Summer Time.

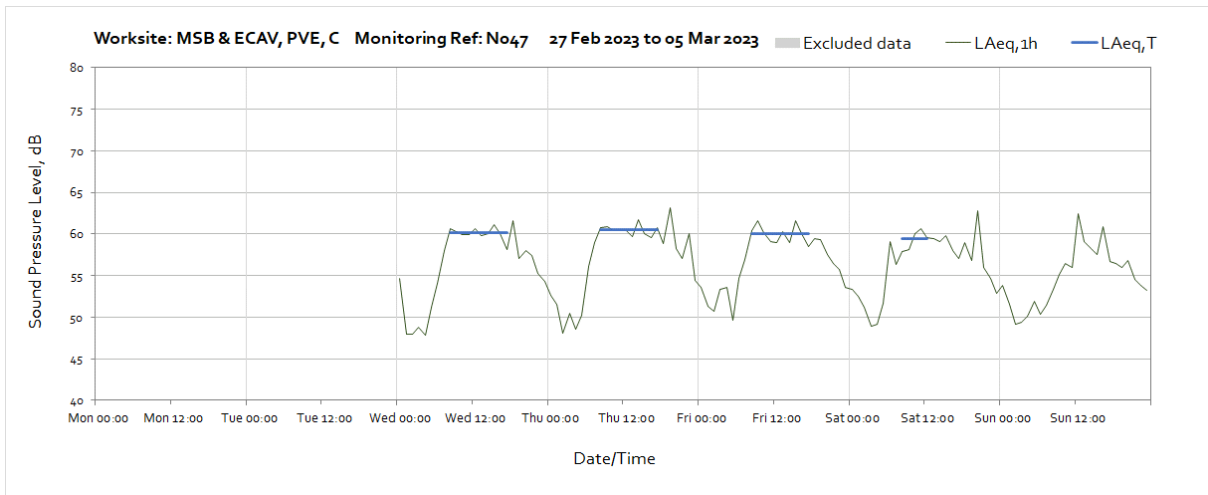
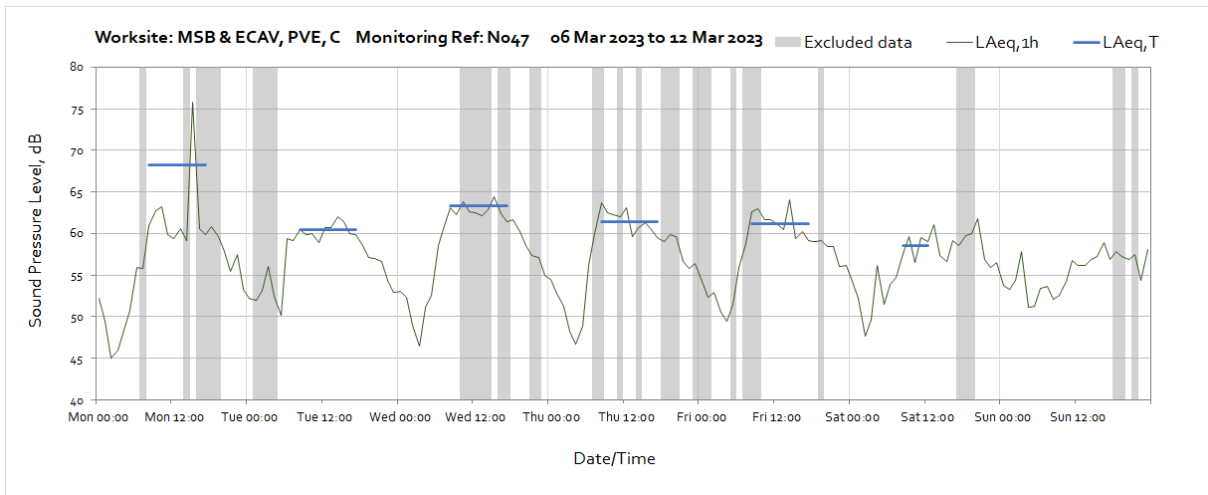
### Worksite: MSB & ECAV, PVE, C - Monitoring Ref: N047

Note: Missing data between 01:00 and 03:00 on Sunday 26th March was due to a monitor time adjustment at the start of British Summer Time.

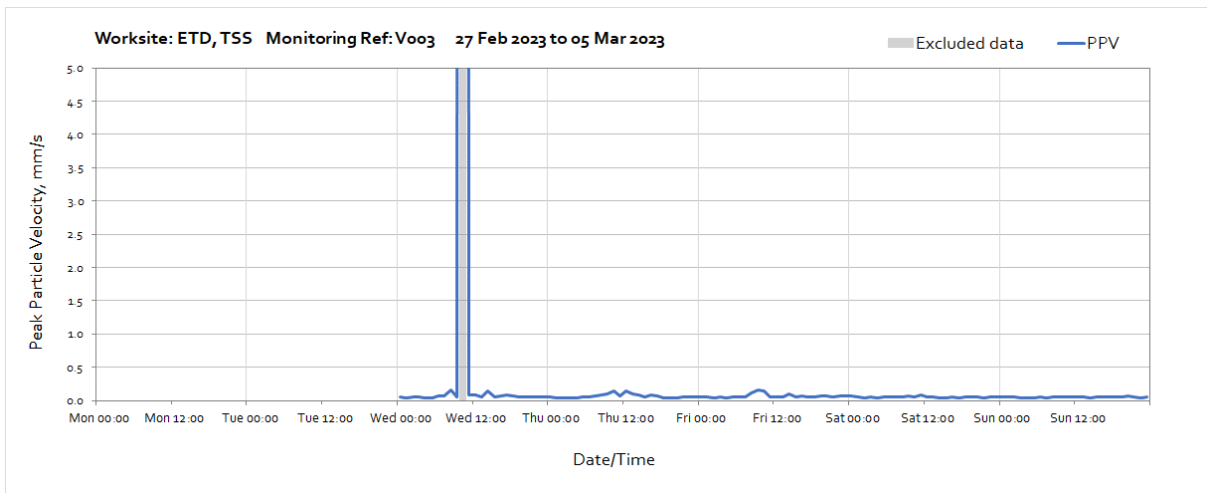
**Worksite: ETD, TSS - Monitoring Ref: V003**

Note: Missing data between 01:00 and 02:00 on Sunday 26th March was due to a monitor time adjustment at the start of British Summer Time.
