High Speed Rail (Crewe – Manchester)

**Background information and data
accompanying SES2 and AP2 ES**

BID WR-002-00001 SES2 and AP2 ES

Water Framework Directive compliance assessment
baseline data - Part 1 of 2

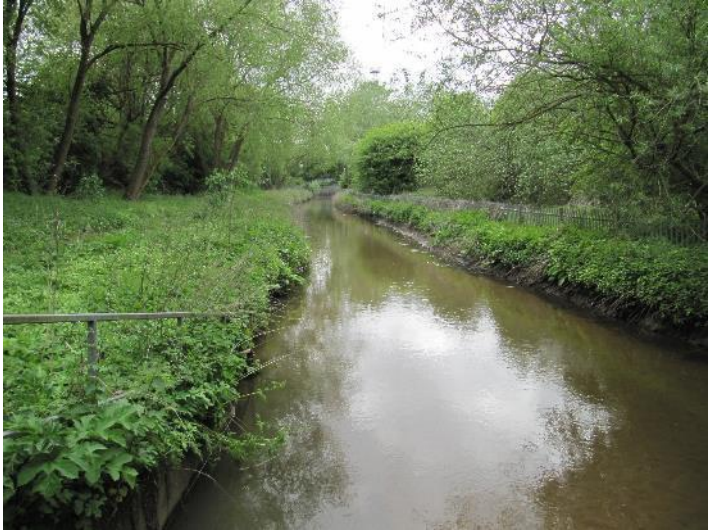
<p>Photograph taken from NGR SJ7122255178</p>

Baseline description	Example photograph
<p>Upstream of AP2 revised scheme Flow: Glide, run Substrate: Sand Riparian vegetation: Scrub and broadleaf vegetation on both banks, some overhanging vegetation, slight channel shading Morphological pressures/modifications: Straight channel between culverts up and downstream. Low gradient and highly modified in centre of Crewe. Very low habitat value. No macrophytes, silty, limited fish habitat Land use: Urban (with park areas)</p>

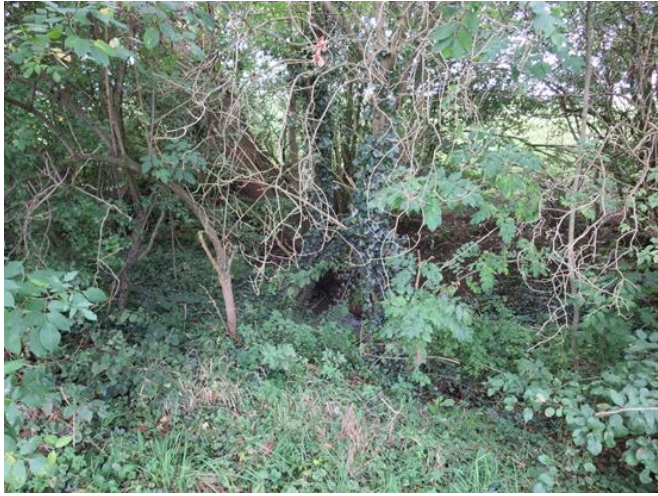
<p>Photograph taken from NGR SJ6829062080</p>

Baseline description	Example photograph
<p>Downstream of AP2 revised scheme Flow: Run, glide, with some riffles Substrate: Obscured, banks cohesive earth Riparian vegetation: Scrub and broadleaf vegetation on both banks, some overhanging vegetation, high channel shading Morphological pressures/modifications: Incised channel Land use: Rough pasture grassland</p>

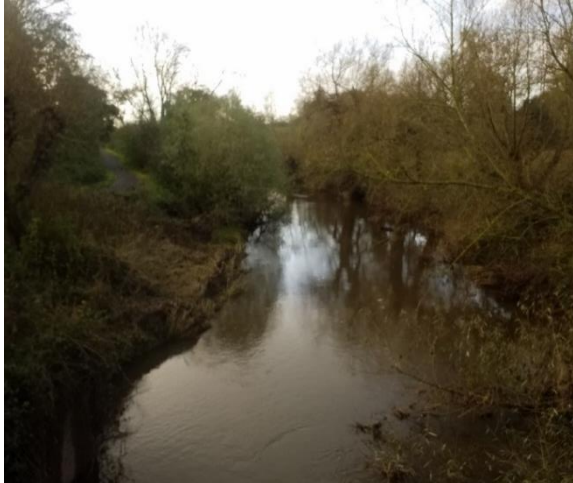
Survey description	Example photographs
<p>Glide and run flow characteristics typical of the survey reach</p> <p>Photograph taken upstream of AP2 revised scheme</p>

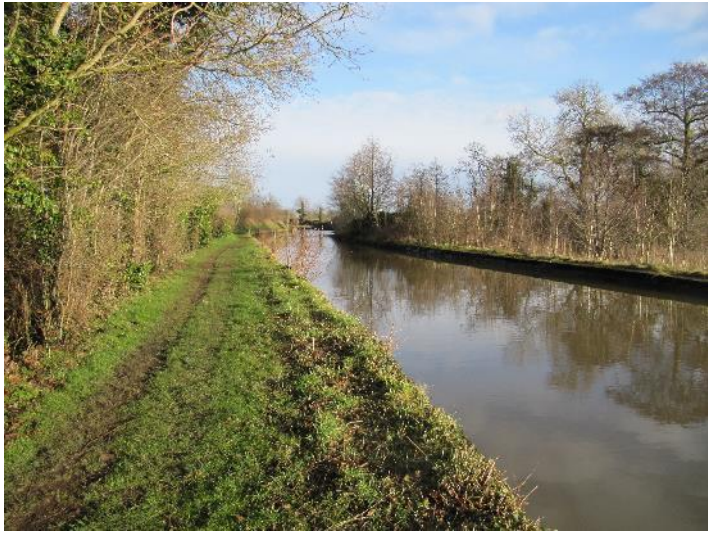
Baseline description	Example photograph
<p>At location of AP2 revised scheme – Crossing 2</p> <p>Flow: Impounded by canal locks</p> <p>Substrate: Not visible but expected to be silt, sand and clay</p> <p>Riparian vegetation: Broadleaf vegetation on right bank, grasses on left bank, no low overhanging vegetation and slight channel shading</p> <p>Morphological pressures/modifications: Canal - reinforced banks</p> <p>Land use: Improved pasture, broadleaf woodland, arable and scrub</p>

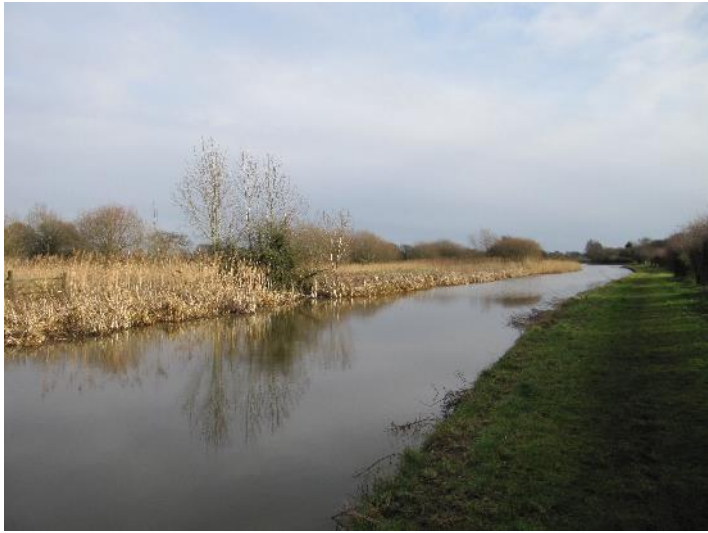
<p>Photograph taken from NGR SJ6850068700</p>

<p>Photograph taken from NGR SJ6830070300</p>
<p>At location of AP2 revised scheme – Crossing 3</p> <p>Flow: Impounded by canal locks. Large backwaters formed from subsidence</p> <p>Substrate: Not visible but expected to be silt, sand and clay</p> <p>Riparian vegetation: Grasses on both banks, reedbed margin on right bank and slight channel shading</p> <p>Morphological pressures/modifications: Canal - reinforced banks</p> <p>Land use: Improved pasture, arable, woodland, scrub and wetland</p>

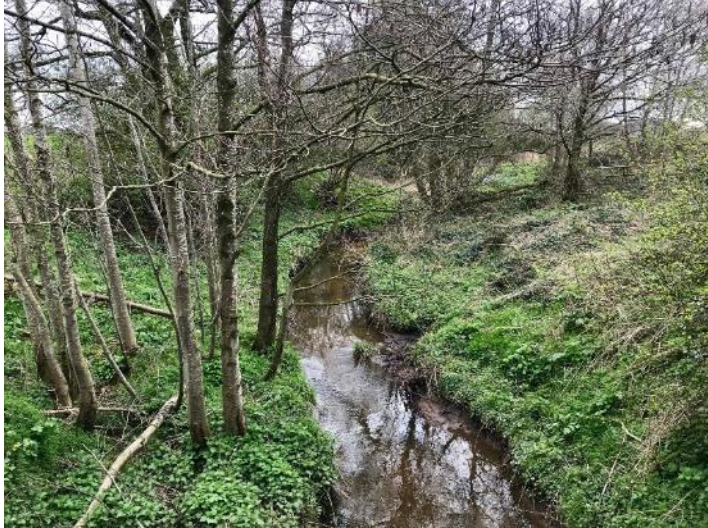
<p>Photograph taken from NGR SJ6842870075</p>

Baseline description	Example photograph
<p>At location of AP2 revised scheme</p> <p>Flow: Run, glide, riffle and pool</p> <p>Substrate: Coarse gravel, cobbles, fine gravel, sand, silt and clay</p> <p>Riparian vegetation: Broadleaf trees on both banks, some overhanging vegetation and high channel shading</p> <p>Morphological pressures/modifications: Culvert under canal (possible siphon). Planform constrained by canal embankment. Disconnected from floodplain due to steep high banks - possibly historically modified as well as local topography. Localised bank undercutting. Small culverts for farm tracks</p> <p>Land use: Improved pasture and broadleaf woodland, some arable and scrub</p>

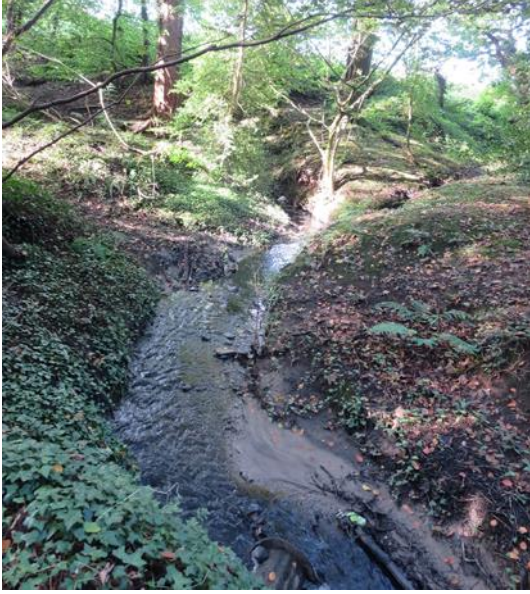
<p>Photograph taken from NGR SJ7018075530</p>

Baseline description	Example photograph
<p>At location of AP2 revised scheme</p> <p>Flow: Run, glide, riffles, pools</p> <p>Substrate: Silt, with some coarse gravel, fine gravel, sand and clay. Some exposed bedrock in places</p> <p>Riparian vegetation: Broadleaf trees on both banks, some overhanging vegetation, moderate channel shading</p> <p>Morphological pressures/modifications: None in survey location, flows under A559 upstream of survey location</p> <p>Land use: Broadleaf woodland</p>

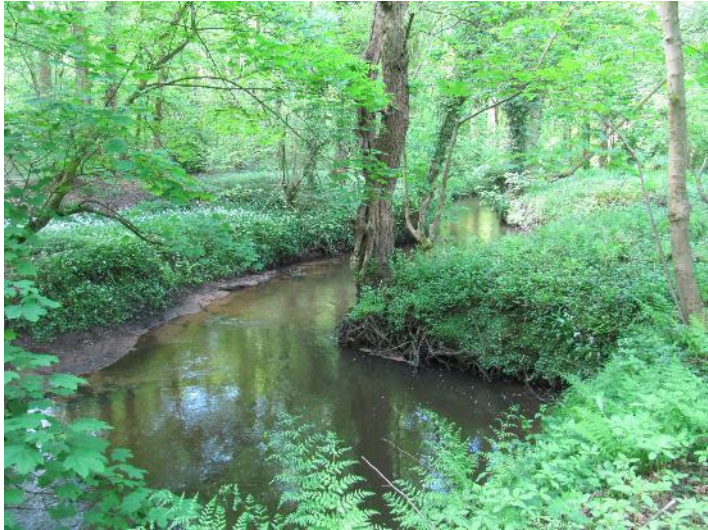
<p>Photograph taken from NGR SJ7022075680</p>

Baseline description	Example photograph
<p>At location of AP2 revised scheme</p> <p>Flow: Glide, run, pools</p> <p>Substrate: Sand, coarse and fine gravel, silt and clay</p> <p>Riparian vegetation: Broadleaf trees on both banks, some overhanging vegetation and high channel shading</p> <p>Morphological pressures/modifications: None in survey location, straightened further upstream alongside A559</p> <p>Land use: Broadleaf woodland and some arable</p>

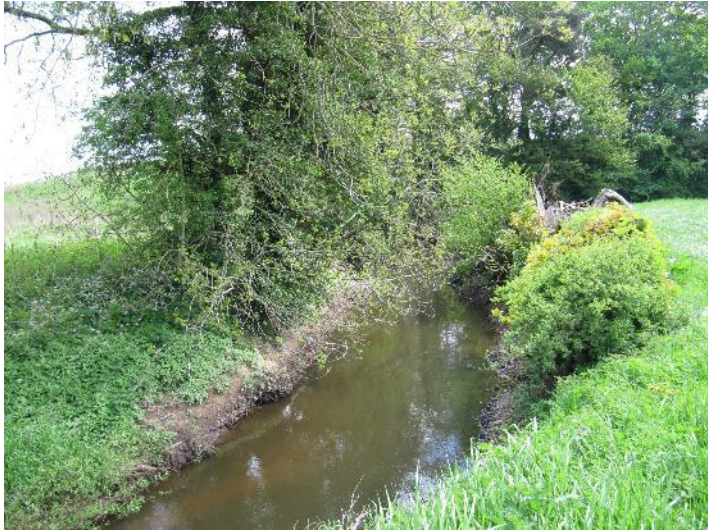
<p>Photograph taken from NGR SJ7029375965</p>

Baseline description	Example photograph
<p>Downstream of AP2 revised scheme</p> <p>Flow: Run, glide, riffles, pools</p> <p>Substrate: Coarse and fine gravel, sand, silt, clay and cobbles</p> <p>Riparian vegetation: Broadleaf vegetation on both banks, grasses and shrubs, some low overhanging vegetation and moderate channel shading</p> <p>Morphological pressures/modifications: Existing road bridge at Leonard's Bridge/Linnards Lane - does not appear to affect morphology</p> <p>Land use: Broadleaf woodland, improved pasture</p>

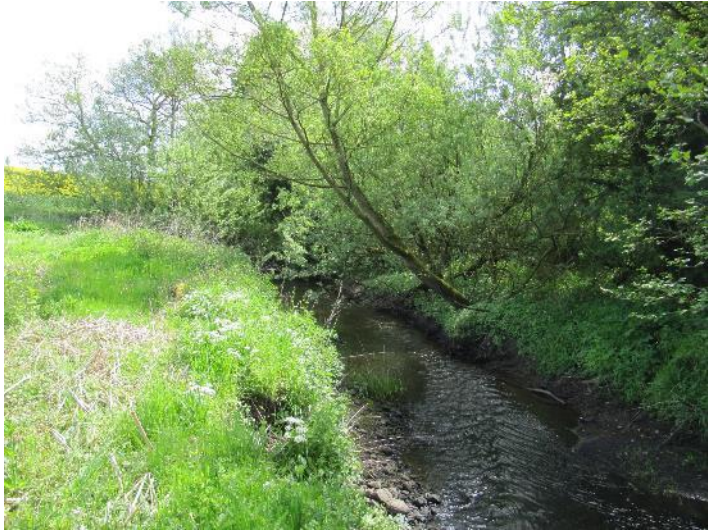
<p>Photograph taken from NGR SJ7069778672</p>

Baseline description	Example photograph
<p>At location of AP2 revised scheme</p> <p>Flow: Run, glide, riffles, pools</p> <p>Substrate: Coarse and fine gravel and cobbles</p> <p>Riparian vegetation: Grasses on right bank, broadleaf trees on left bank, some low overhanging vegetation and high channel shading</p> <p>Morphological pressures/modifications: Existing bridge crossing at Budworth Road/Waterless Bridge - no clear impact on morphology</p> <p>Land use: Improved pasture, scrub, woodland and arable</p>

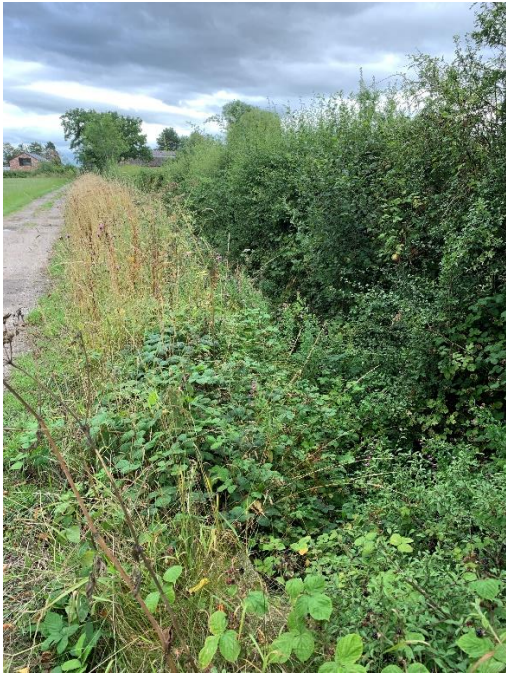
<p>At location of AP2 revised scheme Small field ditch with steep banks Artificial/over-deep channel Low flow velocity and energy Intermittently dry</p>

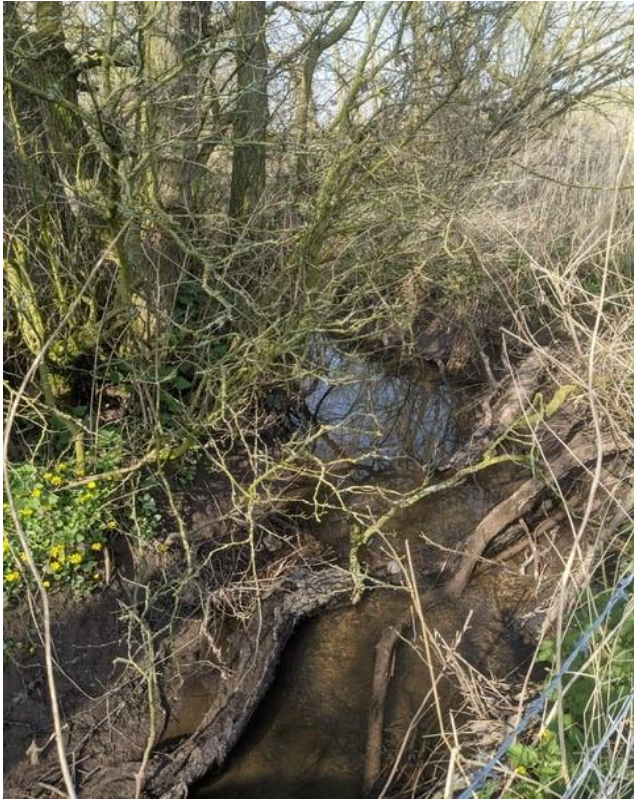
<p>Photograph taken from NGR SJ7112379945</p>

Baseline Description	Example Photograph
<p>At location of AP2 revised scheme Small field ditch through agricultural land with steep banks Bare bank toes, silt margins and woody debris present intermittently Sand and silt dominate the channel substrate Low flow velocity and energy</p>

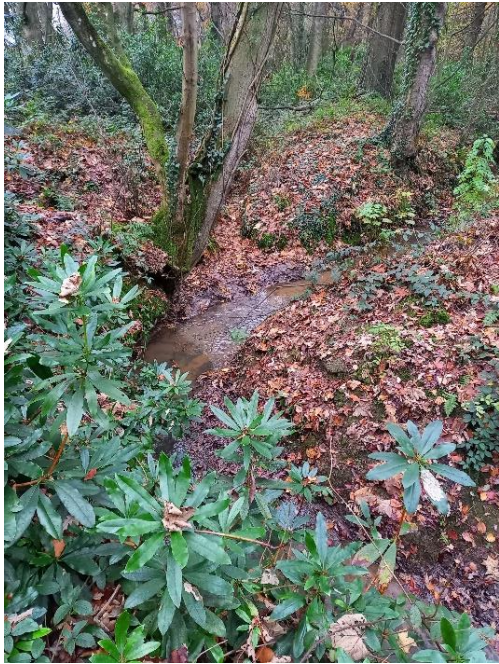
Baseline description	Example photograph
<p>Downstream of AP2 revised scheme: upstream section through woodland</p> <p>Typically, field drainage ditch with some sinuosity in woodland Watercourse in woodland is heavily shaded, with substantial leaf litter and silty substrate Roots and undercut banks Very turbid and bed choked with fine sediment – likely to be dry in summer</p>

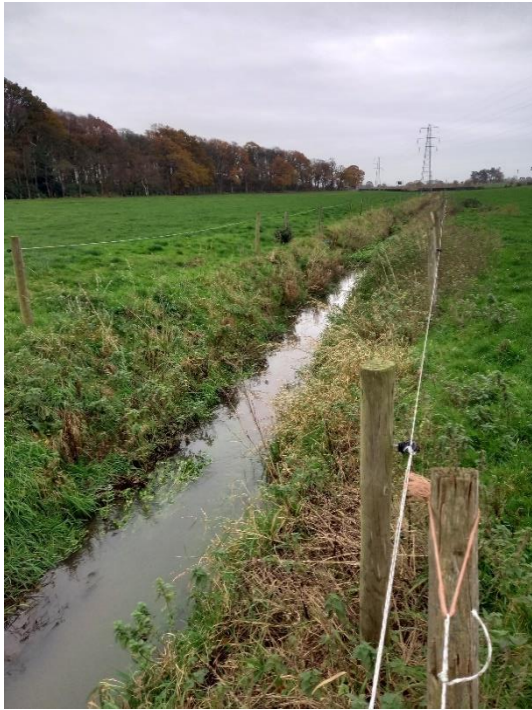
<p>Photography taken from NGR SJ7176581109</p>

<p>Photograph taken from NGR SJ7179181768</p>
<p>Downstream of AP2 revised scheme: downstream surveyed section through farmland</p> <p>Becomes more of a straight, field ditch downstream Some sections with very scarce riparian vegetation Several culverts and small pond area Some submerged and emergent plant species and limited flow variation</p>

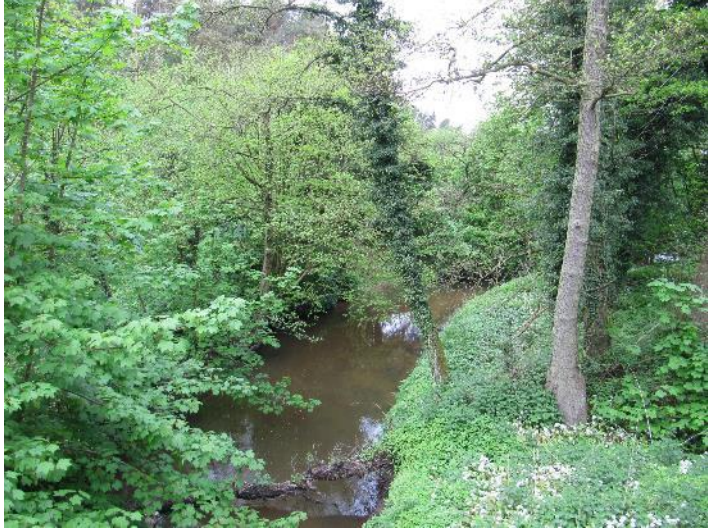
<p>Photograph taken from NGR SJ7635083871</p>

Baseline description	Example photograph
<p>Upstream of AP2 revised scheme</p> <p>Flow: Glide, run, pools, riffles</p> <p>Substrate: Coarse and fine gravel, sand, silt and clay</p> <p>Riparian vegetation: Broadleaf vegetation on both banks, some overhanging vegetation and high channel shading</p> <p>Morphological pressures/modifications: Bridge crossings under roads and the channel has been straightened adjacent to the M56</p> <p>Land use: Improved and rough pasture, broadleaf woodland and scrub</p>

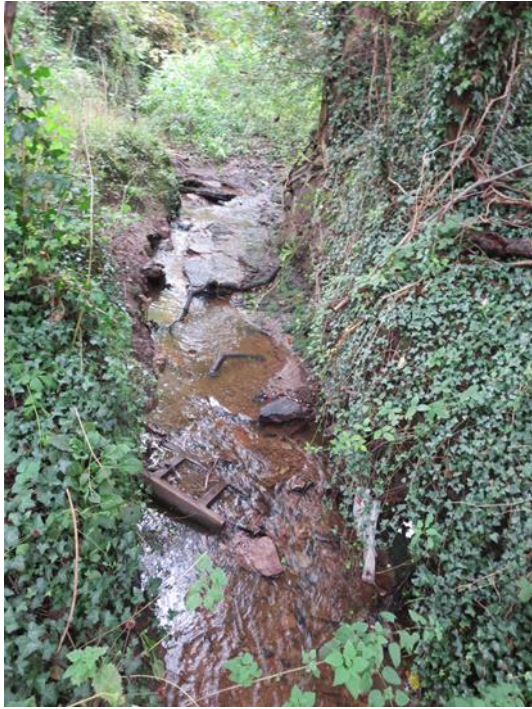
<p>Photograph taken from NGR SJ7932084360</p>

Baseline description	Example photograph
<p>Downstream of AP2 revised scheme Flow: Riffle, run, glide, pool, cascade Substrate: Coarse and fine gravel, sand, silt, clay with some exposed bedrock Riparian vegetation: Broadleaf trees on both banks, some low overhanging vegetation and high channel shading Morphological pressures/modifications: Footbridge at downstream end Land use: Broadleaf woodland</p>

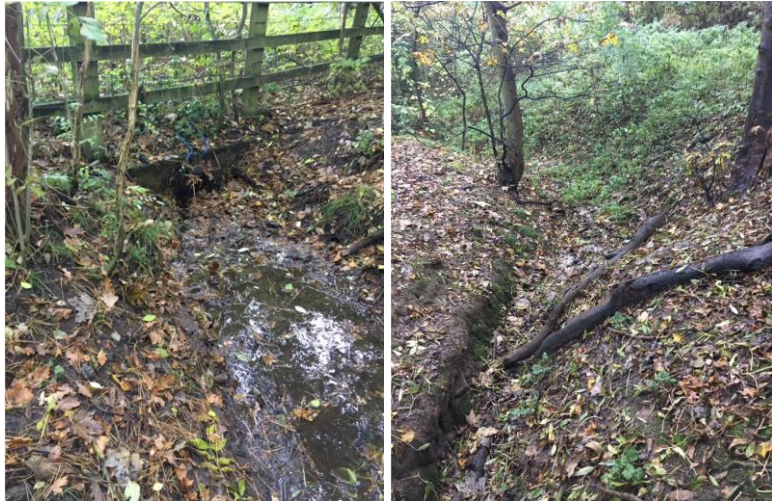
<p>Photograph taken from NGR SJ7955584544</p>

Baseline description	Example photograph
<p>Upstream of AP2 revised scheme</p> <p>Flow: Shallow flow. No distinct flow type due to minor watercourse</p> <p>Substrate: Predominantly fines/earth</p> <p>Riparian vegetation: Woodland</p> <p>Morphological pressures/modifications: Two land drainage outfalls. Turbid flow originating from outfalls. Modified, culverted section of watercourse through M56</p> <p>Land use: Scrub and woodland upstream of M56 crossing</p>

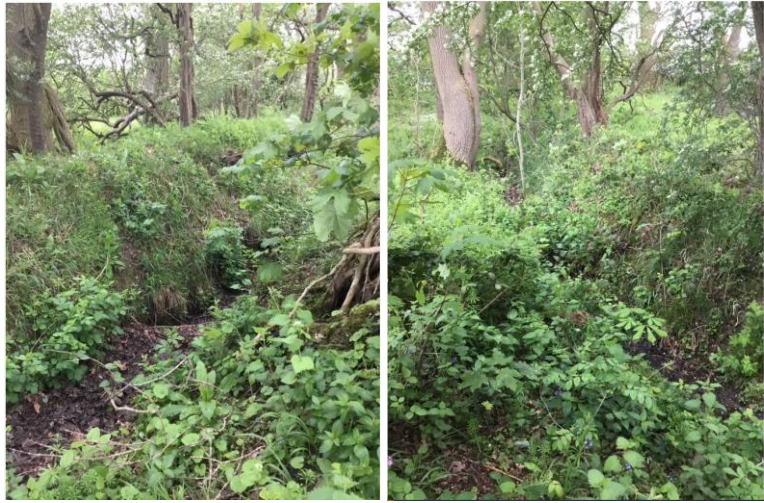
<p>Photographs taken from NGR SJ7862684637</p>

Baseline description	Example photographs
<p>Downstream of AP2 revised scheme</p> <p>Flow: Still water with no flow evident. No distinct flow type due to artificial nature of watercourse</p> <p>Substrate: Predominantly fines/earth</p> <p>Riparian vegetation: Scrub and woodland</p> <p>Morphological pressures/modifications: Artificial drainage ditch. Piped discharges into ditch predicted to be land drainage outfalls</p> <p>Land use: Wetland area with scrub and woodland, upstream of M56 crossing</p>

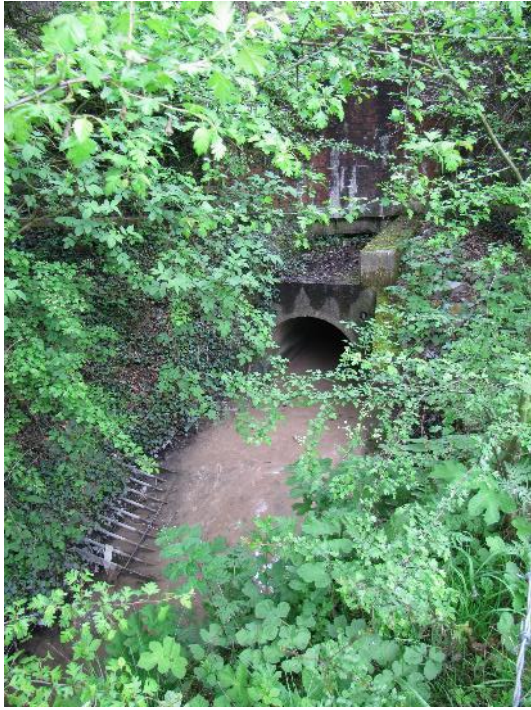
Baseline description	Example photograph
<p>Upstream of AP2 revised scheme</p> <p>Flow: Ponded reach between culverts</p> <p>Substrate: Silt and clay</p> <p>Riparian vegetation: Broadleaf vegetation on both banks, some low overhanging vegetation and high channel shading</p> <p>Morphological pressures/modifications: Culverted under M56, carrying runoff from Manchester Airport in upper catchment</p> <p>Land use: Improved pasture, urban/suburban and woodland</p>

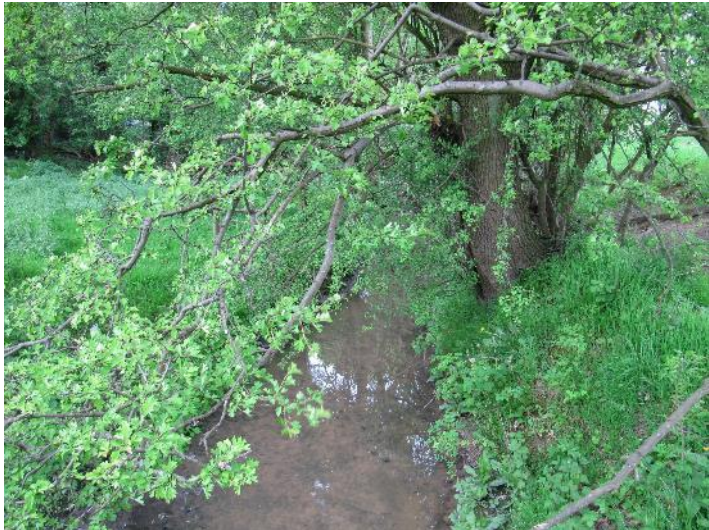
<p>Photograph taken from NGR SJ8060086003</p>
<p>At location of AP2 revised scheme</p> <p>Flow: glide</p> <p>Substrate: Silt and clay</p> <p>Riparian vegetation: Broadleaf vegetation on both banks, some low overhanging vegetation and high channel shading</p> <p>Land use: Improved pasture, urban/suburban and woodland</p>

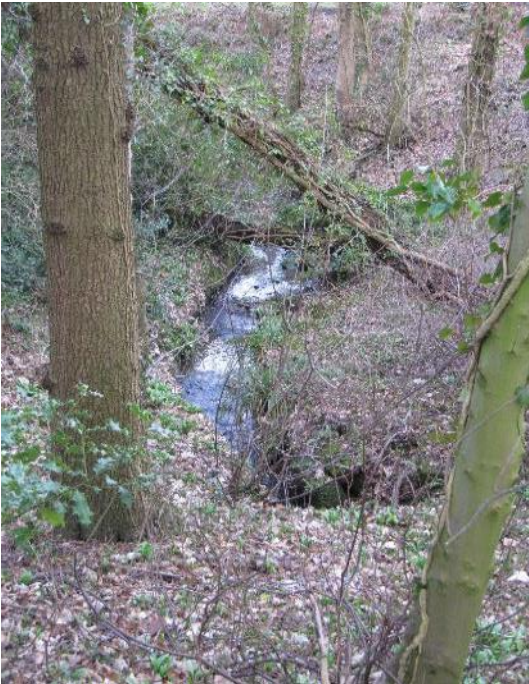
<p>Photograph taken from NGR SJ8021786160</p>

Baseline description	Example photograph
<p>Downstream of AP2 revised scheme Flow: More free flow – shallow riffles and runs Substrate: Fine and coarse gravel Riparian vegetation: Broadleaf vegetation on both banks, some low overhanging vegetation and high channel shading Land use: Improved pasture, urban/suburban and woodland</p>

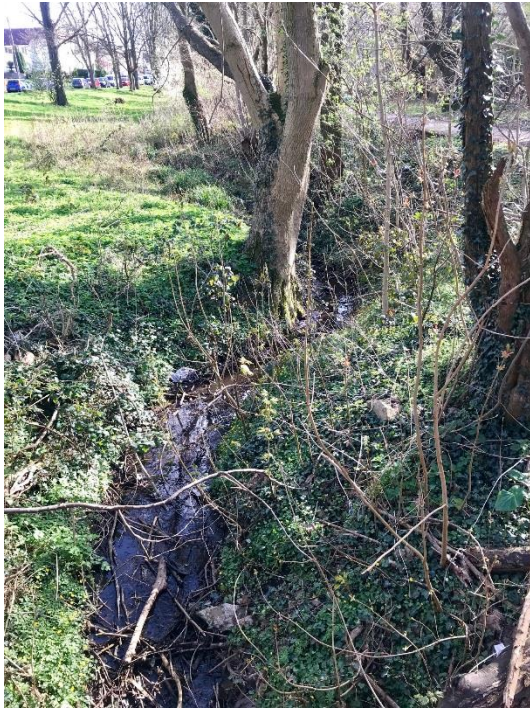
<p>Photograph taken from NGR SJ8129087600</p>

Baseline description	Example photograph
<p>At location of AP2 revised scheme</p> <p>Flow: Run</p> <p>Substrate: Fine and coarse gravel, silt</p> <p>Riparian vegetation: Broadleaf vegetation (willow, alder), grass and scrub, some low overhanging vegetation</p> <p>Morphological pressures/modifications: Urbanised catchment, culverted approximately 150m downstream of the AP2 revised scheme</p> <p>Land use: Urban/suburban, amenity grassland</p>

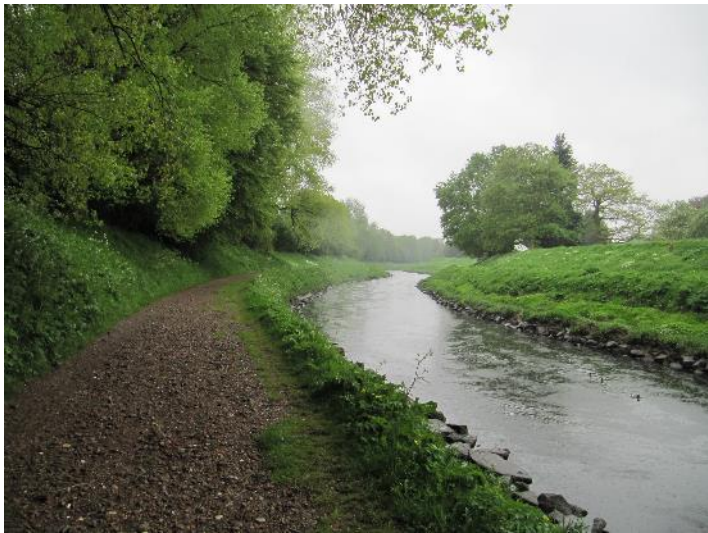
<p>Photograph taken from NGR SJ8337991733</p>

Baseline description	Example photograph
<p>Downstream of AP2 revised scheme</p> <p>Flow: Glide, run, rapid</p> <p>Substrate: Obscured by flow. Substrate likely to be mixed cobbles, coarse gravel, fine gravel, sand, silt and clay</p> <p>Riparian vegetation: Grasses on both banks, trees behind bank top</p> <p>Morphological pressures/modifications: Heavily engineered in a trapezoidal channel with large earth embankments and rock reinforced toe. Floodplain controlled as flood storage areas with side-spill weirs/sluices. Series of rock ramps form grade control weirs which create small rapids</p> <p>Land use: Amenity grassland, urban/suburban, woodland</p>

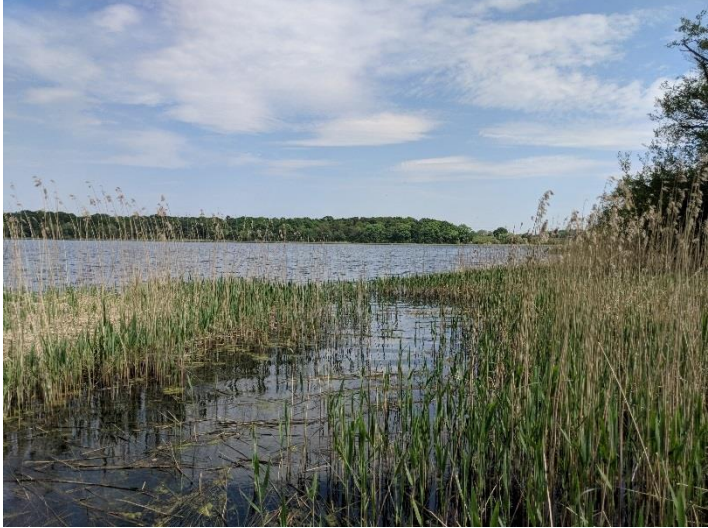
<p>Photograph taken from NGR SJ7430483802</p>

Description of feature	Example photograph
<p>Rostherne Mere has a surface area of approximately 48ha and a mean depth of 13.6m</p> <p>The Mere is fringed in places by a band of reedbed swamp</p> <p>There are also areas of willow carr⁷</p> <p>Rostherne Mere is supported by watercourses feeding in from the catchment. Rostherne Brook provides approximately 80% of the inflow into Rostherne Mere</p> <p>These streams are determined to be fed by spring, hence Rostherne Mere is at least partly a groundwater dependent habitat</p>
