High Speed Rail (Crewe – Manchester)

Water resources and flood risk

BID WR-002-00001 SES2 and AP2 ES

Water Framework Directive compliance assessment
baseline data - Part 2 of 2

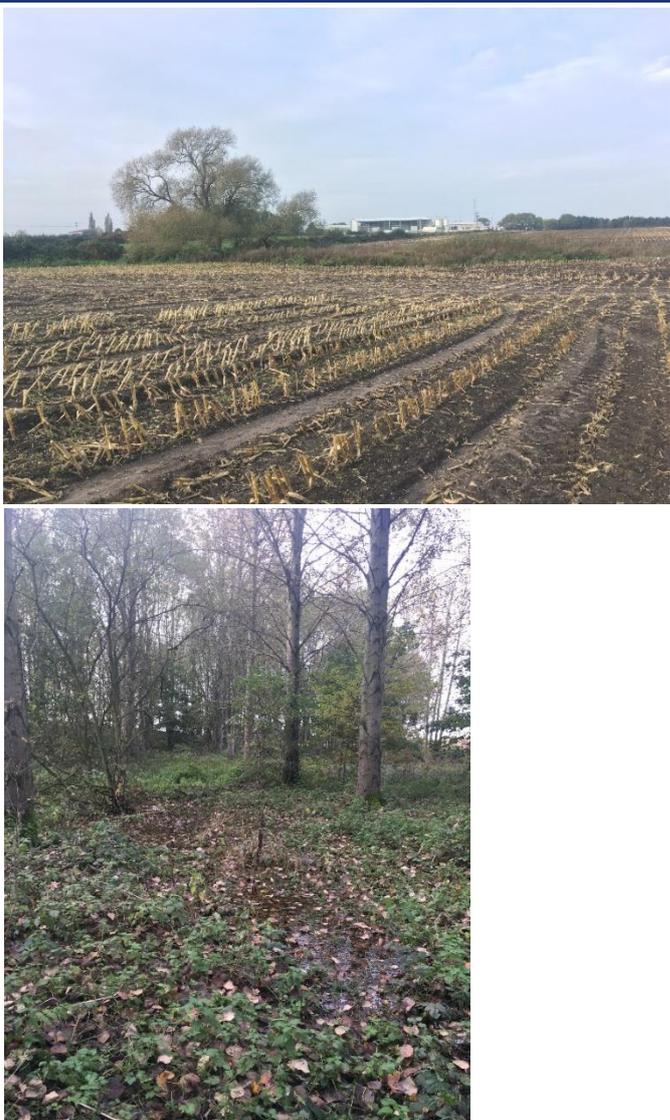
Table 89: Summary of baseline condition of potential spring S_02

Description of feature	Example photographs
<p>Surveys show this is a buried stream, feeding into a boggy area which is acting similar to a groundwater collect (surface expression of buried stream). There is evidence here that habitat has been cleared although willows remain at this site suggesting permanent water availability. The stream is buried across two fields until the GWDTE of Basford Brook is reached where surface water is observed. The stream flows into the Basford Brook watercourse. The topography in the fields is sloped towards the buried stream and there was evidence of river transportation across the field due to heavy rainfall before survey.</p>

<p>The top photograph shows a wide view of a harvested agricultural field with rows of stubble under a cloudy sky. The bottom photograph shows a wooded area with many bare trees and a ground covered in fallen leaves and some green plants.</p> <p>Photographs taken from NGR SJ7256251353</p>

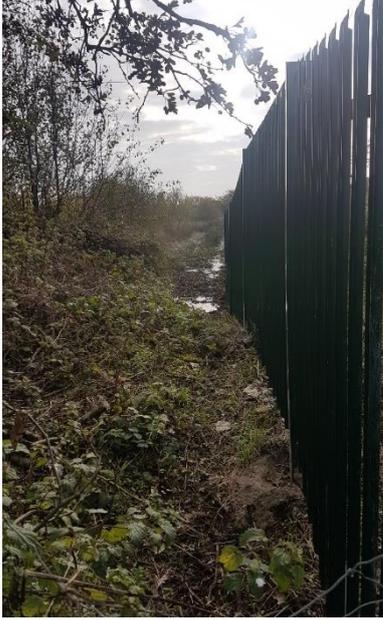
Table 90: Summary of baseline condition of potential spring S_09

Description of feature	Example photograph
<p>DRN indicates this is feature is a culvert however a survey was also completed at this site. The site visit showed there is a potential culvert passing under the railway track which feeds into a ditch. Raised hummock seen at site of potential spring although an outfall was not observed. The ditch likely receives water from land drainage. The fields in the area were very waterlogged due to the underlying clayey geology and heavy rainfall prior to the survey.</p>

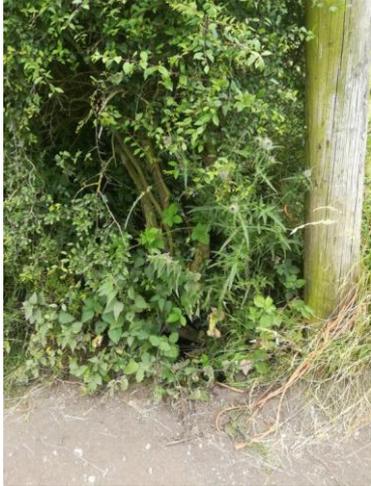
Table 91: Summary of baseline condition of potential spring S_11

Description of feature	Example photograph
Culvert passing under agricultural track – not a groundwater feature.

<p data-bbox="639 954 1126 987">Photograph taken from NGR SJ6872460599</p>

- 4.2.18 The potential spring S_11 is located at Moat House Farm, Minshull Vernon (at NGR SJ6872460599). A baseline desk study and field survey have been undertaken.
- 4.2.19 A summary of the baseline condition of the potential spring S_11, together with some example photographs, are provided in Table 91.

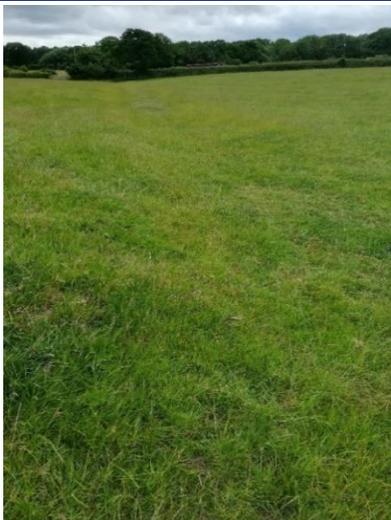
Table 92: Summary of baseline condition of potential spring S_12

Description of feature	Example photograph
No groundwater features identified.

<p data-bbox="639 2036 1137 2069">Photograph taken from NGR SJ68480461061</p>

4.2.22 A summary of the baseline condition of the potential spring S_12, together with some example photographs, are provided in Table 92.

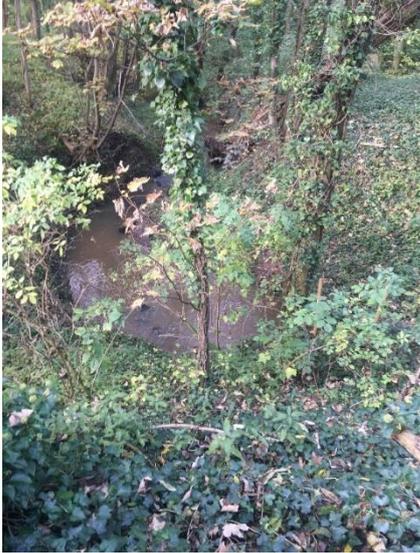
Table 93: Summary of baseline condition of potential spring S_13

Description of feature	Example photograph
<p>Culvert under road (Brookhouse Lane) to allow Tributary of River Weaver 1 to pass through – not a groundwater feature.</p>

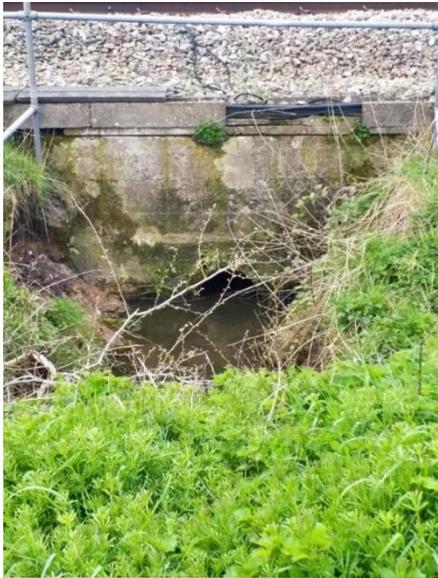
Table 94: Summary of baseline condition of potential spring S_14

Description of feature	Example photograph
Piped discharge from beneath the railway – not a groundwater feature.

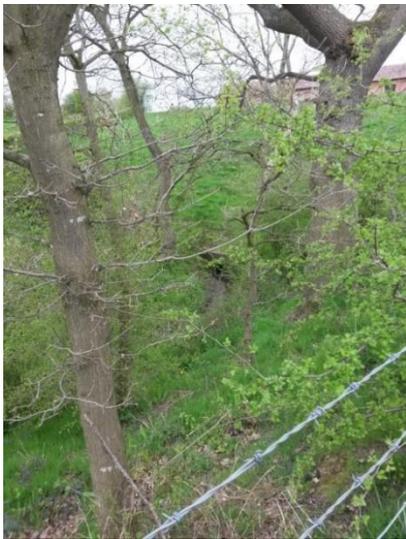
Table 95: Summary of baseline condition of potential sink S_15a

Description of feature	Example photograph
Culvert under the railway – not a groundwater feature.

<p data-bbox="644 2038 1126 2069">Photograph taken from NGR SJ6807562288</p>

- 4.2.30 The potential sink S_15a is located 230m west of Wimboldsley Hall (at NGR SJ6807562288). A baseline desk study and field survey have been undertaken.
- 4.2.31 A summary of the baseline condition of the potential sink S_15a, together with some example photographs, are provided in Table 95.
- 4.2.32 Based on the evidence from the baseline assessment, the potential sink S_15a has not been screened in to support the WFD preliminary assessment.

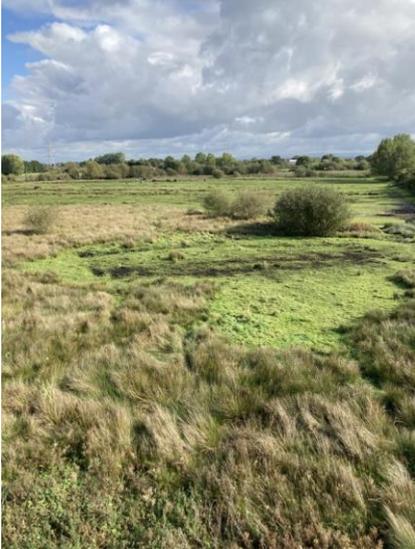
Table 96: Summary of baseline condition of GWDTE G_15b

Description of feature	Example photograph
<p>Moss Bridge Marsh is a marshy grassland habitat with associated water dependent species. Small area of woodland identified as well as a pool, marshes and drainage channels. There may be a groundwater partially supporting the habitat from underlying glacial till. As such, the habitat is classified as a surface water and groundwater dependent habitat.</p>

<p>Photograph taken from NGR SJ6987458613</p>

- 4.2.33 The GWDTE G_15b is located at Moss Bridge Marsh (at NGR SJ6987458613). A baseline desk study and field survey have been undertaken.
- 4.2.34 A summary of the baseline condition of the GWDTE G_15b, together with some example photographs, are provided in Table 96.
- 4.2.35 Based on the evidence from the baseline assessment, the GWDTE G_15b has been screened in to support the WFD preliminary assessment.

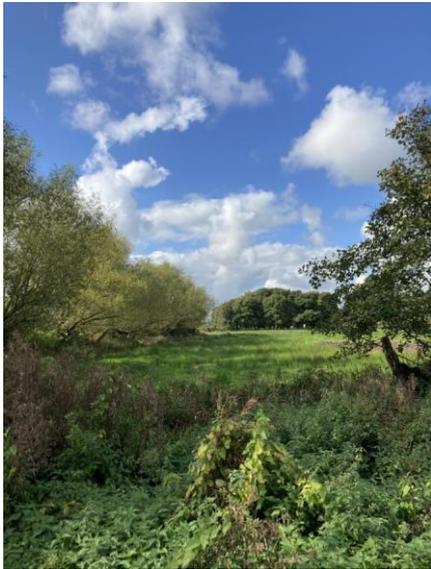
Table 97: Summary of baseline condition of GWDTE G_15c

Description of feature	Example photograph
<p>Spring Plantation Grassland is a managed field with marshy grassland characteristics. Patches of reeds within field and crack willow in drainage ditch surrounding habitat were identified. Drainage ditch had stagnant water with signs of litter dumping. There may be a groundwater partially supporting the habitat from underlying glacial till. As such, the habitat is classified as a surface water and groundwater dependent habitat.</p>

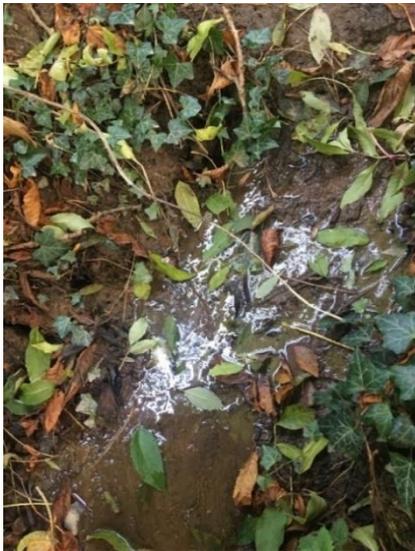
Table 98: Summary of baseline condition of spring S_16

Description of feature	Example photograph
<p>The feature was identified as a spring during surveys. The flow from the spring forms part of the Tributary of River Weaver 2. The spring is located in an open depression facing south-west within an established woodland.</p>

<p>Photograph taken from NGR SJ6829462201</p>

- 4.2.39 The spring S_16 is located 100m south of Wimboldsley Hall (at NGR SJ6829462201). A baseline desk study and field survey have been undertaken.
- 4.2.40 A summary of the baseline condition of the spring S_16, together with some example photographs, are provided in Table 98.
- 4.2.41 Based on the evidence from the baseline assessment, the spring S_16 has been screened in to support the WFD preliminary assessment.

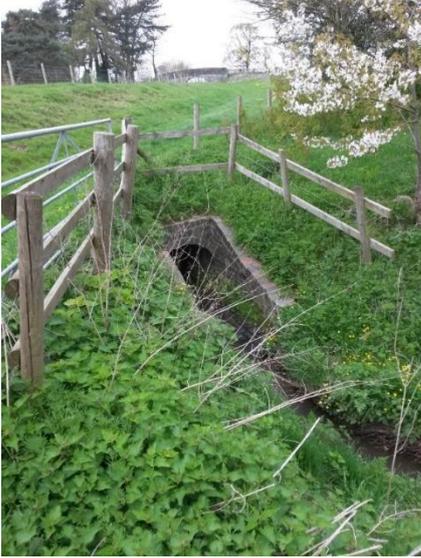
Table 99: Summary of baseline condition of potential sink S_18

Description of feature	Example photograph
Culvert – not a groundwater feature.

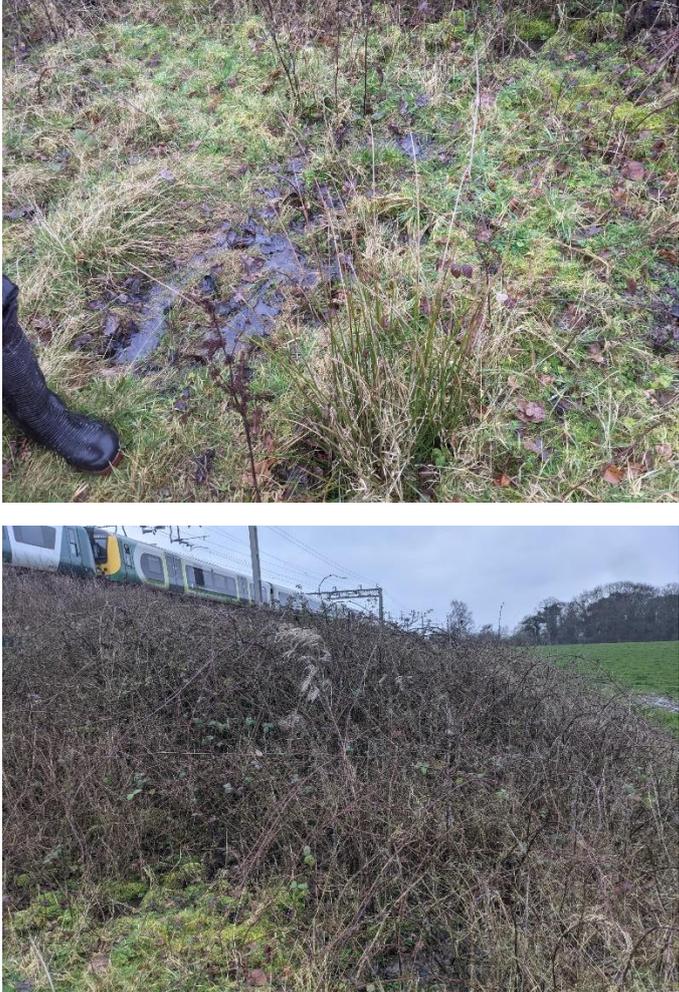
Table 100: Summary of baseline condition of GWDTE G_20

Description of feature	Example photographs
<p>The habitat is not groundwater dependant. Location was covered by brambles and wet ground was attributed to rainfall on the day of the survey.</p>

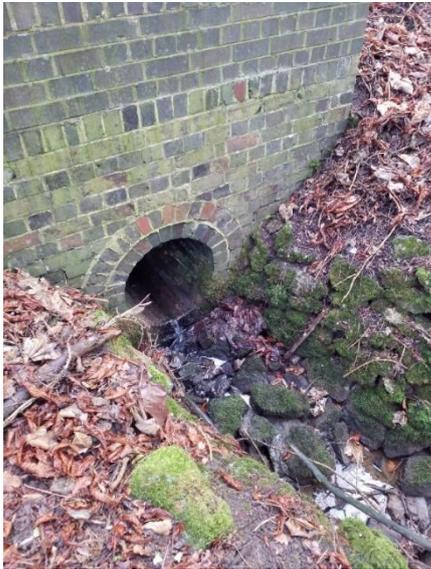
Description of feature	Example photograph
<p>Surveys were unable to identify a saliferous spring in the habitat. Access issues restricted further investigation. The saliferous spring is expected to be in the south of the SSSI habitat, where access was not available. A culvert was identified which drains underneath the Trent and Mersey Canal into Wimboldsley Wood. This is not assumed to be the saliferous spring.</p>

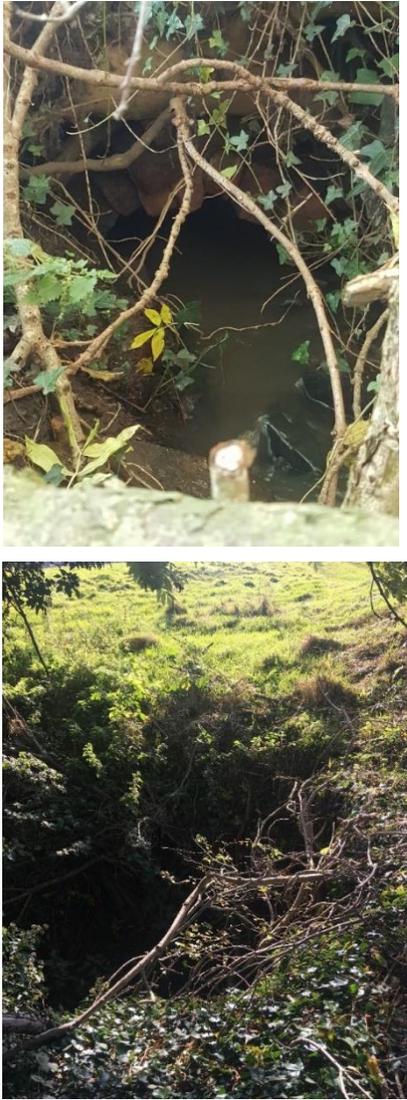
Description of feature	Example photographs
<p>Surveys confirm this is a land drainage feature. On one side of the road, there is a ditch which is culverted under the road. The ditch then opens up into a deeper open depression, possibly due to dissolution and subsidence of halite in the underlying geology. The ditch is also likely receiving overland flow.</p>

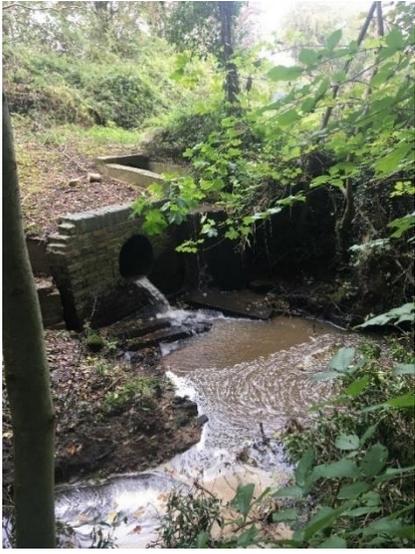
Table 103: Summary of baseline condition of potential spring S_25

Description of feature	Example photograph
<p>Culvert passing Tributary of River Wheelock 5 under the Shropshire Union Canal, not a groundwater feature. Also, a second outfall adjacent to the culvert which is likely an overflow of the Shropshire Union Canal based on OS maps.</p> <p>Scum on the water originates from the discharge from potential spring S_27, which is in proximity.</p>

<p>Photograph taken from NGR SJ6894965735</p>

- 4.2.54 The potential spring S_25 is located 100m east of Yew-Tree Farm, Coalpit Lane (at NGR SJ6894965735). A baseline desk study and field survey have been undertaken.
- 4.2.55 A summary of the baseline condition of the potential spring S_25, together with some example photographs, are provided in Table 103.
- 4.2.56 Based on the evidence from the baseline assessment, the potential spring S_25 has not been screened in to support the WFD preliminary assessment.

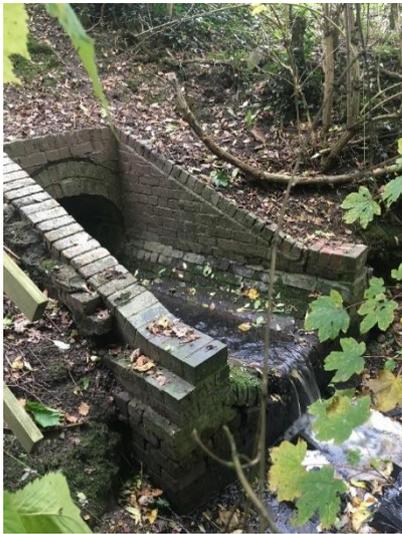
Table 104: Summary of baseline condition of potential spring S_27

Description of feature	Example photograph
<p>Culvert passing under the Shropshire Union Canal, not a groundwater feature. Possibly a sewage outfall based on the scum on top of the water. The culvert discharges into Tributary of River Wheelock 5.</p> <p>This site is in proximity to potential spring S_25.</p>

<p>Photograph taken from NGR SJ6894465736</p>

- 4.2.59 The potential spring S_27 is located 100m east of Yew-Tree Farm, Coalpit Lane (at NGR SJ6894465736). A baseline desk study and field survey have been undertaken.
- 4.2.60 A summary of the baseline condition of the potential spring S_27, together with some example photographs, are provided in Table 104.
- 4.2.61 Based on the evidence from the baseline assessment, the potential spring S_27 has not been screened in to support the WFD preliminary assessment.

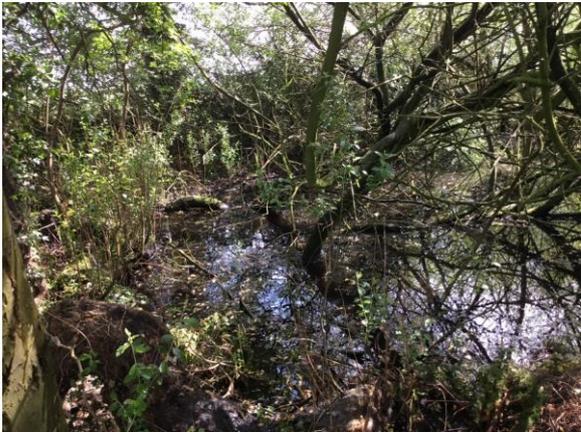
Description of feature	Example photograph
<p>Surveys located a large pond at the site of the spring. The pond is likely partially supported by groundwater, with contribution from land runoff. Water ditches into a manmade ditch running alongside agricultural land.</p>

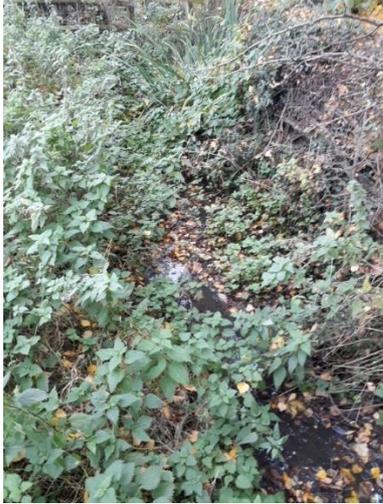
Table 106: Summary of baseline condition of spring S_33a

Description of feature	Example photograph
<p>Surveys identified a spring flowing south-east. It is possible the spring is in hydraulic connection with the River Wheelock approximately 500m south-east of the spring. The water feature is located within a small, narrow ditch and likely receives input from drainage of surrounding fields. As such, the habitat at the spring is deemed partially groundwater dependent.</p>

<p>Photograph taken from NGR SJ6890266690</p>

- 4.2.76 A summary of the baseline condition of the spring S_33a, together with some example photographs, are provided in Table 106.
- 4.2.77 Based on the evidence from the baseline assessment, the spring S_33a has been screened in to support the WFD preliminary assessment.

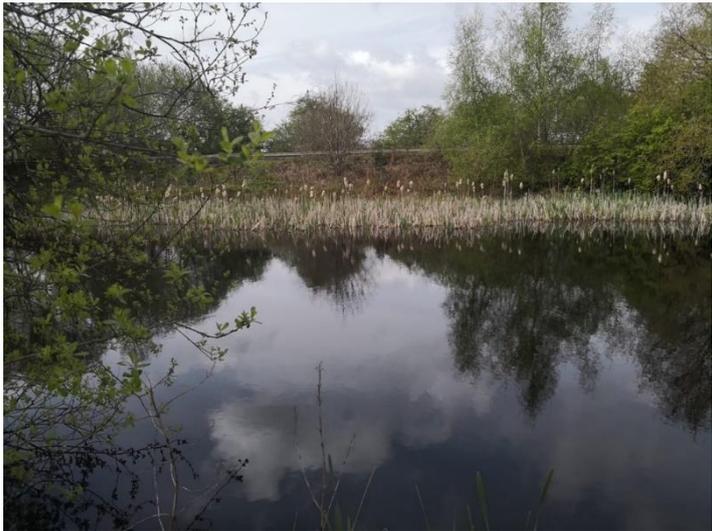
Description of feature	Example photograph
<p>Water dependent habitats identified by surveys but were unable to determine if the habitat is fed by leakage from canal or groundwater.</p>

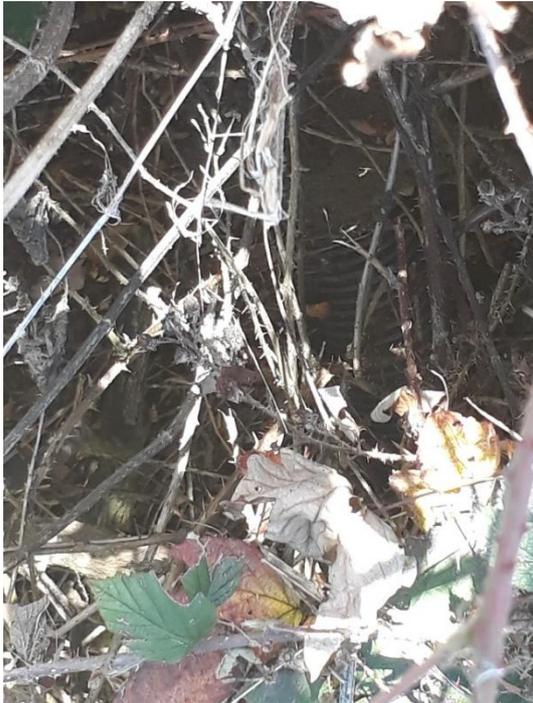
Description of feature	Example photograph
<p>Drainage outfall and no groundwater dependent habitat in the vicinity – not a groundwater feature.</p>

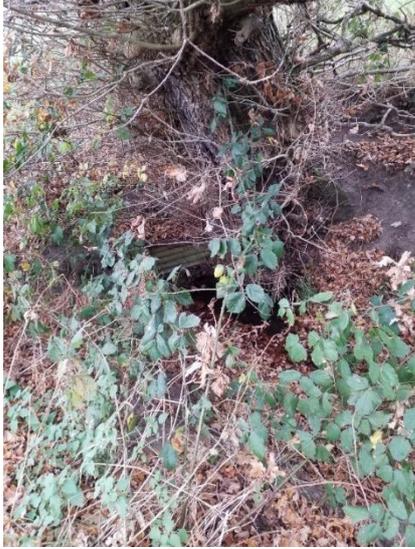
Table 109: Summary of baseline condition of potential spring S_40a

Description of feature	Example photograph
Drainage outfall and no groundwater dependent habitat in the vicinity – not a groundwater feature.

<p>Photograph taken from NGR SJ6971875528</p>

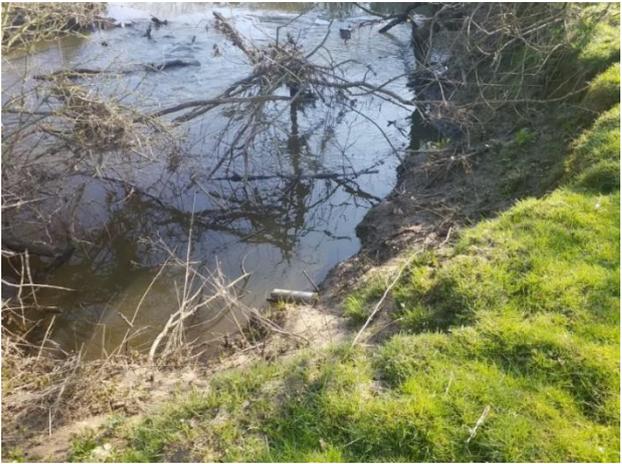
Description of feature	Example photograph
<p>Surveys were restricted by access – further surveys required to fully assess this habitat. The area visited was not groundwater dependent and land drainage into Wincham Brook was identified.</p>

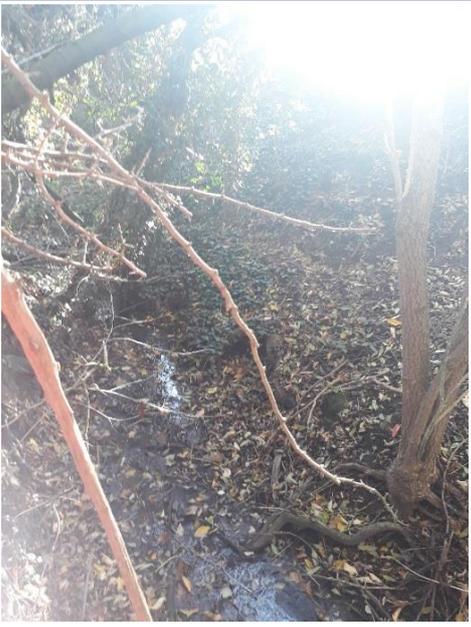
Description of feature	Example photograph
<p>Unclear if drainage ditch or spring, thick mud and hydrogen sulphide smell. Channel likely receives drainage water from surface runoff from surrounding fields. Due to significant overland flow entering the area, it is unlikely to be impacted by the AP2 revised scheme.</p>

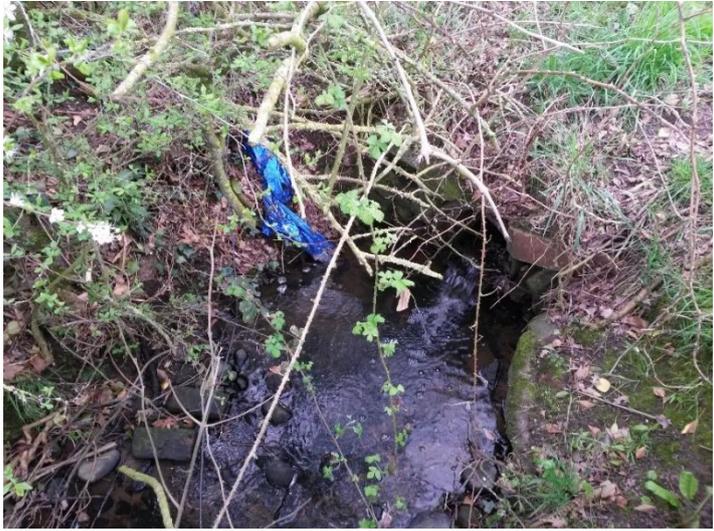
Description of feature	Example photograph
Culvert – not a groundwater feature.

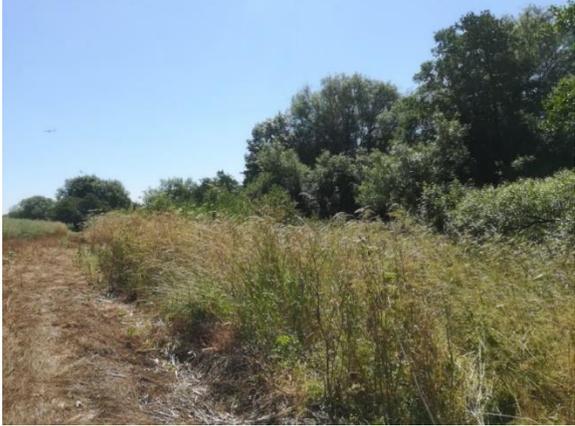
Description of feature	Example photograph
<p>No areas of saturated ground, with no clear evidence of groundwater dependency. Habitat determined to not be groundwater dependent.</p>

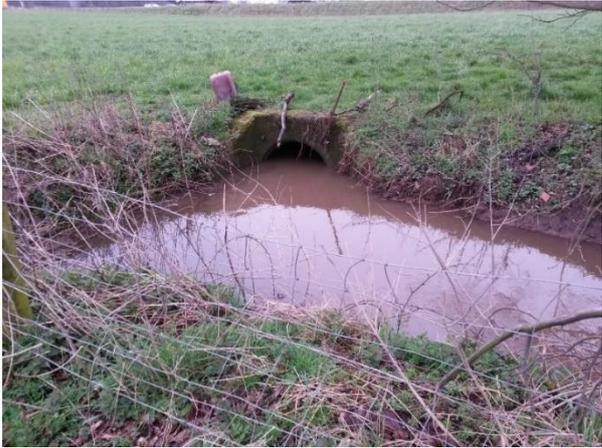
Description of feature	Example photograph
Culvert – not a groundwater feature.

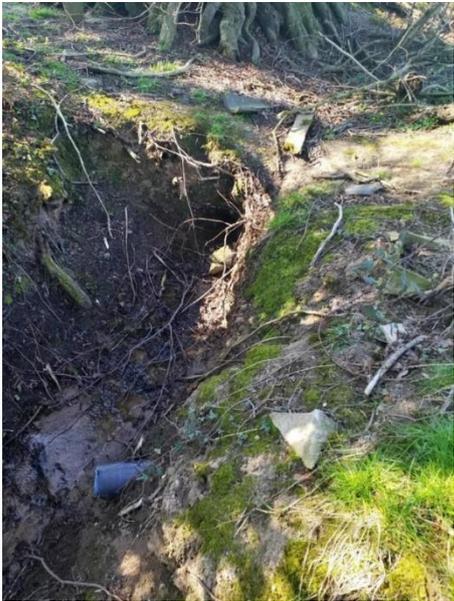
Description of feature	Example photograph
<p>Survey confirmed a culverted land drainage outfall system for agricultural land – not a groundwater feature.</p>

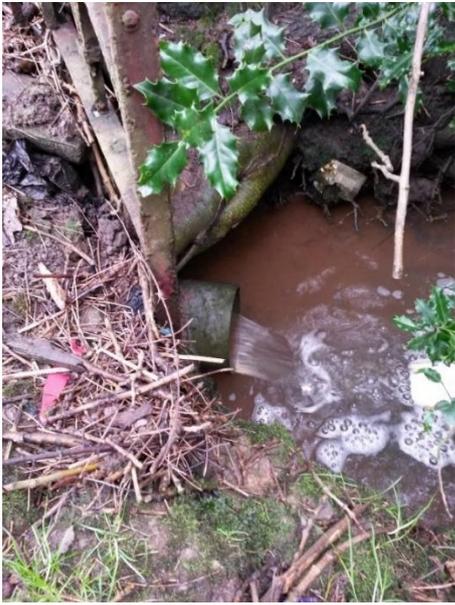
Description of feature	Example photograph
<p>Culvert flowing into a ditch, possibly supported by land drainage – not a groundwater feature.</p>

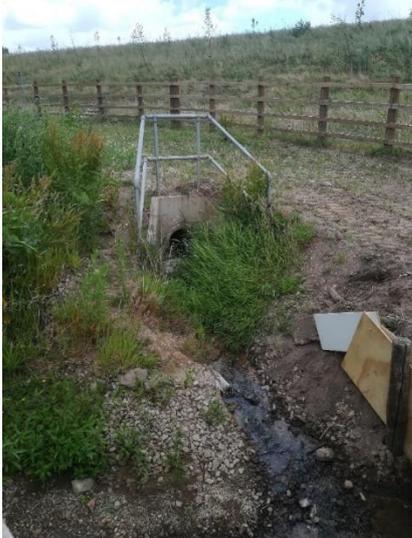
Table 118: Summary of baseline condition of potential spring S_58

Description of feature	Example photograph
<p>The watercourse has been recently dredged, obliterating any natural features. There is a damaged brick outfall at the spring location. Local drainage has been modified by construction of A556 drainage including new channels, culverts and a balancing pond.</p> <p>No indication of a natural spring at the site.</p>

<p>Photograph taken from NGR SJ7186281522</p>

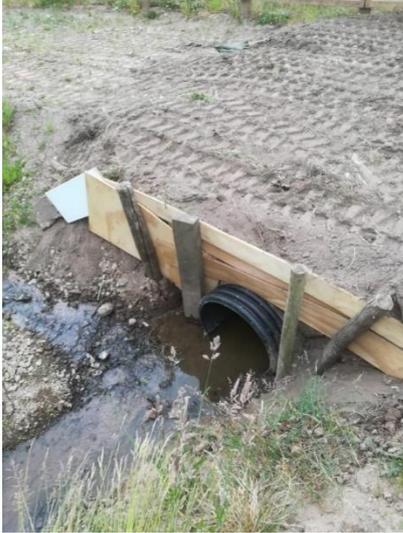
Table 119: Summary of baseline condition of potential spring S_59

Description of feature	Example photograph
<p>Watercourse recently dredged obliterating any natural features. Damaged brick outfall at spring location. Local drainage modified by construction of A556 drainage including new channels, culverts and a balancing pond.</p>

<p>Photograph taken from NGR SJ7185881525</p>

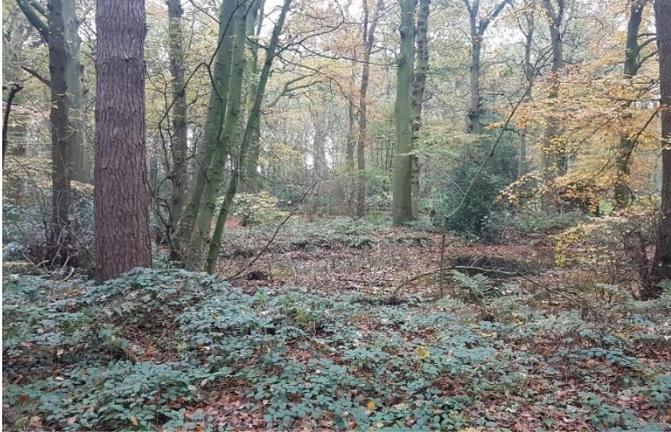
Description of feature	Example photograph
<p>The habitat is not groundwater dependent. Water dependent plants were only located alongside the bank of Tributary of Tabley Brook 9 which is fed from a spring (spring at Belt Wood north). Several ponds and ditches located within the habitat which appear manmade. The habitat has been modified for pheasant shooting.</p>

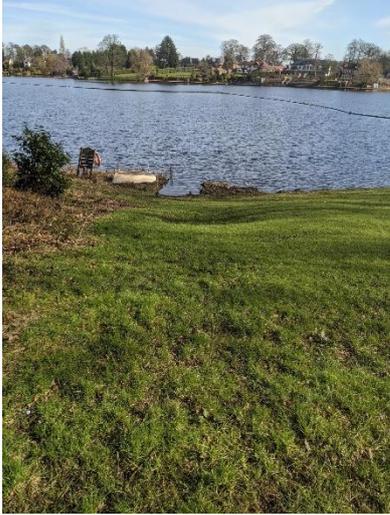
Table 121: Summary of baseline condition of GWDTE G_61

Description of feature	Example photograph
<p>The habitat is not groundwater dependant. Reeds were present at this location.</p>

<p>Photograph taken from NGR SJ7315981832</p>

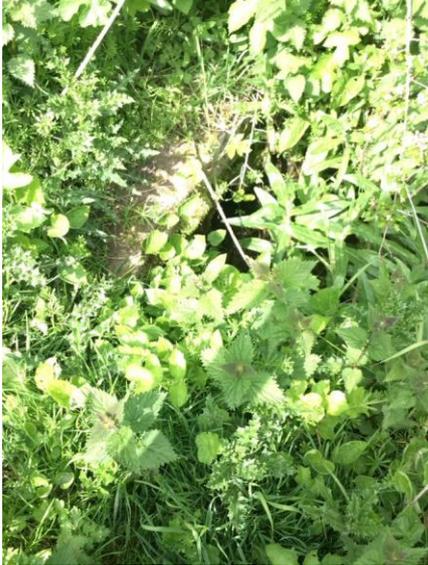
Description of feature	Example photograph
<p>A large pipe, passing under a 250m stretch of agricultural land, was located at the site of the feature. This is part of a series of ditches located around the edge of the agricultural land. Not supporting any significant habitat. This is a land drainage outfall, not a groundwater feature.</p>

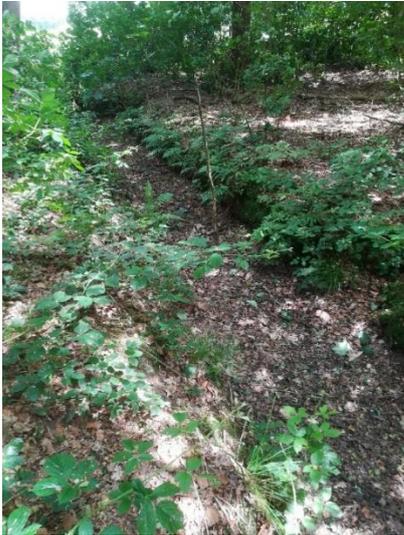
Table 123: Summary of baseline condition of potential spring S_63

Description of feature	Example photograph
<p>Surveys show that a channel has been dug, creating near vertical walls and a uniform straight channel. Unable to determine if this is a modified spring or drainage outfall. Channel was dry at time of visit. Assumed to be a groundwater feature on a precautionary basis.</p>

<p>Photograph taken from NGR SJ7185281892</p>

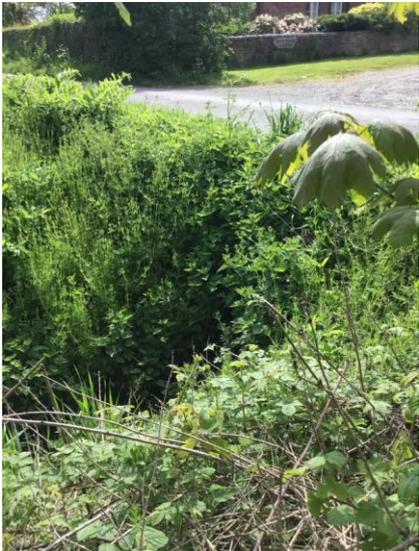
Description of feature	Example photograph
<p>This is a culvert passing under Winterbottom Lane, not a groundwater feature.</p>

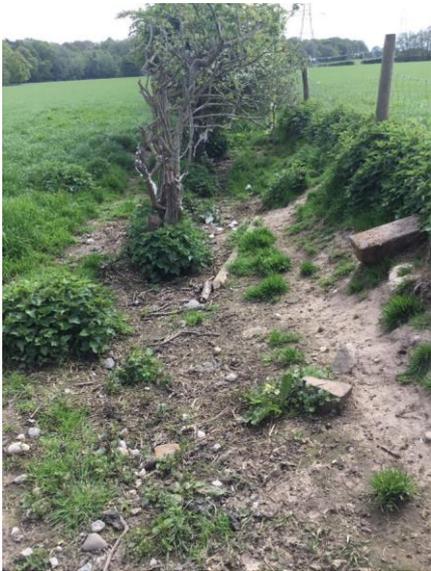
Description of feature	Example photograph
<p>Dry ditch was located during both field surveys. This is a land drainage feature. No evidence of groundwater dependency or wetland habitat.</p>

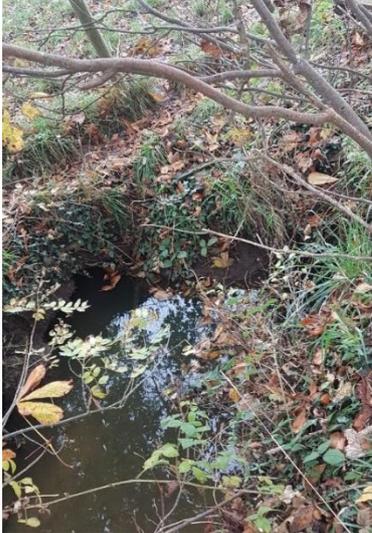
Table 126: Summary of baseline condition of spring S_66

Description of feature	Example photograph
<p>Spring feeding into channel that is composed of sandy soil with river flooding deposition features in comparison with surrounding ditches which are manmade and are muddy with a sulphur odour when disturbed. The water in the stream is fast flowing despite shallow gradient and is clear. At the source, the stream is deeper and forming a localised pool. No pipe was observed at the site during either field survey.</p>

<p>Photograph taken from NGR SJ7189482216</p>

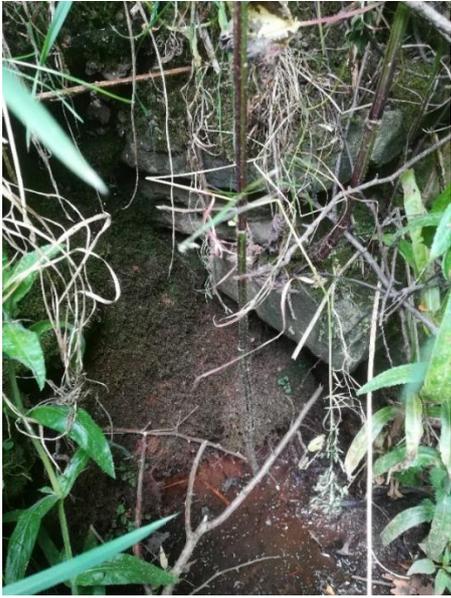
Description of feature	Example photograph
Land drainage outfall – not a groundwater feature.

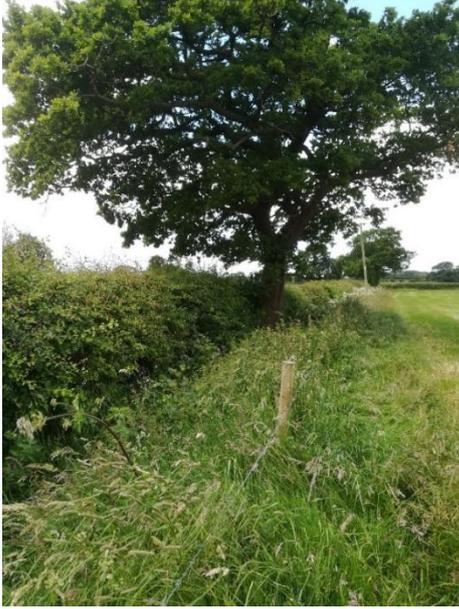
Description of feature	Example photograph
<p>This is part of a series of ditches located around the edge of the agricultural land. Not supporting any significant habitat. This is a land drainage feature, not a groundwater feature.</p>

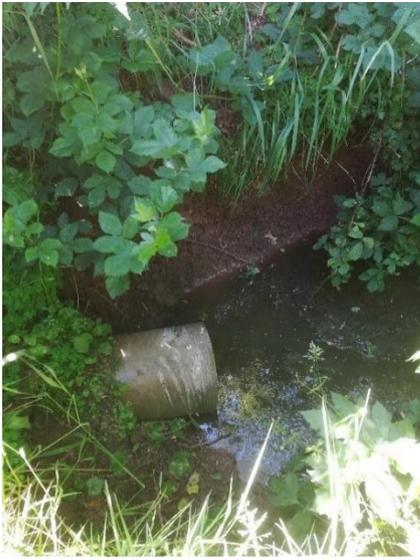
Description of feature	Example photograph
<p>A land drainage outfall was identified at the site. The pipe discharges into a drainage ditch and a flow from the pipe was observed on-site work. Some reeds were found immediately upstream of culvert. This site has been classed as groundwater dependent; it is a moderate value receptor.</p>

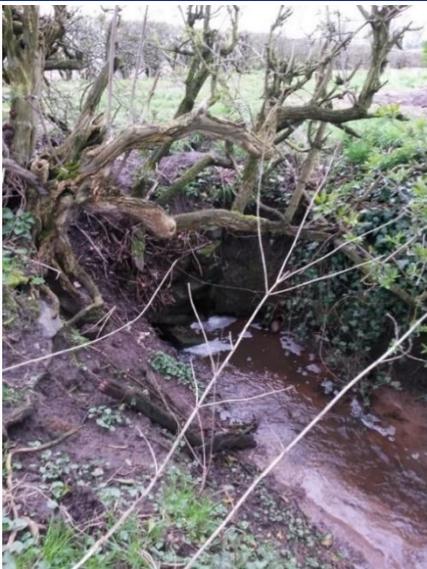
Description of feature	Example photograph
<p>Culvert – not a groundwater feature.</p>

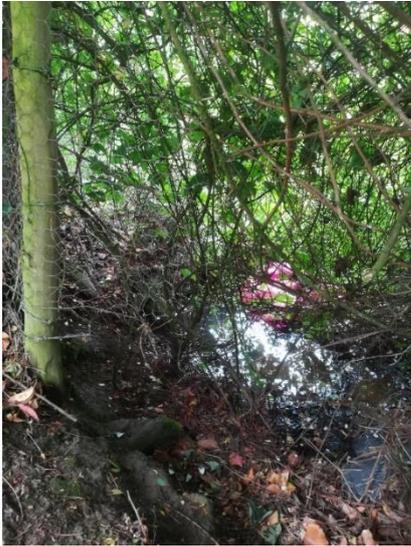
Table 132: Summary of baseline condition of potential spring S_72a

Description of feature	Example photograph
<p>No obvious wetland habitat identified. The nature of the feature is uncertain due to access constraints and overgrown vegetation. The watercourse appears to start at roadside but not obvious if natural spring or culvert outfall as overgrown by hedge.</p>

<p>Photograph taken from NGR SJ7145083461</p>

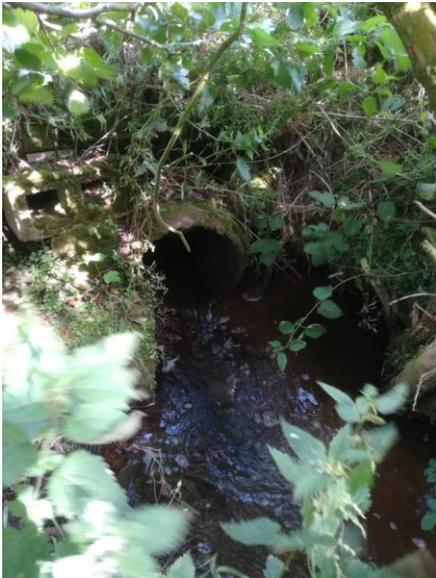
Description of feature	Example photograph
<p>The source of watercourse is piped land drainage outfall supporting useful habitat.</p> <p>Several nearby ponds but it is deemed unlikely that these are supported by groundwater.</p>

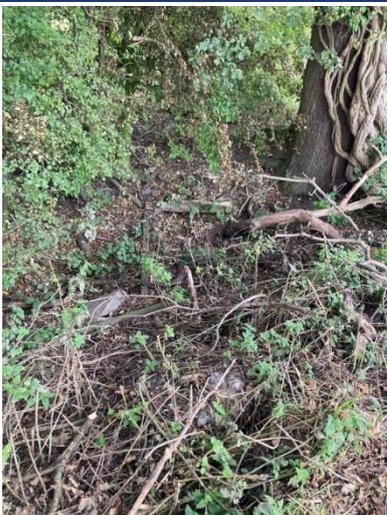
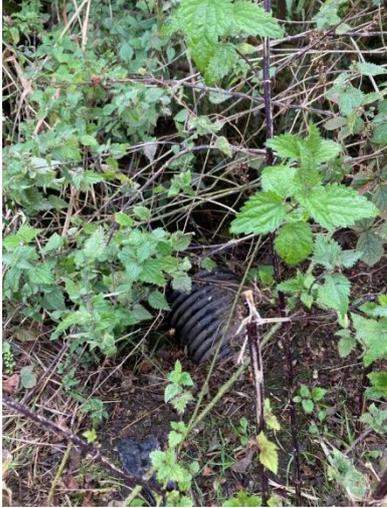
Table 134: Summary of baseline condition of potential spring S_74

Description of feature	Example photographs
<p>Surveys located a shallow, dry ditch with no wetland ecology. Land drainage outfall located across field at NGR SJ7187284566. This is a land drainage feature – not a groundwater feature.</p>

<p data-bbox="639 824 1137 853">Photographs taken from NGR SJ7167484667</p>

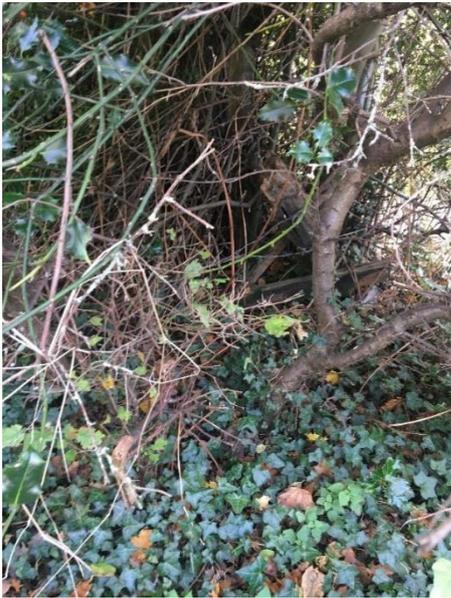
Description of feature	Example photograph
<p>Surveys were unable to identify a groundwater feature at the site. No habitat other than a maintained hedgerow on edge of field. The potential spring possibly feeds into Rostherne Mere so has been assumed to be a spring on a precautionary basis.</p>

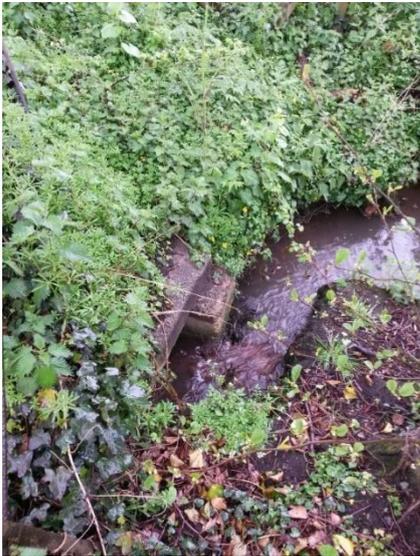
Description of feature	Example photograph
Land drainage outfall – not a groundwater feature.

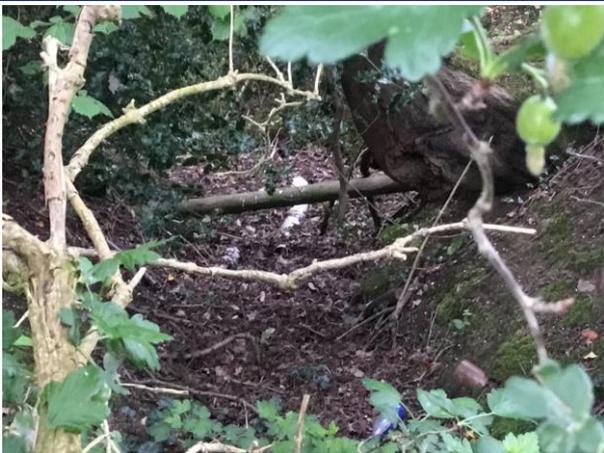
Description of feature	Example photograph
Land drainage channel – not a groundwater feature.

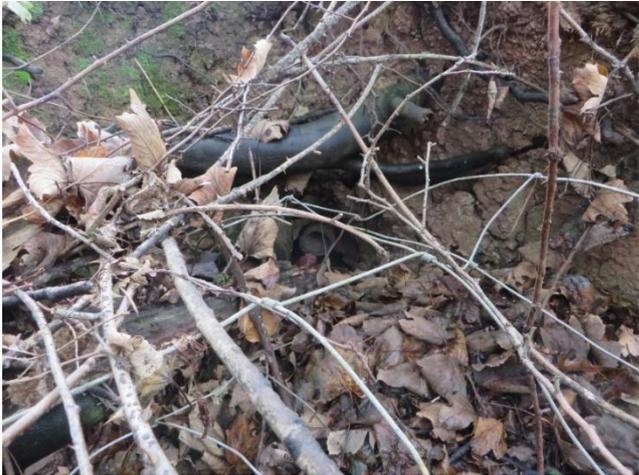
Description of feature	Example photograph
<p>Land drainage outfall – not a groundwater feature.</p>

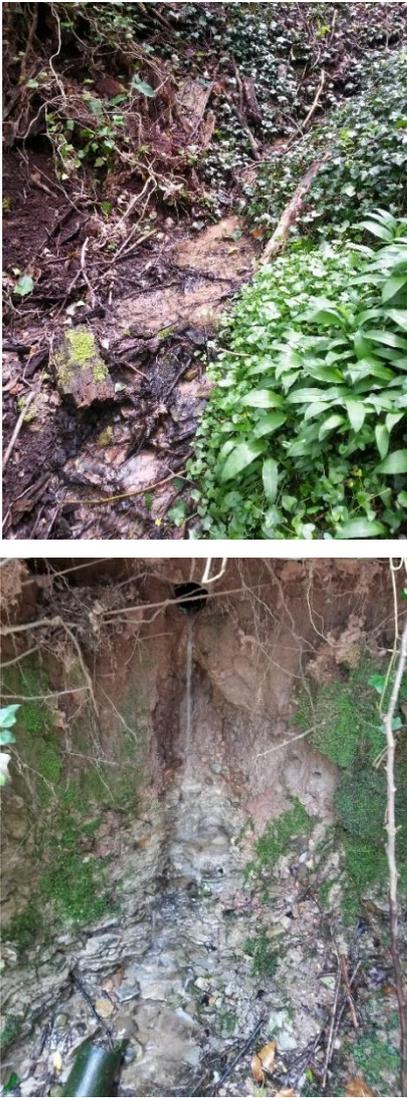
Description of feature	Example photograph
<p>Survey shows there is both a spring and drainage outfall at this location. Revisit survey noted that the watercourse was dry hence this is likely a seasonal spring.</p>

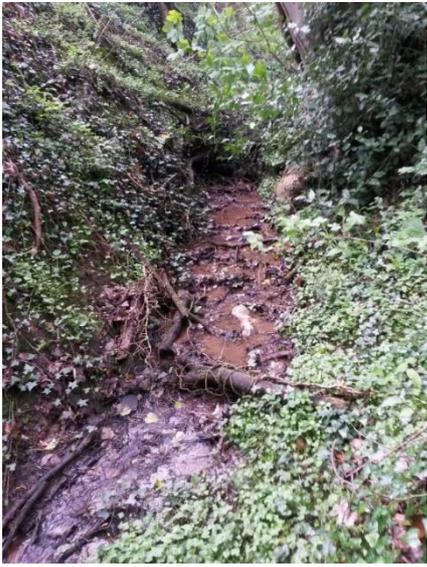
Description of feature	Example photograph
<p>Spring discharging to small tributary of the River Bollin. Revisit survey noted that the watercourse was dry hence this is likely a seasonal spring.</p>

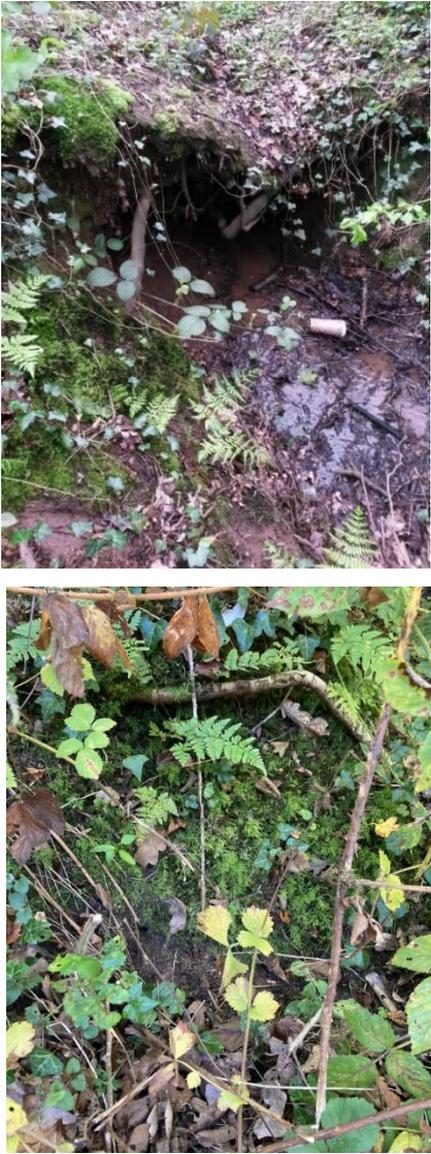
Description of feature	Example photograph
<p>Surveys identified wetland ecology (mosses and Yorkshire fog) at site with a dry channel downslope of the spring. No flow identified from spring at time of survey hence this is likely a seasonal spring. Spring was also identified during a different survey.</p> <p>Buried pipe was also located which may be connected to land drainage system.</p>

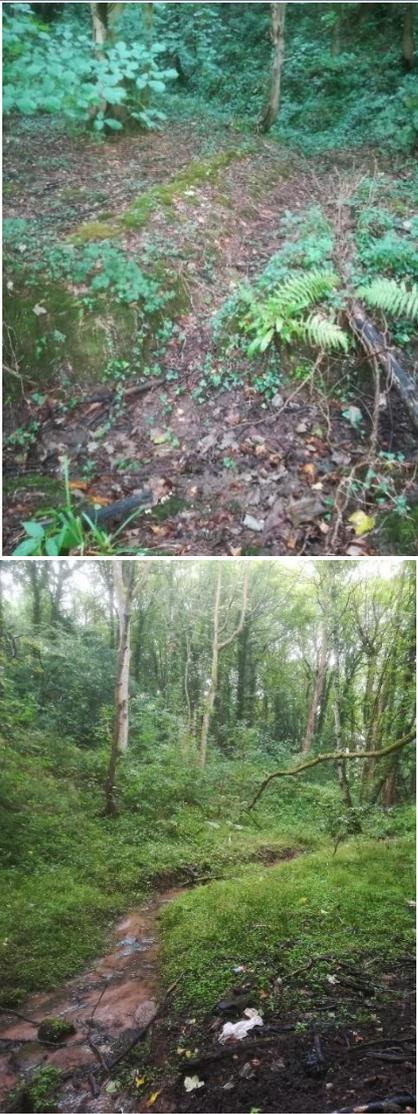
Description of feature	Example photographs
<p>No evidence of wetland but streams located which are supported by springs. Wetland vegetation found adjacent to ponds. This suggests that the woodland is at least partially dependent on groundwater.</p>

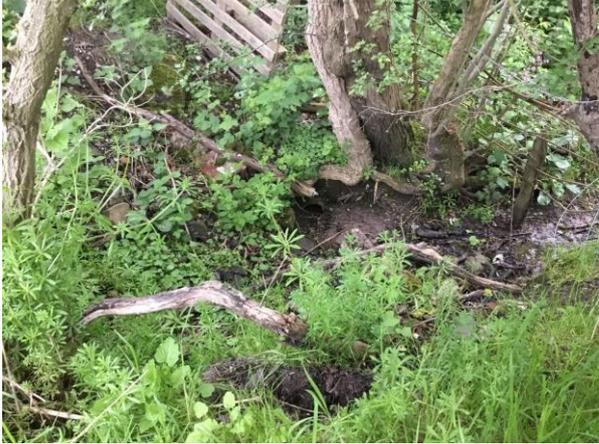
Description of feature	Example photograph
Land drainage outfall – not a groundwater feature.

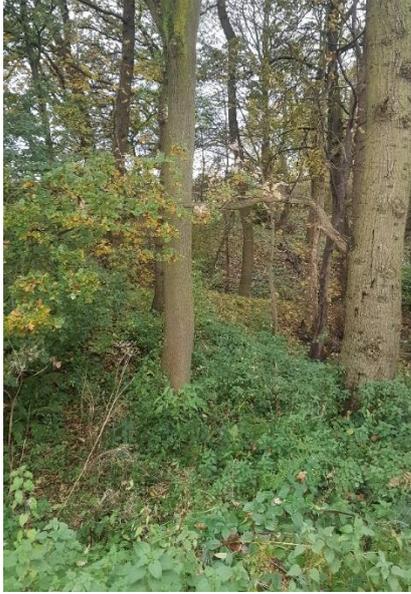
Description of feature	Example photograph
<p>Not a groundwater dependent habitat. Woodland consists of several piped, deep drainage ditches discharging into the River Bollin. Ground level is relatively flat and the large closed depression in the north of the habitat was dry; a groundwater collect would be expected here if the habitat was groundwater dependent.</p>

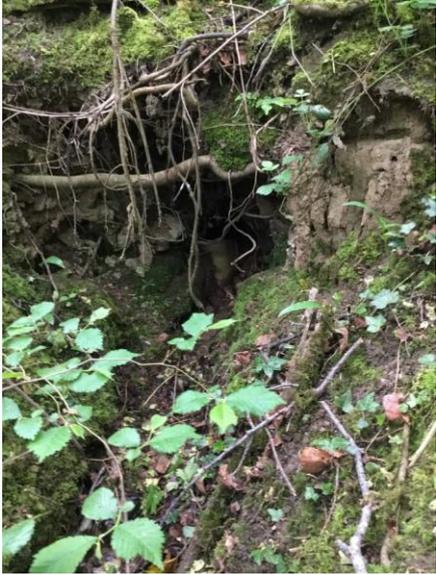
Table 145: Summary of baseline condition of potential spring S_142

Description of feature	Example photograph
Land drainage outfall – not a groundwater feature.

<p data-bbox="639 936 1126 963">Photograph taken from NGR SJ8024384344</p>

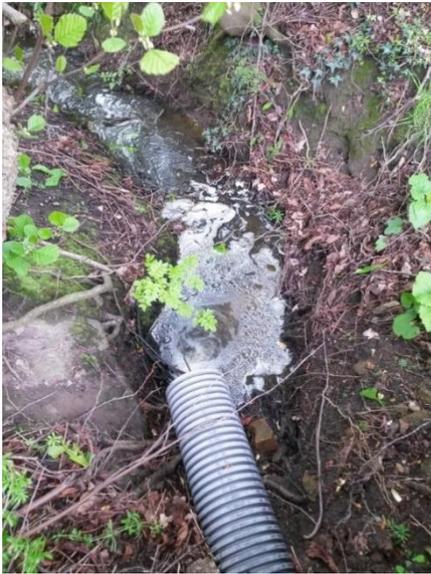
Table 146: Summary of baseline condition of potential spring S_143

Description of feature	Example photograph
<p>Land drainage outfall – not a groundwater feature. No obvious wetland habitat.</p>

<p>Photograph taken from NGR SJ7850484410</p>

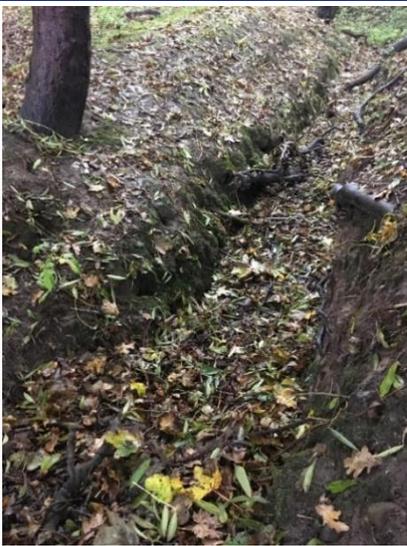
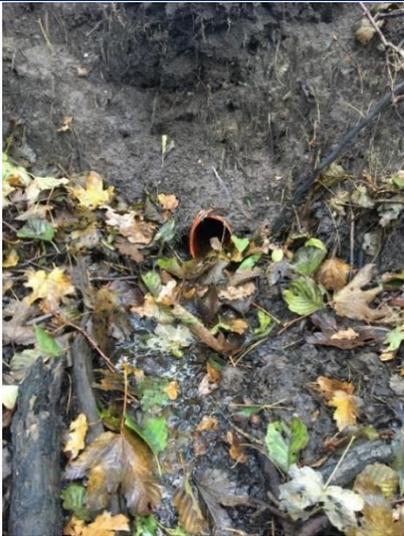
Table 147: Summary of baseline condition of potential spring S_144a

Description of feature	Example photographs
<p>Land drainage channel feeding into dug-out ditch was located at the site of the potential spring. A second piped land drainage outfall (not shown on OS maps) was identified 50m downstream of the potential spring. No wetland habitat.</p>

<p data-bbox="639 846 1139 880">Photographs taken from NGR SJ7903884439</p>

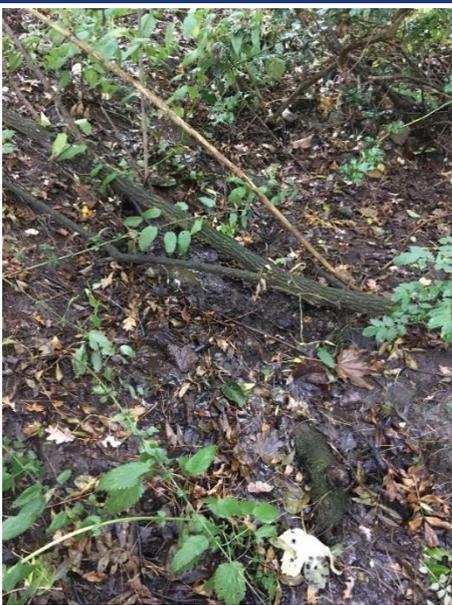
Table 148: Summary of baseline condition of spring S_144b

Description of feature	Example photograph
<p>A spring was located during field survey of potential spring S_144a. There is a brick and slab near the spring however, this has collapsed and been infilled with sediment. When soil was dug away, water seeped out slowly. Natural channel downstream of spring differs from the dug-out channels of the land drains and a few ferns were located around the spring.</p>

<p data-bbox="639 2029 1128 2063">Photograph taken from NGR SJ7905584438</p>
