High Speed Rail (Crewe – Manchester)

Water resources and flood risk

BID WR-002-00001 SES2 and AP2 ES

Water Framework Directive compliance assessment
baseline data - Part 2 of 2

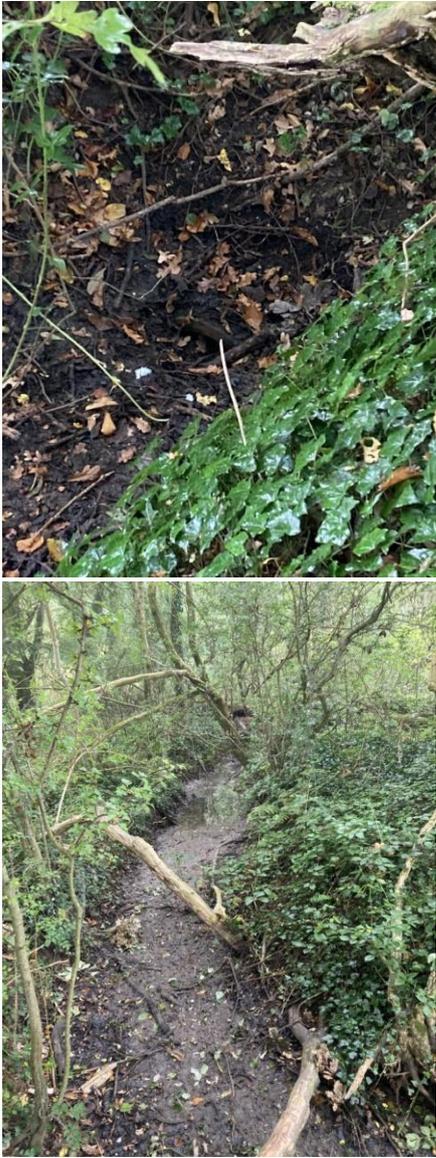
Table 149: Summary of baseline condition of GWDTE G_145a

Description of feature	Example photographs
<p>Partial surveys showed the habitat is not groundwater dependent. Drainage ditch located around edge of habitat and stagnant watercourse within the woodland. However, full access was not available so further surveys are required to confirm the nature of this habitat. As such, Brickhill Wood is assumed to be a groundwater dependent habitat on a precautionary basis until further surveys can be completed.</p>

<p>Photographs taken from NGR SJ7910883633</p>

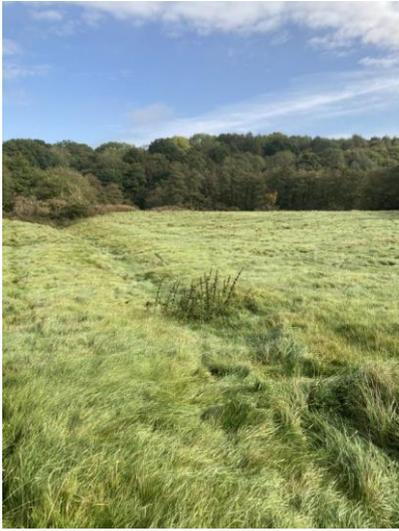
Table 150: Summary of baseline condition of GWDTE G_145b

Description of feature	Example photograph
<p>Habitat located on bank of River Bollin dominated by trees and other water dependent ecology. Habitat will receive runoff from agricultural land. The habitat is also partially groundwater dependent land, with contribution from springs, as several springs identified in proximity to this habitat. Some areas of replanting observed alongside Mill Lane.</p>

<p>Photograph taken from NGR SJ7979283924</p>

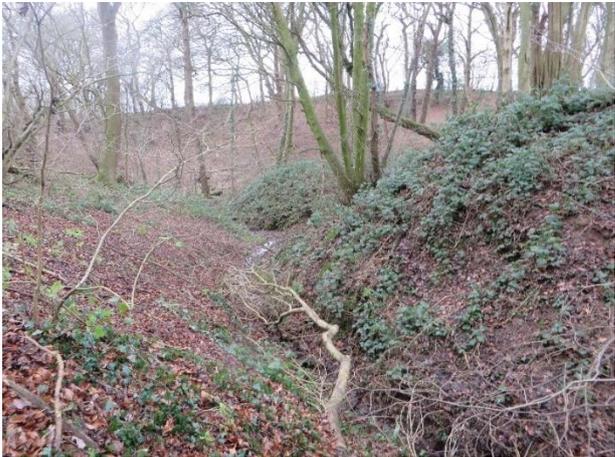
Table 151: Summary of baseline condition of GWDTE G_145c

Description of feature	Example photograph
<p>Surveys confirmed the habitat is broadleaf woodland (predominantly Sycamore and Ash) and is not assessed to be groundwater dependent.</p>

<p>Photograph taken from NGR SJ7943884440</p>

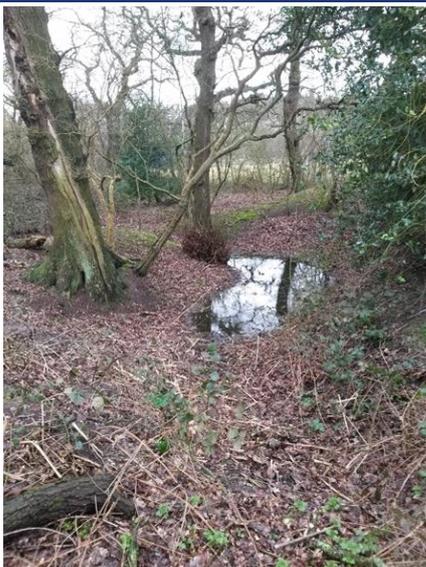
Table 152: Summary of baseline condition of GWDTE G_147

Description of feature	Example photograph
<p>The woodland is dominated by tree species associated with wet woodland, such as willow, alder and silver birch. In addition, the woodland floor contains large pools and is dominated by Indian balsam, which is a weed found in aquatic habitats.</p> <p>Several springs and minor watercourses were identified along with areas of standing water. This area of the site is likely to be partially groundwater dependent.</p>

<p>Photograph taken from NGR SJ7574684507</p>

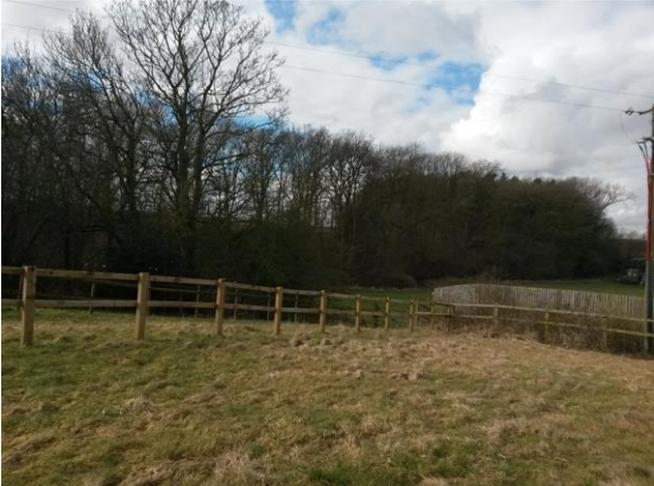
Table 153: Summary of baseline condition of GWDTE G_150

Description of feature	Example photograph
<p>Wood in small valley. Access restricted to PRoW. As such, a habitat survey required to assess extent and value of habitat.</p>

<p>Photograph taken from NGR SJ7553284560</p>

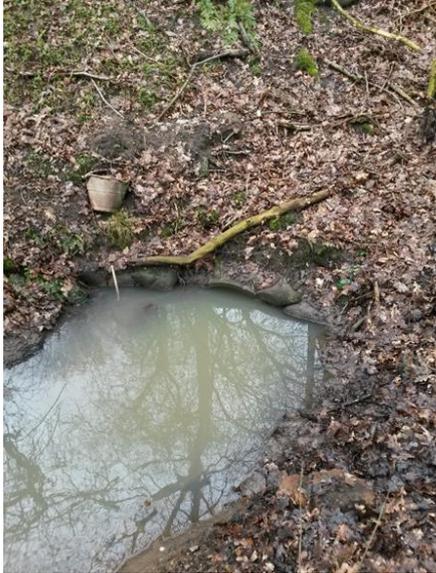
Table 154: Summary of baseline condition of potential spring S_151

Description of feature	Example photograph
Culvert – not a groundwater feature.

<p data-bbox="644 936 1126 963">Photograph taken from NGR SJ7610684563</p>

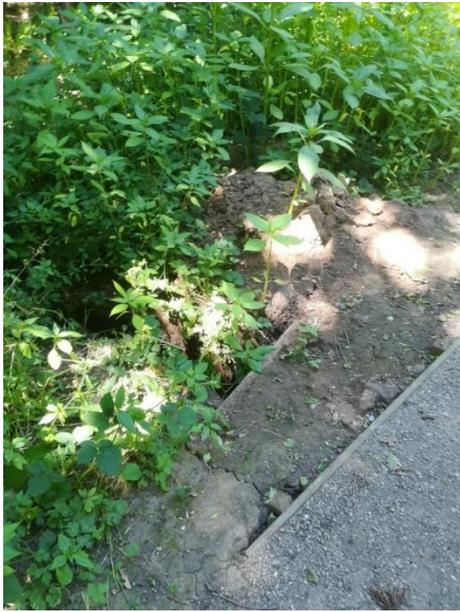
Table 155: Summary of baseline condition of potential spring S_152

Description of feature	Example photograph
<p>No specific feature identified, however path was clearly muddy with a raised stone section and a newly dug drain. This indicates that there is flow at this location, with the spring potentially being seasonal and not flowing at the time of the survey.</p> <p>Possible wetland species (willow) were also identified.</p>

<p>Photograph taken from NGR SJ7922584612</p>

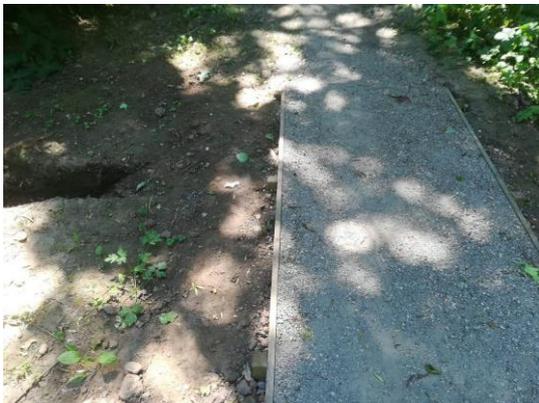
<p>Photograph taken from NGR SJ7922584612</p>

Description of feature	Example photograph
<p>No specific feature identified, however path was clearly muddy with a raised stone section and a newly dug drain. This indicates that there is flow at this location, with the spring potentially being seasonal and not flowing at the time of the survey.</p> <p>Possible wetland species (willow) were also identified.</p>

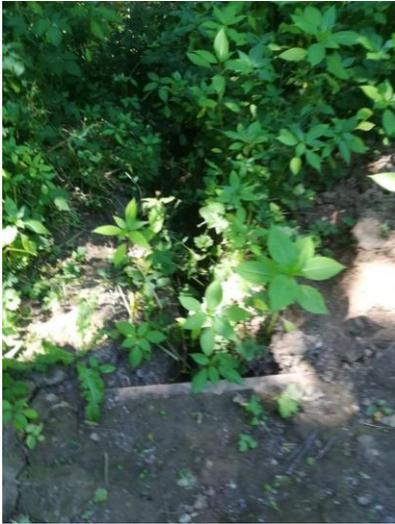
<p>Photograph taken form NGR SJ7922584612</p>

Description of feature	Example photograph
<p>No specific feature identified, however path was clearly muddy with a raised stone section and a newly dug drain. This indicates that there is flow at this location, with the spring potentially being seasonal and not flowing at the time of the survey.</p> <p>Possible wetland species (willow) were also identified.</p>

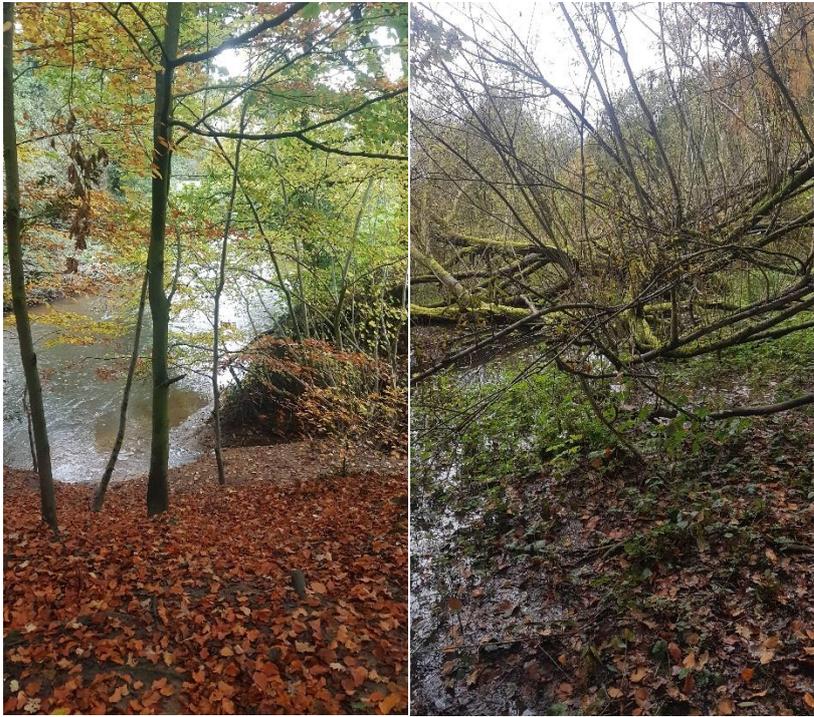
<p>Photograph taken from NGR SJ7926084652</p>

Description of feature	Example photograph
<p>Habitat is not considered to be groundwater dependent. Several ponds observed within the habitat at base of valley sides at the break in slopes. No evidence these ponds are groundwater collects but likely instead originate from overland flow down valley sides, and the ponds had little marginal habitat. Culverted ditches within the habitat.</p> <p>Some evidence of groundwater flow into the River Bollin so likely groundwater is at depth; no evidence of groundwater geomorphology or dependency away from the River Bollin.</p>

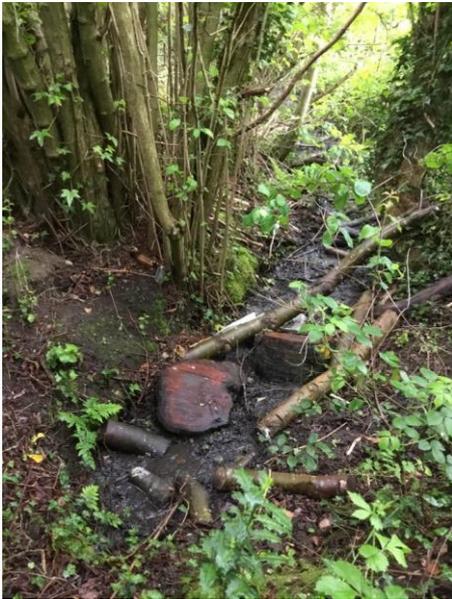
<p>Photograph taken from NGR SJ8006984653</p>

Description of feature	Example photograph
<p>This is a spring discharging into Tributary of River Bollin 2 and is supporting wetland habitat.</p>

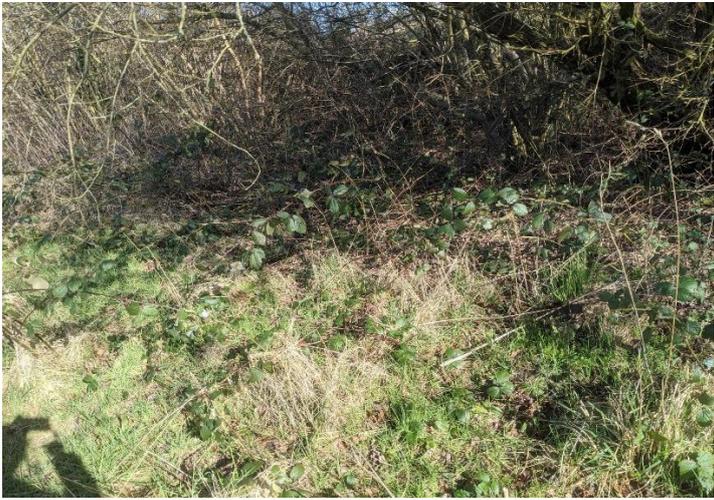
<p>Photograph taken from NGR SJ8006784668</p>

Description of feature	Example photographs
<p>Survey could not find evidence of groundwater features at the site.</p>

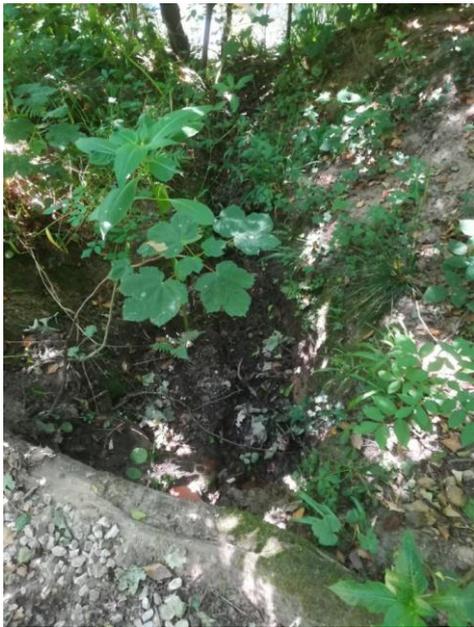
<p>Photograph taken from NGR SJ7920584687</p>

Description of feature	Example photograph
<p>Surveys could not find any evidence of a sink (as shown on OS maps) at the site. The only feature located was a culvert.</p>

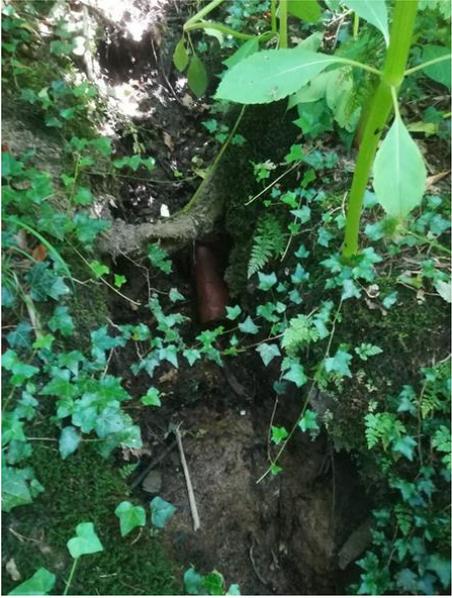
<p>Photograph taken from NGR SJ7923184720</p>

Description of feature	Example photograph
<p>Surveys located a small stream flowing down a steep hillside. A small pipe discharges into the stream. This is a land drainage outfall, not a groundwater feature.</p>

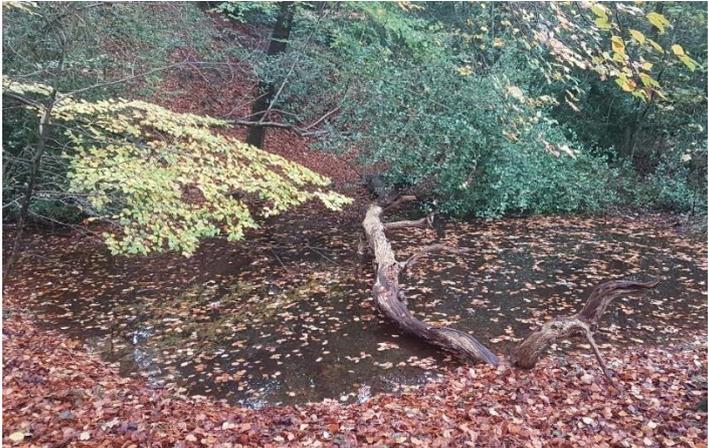
<p>Photograph taken from NGR SJ7908484743</p>

Description of feature	Example photograph
<p>Several ponds observed within the habitat at break in slopes. No evidence that these ponds are groundwater collects but, likely instead, originate from overland flow down valley sides. The ponds had little marginal habitat. Culverted ditches identified within the habitat.</p> <p>Some evidence of groundwater flow into the River Bollin so likely groundwater flow at depth. The spring 90m west of Halesmere Avenue, Hale, located at the northern edge of the habitat, flows through the habitat into the River Bollin. However, there is little evidence of groundwater geomorphology or dependency away from the River Bollin. Habitat is deemed surface water and groundwater dependent although is scoped out due to the lack of impact pathway for hydrological impact.</p>

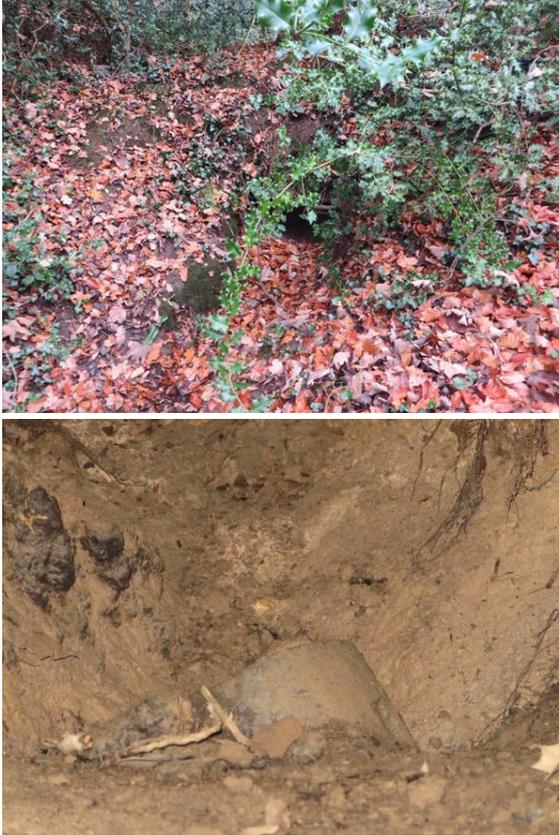
<p>Photographs taken from NGR SJ7874684770</p>

Description of feature	Example photographs
<p>A culvert was observed during the site visit. No flow observed during the visit. Not a groundwater feature.</p>

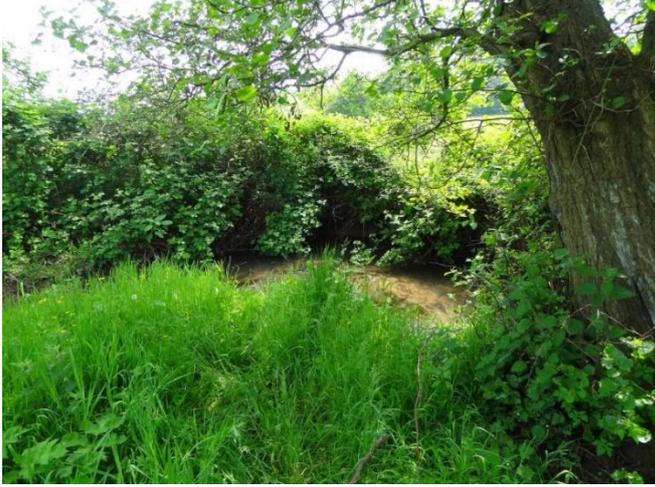
<p>Photograph taken from NGR SJ7418884914</p>

Description of feature	Example photograph
<p>Rostherne Mere is supported by the watercourses feeding into the Mere from the catchment. Rostherne Brook provides approximately 80% of the inflow into Rostherne Mere. These streams are determined to be fed by springs hence Rostherne Mere is a groundwater dependent habitat.</p>

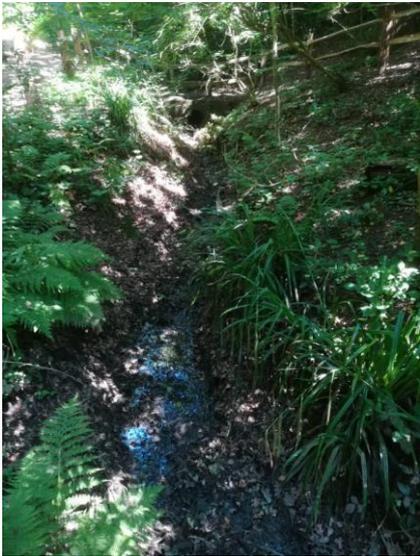
<p>Photograph taken from NGR SJ7878884945</p>

Description of feature	Example photograph
<p>Spring feeding into a small stream flowing straight down steep hillside. The channel is very steep sided, the form suggesting large flows during wet periods. Parts of the channel are culverted.</p>

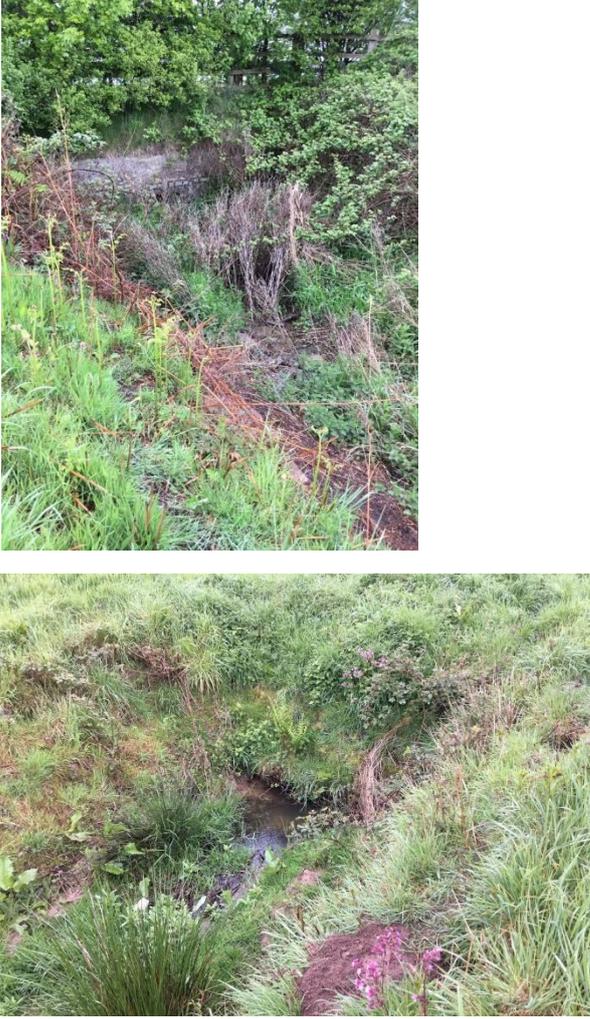
<p>Photographs taken from NGR SJ7380485163</p>

Description of feature	Example photographs
<p>This is a land drainage outfall, discharging into a culvert passing under the M56 and feeding into Tributary of River Bollin 11.</p>

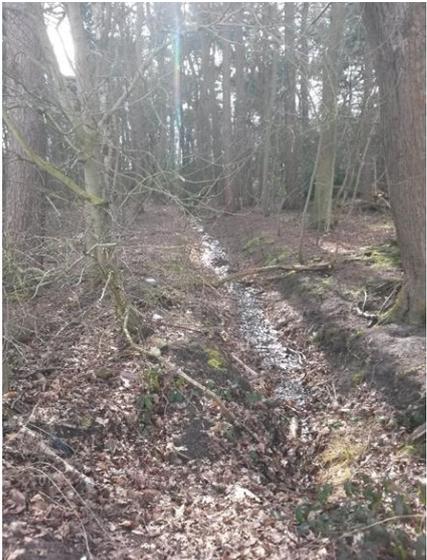
<p>Photograph taken from NGR SJ7451985190</p>

Description of feature	Example photograph
<p>Site visit identified a shallow drainage ditch through woodland in a north-south direction through coniferous woodland, terminating in ponds in the south-eastern corner of the woodland. The ditch was shallow and not flowing at the time of survey.</p>

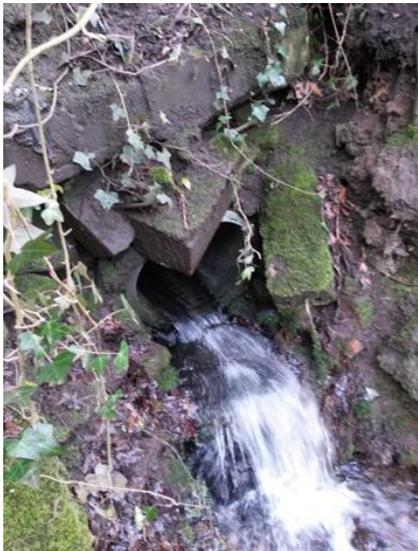
<p>Photograph taken from NGR SJ7632285267</p>

Description of feature	Example photograph
<p>Site visits identified a pipe in the side of depression. This is a probable land drainage outfall – a concrete manhole cover was located upslope.</p>

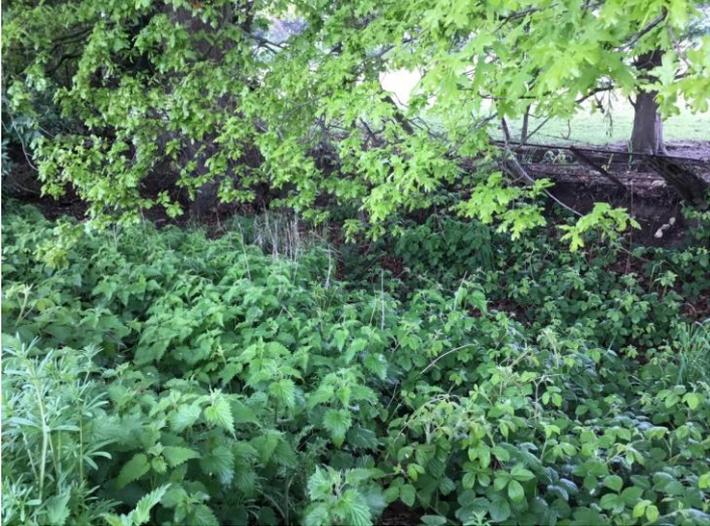
<p>Photograph taken from NGR SJ7326185393</p>

Description of feature	Example photograph
<p>This is a land drainage feature with no evidence of wetland habitat or groundwater dependency at the feature. The ditch was dry during the field survey however likely supports overland flow during high precipitation events. Not a groundwater feature.</p>

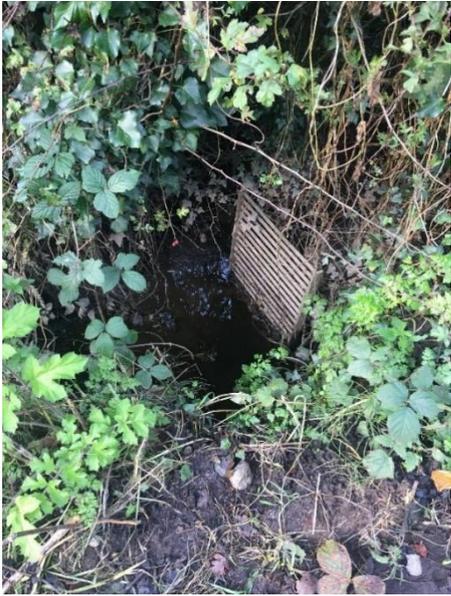
<p>Photograph taken from NGR SJ7339985553</p>

Description of feature	Example photograph
<p>Manmade drain with metal grid with a square brick hole at bottom of drain. Connected to dug out drain alongside road. Ditch is culverted under driveways further upstream. Likely connected to local drainage network. Road drain adjacent to the potential sink.</p>

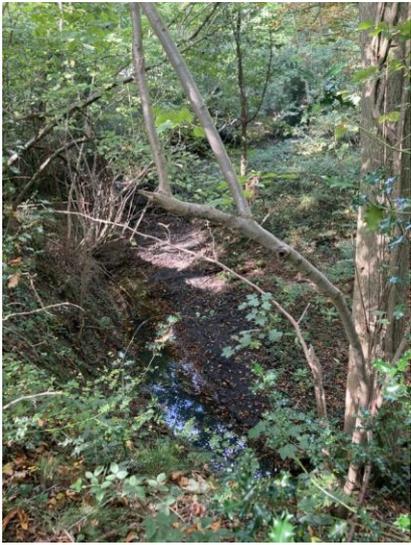
<p>Photograph taken from NGR SJ8045086210</p>

Description of feature	Example photograph
<p>Citation information and partial survey identified no areas of saturated ground with no clear evidence of groundwater dependency or wetland ecology. Timperley Brook flows through the habitat.</p>

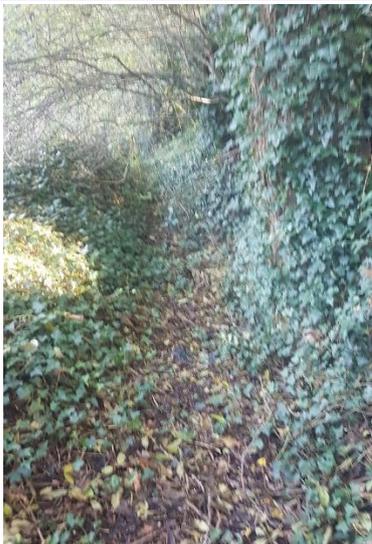
<p>Photograph taken from NGR SJ7968786290</p>

Description of feature	Example photograph
<p>Surveys confirmed this is a constructed ditch between farmland and road. Break of slope into ditch from road. No wetland habitat or groundwater features.</p>

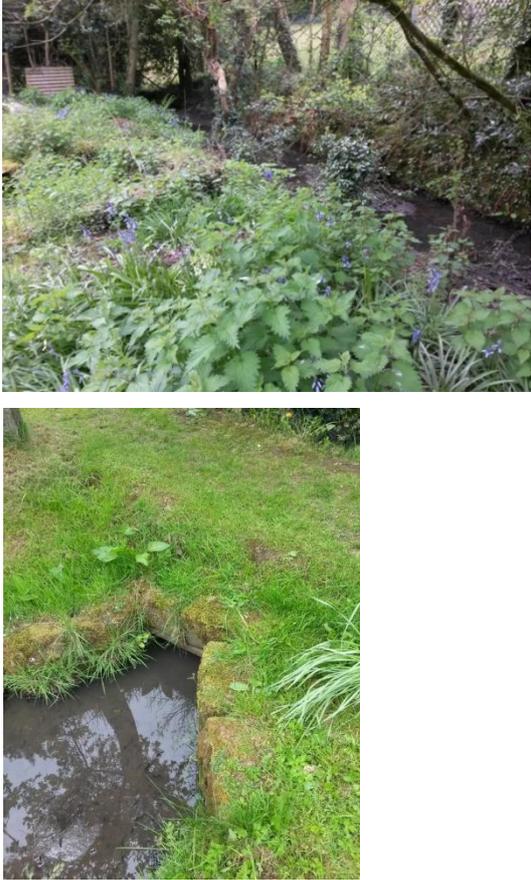
<p>Photographs taken from NGR SJ8041786572</p>

Description of feature	Example photographs
<p>The spring feature is located in a garden in a shallow valley. Soil absolutely saturated despite dry weather. There are two drainage outfalls located in proximity to the spring, but these were not flowing.</p>

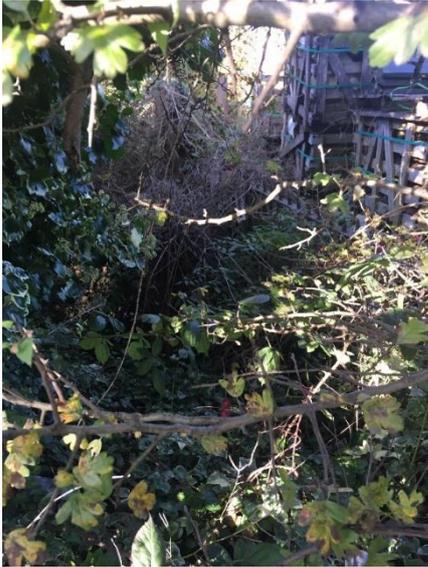
<p>Photograph taken from NGR SJ8030587774</p>

Description of feature	Example photograph
<p>Culvert passing under road (Dobbinetts Lane). Water from land drainage feeding into a ditch located behind houses and an industrial yard. Not a groundwater feature.</p>

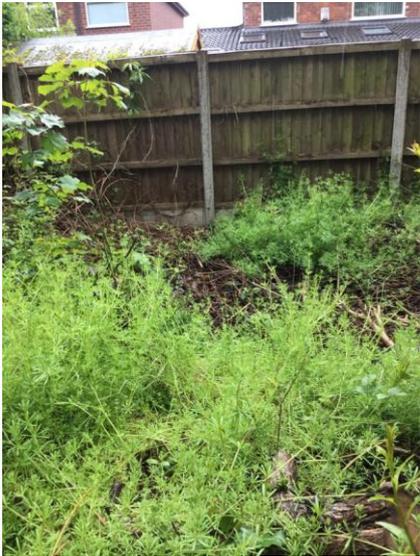
<p>Photograph taken from NGR SJ8180988919</p>

Description of feature	Example photograph
<p>Surveys unable to identify a feature during the field survey. The feature is connected to a culvert under a railway. Assumed to be a high value receptor until confirmed by further field surveys.</p>

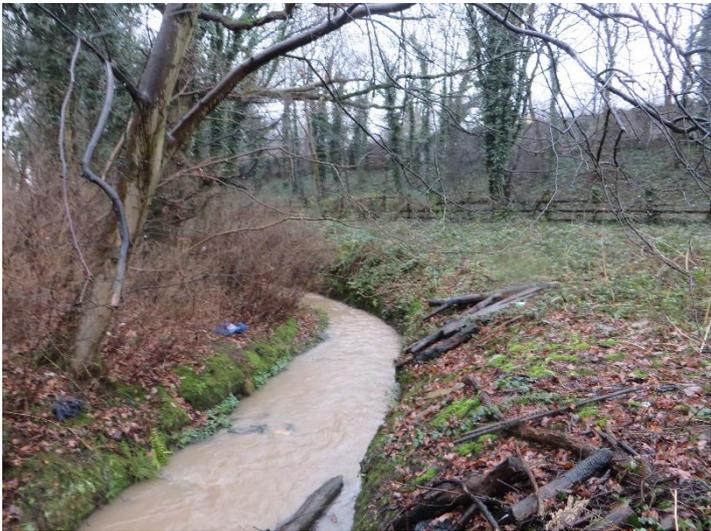
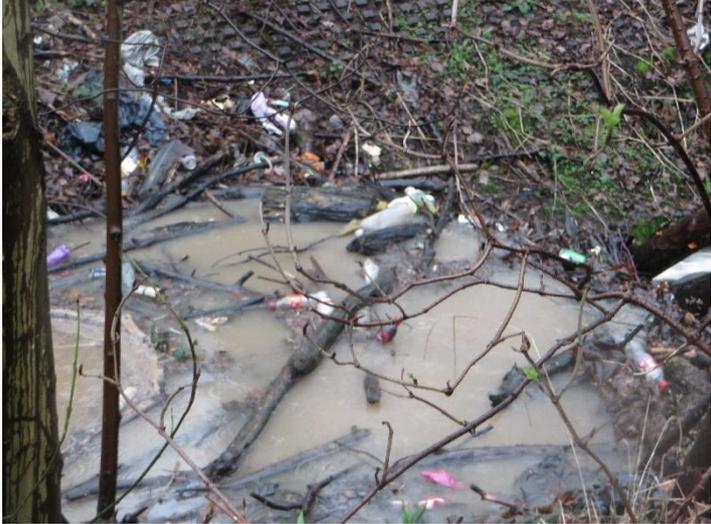
<p data-bbox="639 840 1137 869">Photographs taken from NGR SJ8212188985</p>

Description of feature	Example photographs
<p>Partial surveys confirm the habitat is unlikely to be groundwater dependent due to the large watercourse flowing within the habitat. Small area of woodland identified next to the river. The habitat is not considered to be favourable due to the large amount of litter within it. However, further surveys are required for a full assessment of the habitat to confirm the dependency of the habitat.</p>

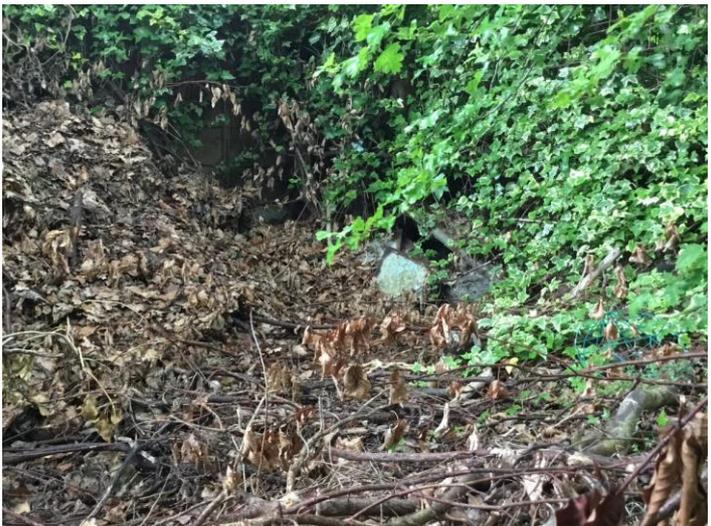
<p data-bbox="639 1928 1126 1957">Photograph taken from NGR SJ8180289023</p>

Description of feature	Example photograph
<p>Culvert under a railway – not a groundwater feature.</p>

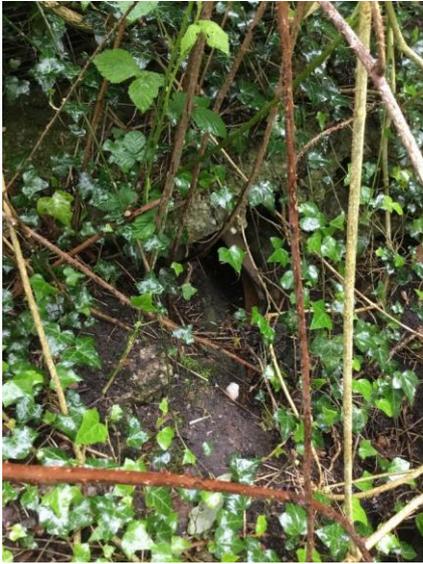
<p data-bbox="639 1317 1126 1350">Photograph taken from NGR SJ8243589244</p>

Description of feature	Example photograph
Culvert – not a groundwater feature.

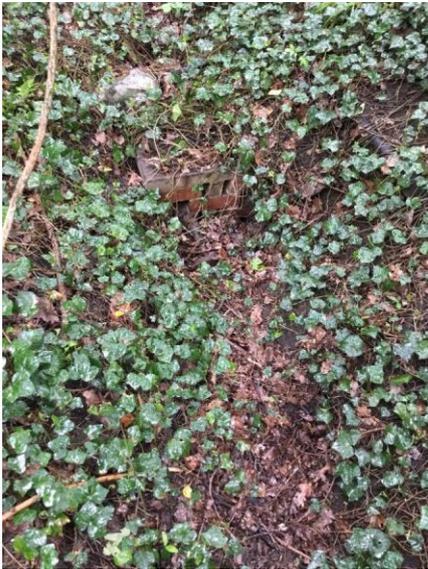
<p data-bbox="639 929 1126 958">Photograph taken from NGR SJ8248589335</p>

Description of feature	Example photograph
Culvert – not a groundwater feature.

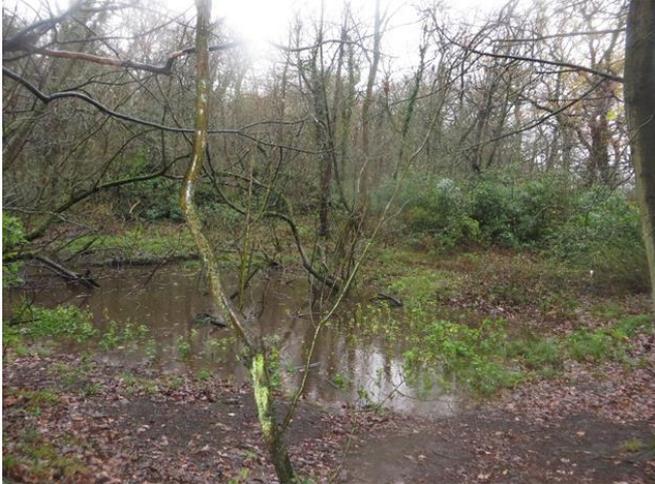
<p>Photograph taken from NGR SJ8162789763</p>

Description of feature	Example photograph
Pools and ponds which have formed within areas of marginally lower topography (less than 1m) suggest the water level is high and likely to be similar depth to the Basford Brook. Some areas of ponds have likely formed due to the glacial till preventing sufficient infiltration during rainfall events, hence perched groundwater. However, due to habitat value screened in for further assessment.

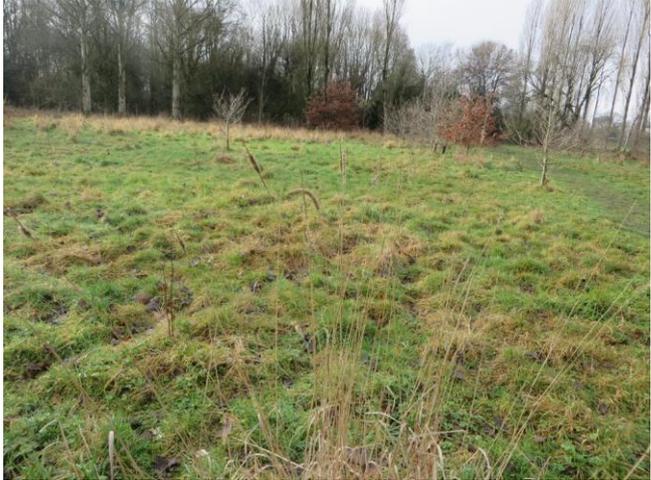
<p>Photograph taken from NGR SJ8425790067</p>

Description of feature	Example photograph
<p>Boggy areas within slight depressions and around ponds. This suggests groundwater levels are relatively high and are forming collects. Drainage ditch indicates this area floods and may be a wetland at certain times of the year. There are areas of wetland vegetation surrounding the ponds. This habitat is at least partially groundwater dependent. Access was only available via PRoW so further surveys are required to assess the full extent of the habitat.</p>
