April 202**3**

HS2

Air Quality and Dust Monitoring Monthly Report — April 2023 Buckinghamshire Council

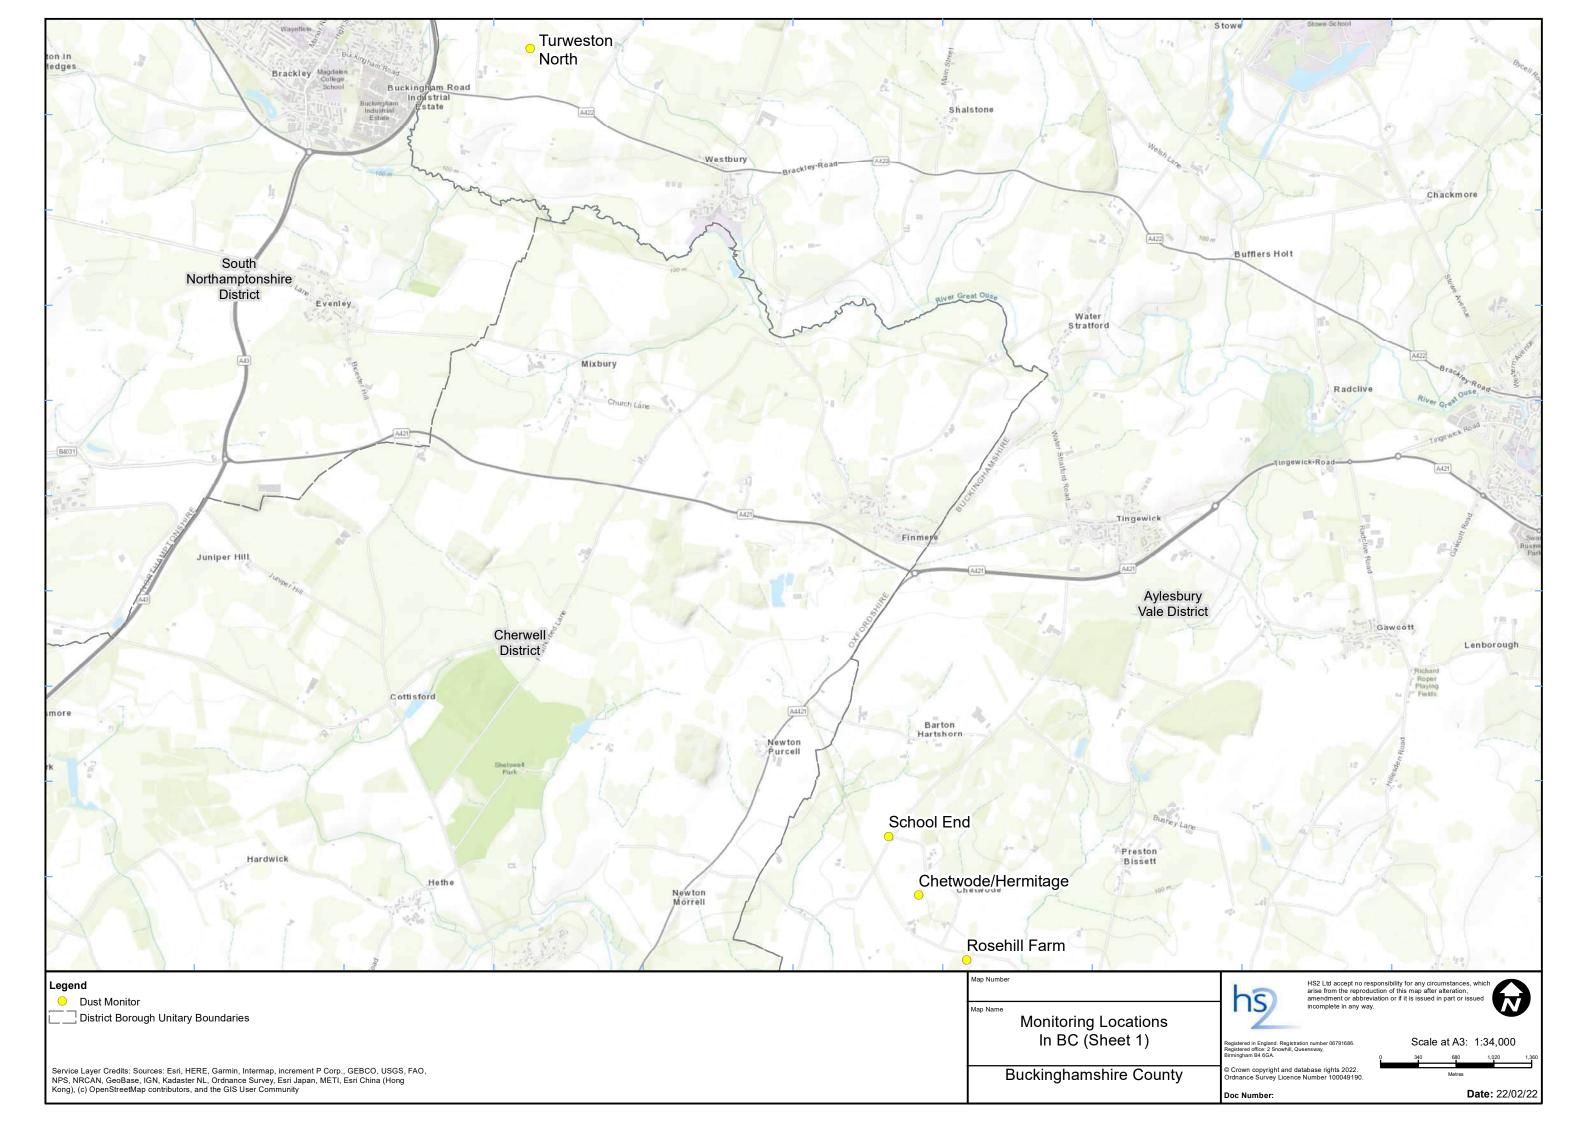
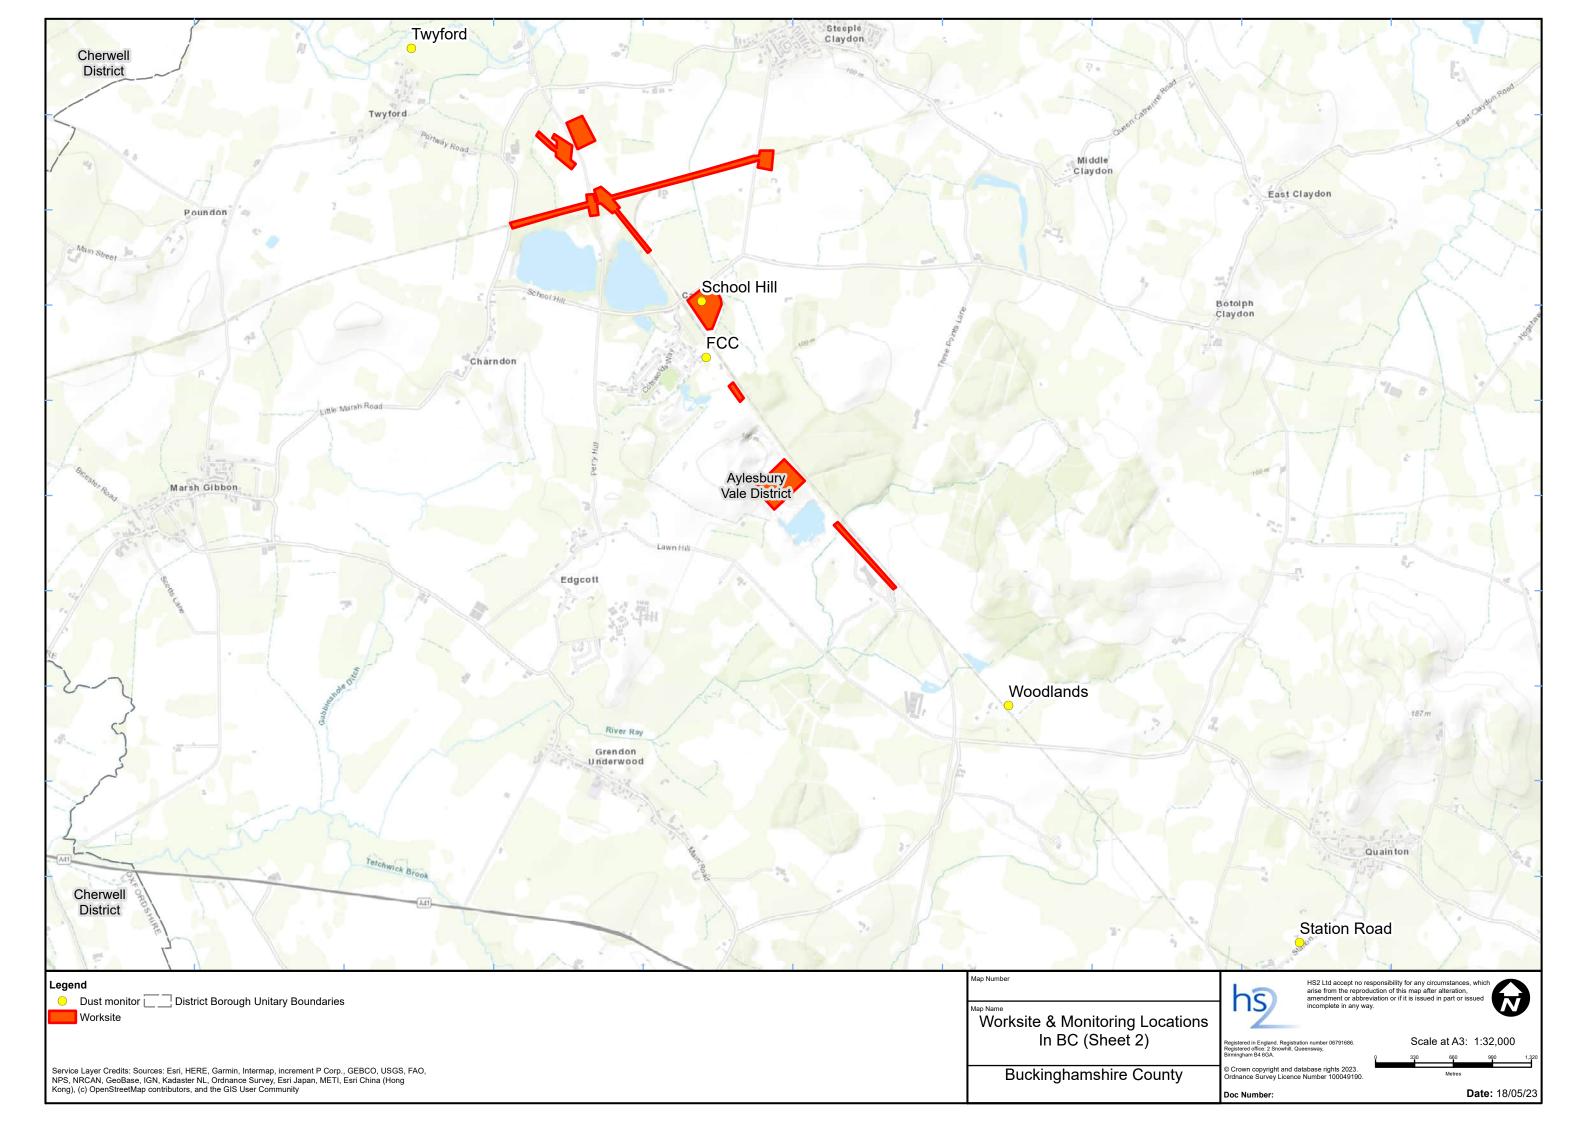
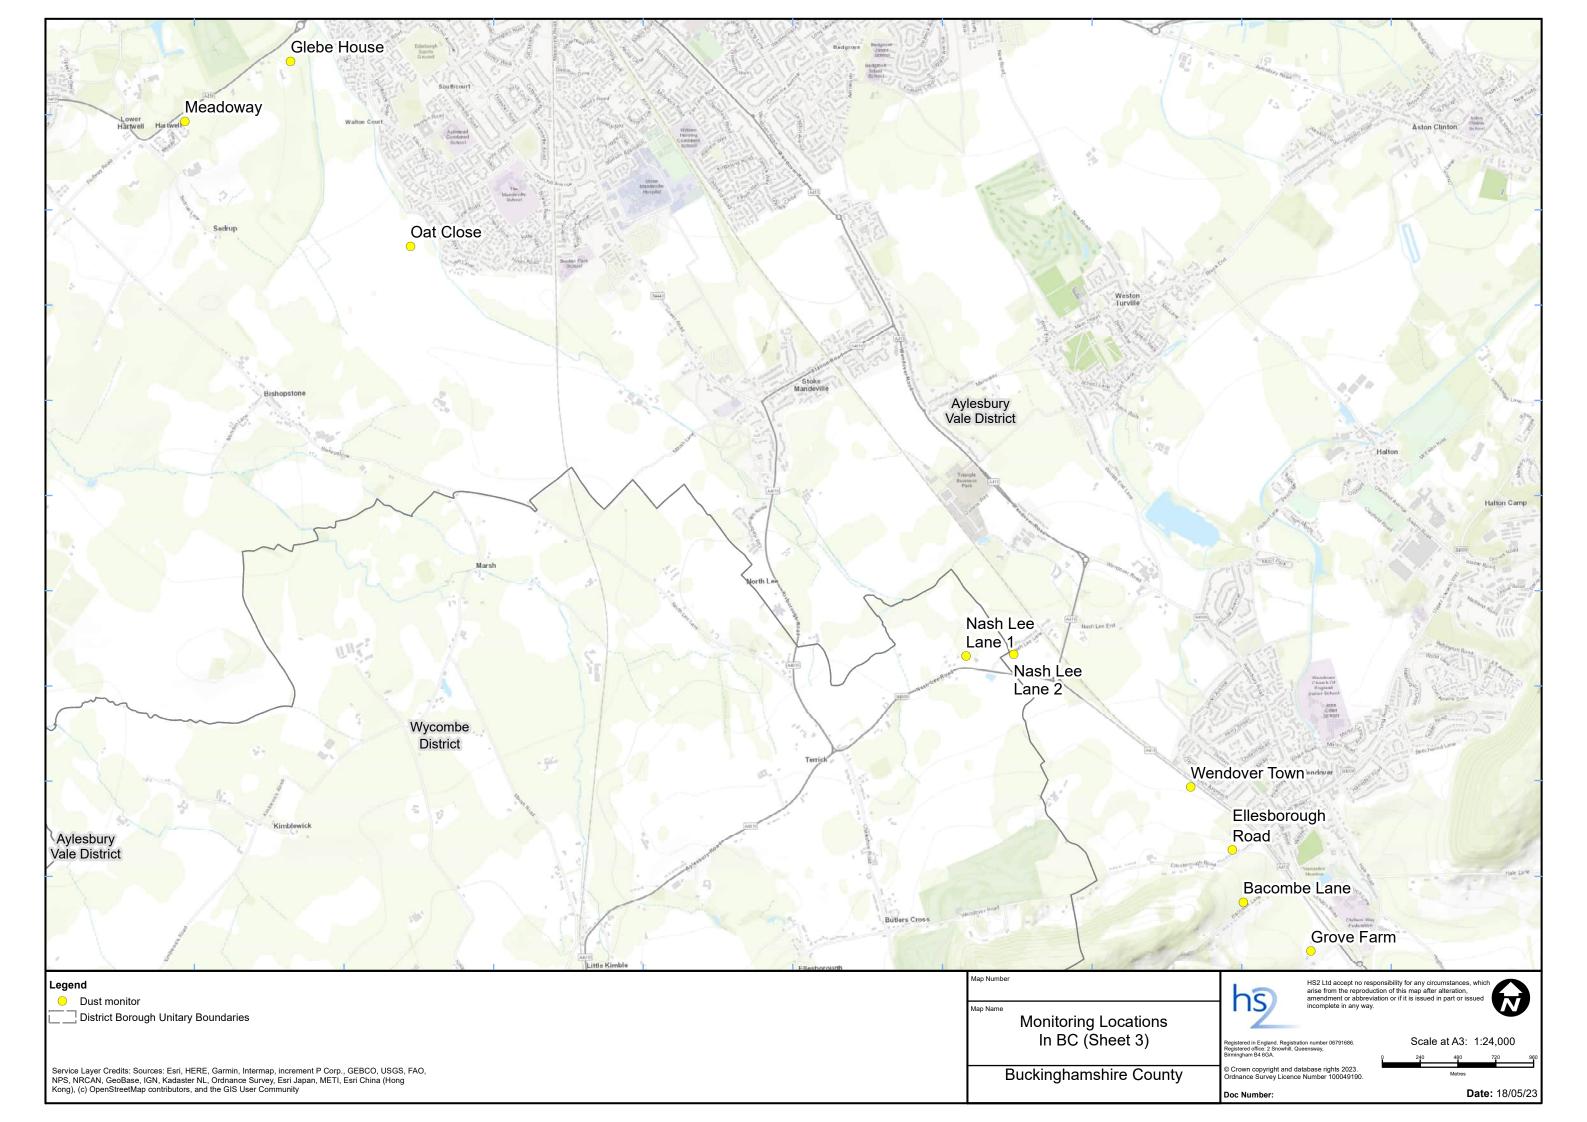
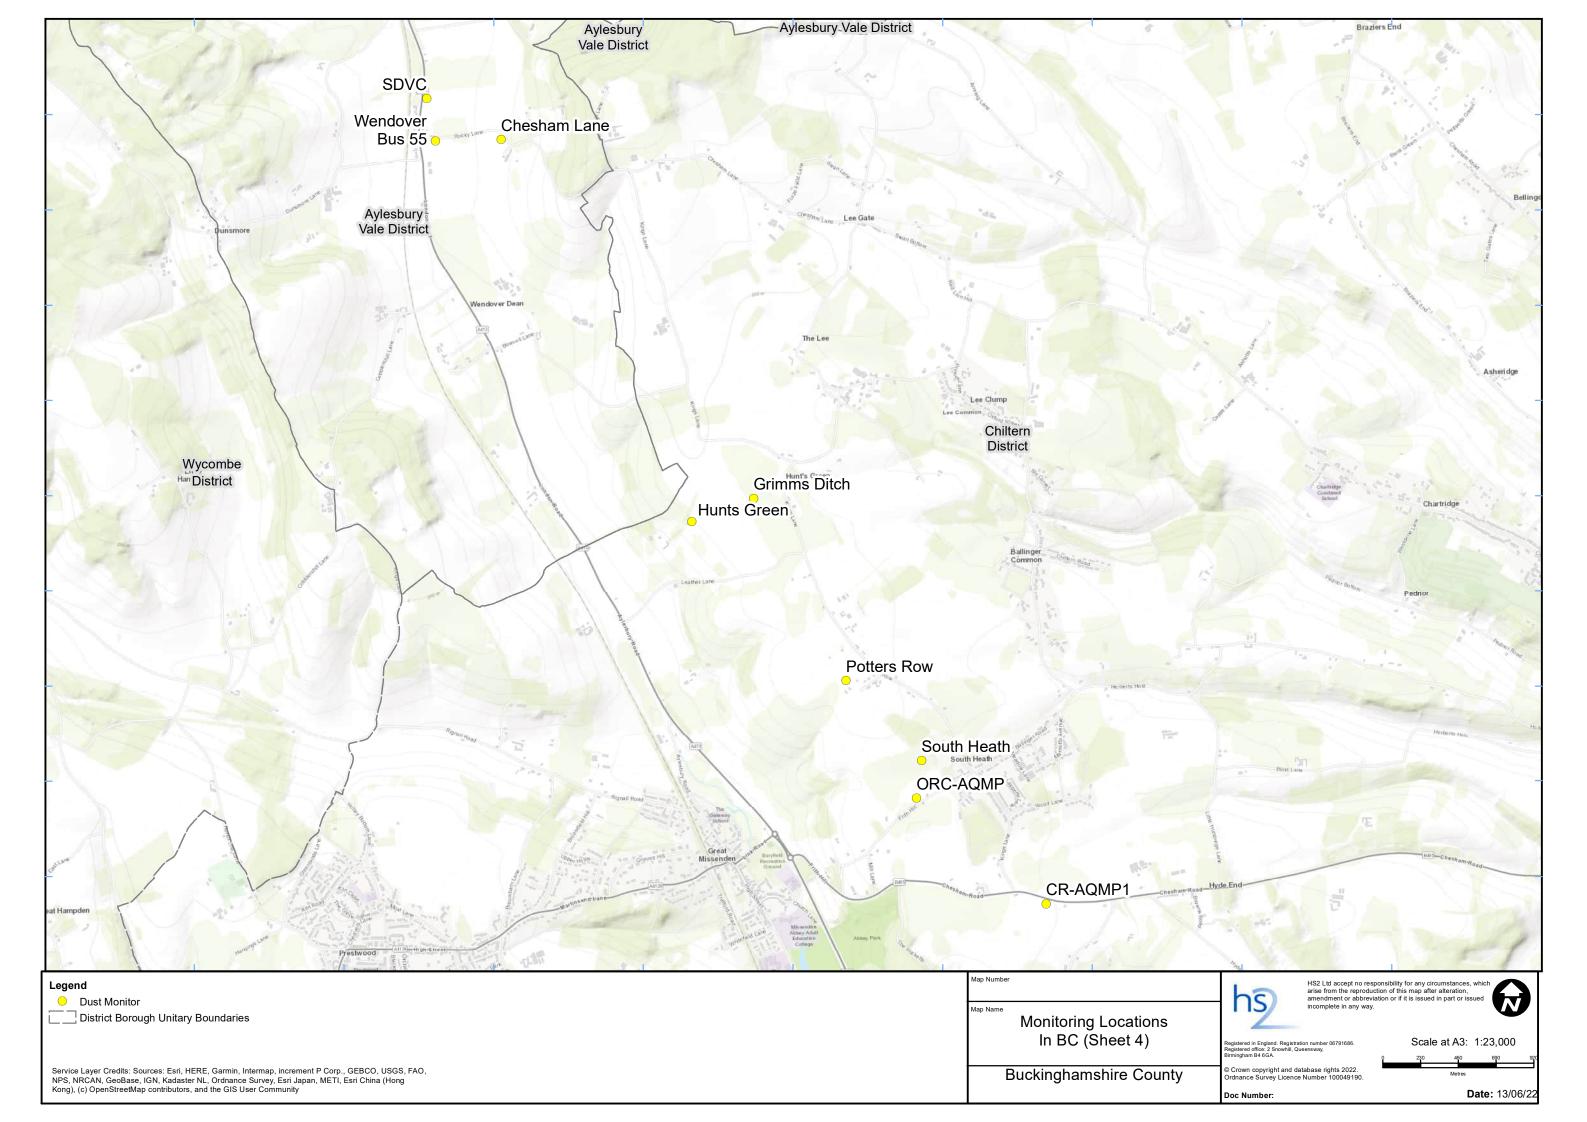
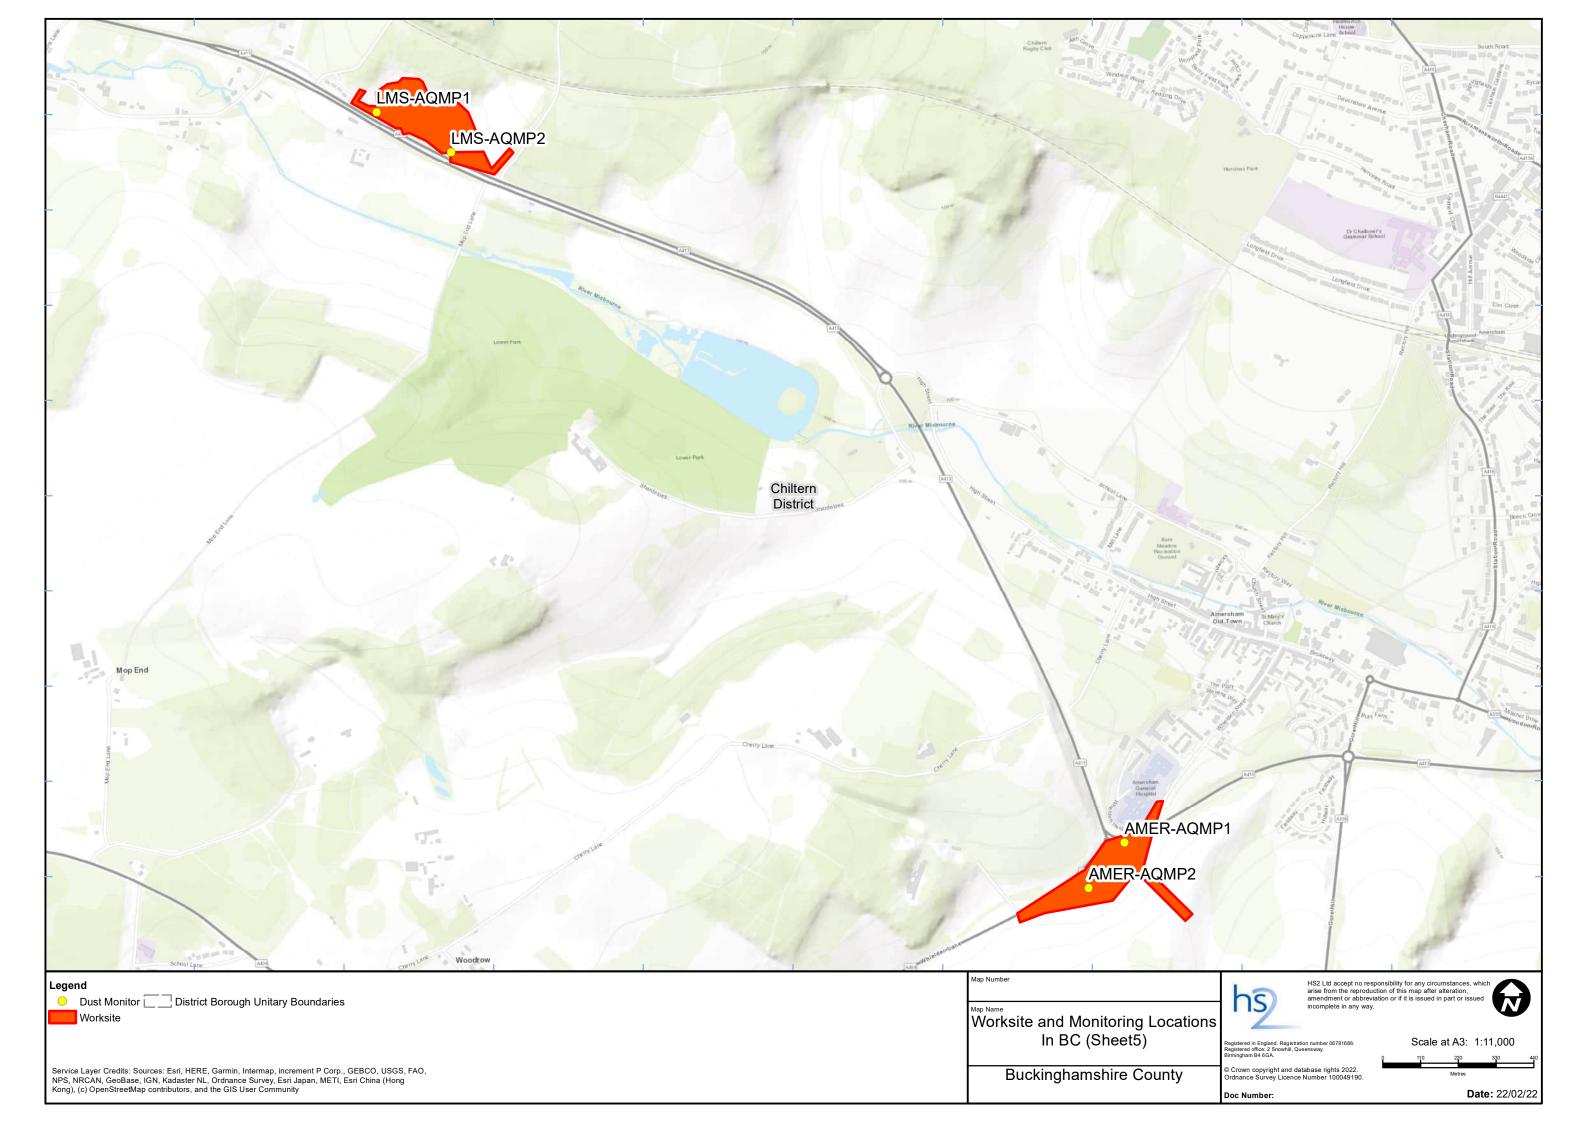
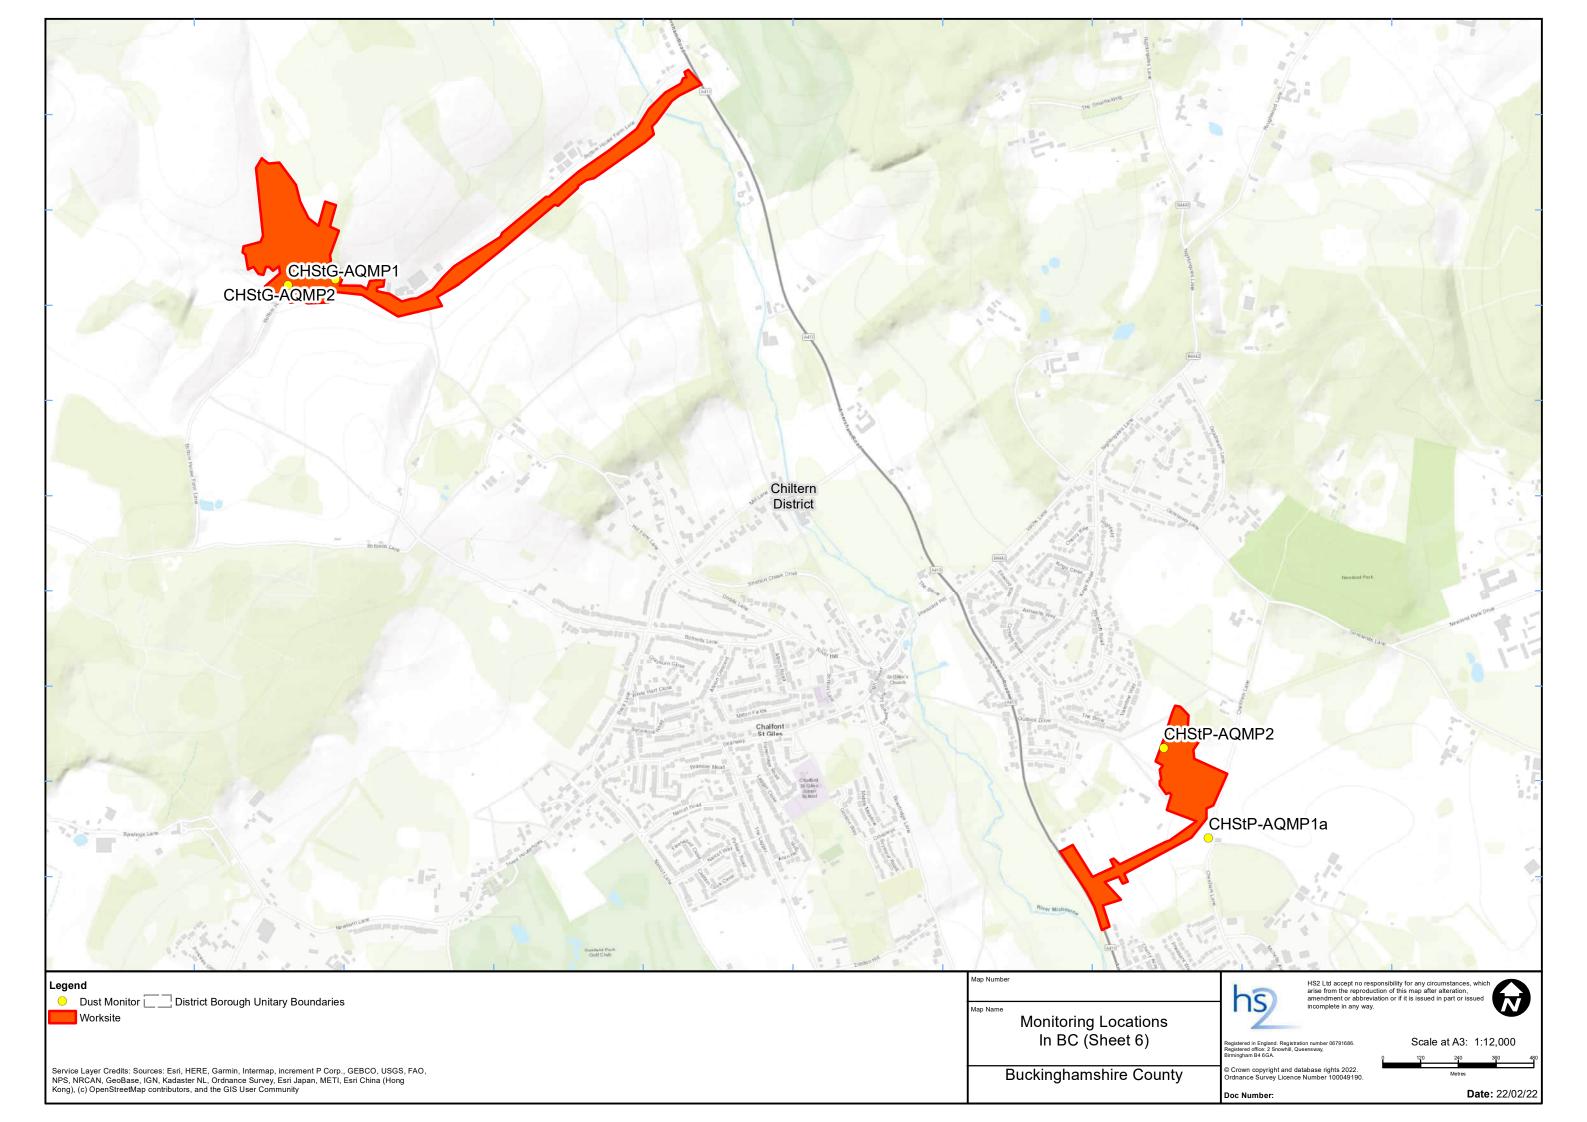
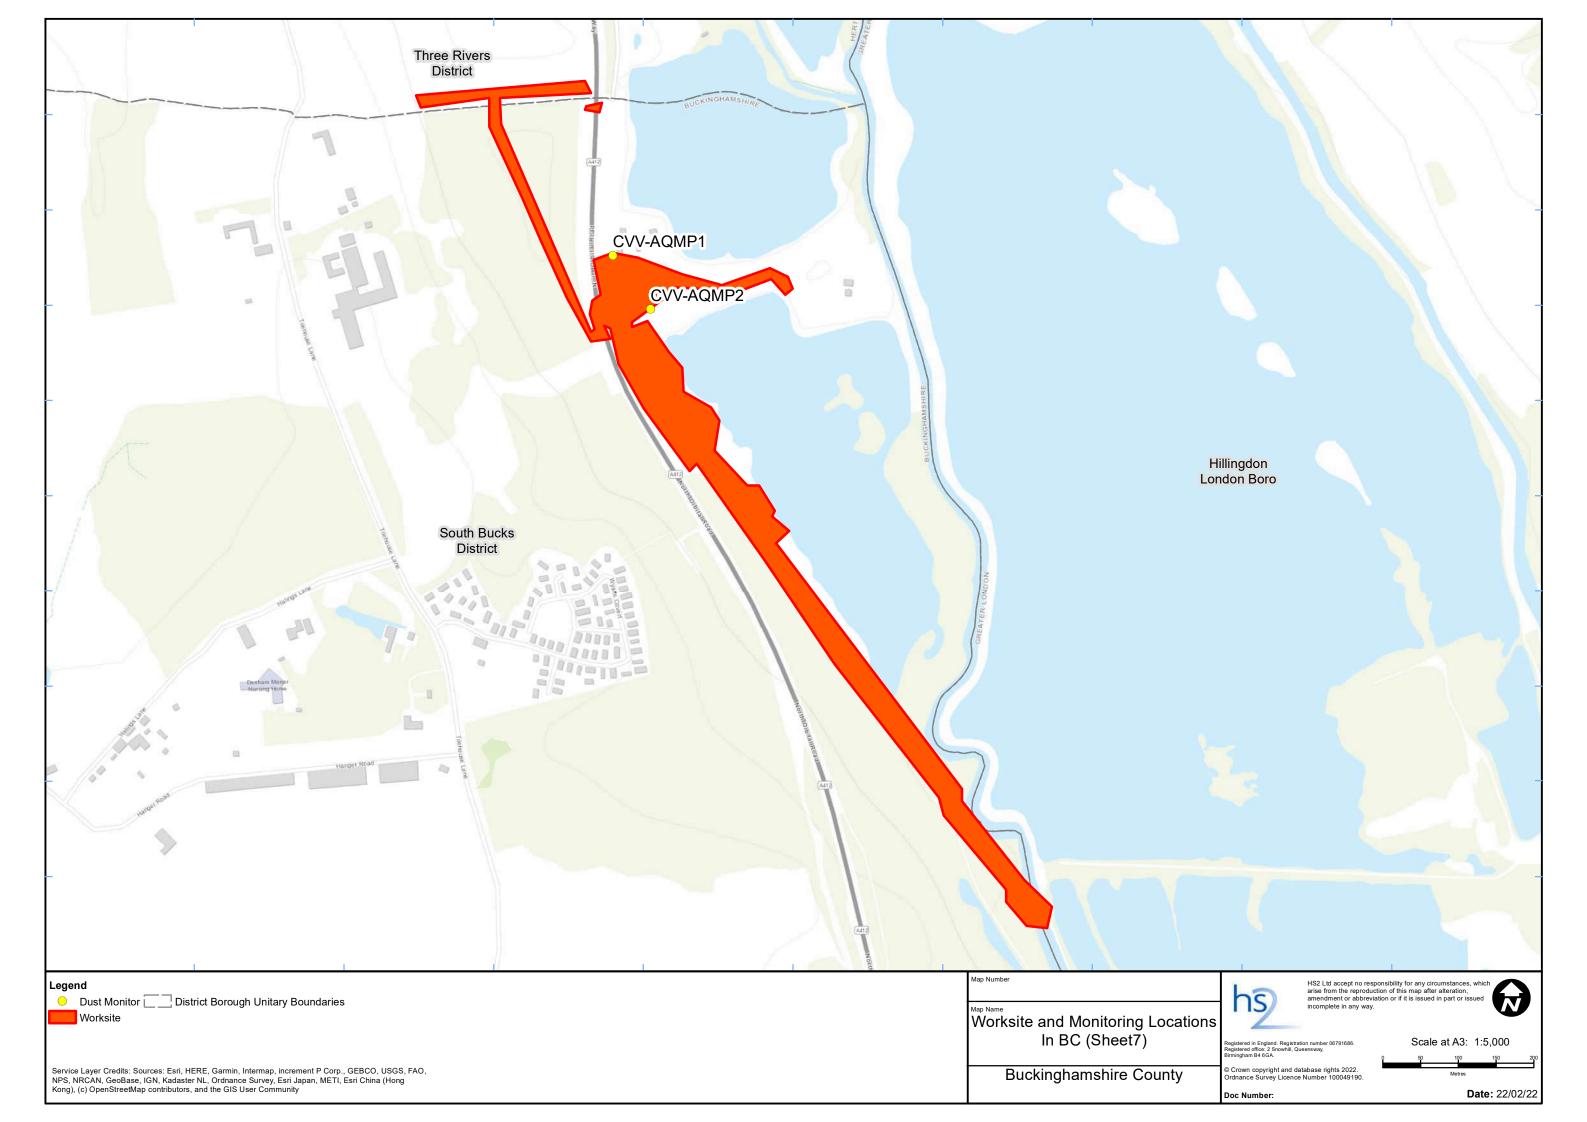
Figures 1-7: Worksite and Monitoring locations within BC

- 1.1.2 Figures 1 7 in Appendix A presents the current worksites together with the dust monitoring locations for April 2023.
- 1.1.3 This summary should be read in conjunction with the overview monitoring report available from www.gov.uk/government/collections/monitoring-the-environmental-effects-of-hs2, which highlights: the applicable standards and guidance, as well as the air quality and dust monitoring methodologies to be implemented by nominated undertakers throughout construction.

- 1.1.4 The current worksites as presented in Appendix A, Figures 1-7, include:

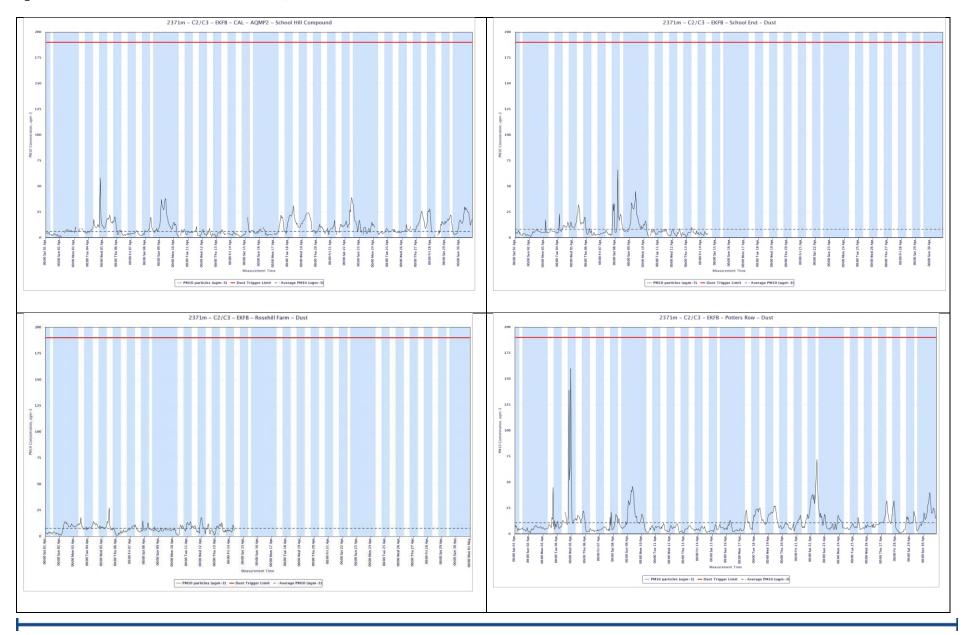
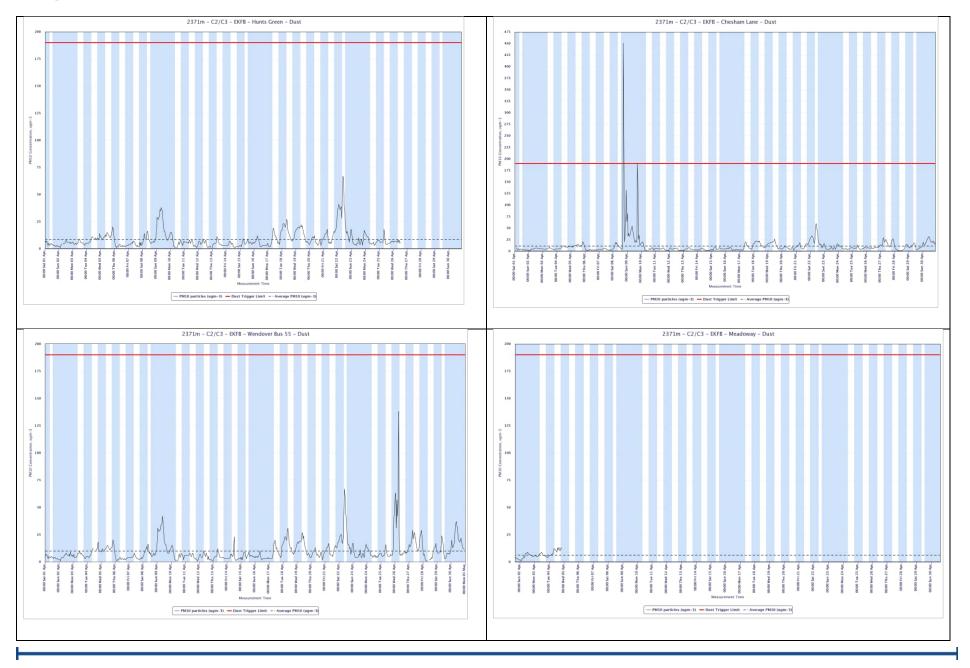
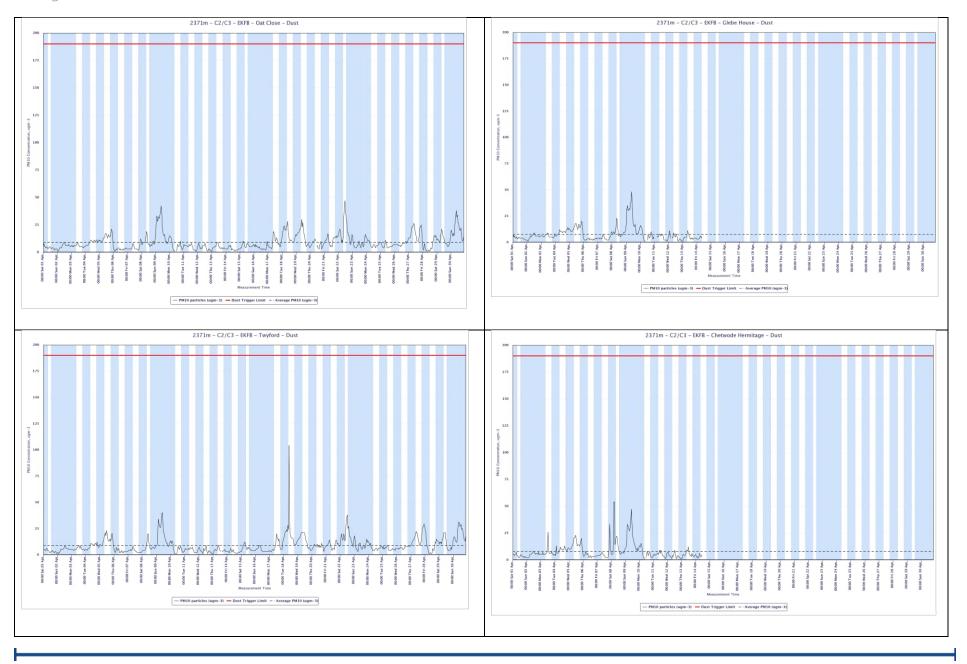
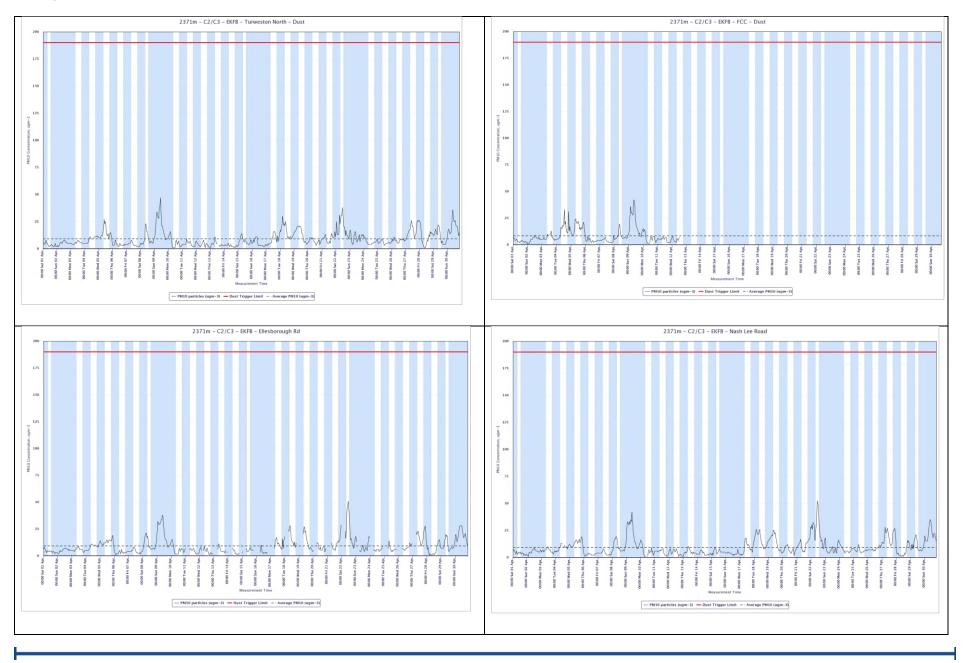
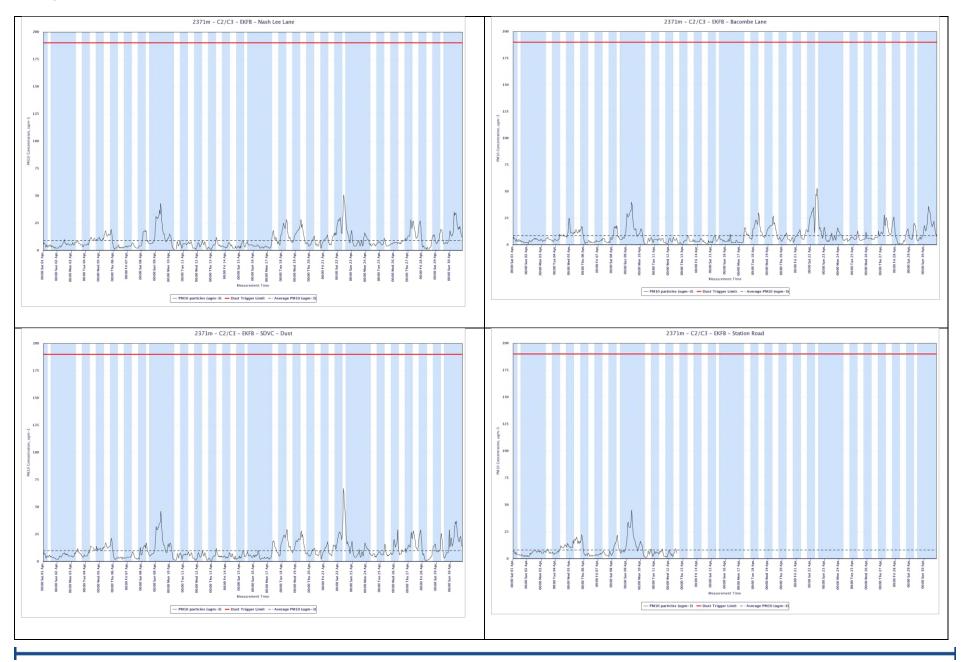
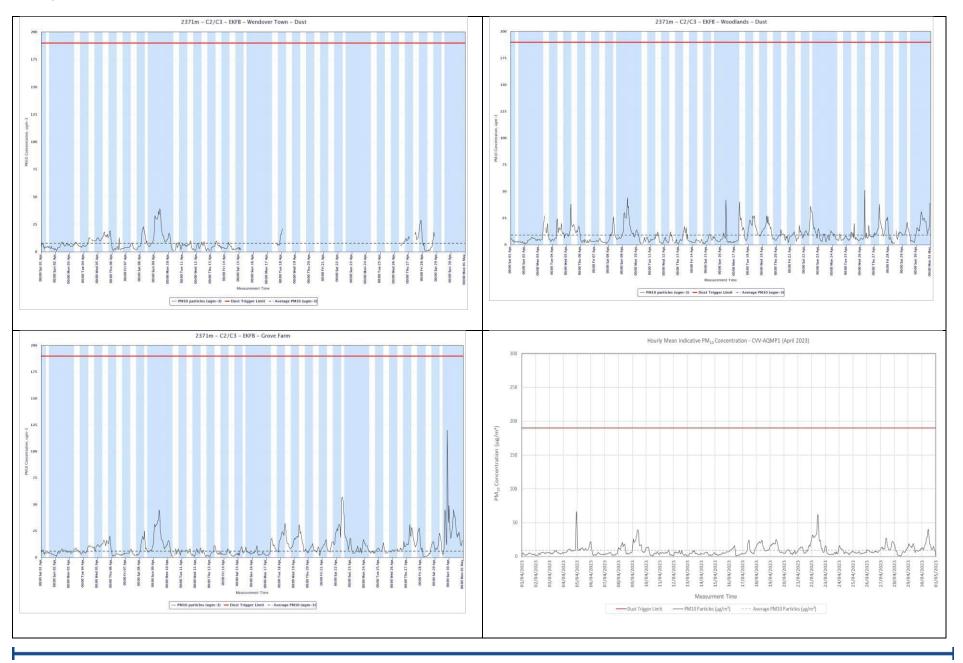
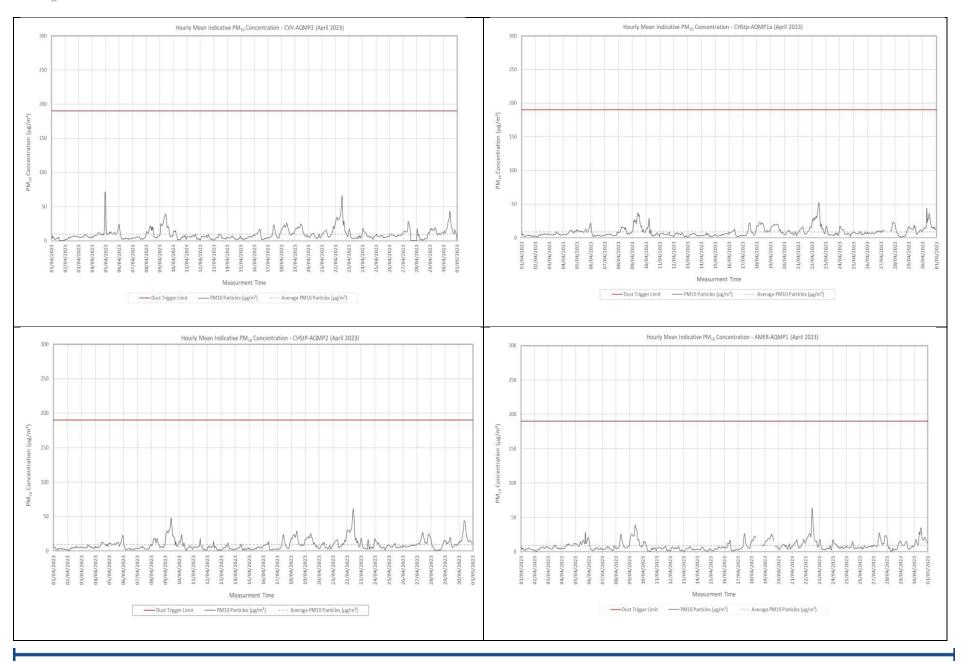
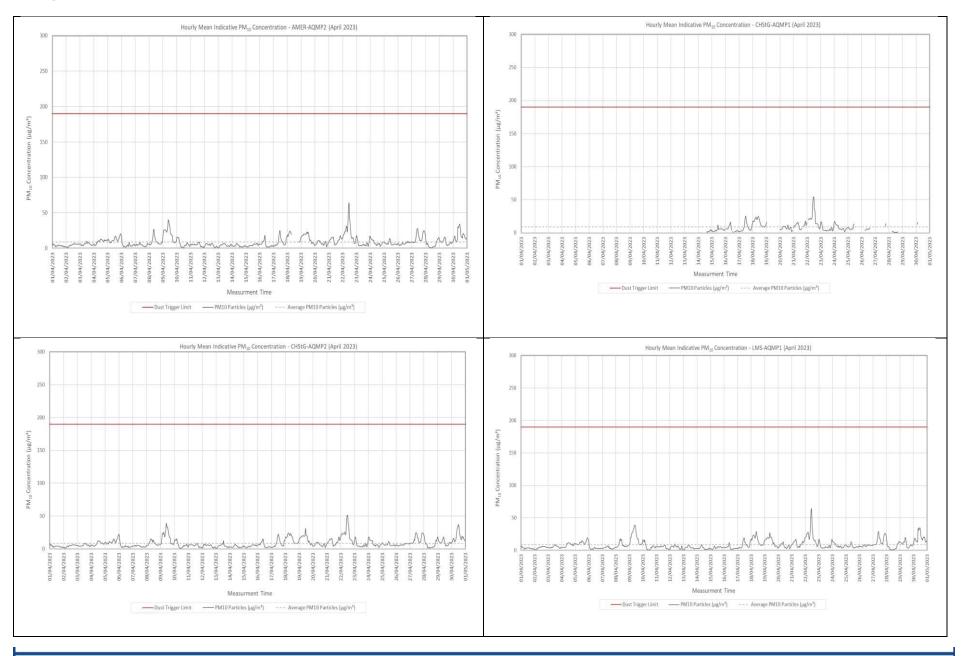
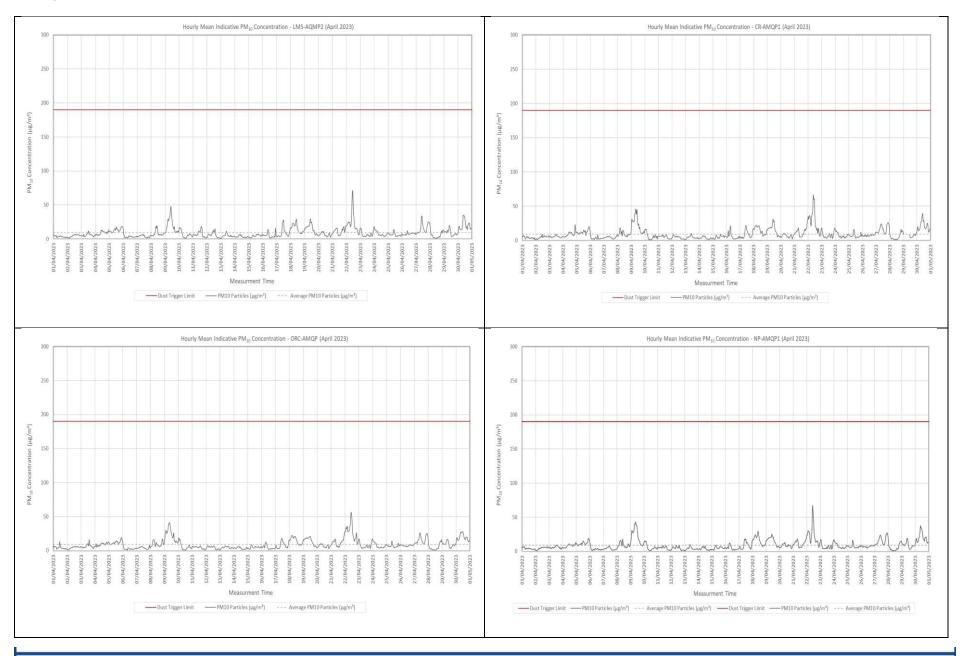
Figure 8: Continuous dust 1-hour mean indicative PM₁₀ concentration for all dust monitors

- Portal Drainage: excavation / drainage installation / backfilling; and
- Porous Portal Structure: RC works and concrete pours.
- 1.1.5 The trigger level for PM_{10} concentrations of 190 μ g/m³, over a 1-hour period, in accordance with the updated guidance document 'Guidance on Monitoring in the Vicinity of Demolition and Construction Sites (October 2018)' has been applied.

- 1.1.7 Dust monitoring locations and results are presented in Appendix B, Table 1, together with a line chart of monthly data from the dust monitors presented in Figure 8. All continuous dust monitoring is undertaken using indicative monitors. Despite being Environment Agency (MCERTS) certified, indicative monitors carry a higher level of uncertainty than reference monitors, and therefore cannot be strictly compared with Air Quality Standards for human health and the environment. The purpose of the monitoring undertaken is to ensure the effectiveness of the on-site mitigation.

Monitoring Site ID	Period of trigger alert & Concentration	Investigation	Outcomes / Resolution / Remedial measures implemented		
	recorded (µg m ⁻³				
Chesham Lane – Dust	08/04/23 16:00–16:59; 451 μg/m ⁻³ 17:00–17:59; 201 μg/m ⁻³	This was the easter weekend and no works were undertaken during the period	N/A		
	09/04/23 16:00–16:59; 191 μg/m ⁻³	This was the easter weekend and no works were undertaken during the period	N/A
