Construction Noise and Vibration Monthly Report – April 2023

Buckinghamshire

This Noise and Vibration Monitoring Report fulfils HS2 Limited's commitment detailed in the Environmental Minimum Requirements (EMRs), Annex 1, Code of Construction Practice, to present the results of noise monitoring carried out within Buckinghamshire (BS) during the month of April 2023.

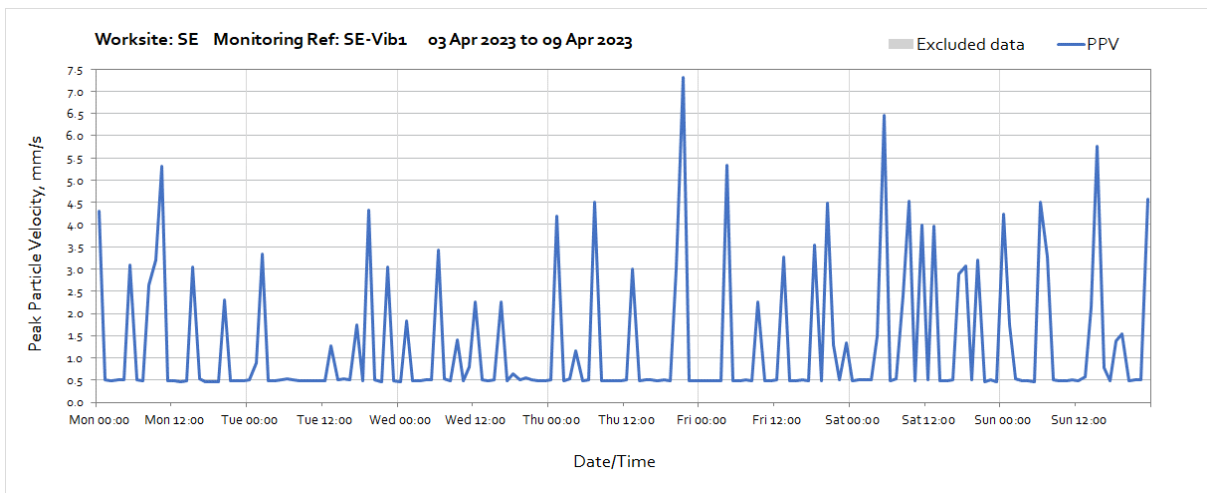
Worksite: SE – Monitoring Ref: SE-Vib 1

The following graphs show the hourly measured peak particle velocity PPV recorded during the monitoring period. The graphs show the highest PPV of the three orthogonal axes x, y and z. Where high values of PPV were caused by local interference with the vibration monitor, which are not representative of HS2 construction works, these values have been greyed out in the following charts and have been excluded to calculate values in Table 4 of the main report.

Note: Missing data between 13:00 and 14:00 on Friday 14th April was due to monitor replacement as part of a review into the unexpected data obtained at this monitoring location to date.
