Construction Noise and Vibration Monthly Report – April 2023

London Borough of Camden

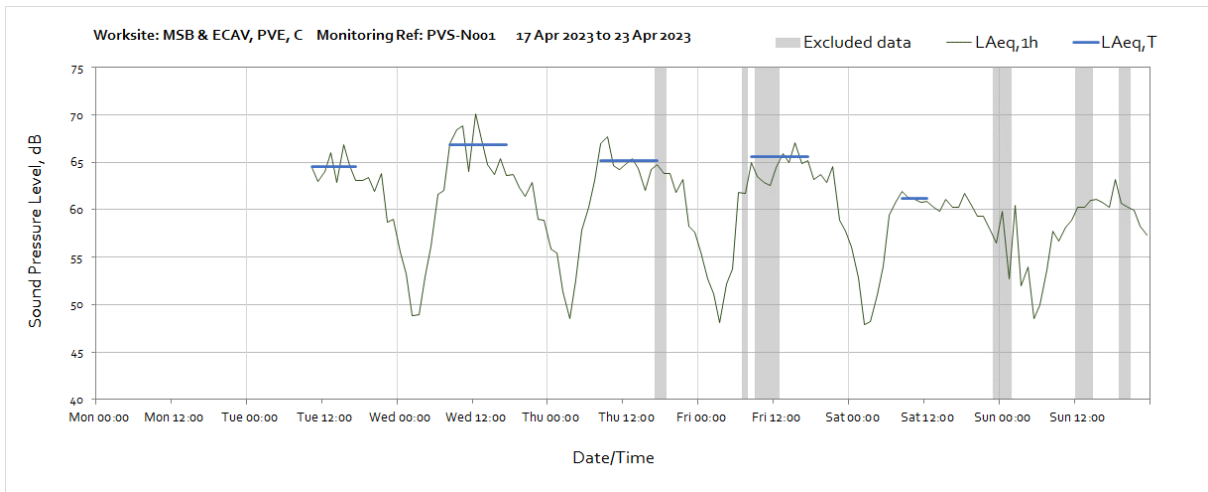
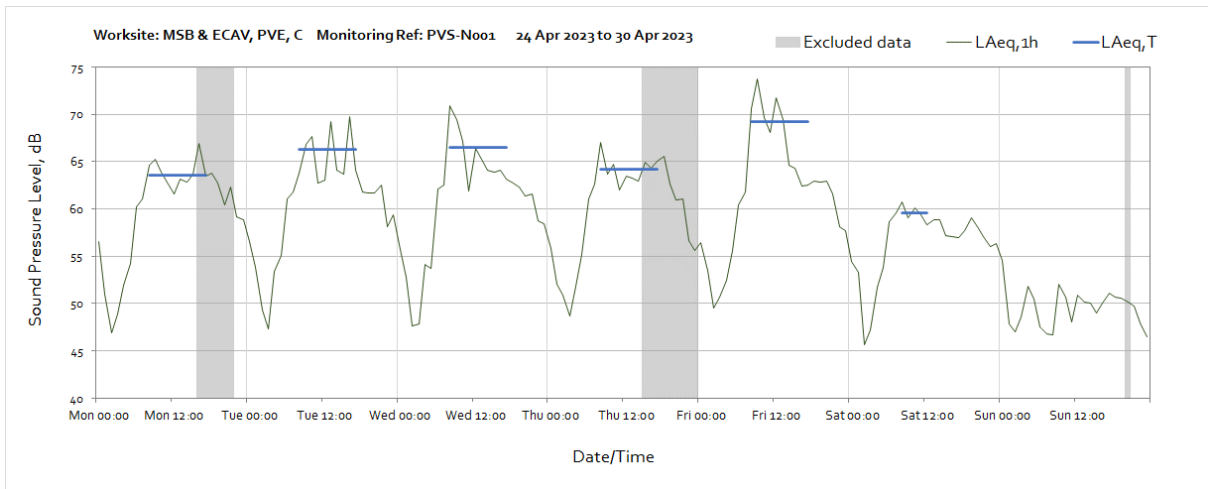
Worksite: MSB & ECAV, PVE, C - Monitoring Ref: PVS-N001

Note: Monitor installed at 10:00 on Tuesday 18th April.

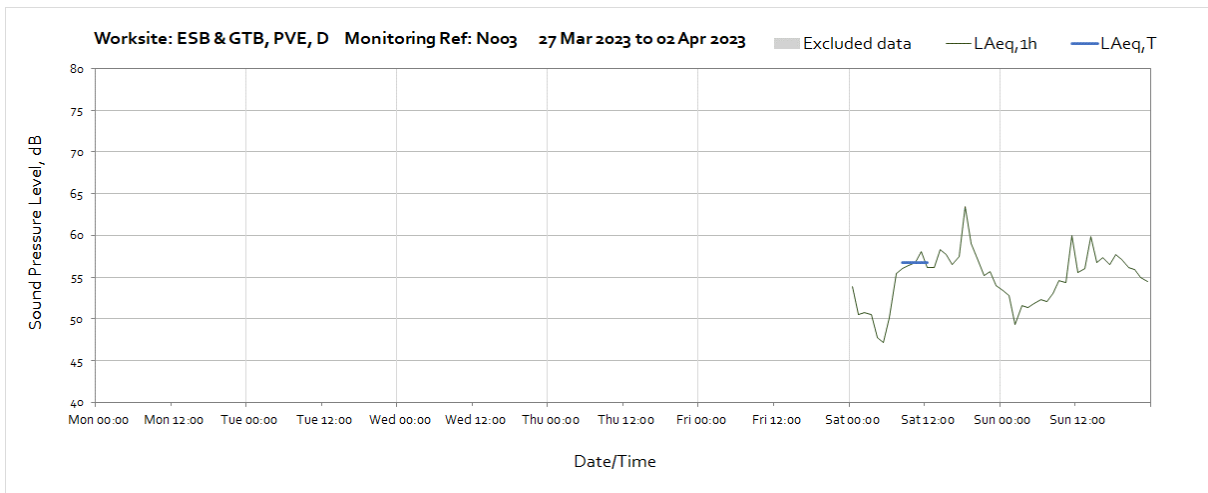
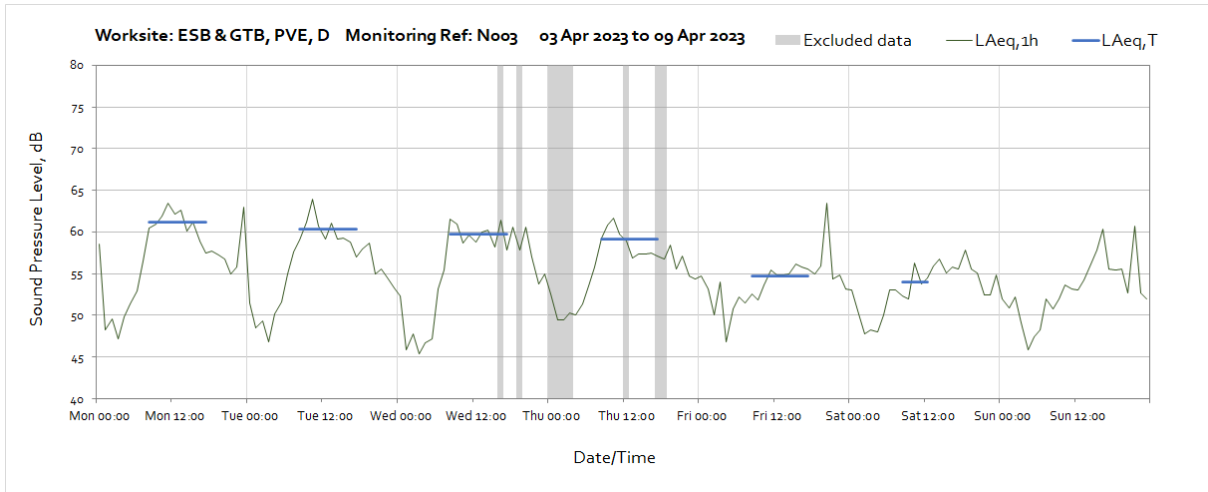
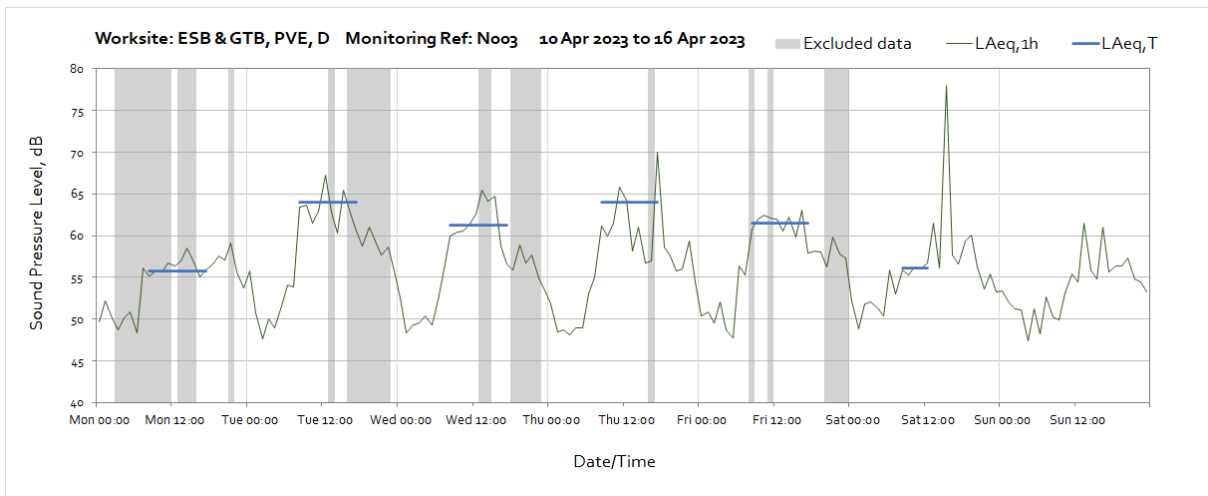
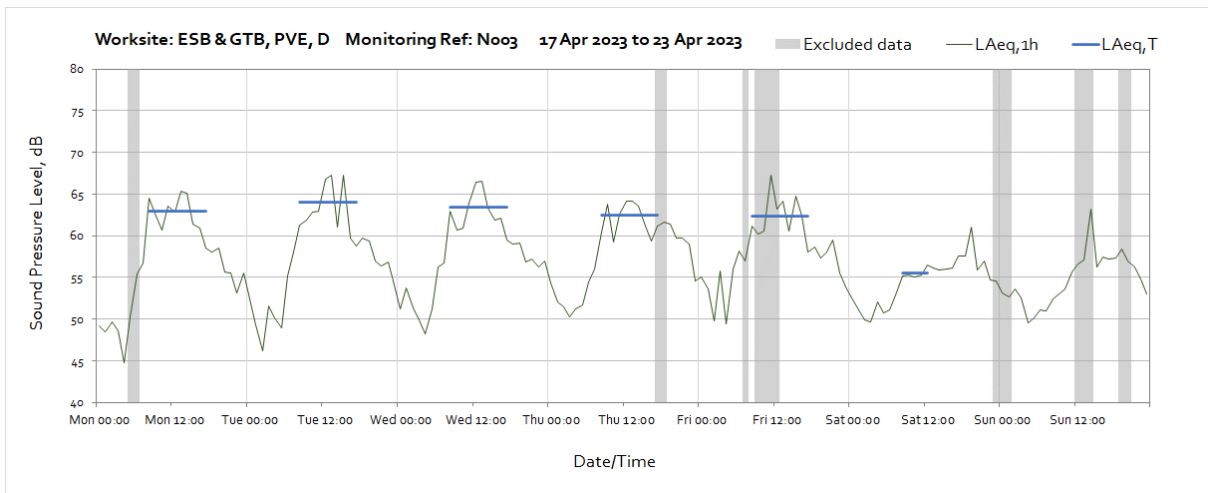
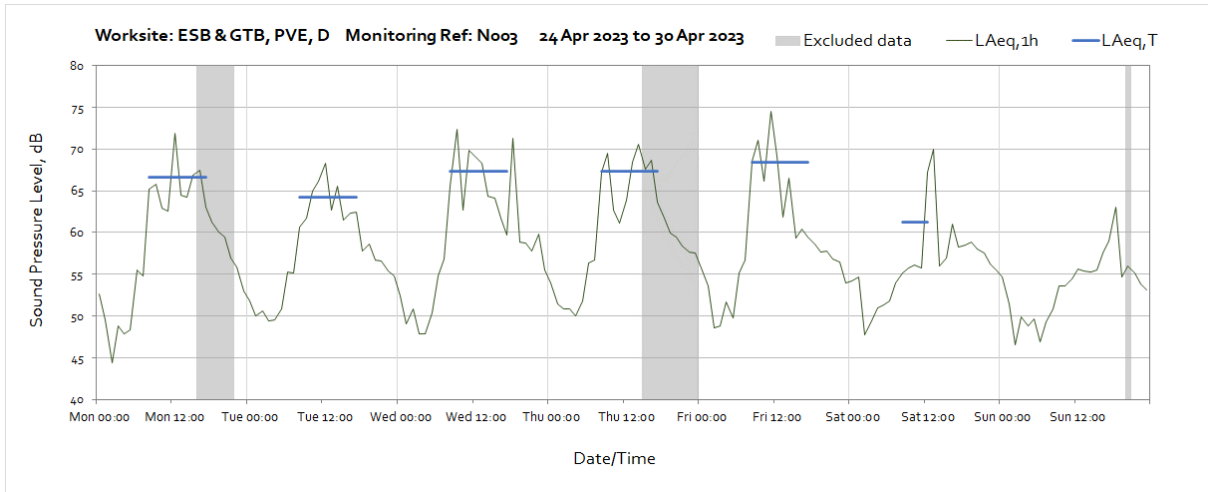
Worksite: ESB & GTB, PVE, D – Monitoring Ref: N003

2.1.3 Appendix C presents graphs of the noise and vibration monitoring data over the month for each of the measurement locations. Noise data presented consists of the hourly L_{Aeq} values and, where relevant, the $L_{Aeq,T}$ values (where the time period T has been taken to be the averaging period as specified in Table 1 of HS2 Information Paper E23). Vibration data presented consist of hourly PPV values. The full data set for the monitoring equipment can be found at the following location:

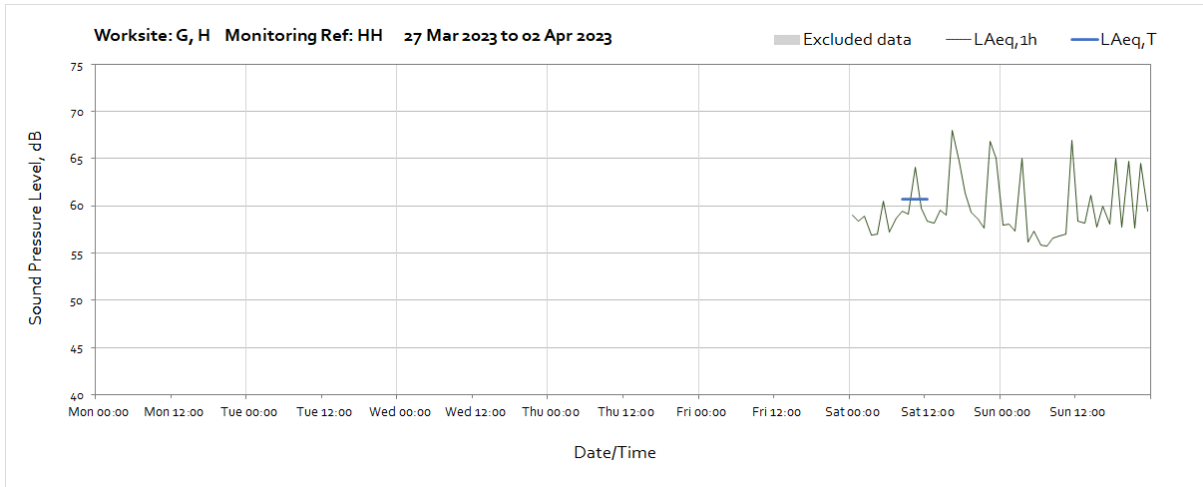
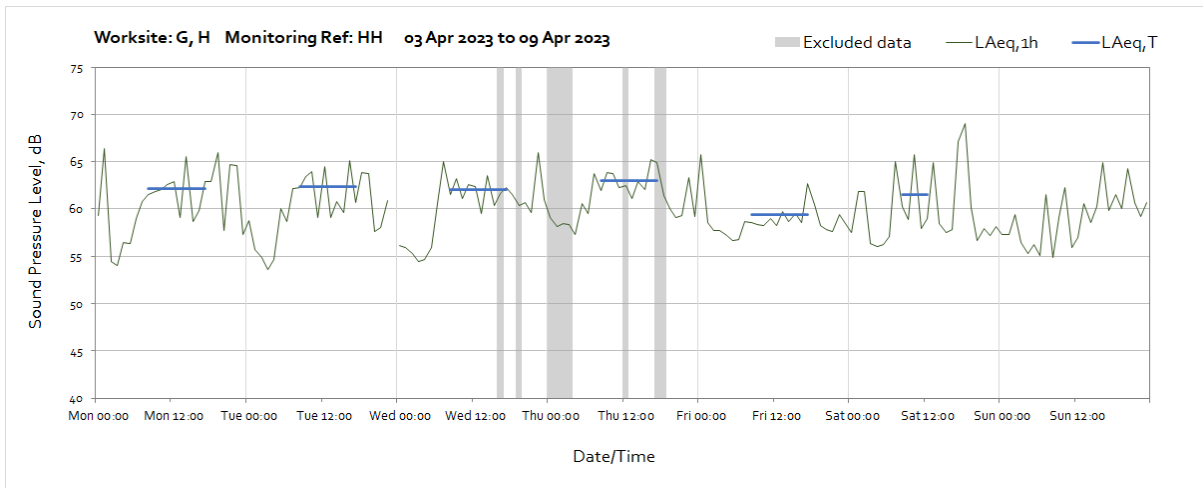
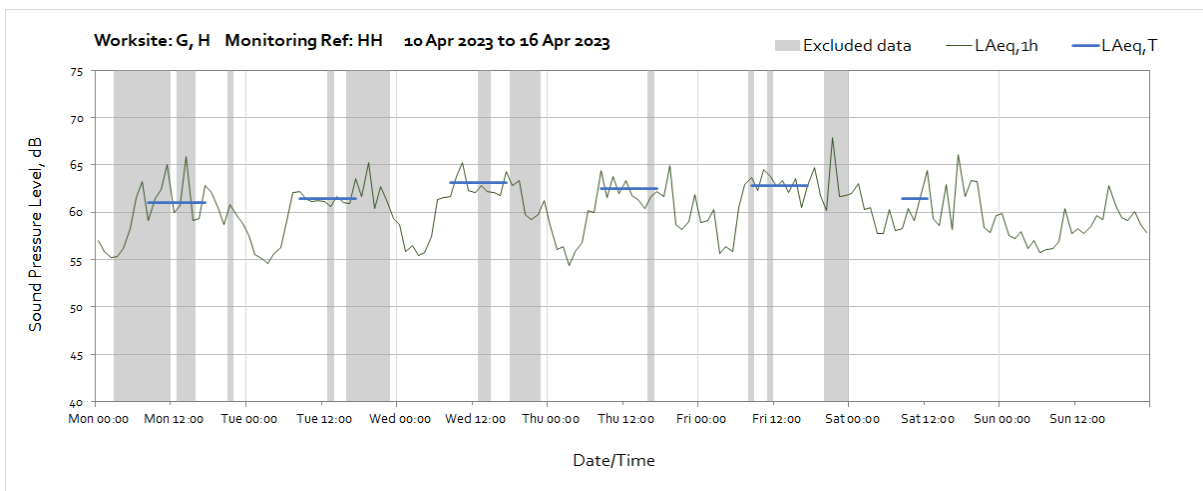
Worksite: G, H – Monitoring Ref: HH

Note: Missing data from 23:00 on Tuesday 4th April until 00:00 on Wednesday 5th April was due to loss of power to the monitoring station.

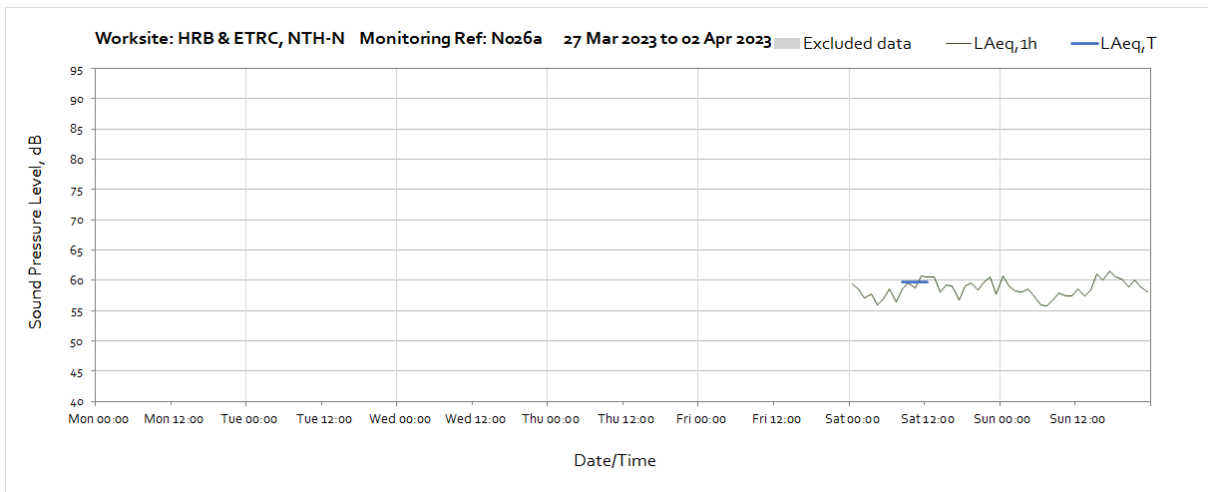
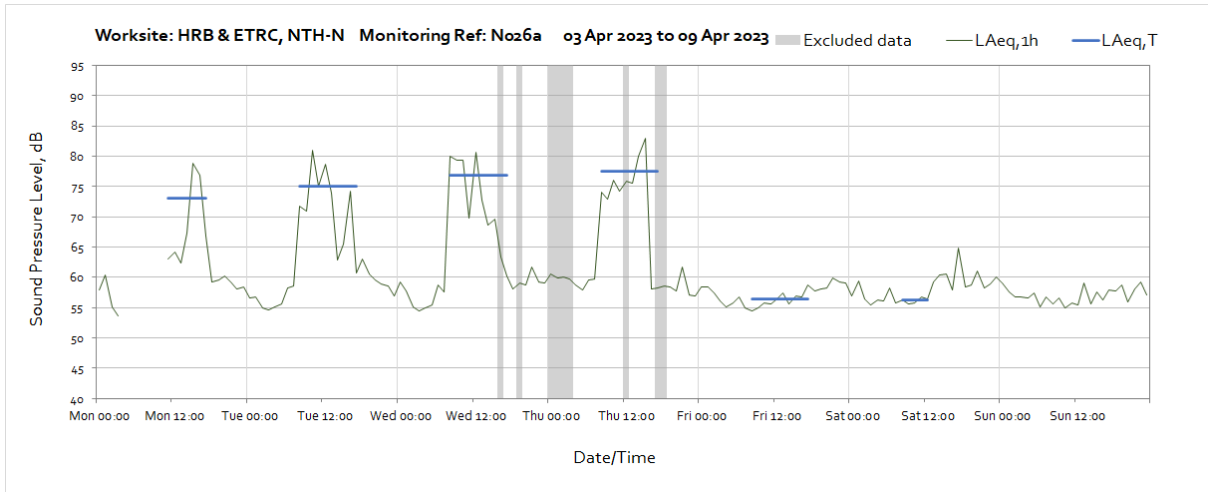
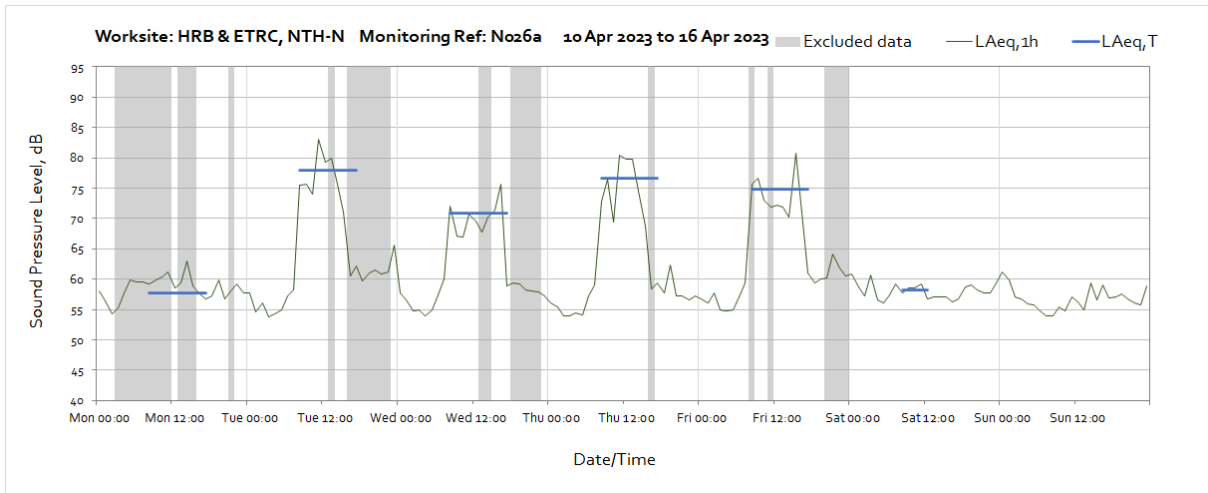
Worksite: HRB & ETRC, NTH-N - Monitoring Ref: N026a

Note: Missing data between 04:00 and 10:00 on Monday 3rd April was due to the loss of continuous power to site.

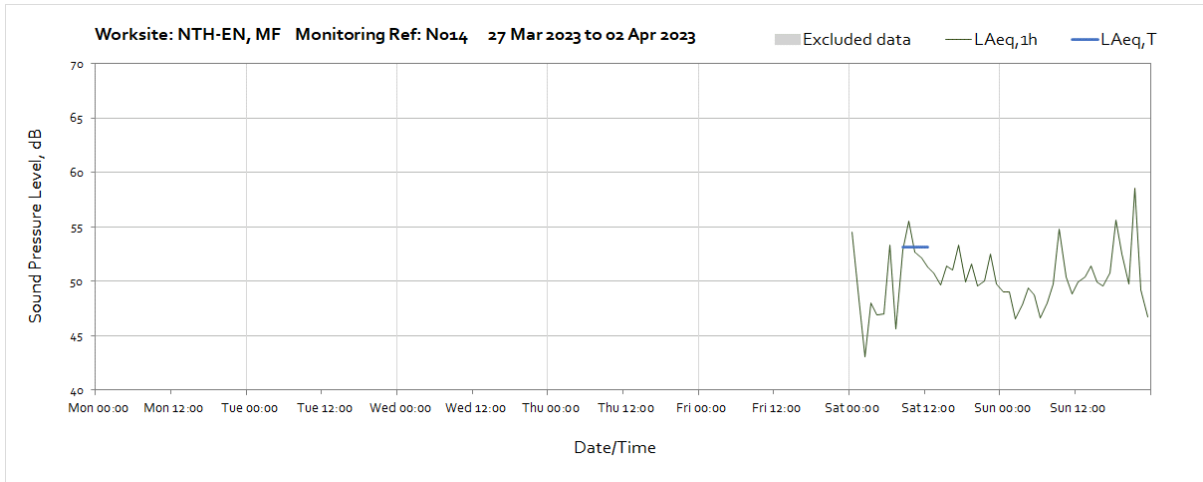
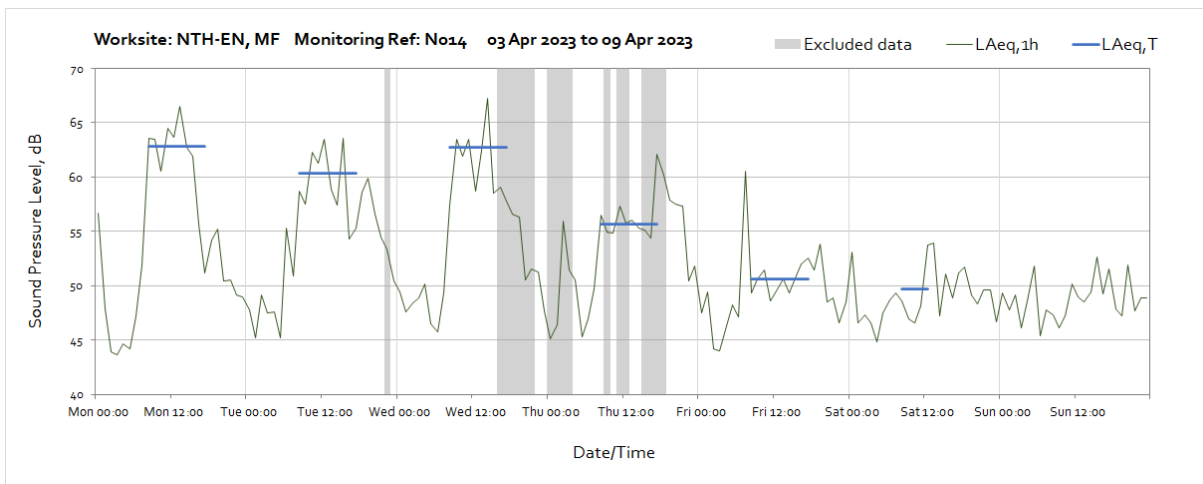
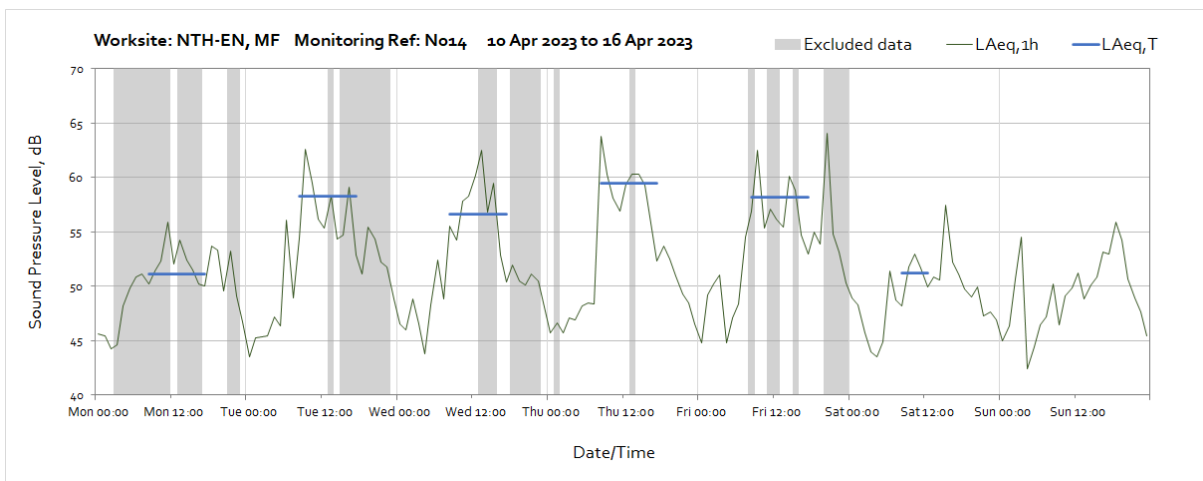
Worksite: NTH-EN, MF - Monitoring Ref: N014

Note: Data exclusion from 00:00 on Tuesday 18th April until the end of the month is due to expiration of the monitoring station calibration. Access to the monitor for replacement is currently being arranged.

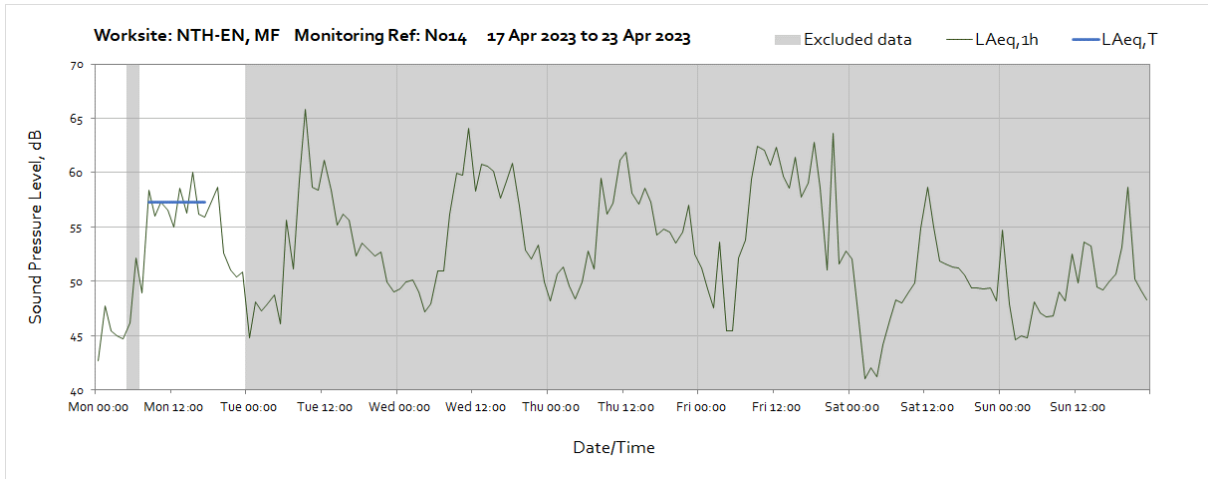
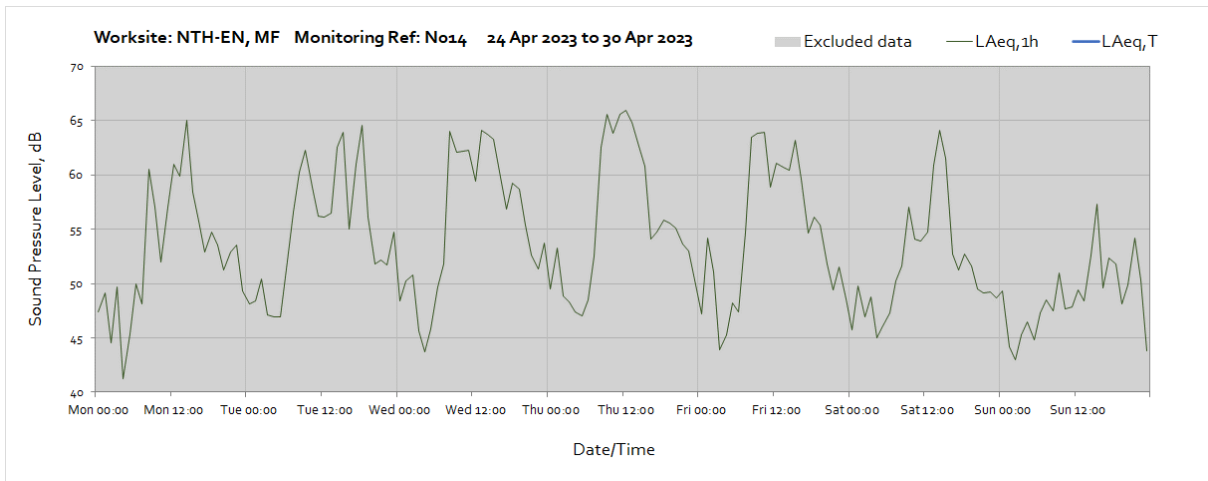
Note: Data exclusion from 00:00 on Tuesday 18th April until the end of the month is due to expiration of the monitoring station calibration. Access to the monitor for replacement is currently being arranged.

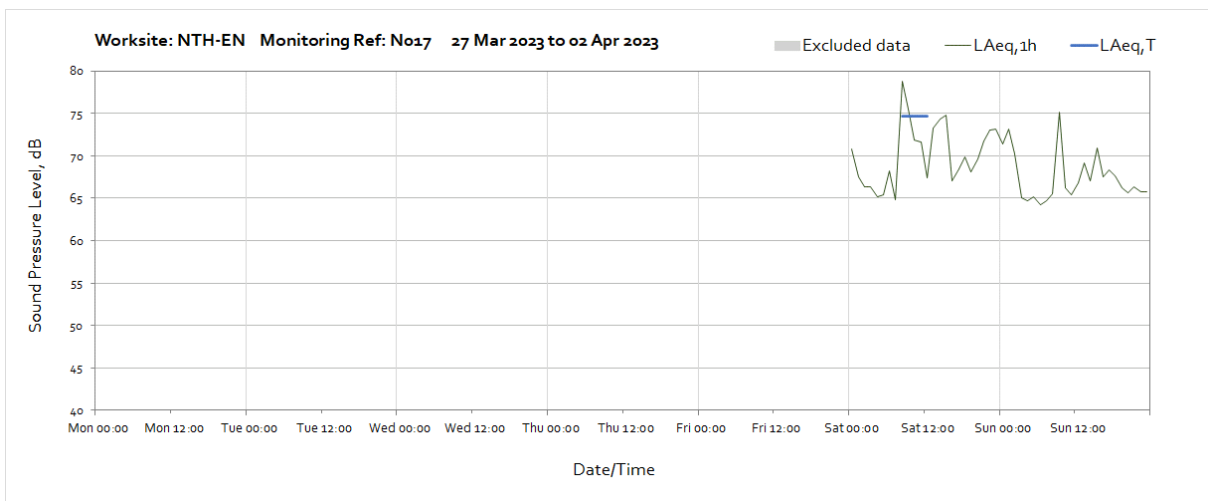
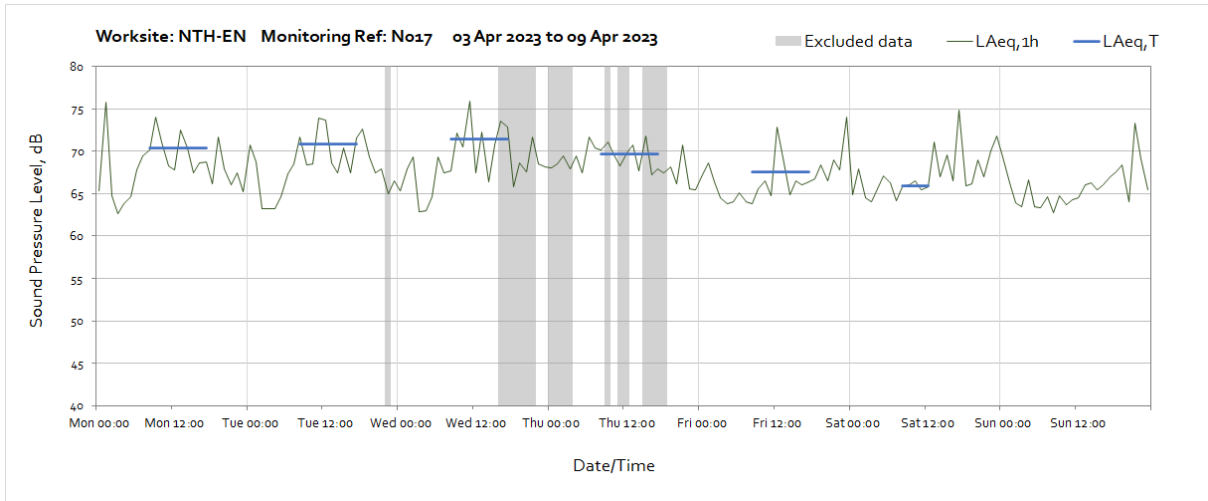
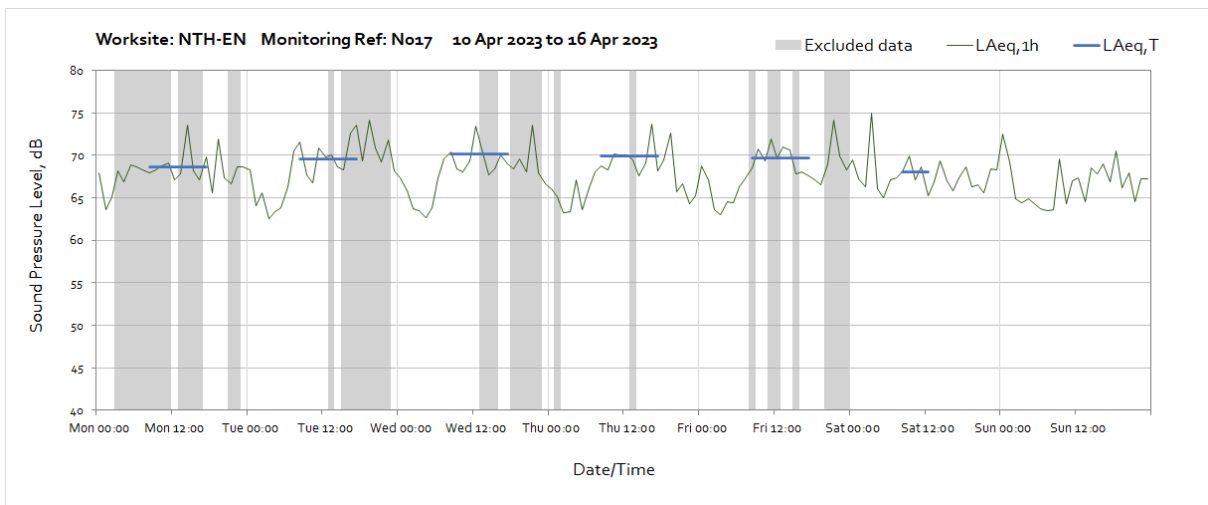
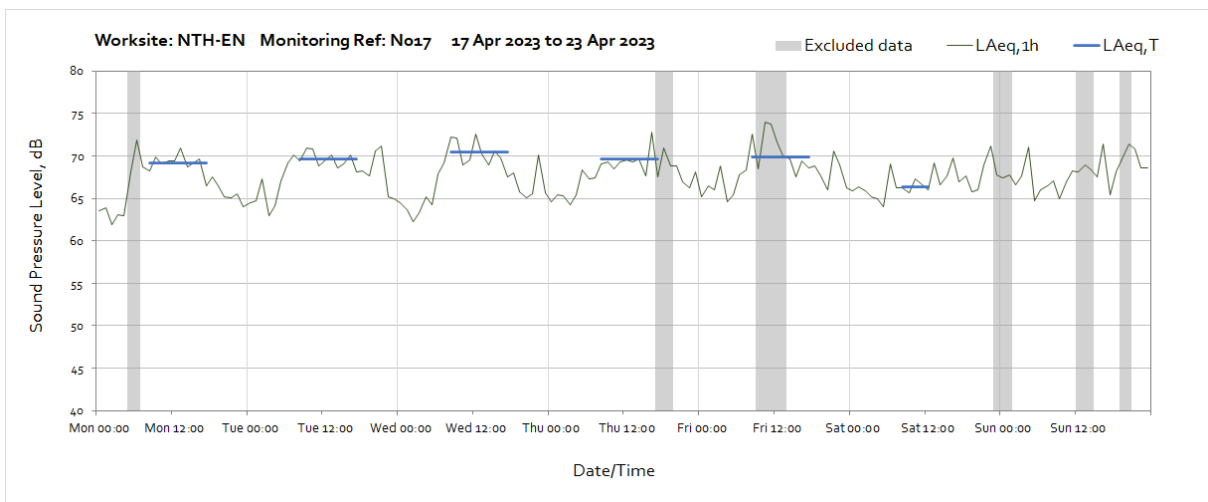
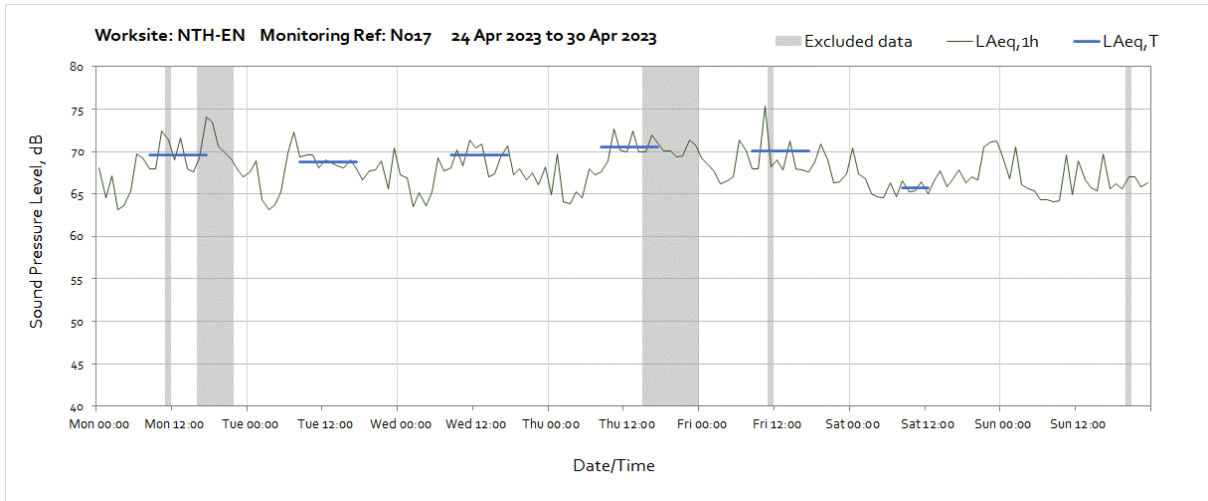
Worksite: NTH-EN - Monitoring Ref: N017

NTH-EN	N017	Hampstead Road, lamppost #48	Free-field	68.7 (72.3)	69.8 (71.4)	67.9 (72.6)	68.2 (72.6)	66.8 (75.0)	65.5 (67.3)	68.2 (74.7)	69.4 (73.3)	68.7 (74.9)	68.6 (73.2)	67.5 (75.1)	66.6 (75.8)
ETRC & HRB, NTH-N	N018	Outside replacement housing, Hampstead Road	Free-field	68.1 (71.2)	70.5 (76.0)	68.3 (73.6)	68.8 (73.9)	66.8 (76.5)	66.1 (68.7)	67.4 (70.9)	69.0 (70.8)	68.4 (76.1)	67.7 (72.1)	67.9 (73.7)	66.2 (72.9)

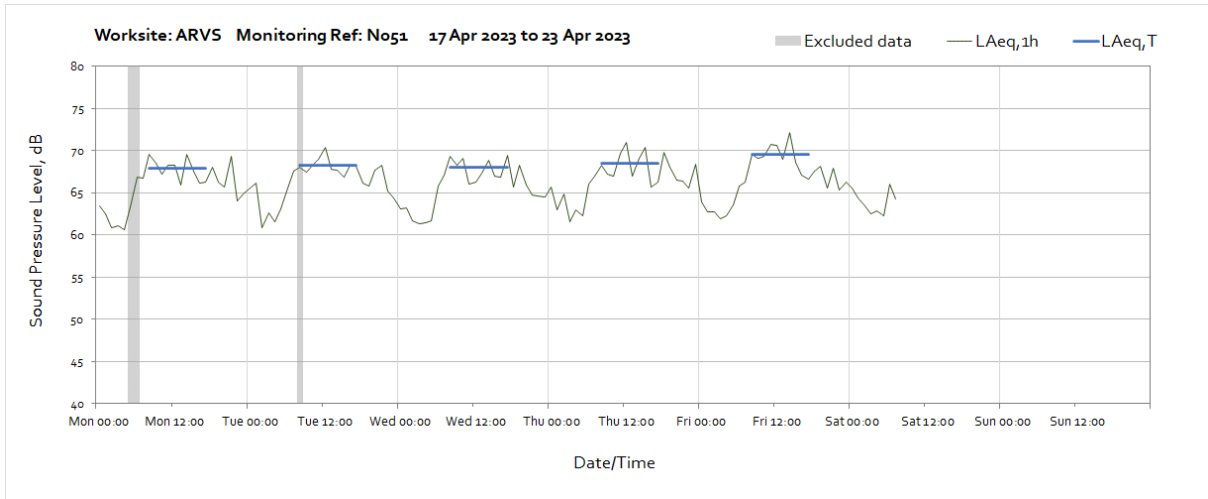
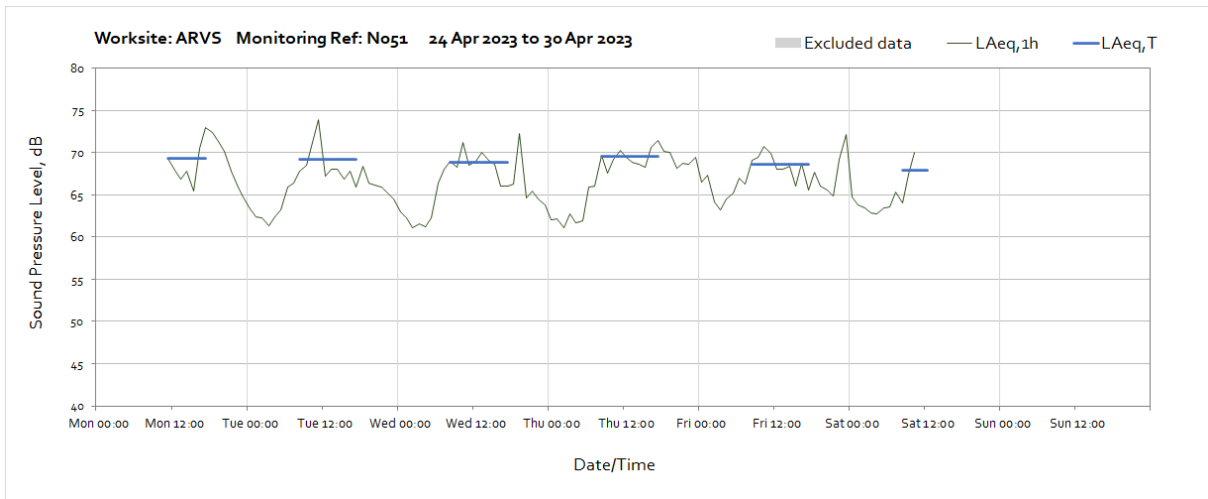
Adelaide Road Ventilation Shaft (ARVS) – Monitoring Ref: N051

Note: Missing data between 08:00 Saturday 22nd April and 11:00 Monday 24th April was due to a loss of continuous power to the site.

Note: Missing data from 11:00 Saturday 29th April and the end of the month was due to a loss of continuous power to the site.

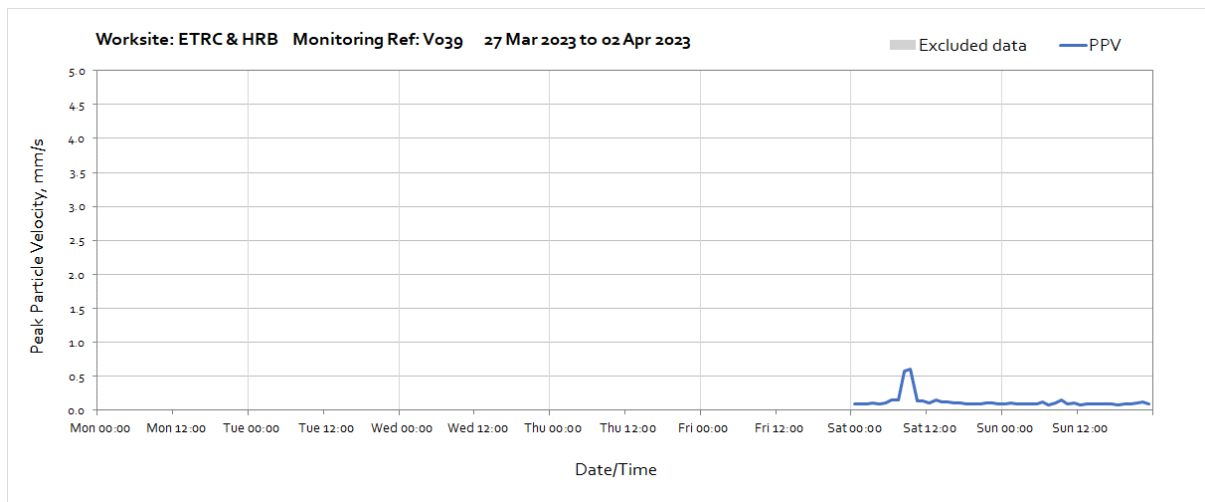
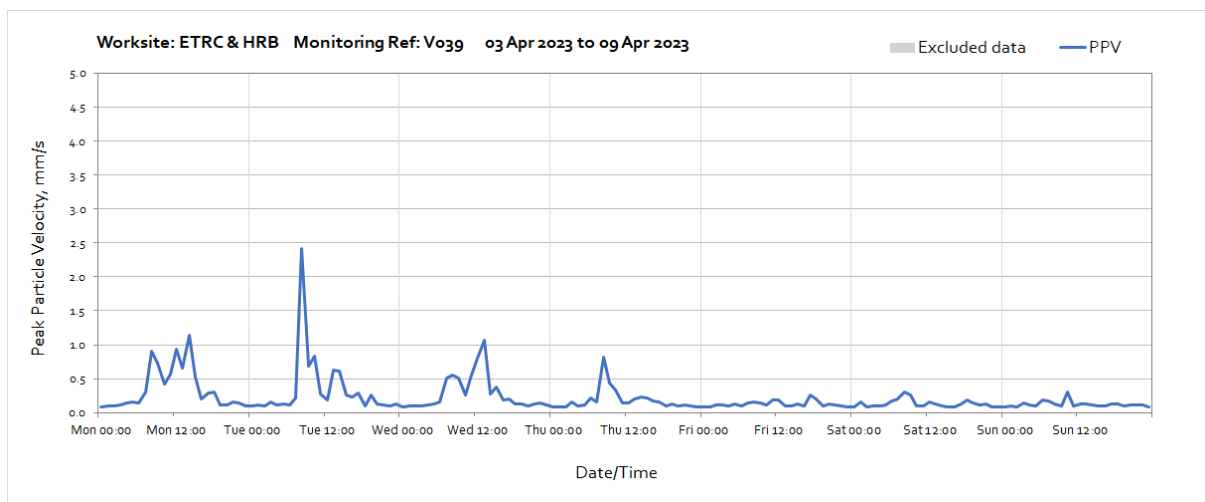
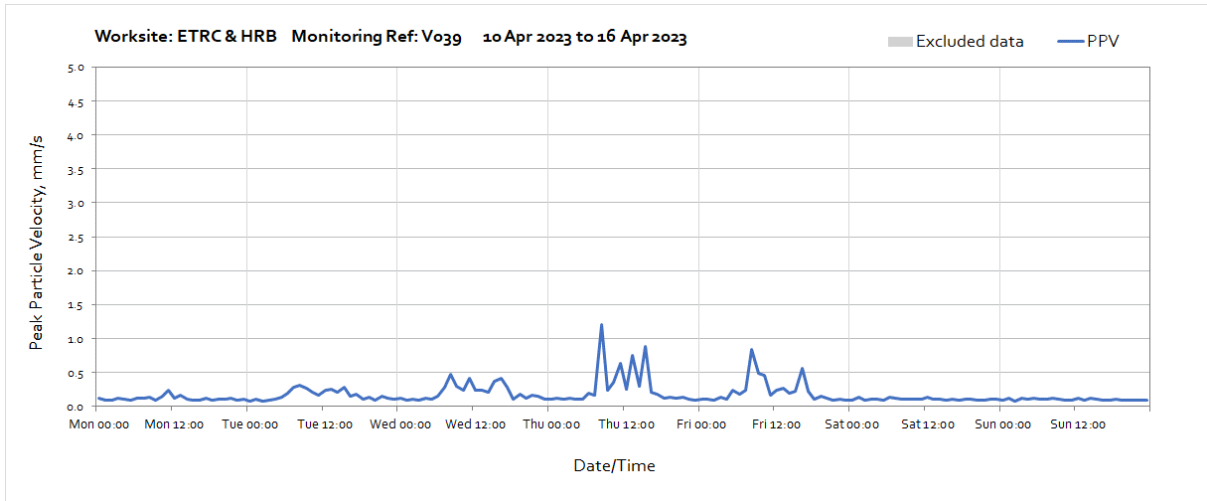
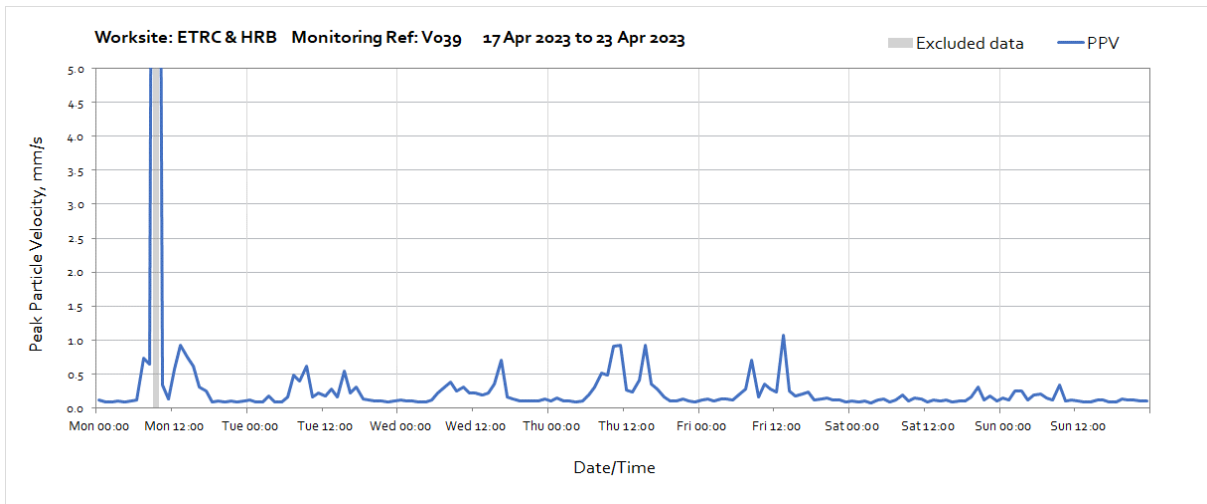
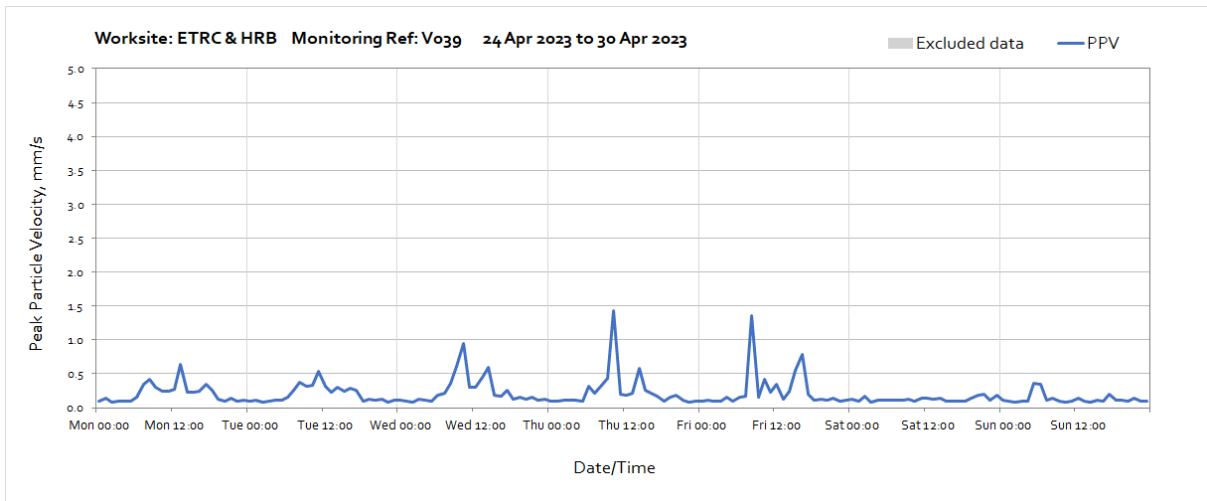
Worksite: ETRC & HRB – Monitoring Ref: V039

The following graphs show the hourly measured peak particle velocity PPV recorded during the monitoring period. The graphs show the resultant PPV due to vibration components on three orthogonal axes x, y and z. Where resultant PPV data is not available (monitors V039 and V043), the highest vibration component in either of the three axes is presented for each 1 hr measurement period respectively. Where high values of PPV were caused by local interference with the vibration monitor, which are not representative of HS2 construction works, these values have been greyed out in the following charts and have been excluded to calculate values in Table 4 of the main report.

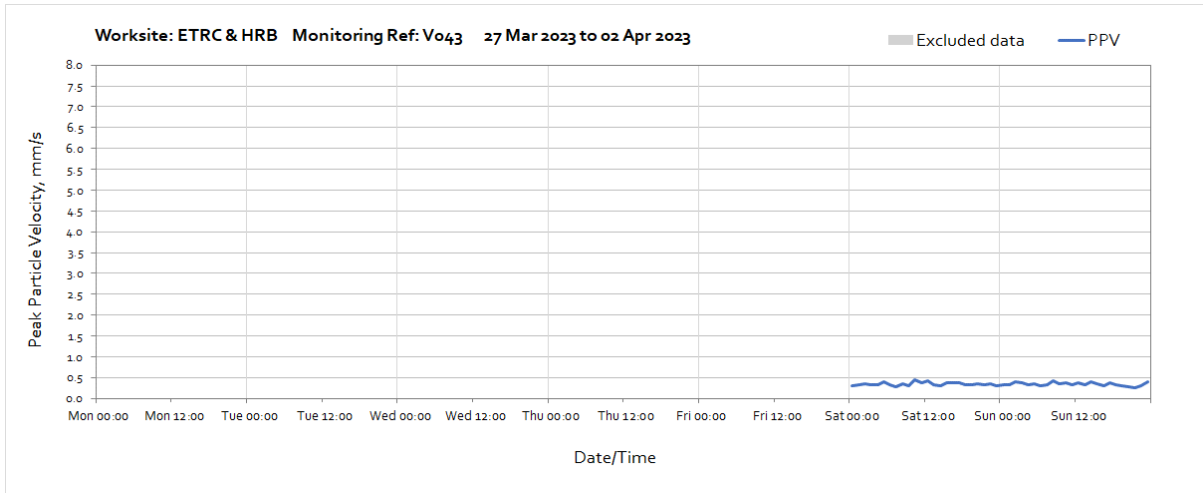
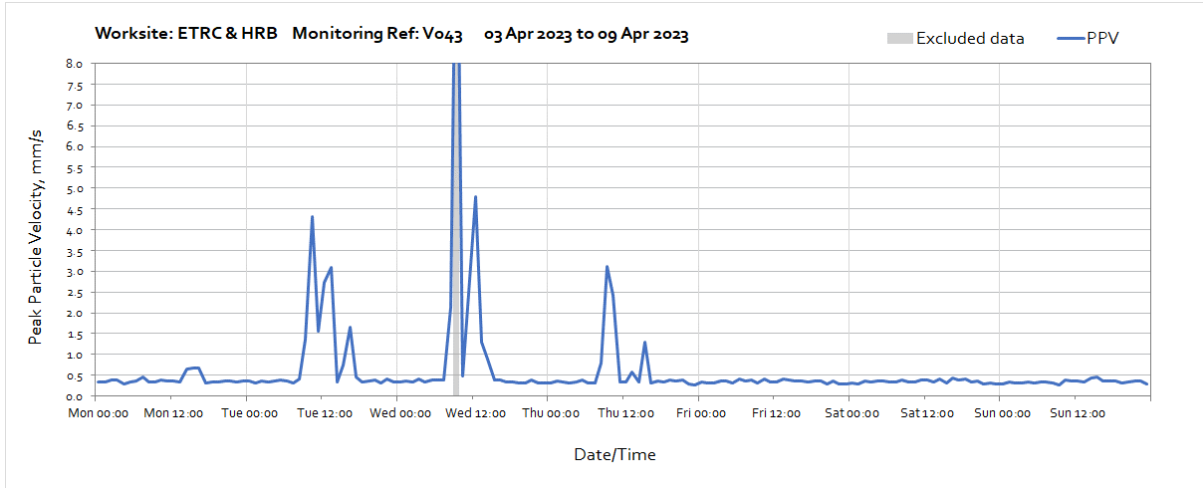
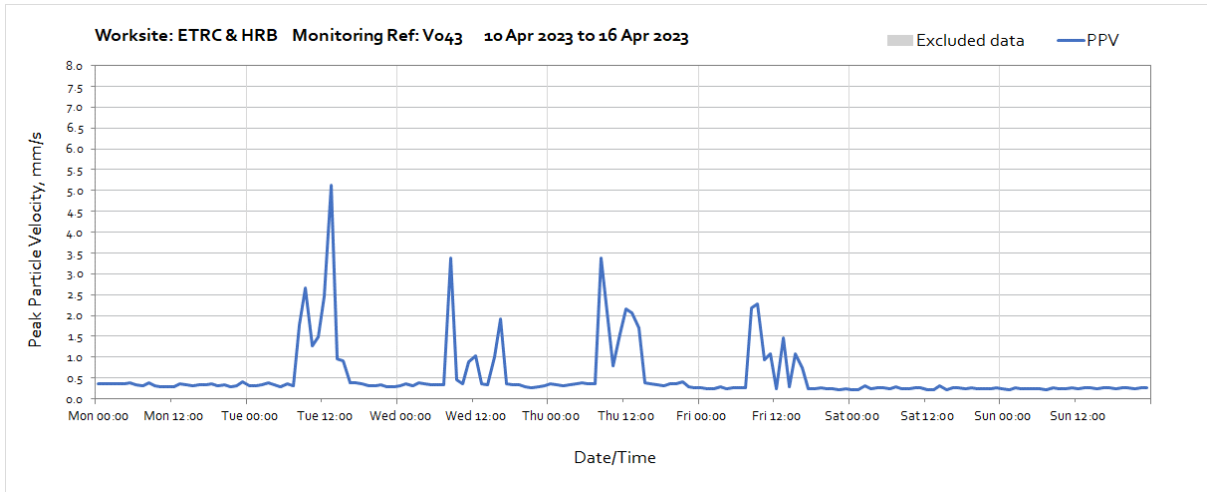
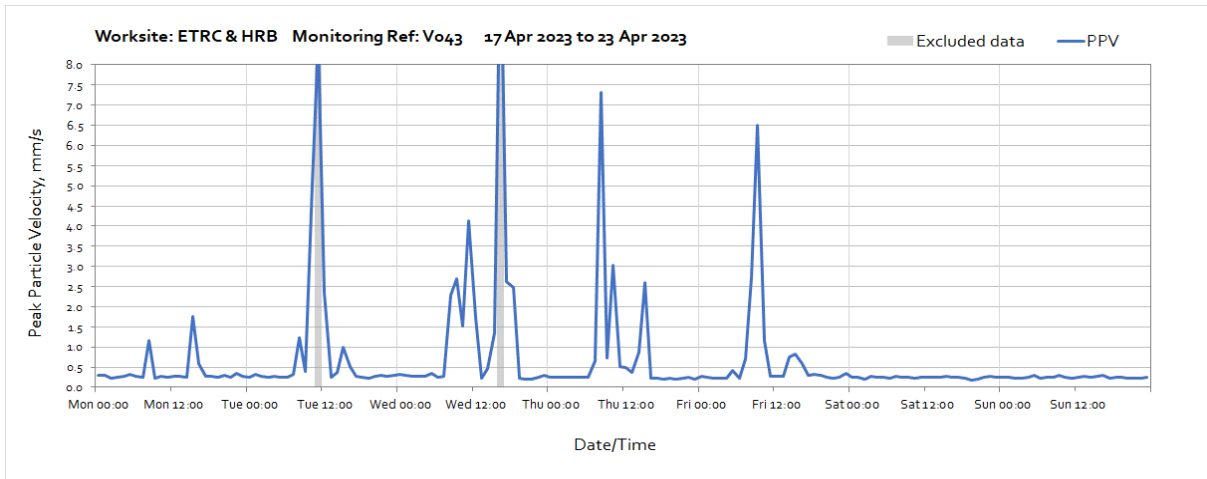
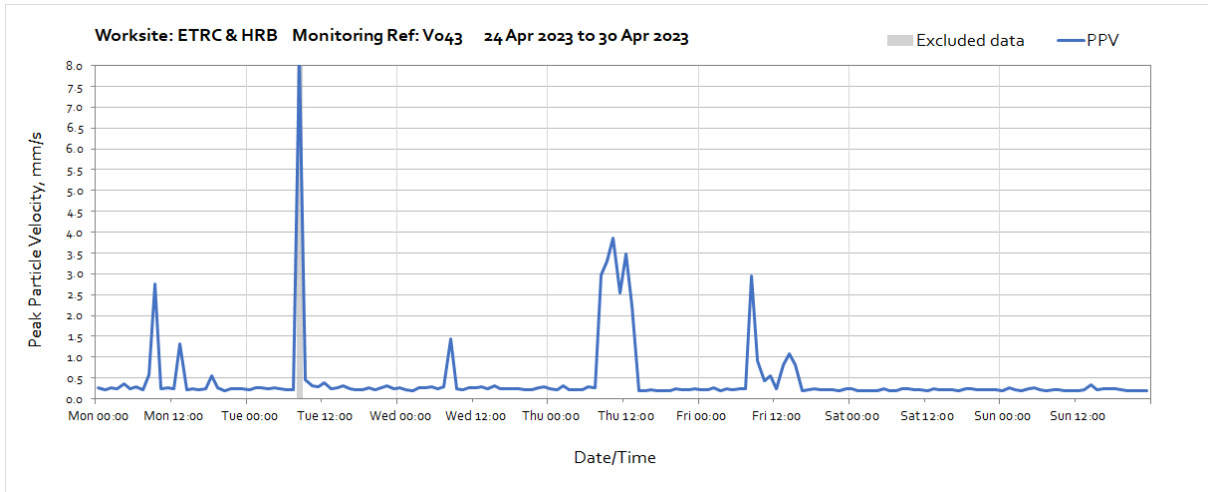
Worksite: ETRC & HRB – Monitoring Ref: V043

Note: High levels of vibration caused by works close to the monitor. Lower vibration levels anticipated at nearest receptor.

* High levels of vibration caused by works close to the monitor. Lower vibration levels anticipated at nearest receptor.
