## **Construction Noise and Vibration Monthly Report – April 2023**

**Solihull Metropolitan Borough Council**

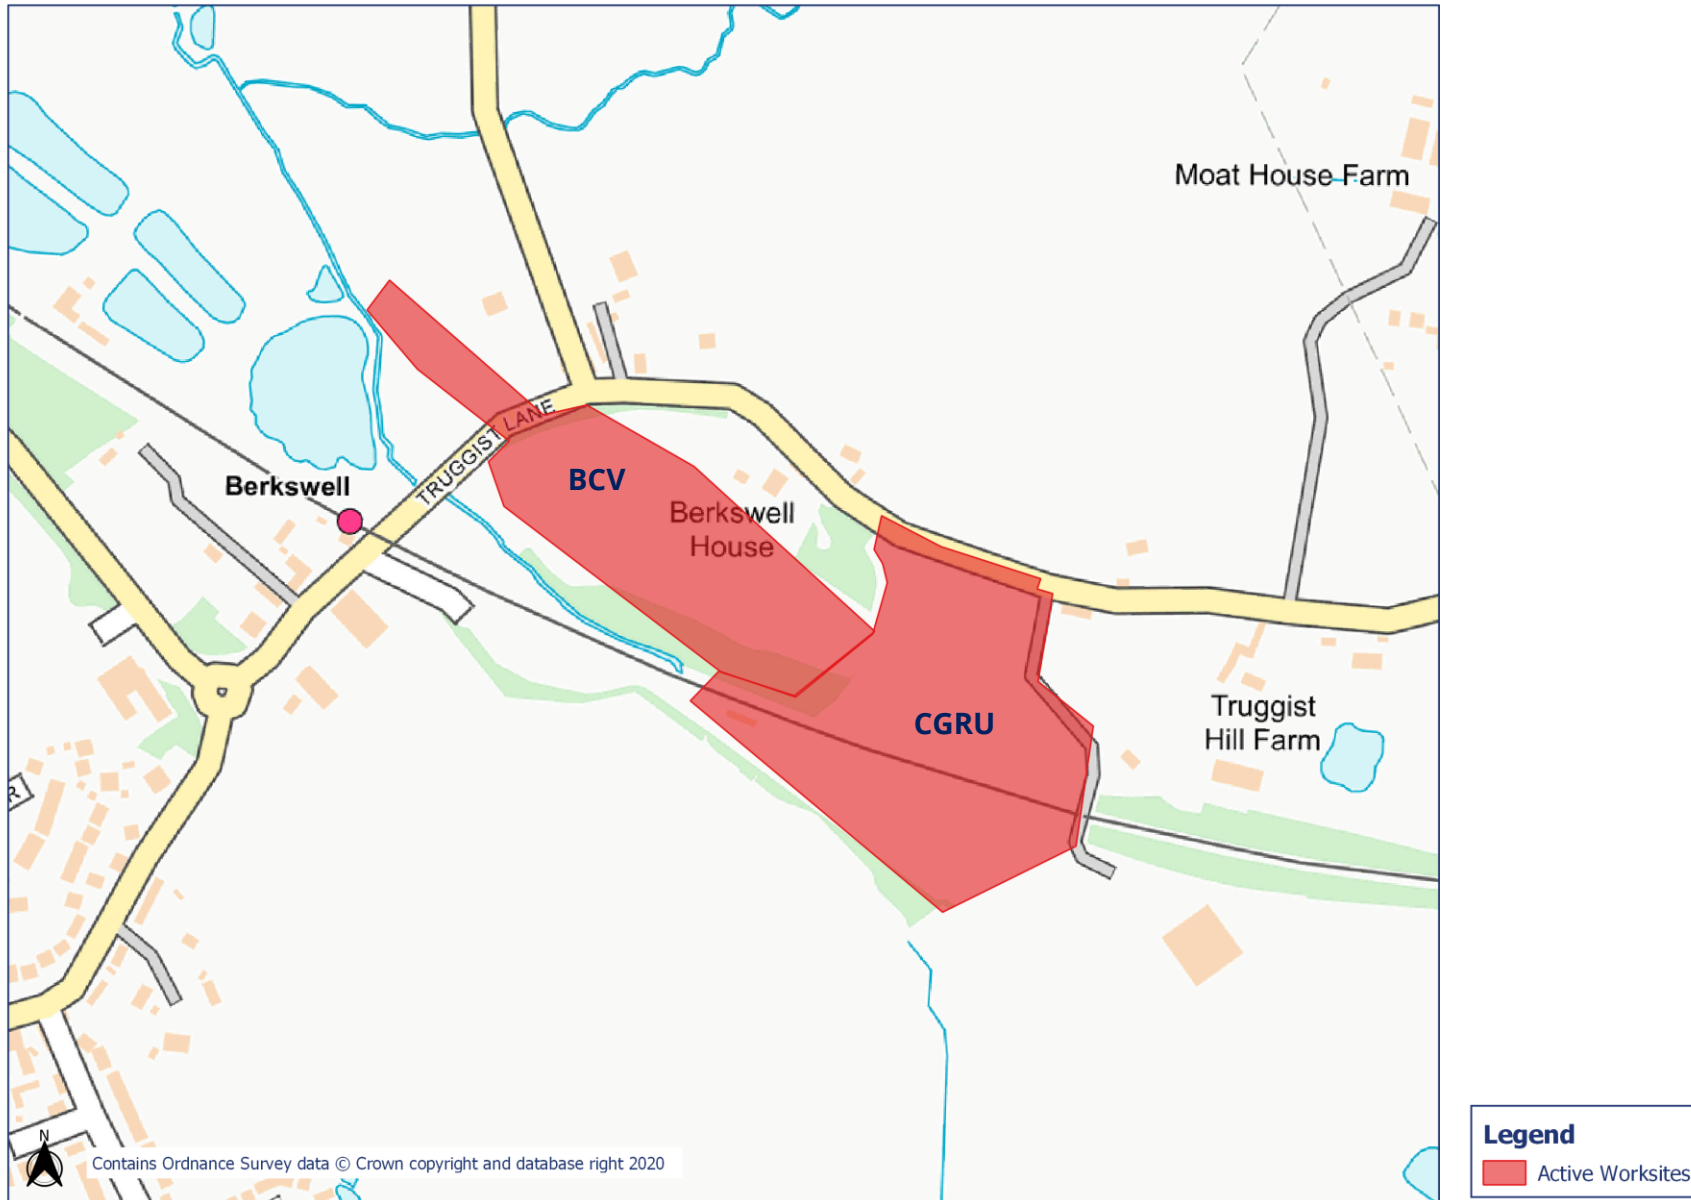
# Worksite Identification Plan - 7

- Stone backfilling and compaction.
- Road works, including realignment and repairs.
- Excavating, backfilling and compressing.
- Material haulage.
- Balsall Common Viaduct worksite, reference - BCV (see plan 7 in Appendix A), where work activities included:
  - Plant crossing.
  - Material haulage.
- Carol Green Rail Underbridge worksite, reference - CGRU (see plan 7 in Appendix A), where work activities included:
  - Decommissioning of monitor.
  - Vegetation clearance.
  - Material haulage.
  - Pile cap removal.
- Waste Lane Overbridge and Satellite worksite, reference WLOS (see plan 8 in Appendix A), where work activities included:
  - Diaphragm wall installation.
  - Material haulage.
  - Piling works.
  - Platform compaction.
  - Road sweeping.

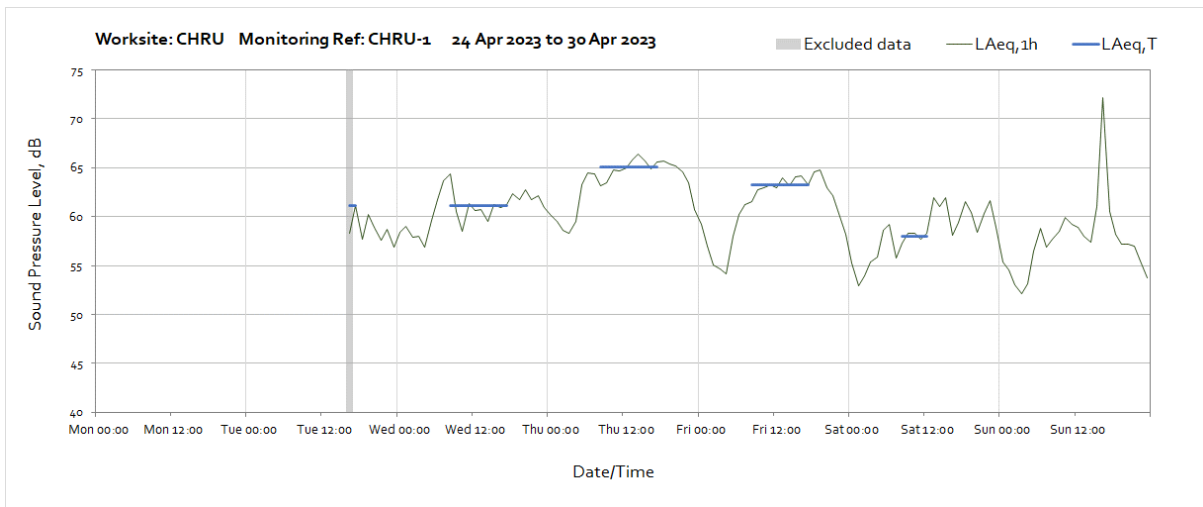
### Worksite: CHR - Monitoring Ref: CHR-1

Note: Noise monitor ref: CHR-1 was decommissioned in the previous months due to loss of power caused by the theft of solar panels. Noise monitor reinstalled at 16:00 on Tuesday 25<sup>th</sup> April 2023.

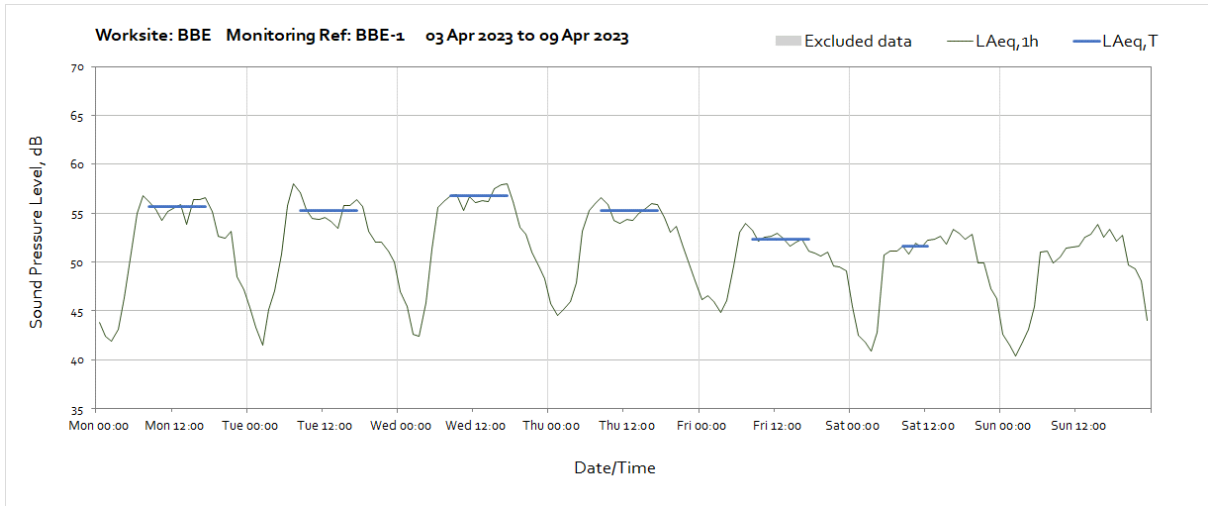
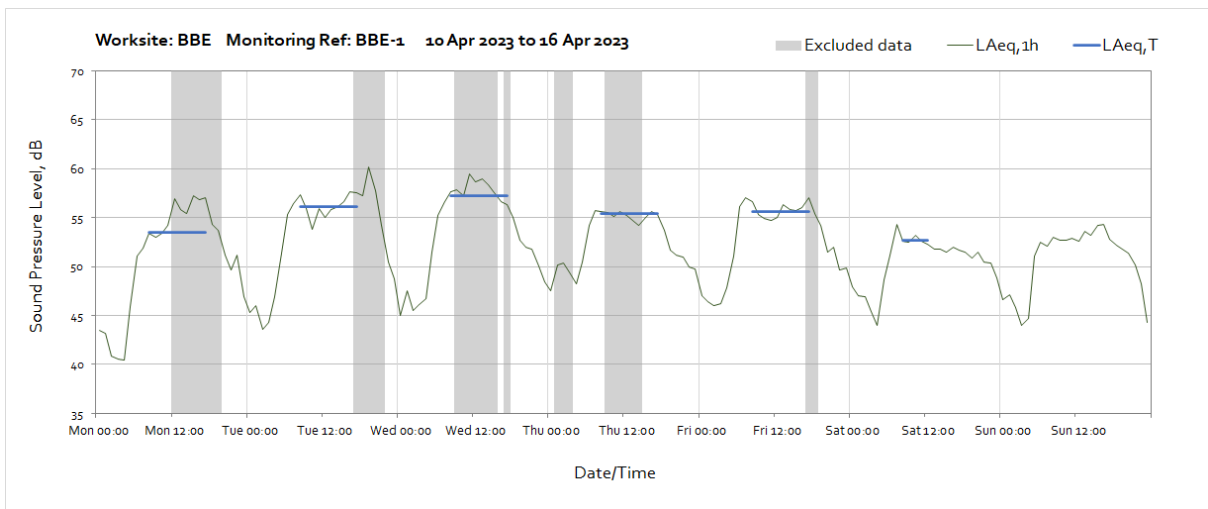
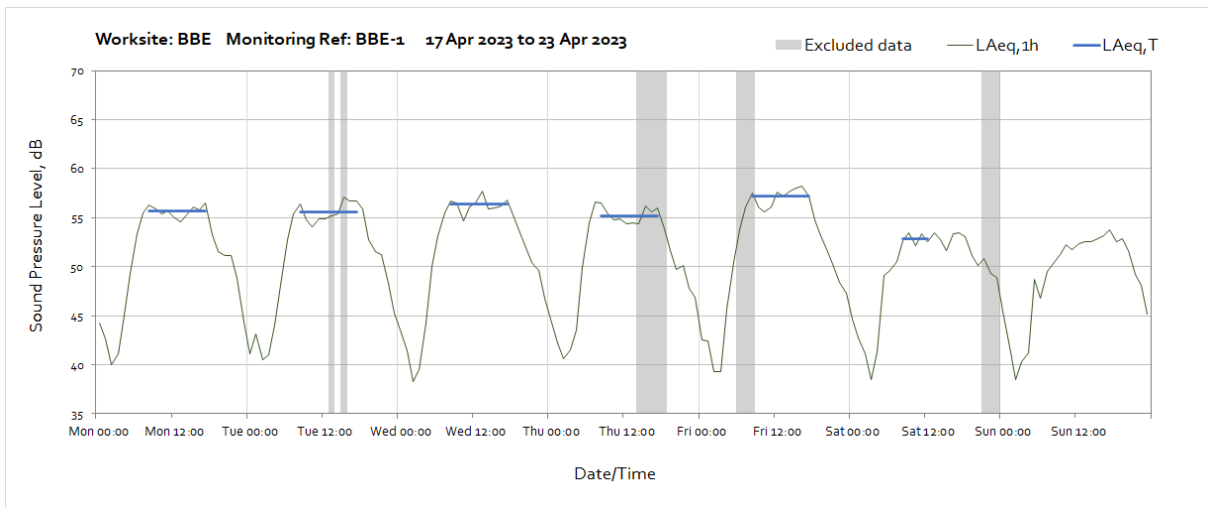
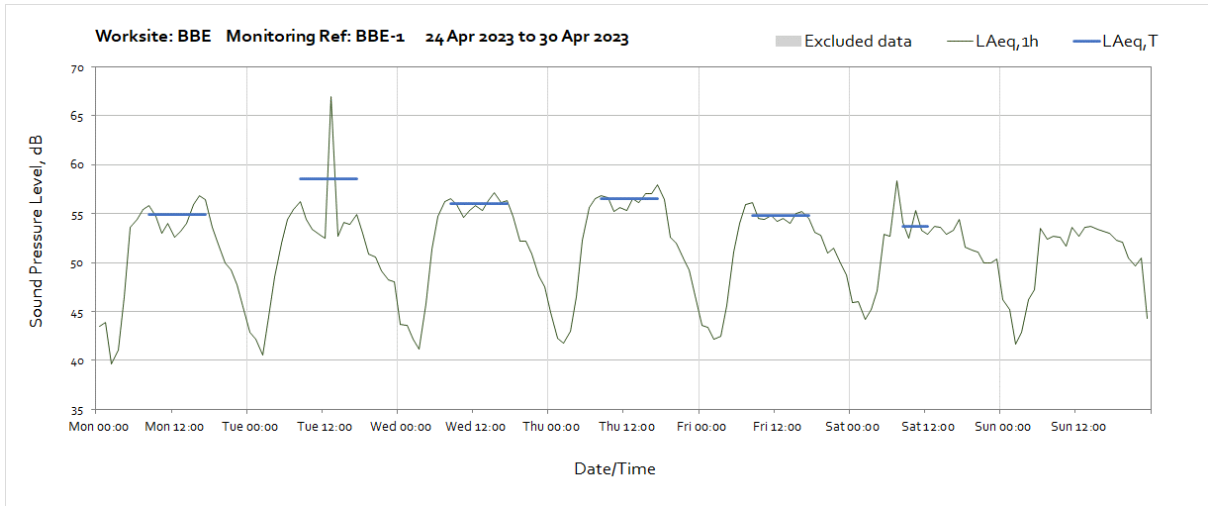
**Worksite: BBE – Monitoring Ref: BBE-1**

2.1.3 Appendix C presents graphs of the noise and vibration monitoring data over the month for each of the measurement locations. Noise data presented consists of the hourly  $L_{Aeq}$  values and, where relevant, the  $L_{Aeq,T}$  values (where the time period T has been taken to be the averaging period as specified in Table 1 of HS2 Information Paper E23). Vibration data presented consist of hourly PPV values. The full data set for the monitoring equipment can be found at the following location: <https://data.gov.uk/dataset/24542ae7-dd44-444f-b259-871c4cc43b5e/environmental-monitoring-data>.

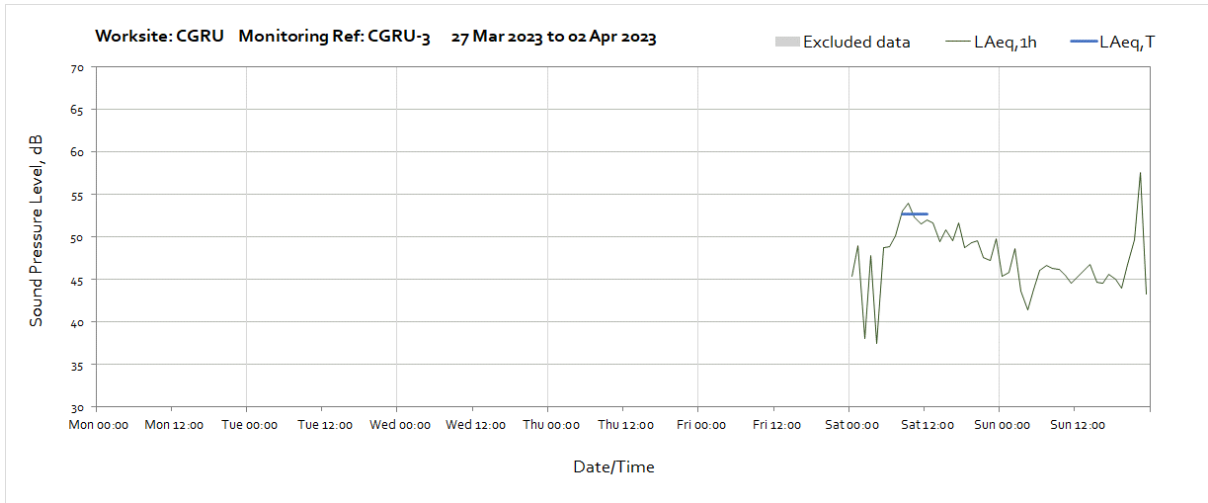
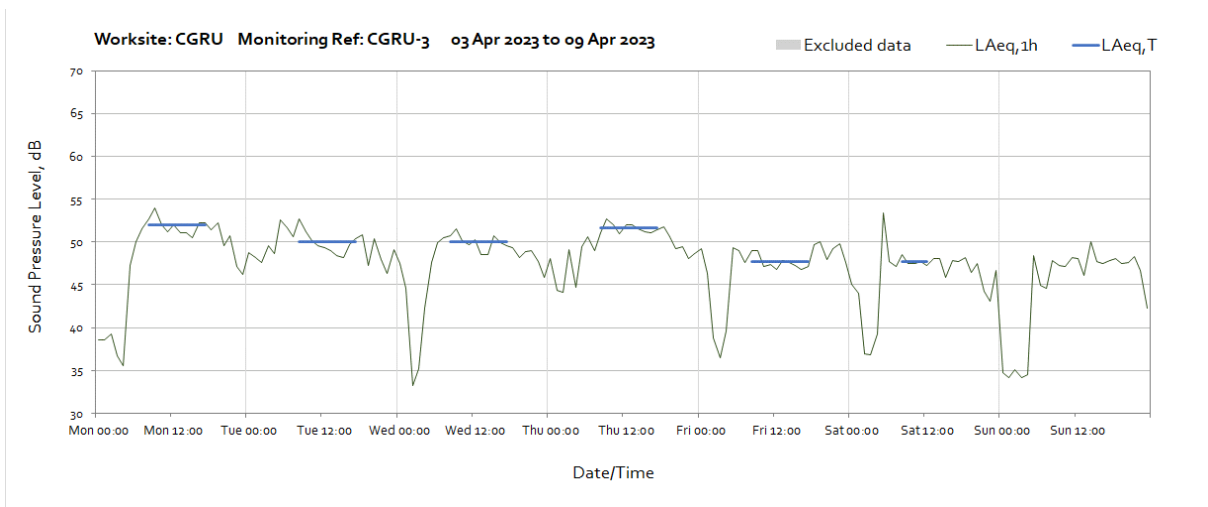
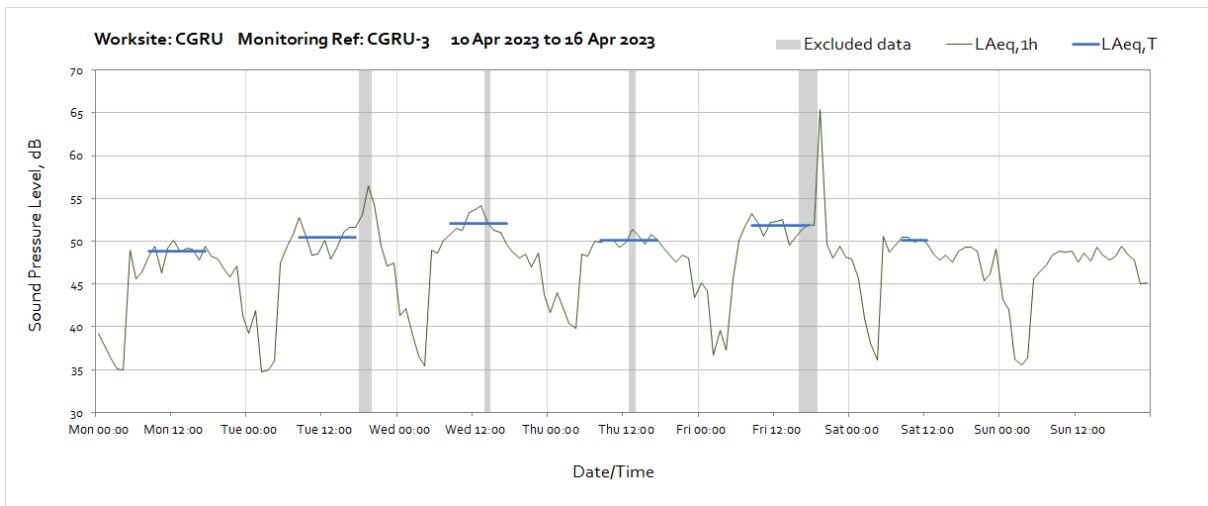
**Worksite: CGRU- Monitoring Ref: CGRU-3**

Note: Missing data between 17:00 on Monday 17<sup>th</sup> April and till the end of the month was due to loss of power to the monitor.

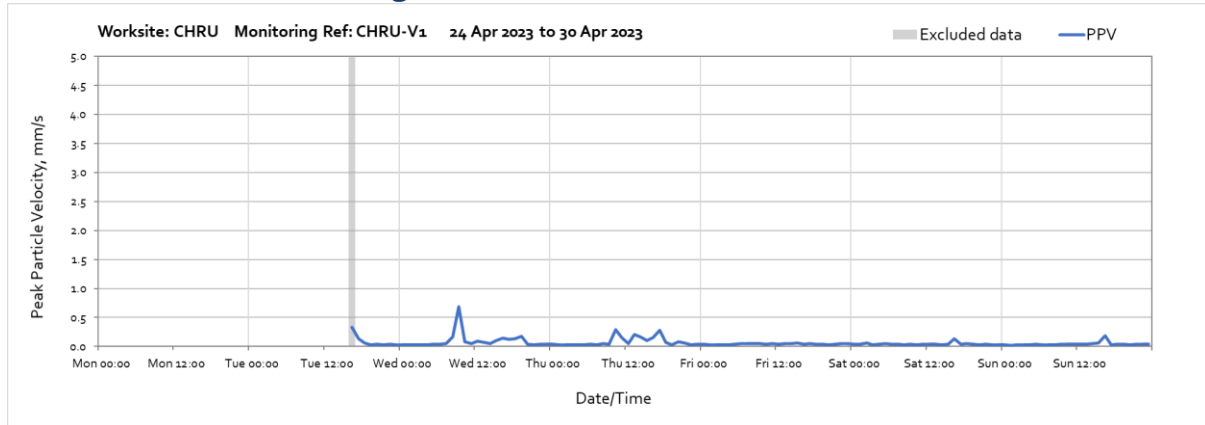
### Worksite: CHR – Monitoring Ref: CHR-U-V1

Note: Noise monitor ref: CHR-U-V1 was decommissioned in the previous months due to loss of power caused by the theft of solar panels. Noise monitor reinstalled at 16:00 on Tuesday 25<sup>th</sup> April 2023.

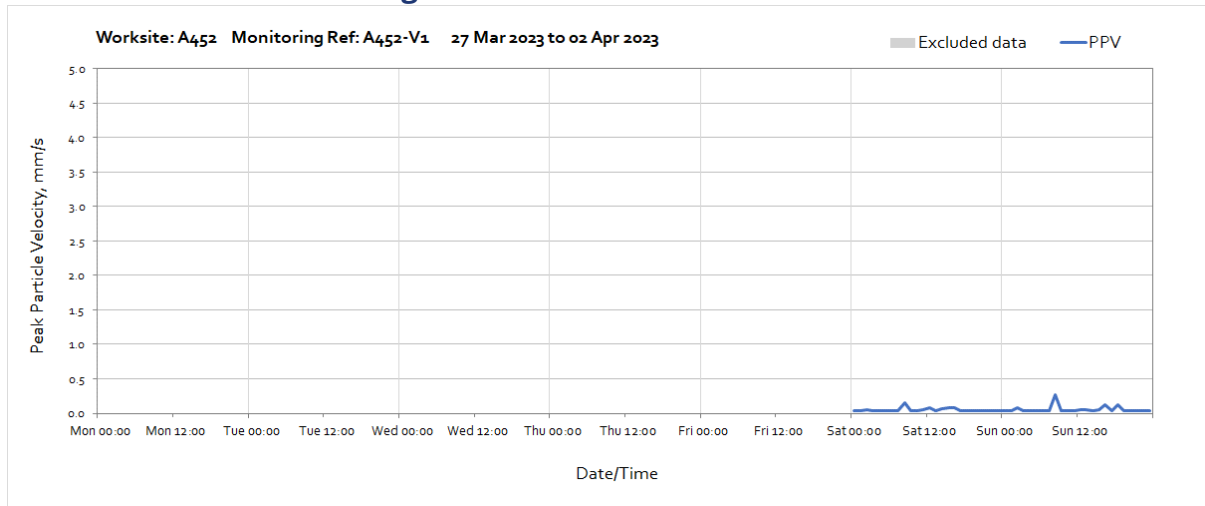
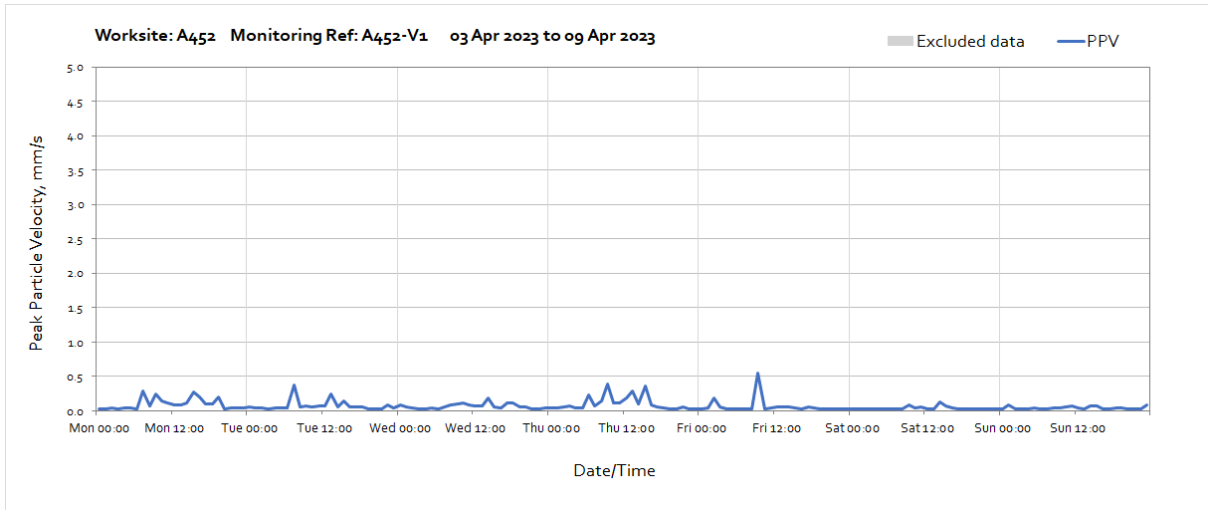
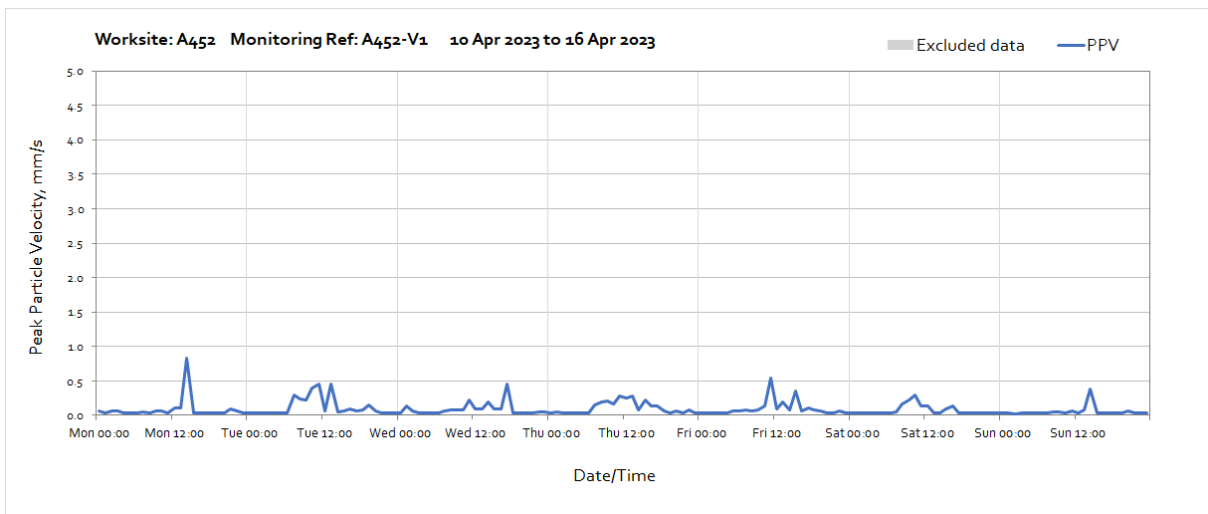
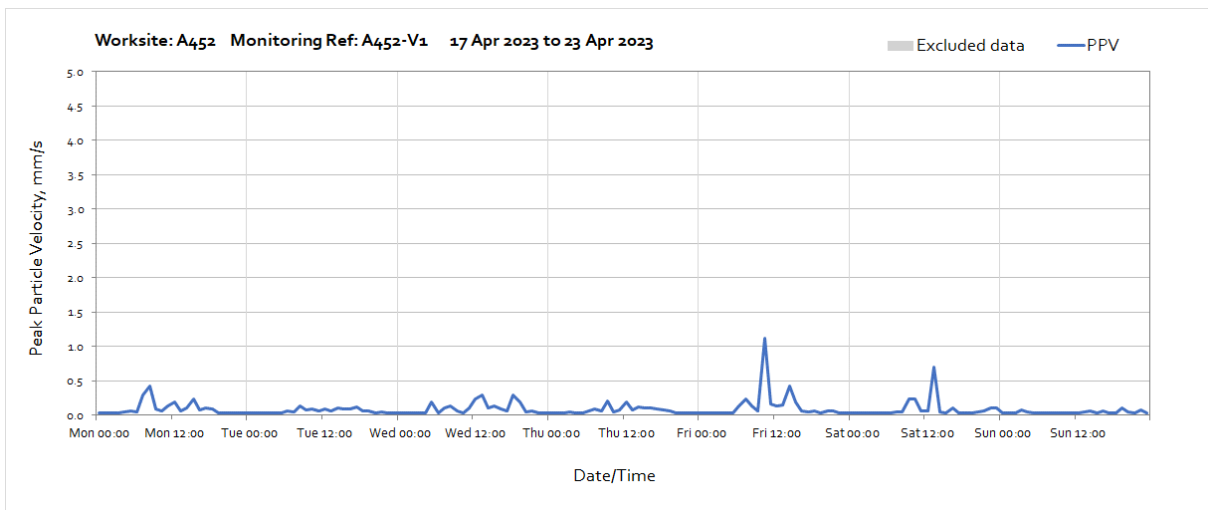
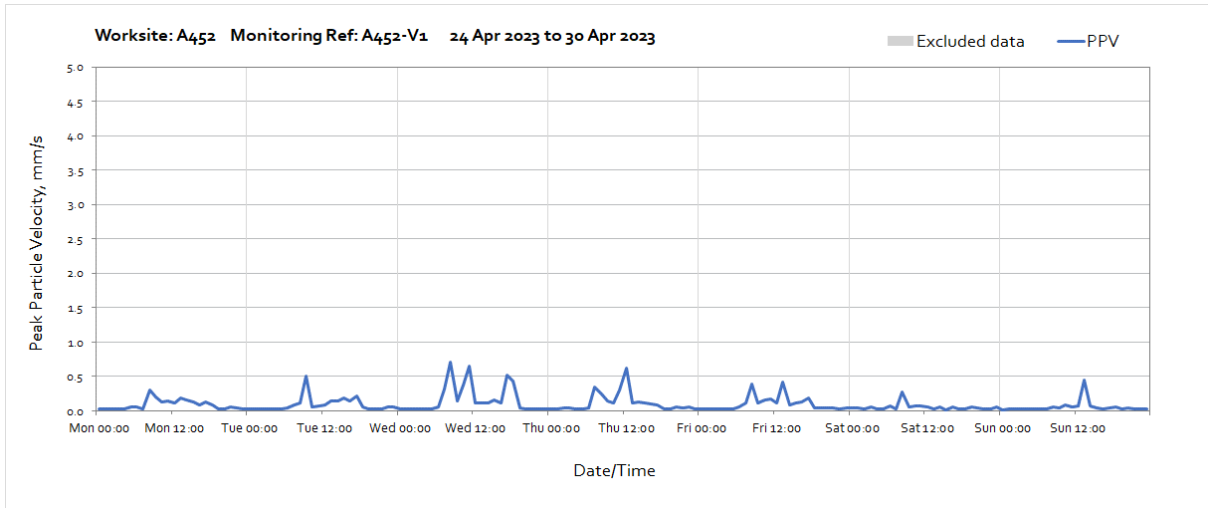
### Worksite: A452 – Monitoring Ref: A452-V1

The following graphs show the hourly measured peak particle velocity PPV recorded during the monitoring period. The graphs show the highest PPV of the three orthogonal axes x, y and z. Where high values of PPV were caused by local interference with the vibration monitor, which are not representative of HS2 construction works, these values have been greyed out in the following charts and have been excluded to calculate values in Table 4 of the main report.

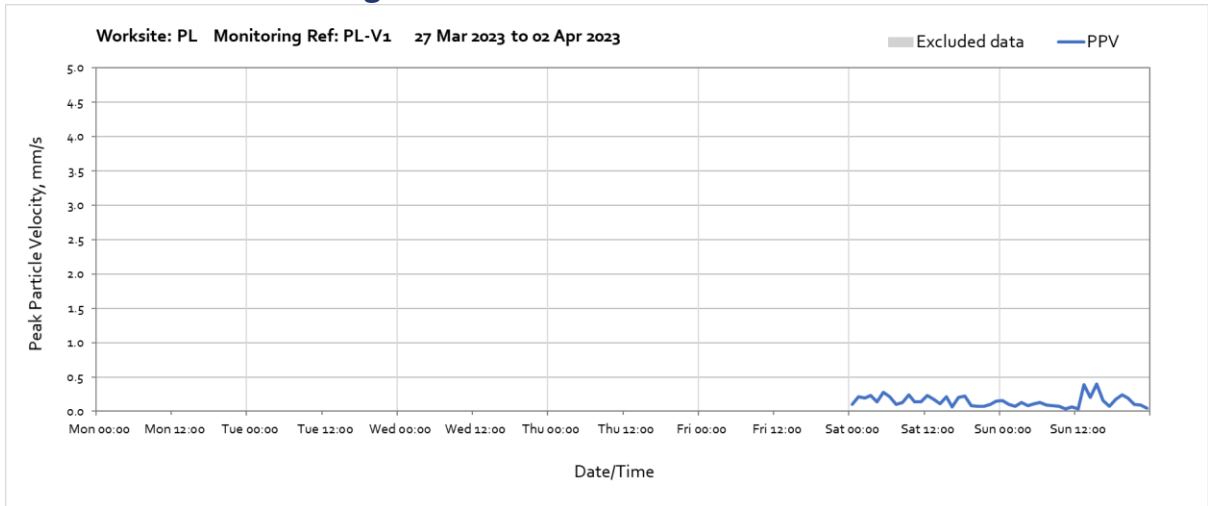
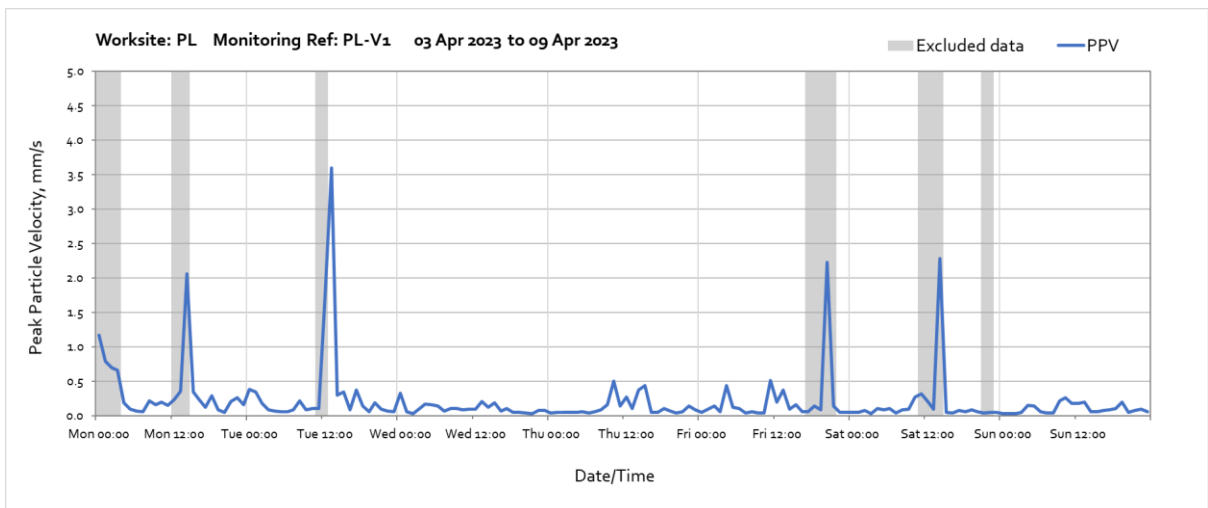
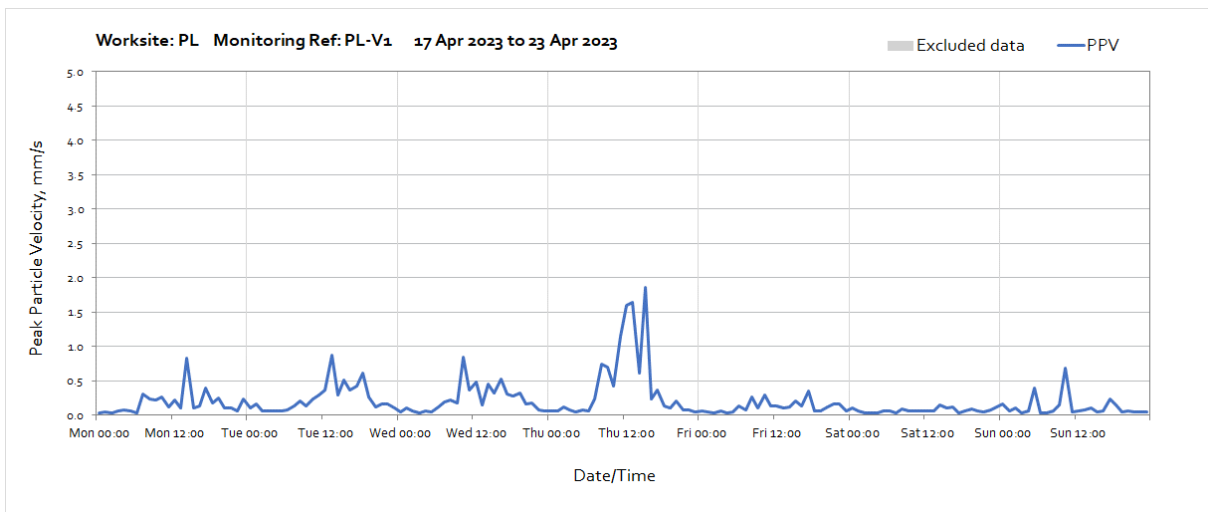
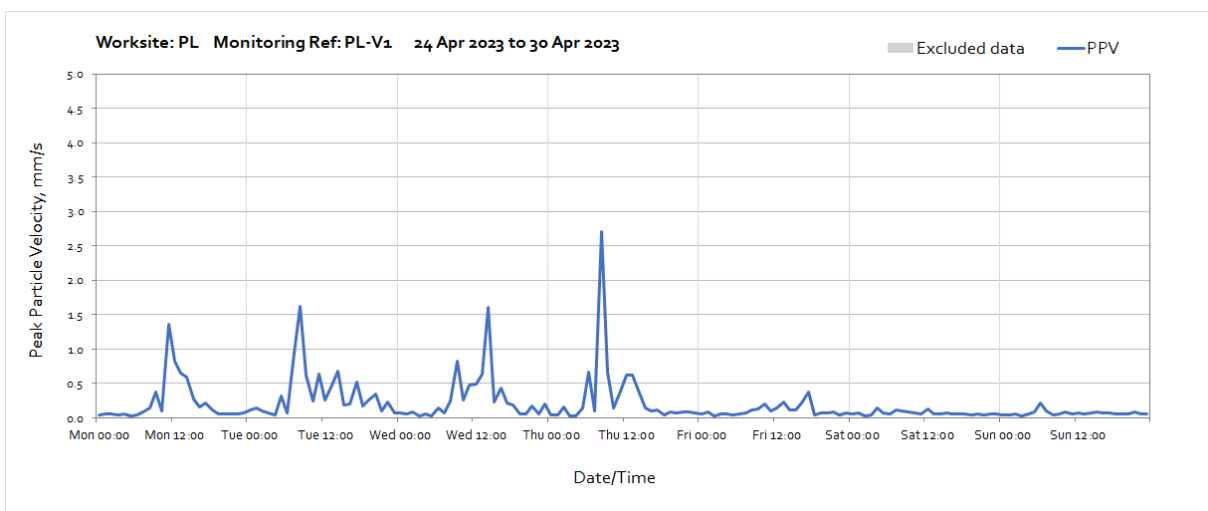
### Worksite: PL – Monitoring Ref: PL-V1

Note: High vibration levels measured at 13:00 on Tuesday 4<sup>th</sup> April was due to topsoiling of bun and heavy plant usage in the vicinity of the monitor.

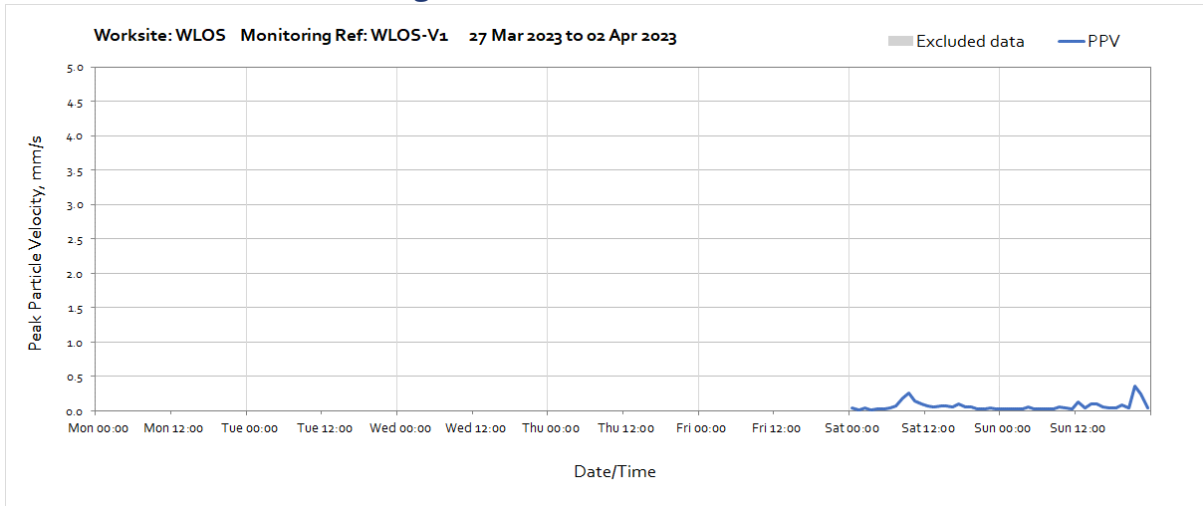
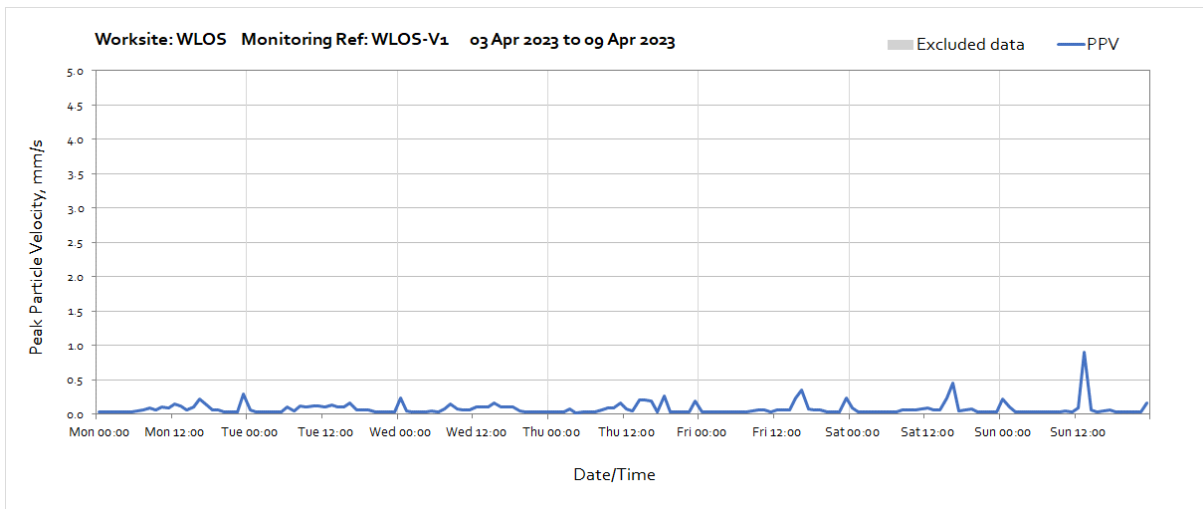
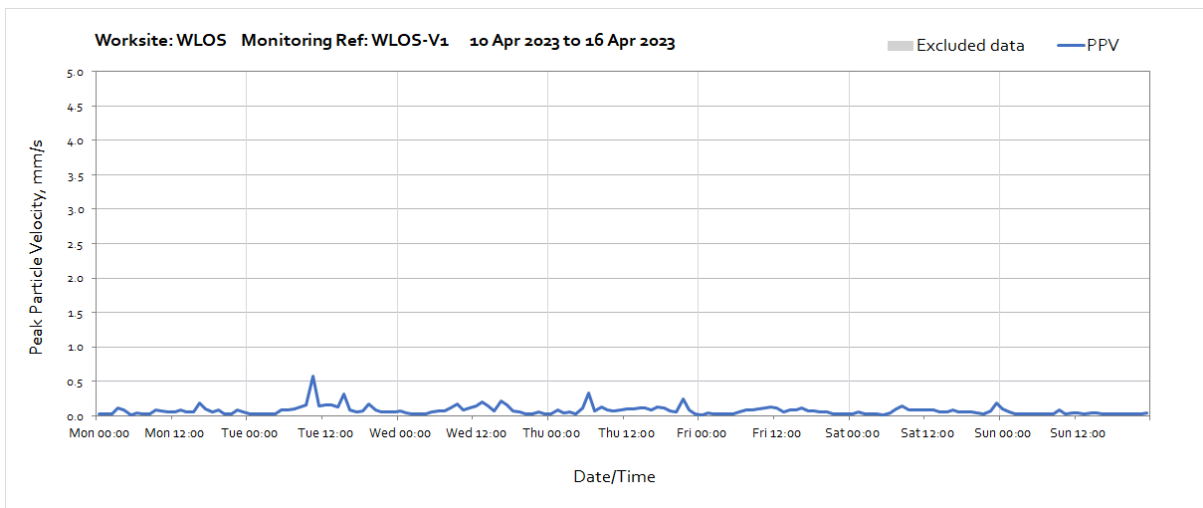
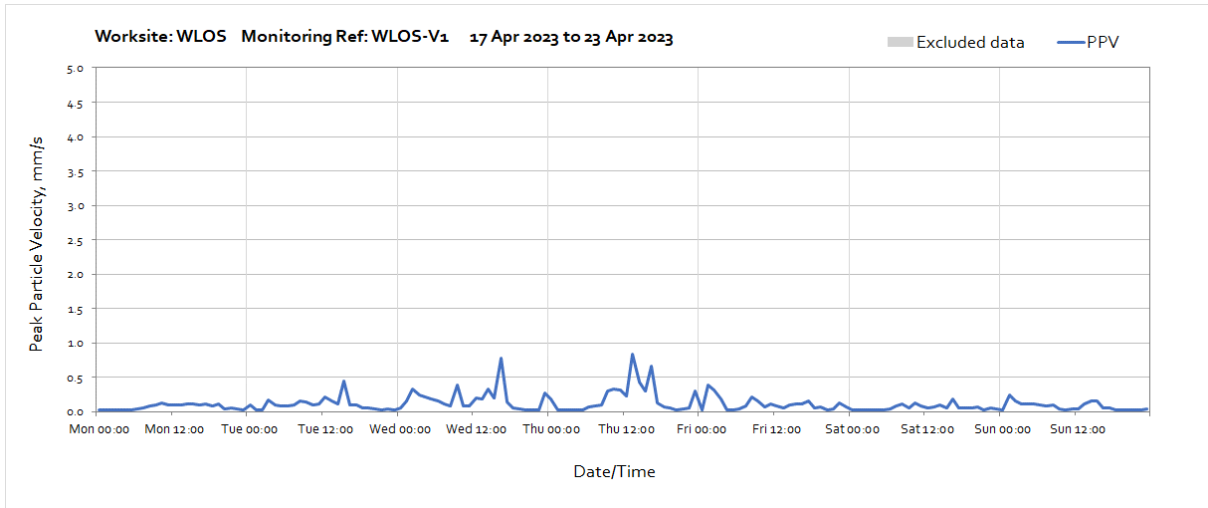
## Worksite: WLOS – Monitoring Ref: WLOS-V1

Note: High vibration levels measured between 13:00 and 14:00 on Tuesday 25<sup>th</sup> April and between 12:00 and 16:00 on Thursday 27<sup>th</sup> April was due to piling works, roof installation and diaphragm wall works.

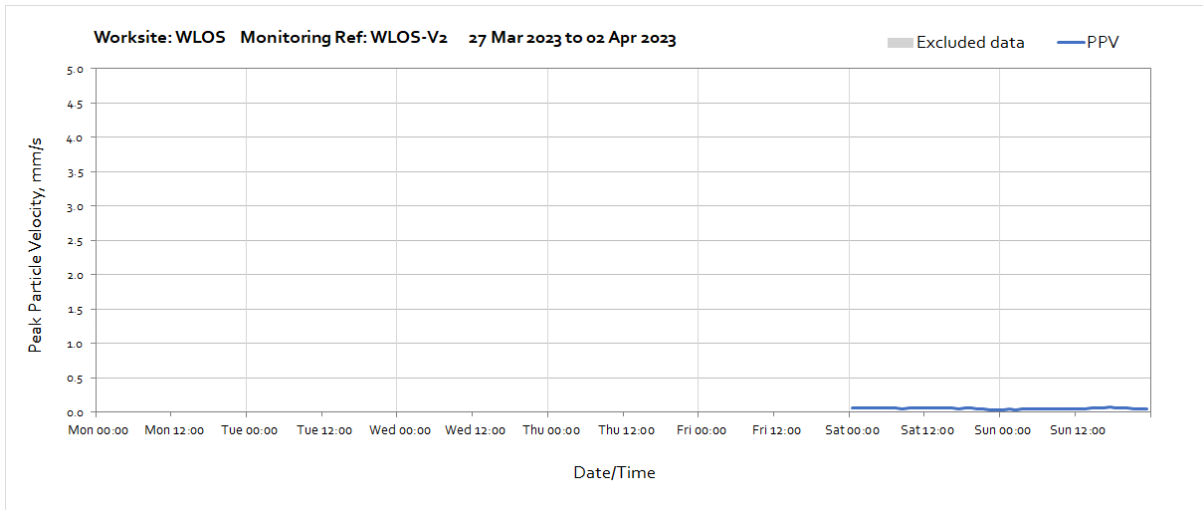
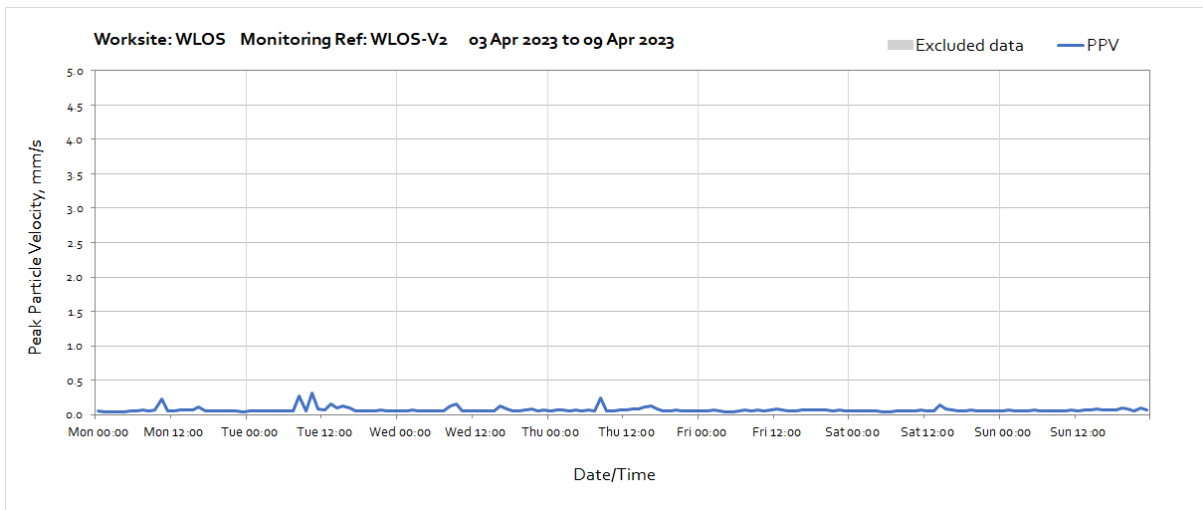
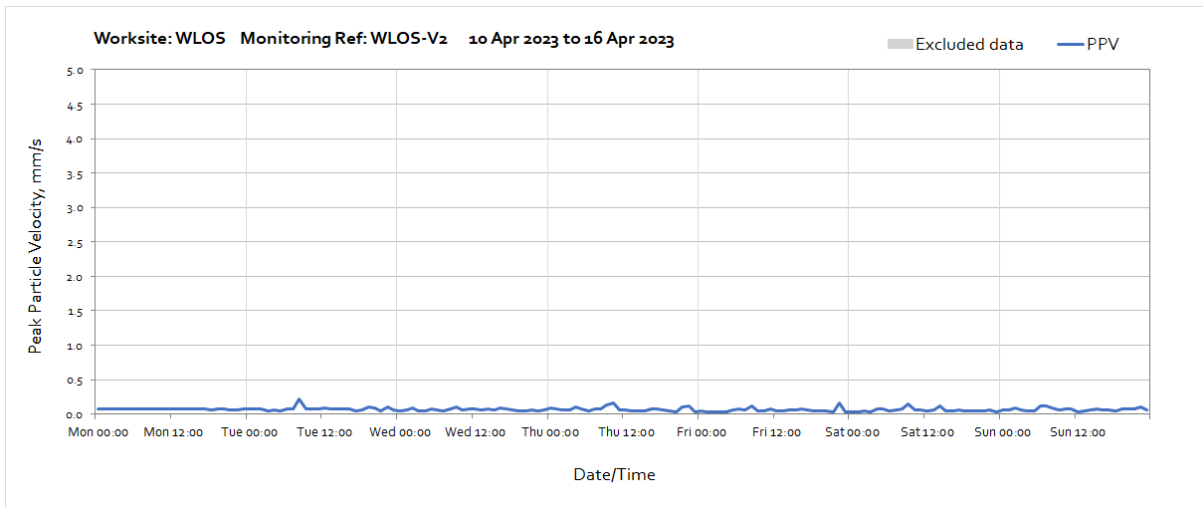
## Worksite: WLOS - Monitoring Ref: WLOS-V2

Note: Missing data between 01:00 and 11:00 on Wednesday 26<sup>th</sup> April was due to malfunction of SD card. High vibration levels measured between 15:00 and 16:00 on Friday 28<sup>th</sup> April was due to piling works in the vicinity of the monitor, lower levels are expected at the nearest receptors.
