# **Construction Noise and Vibration Monthly Report – May 2023**

**Lichfield District Council**

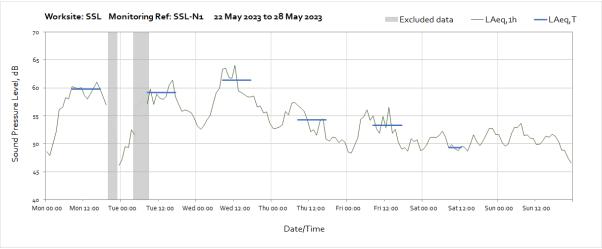
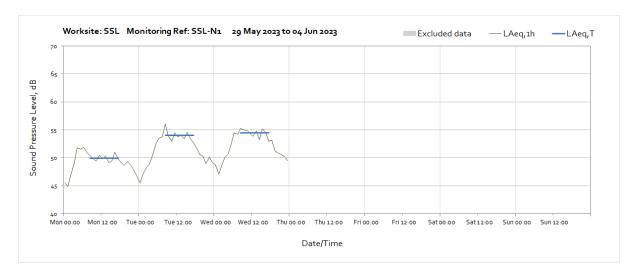
## **Worksite: SCRS - Monitoring Ref: SSL-N1**

Note: Missing data between 22nd May and 23rd May 20:00 TO 08:00 due to malfunction of Micro SD which has been replaced.

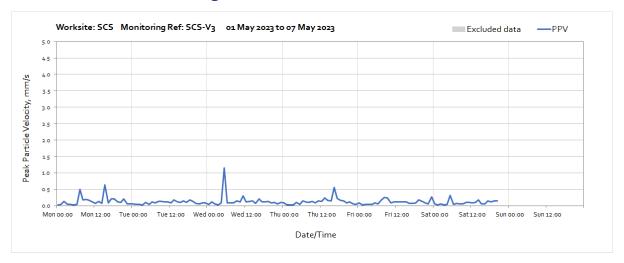
#### **Worksite: TROS - Monitoring Ref: SCS-V3**

Note: Missing data between  $06^{th}$  May 21:00 and  $31^{st}$  May 23:00 due to failure of mains which powers the system so it stopped measuring.
