Construction Noise and Vibration Monthly Report – June 2023

Buckinghamshire

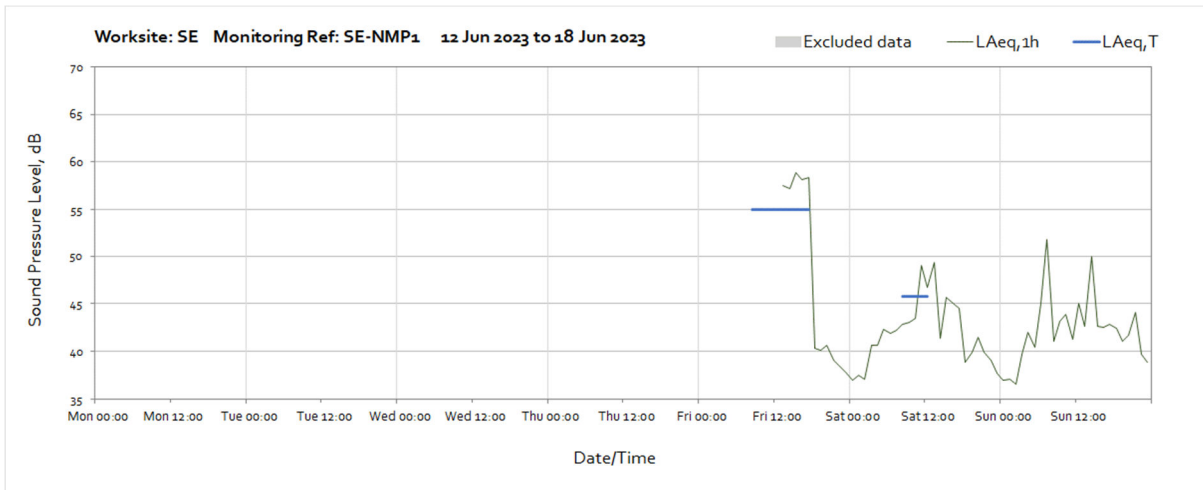
Worksite: SE – Monitoring Ref: SE-NMP1

Note: Missing data from the start of the month until 13:00 on Friday 15th June was due to a damaged power cable which has now been replaced.

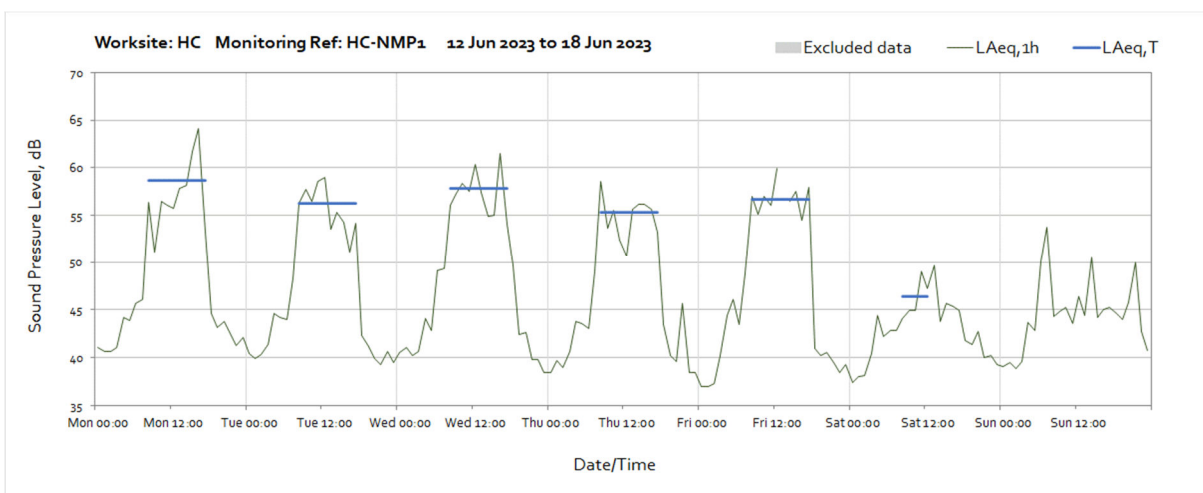
Worksite: HC – Monitoring Ref: HC-NMP1

Note: Missing data between 13:00 and 14:00 on Friday 16th June was due to monitor maintenance.

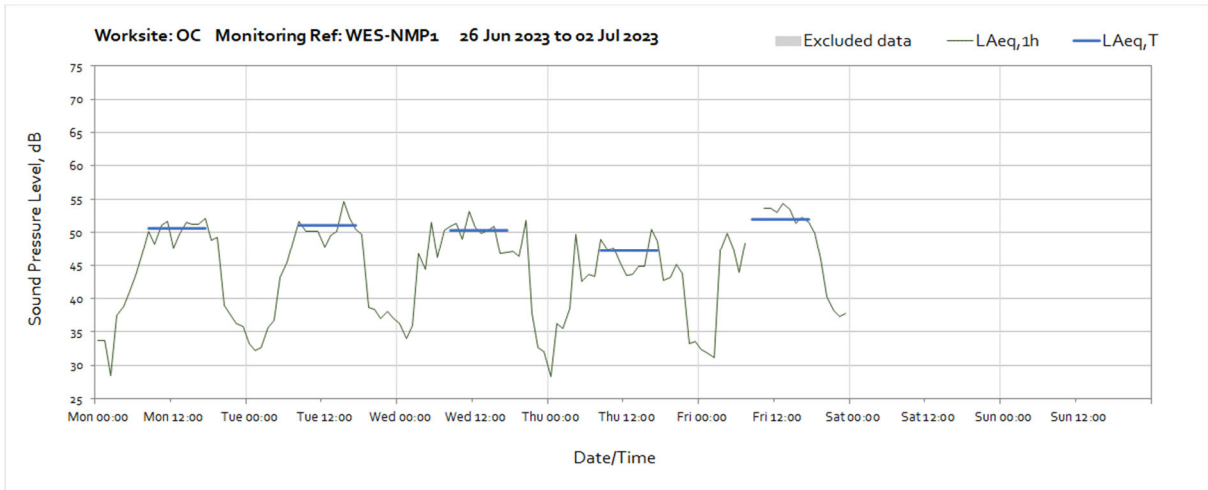
Worksite: OC - Monitoring Ref: WES-NMP1

Note: Missing data between 08:00 and 10:00 on Friday 30th June was due to monitor maintenance.

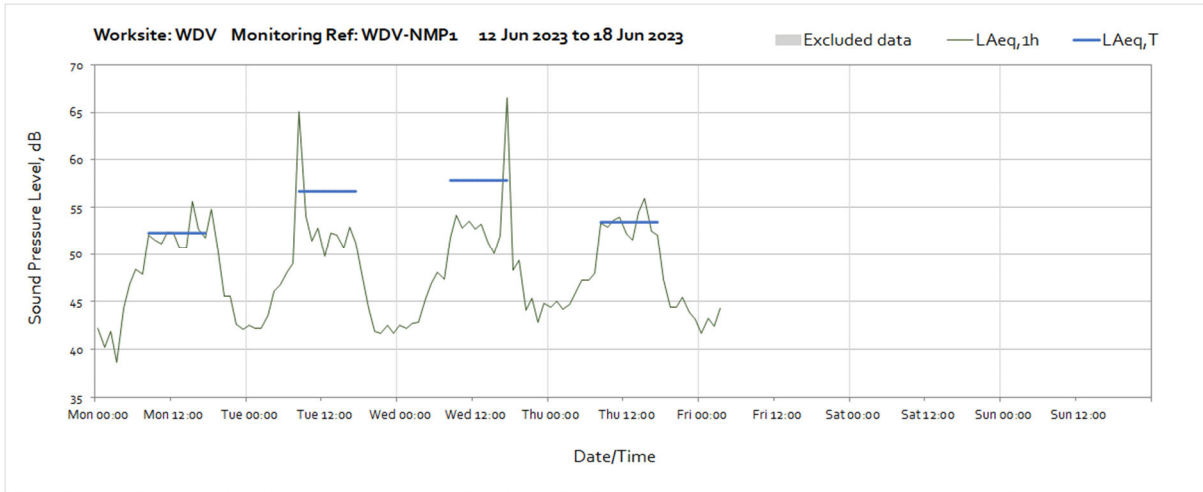
Worksite: WDV – Monitoring Ref: WDV-NMP1

Note: Missing data from 04:00 on Friday 16th June until the end of the month was due to a damaged power cable.

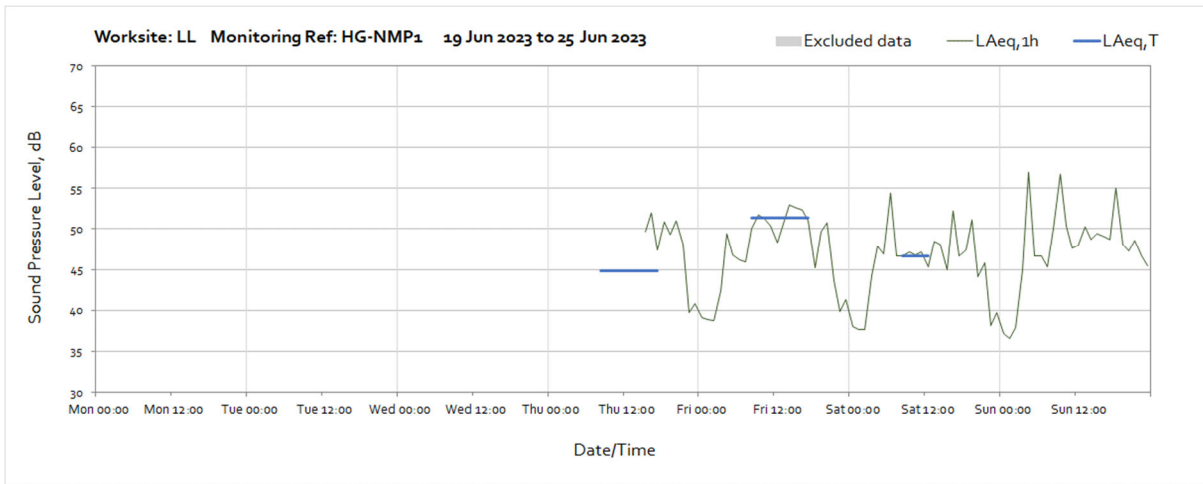
Worksite: LL – Monitoring Ref: HG-NMP1

Note: Monitor was reinstalled at 15:00 on Thursday 22nd June.

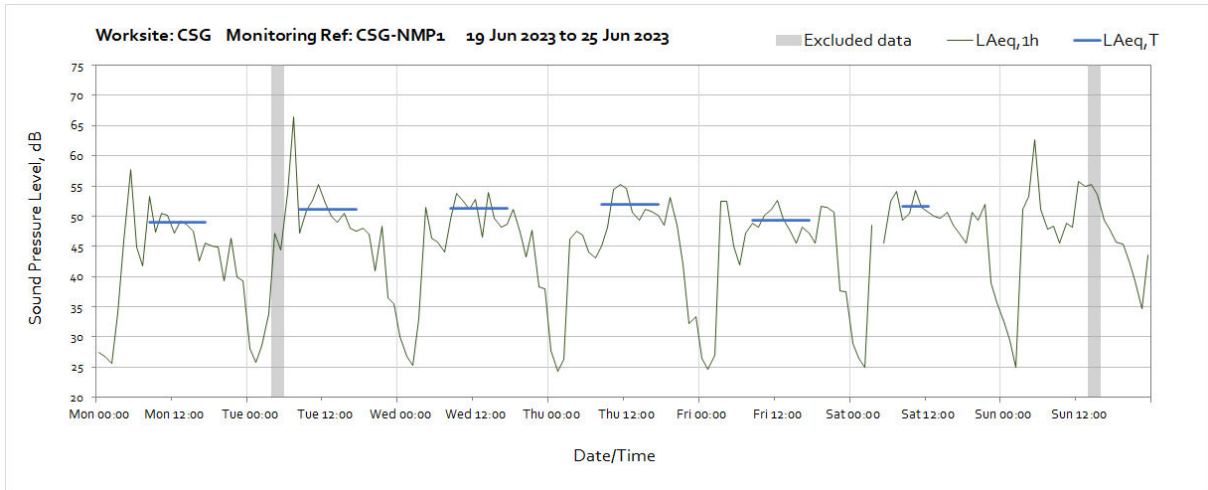
Worksite: CSG – Monitoring Ref: CSG-NMP1

Note: Missing data between 04:00 and 05:00 on Saturday 24th June was due to a monitor system update.

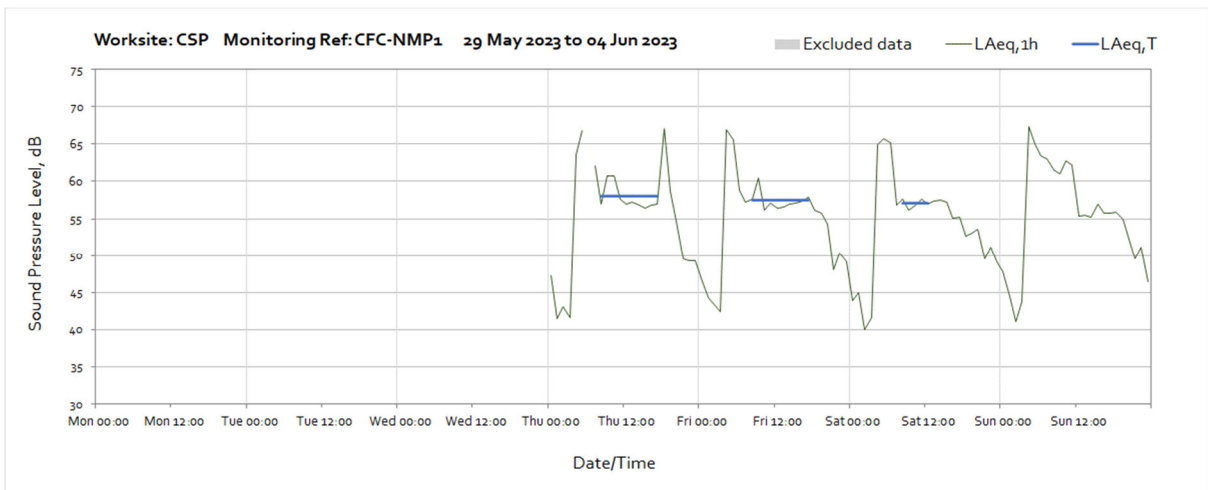
Worksite: CSP - Monitoring Ref: CFC-NMP1

Note: Missing data between 06:00 and 07:00 on Thursday 1st June was due to a communication error between the server and the monitoring system.

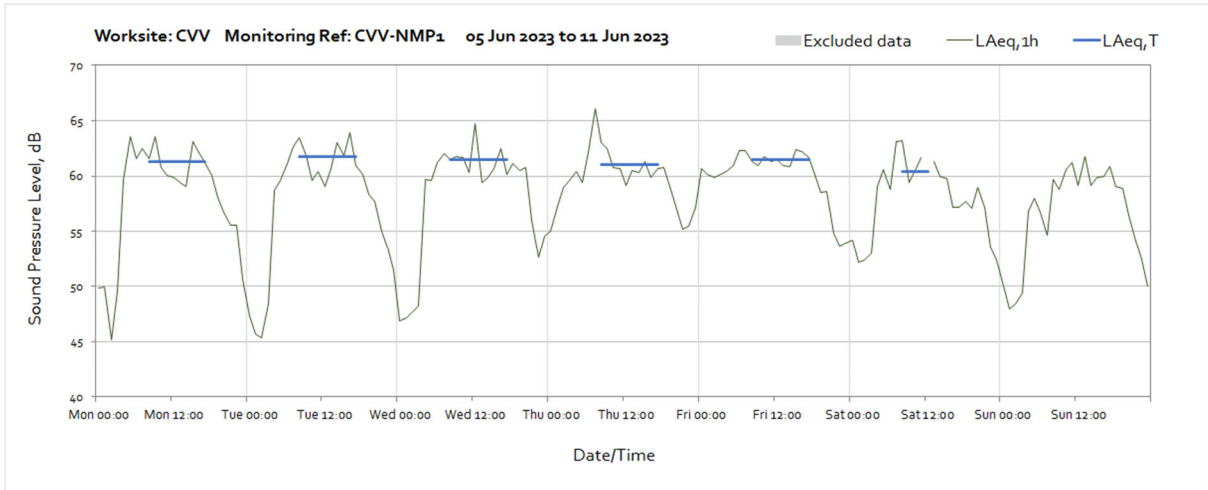
Worksite: CVV- Monitoring Ref: CVV-NMP1

Note: Missing data between 12:00 and 13:00 on Saturday 10th June was due to a communication error between the server and the monitoring system.

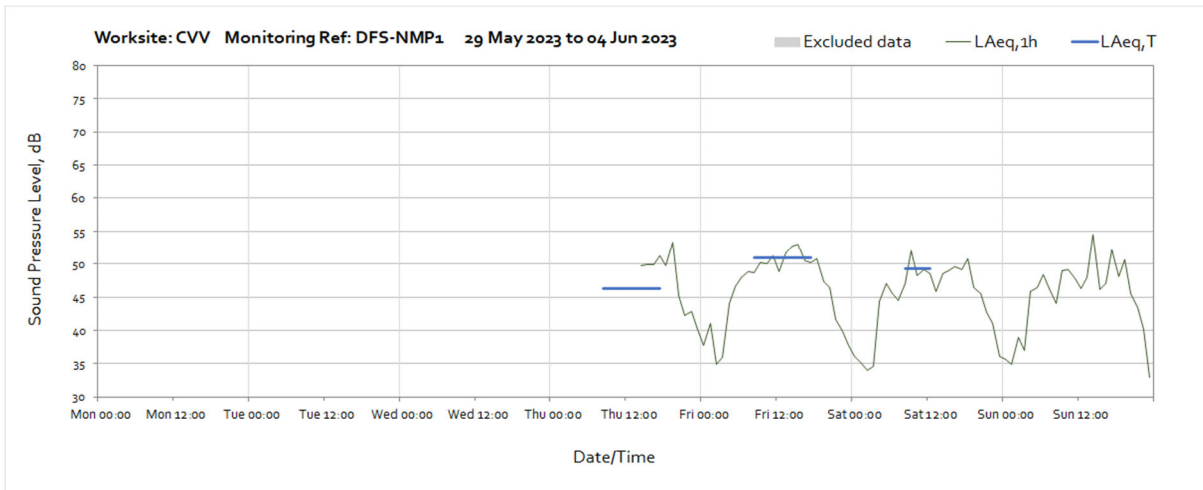
Worksite: CVV – Monitoring Ref: DFS-NMP1

Note: Missing data between 00:00 and 14:00 on Thursday 1st June was due to depleted monitor battery.

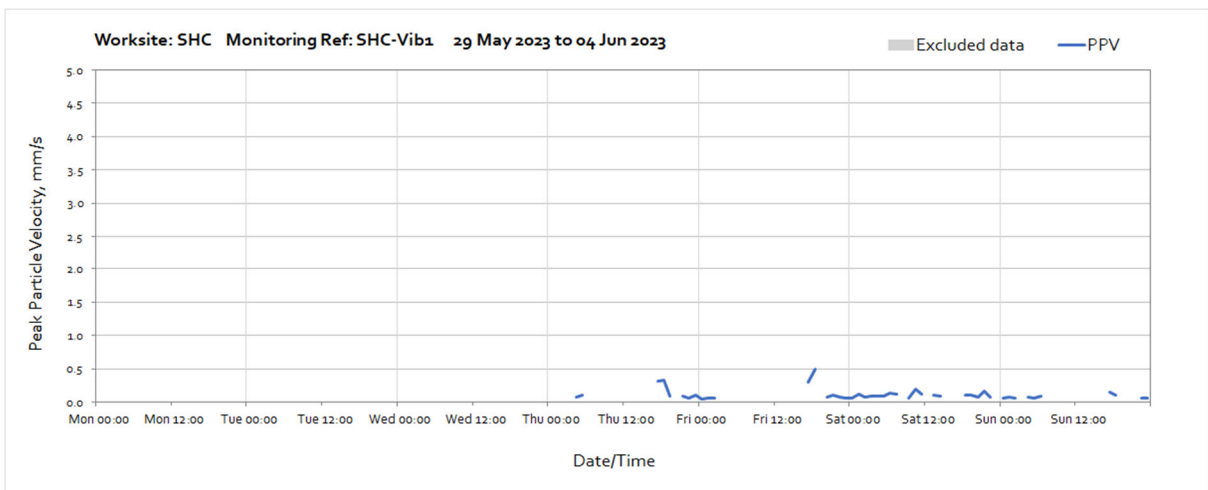
Worksite: SHC - Monitoring Ref: SHC-Vib1

Note: Missing data throughout this week was due to a communication error between the server and the monitoring system.

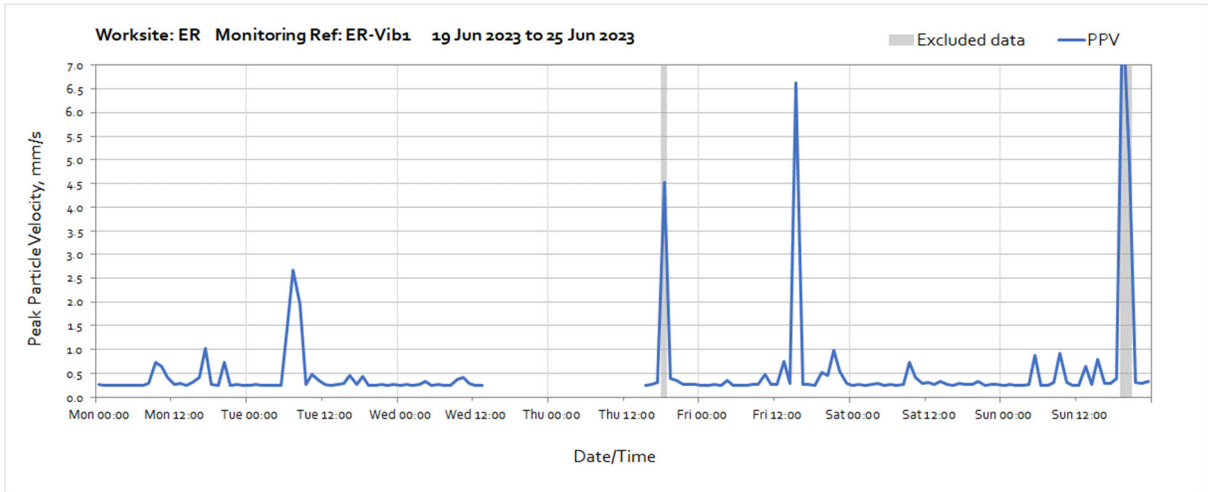
Note: Missing data between 14:00 on Wednesday 21st June and 15:00 on Thursday 22nd June was due to depleted monitor battery. High vibration level at 15:00 on Friday 23rd June was due to stoning of road and installation of kerbs.

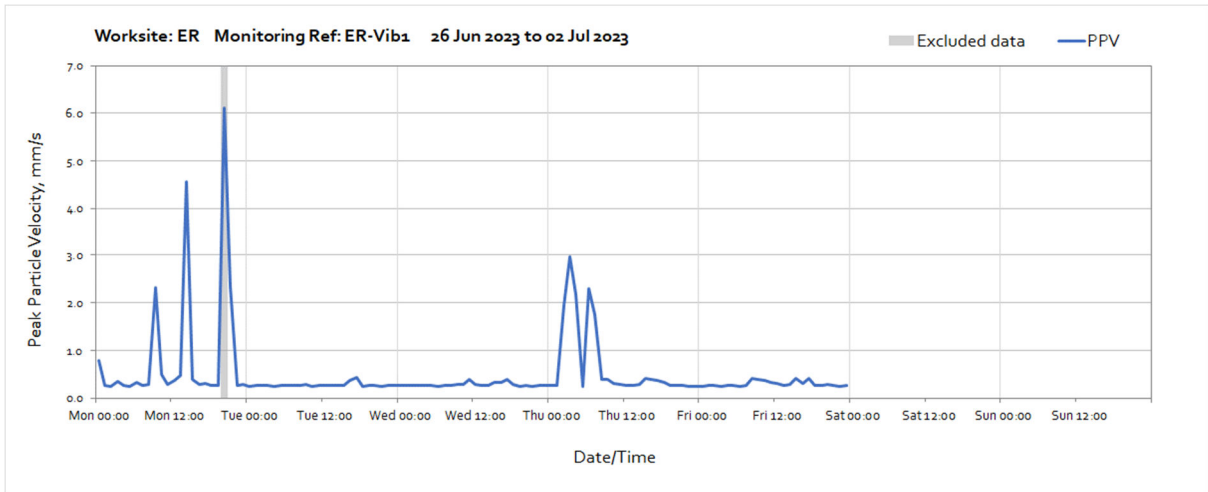
Note: High vibration level at 14:00 on Monday 26th June was due to stoning of road and installation of kerbs.
