Air Quality and Dust Monitoring Monthly Report - July 2023

Warwick District Council

Monthly Summary

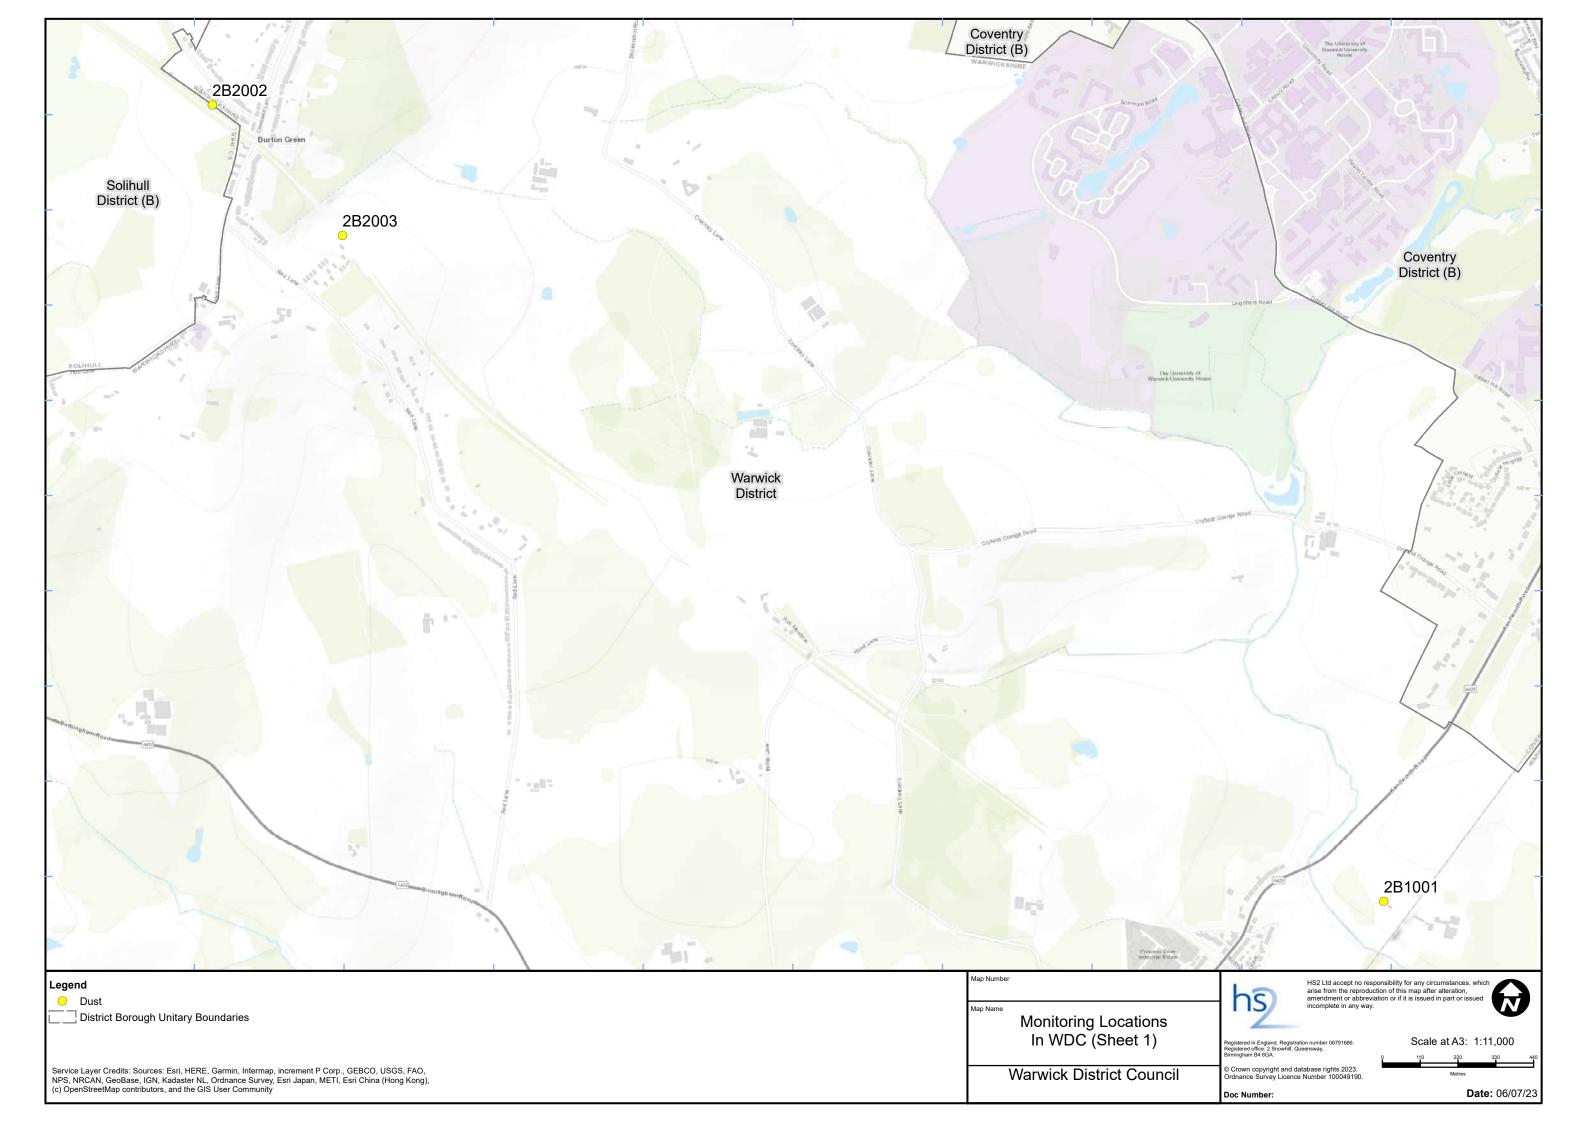
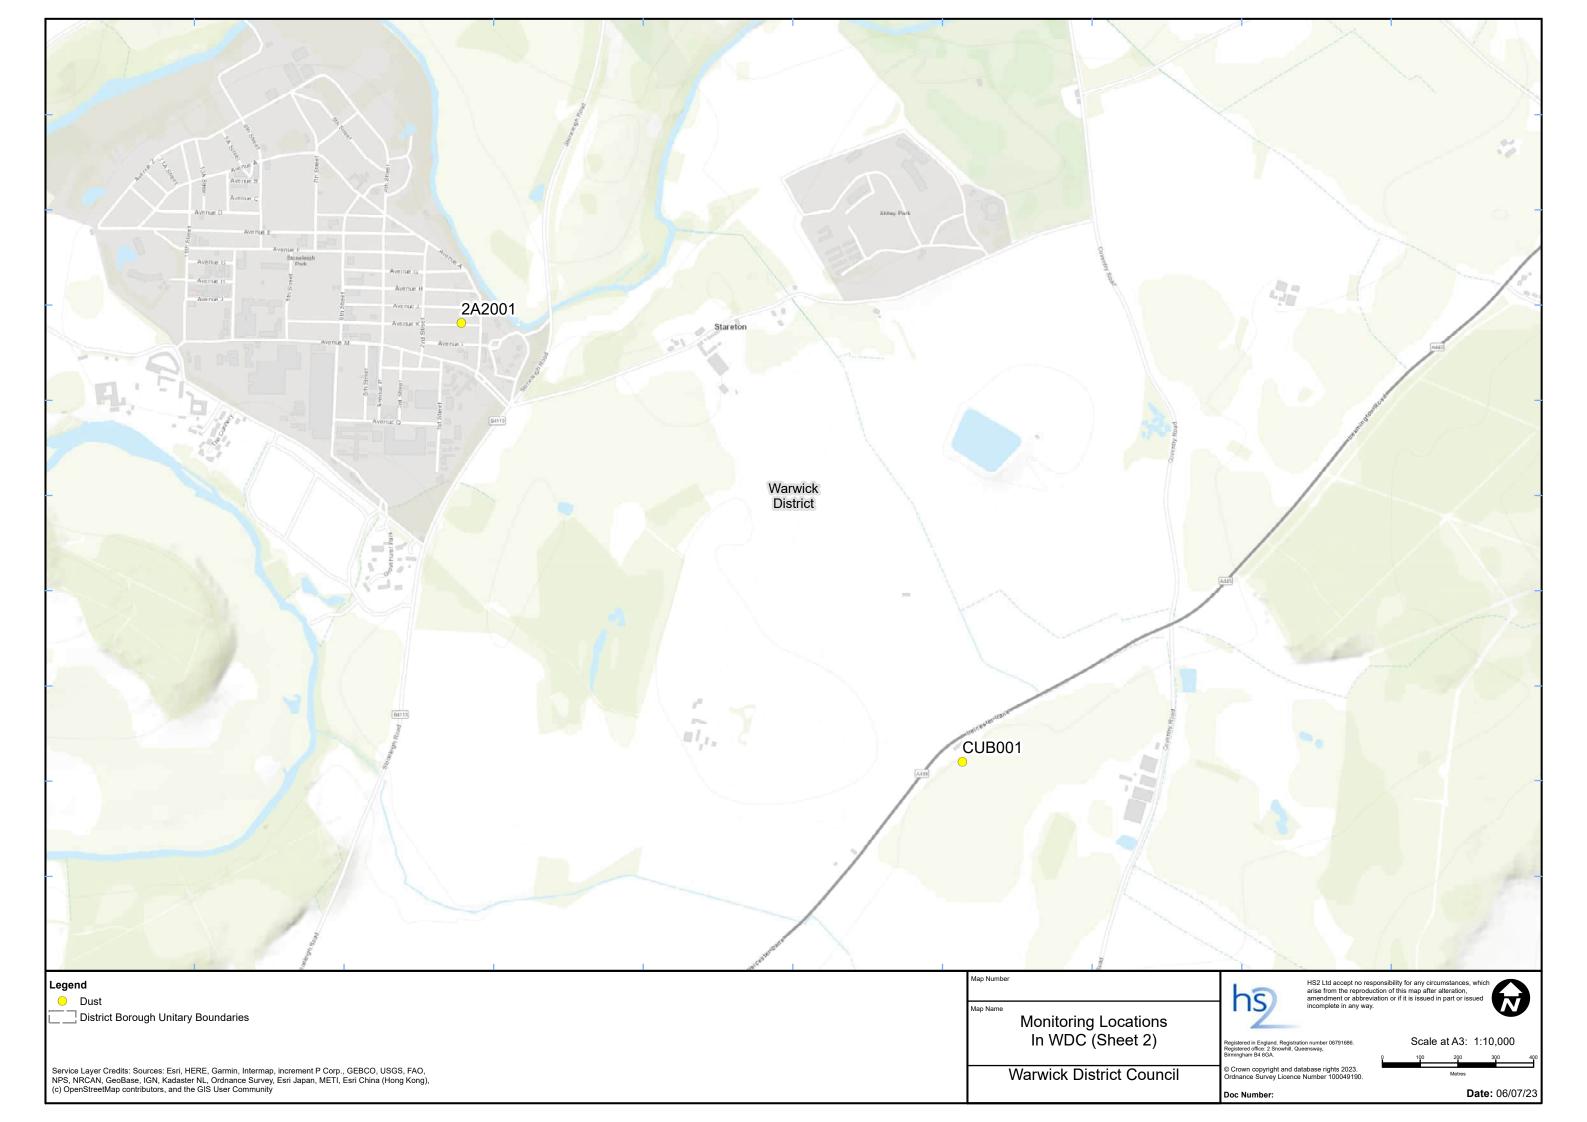
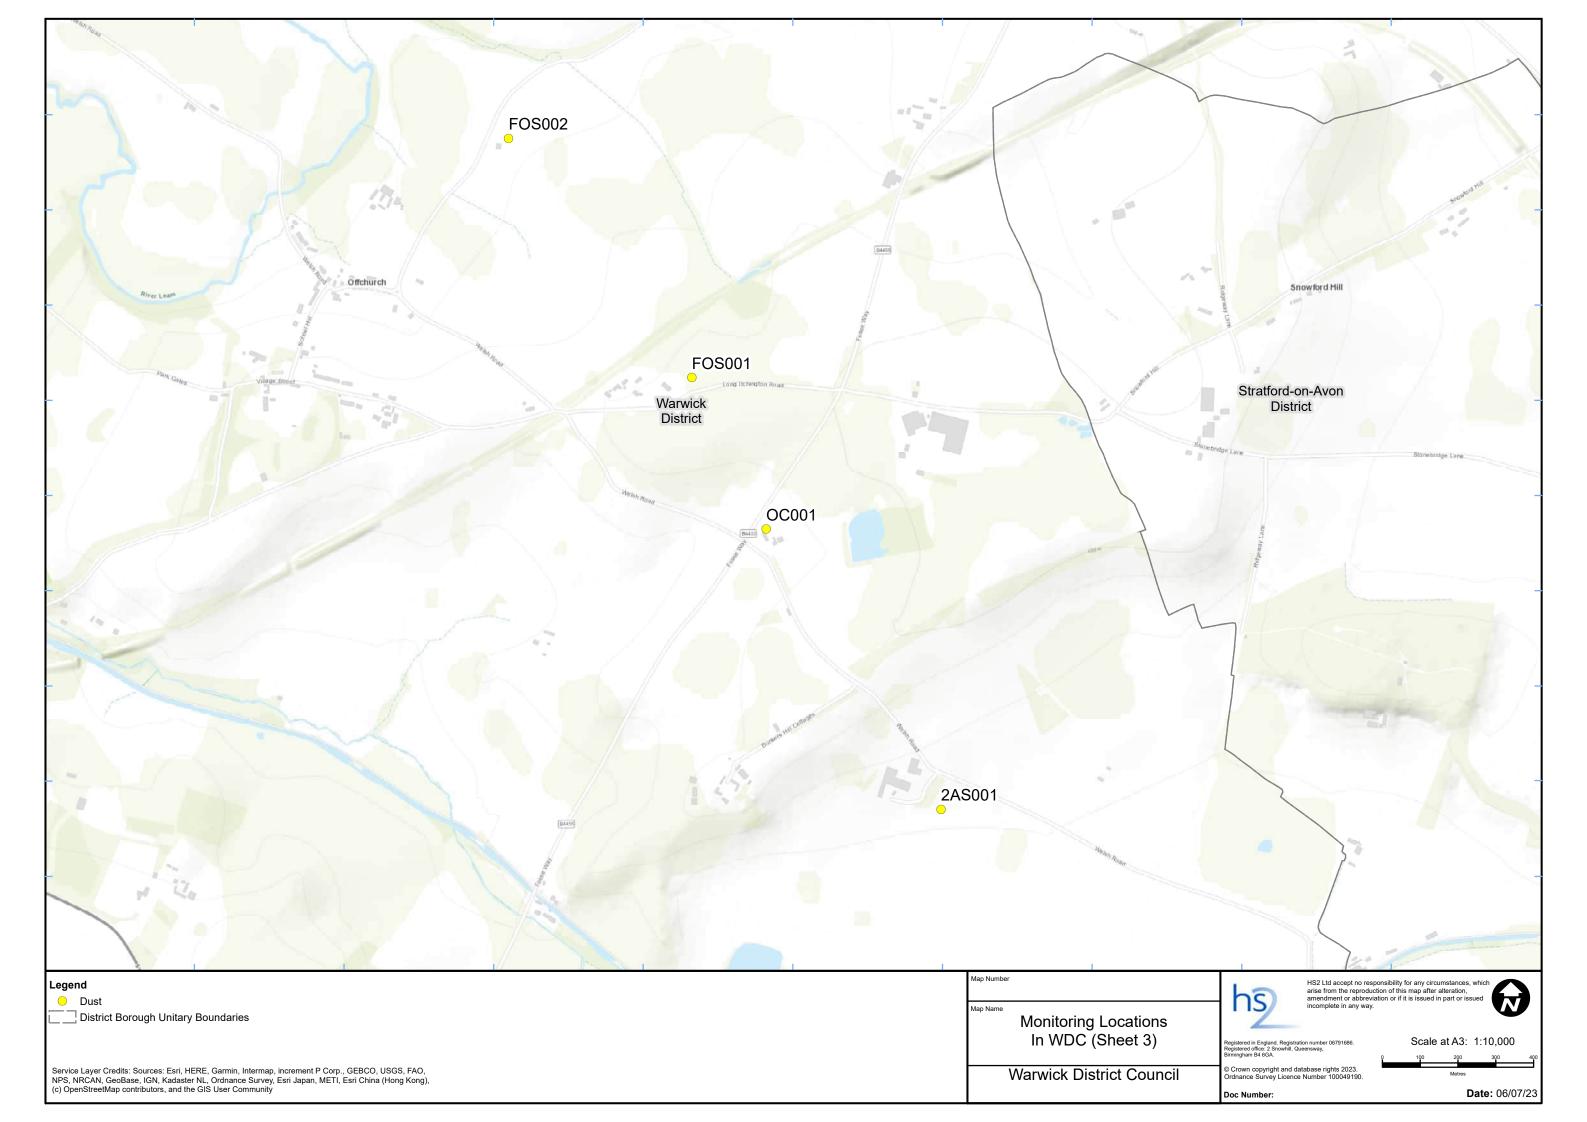
Figure 1 to Figure 2: Worksites and Monitoring Locations within WDC

- 1.1.2 Figure 1 to Figure 3 in Appendix A indicate the current worksites together with the dust monitoring locations for July 2023.
- 1.1.3 This summary should be read in conjunction with the overview monitoring report available from www.gov.uk/government/collections/monitoring-the-environmental-effects-of-hs2, which highlights: the applicable standards and guidance, as well as the air quality and dust monitoring methodologies to be implemented by nominated undertakers throughout construction.

- 1.1.4 The current worksites, as presented in Appendix A, Figure 1 to Figure 3, include:

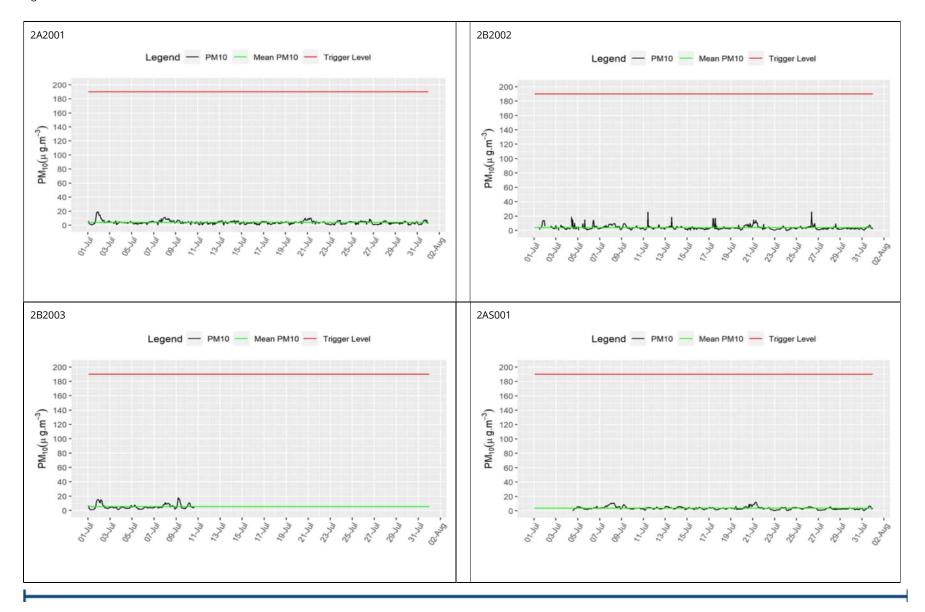
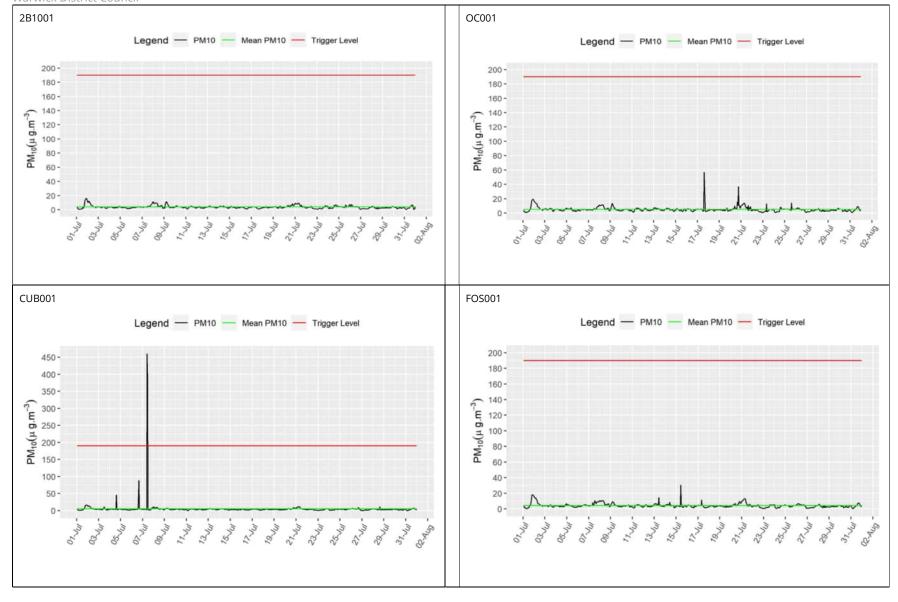
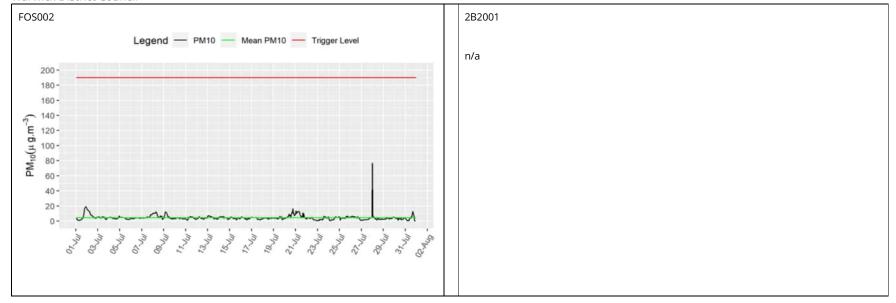
Figure 3: Continuous dust 1-hour mean indicative PM10 concentration for dust monitors

- 1.1.6 Dust monitoring locations and results are presented in Appendix B, Table 1, together with line charts of monthly data from each dust monitor, in Figure 3. All continuous dust monitoring is undertaken using indicative monitors. Despite being Environment Agency (MCERTS) certified, indicative monitors carry a higher level of uncertainty than reference monitors, and therefore cannot be strictly compared with Air Quality Standards for human health and the environment. The purpose of the monitoring undertaken is to ensure the effectiveness of the on-site mitigation.

- 1.1.7 The trigger level for PM_{10} concentrations of 190 µg/m³, over a 1-hour period, in accordance with the updated guidance document 'Guidance on Monitoring in the Vicinity of Demolition and Construction Sites (October 2018)' has been applied.

- 1.1.8 Dust trigger alerts were recorded during the monitoring period (July 2023) and are reported in Appendix B, Table 2.
- 1.1.9 Data capture was below 90% for multiple monitors in July 2023. Data capture at 2B2003 was affected by the removal of isolated readings of unrealistically low data early in the month. A battery refresh and vegetation clearance were carried out, and vegetation mats were installed after clearance. Data quality was much improved thereafter with no further issues. Low data capture recorded at 2B2003 was due to the removal of spurious data from 10th July 2023 onwards. A site visit found the cause to be due to overgrowing vegetation resulting in a power supply issue. A battery refresh and vegetation clearance were carried out in early August 2023, and vegetation mats were installed after clearance. Data capture at 2AS001 was affected by a faulty monitor with no data being collected prior to 4th July 2023. The monitor was replaced with a new one at the same location on 4th July 2023, and the issues resolved.

Monitoring site ID	Period exceeding trigger level	Investigation	Outcomes / Resolution / Remedial measures implemented	
		07/07/2023	There were no construction activities in the area at the times of the		
(CUB001	09:01 – 10:00; 459.8 μg/m ³	exceedances and so the exceedances are considered unrelated to BBV	n/a	
		10:01 – 11:00; 402.8 μg/m ³	activities.
