Construction Noise and Vibration Monthly Report – July 2023

Buckinghamshire

Non-Technical Summary

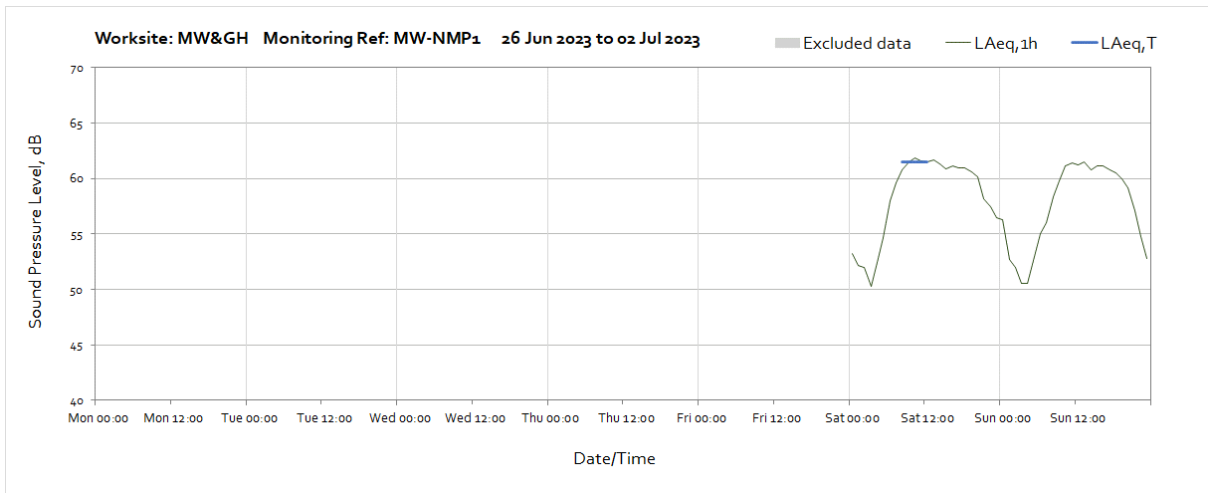
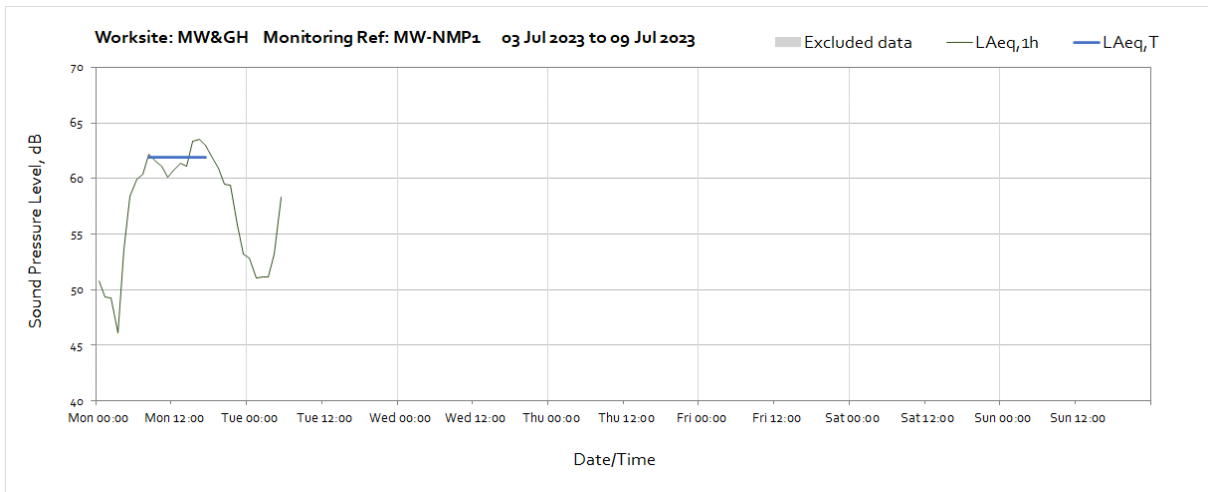
Worksite: MW&GH - Monitoring Ref: MW-NMP1

Note: Missing data from 06:00 on Tuesday 4th July until month end was due to loss of power to monitoring station caused by the theft of solar panels and battery.

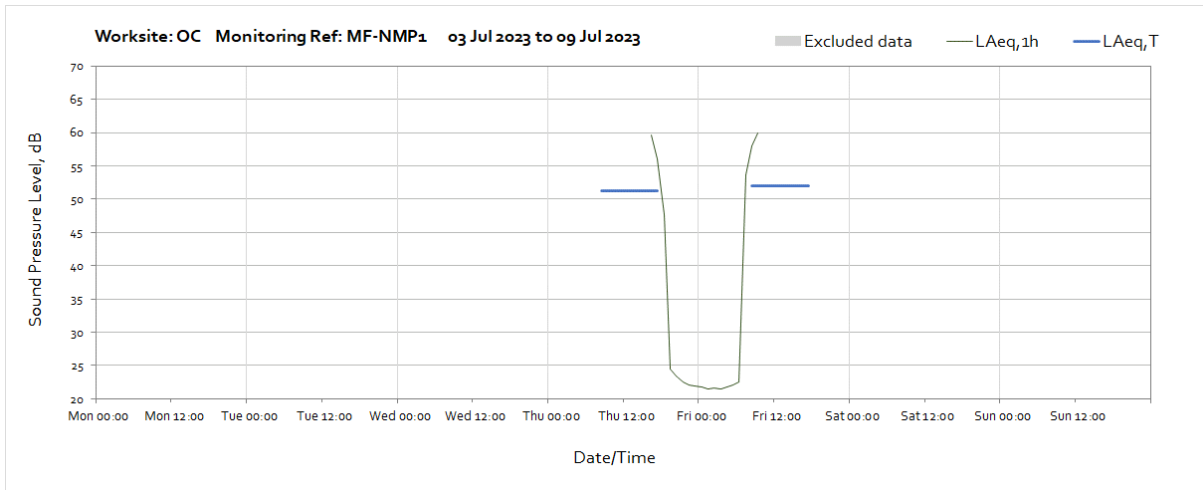
Worksite: OC – Monitoring Ref: MF-NMP1

Note: Monitor was reinstalled at 16:00 on Thursday 6th July. Missing data between 10:00 Friday 7th July and 15:00 on Wednesday 12th July was due to monitor battery fault which has now been replaced.

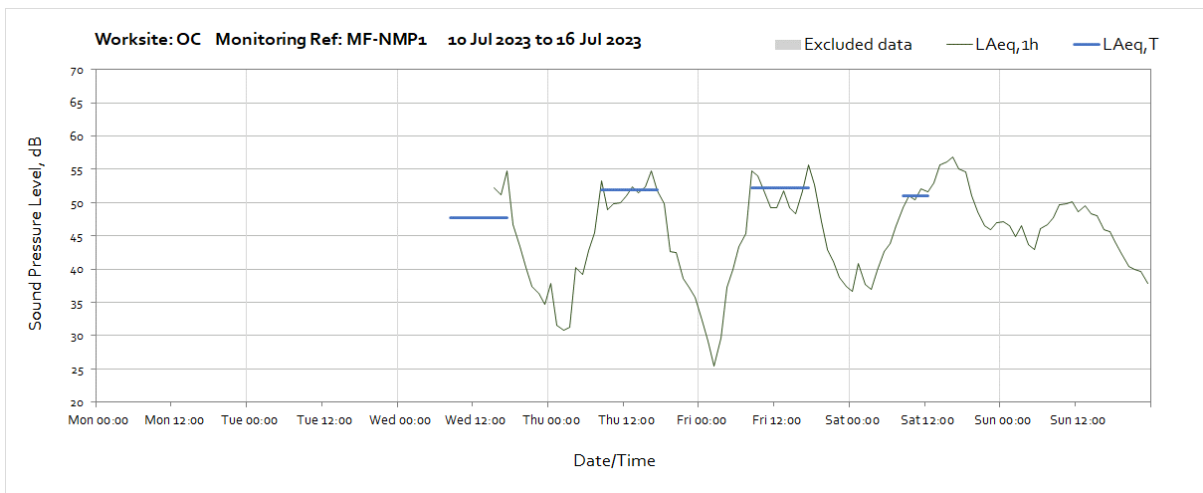
Note: Missing data between 10:00 Friday 7th July and 15:00 on Wednesday 12th July was due to monitor battery fault which has now been replaced.

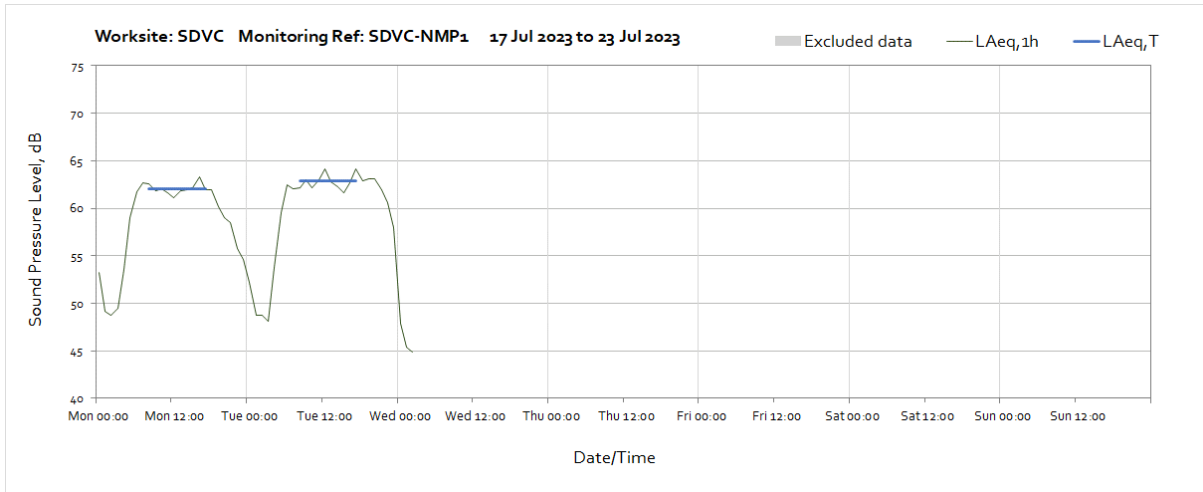
Note: Missing data between 03:00 on Wednesday 19th July and 12:00 on Monday 31st July was due to depleted monitor battery.

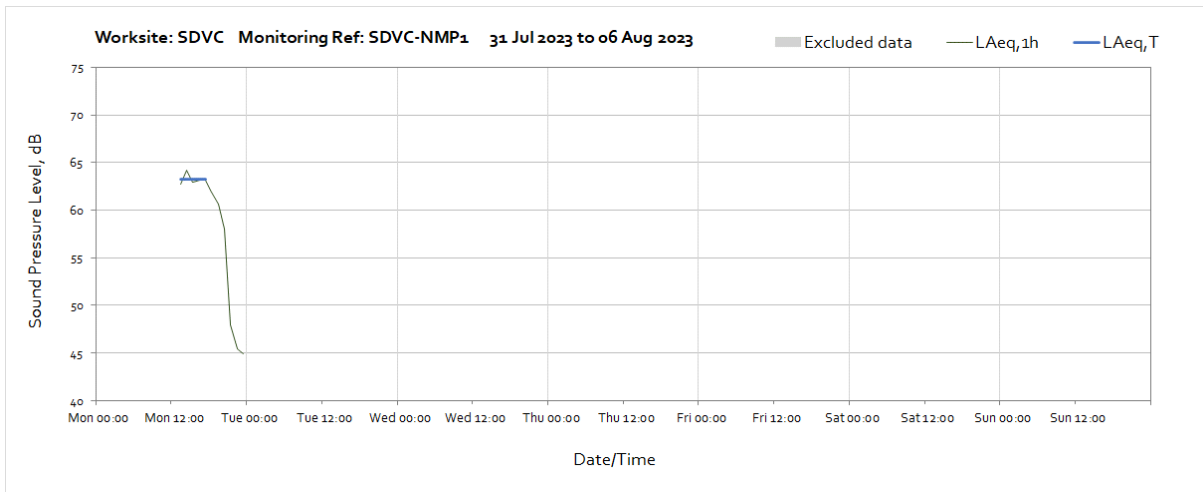
Note: Missing data between 03:00 on Wednesday 19th July and 12:00 on Monday 31st July was due to depleted monitor battery.

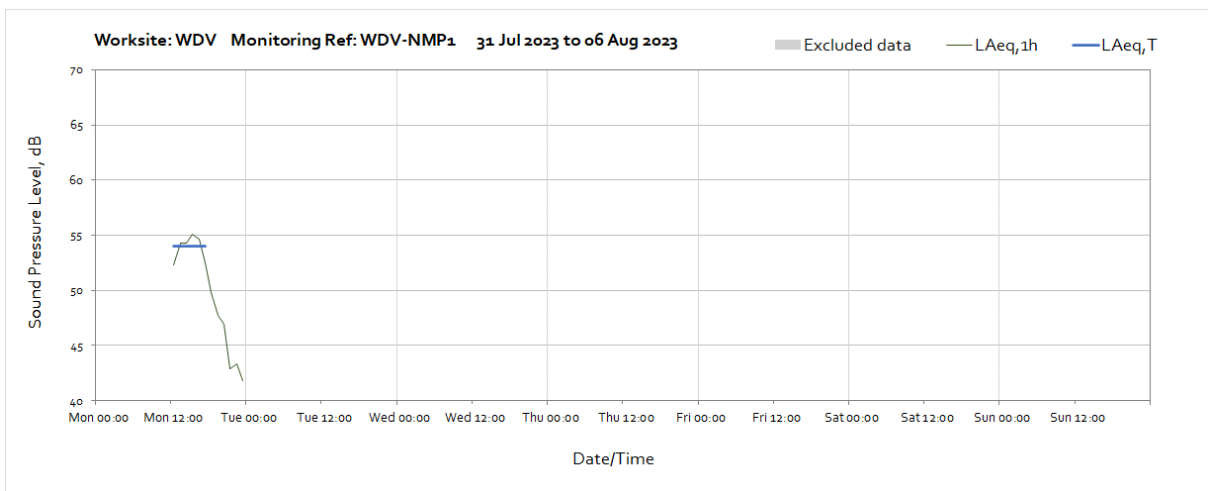
Worksite: WDV – Monitoring Ref: WDV-NMP1

* Missing data at monitor WDV-NMP1 was due to a damaged power cable which has now been replaced.

Note: Missing data until 12:00 on Monday 31st July was due to damage to monitor power cable which has now been replaced.

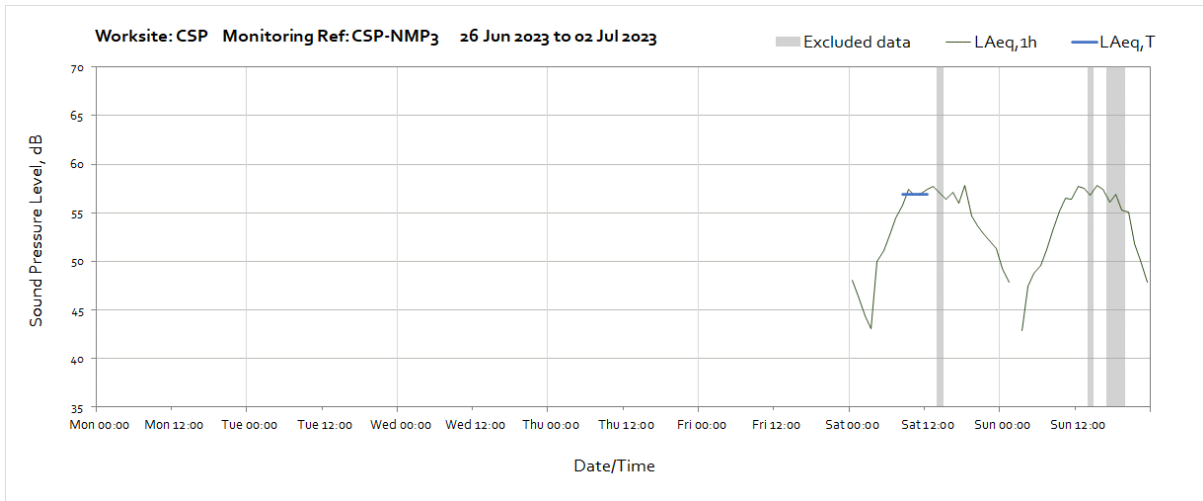
Note: Missing data between 02:00 and 03:00 on Sunday 2nd July was due to a communication error between the monitor and the server.

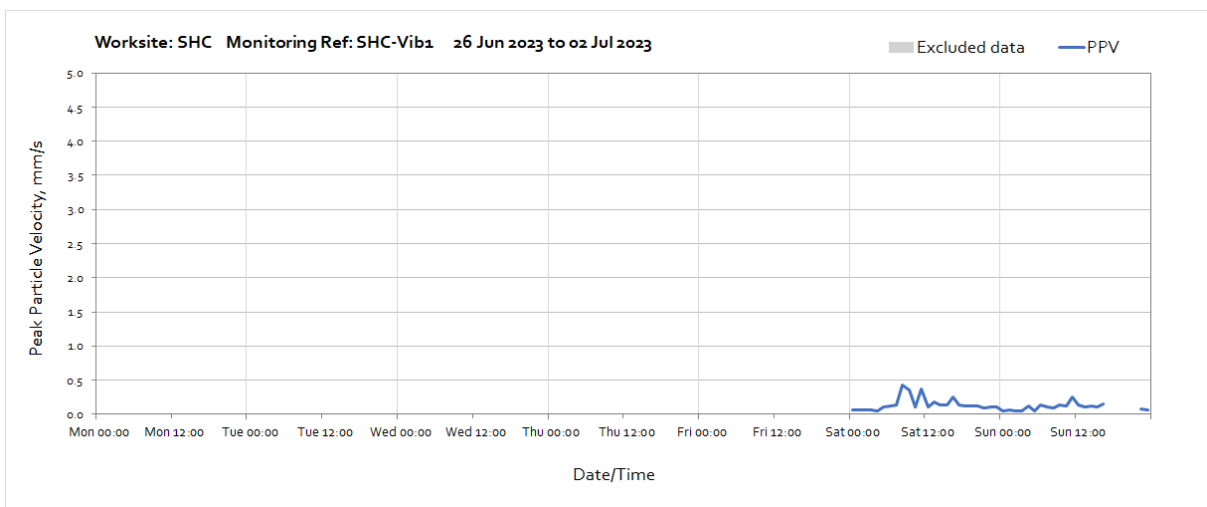
Worksite: SHC – Monitoring Ref: SHC-Vib1

Note: Missing data between 17:00 and 22:00 on Saturday 2nd July was due to connection issues at the monitoring station, the monitor will be replaced shortly.

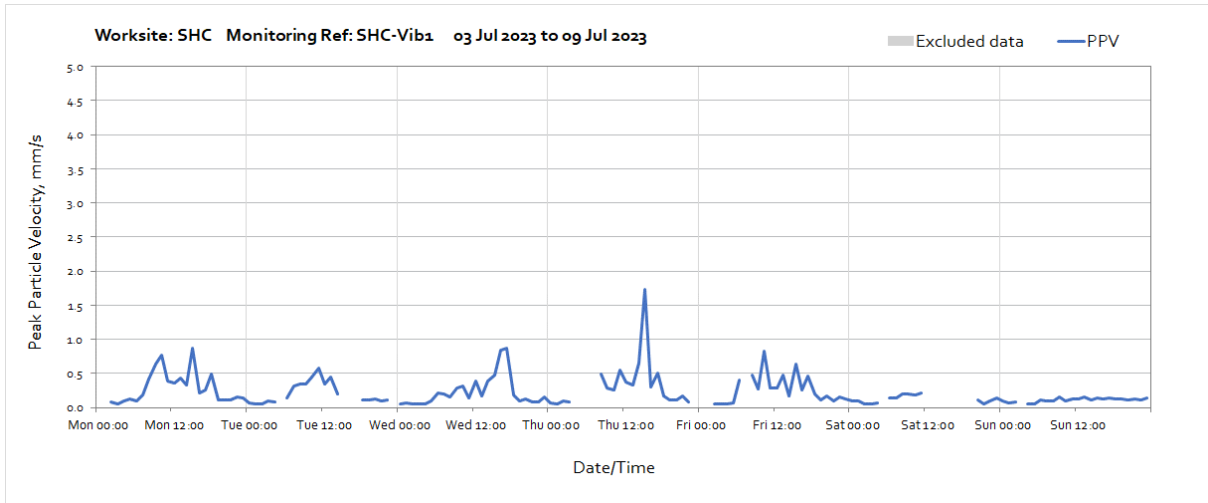
Note: Missing data throughout the week was due to connection issues at the monitoring station, the monitor will be replaced shortly.

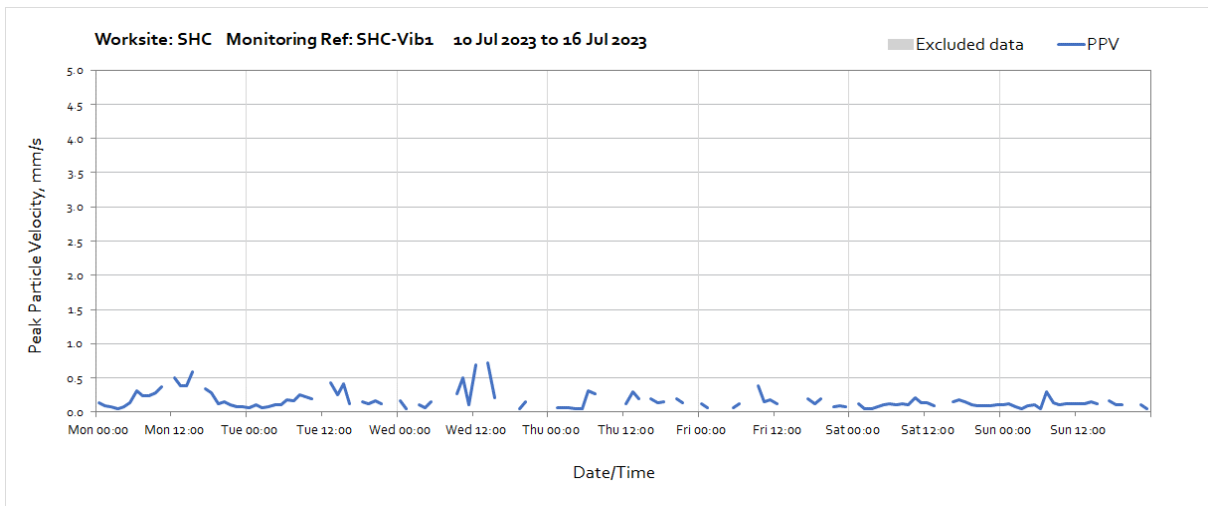
Note: Missing data throughout the week was due to connection issues at the monitoring station, the monitor will be replaced shortly.

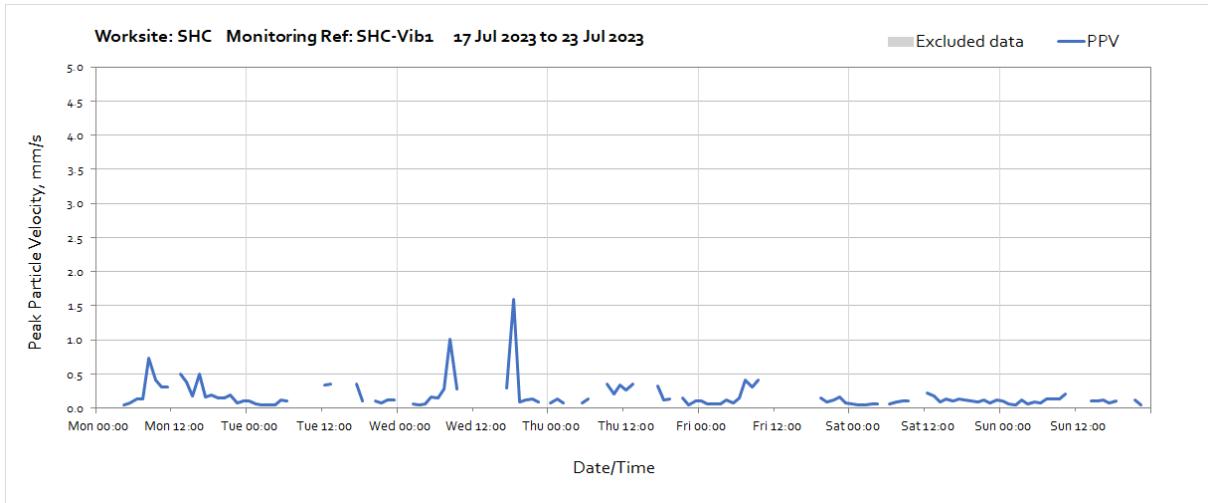
Note: Missing data throughout the week was due to connection issues at the monitoring station, the monitor will be replaced shortly.

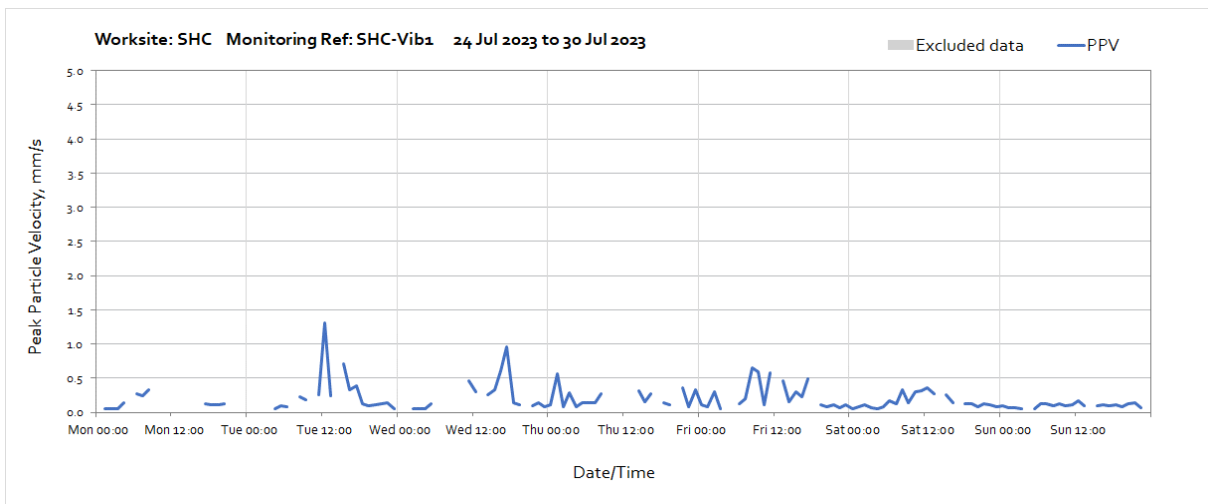
Note: Missing data throughout the week was due to depleted monitor battery, the monitor will be replaced shortly.

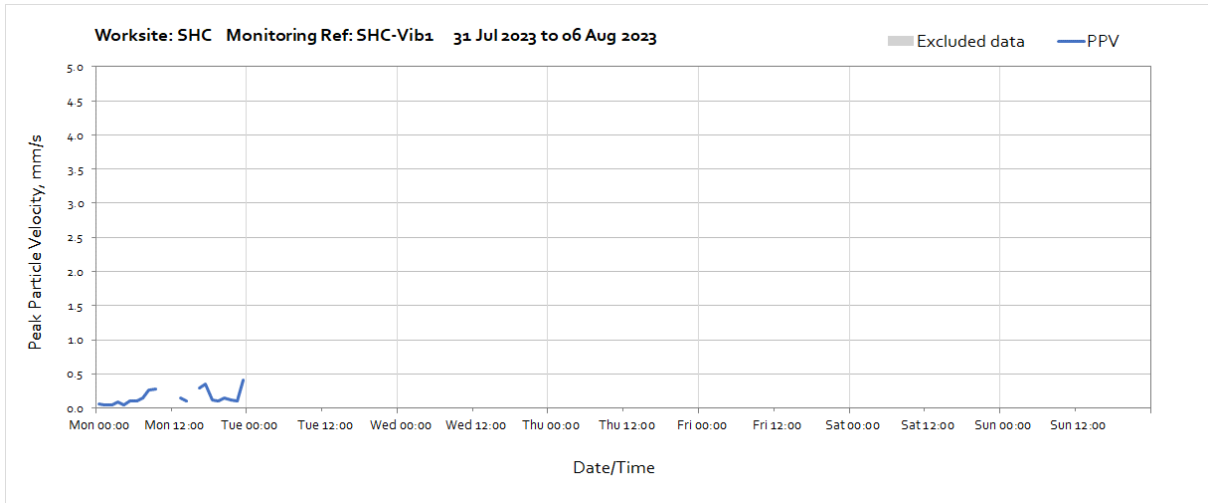
Note: Missing data to the end of the month was due to depleted monitor battery, the monitor is planned to be swapped with a new one.

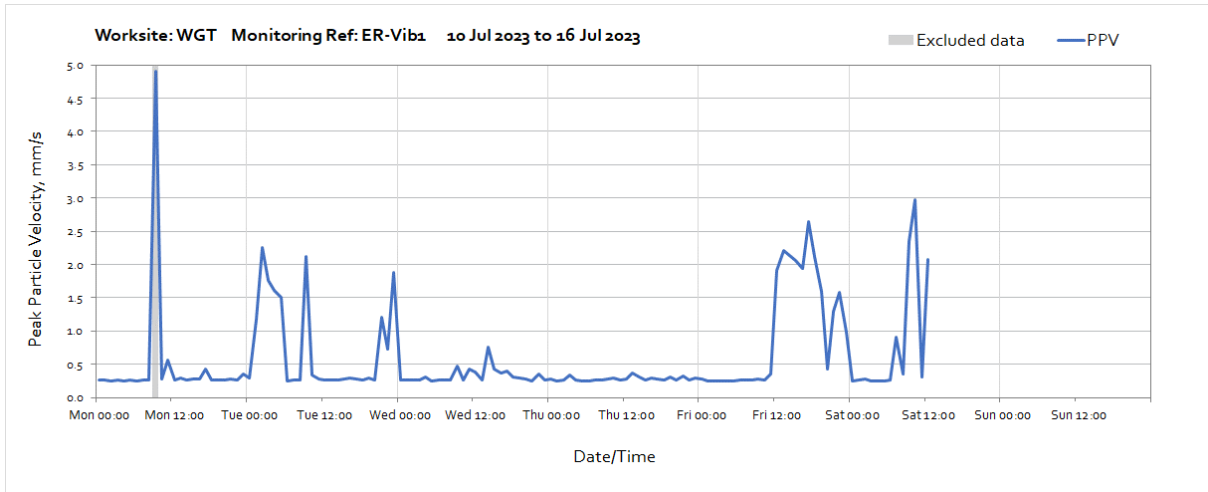
Note: Missing data between 13:00 on Saturday 15th July and 16:00 on Friday 21st July was due to depleted monitor battery.

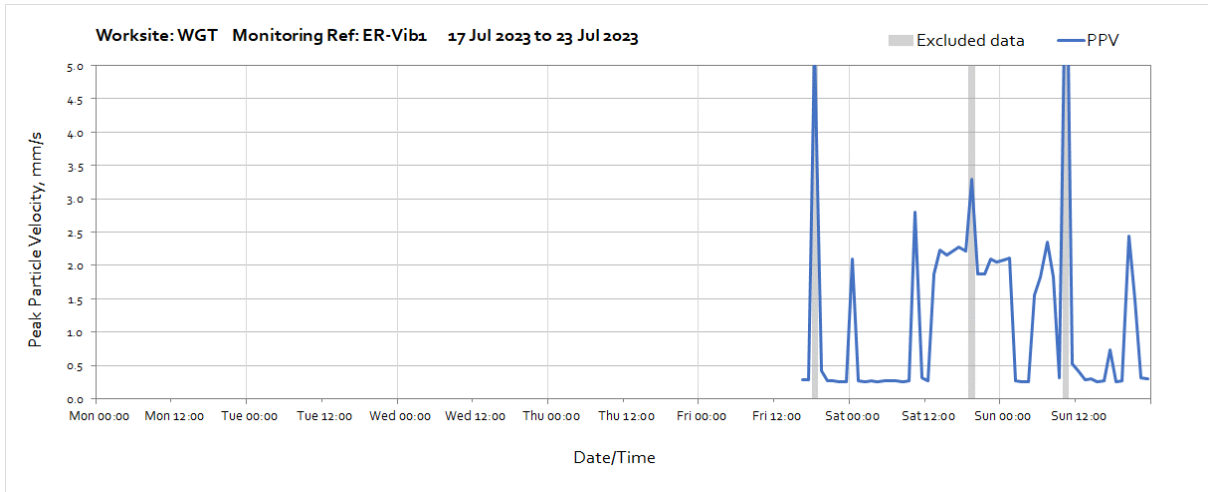
Note: Missing data between 13:00 on Saturday 15th July and 16:00 on Friday 21st July was due to depleted monitor battery.

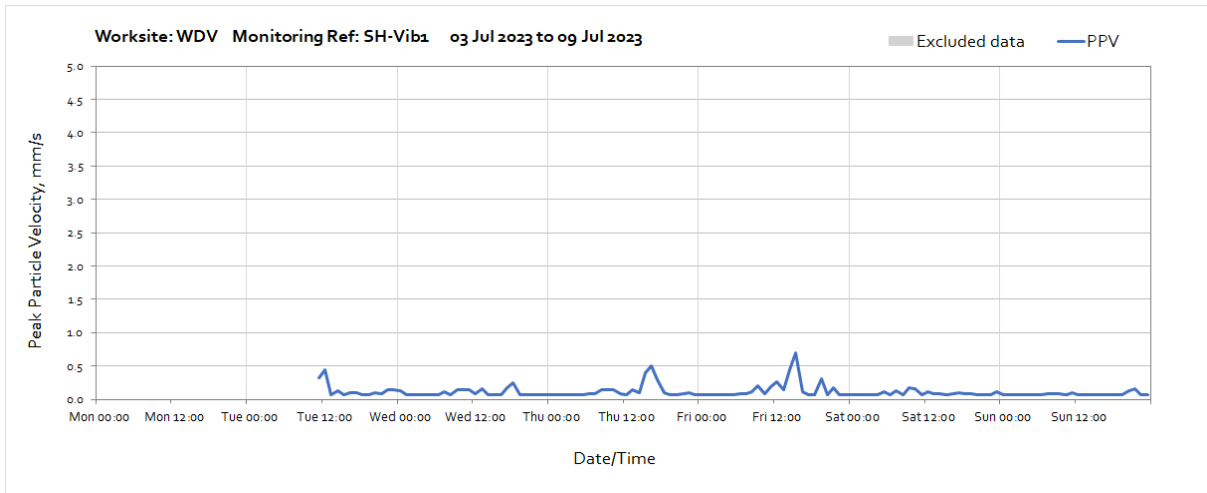
Worksite: WDV – Monitoring Ref: SH-Vib1

Note: Missing data from the beginning of the month to 10:00 on Tuesday 4th July was due to depleted monitor battery.
