Construction Noise and Vibration Monthly Report – July 2023

London Borough of Camden

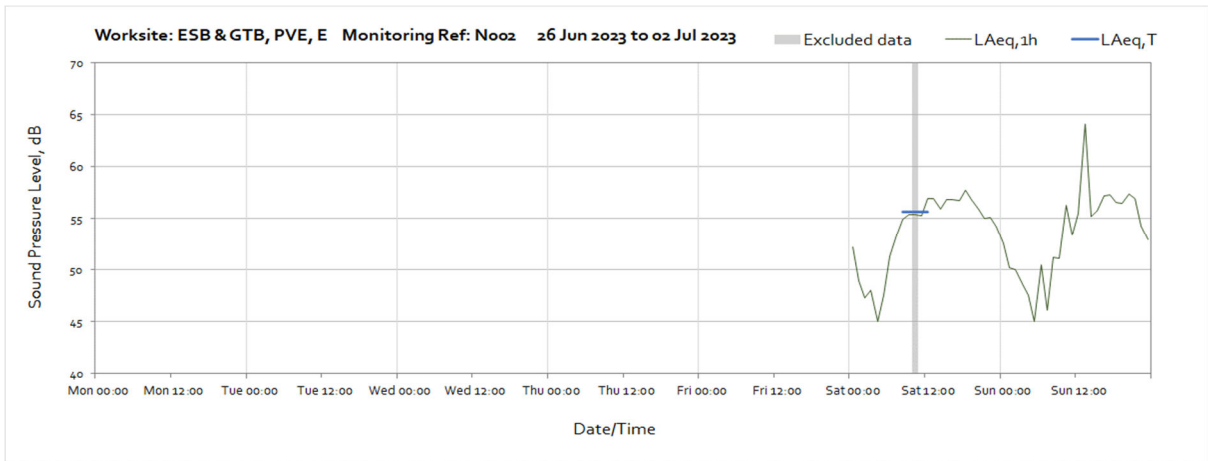
Worksite: ESB & GTB, PVE, E – Monitoring Ref: N002

Note: Missing data from 20:00 on Tuesday 3rd until 09:00 on Thursday 6th July was due to loss of power to the lighting column which supplies power to the monitoring station.
