Construction Noise and Vibration Monthly Report – July 2023

Warwick District Council

Non-Technical Summary

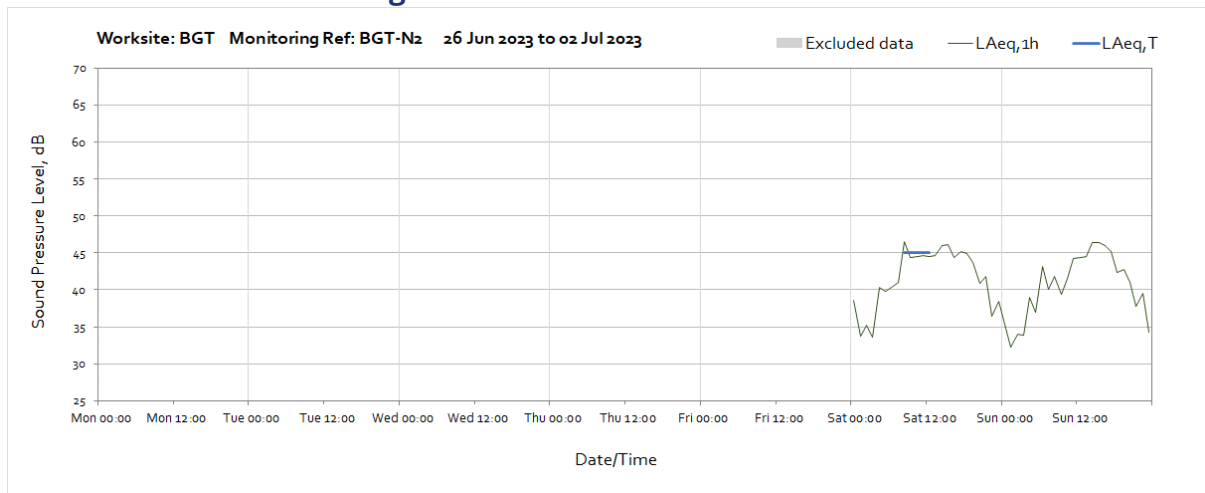
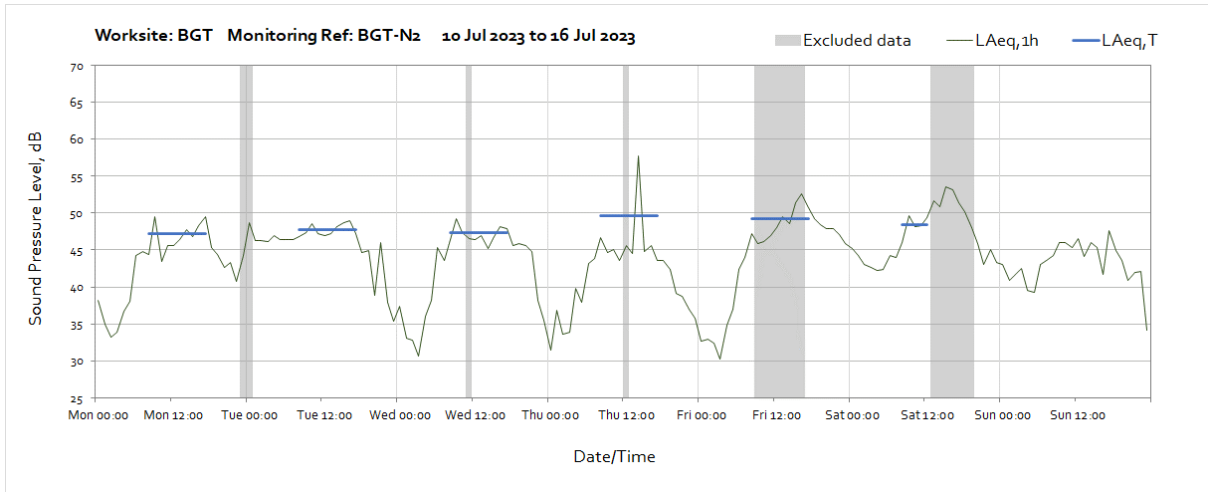
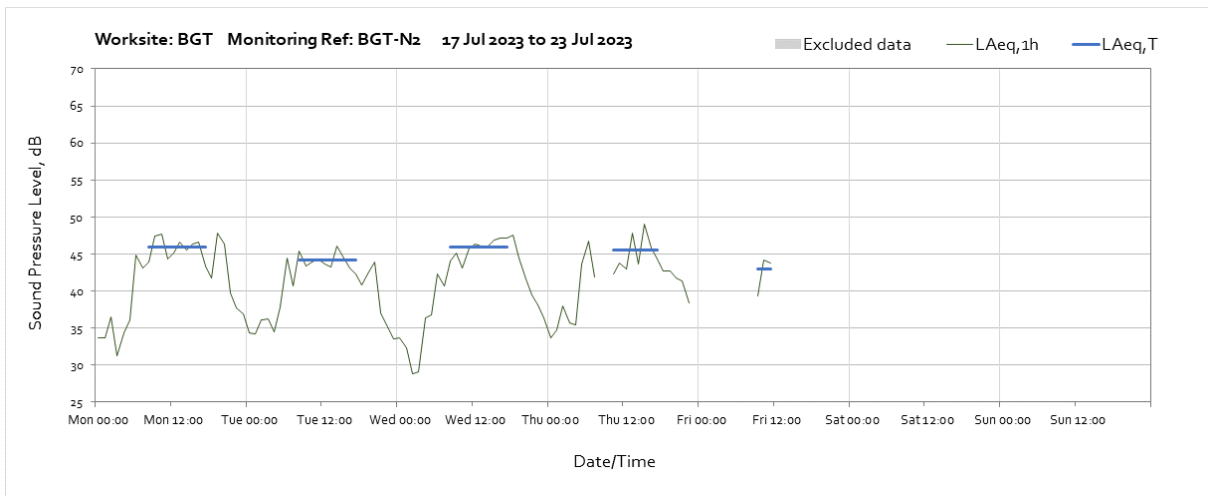
Worksite: BGT - Monitoring Ref: BGT-N2

The following graphs show the hourly measured ambient noise level $L_{Aeq,1h}$ and, where relevant, the averaged noise level $L_{Aeq,T}$ values, where the time period T is as specified in Table 1 of HS2 Information Paper E23. Periods with adversely weather affected noise levels are greyed out and have been excluded from the calculation of the $L_{Aeq,T}$ values in Table 3 of the main report.

Note: Missing data from 08:00 to 10:00 on Thursday 20th July, from 23:00 on Thursday 20th July to 09:00 on Friday 21st July and from 13:00 on Friday 21st July onwards was due to a power issue arising from difficulty in accessing the monitor. The battery will be refreshed once de-vegetation work is completed.

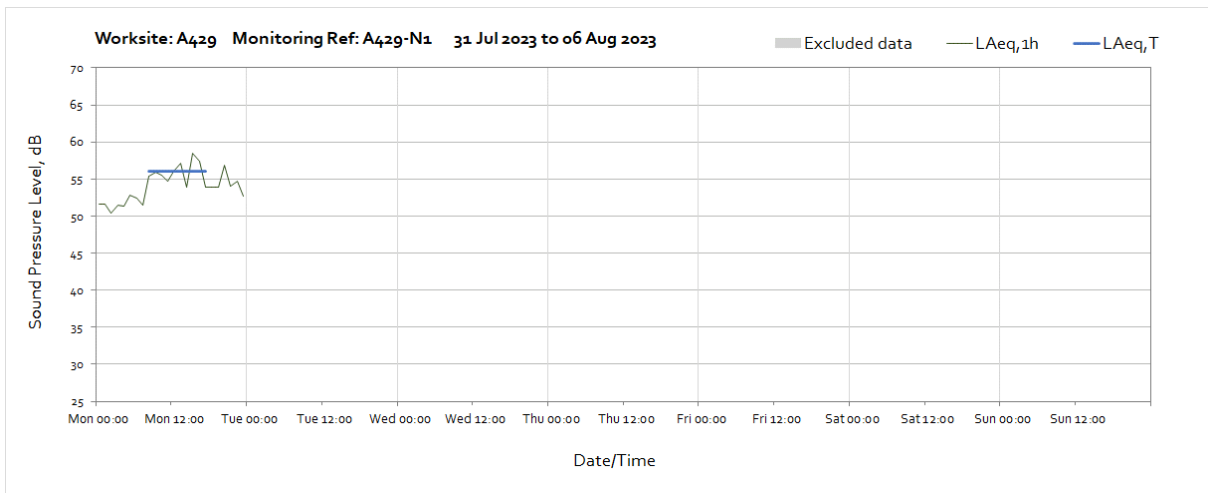
Worksite: A429 – Monitoring Ref: A429-N1

2.2.8 One (1) SOAEL exceedance was recorded due to HS2 construction works during the reporting period. This occurred during a weekend night period.

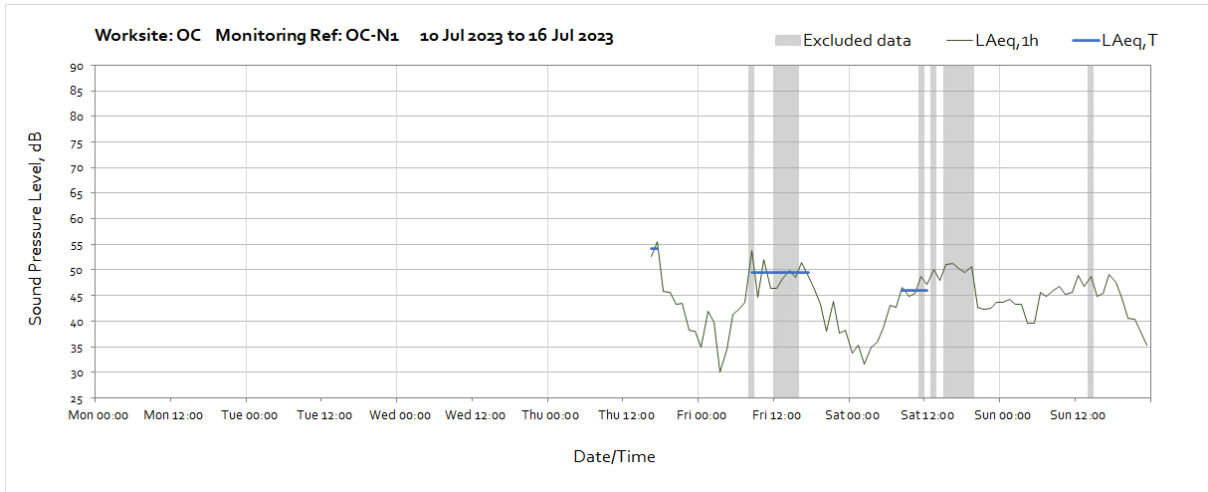
Worksite: OC – Monitoring Ref: OC-N1

Note: Missing data from 11:00 on Tuesday 4th July to 16:00 on Thursday 13th July was due to monitor damaged, the monitor has now been replaced.
