## Construction Noise and Vibration Monthly Report – August 2023

### Buckinghamshire

# Non-Technical Summary

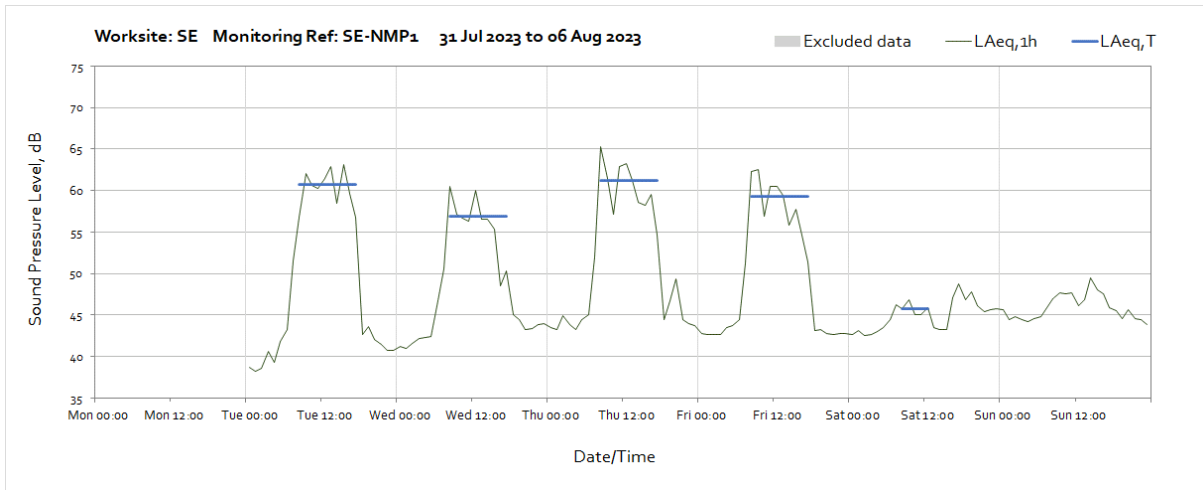
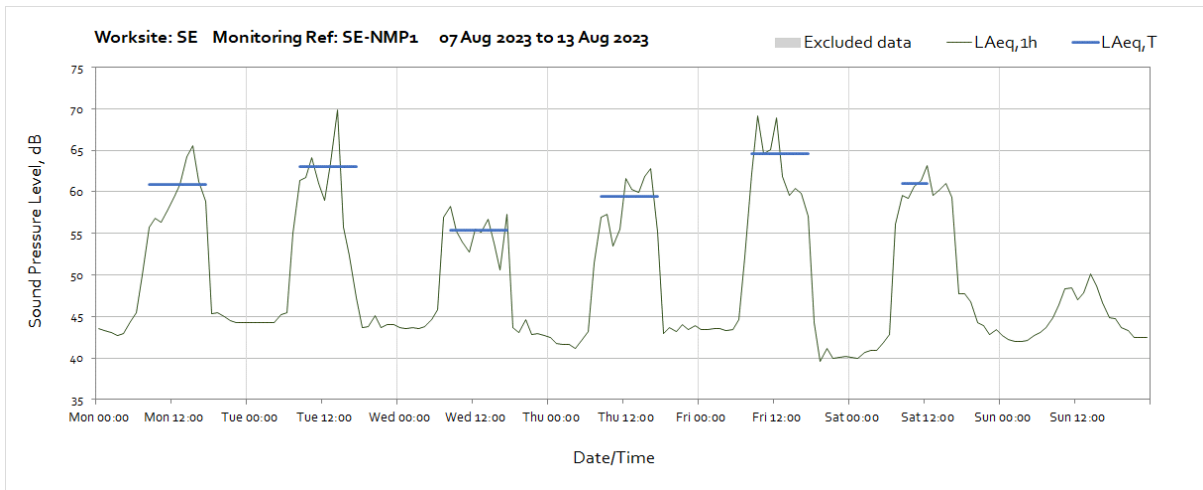
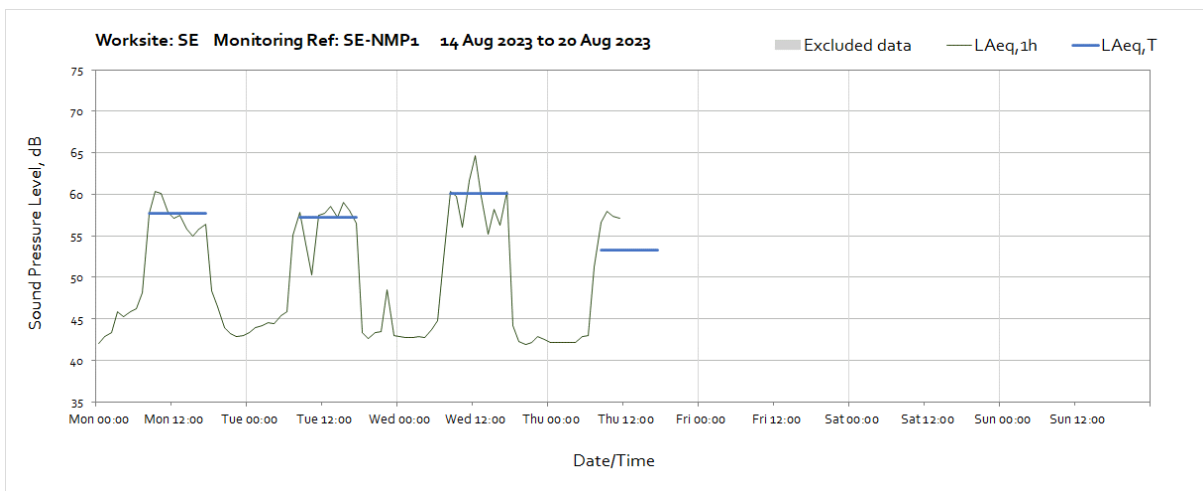
## Worksite: SE – Monitoring Ref: SE-NMP1

Note: Missing data from 12:00 on Thursday 17<sup>th</sup> August until month end was due to damage to the communication cable & a loose power connection

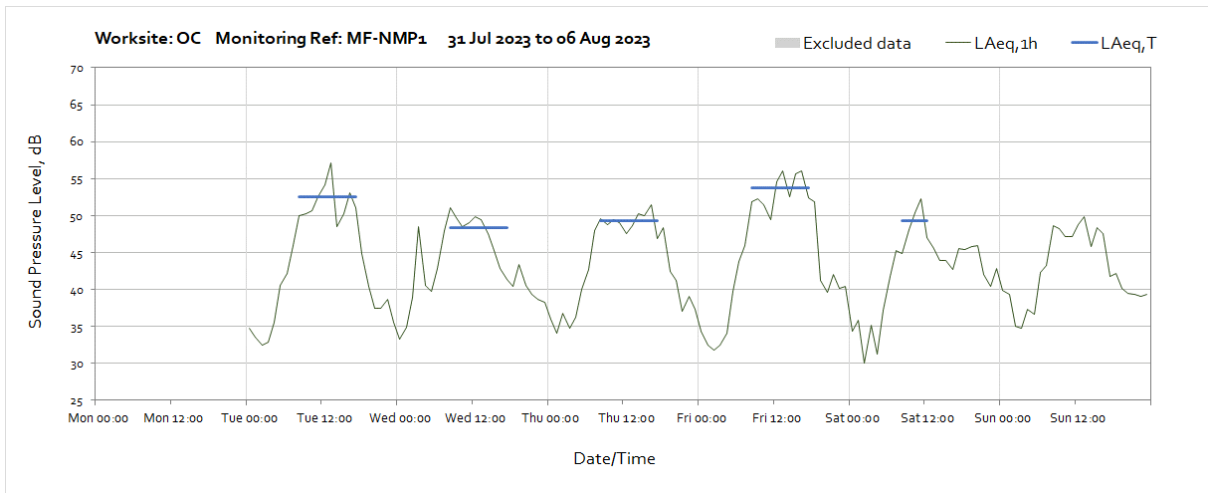
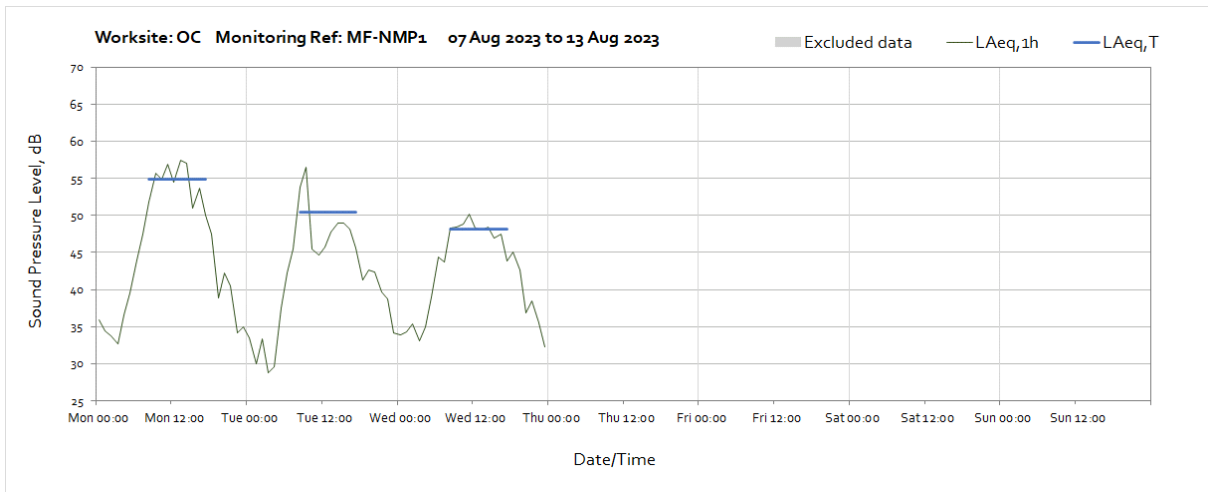
**Worksite: OC - Monitoring Ref: MF-NMP1**

Note: Missing data from 00:00 on Thursday 10<sup>th</sup> August until month end was due to loss of battery power due to a fault with the solar charge controller. A new solar controller is being deployed shortly.

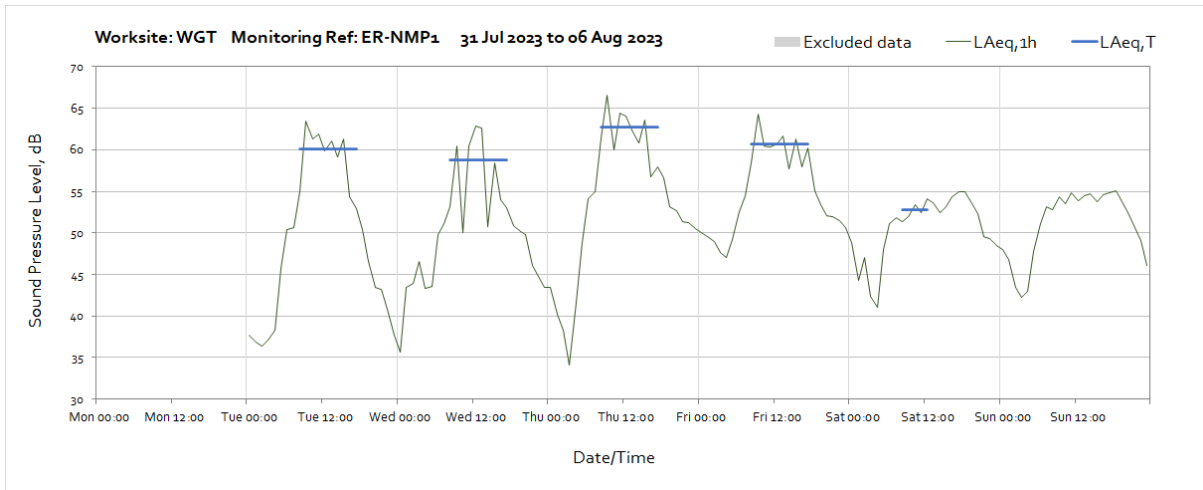
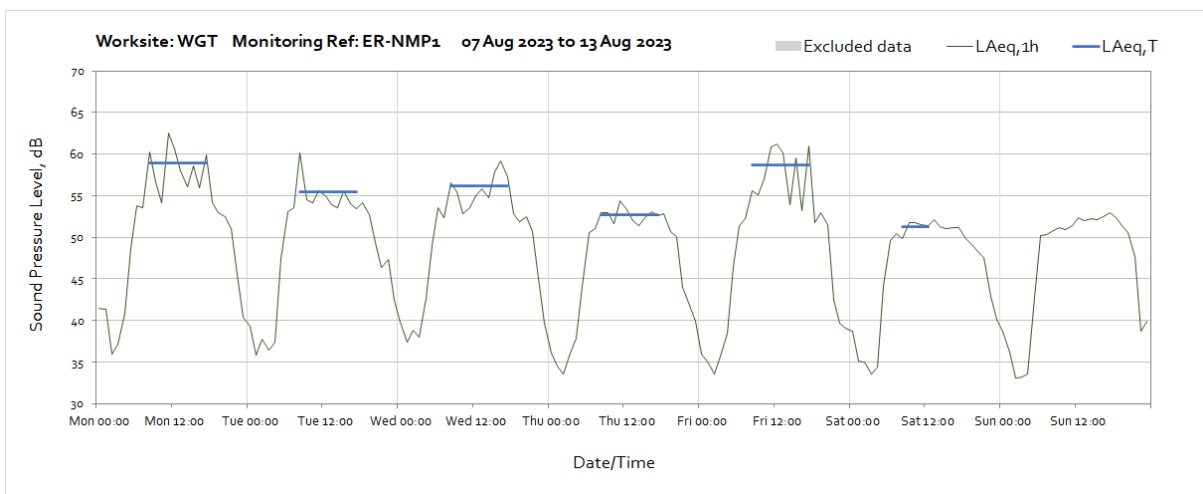
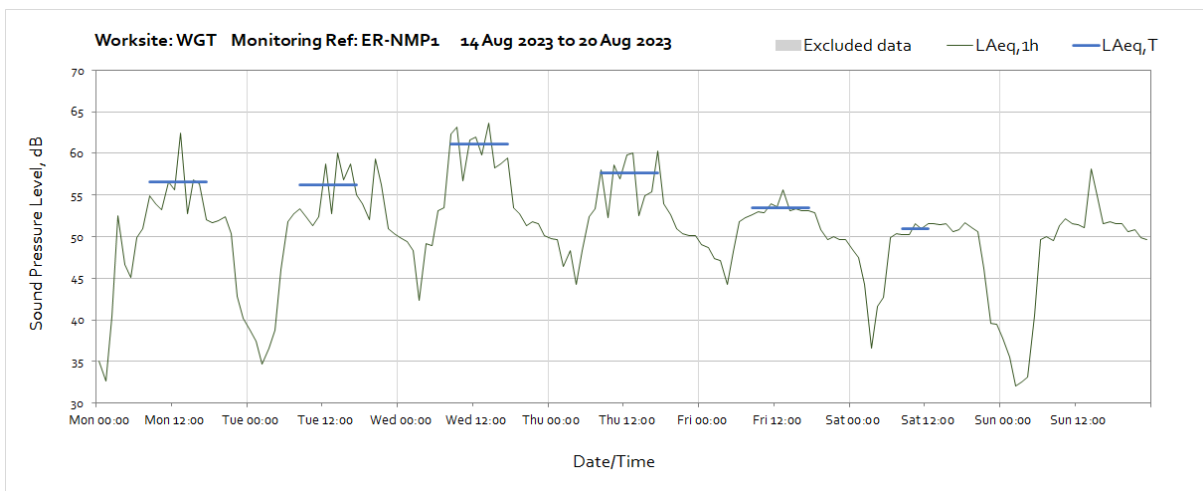
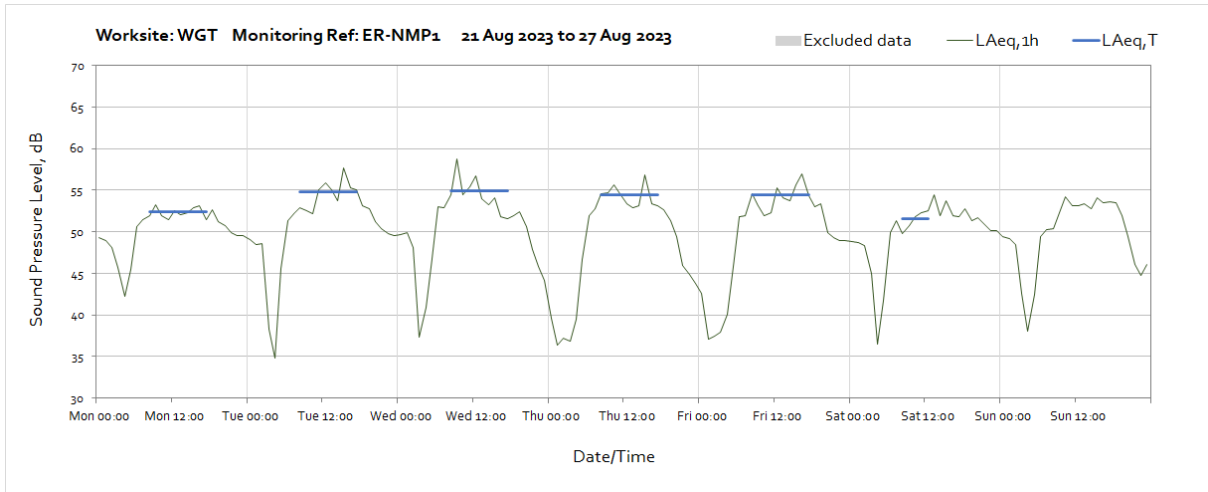
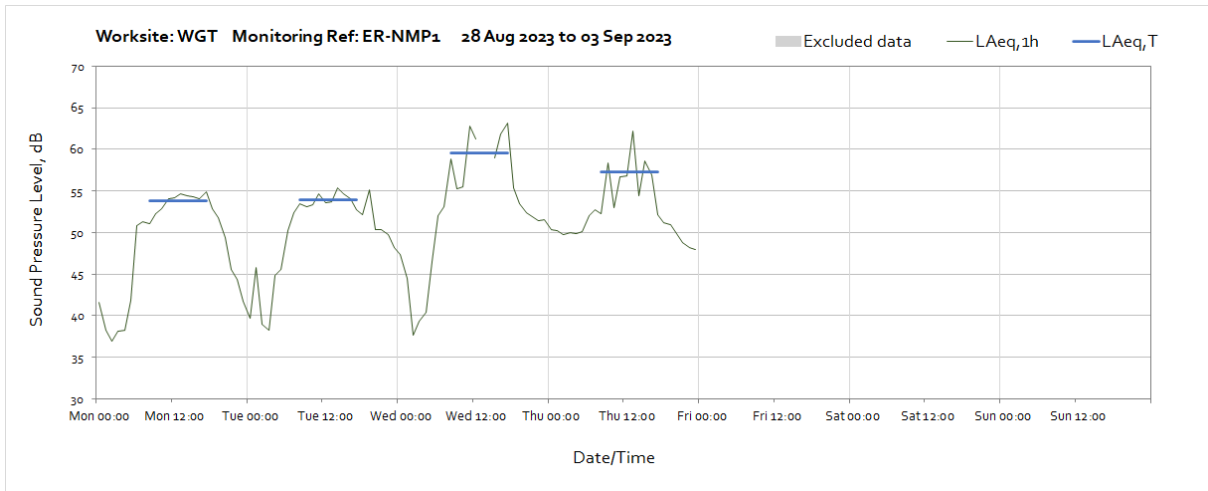
## Worksite: WGT – Monitoring Ref: ER-NMP1

Note: Missing data between 13:00 and 14:00 on Wednesday 30<sup>th</sup> August was due to monitor maintenance.

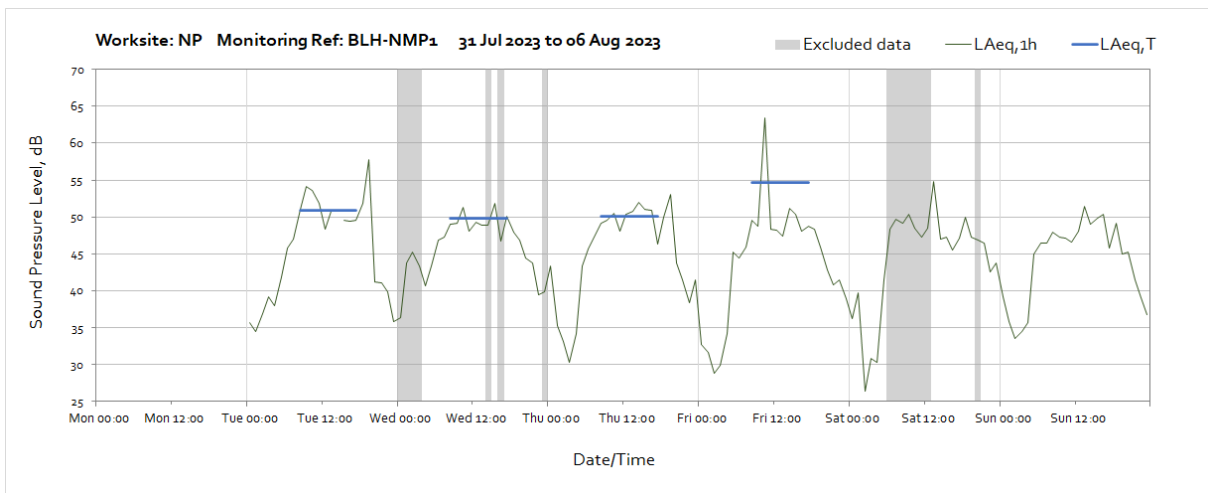
**Worksite: NP - Monitoring Ref: BLH-NMP1**

Note: Missing data between 14:00 and 15:00 on Tuesday 1<sup>st</sup> August was due to monitor maintenance.

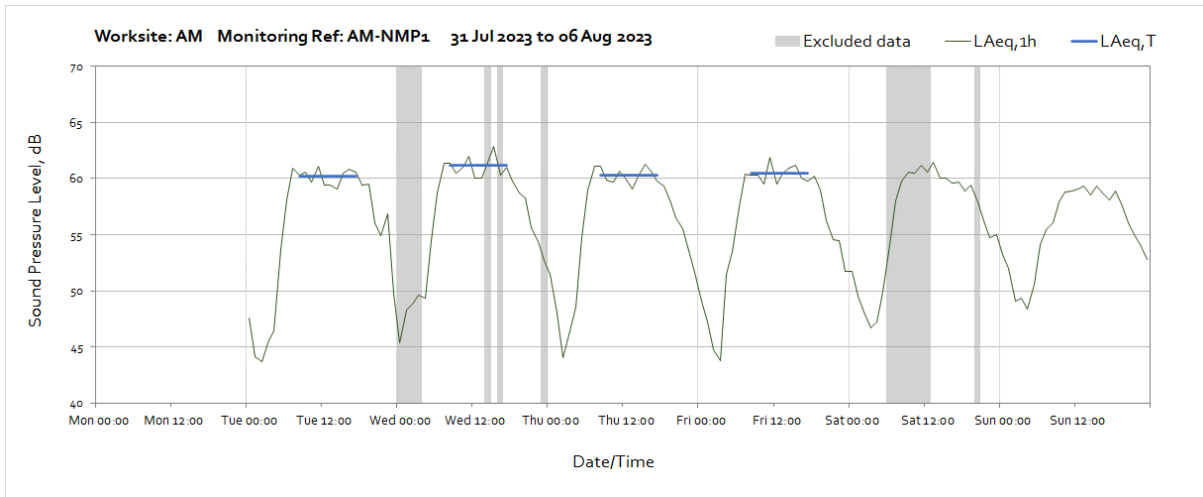
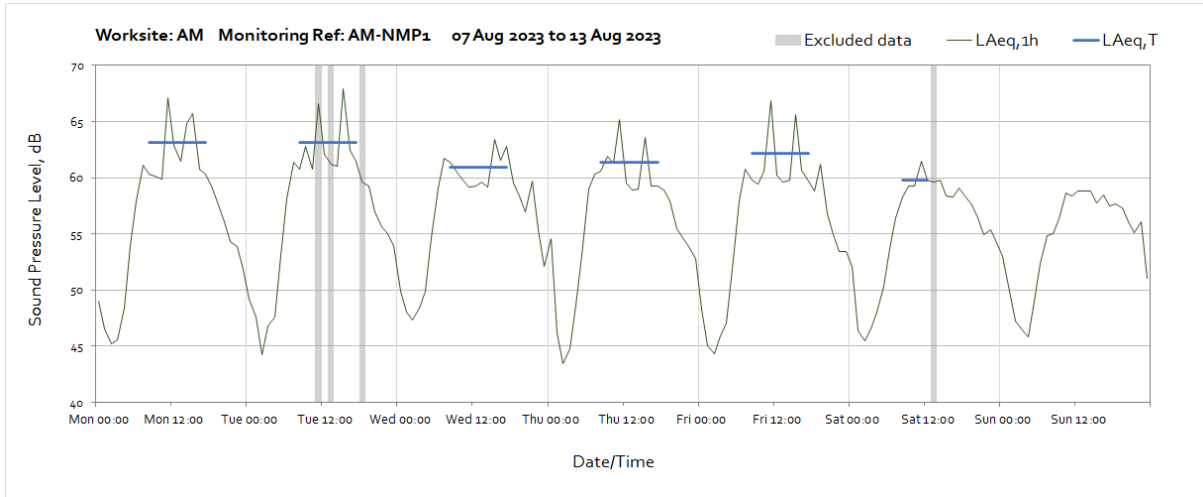
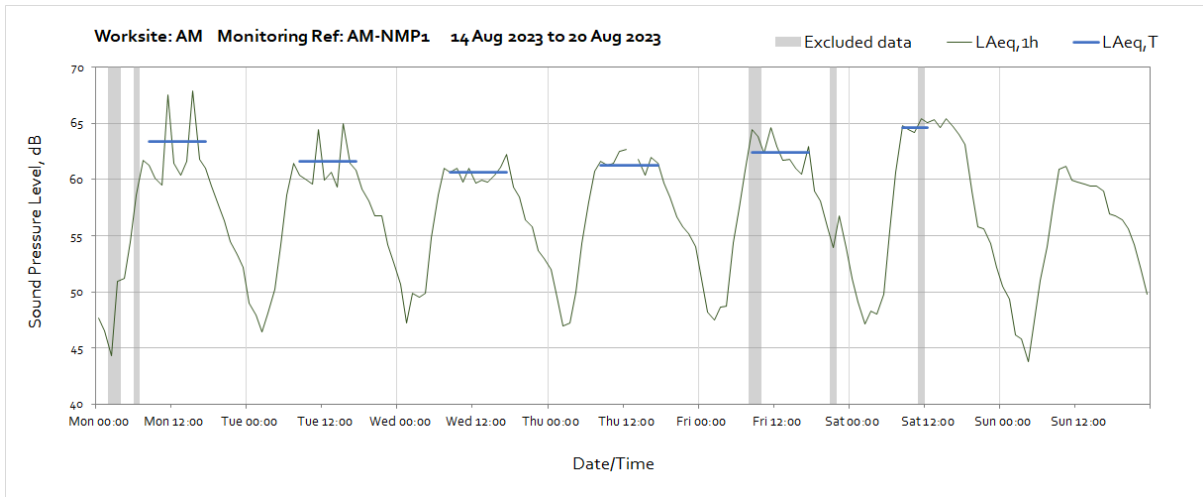
## Worksite: AM - Monitoring Ref: AM-NMP1

Note: Missing data between 13:00 and 14:00 on Thursday 17<sup>th</sup> August was due to monitor maintenance.

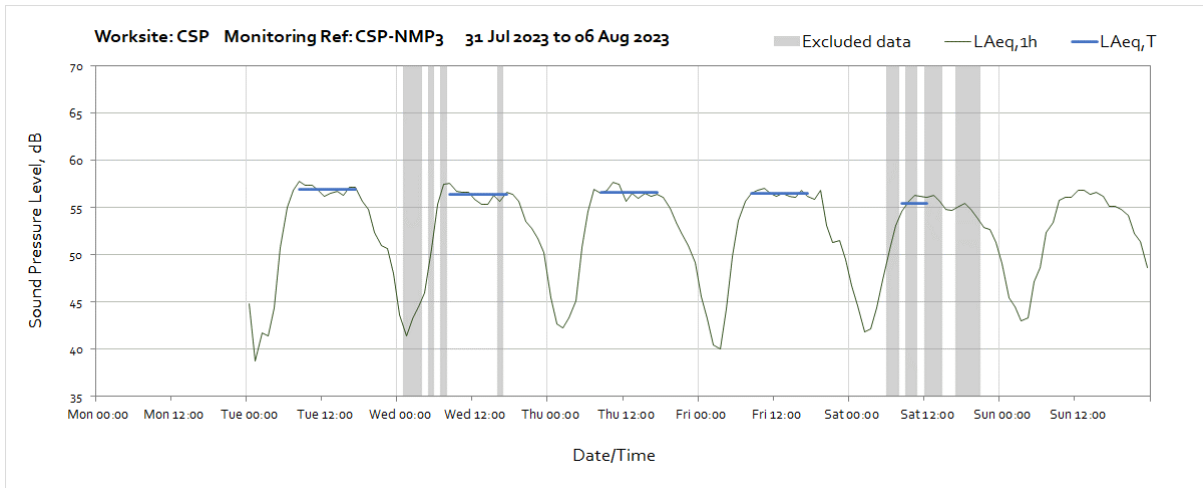
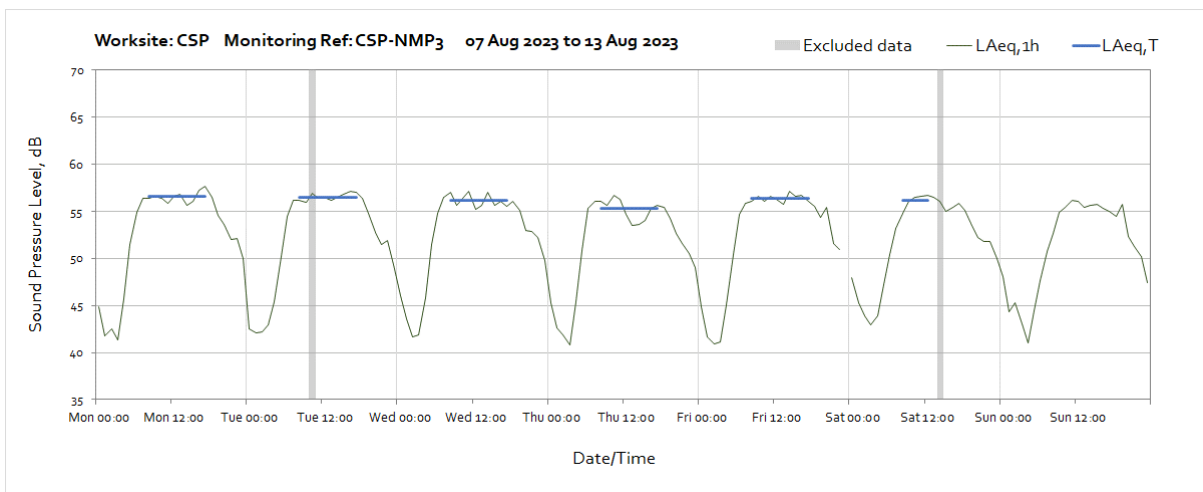
## Worksite: CSP – Monitoring Ref: CSP-NMP3

Note: Missing data between 23:00 and 00:00 on Friday 11<sup>th</sup> August was due to monitor settings update.

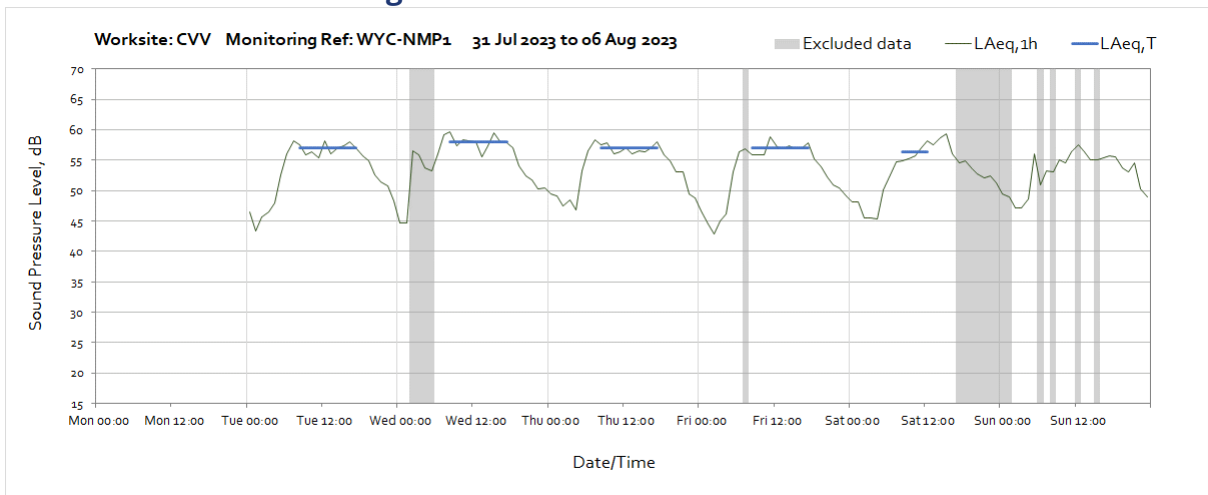
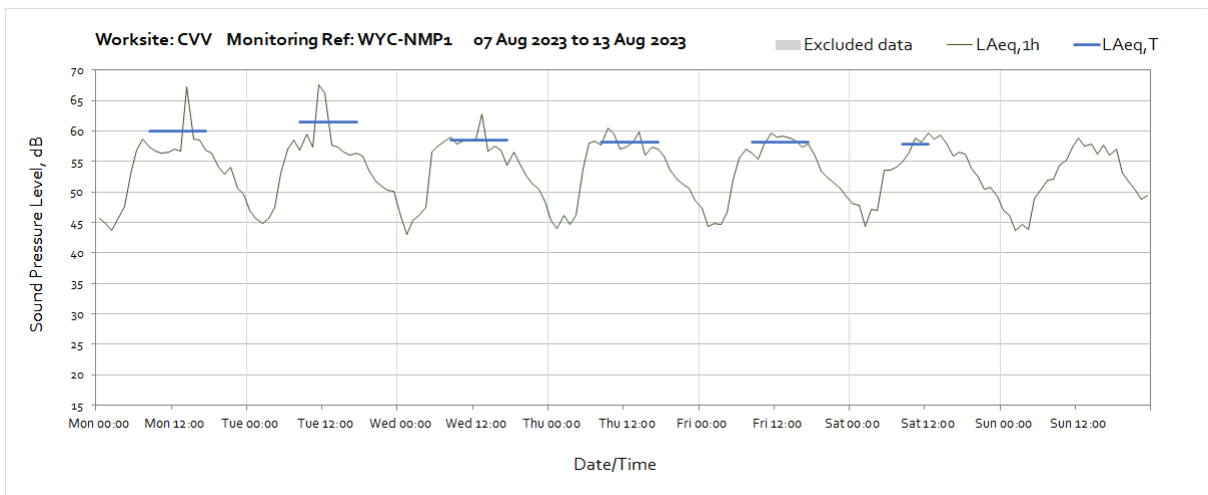
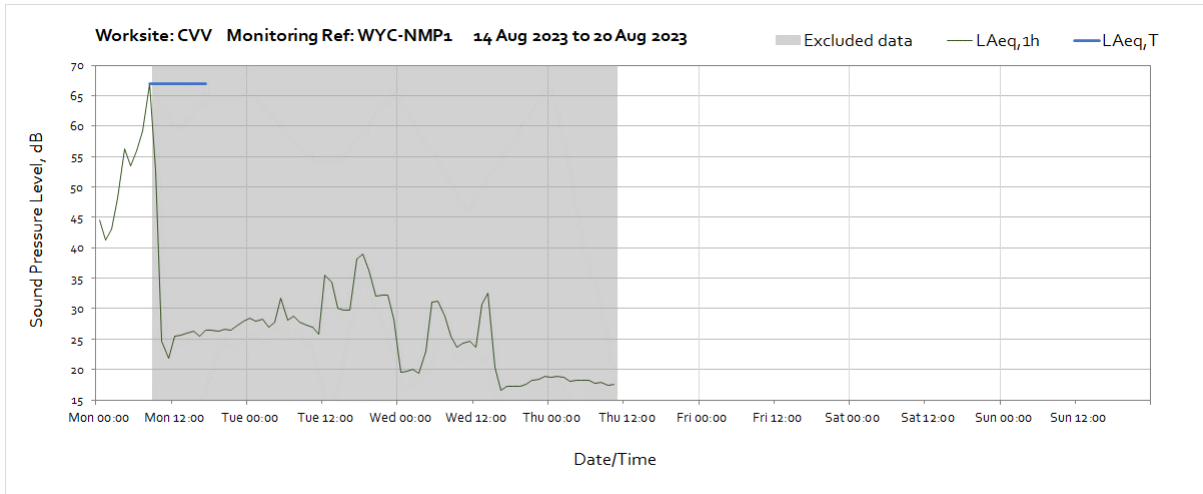
**Worksite: CVV – Monitoring Ref: WYC-NMP1**

Note: Missing data from 11:00 on Thursday 17<sup>th</sup> August was due to monitor vandalism, monitor has now be decommissioned.

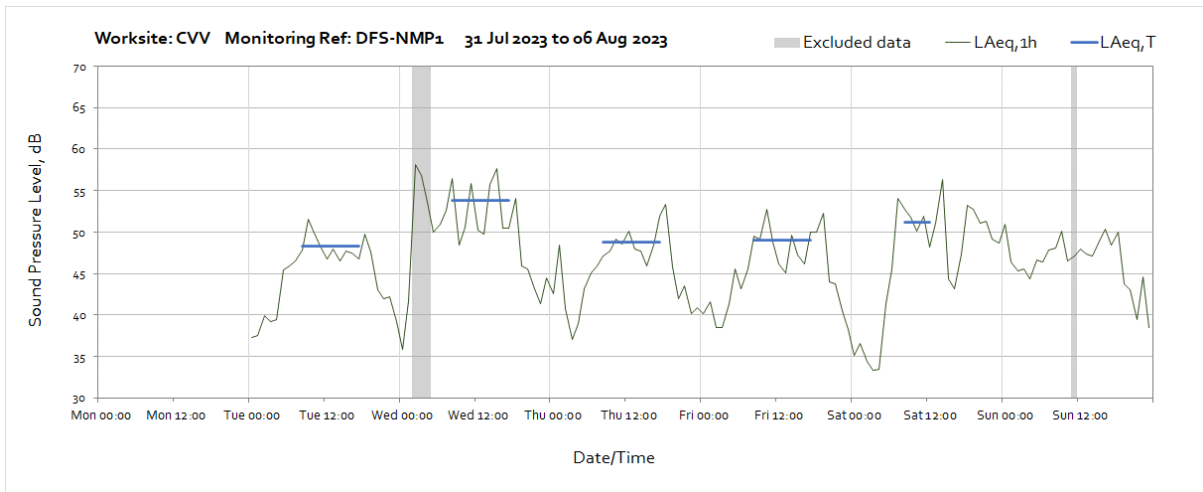
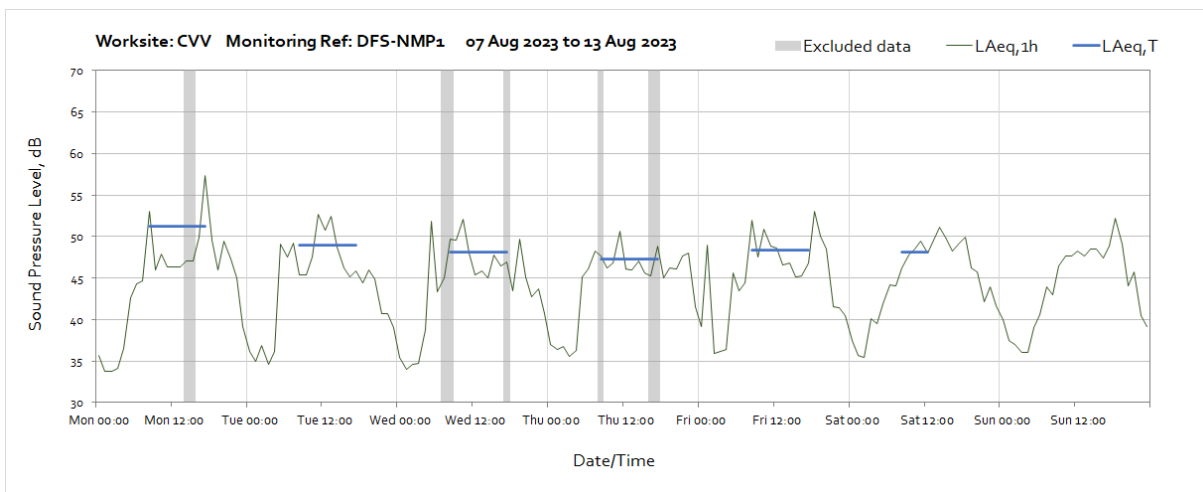
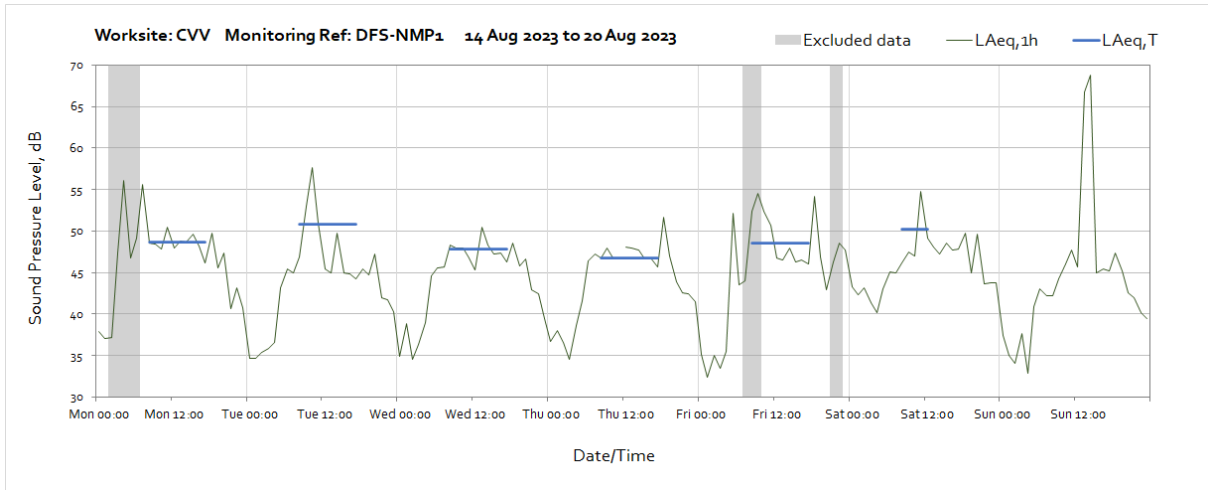
### Worksite: CVV - Monitoring Ref: DFS-NMP1

Note: Missing data between 11:00 and 12:00 on Thursday 17<sup>th</sup> August was due to monitor maintenance.

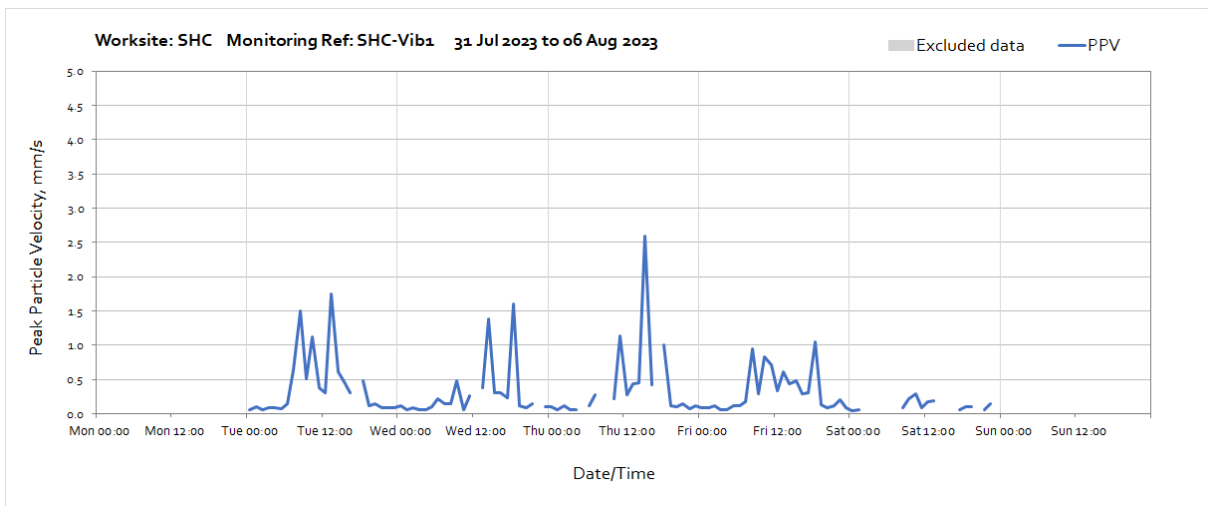
### Worksite: SHC – Monitoring Ref: SHC-Vib1

Note: Missing data throughout the week was due to poor signal.

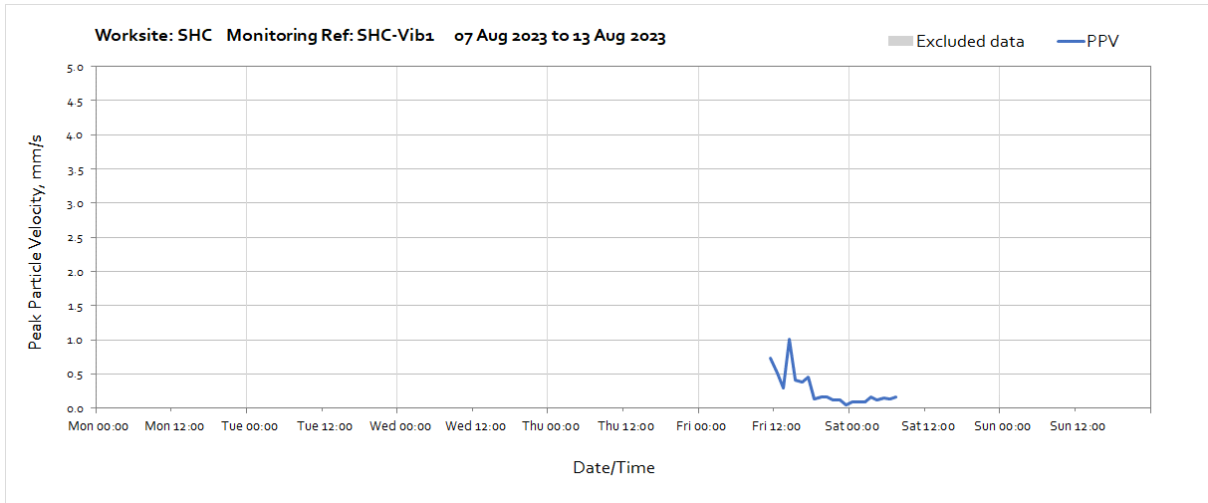
Note: Missing data throughout the week was due to loss of power.

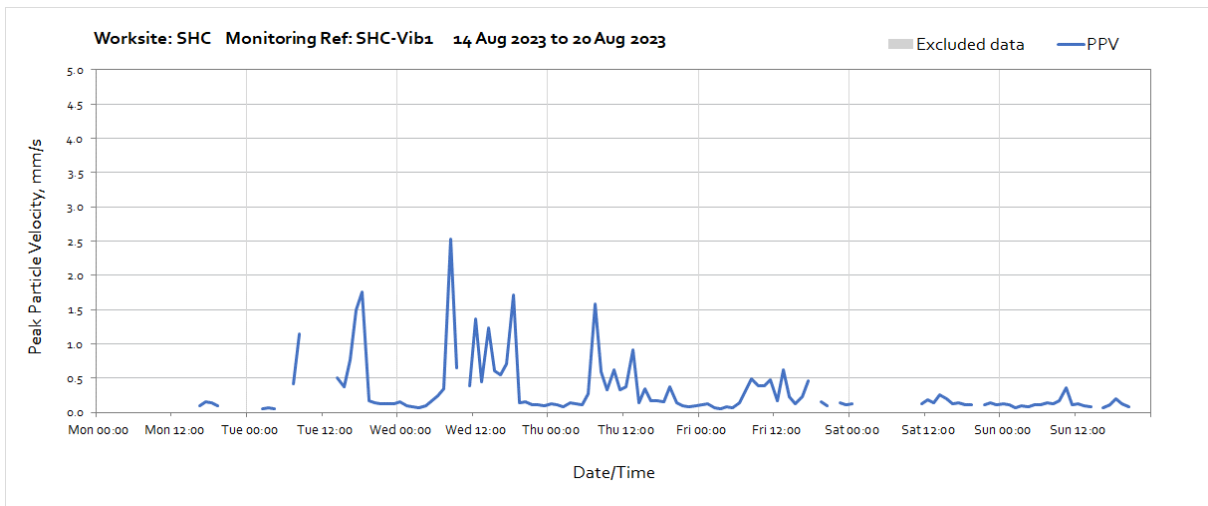
Note: Missing data throughout the week was due to poor signal.

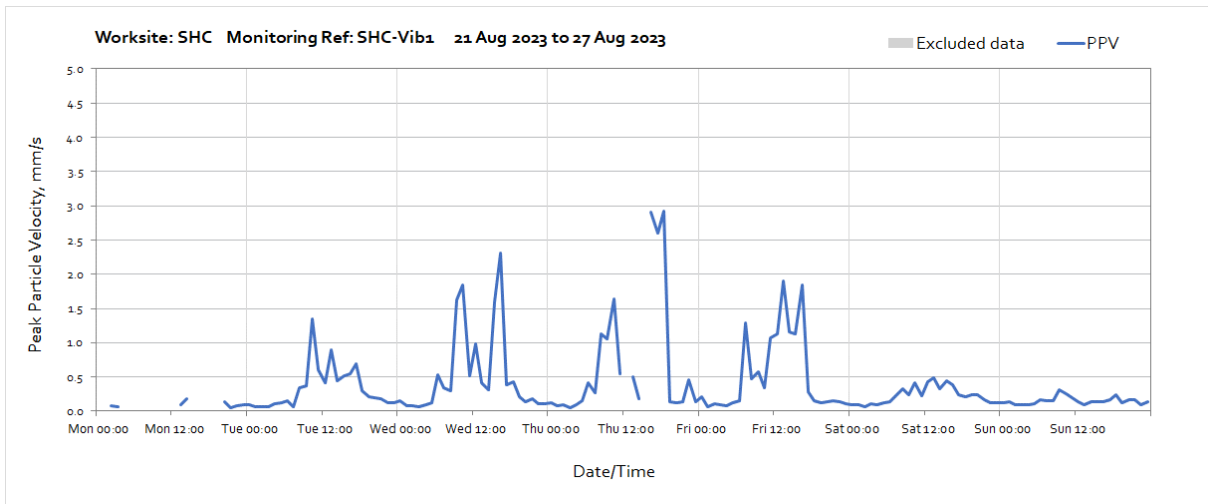
Note: Missing data throughout the week was due to poor signal.

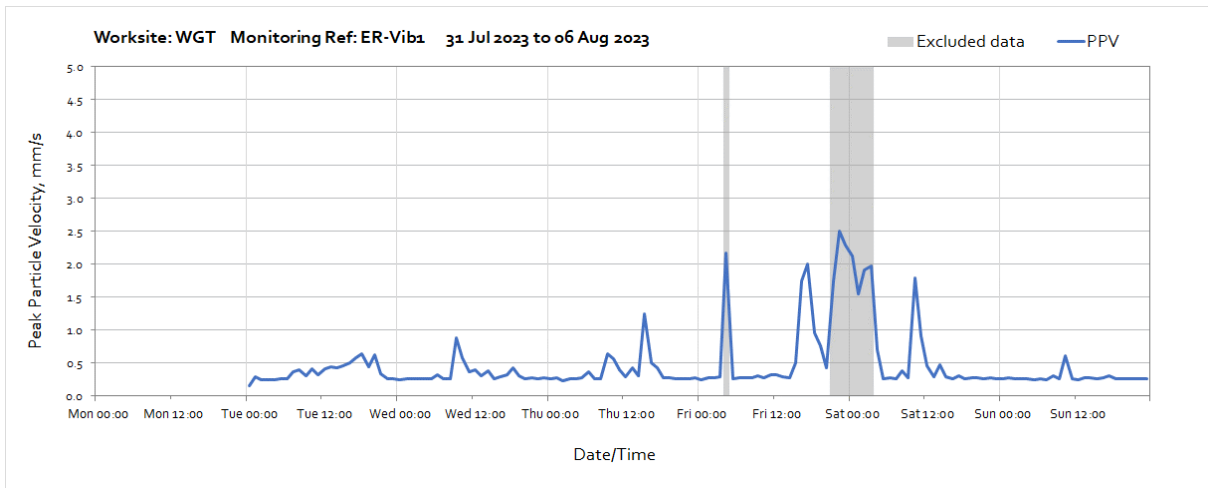
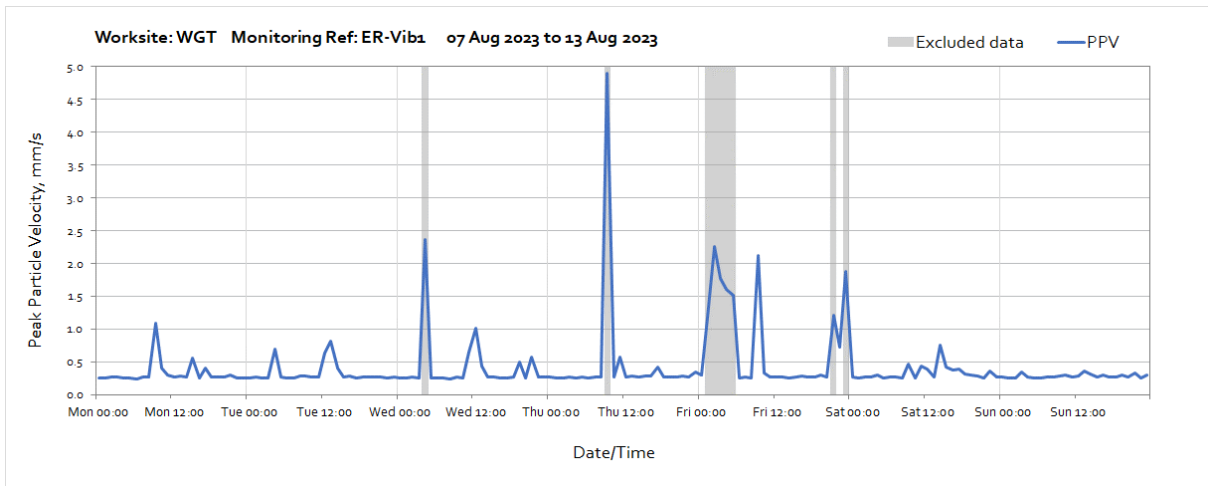
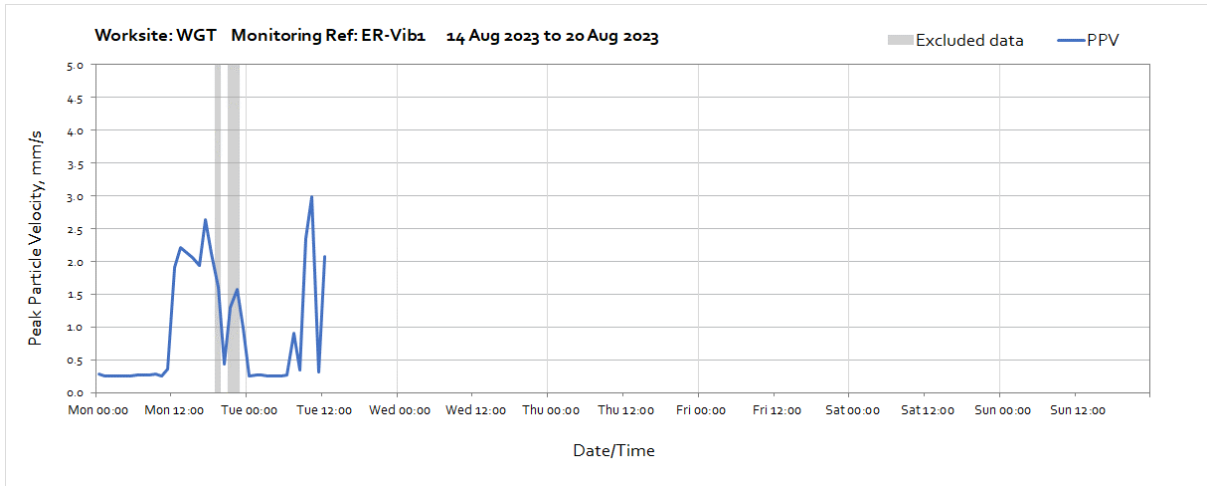
### Worksite: WGT – Monitoring Ref: ER-Vib 1

Note: Missing data from 13:00 on Tuesday 15<sup>th</sup> August until month end was due to depleted monitor battery.

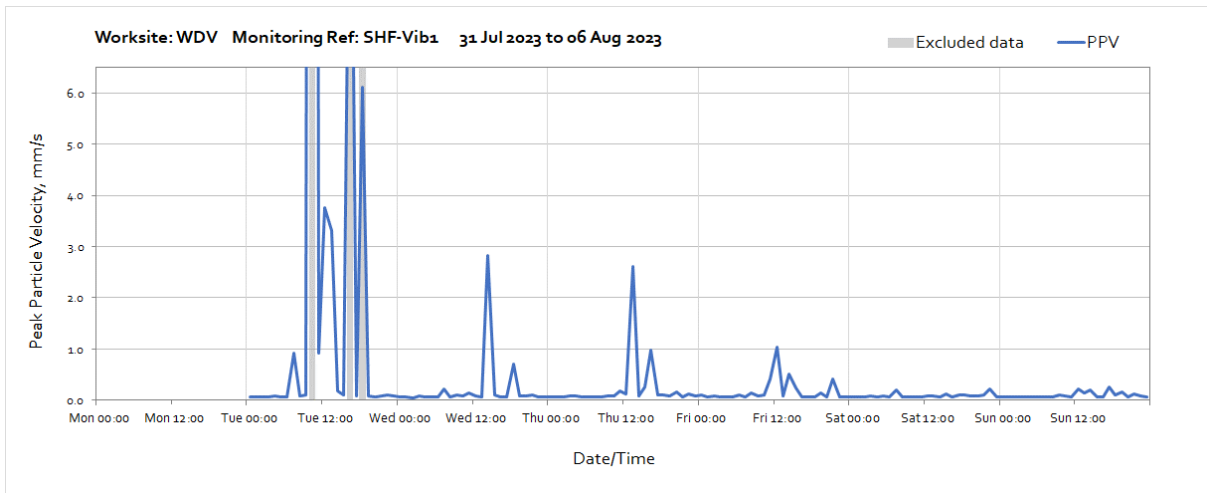
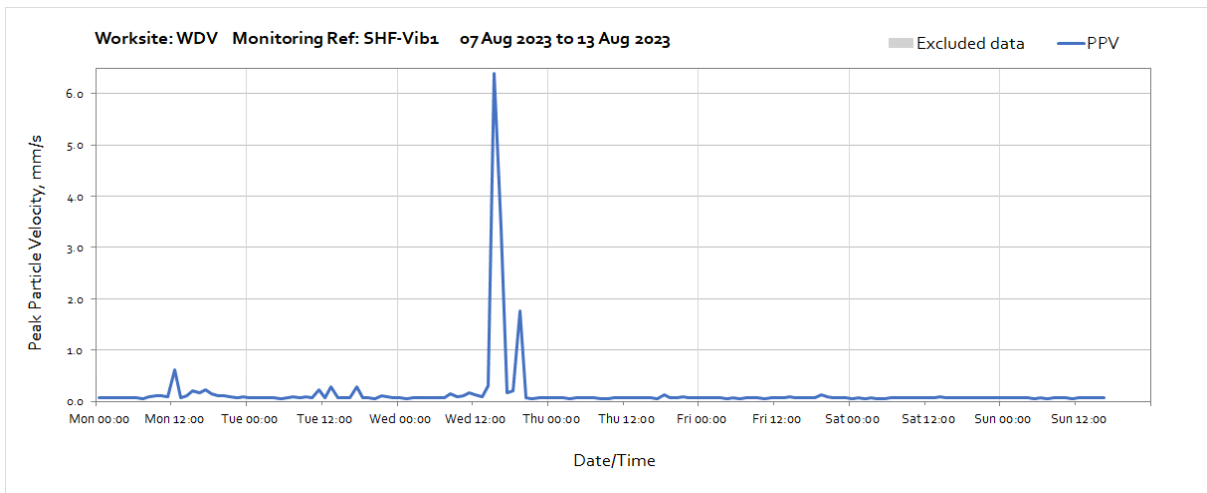
### Worksite: WDV – Monitoring Ref: SHF-Vib1

Note: High vibration level at 15:00 on Wednesday 9<sup>th</sup> August was due to piling works. Missing data from 17:00 on Sunday 13<sup>th</sup> August until month end was due to a monitor fault.
