Investigating the derailment of a passenger train at Carmont

Overview of the accident and causes

**Derailment of a passenger train at Carmont,
Aberdeenshire
12 August 2020**

Report 02/2022
March 2022

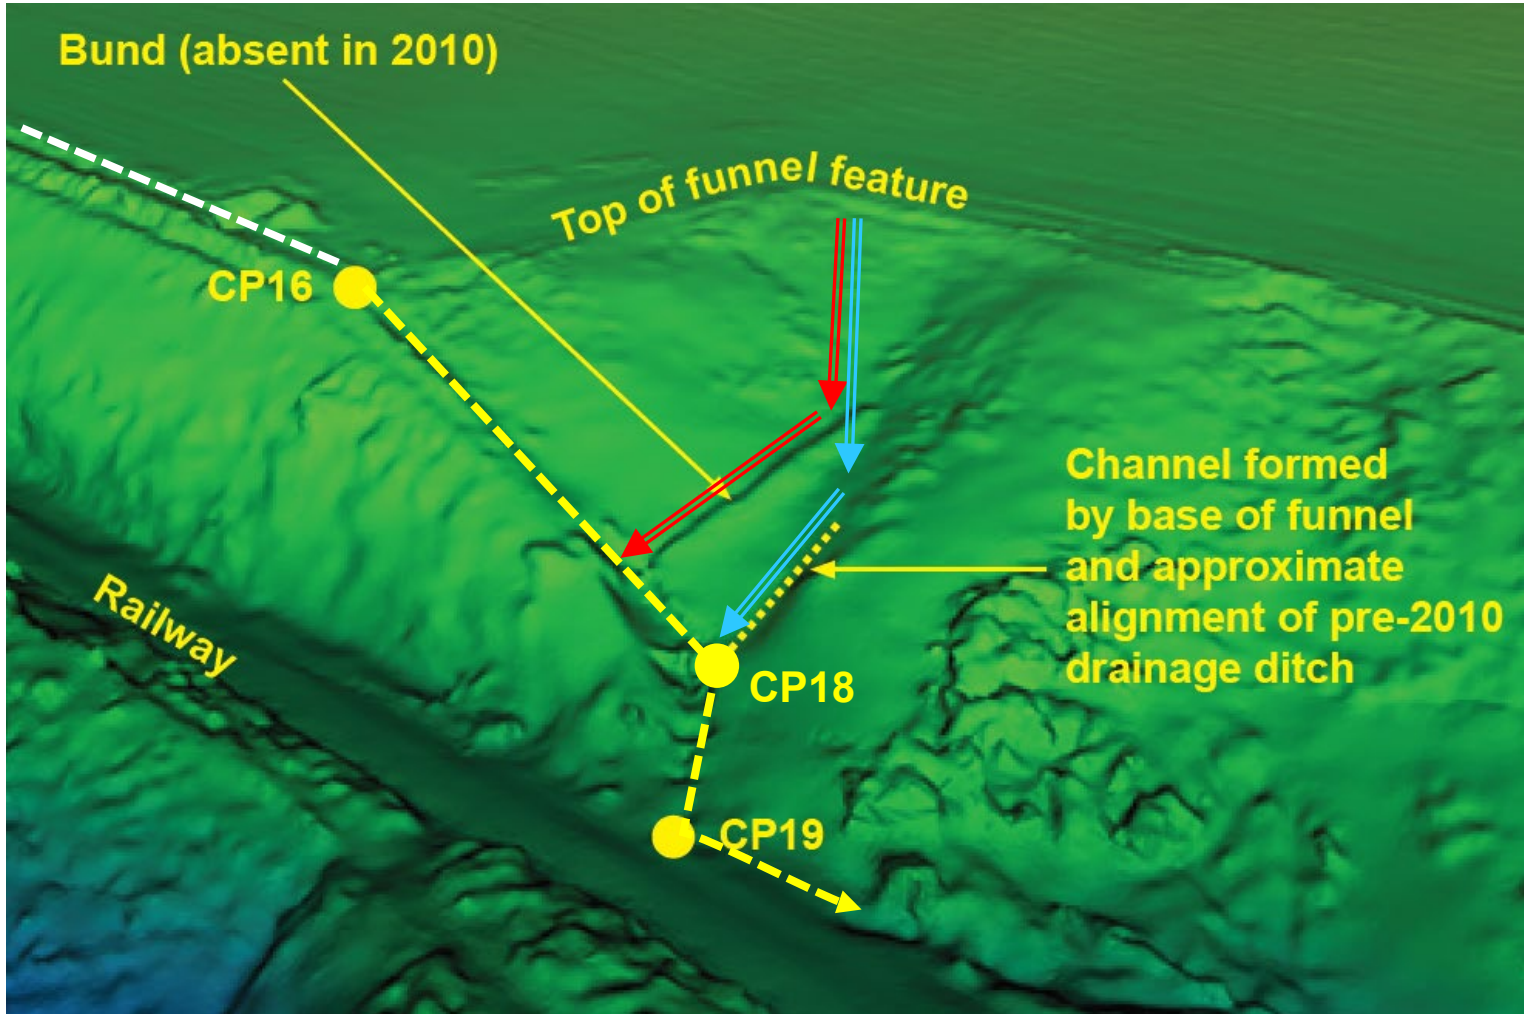
Site topography from LiDAR data

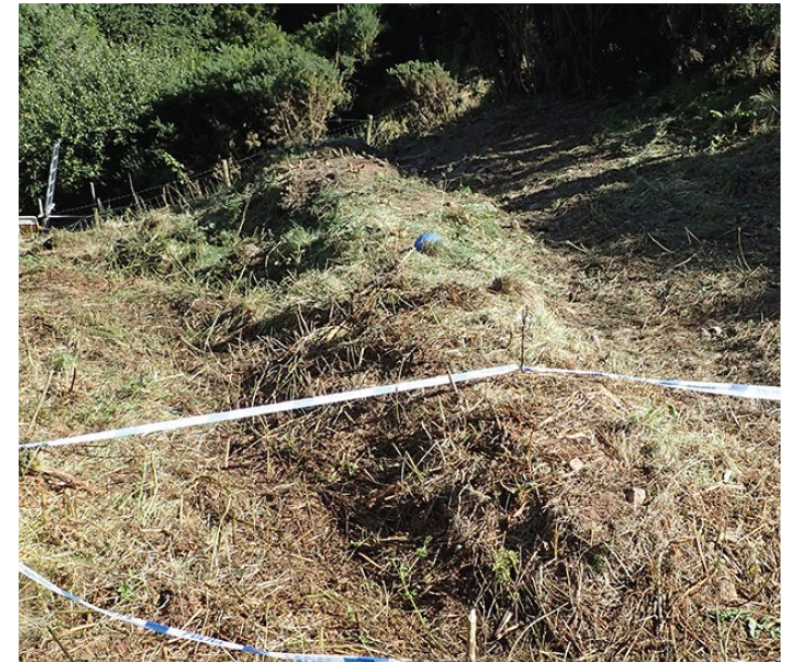
The drain was not installed as designed

Bund (was hidden by gorse)

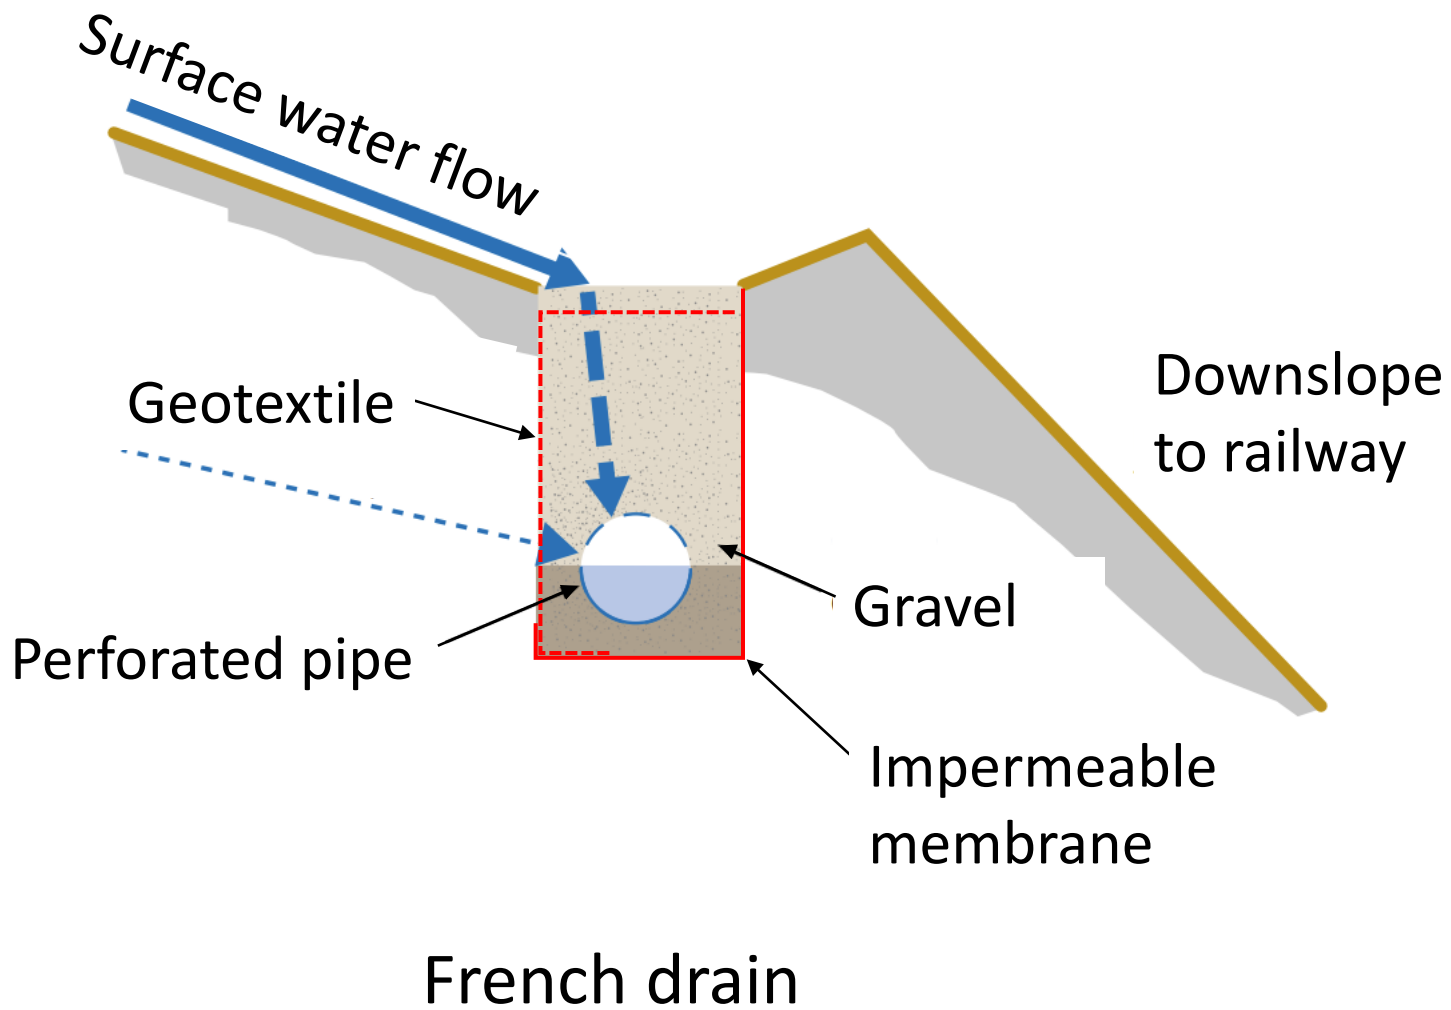
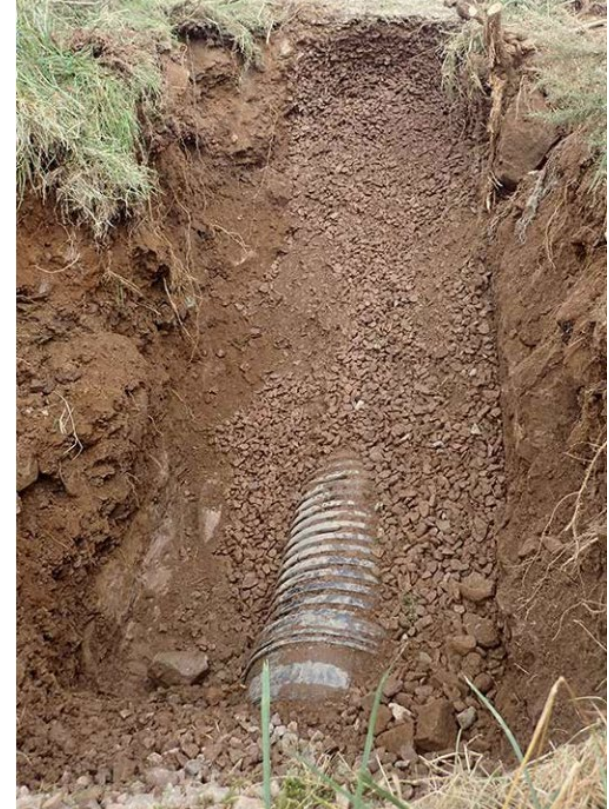
The drain's geotextile lining was omitted in the area of the washout

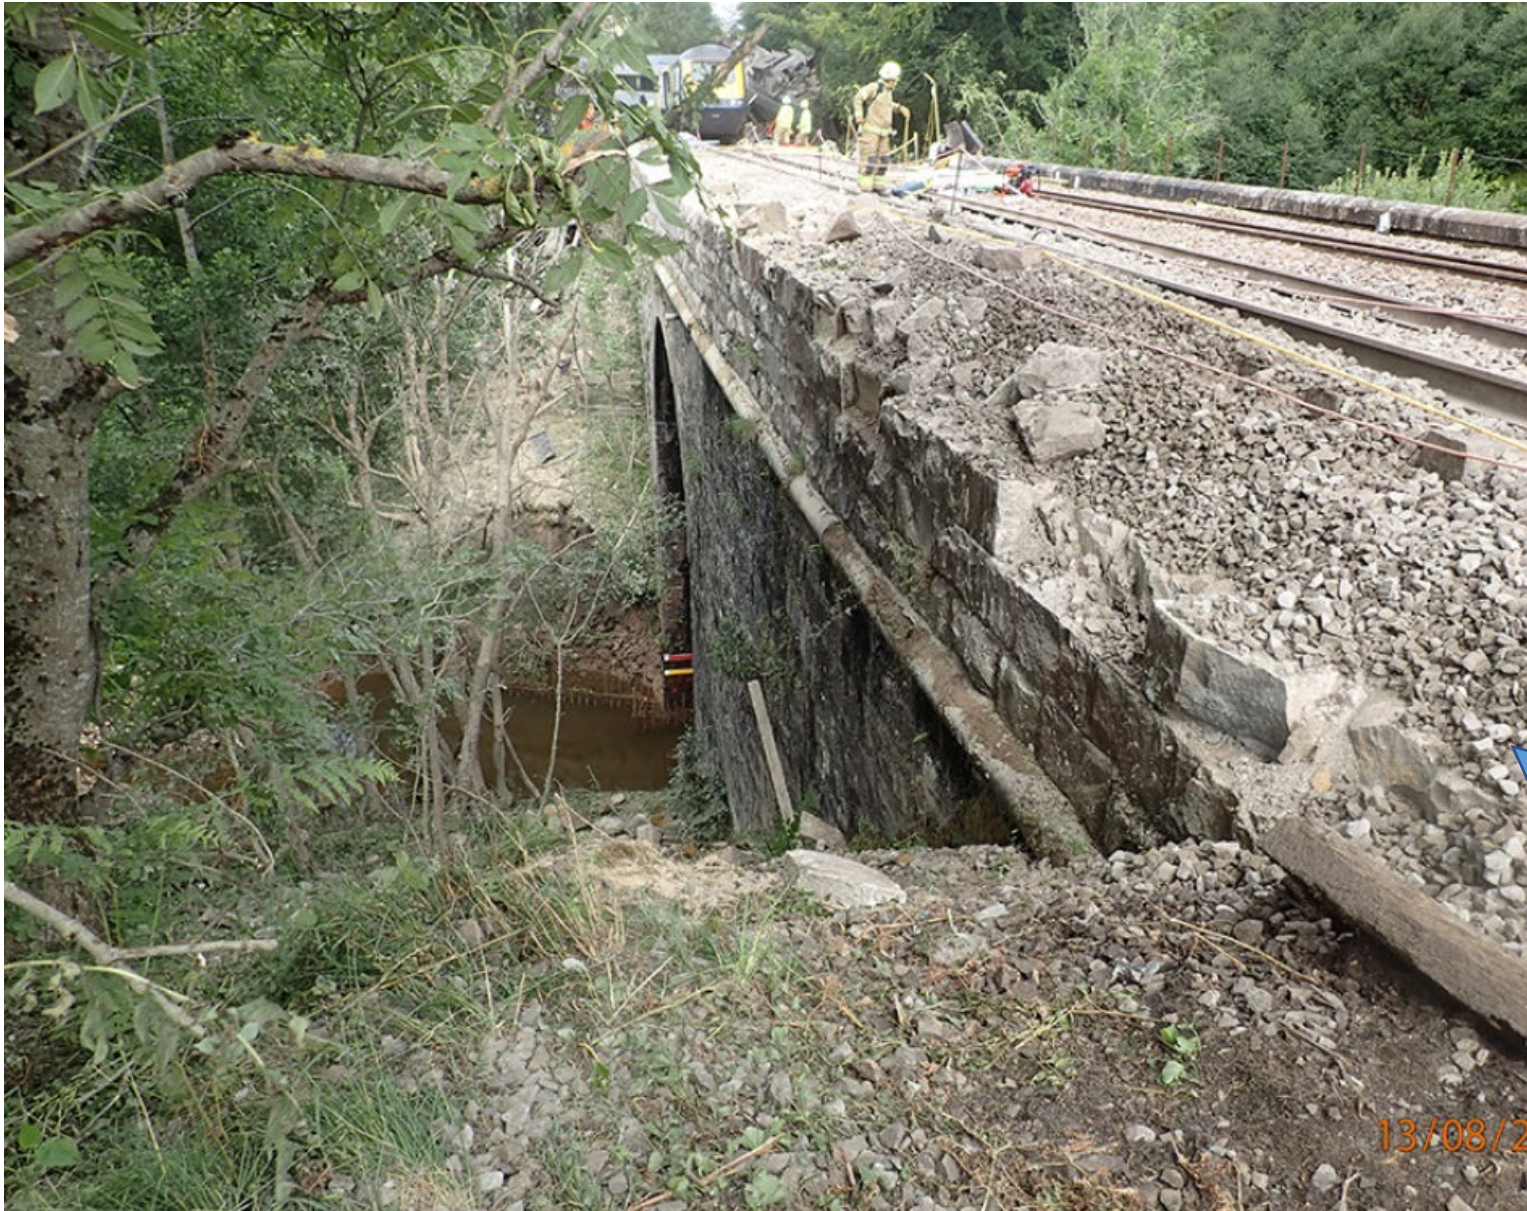
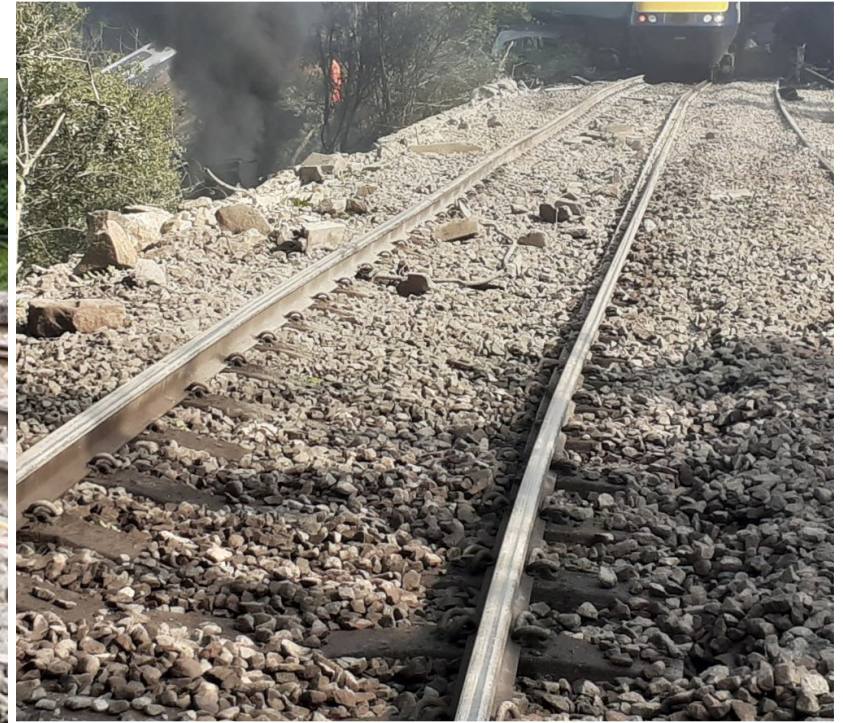
Derailed wheelset

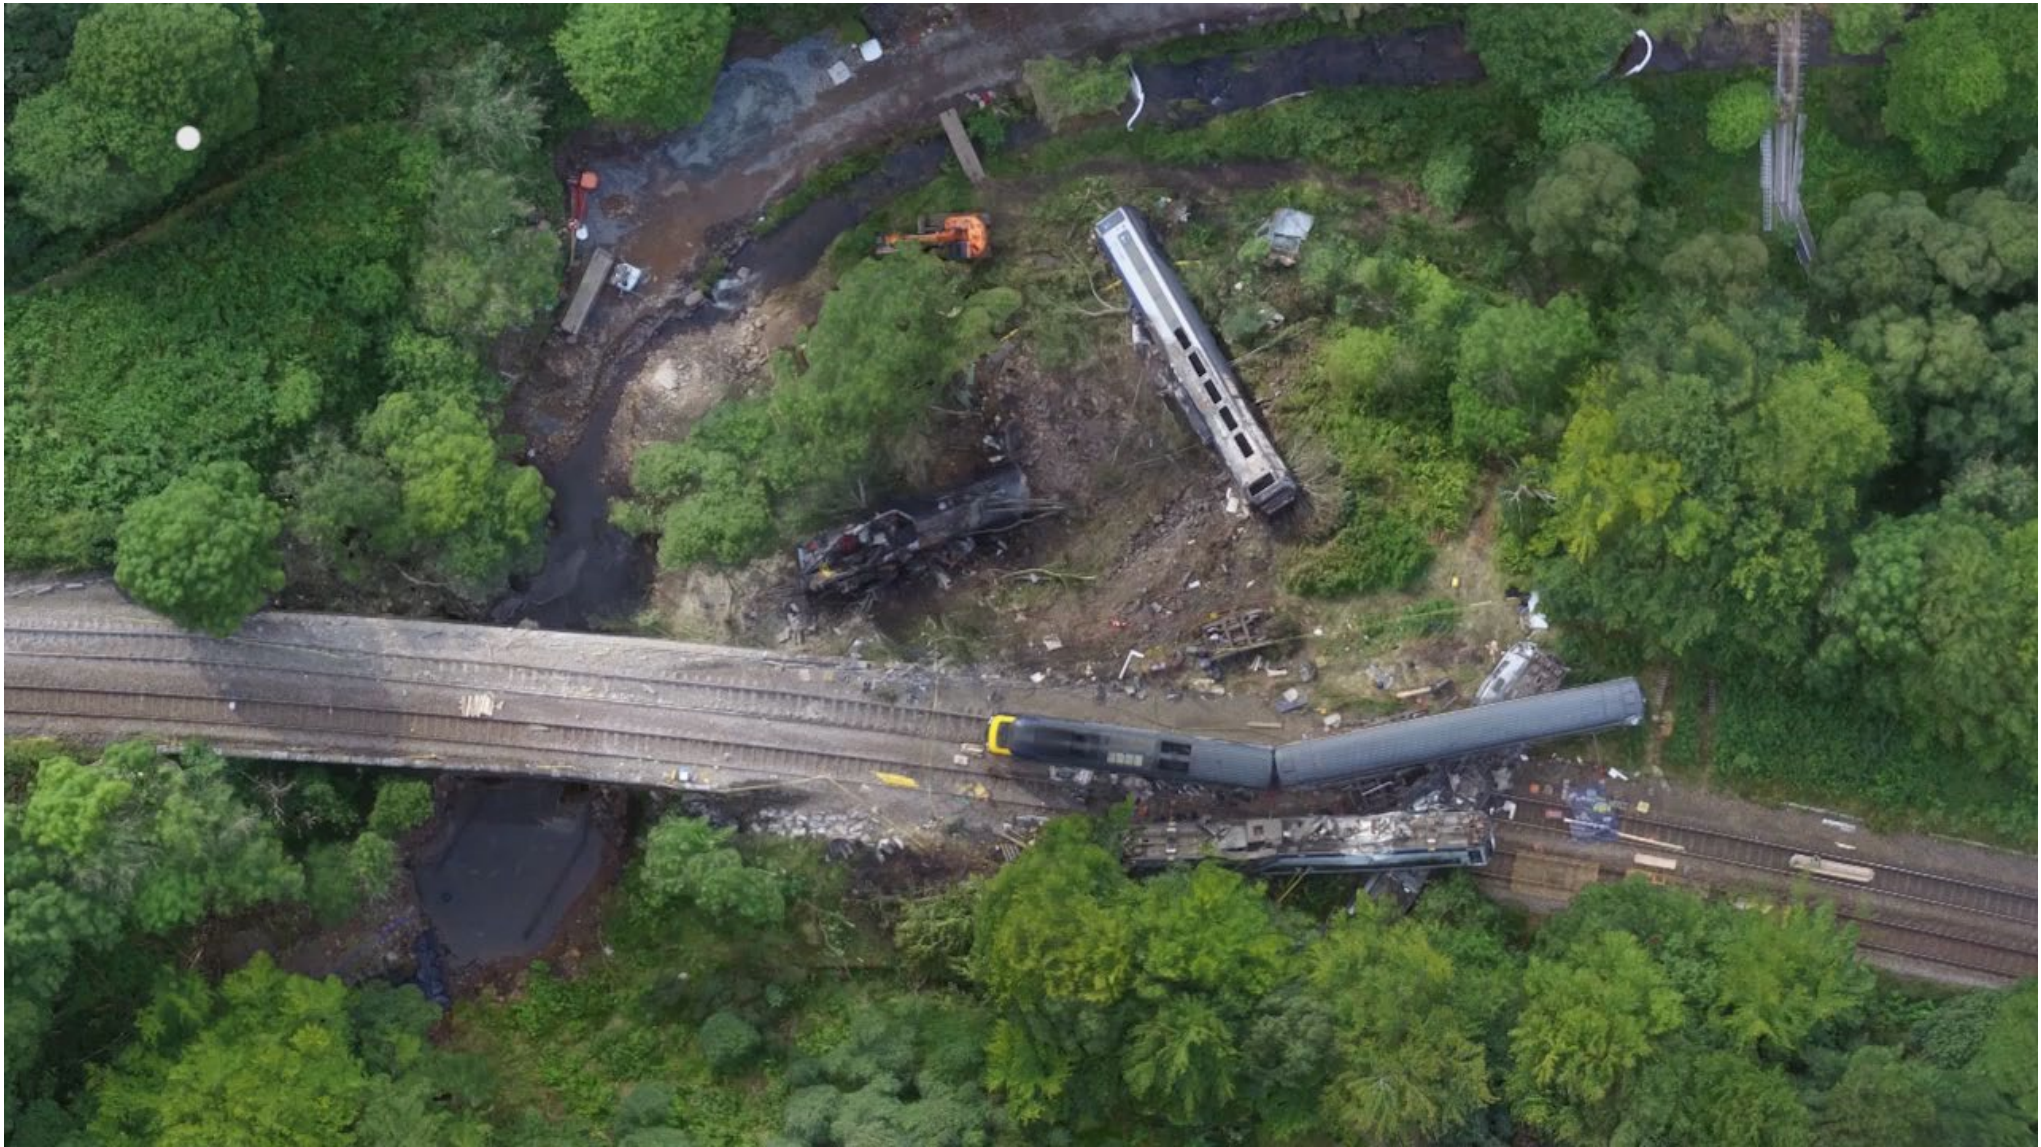
Computer modelling was used to assimilate evidence
