# Air Quality and Dust Monitoring Monthly Report – September 2023 Buckinghamshire Council

Figures 1-7: Worksite and Monitoring locations within BC

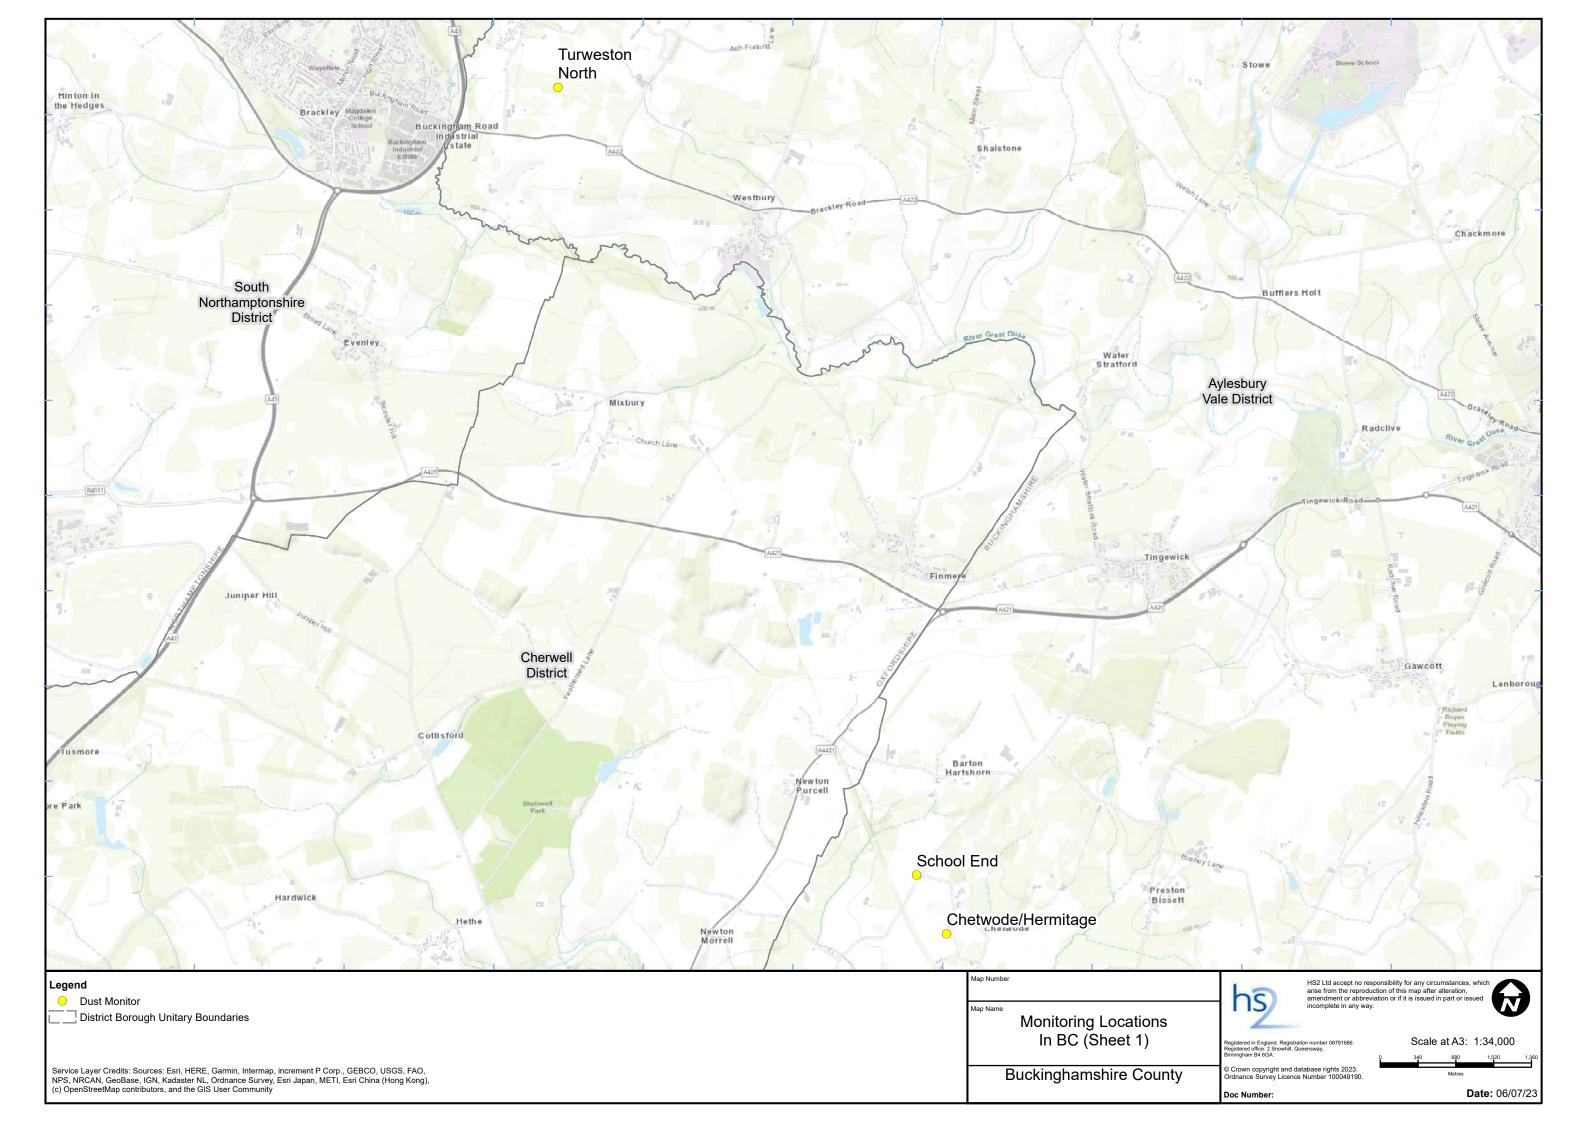
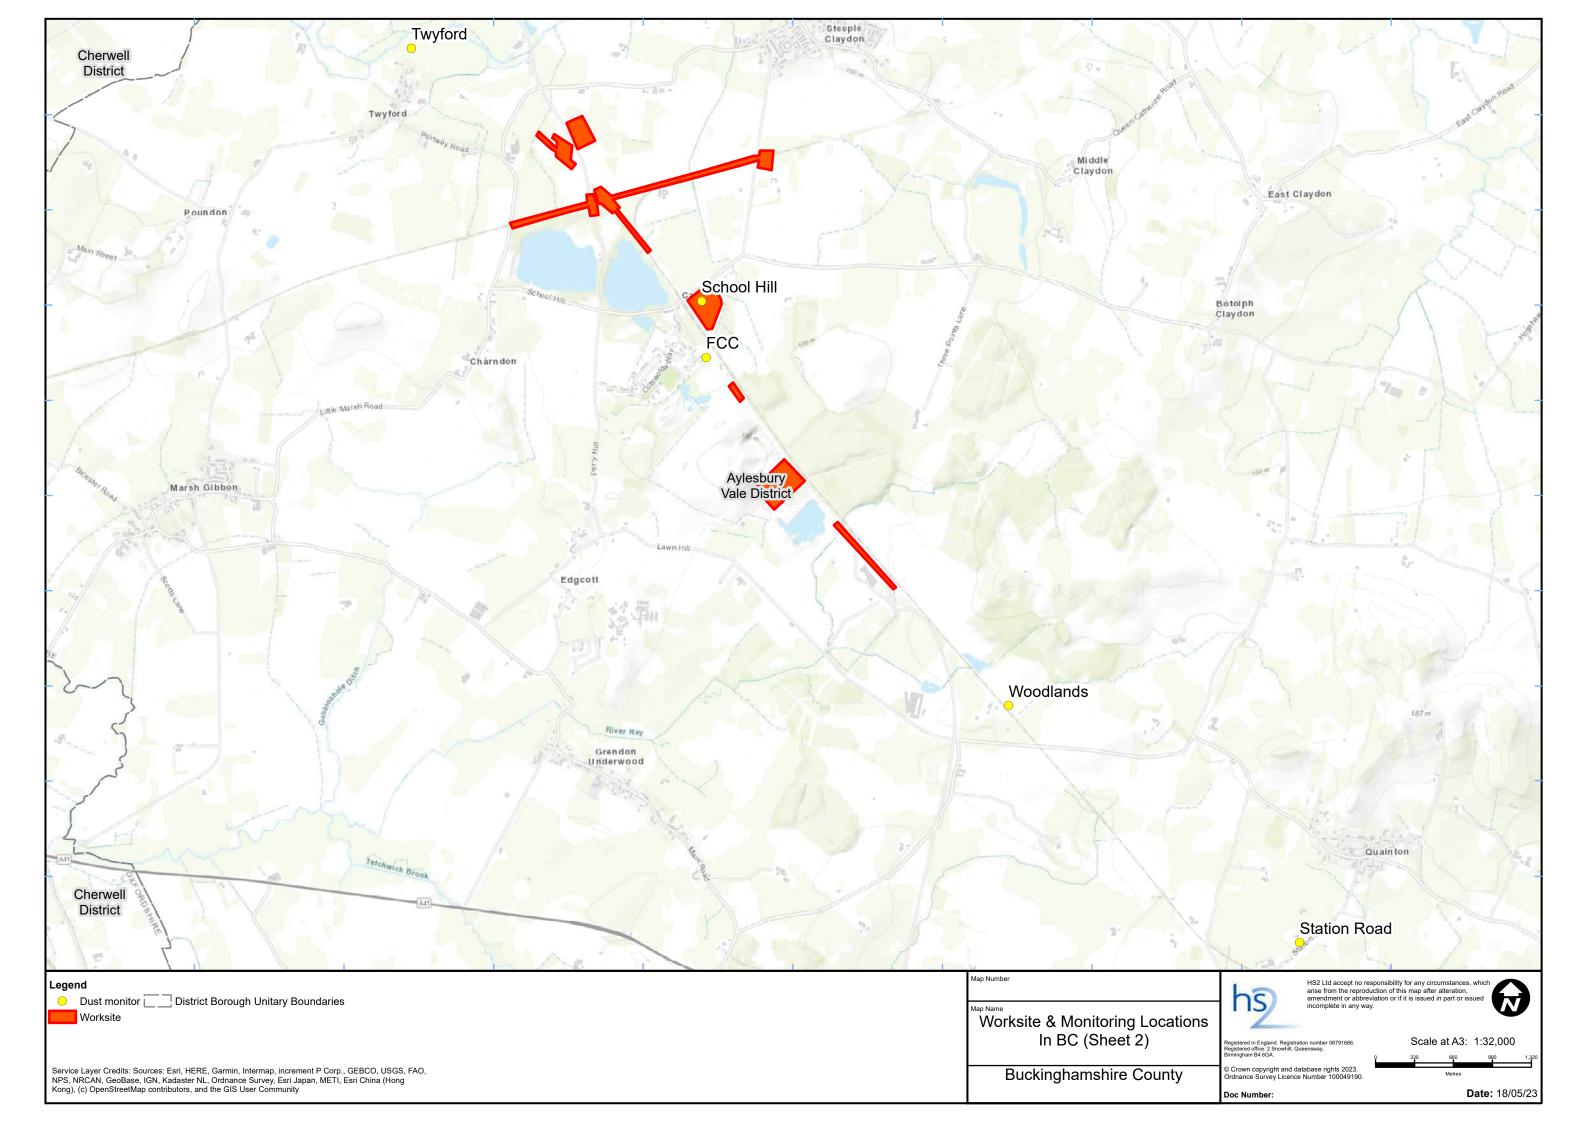
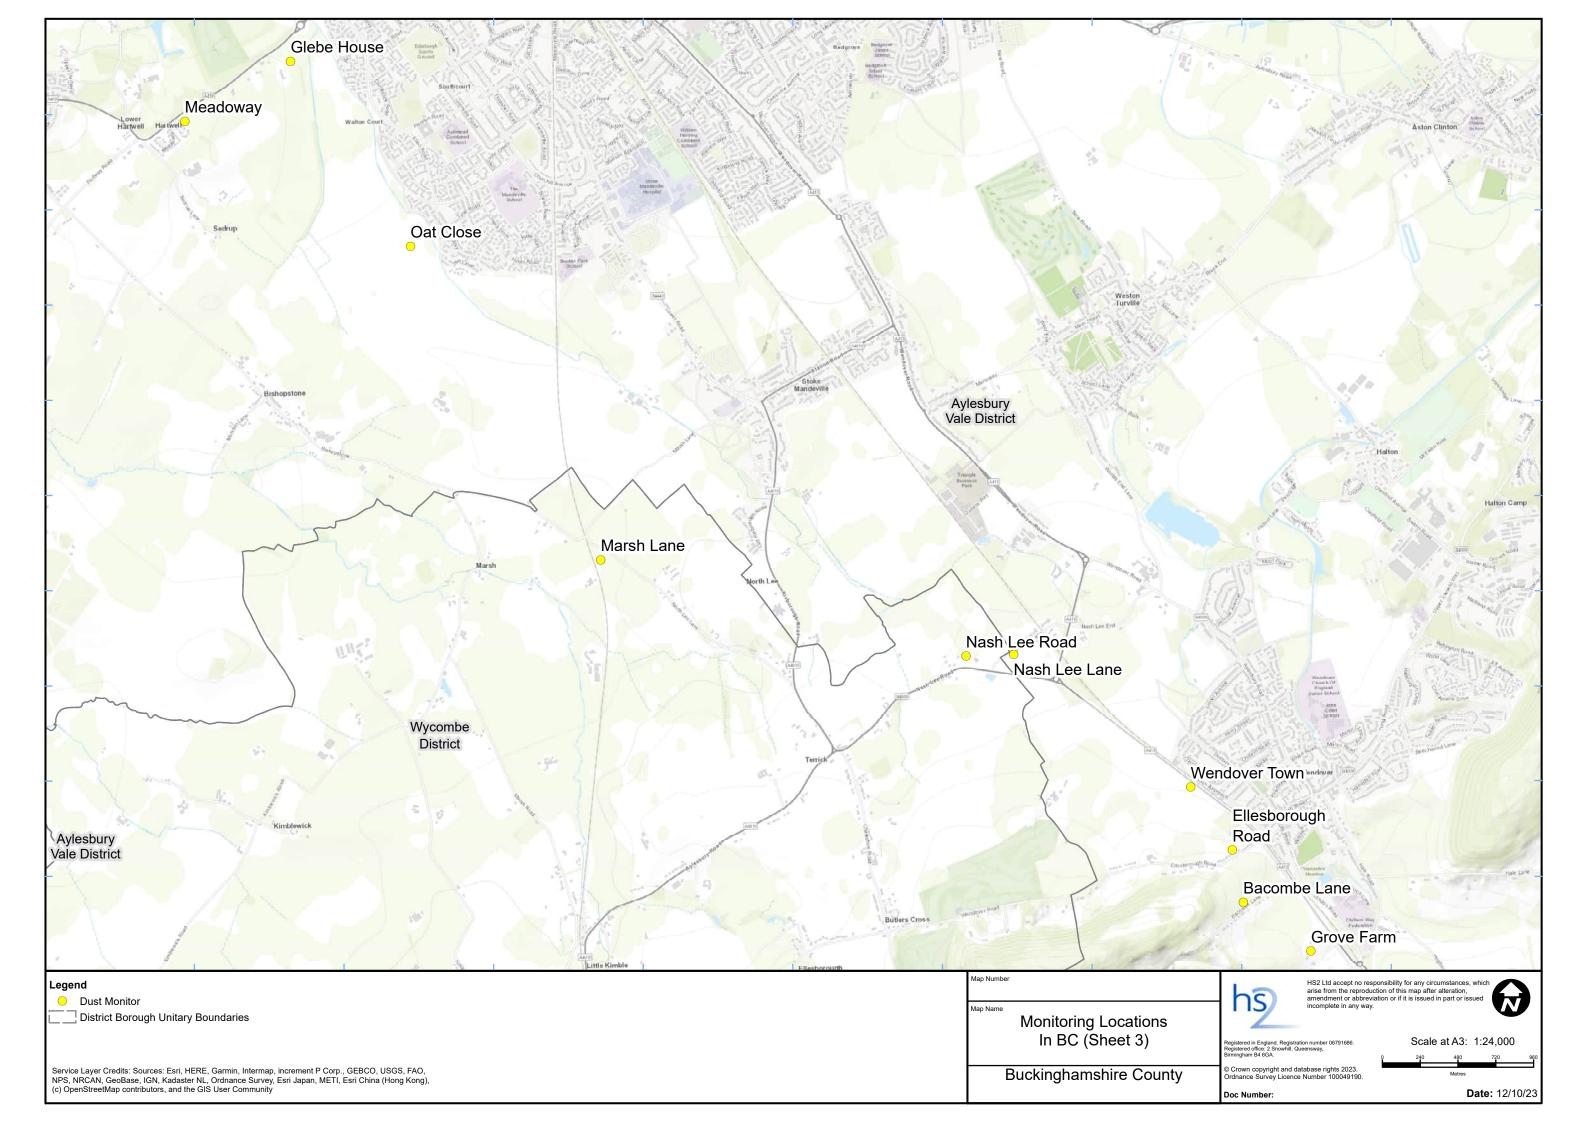
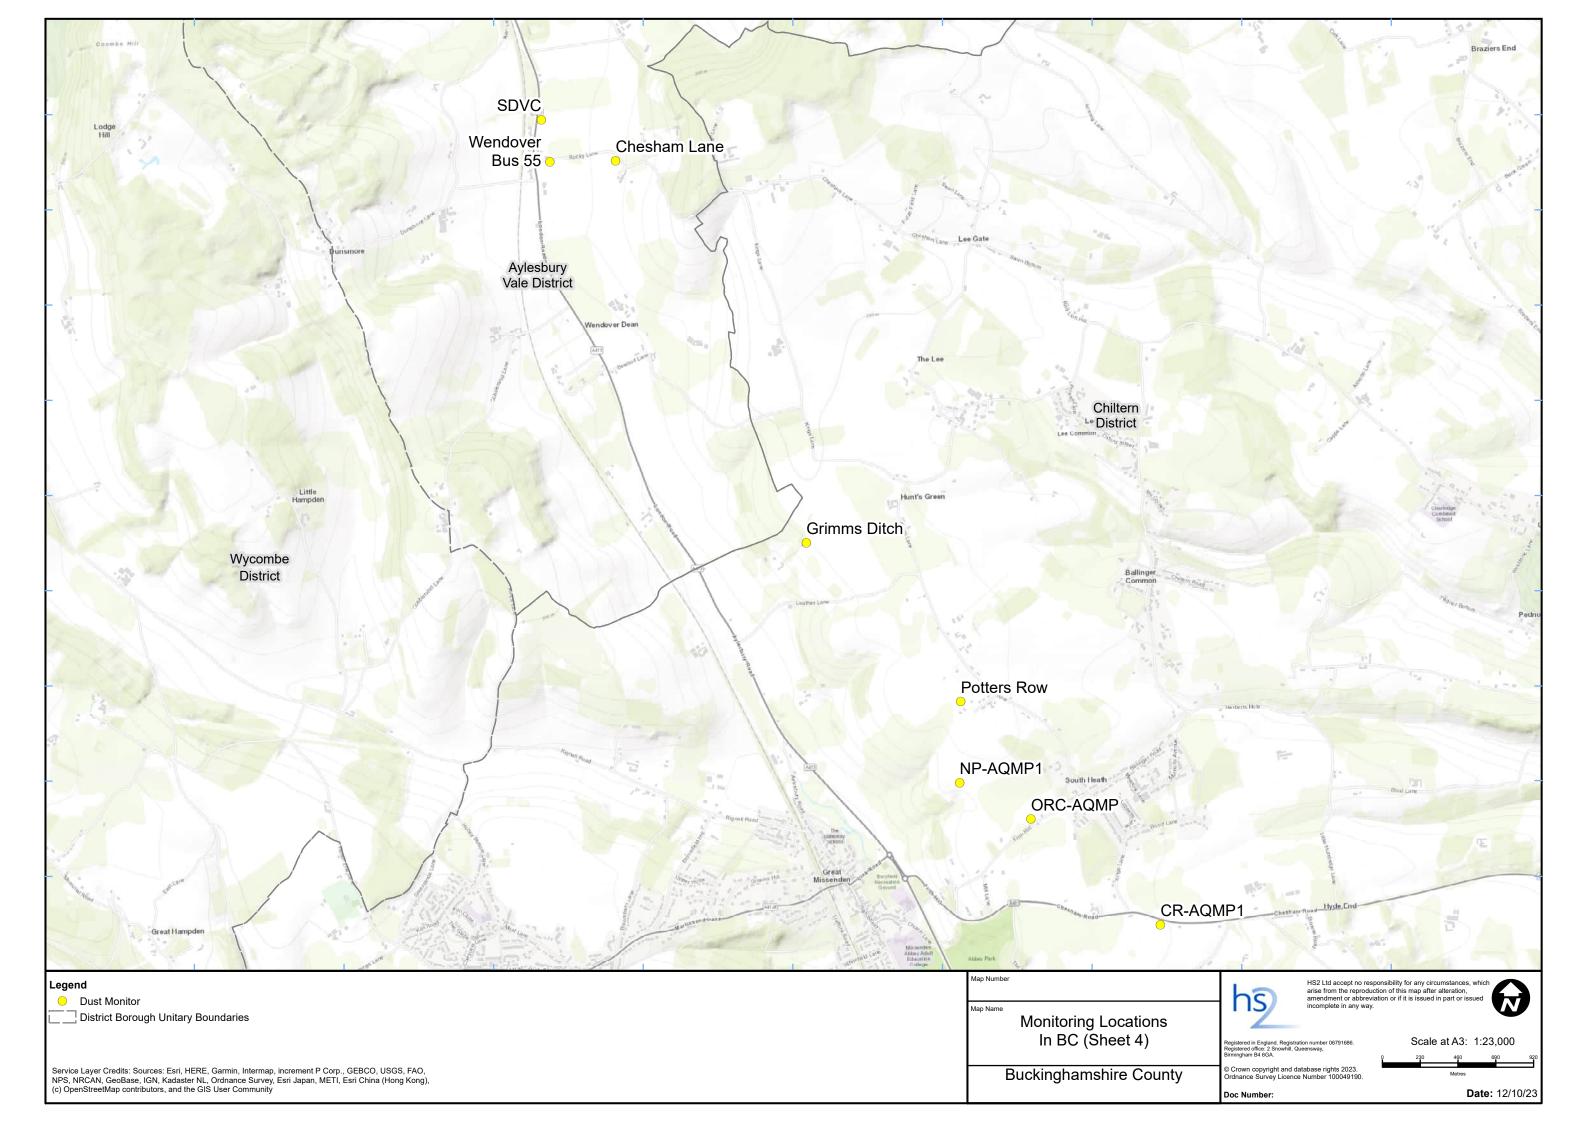
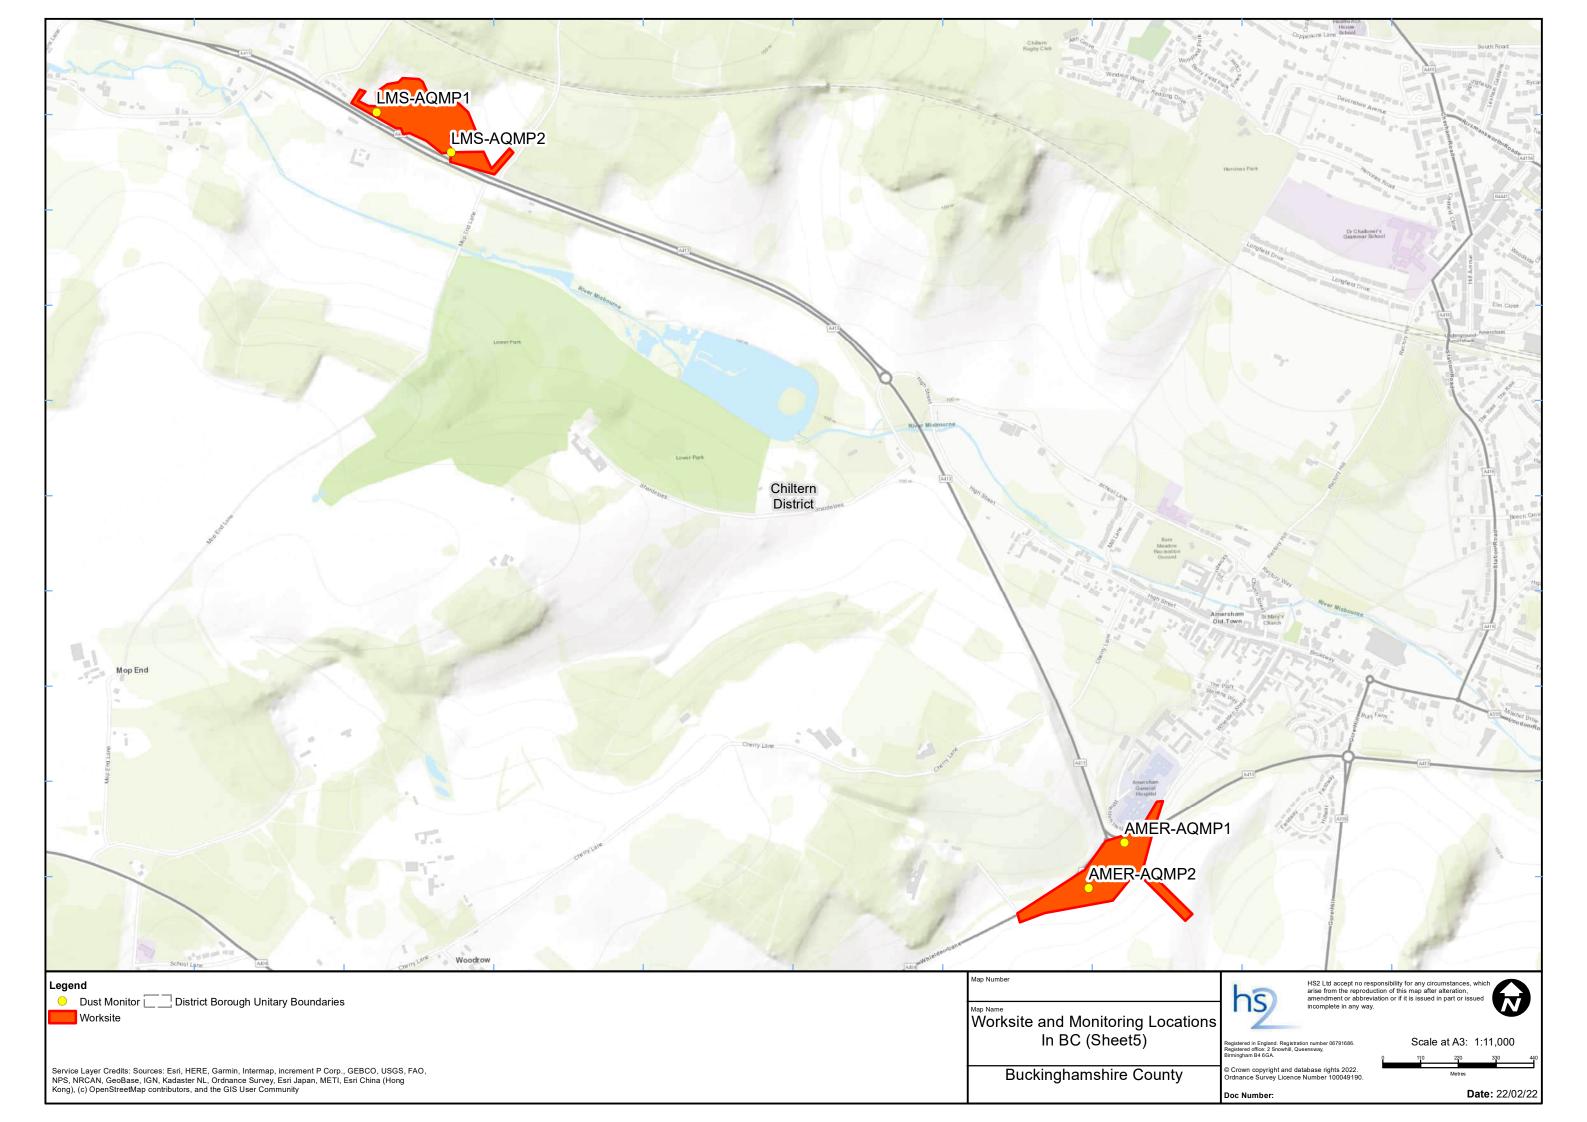
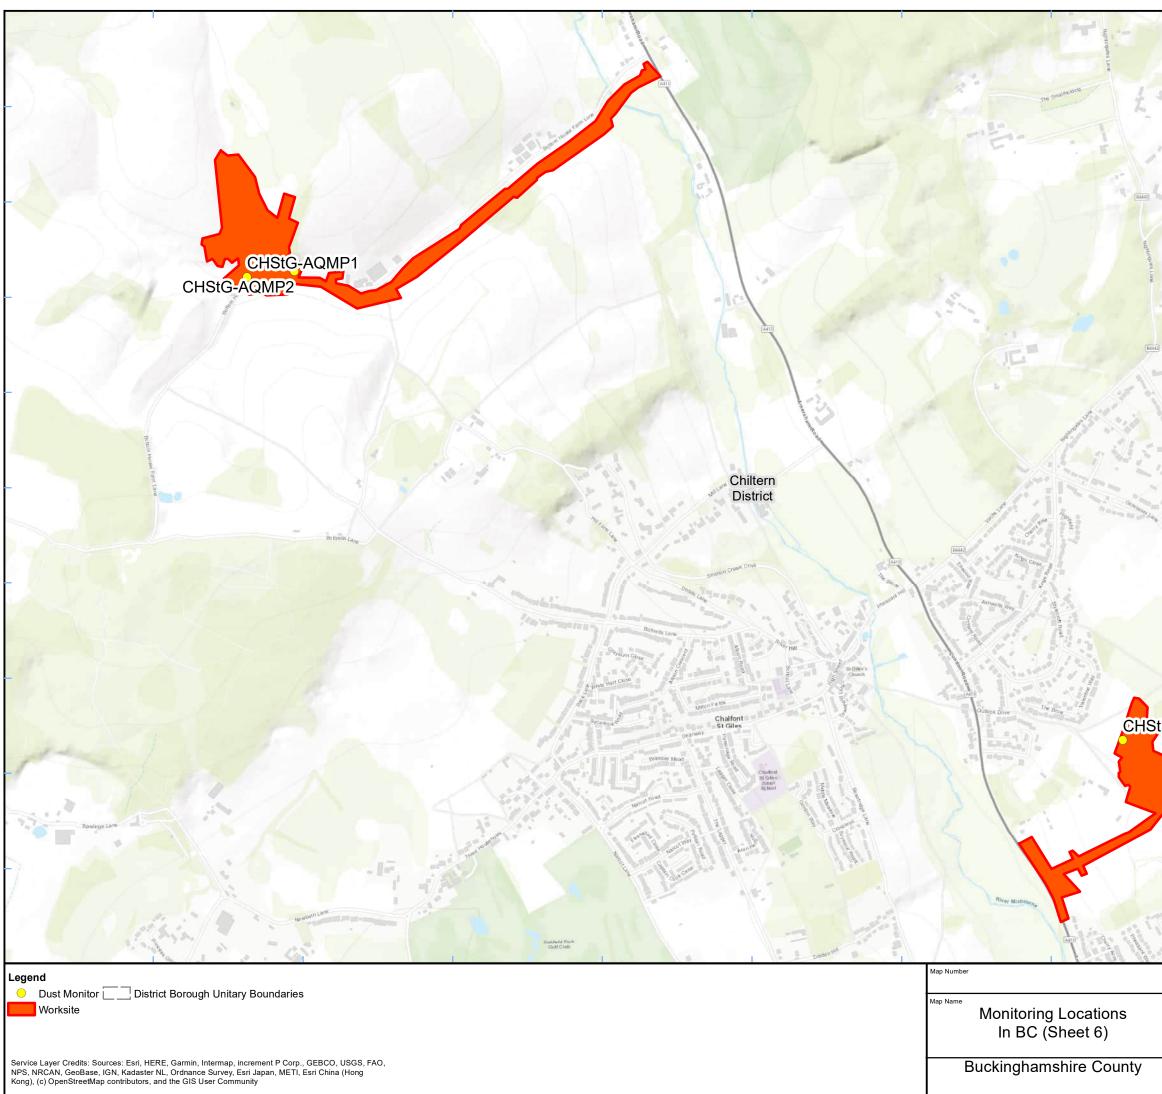
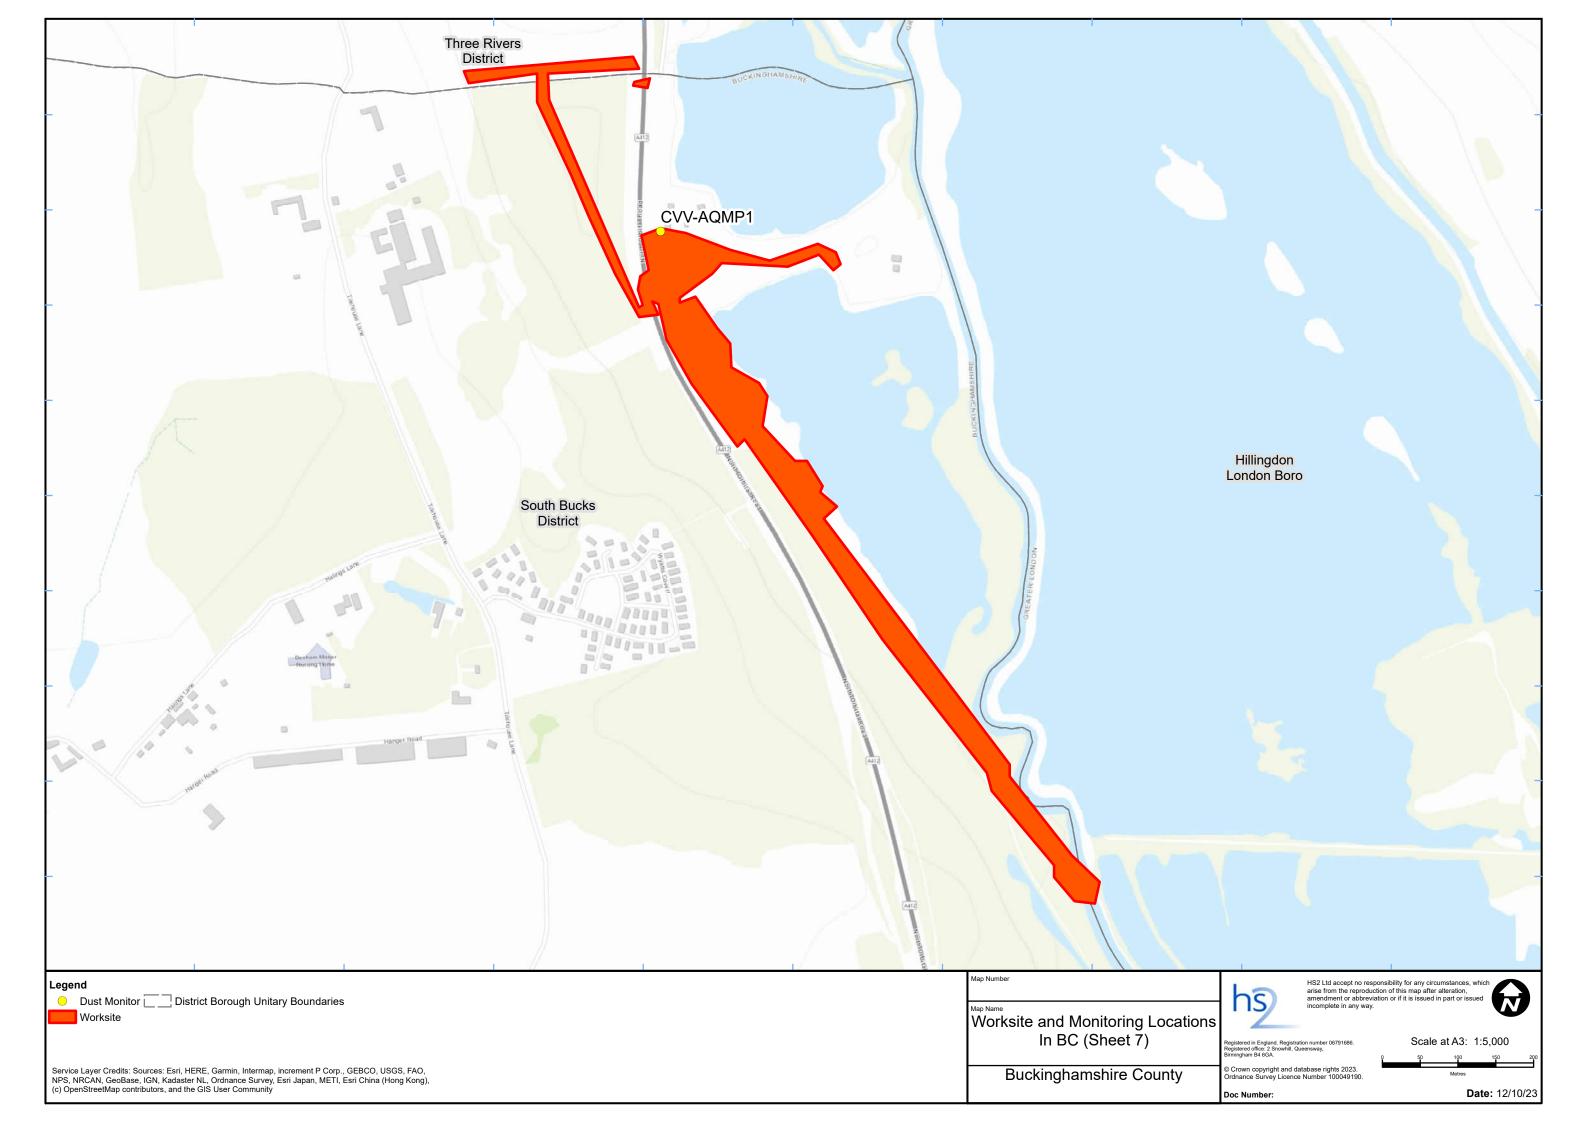
- 1.1.2 Figures 1-7 in Appendix A present the current worksites together with the dust monitoring locations for September 2023.
- 1.1.3 This summary should be read in conjunction with the overview monitoring report available from <u>www.gov.uk/government/collections/monitoring-the-environmental-</u> <u>effects-of-hs2</u>, which highlights the applicable standards and guidance, as well as the air quality and dust monitoring methodologies to be implemented by nominated undertakers throughout construction.

- 1.1.4 The current worksites, as presented in Appendix A, Figures 1-7, include:

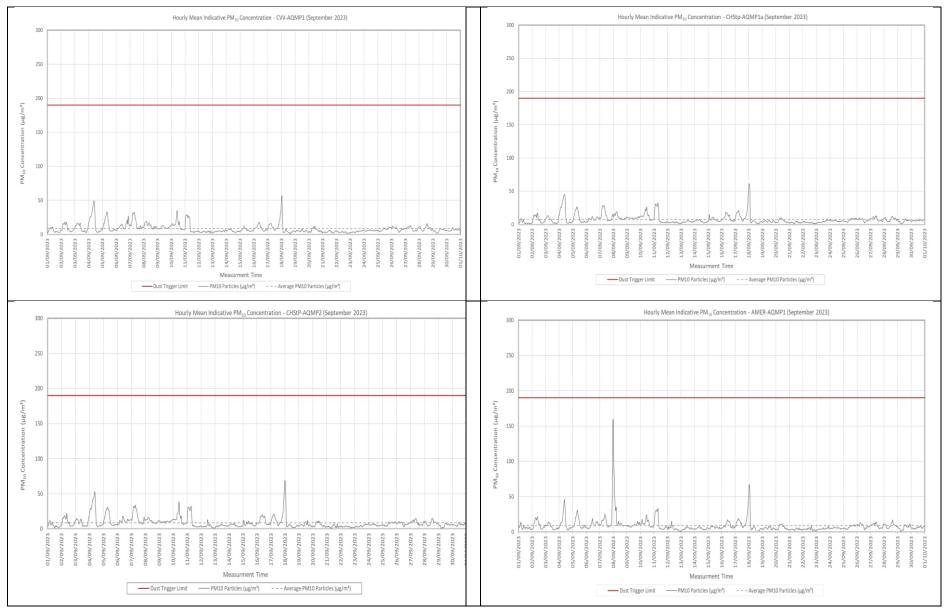
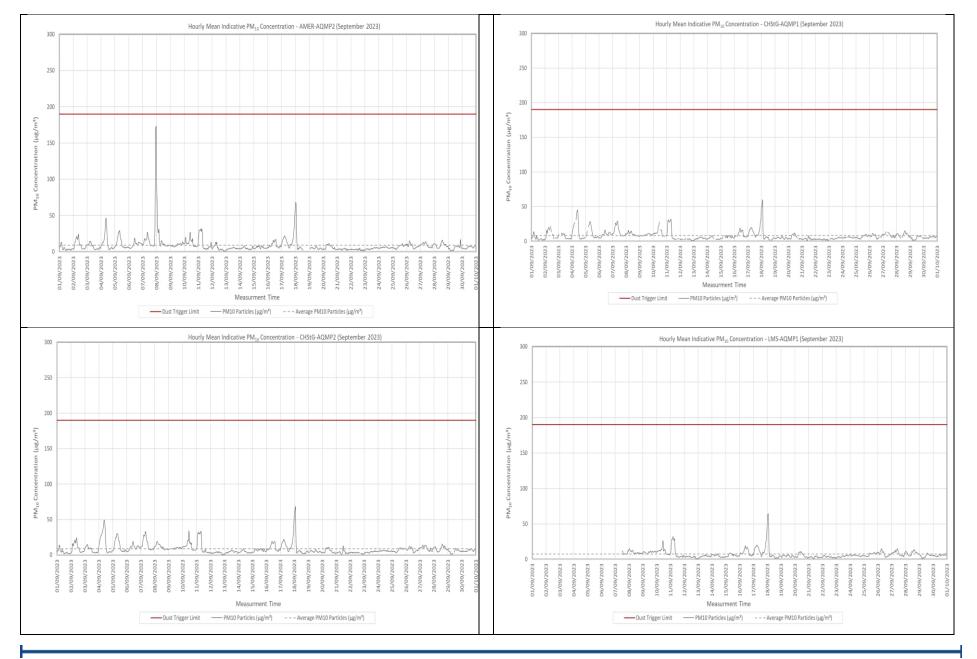
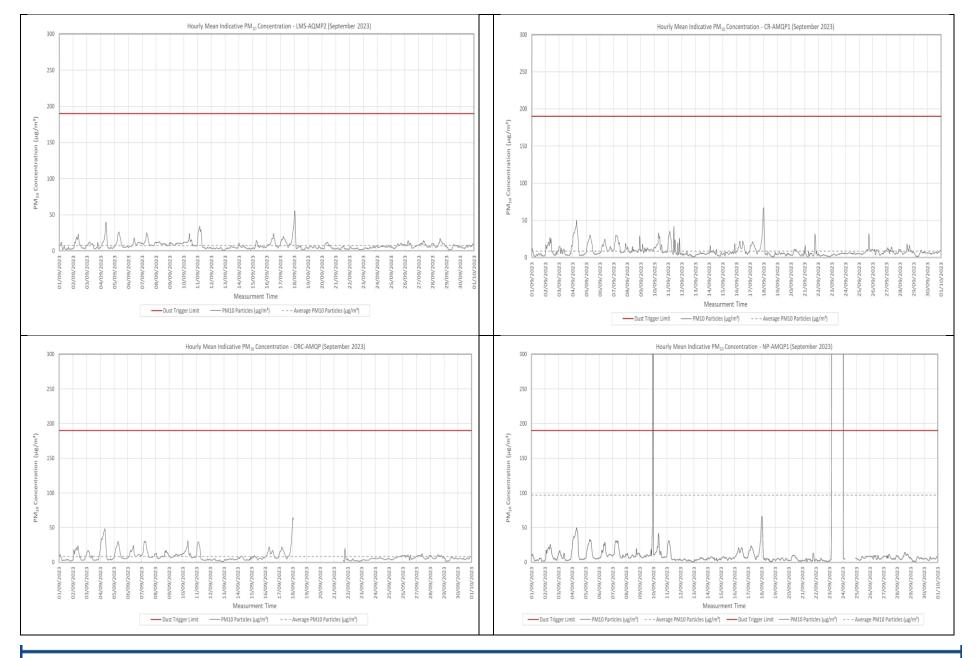
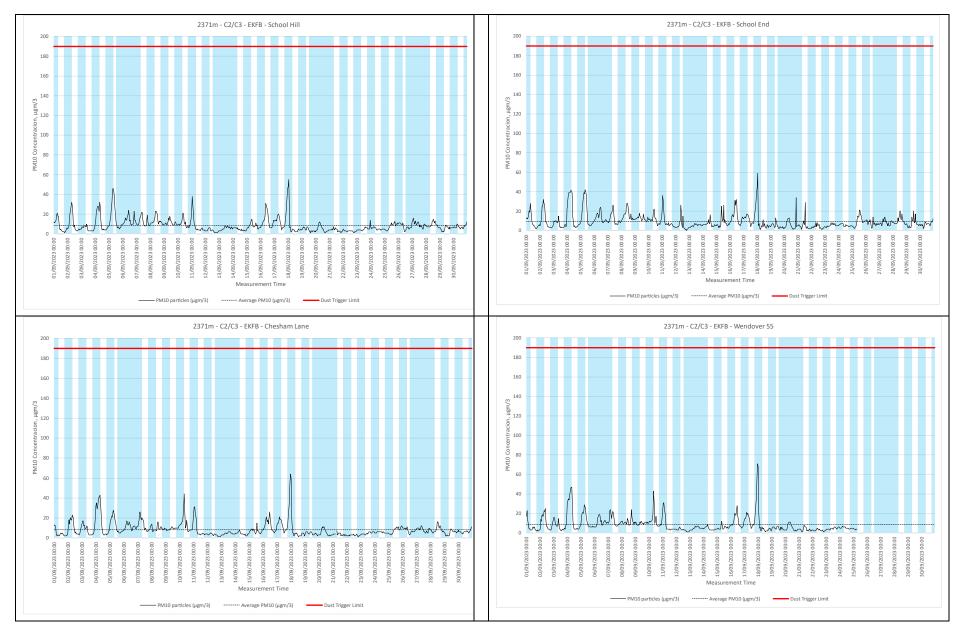
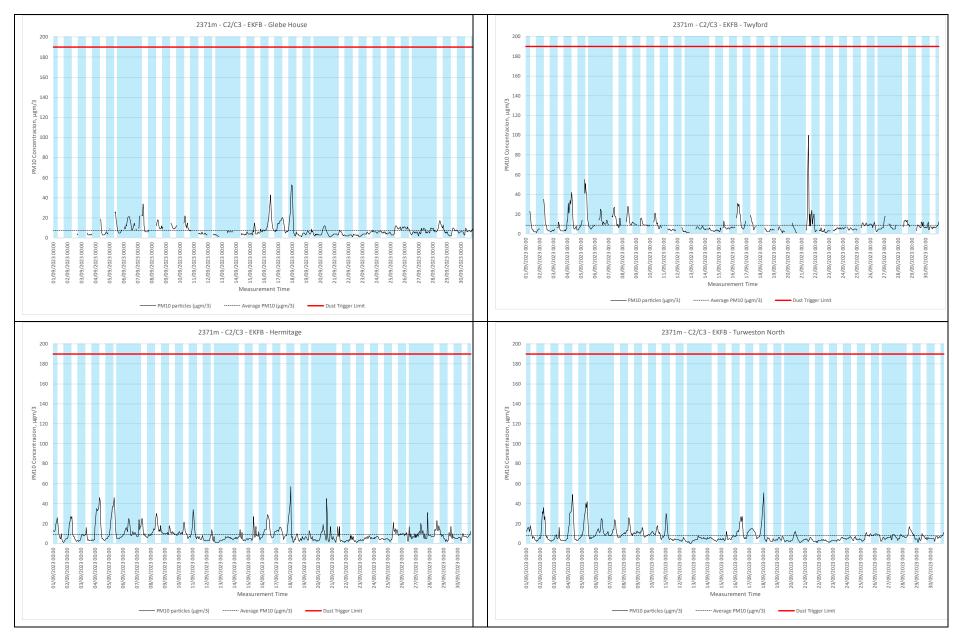
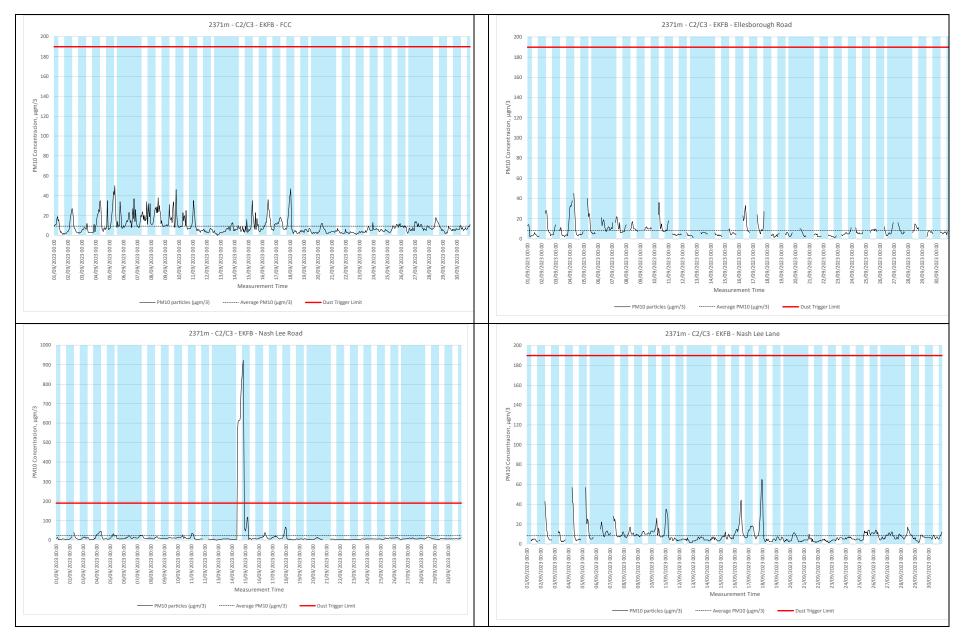
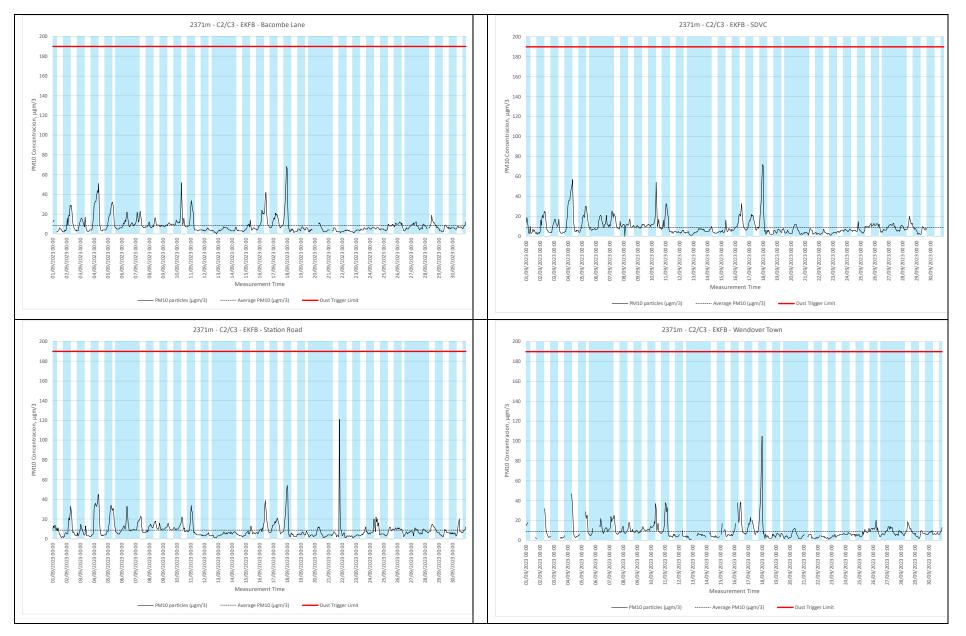
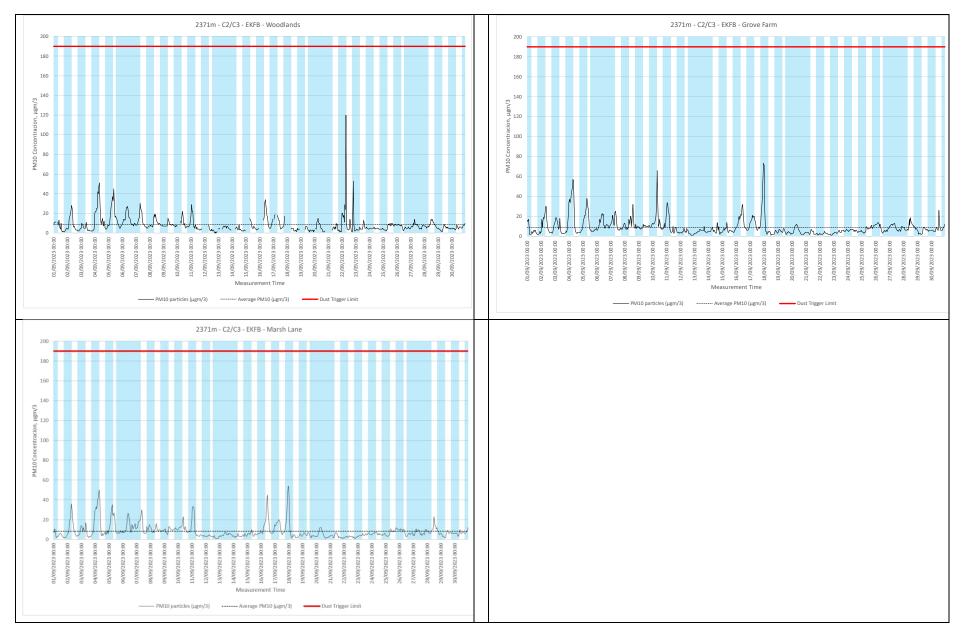
#### Figure 8: Continuous dust 1-hour mean indicative PM<sub>10</sub> concentration for all dust monitors

- 1.1.6 Dust monitoring locations and results for are presented in Appendix B, Table 1, together with a line chart of monthly data from each dust monitor presented in Figure 8. All continuous dust monitoring is undertaken using indicative monitors. Despite being Environment Agency (MCERTS) certified, indicative monitors carry a higher level of uncertainty than reference monitors, and therefore cannot be strictly compared with Air Quality Standards for human health and the environment. The purpose of the monitoring undertaken is to ensure the effectiveness of the on-site mitigation.

- 1.1.7 The trigger level for PM<sub>10</sub> concentrations of 190 μg/m<sup>3</sup>, measured as a 1-hour mean, in accordance with the updated guidance document '*Guidance on Monitoring in the Vicinity of Demolition and Construction Sites (December 2018)*' has been applied.
